# & SE FIELD REPORT

EQUIP. Feed Pump Turbines S/N 126191-92 575 HP

SUBJECT SS Exxon Lexington

FSR 339M1713

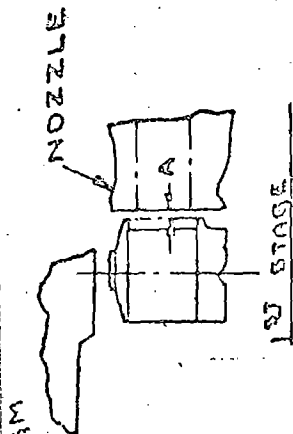
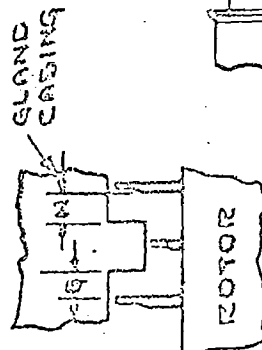
# EXXON LEXINGTON 473-E BEFORE OVERHAUL JULY 1974

BRG. WEAR MIC.

FORD. 3.994

AFT 3.993

| STG | MEAS. | DESIGN |
| 2 | B | .075 .070" |
| 5 | B | .081 .070" |
| 9 | B | .081 .070" |

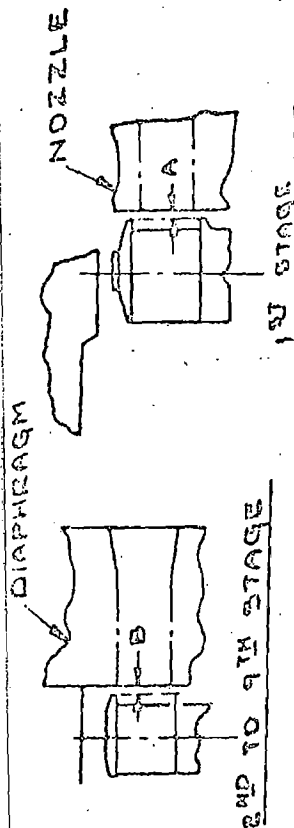
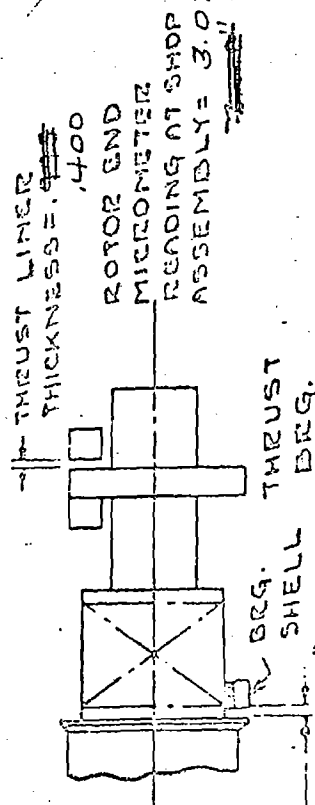
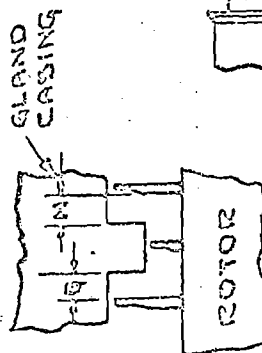
AFTER OVERHAUL

BRG. WEAR MIC  
FORD 3.992  
AFT 3.992

| THRUST CLEARANCE | DESIGN | MEAS. |
| | .000 TO .010 | .008 |

AXIAL CLEARANCES ARE FOR AHEAD  
RUNNING POSITION. ROTOR HARD AFT.  
IN THIS POSITION.  
STAMPED .505  
ACTUAL .506

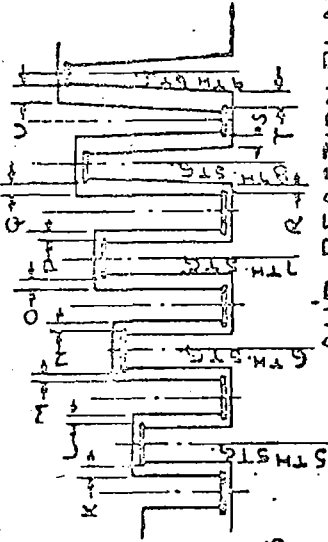
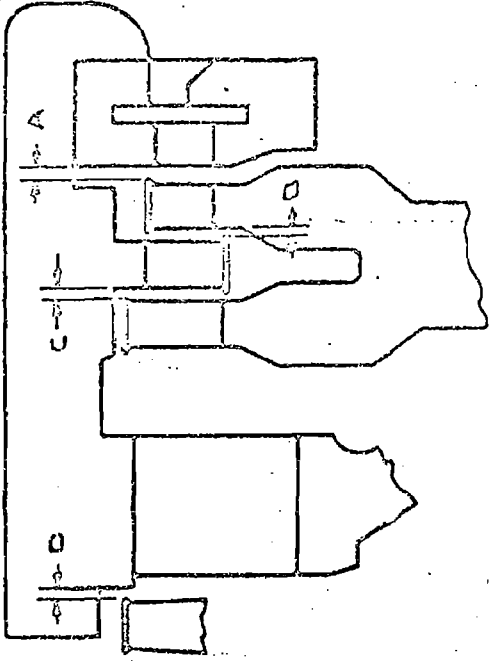
BEFORE OVERHAUL

# ALD. REACTION BLADES

| | MEAS. | DESIGN |
| K | 354 | 314 |

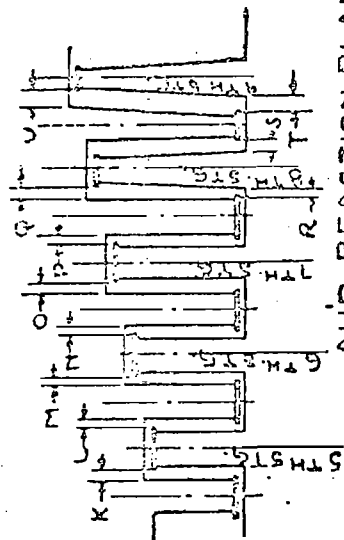
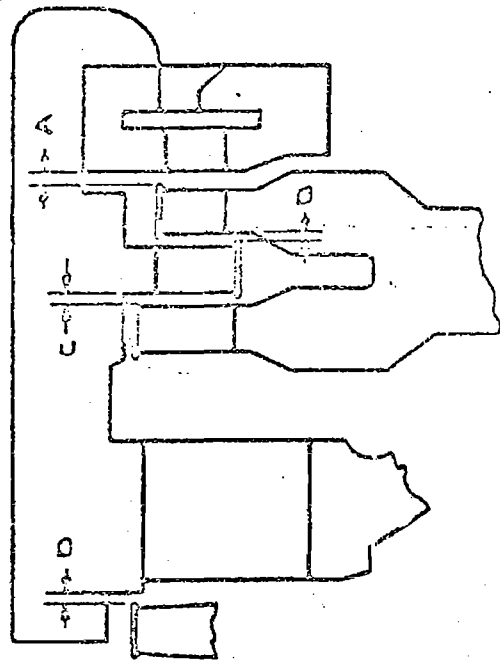
AFTER OVERHAUL

| THRUST CLEARANCE | DESIGN | MEAS. |
| | .012" TO .016" | .012 |

THRUST LINER  
THICKNESS = 1.1145

STAMPED .465 ACTUAL .466  
AIRIAL CLEARANCES ARE FOR AHEAD  
RUNNING POSITION, ROTOR HAND POUND  
IN THIS POSITION.
