**Well Inspection**  
**Osage DNR / Environmental Protection Agency**  
**1201 Elm Street, Suite 500**  
**Dallas, Texas 75270**

| <b>Operator Info</b> | CapturePoint, LLC | <b>Inventory ID</b> OS0751000 | | | |
| | Allen, TX 75013 | <b>Well ID</b> R-W9 | | | |
| <b>Inspection Reason</b> | Plugging Witnessed | <b>Responsible Company at</b> | | CapturePoint, LLC | |

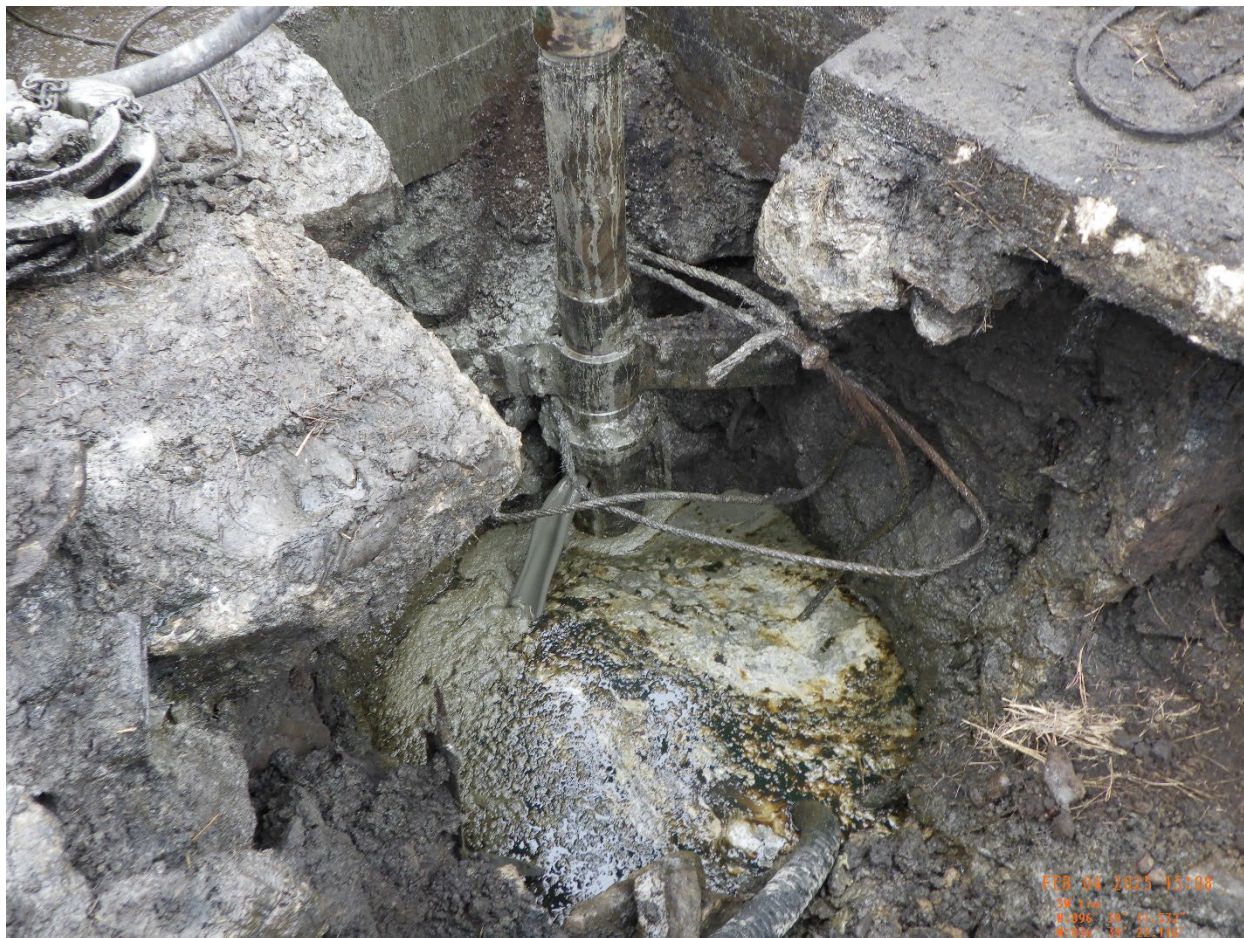
Photo No. 1

**Description:** This was well OS0751000 with cement circulated to surface.
