Clean Water Act (CWA) Inspection Report

| <b>Type of Inspection</b> | CEI - Compliance Evaluation Inspection | | | |
| <b>Permittee Name</b> | Hamilton Excavating, LLC | | | |
| <b>Facility or Site Name</b> | Highland Terrace | | | |

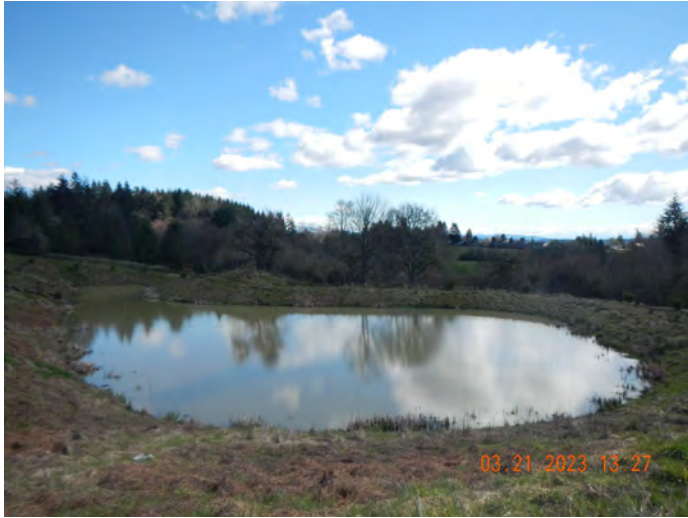
Photo #:01 (DSCN3180)

| We first observed the stormwater collection pond ( <b>Photo 1</b> ). Mr. Hamilton explained that the pond was engineered with a 10-foot wall that stretches across the length of the pond, separating it into two sub-basins to promote settling. It was discussed that the pond's intake piping is fairly low within the pond which seems to result in additional turbidity as inflow agitates previous settled solids on occasion. The pond slopes were observed to be well vegetated, we discussed that we would tour the pond's outfall and sample location at the end the walk-through, as it's only accessible from NW Pacific Highway. |

Description: Facing southeast, photo of the project's stormwater pond.

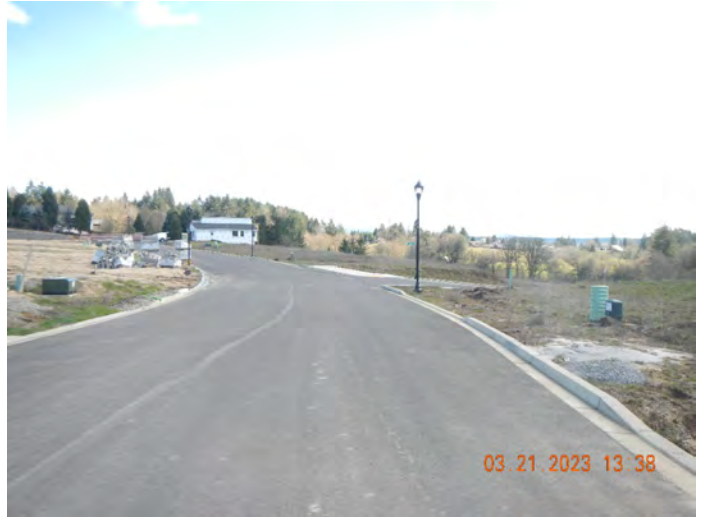
Photo #:02 (DSCN3181)

| At the time of our walk-through northwest of the stormwater pond along NW 15 <sup>th</sup> Street, we observed a small concrete washout pile just past the curb on the south end of NW 15 <sup>th</sup> Street ( <b>Photo 2</b> ). It was discussed that at the |

current stage of the project there was no dedicated concrete washout area. We discussed generally the permit requirements regarding concrete washout. Disturbed areas in within the southeast construction areas appeared to be well vegetated/stabilized and the roadway was generally free of sediment and debris (**Photo 3 & Photo 4**).

At the time of inspection during the walk-through, we observed and discussed three separate concrete washout piles within the construction areas. One concrete washout pile was located on the south end of the NW 15<sup>th</sup> Street (**Photo 2**), and two concrete washout piles were located near a homebuilder lot (lot #45) (**Photo 6 & Photo 7**). At the time of inspection, it was discussed that the Project did not have a designated concrete washout area. The concern is that these instances of concrete washout was not disposed of in a designated or formed area as required by the CGP.

Description: Facing east, photo of the southeast access road, northwest of the stormwater pond. Small pile of concrete washout observed on the south end of NW 15<sup>th</sup>.

At the time of inspection during the closing conference, Mr. Hamilton stated he would address the concern by removing the washout piles. On March 29, 2022, I received an email from Mr. Hamilton stating that “we have taken care of all the issues that we spoke of to include concrete wash out.” See **Attachment D**, Post Inspection Correspondence.

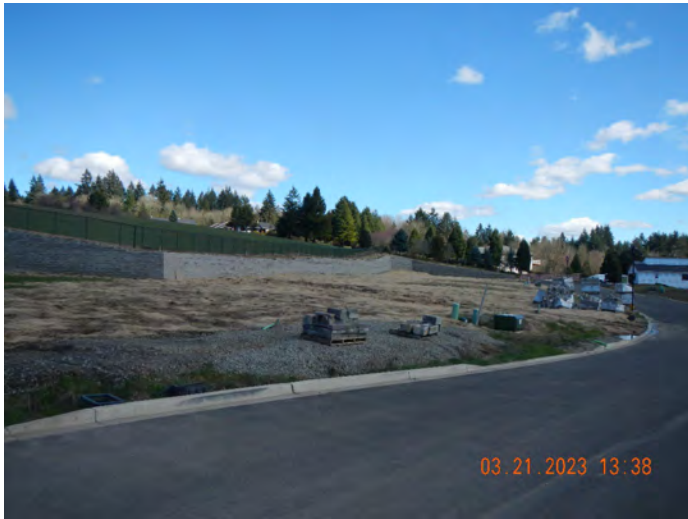
Photo #:03 (DSCN3182)

Description: Facing east, photo of the area north of NW 15th and straw application on disturbed areas.

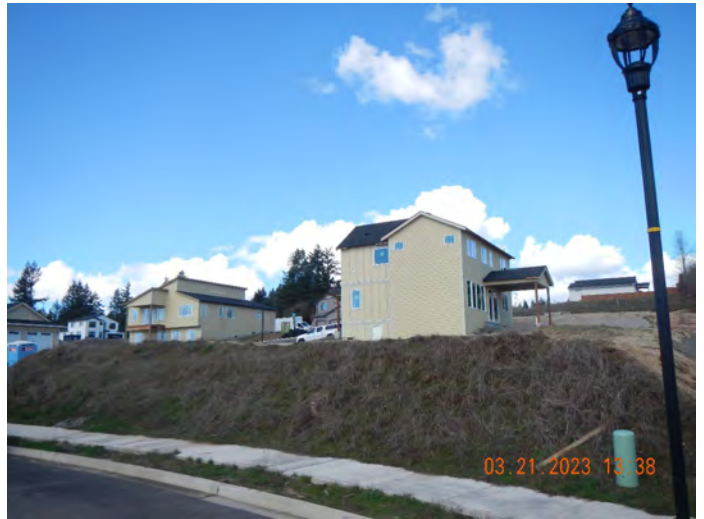
Photo #:04 (DSCN3183)

Description: Facing north, photo of the southern portion of the development north of NW 15th.

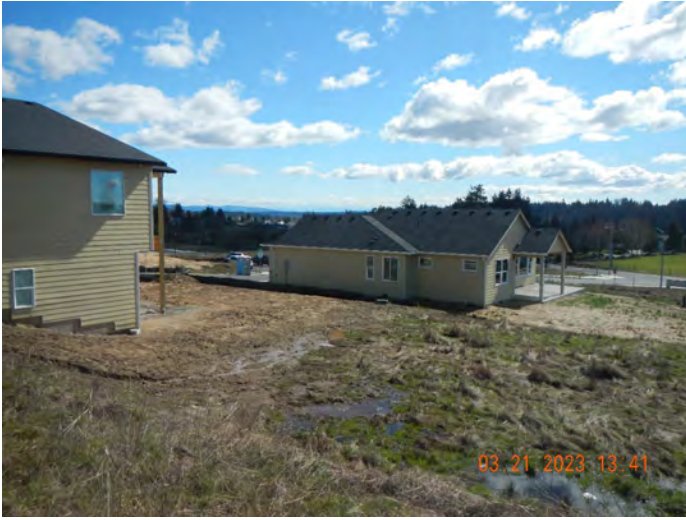
Photo #:05 (DSCN3184)

We continued the tour west within Phase 1 areas, we observed a housing lot under construction at or near lot #45. We observed a hose connected to the partially constructed house's outdoor spigot; homebuilders/contractors were on-site working within the partially constructed home. It appeared the hose had a poor connection as we observed water leaking from the spigot, downslope within the lot. The water was causing some channeled erosion below the home, within an unstabilized area of the lot (**Photo 5**). Mr. Besteman notified the homebuilders/contractors of the concern. We also observed a concrete washout pile at or near lot #45 and a second concrete washout pile across the street from lot #45 (**Photo 6 & Photo 7**).

At the time of inspection during our walk-through, we observed numerous areas of unstabilized soils. Specifically, in the southwest construction areas below lot #45 (**Photo 5**), areas near lot #40, #41 (**Photo 8 & Photo 17**), lot #52 (**Photo 9**) and areas within Phase 2 (**Photo 11, Photo 13 & Photo 16**). According to Mr. Hamilton, he was last on-site approximately one week prior to the inspection, he removed a stockpile that was within the upper portion of the Project, within Phase 2. The concern is the number of exposed construction areas being unstabilized/unworked for a period over 2 days, when compared to the language in the CGP.

Description: Facing south, photo of unstabilized south and southwest areas near lot #45. Water observed leaking from the outdoor spigot and channeling downslope.

At the time of inspection during the closing conference, Mr. Hamilton stated he would address the concern. On March 29, 2022, I received an email from Mr. Hamilton stating that “we have taken care of all the issues that we spoke of to include concrete wash out.” See **Attachment D**, Post Inspection Correspondence.

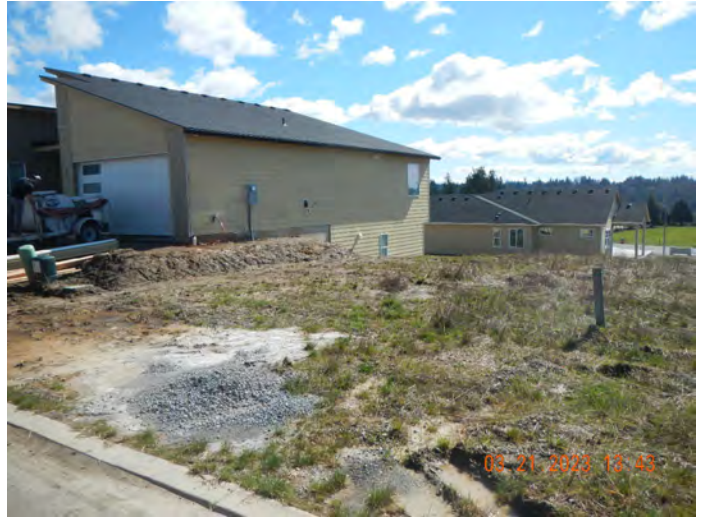
Photo #:06 (DSCN3185)

Description: Facing southeast, photo of concrete washout observed near lot #45.

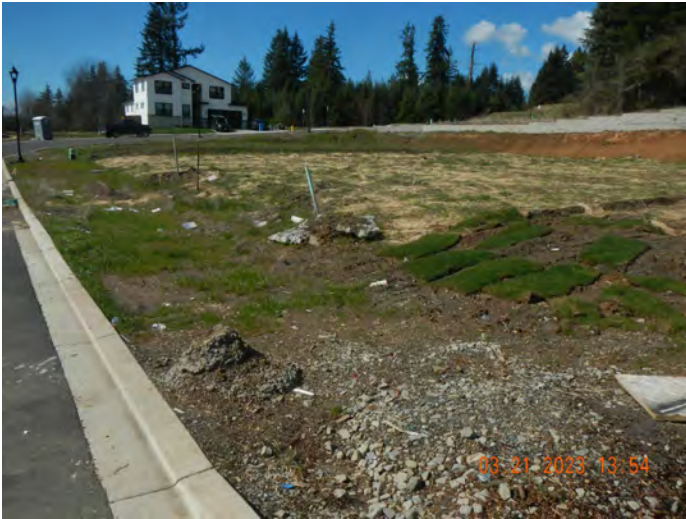
Photo #:07 (DSCN3187)

Description: Facing west, concrete washout observed across the street from lot #45.

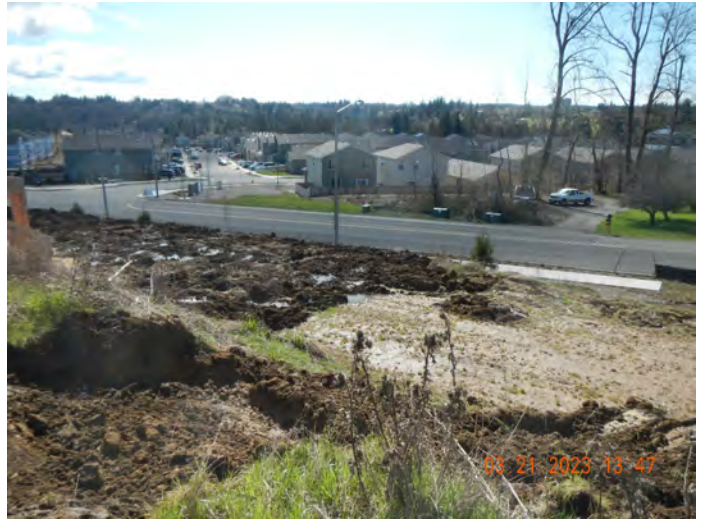
Photo #:08 (DSCN3186)

To the west of housing lot #45, we observed unstabilized areas at or near lot #40 and #41 (**Photo 8**). It appeared both housing lots had been cleared for vertical construction, no stormwater BMPs were observed within the two lots. Downslope of this area was only a small vegetative area north of NW Pacific Highway.

Description: Facing south, photo of disturbed areas within lot #40 and #41.

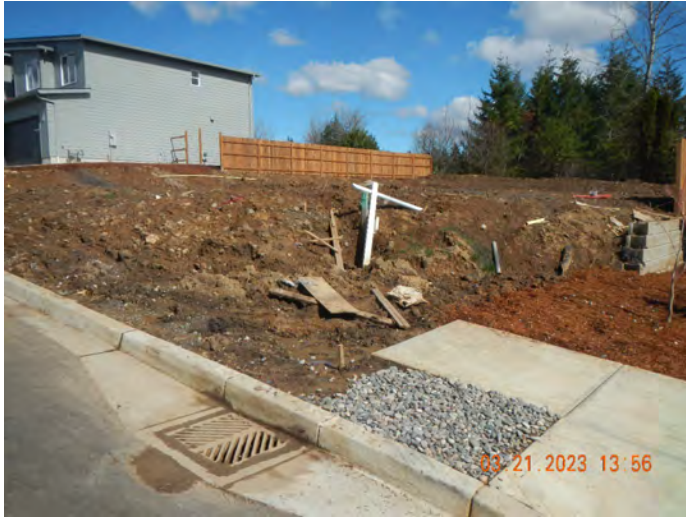
We continued the walk-through to north, along the main access road toward the southern areas of Phase 2. We observed unstabilized areas at or near lot #52, near a roadside catch basin (**Photo 9**). It appeared the lot had been cleared for vertical construction, no stormwater BMPs were observed within the cleared area. Catch basin inserts were installed within roadside catch basins.

Photo #:09 (DSCN3188)  
Description: Facing northeast, photo of unstabilized lot (lot #52).

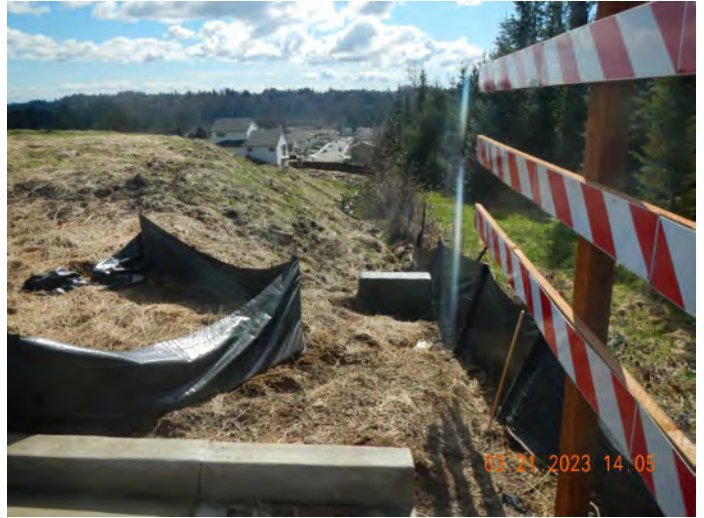
We continued north and observed the northwest perimeter of Phase 1. Disturbed areas appeared to be well vegetated/stabilized with hydroseed and/or straw mulch, silt fencing extended along the western perimeter (**Photo 10**). One section of perimeter silt fencing appeared to be in need maintenance.

Specifically, one area of silt fencing along the northwest perimeter of Phase 1 was observed to have deposited material above one-third the height of the silt fence. Two sections of silt fencing along in the northeast corner of Phase 2 were observed to need maintenance, as one section was down, and another had eroded beneath the fence allowing for pass-through (**Photo 12**). It was also observed that silt fencing was not extended fully to the northern perimeter along the northwest corner of Phase 2 (**Photo 14**). The concern is the BMP in need of maintenance based upon the written standard.

Photo #:10 (DSCN3189)  
Description: Facing south, photo of western perimeter within Phase 1.

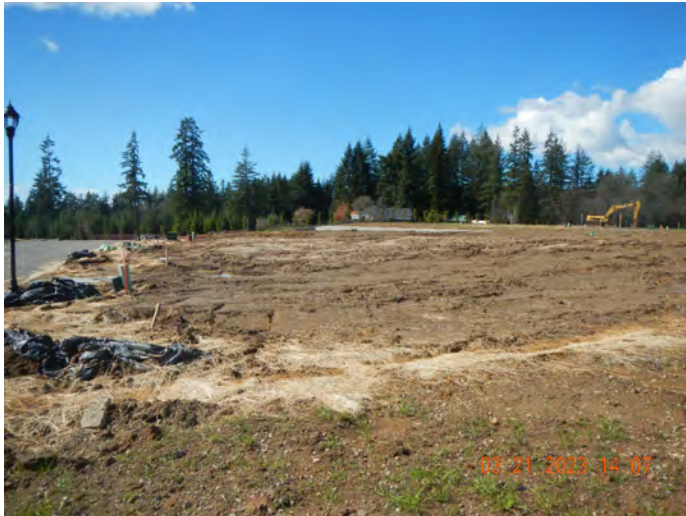
We continued the walk-through to Phase 2. We observed unstabilized areas generally throughout the southern areas Phase 2 (**Photo 11**). Mr. Hamilton discussed that within Phase 2, a covered stockpile was removed the week prior by Hamilton Excavating LLC. We also observed some straw bales staged near the southern perimeter of Phase 2.

Photo #:11 (DSCN3190)  
Description: Facing west, photo of unstabilized areas within Phase 2. According to Mr. Hamilton, the stockpile was removed within the area the week prior.

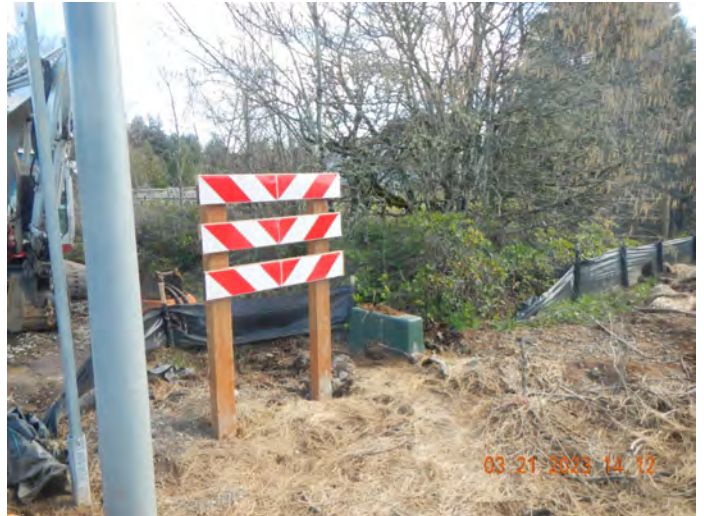
We continued to northeast corner of Phase 2, we observed straw mulch and silt fencing as BMPs within this area. Two sections of silt fencing were observed to be in need of maintenance, one section of silt fencing was down, and another had eroded beneath the fence allowing for pass-through (**Photo 12**). Adjacent areas within the northeast corner of Phase 2 were observed to be unstabilized (**Photo 13**).

Photo #:12 (DSCN3191)  
Description: Facing east, photo of the northeast corner of Phase 2. Silt fencing in need of repair.

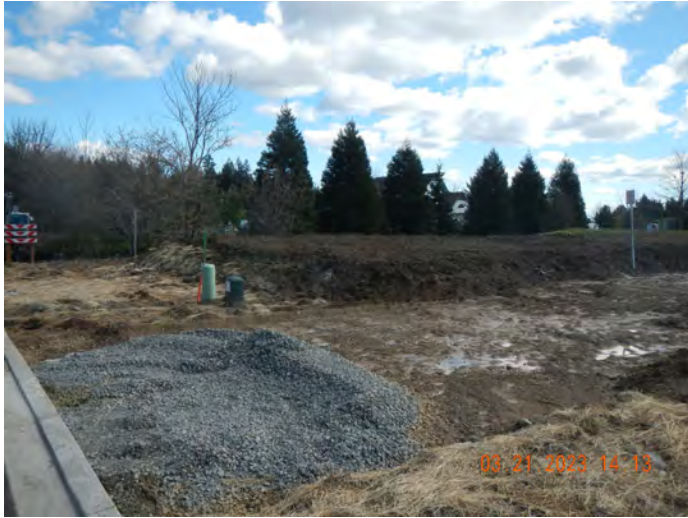
Photo #:13 (DSCN3192)  
Description: Facing east, photo of disturbed areas within the northeast corner of Phase 2.

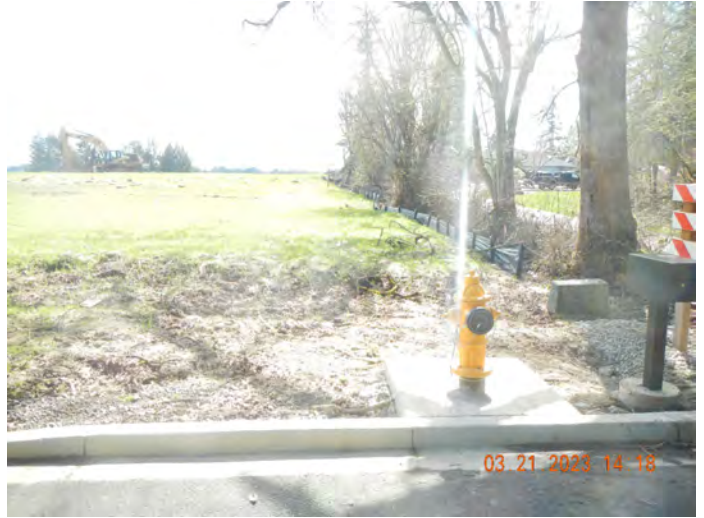
We continued west and observed silt fencing and hydroseeded areas within the northwest corner of Phase 2 (**Photo 14 & Photo 15**). Northwest areas appeared to be well vegetated/stabilized with hydroseed. Silt fencing did not extend the full length of the property boundary.

Photo #:14 (DSCN3193)  
Description: Facing south, photo of the northwest corner of Phase 2. Silt fencing was observed to be not extended to the corner.

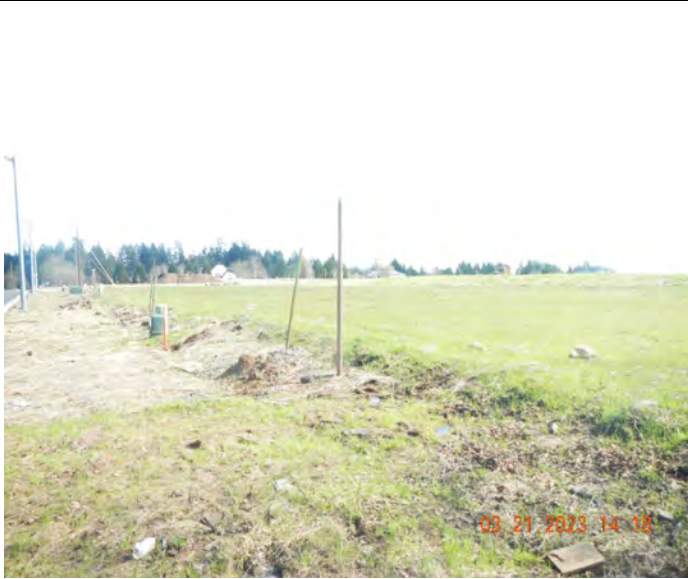
Photo #:15 (DSCN3194)  
Description: Facing east, photo of the north end of Phase 2. Photo taken from the northwest corner.

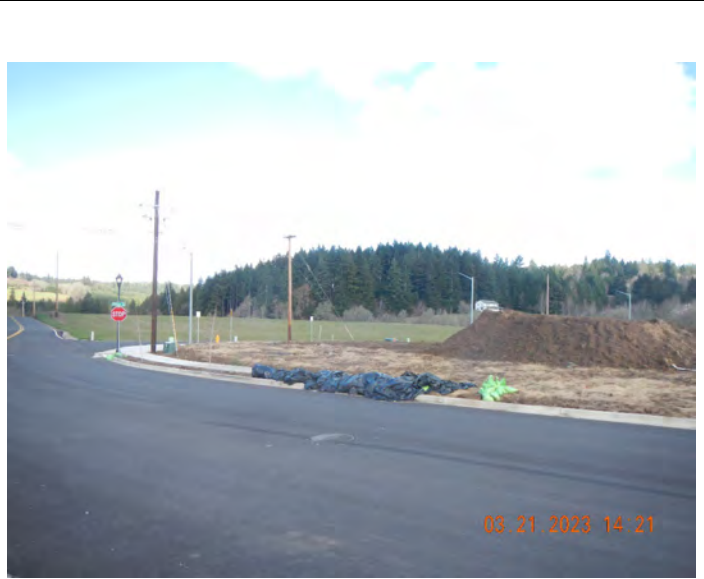
The walk-through continued back east to the northern areas of Phase 2, along Bolen Street and the development's main access road. An uncovered/unstabilized stockpile was observed within this northern area of Phase 2, areas around the stockpile were also unstabilized (**Photo 16**).

At the time of inspection, during our walk through within the northeastern area of Phase 2, we observed/discussed an uncovered stockpile (**Photo 16**). According to Mr. Hamilton, he was last on-site approximately one week prior to the inspection, he removed a stockpile that was within the upper portion of the Project, within Phase 2. The concern is the unstabilized stockpile being unstabilized/unworked for a period over 2 days, when compared to the language in the CGP.

Photo #:16 (DSCN3195)  
Description: Facing north, photo of stockpile located in the northeast corner of Phase 2, near Bolen Street.

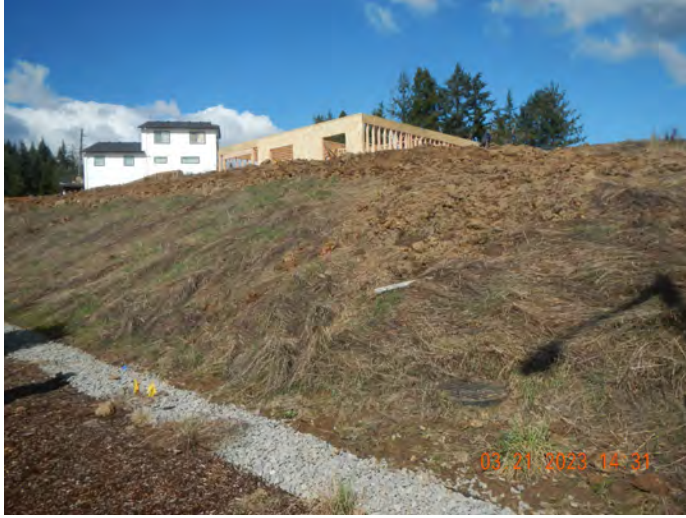
We returned to the southwest area of Phase 1 to view the area(s) below housing lots #40 and #41 (previously observed in Observation #OB-04). We observed a curtain drain installed to capture and route stormwater off the hillside (between the housing lots and NW Pacific Highway) to the stormwater pond (**Photo 17 & Photo 18**). It was observed that a small trench/channel was dug from one of the above housing lots to connect to the curtain drain and/or stormwater manhole. Based on our observations, the trench was likely constructed to drain ponded stormwater from the above lot. Mr. Hamilton stated that he was previously unaware of the small trench and assumed it was likely the work of a contractor associated with the homebuilder.

Photo #:17 (DSCN3196)  
Description: Facing northeast, photo from below lot #40 and lot #41. Exposed soil observed along the southern slope and without perimeter BMPs.

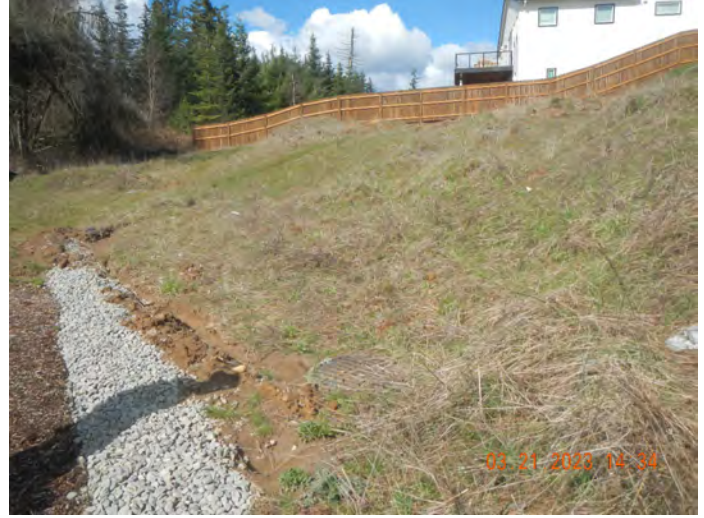
At the time of inspection during our walk-through of the unstabilized areas south of lot # 40 and #41, we observed that a small trench/channel had been dug from one of the above housing lots to connect to the curtain drain and/or stormwater manhole. Based on our observations, the trench was likely constructed to drain ponded stormwater from the above lot (**Photo 17 & Photo 18**). The concern is the unstabilized channel directing stormwater directly to the curtain drain and/or stormwater manhole within out any additional BMPs. Mr. Hamilton stated that he was previously unaware of the small trench and assumed it was likely the work of a contractor associated with the homebuilder.

Photo #:18 (DSCN3197)  
Description: Facing west, photo of channeled drainage entering a constructed trench drain along the southwest perimeter of Phase 1.

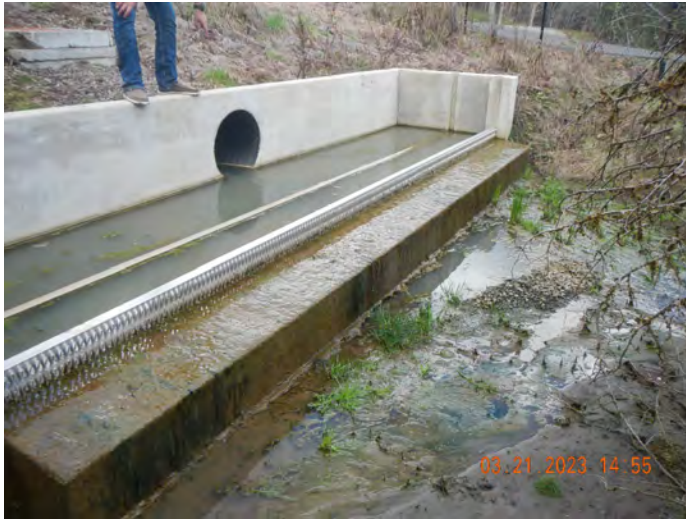
Following our walk-through of the construction areas, we observed the stormwater pond outfall area and associated headwall (**Photo 19 & Photo 20**). The pond was discharging at the time of inspection. According to Mr. Hamilton, stormwater samples for permit compliance are collected at this location by Ms. Paris. We observed the discharge entering a heavily vegetative/wetland area. According to Mr. Hamilton, the discharge is conveyed from this location to Jenny Creek located just east of the project. Following the closing conference, we briefly observed Jenny Creek from NW Pacific Highway.

Photo #:19 (DSCN3198)  
Description: Facing northeast, photo of the constructed outfall from the stormwater pond to a tributary of Jenny Creek.

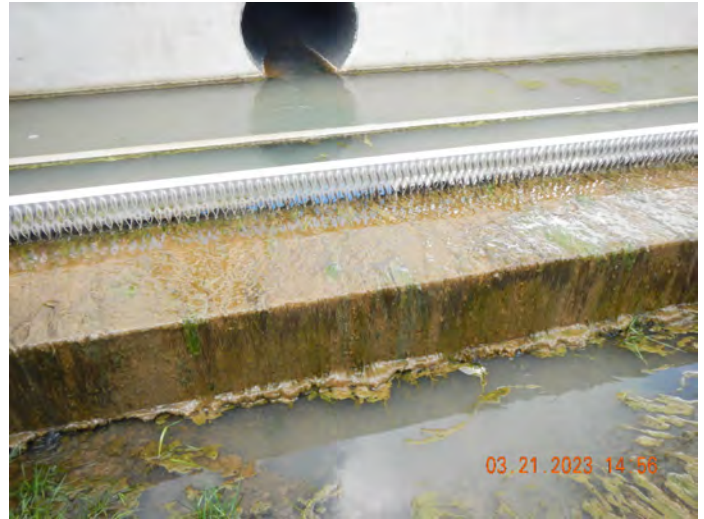
Photo #:20 (DSCN3199)  
Description: Facing north, photo of the constructed outfall from the stormwater pond to a tributary of Jenny Creek.
