**Well Inspection**  
**Osage DNR / Environmental Protection Agency**  
**1201 Elm Street, Suite 500**  
**Dallas, Texas 75270**

| <b>Operator Info</b> | CapturePoint, LLC | <b>Inventory ID</b> OS6273034 | | | |
| | Allen, TX 75013 | <b>Well ID</b> 15-W21 | | | |
| <b>Inspection Reason</b> | Plugging Witnessed | <b>Responsible Company at Time of Inspection</b> | | CapturePoint, LLC | |

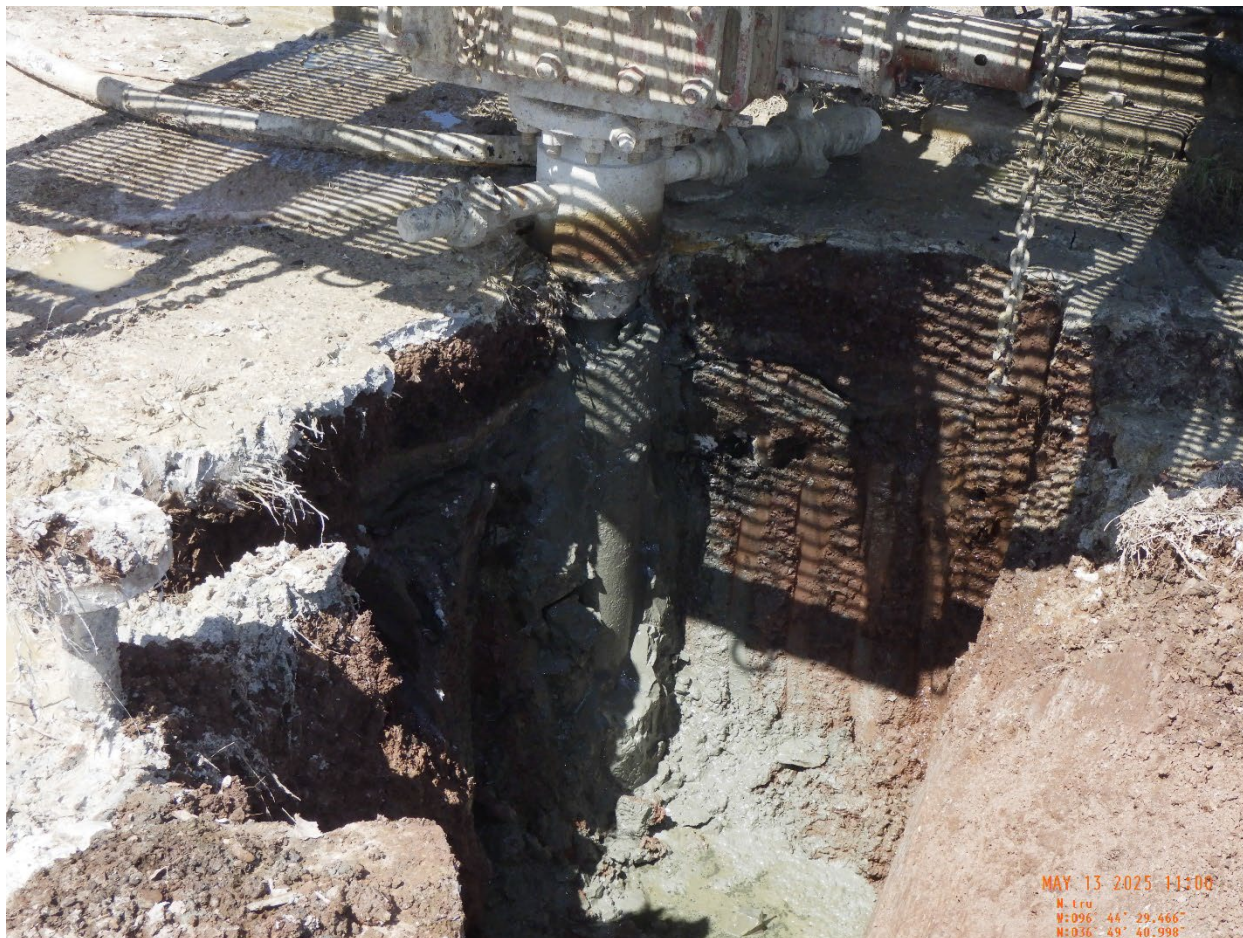
Photo No. 1

**Description:** This was well OS6273034 with cement circulated to the surface.
