**Region 6 Compliance Assurance and Enforcement Division  
INSPECTION REPORT**

| Inspection Date(s): | 10/18/2017 | | |
| Facility Name: | [REDACTED] | | |
| Identification/Permit Number: | LAU000475 | | |

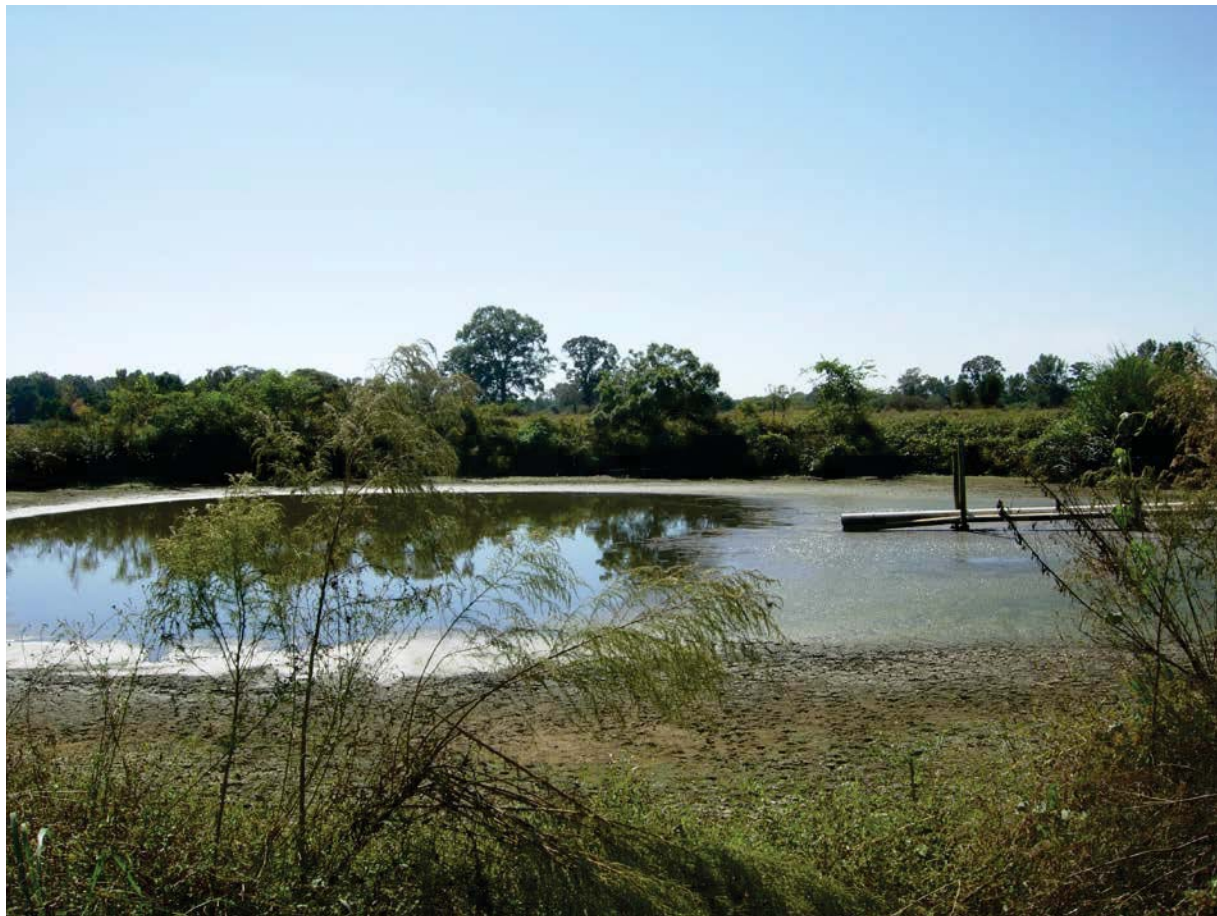
Photo No. 1

Upon our inspection of the RCS, we observed a buildup of solids within the lagoon and that trees and woody vegetation were growing on the embankments (Appendix 1, Photo 1).

- There was a buildup of solids within the RCS
- Trees and woody vegetation were growing on the embankments
- Mortalities were mixed in with other waste

Description: Photo taken facing south across RCS. Note the accumulated solids and woody vegetation rooted within berm.
