PHOTO LOG

| Facility Name: | Gloster Forest Products CSW |
| EPA Media: | Stormwater - Industrial |

| Date Stamp: | 3/6/2024 |

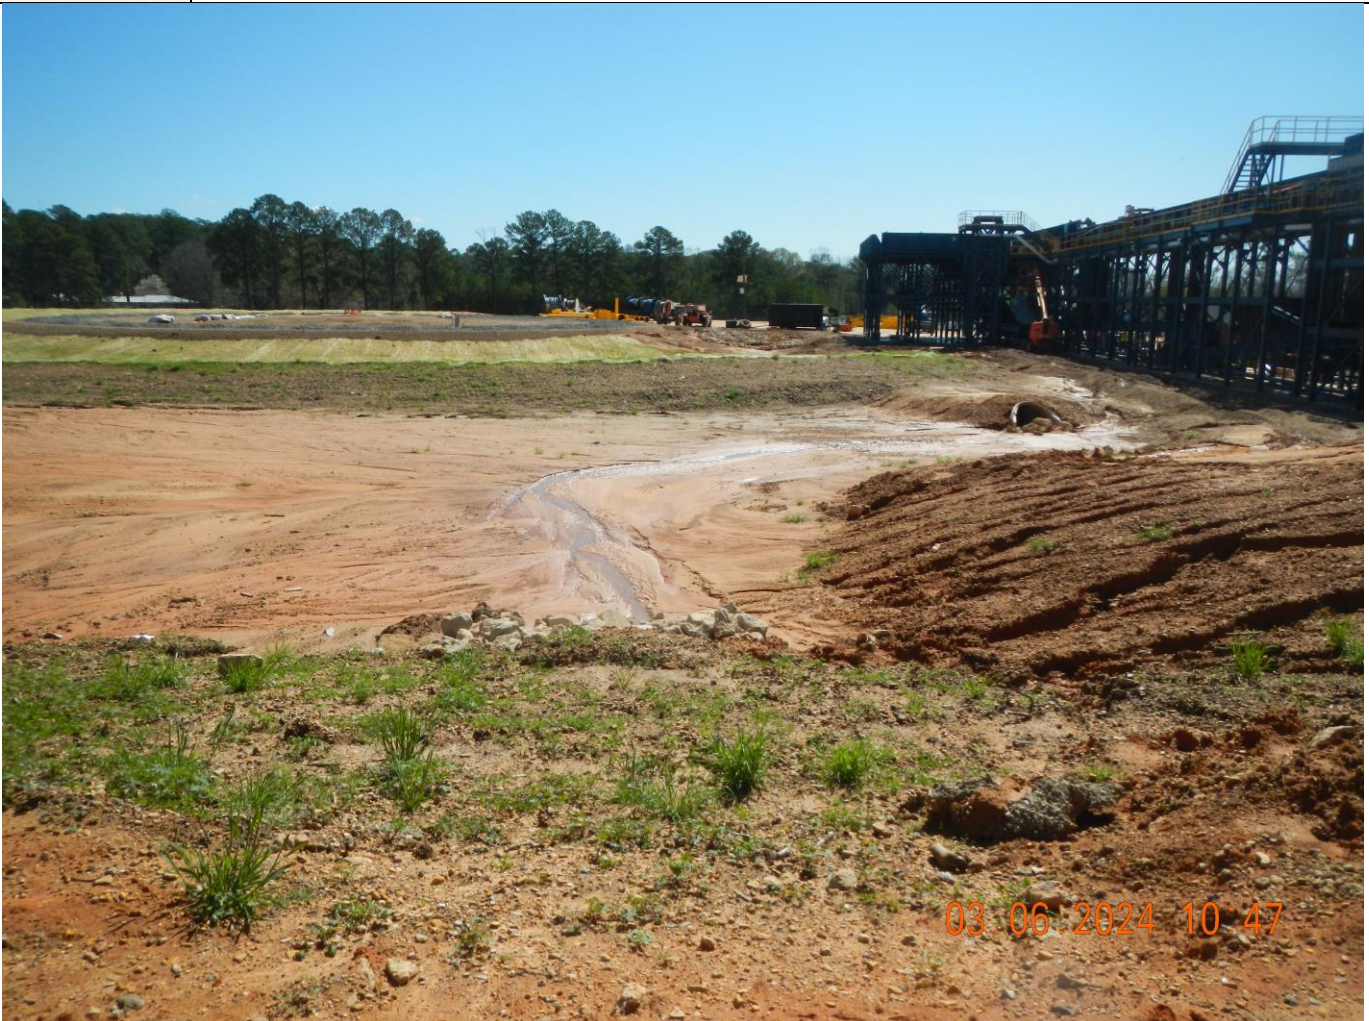
| <b>Description:</b> | The processing plant's internal drainage system was installed at the time of the inspection. This drainage system outlets into this swale and is conveyed in the direction shown here, where it connects to the drainage system of one of the radial cranes. As shown on the right hand side of the photo, the slopes of the swale were not stabilized, and erosion rills had formed. Facility personnel said that they are considering erosion mats for these slopes. |

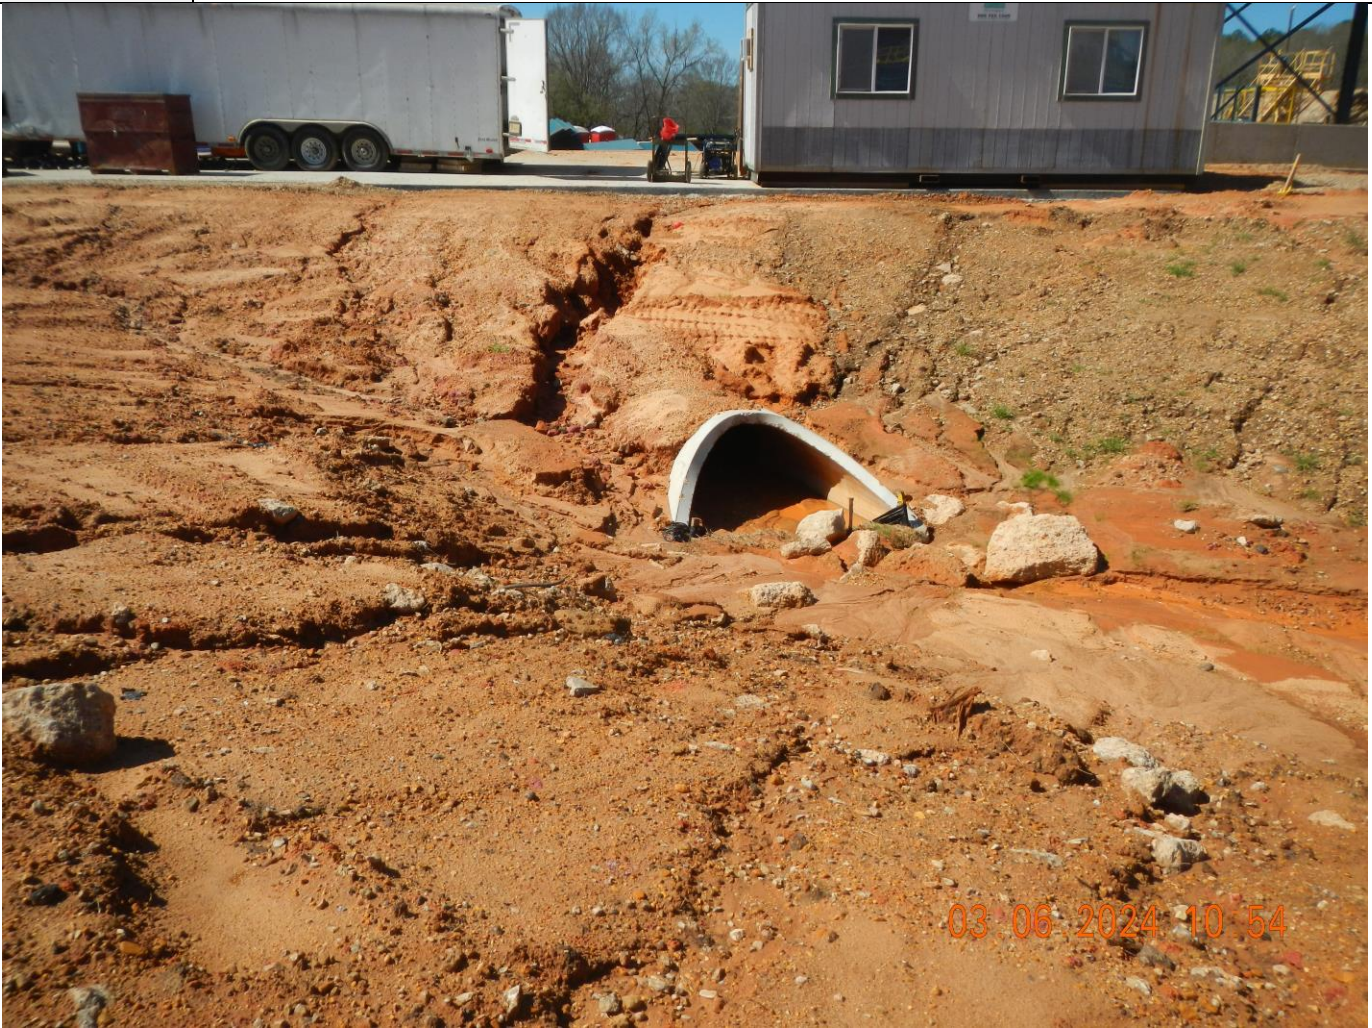
| <b>Photo ID:</b> | DSCN2922.JPG |

| <b>Description:</b> | Looking downgradient at the culvert of a drainage swale on the southwestern side of the site. Rills have formed in surrounding area. See photo DSCN2923. |

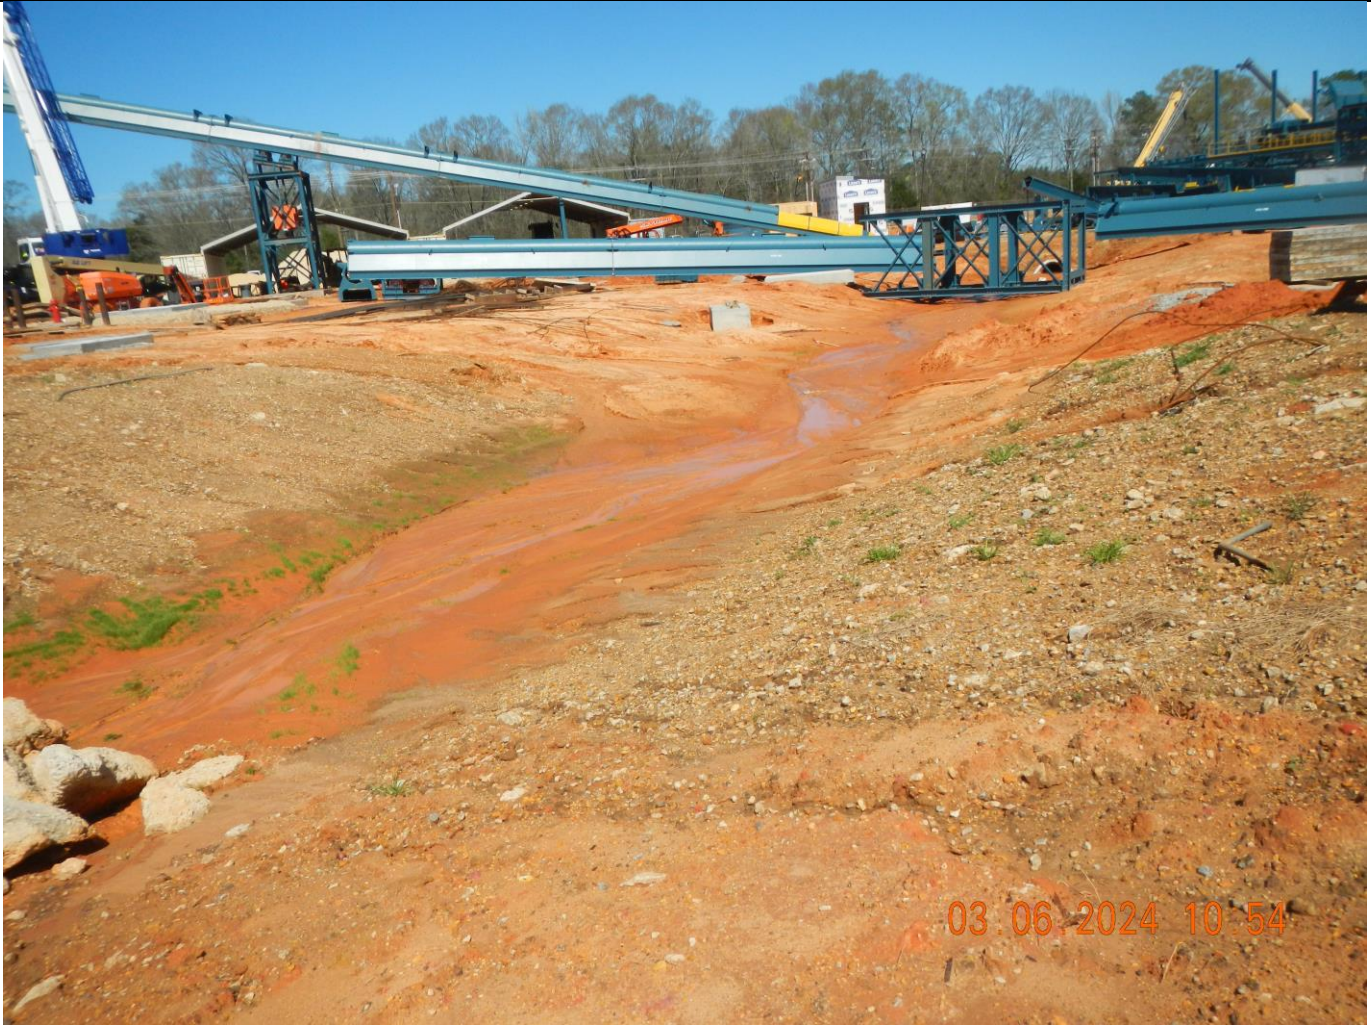
| <b>Photo ID:</b> | DSCN2923.JPG |

| <b>Description:</b> | Upgradient view of a drainage swale. Swale drains into the inlet shown in photo DSCN2922. Water collected by this drainage system is conveyed into the detention area shown in photo DSCN2924. |

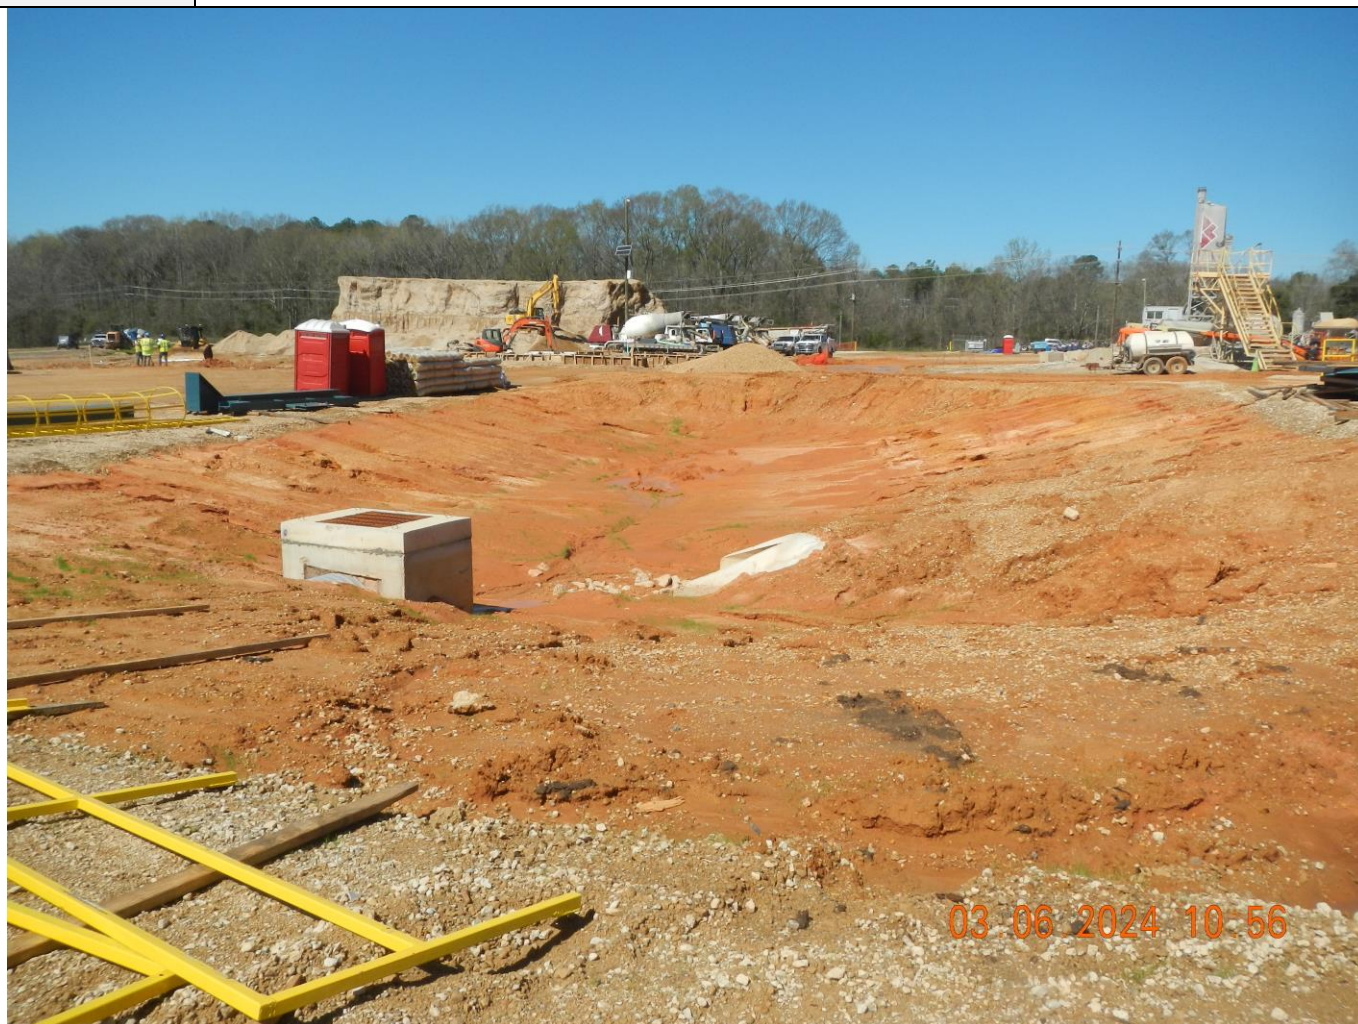
| <b>Description:</b> | The swale shown in photo DSCN2923 eventually outlets into this retention area via the pipe near the center-right of the photo. According to facility personnel, this basin was installed last September. The basin's outlet structure discharges into the channel shown in photo DSCN2925. |

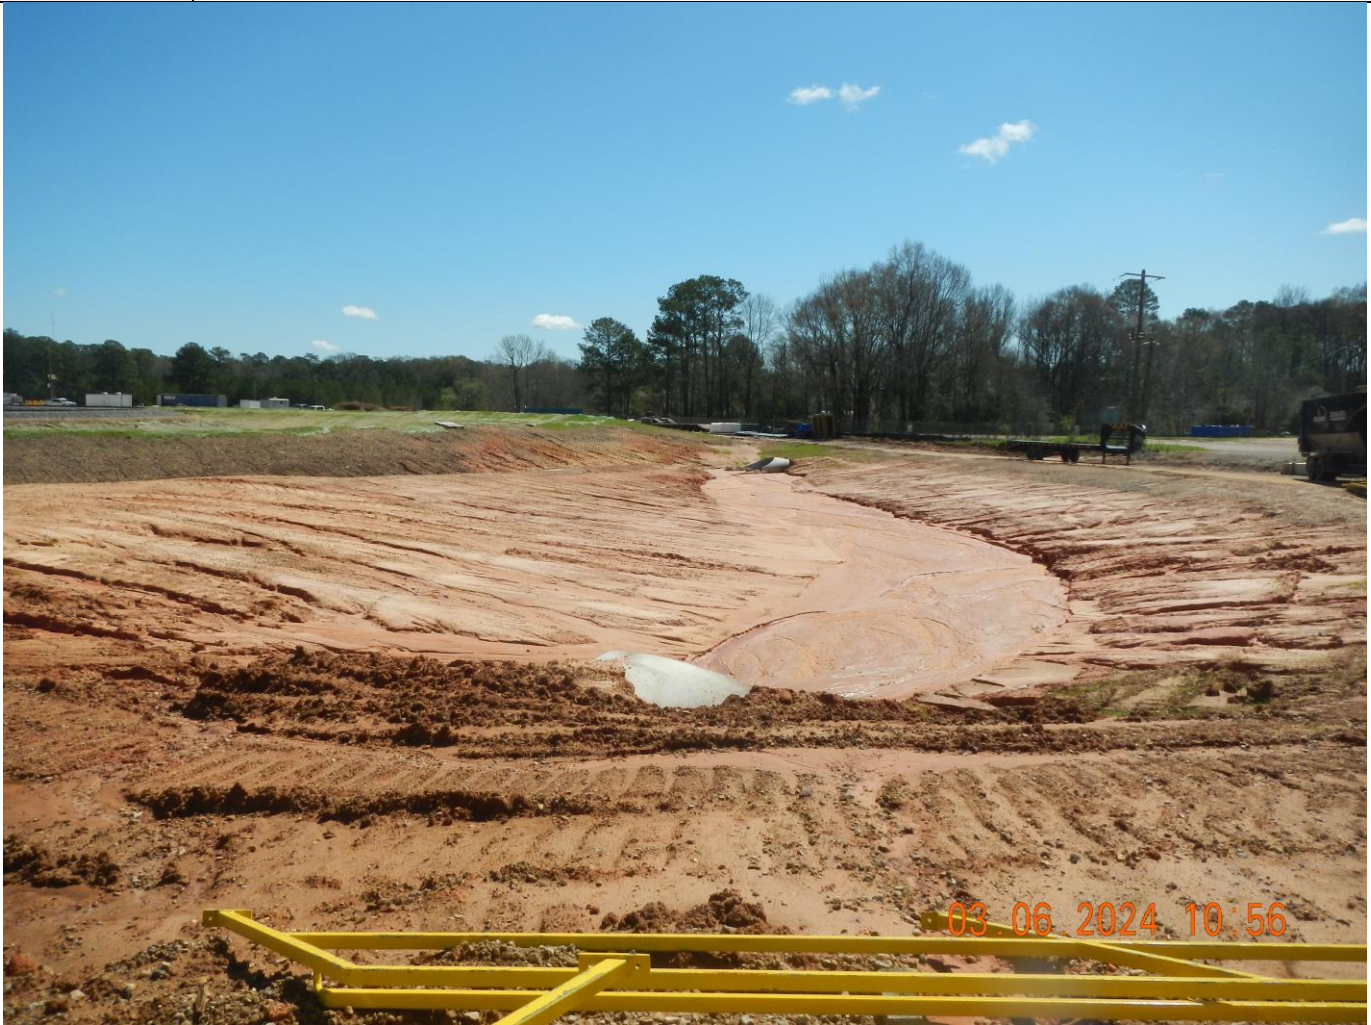
| <b>Photo ID:</b> | DSCN2925.JPG |

| <b>Description:</b> | Looking downgradient from the outlet of the basin shown in DSCN2924. An additional view of the inlet pipe in the middle background is shown in photo DSCN2926. |

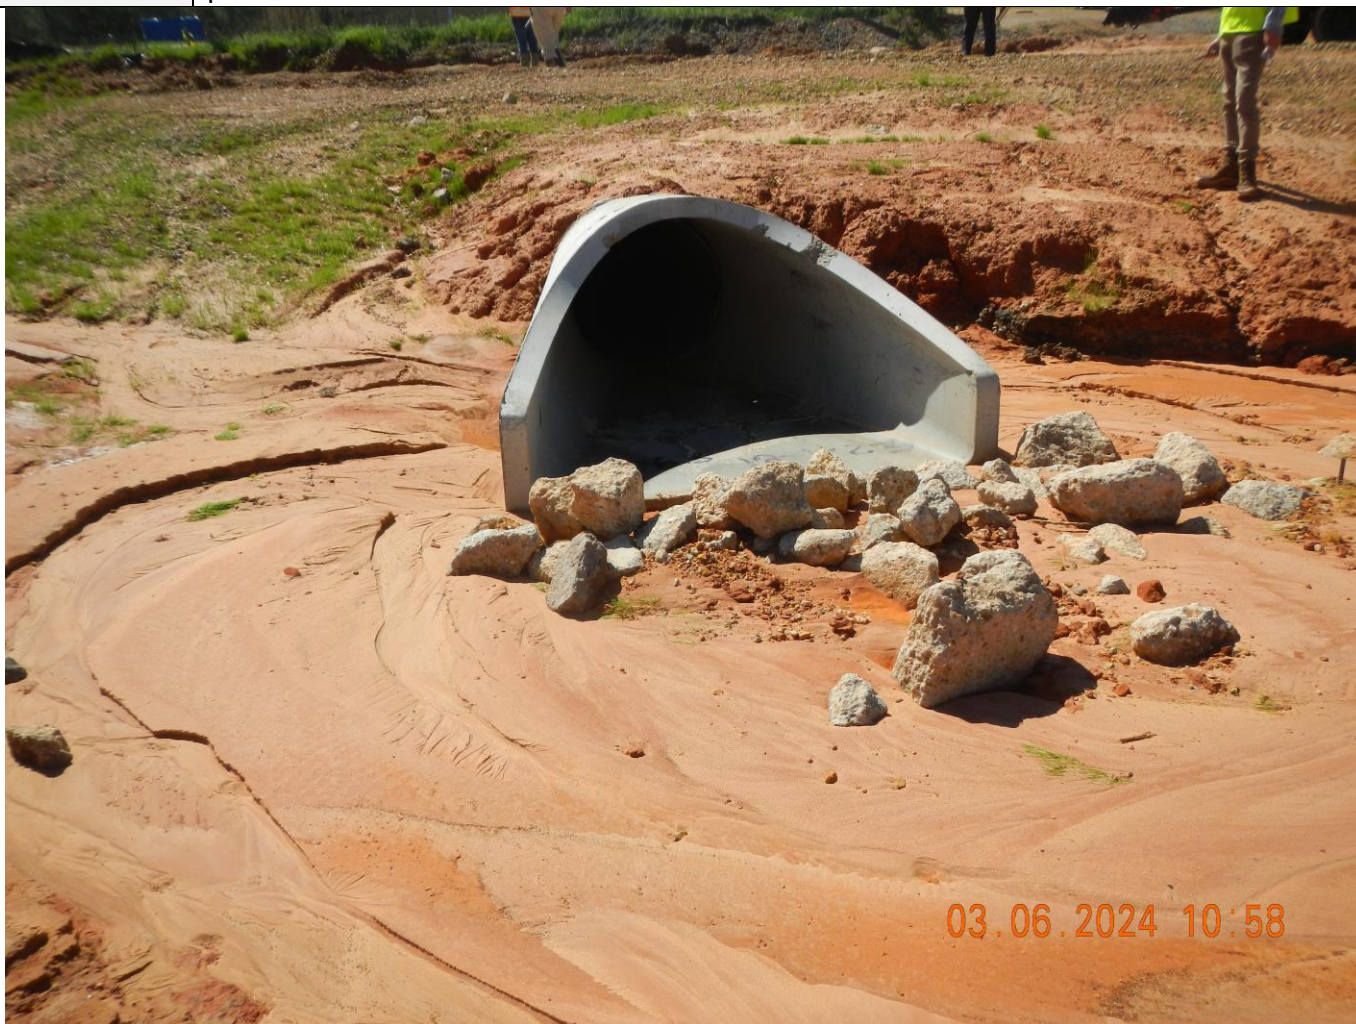
| <b>Description:</b> | Water is conveyed into the inlet shown here and towards the swale along the southern boundary before discharging into Sedimentation Basin #3 in the southern corner of the site. Inlet conveys runoff from the drainage system shown in photos DSCN2923-2925 as well as runoff from the radial crane's drainage system. The specifications for the inlet protection should be checked to confirm correct installation. |

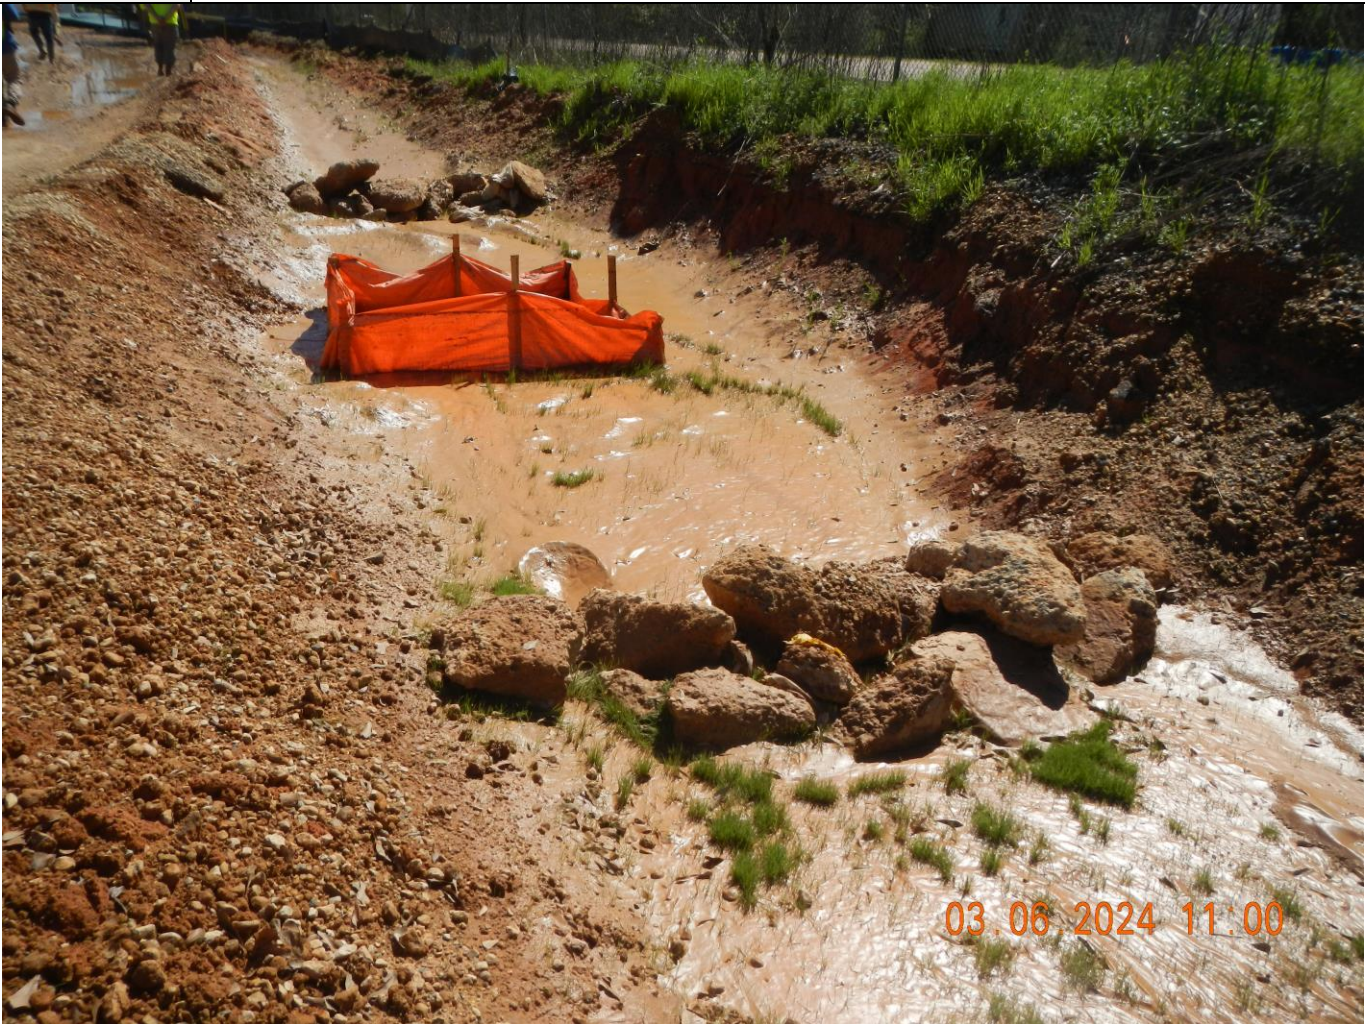
| Description: | View of a drainage swale along the southern boundary of the site with rock check dams. Swale drains in the direction shown into Sedimentation Basin #3. Inlet protection, including a piece of filter fabric, is installed over and around this storm drain inlet which outlets in photo DSCN2929. |

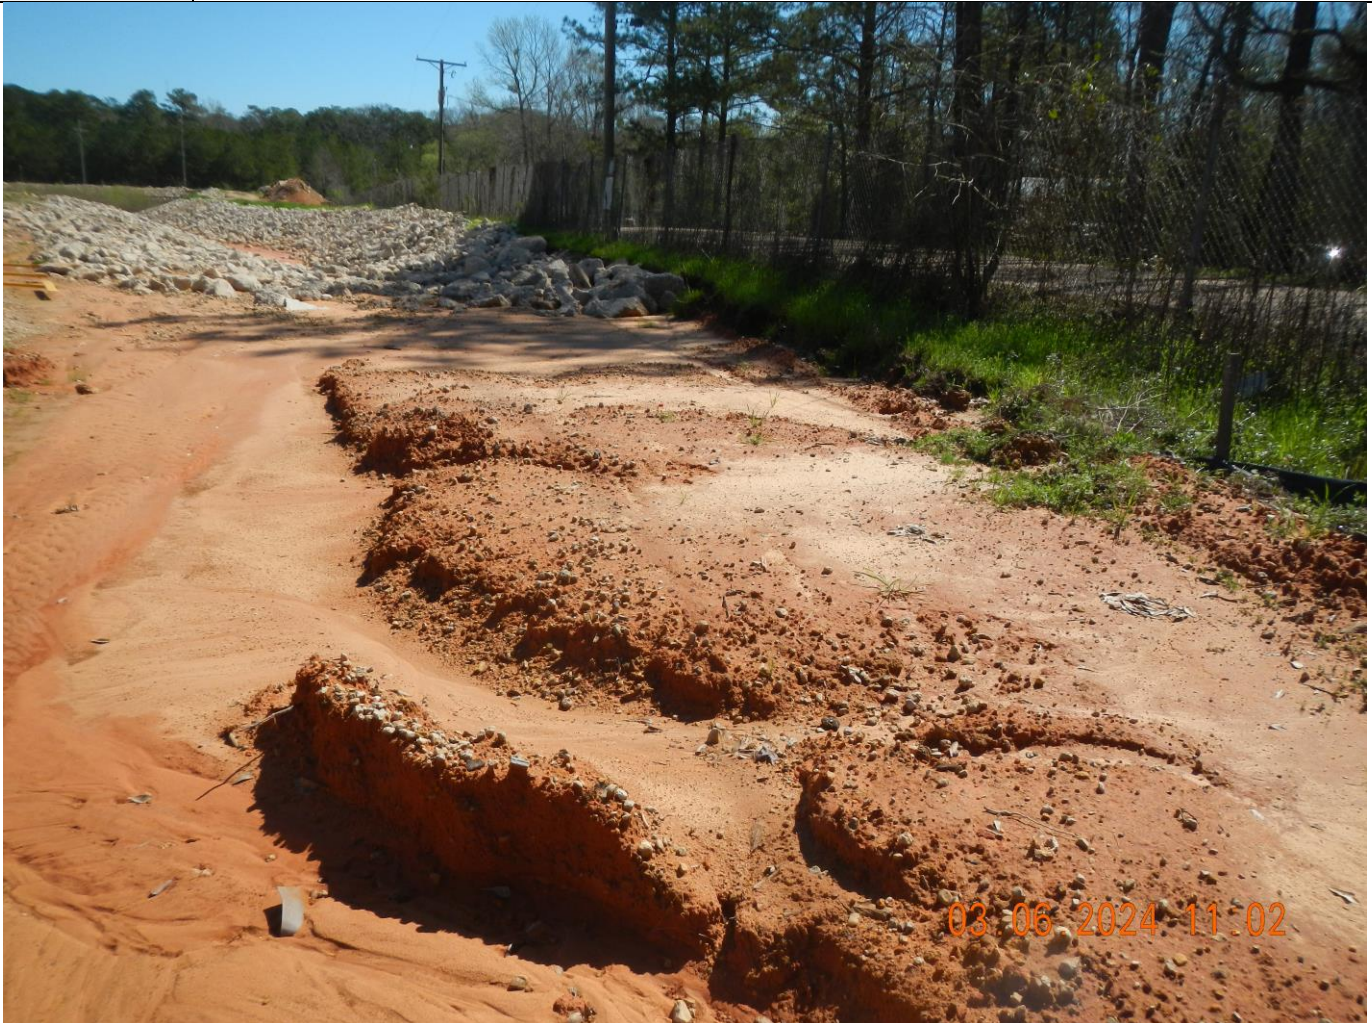
| <b>Photo ID:</b> | DSCN2928.JPG |

| <b>Description:</b> | The drainage swale shown in DSCN2927 flows into the rock-lined conveyance, visible in the upper-left quadrant of the photo, before discharging into Sedimentation Basin #3. |

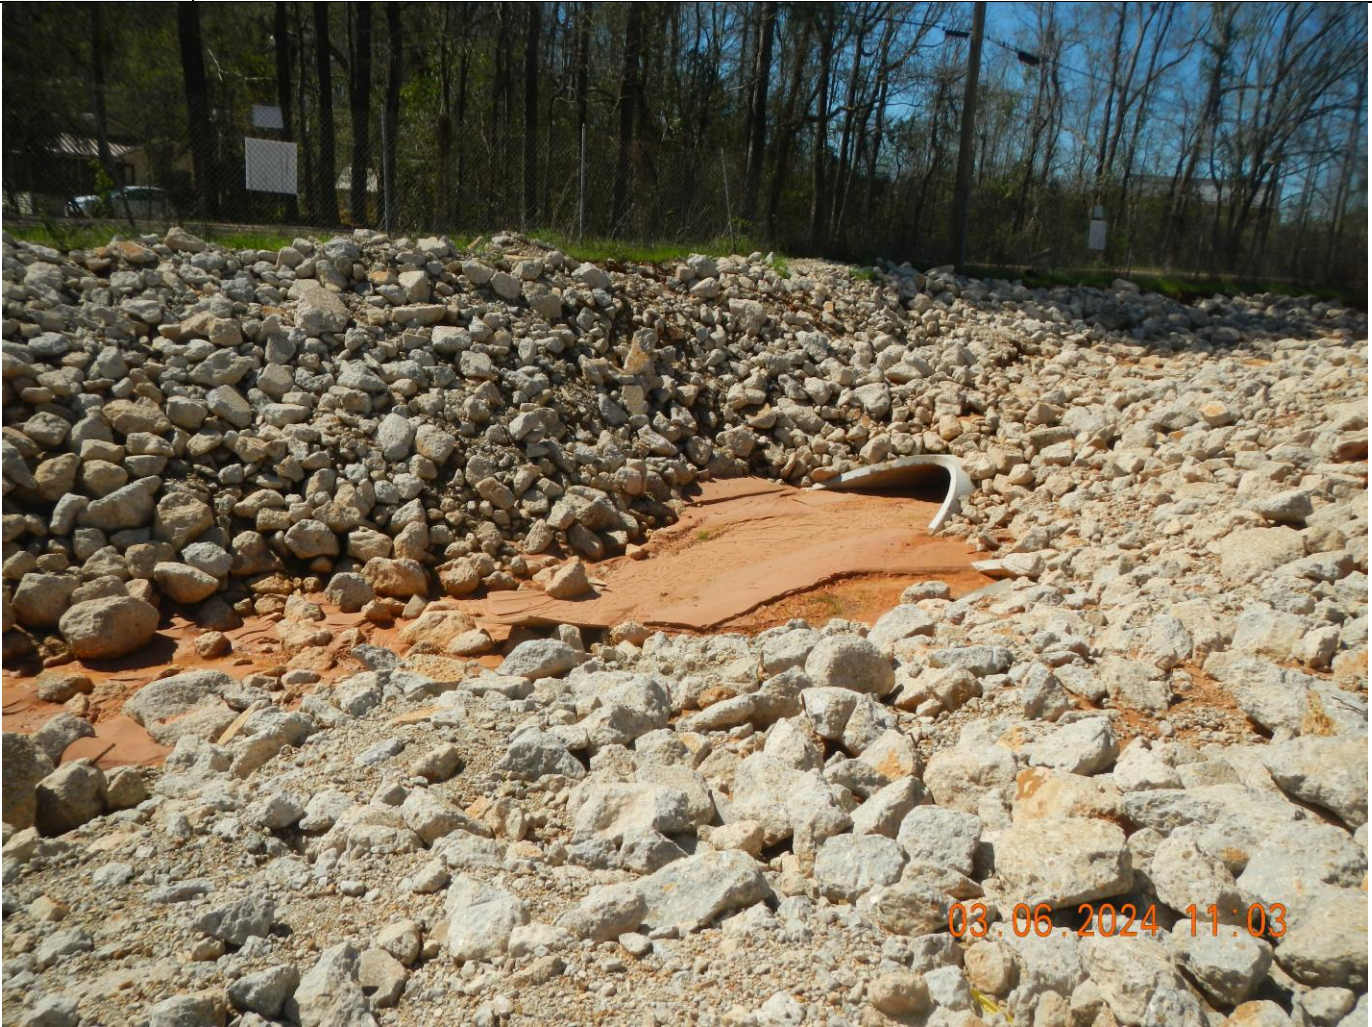
| <b>Photo ID:</b> | DSCN2929.JPG |

| <b>Description:</b> | Sediment has accumulated at the outlet of the underground drainage system, pictured here, partially obstructing the outlet pipe. |

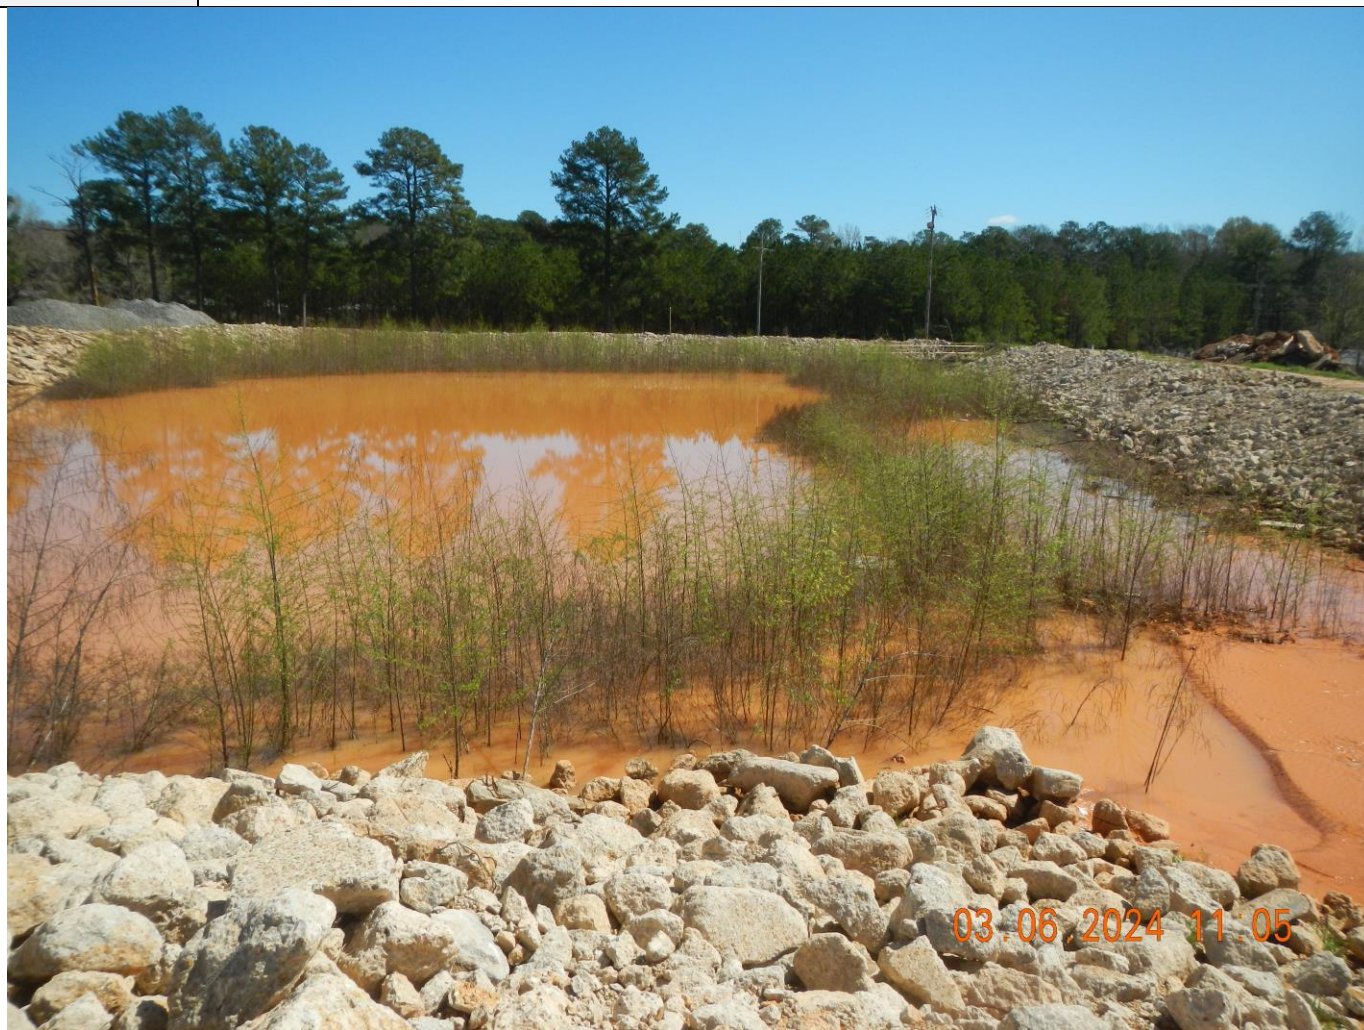
| <b>Description:</b> | View of Sedimentation Basin #3, located in the southeastern corner of the site. The basin and its outlet structure were both pre-existing as part of the Georgia-Pacific site. Rip rap was installed on the basin slopes as part of this construction project and along the inlet channel visible in photo DSCN2928. The pond's outlet structure is shown in photo DSCN2933. |

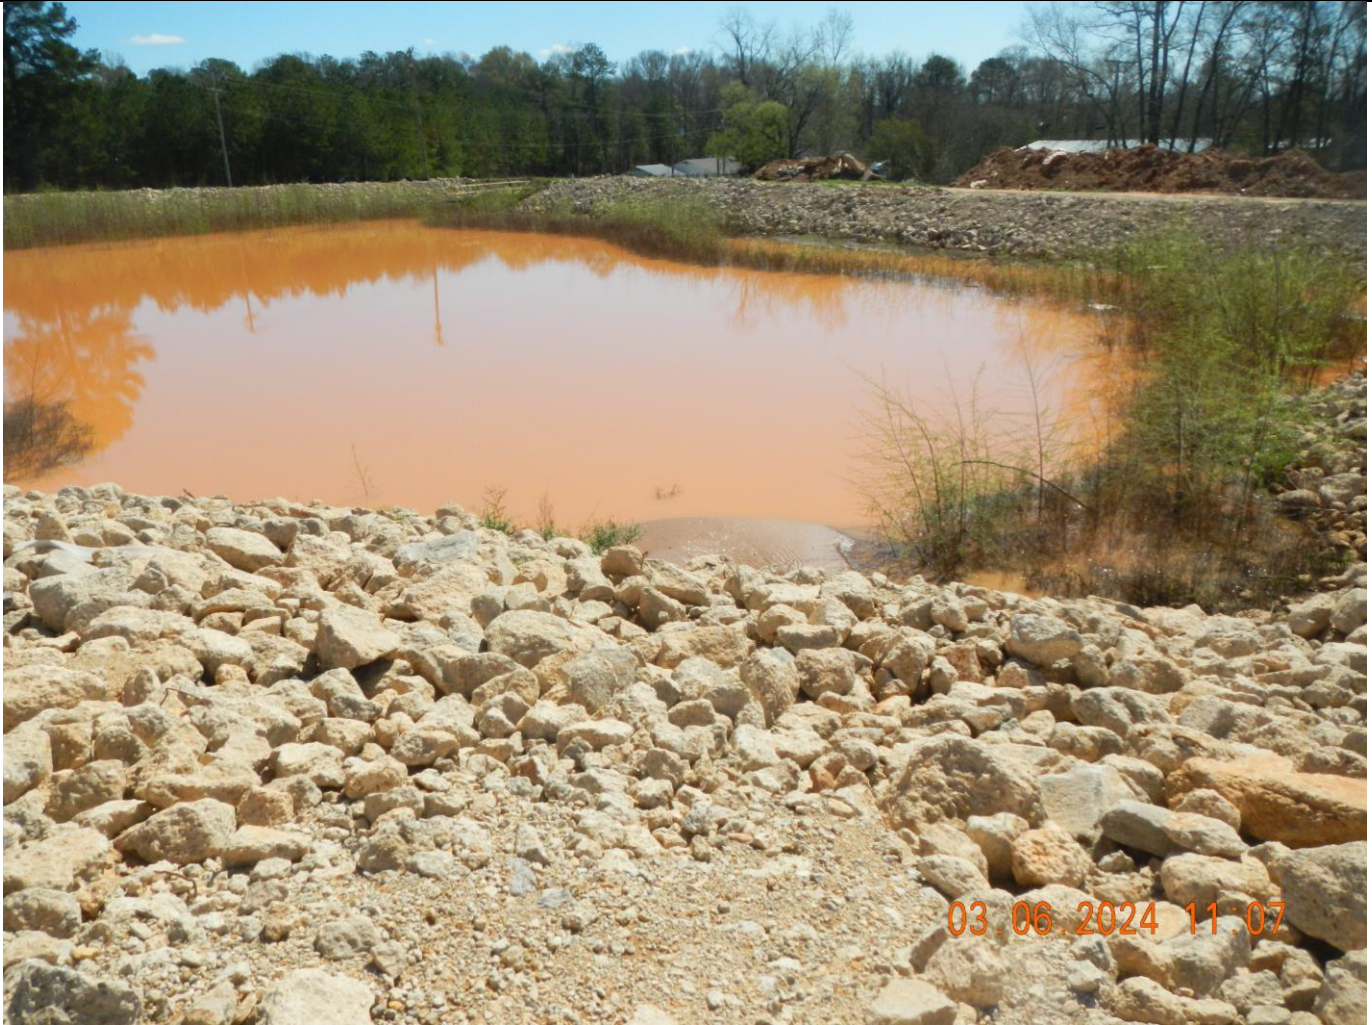
| <b>Photo ID:</b> | DSCN2931.JPG |

| <b>Description:</b> | The drainage system around one of the radial cranes discharges into Sedimentation Basin #3 at this location. The outlet into this pond is located near the center of the photo, where sediment has accumulated. |

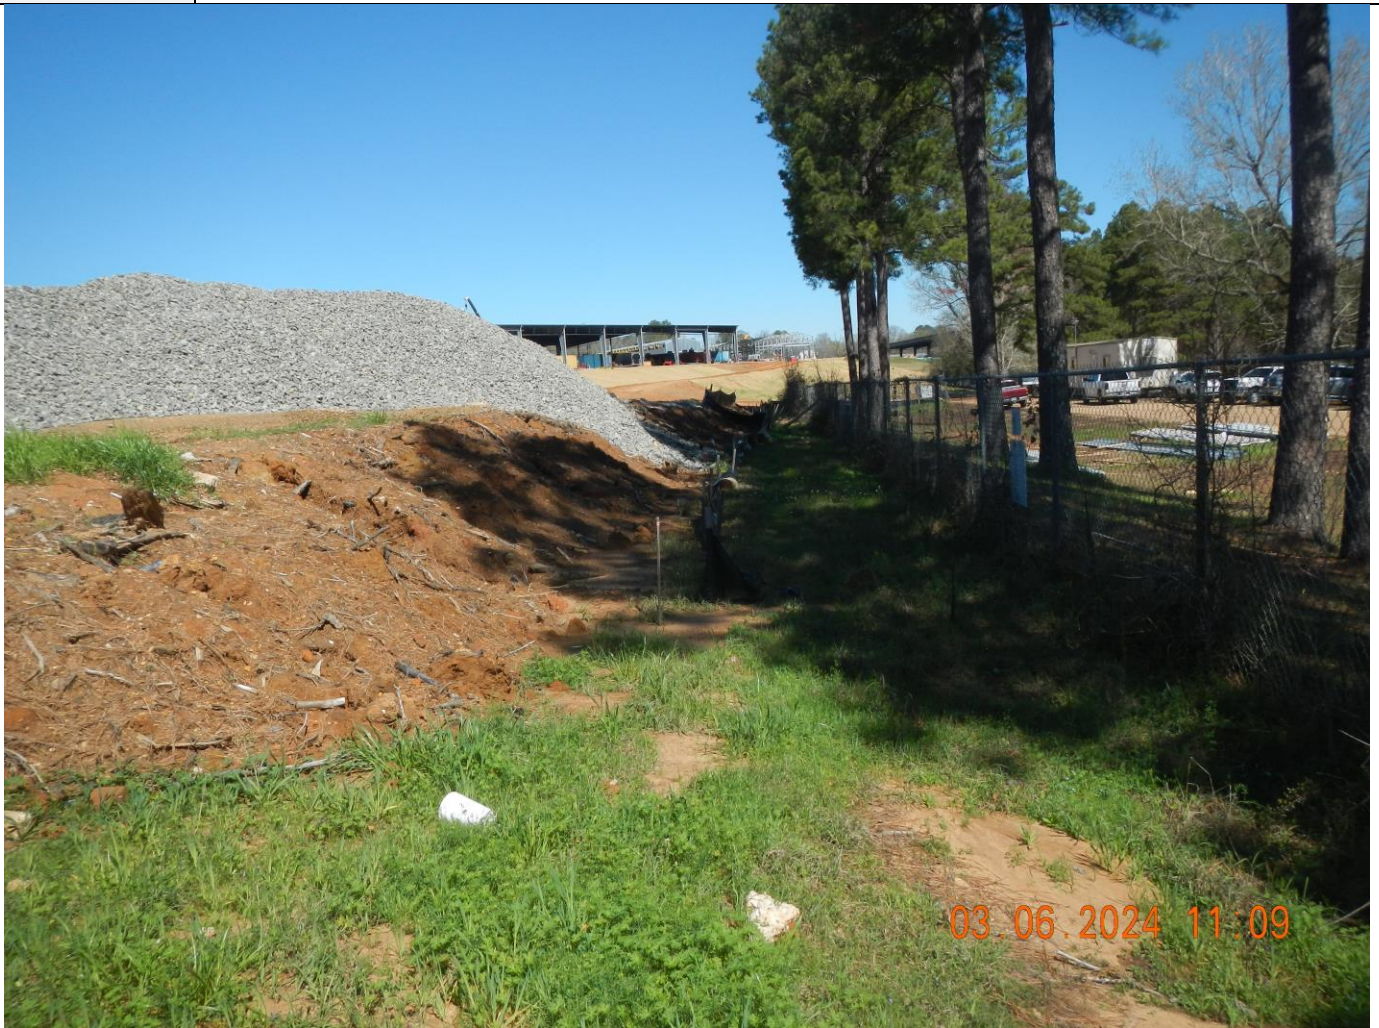
| <b>Photo ID:</b> | DSCN2932.JPG |

| <b>Description:</b> | View of silt fences installed along the back southeastern boundary of the site. Due to sediment accumulation behind the silt fences, they may be in need of cleanout/maintenance soon. |

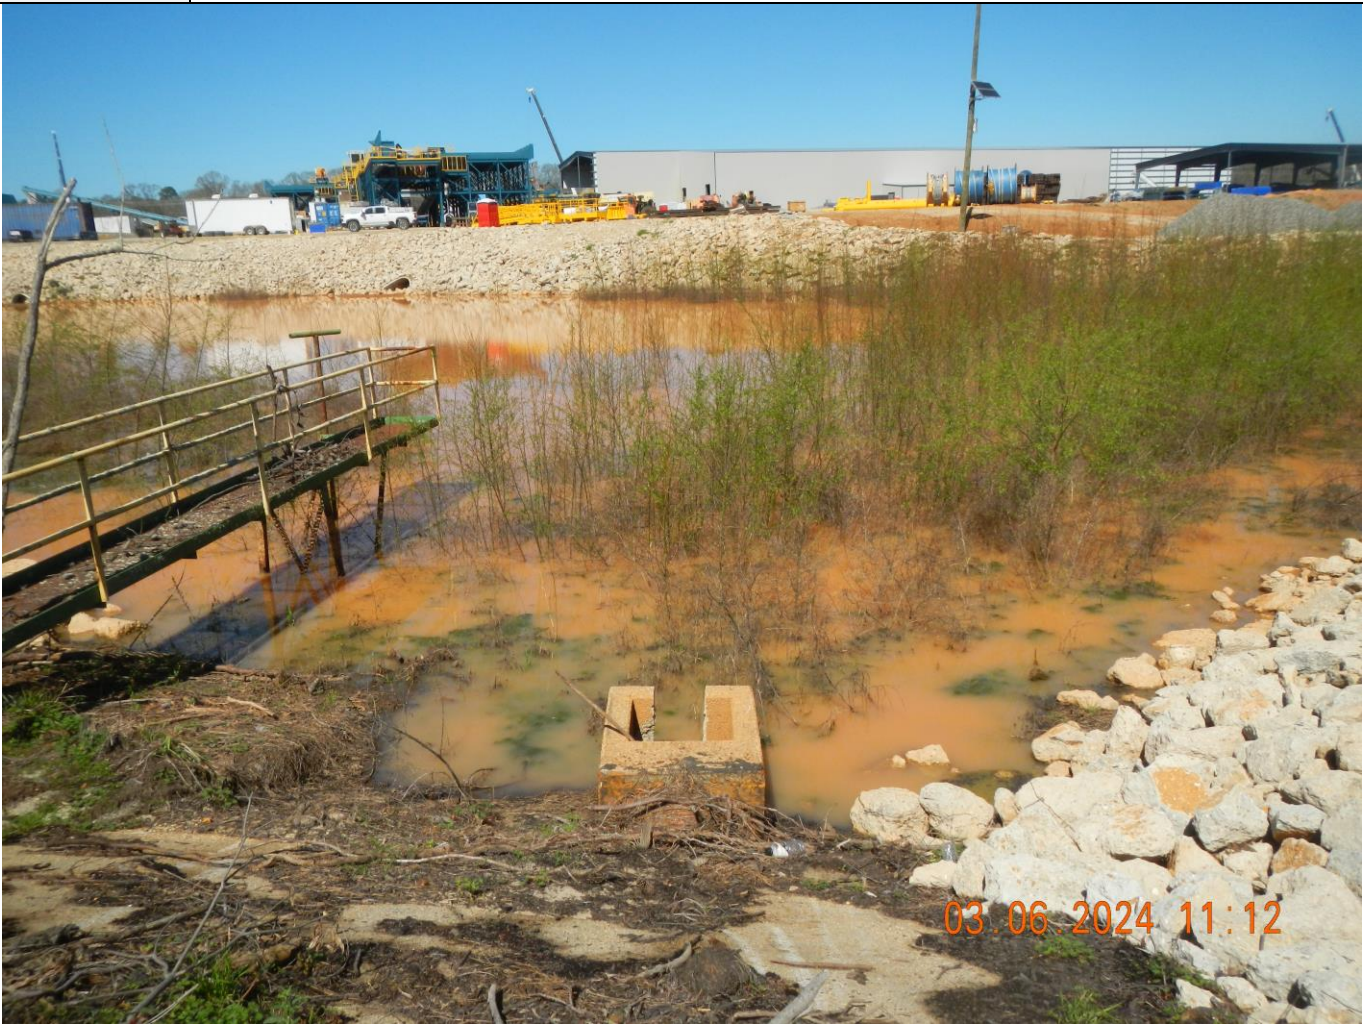
| Description: | Inlet of the outlet structure for sedimentation basin #3 in the southern corner of the site. Outfall configuration was not modified as part of the construction project. Water outlets via the flume shown in photo DSCN2934 and then enters the roadside drainage system via the pipes shown in photo DSCN2955. |

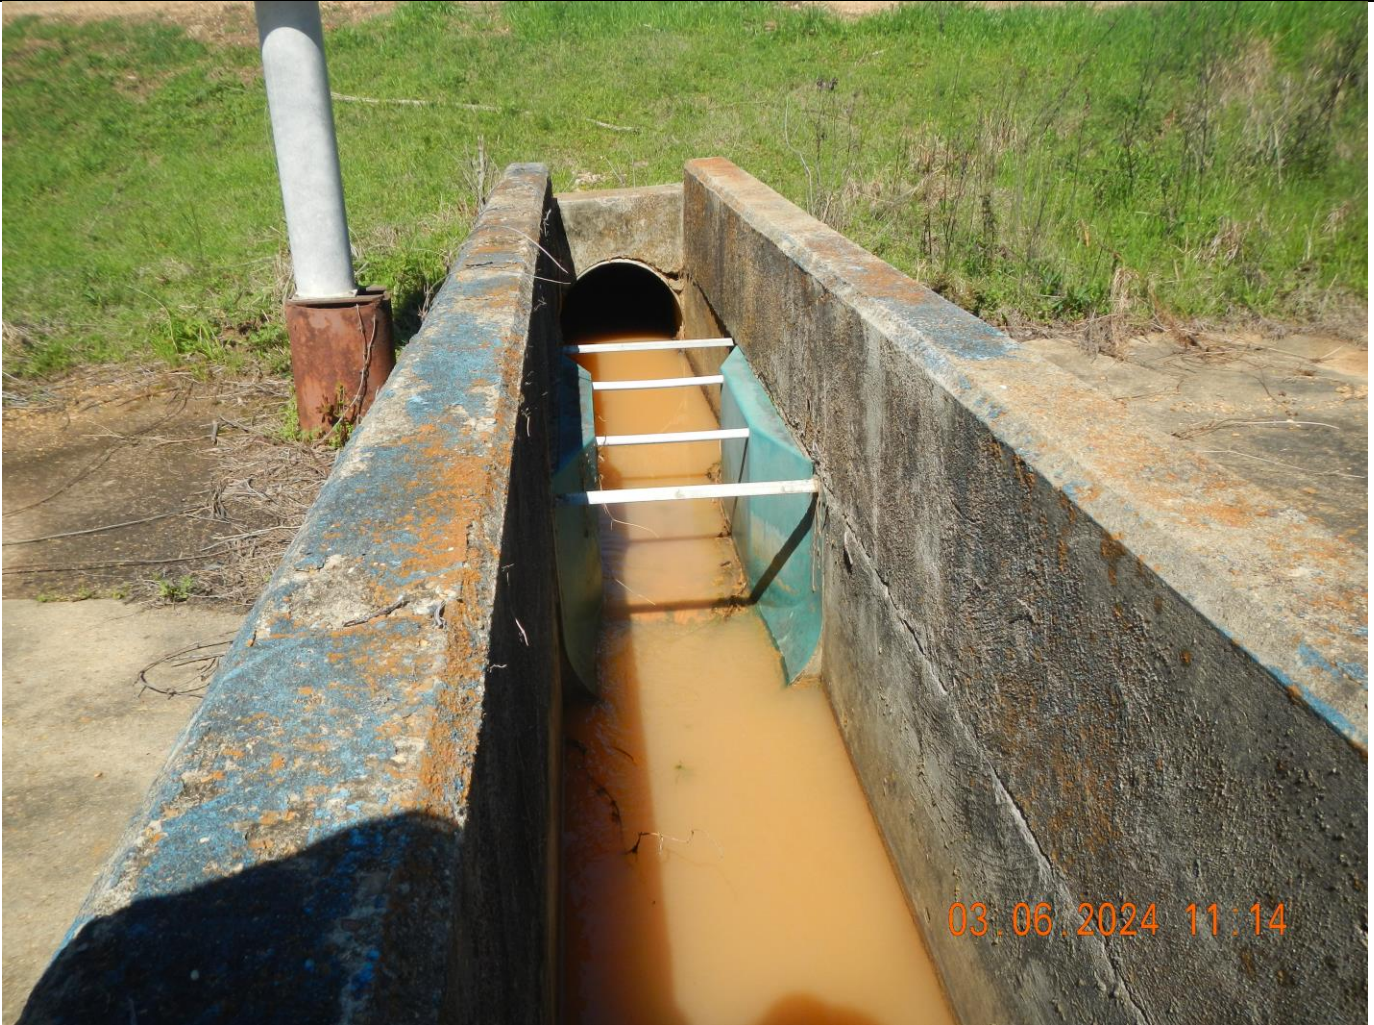
| <b>Photo ID:</b> | DSCN2934.JPG |

| <b>Description:</b> | Looking upgradient at a flume which receives water from Pond #3's outlet structure (photo DSCN2933). Water was heard discharging at the time of the inspection. Water from the flume discharges into the roadside drainage system shown in photo DSCN2955. |

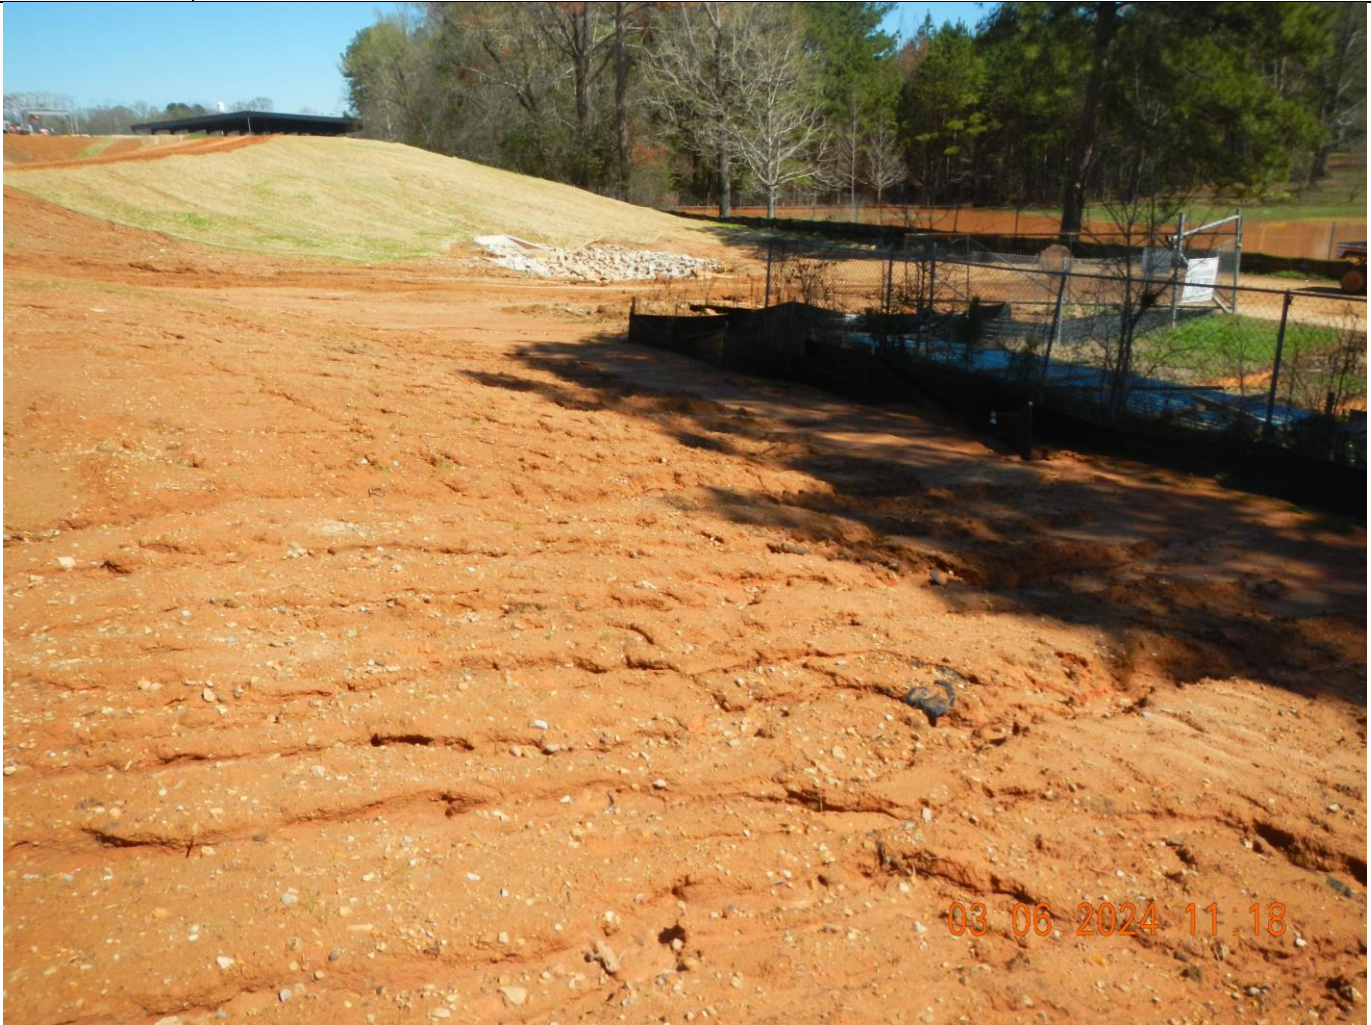
| <b>Photo ID:</b> | DSCN2935.JPG |

| <b>Description:</b> | View of a bare area near the southern corner of the site. The slope of Basin #2, visible in the upper left quadrant of the photo, was recently matted/seeded for stabilization. |
