PHOTO LOG

| Facility Name: | Gloster Forest Products CSW |
| EPA Media: | Stormwater - Industrial |

| Date Stamp: | 3/6/2024 |

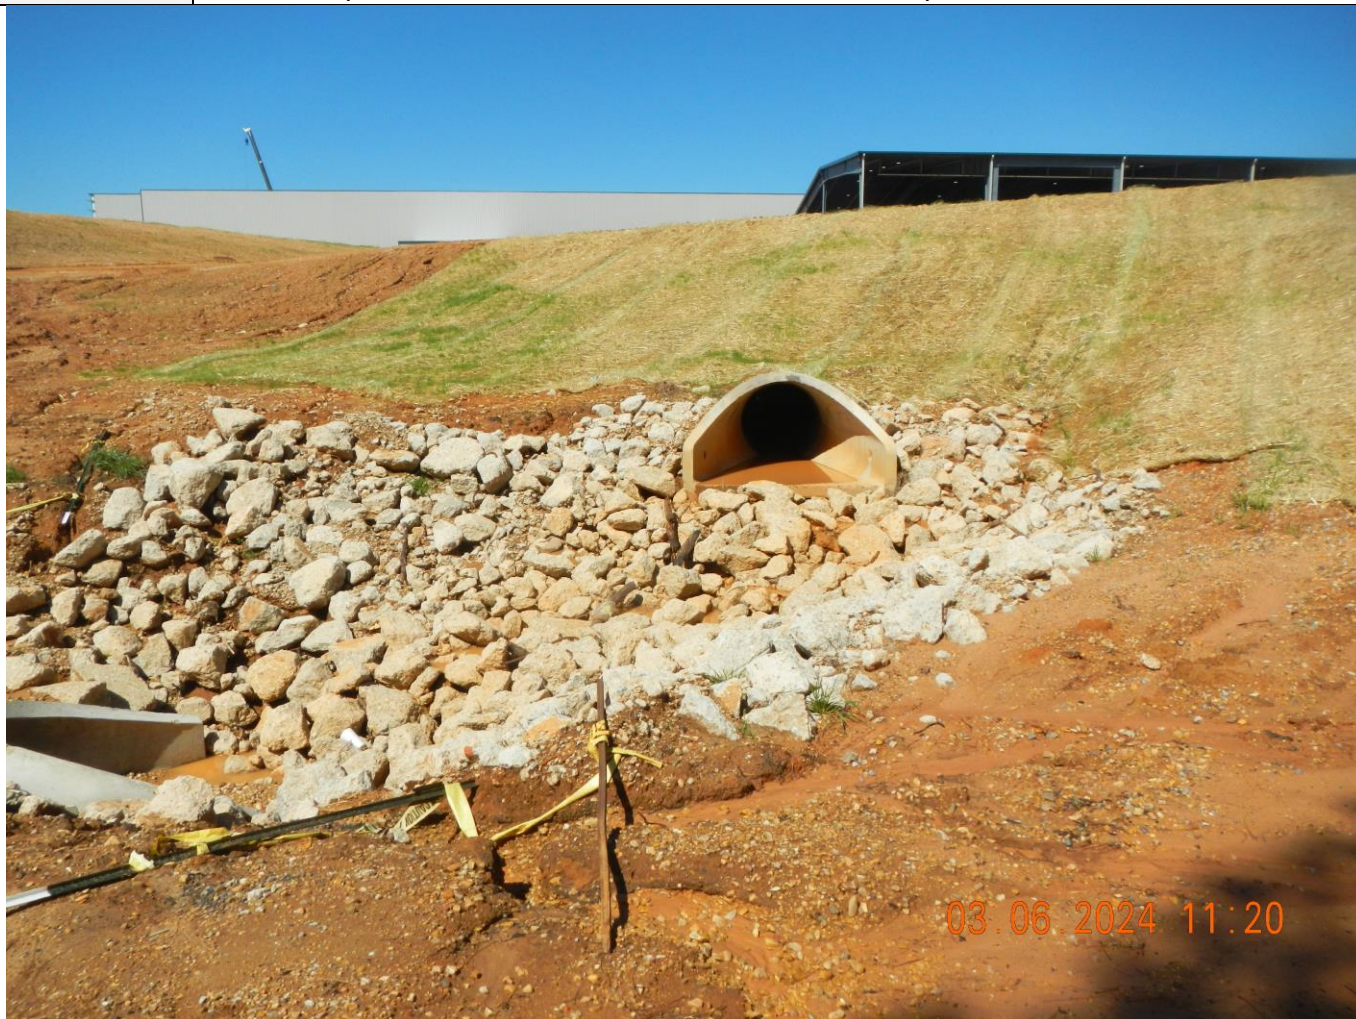
| <b>Description:</b> | Looking upgradient at the outlet of Sedimentation Basin #2. Discharge enters the culvert in the lower left quadrant of the photo which conveys water into the city storm drain system. Flow continues in the direction shown in photo DSCN2937. Water was discharging at the time of inspection. Sedimentation Basin #2 is shown in photo DSCN2944. |

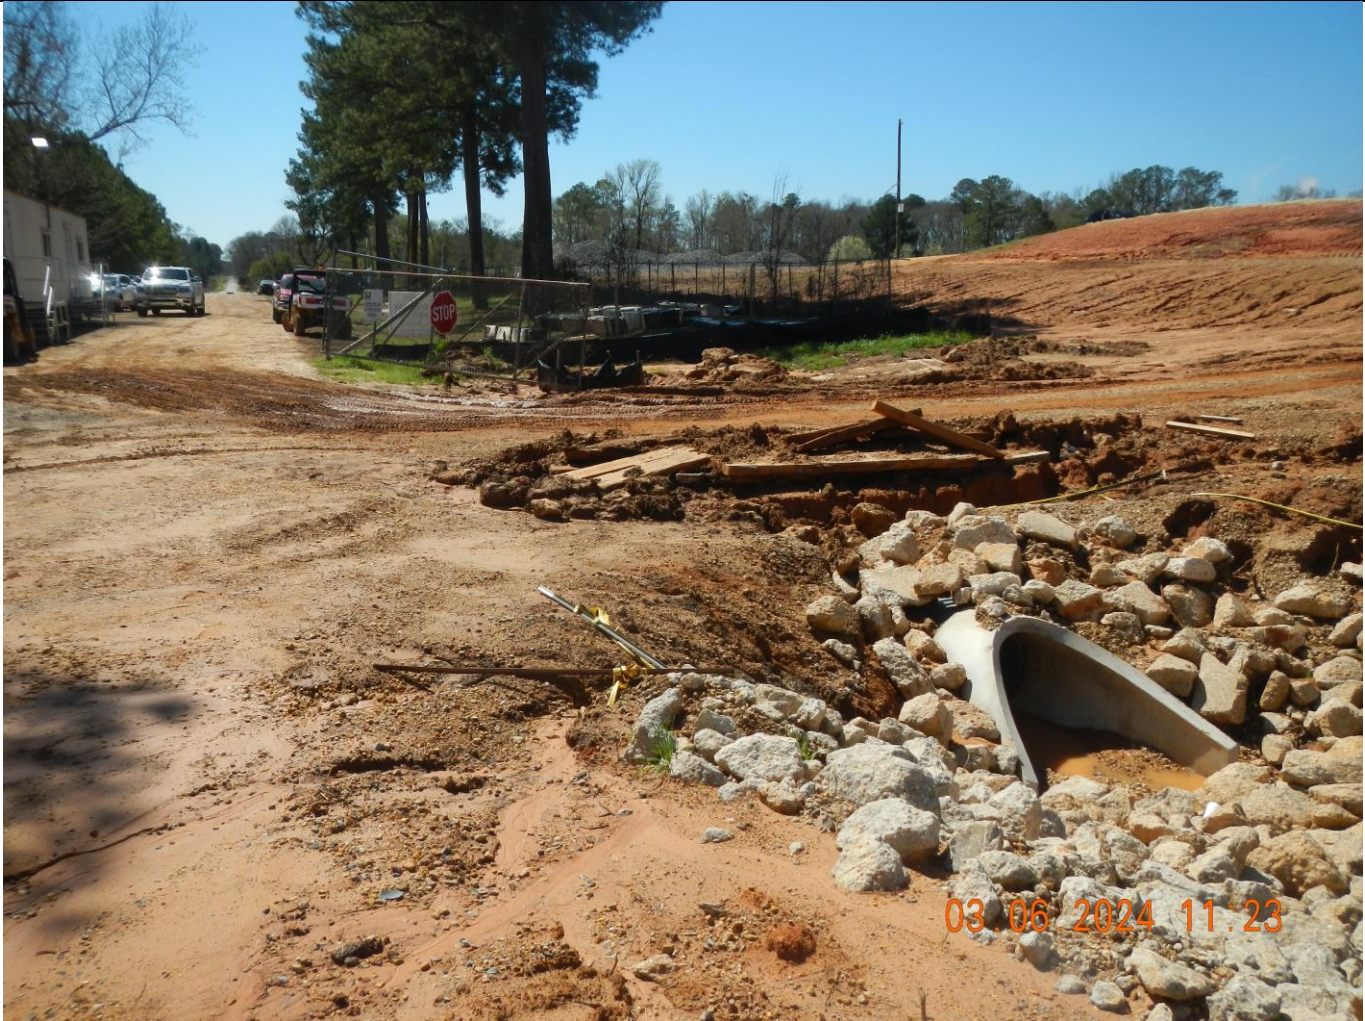
| <b>Photo ID:</b> | DSCN2937.JPG |

| <b>Description:</b> | Looking downgradient in direction of flow. Additional view of the culvert shown in photo DSCN2936 which conveys water into the city drainage system. Inlet protection was installed around a previously existing drain inlet, located in the upper center of the photo. |

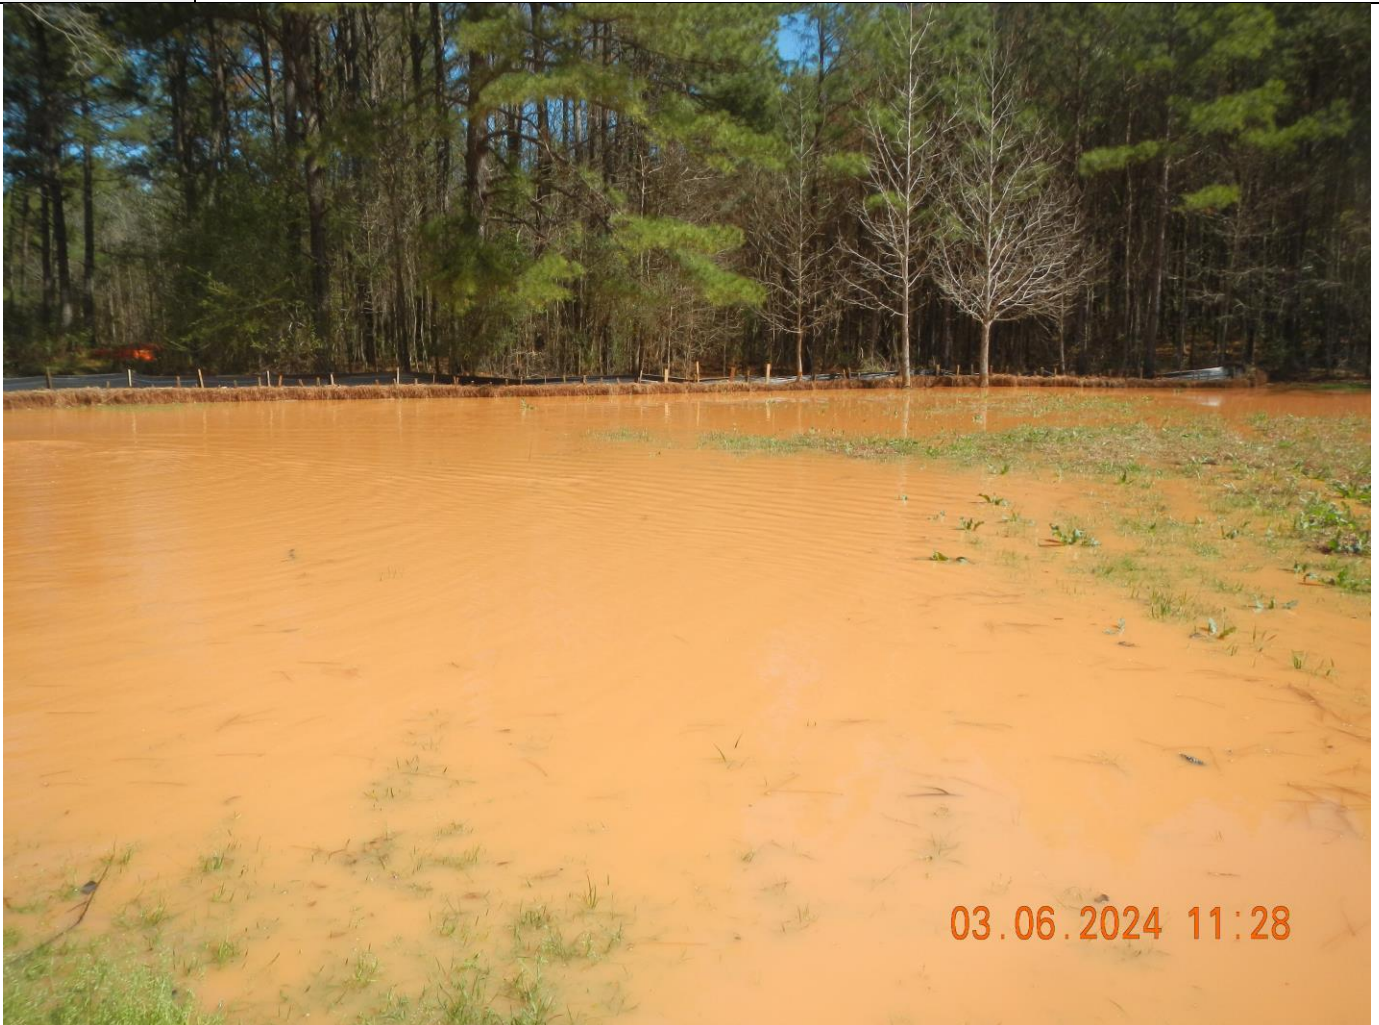
| <b>Description:</b> | The adjacent property, including the pond pictured here, was acquired by the owner approximately 1-2 months ago. Sedimentation Basin #1, shown in photo DSCN2942-2943, discharges into the pond pictured here (see photos DSCN2939-2941). Hay bales and silt fences were installed across the conveyance in between these ponds. The outlet of this pond is shown in photo DSCN2957. The SWPPP did not indicate that this pond was being used as for treatment purposes. |

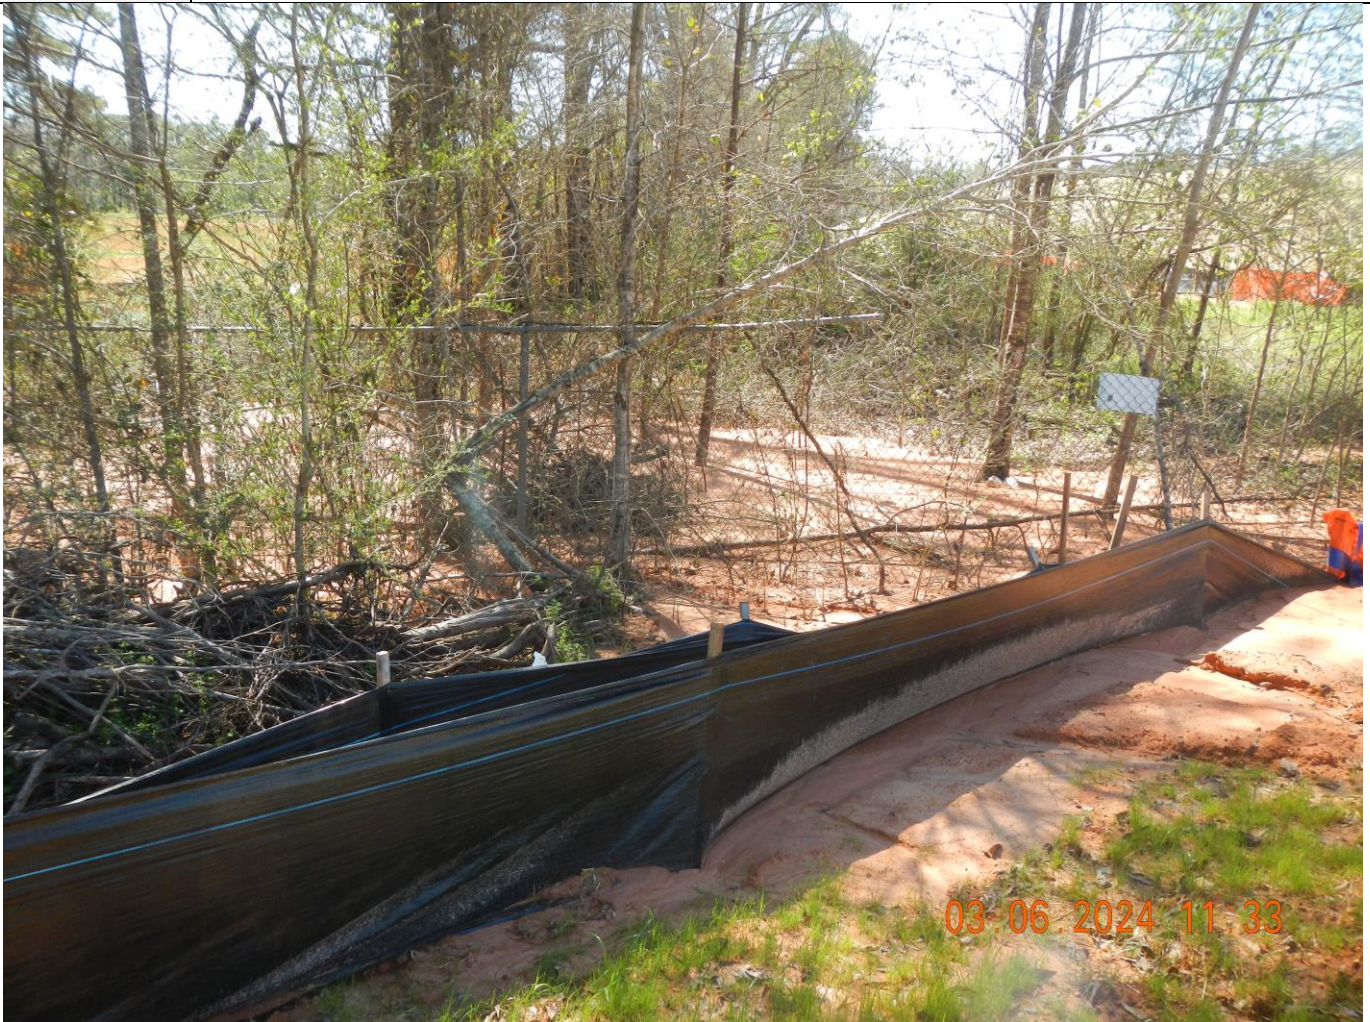
| <b>Photo ID:</b> | DSCN2939.JPG |

| <b>Description:</b> | View of sediment deposition downstream of Sedimentation Basin #1, near the entrance of the adjacent pond shown in photo DSCN2937 |

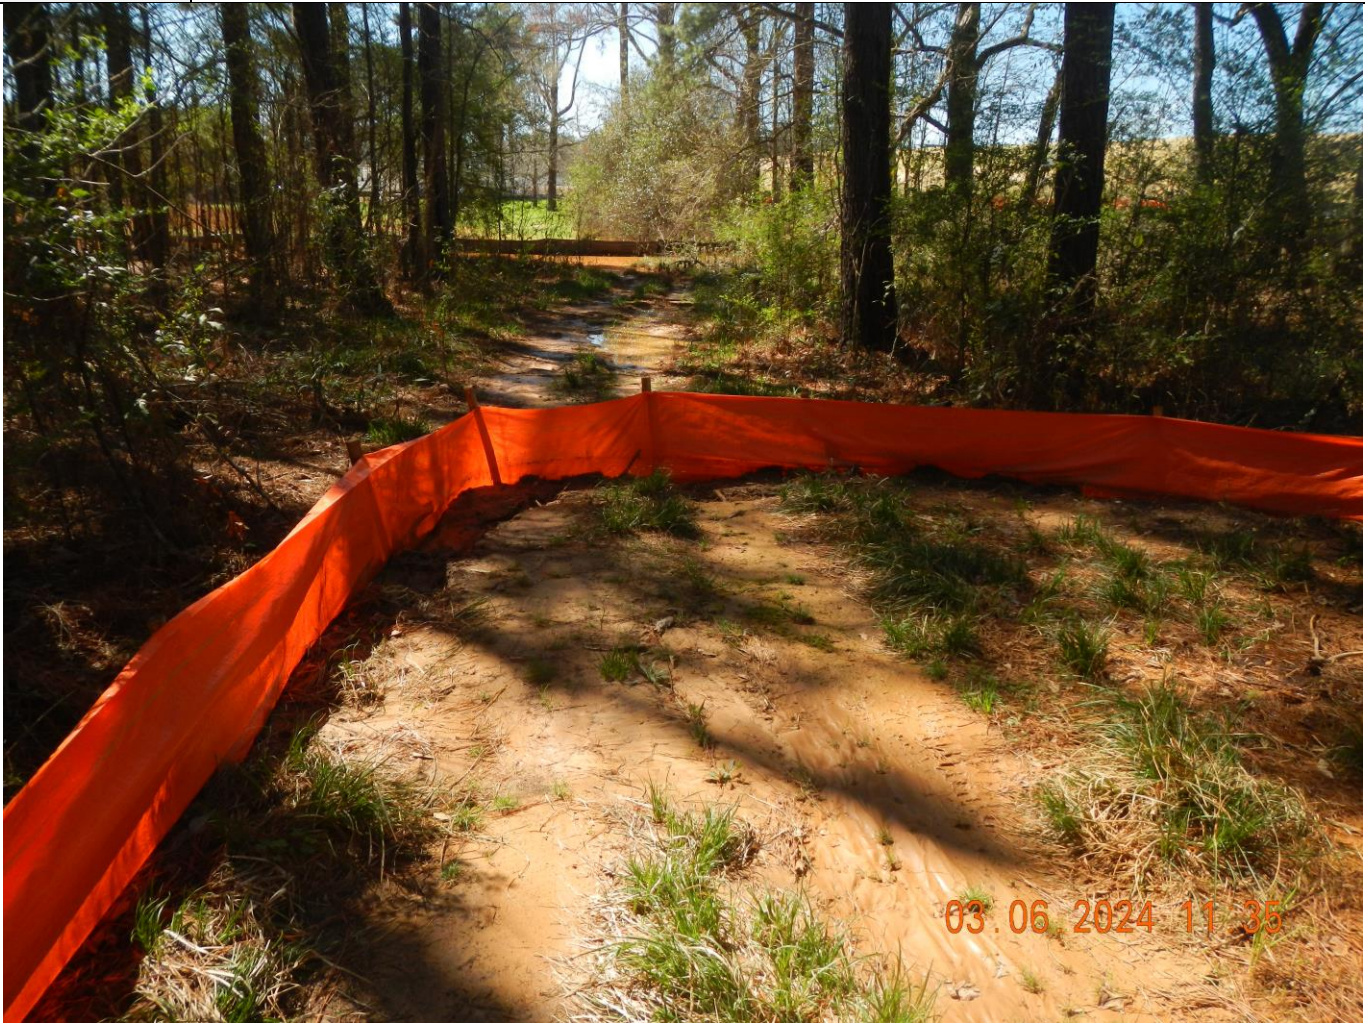
| <b>Photo ID:</b> | DSCN2940.JPG |

| <b>Description:</b> | Looking downgradient. Additional view of the conveyance between Sedimentation Basin #1 and the adjacent pond shown in DSCN2937. |

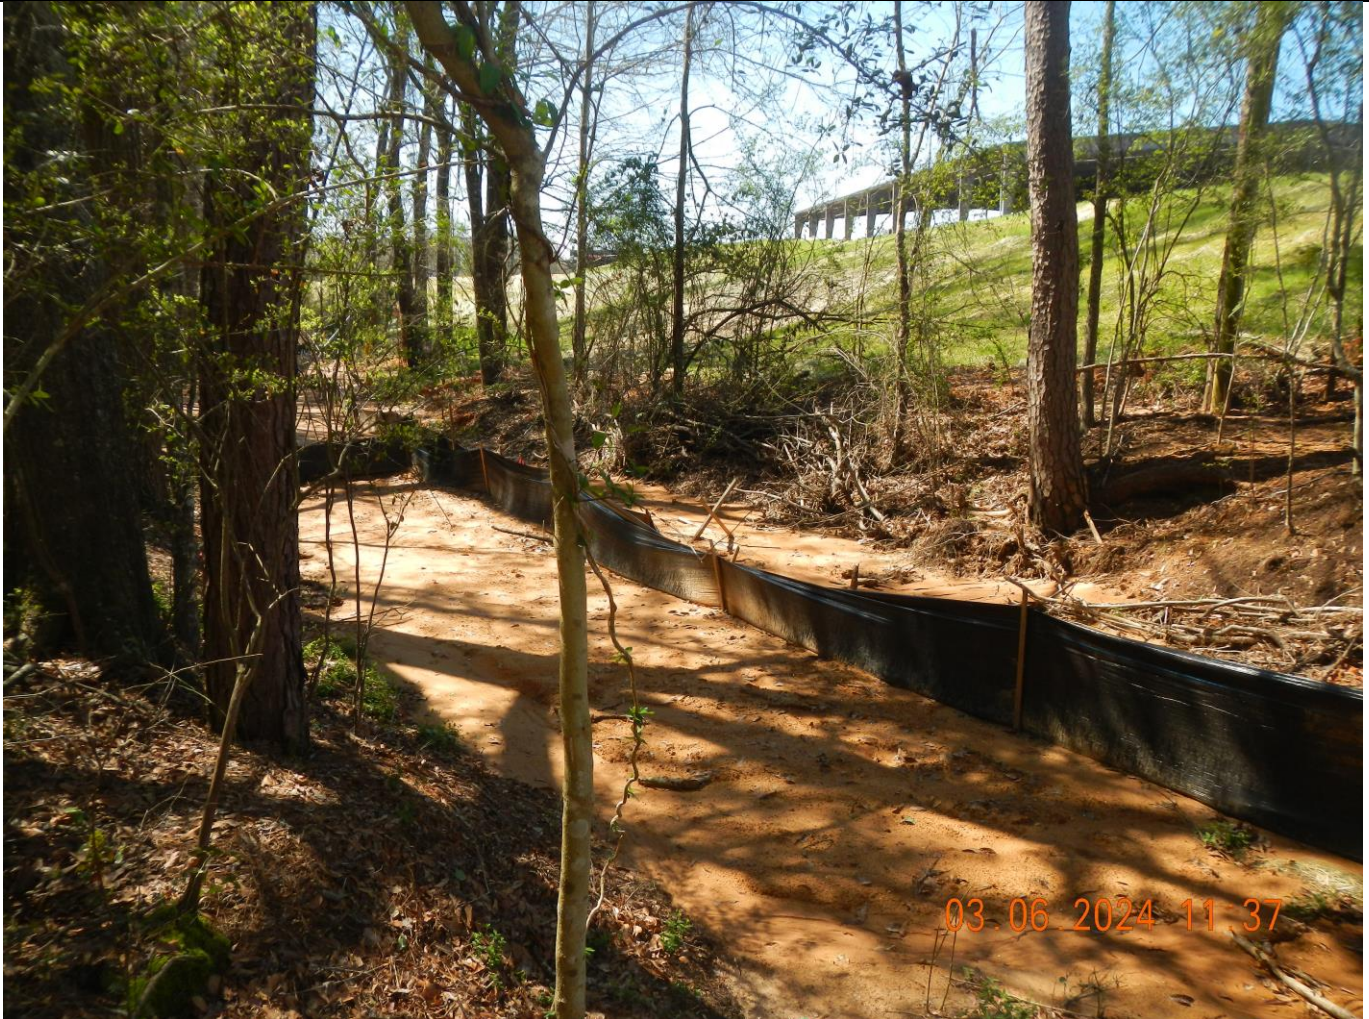
| <b>Photo ID:</b> | DSCN2941.JPG |

| <b>Description:</b> | Additional view of sediment deposition in the conveyance downstream of Sedimentation Basin #1. According to facility personnel, the property line is demarcated by the pink flags here, which is approximately along the berm the photographer is standing on. |

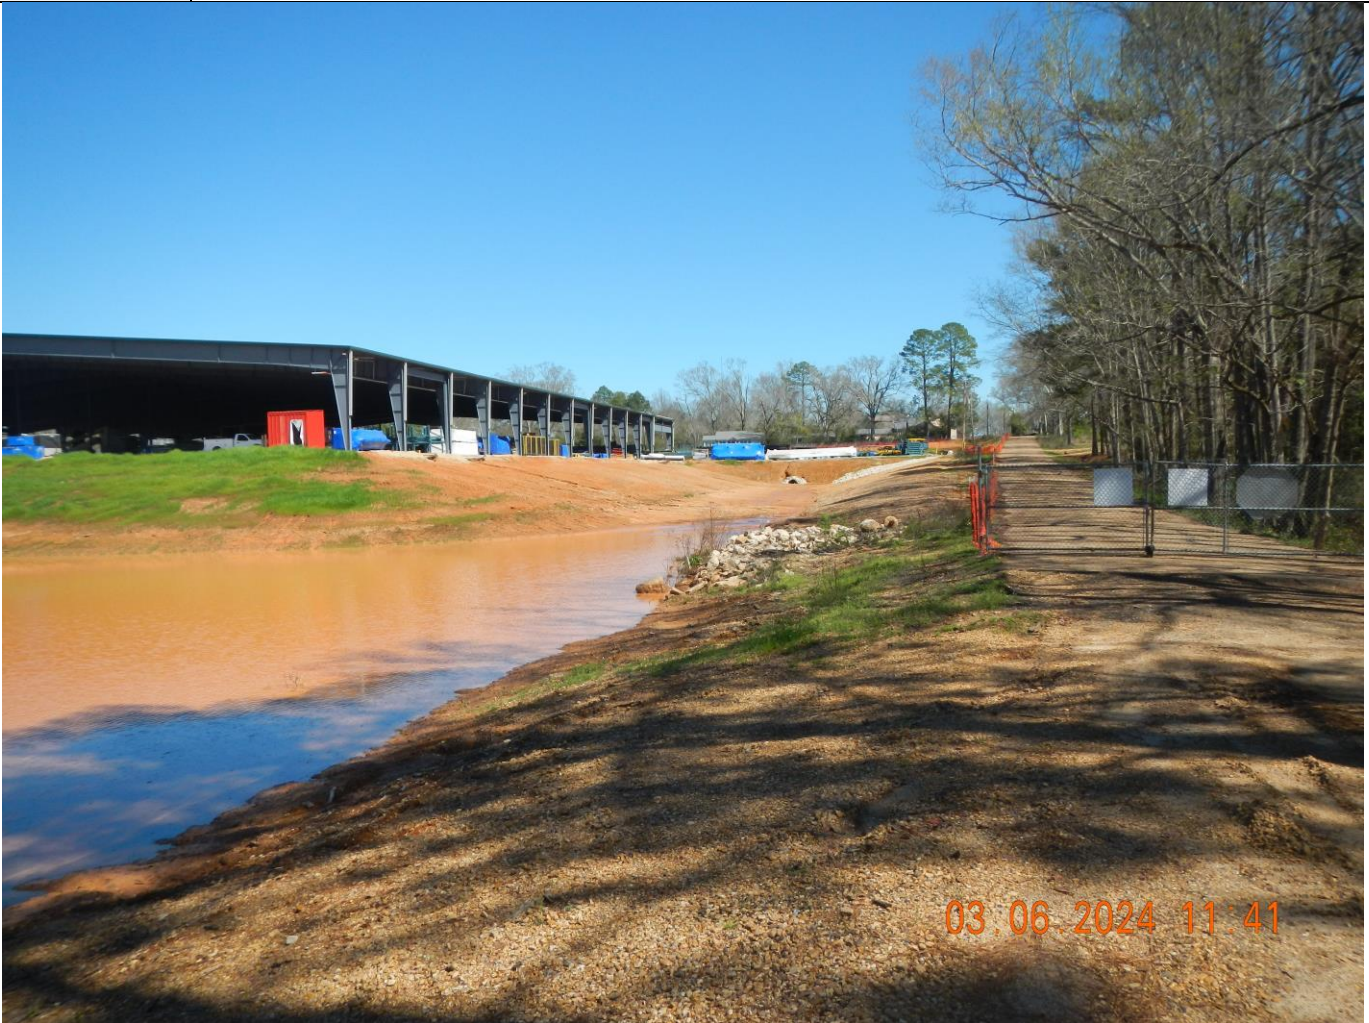
| <b>Description:</b> | View of Sedimentation Basin #1. The outlet of the pond is located at the rock filter dam, pictured near the center of the photo. Sedimentation Basin #1A discharges into Sedimentation Basin #1 via the pipe visible in the center background of the photo. Additional views of Basin #1's outlet structure is shown in photo DSCN2945 and DSCN2946. |

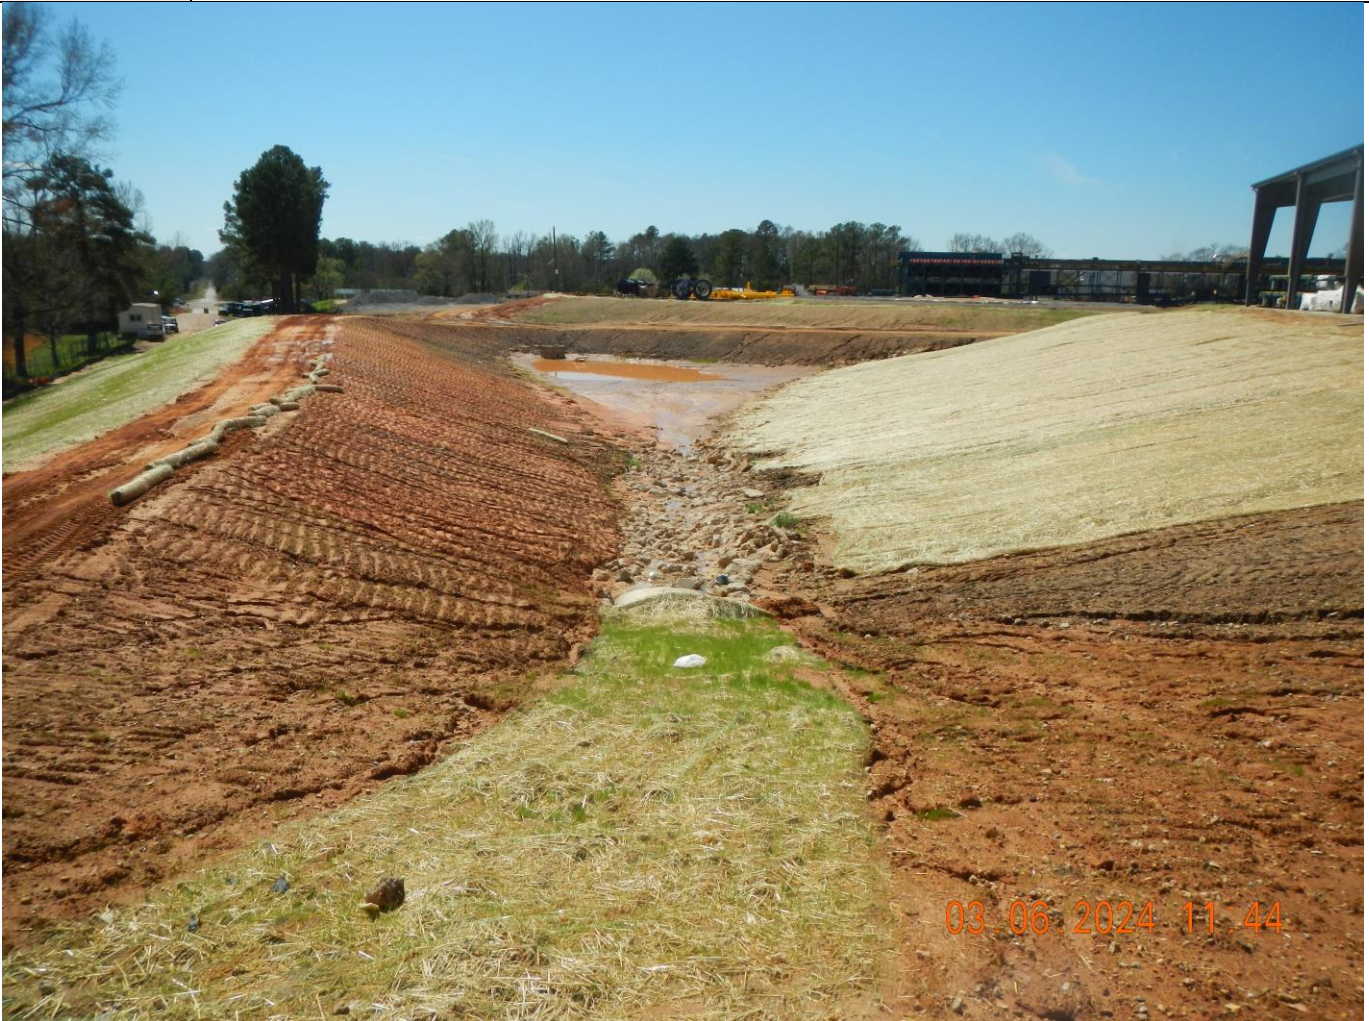
| <b>Photo ID:</b> | DSCN2944.JPG |

| <b>Description:</b> | View of Sedimentation Basin #2. The riser structure was equipped with a floating surface skimmer. The pond's outfall is shown in photo DSCN2936. |

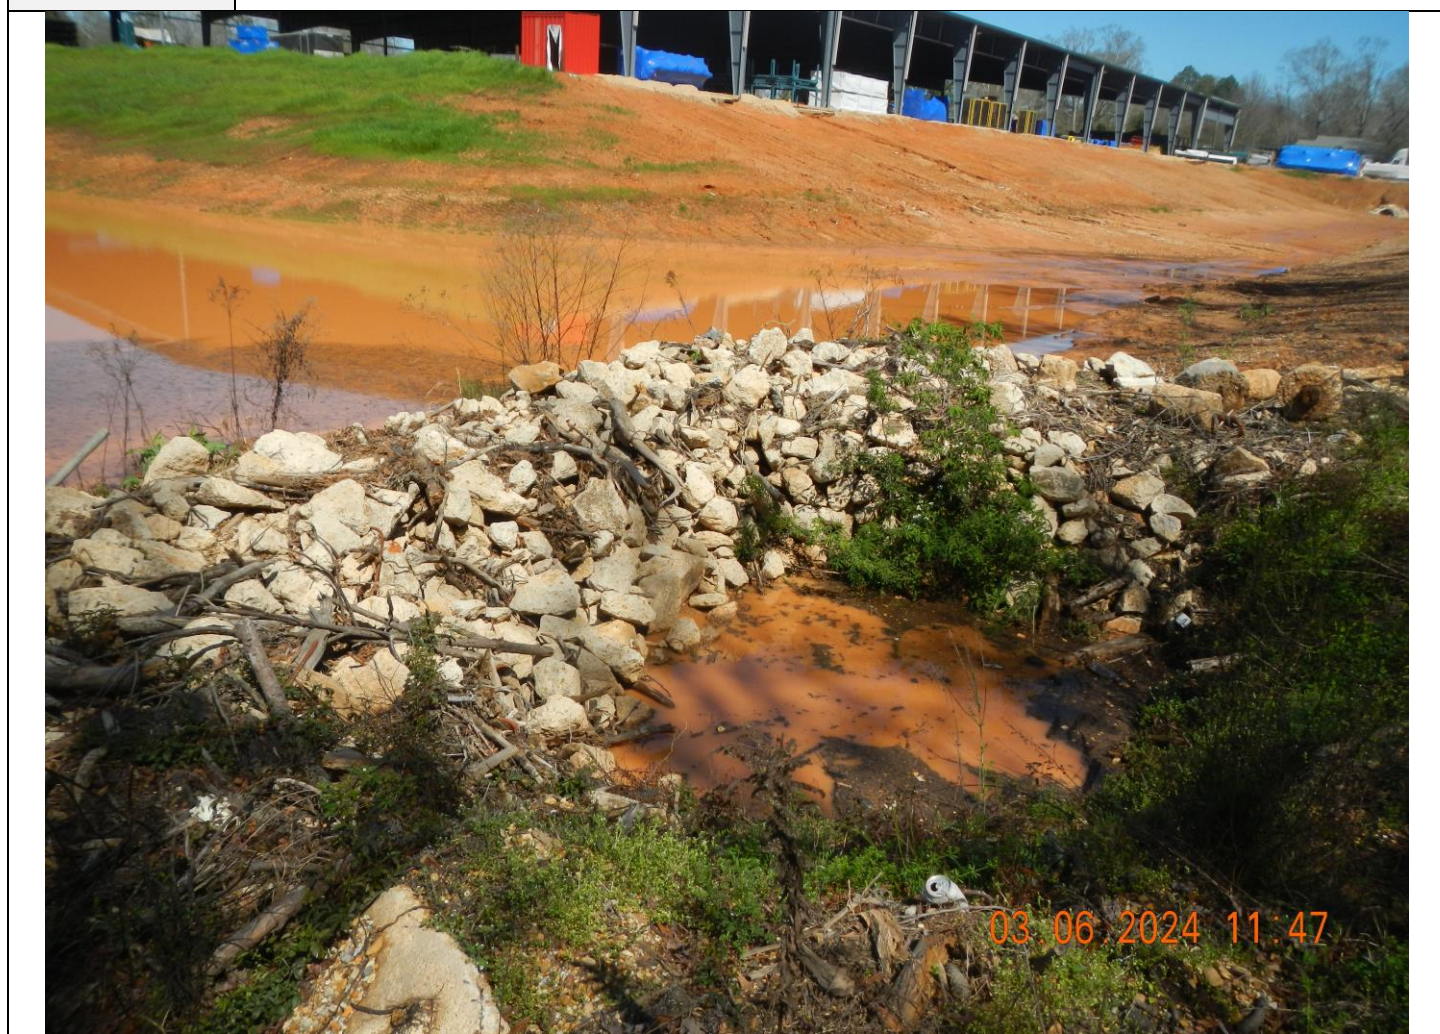
| <b>Photo ID:</b> | DSCN2945.JPG |

| <b>Description:</b> | Rock filter ring installed at the outlet of sedimentation basin #1. |

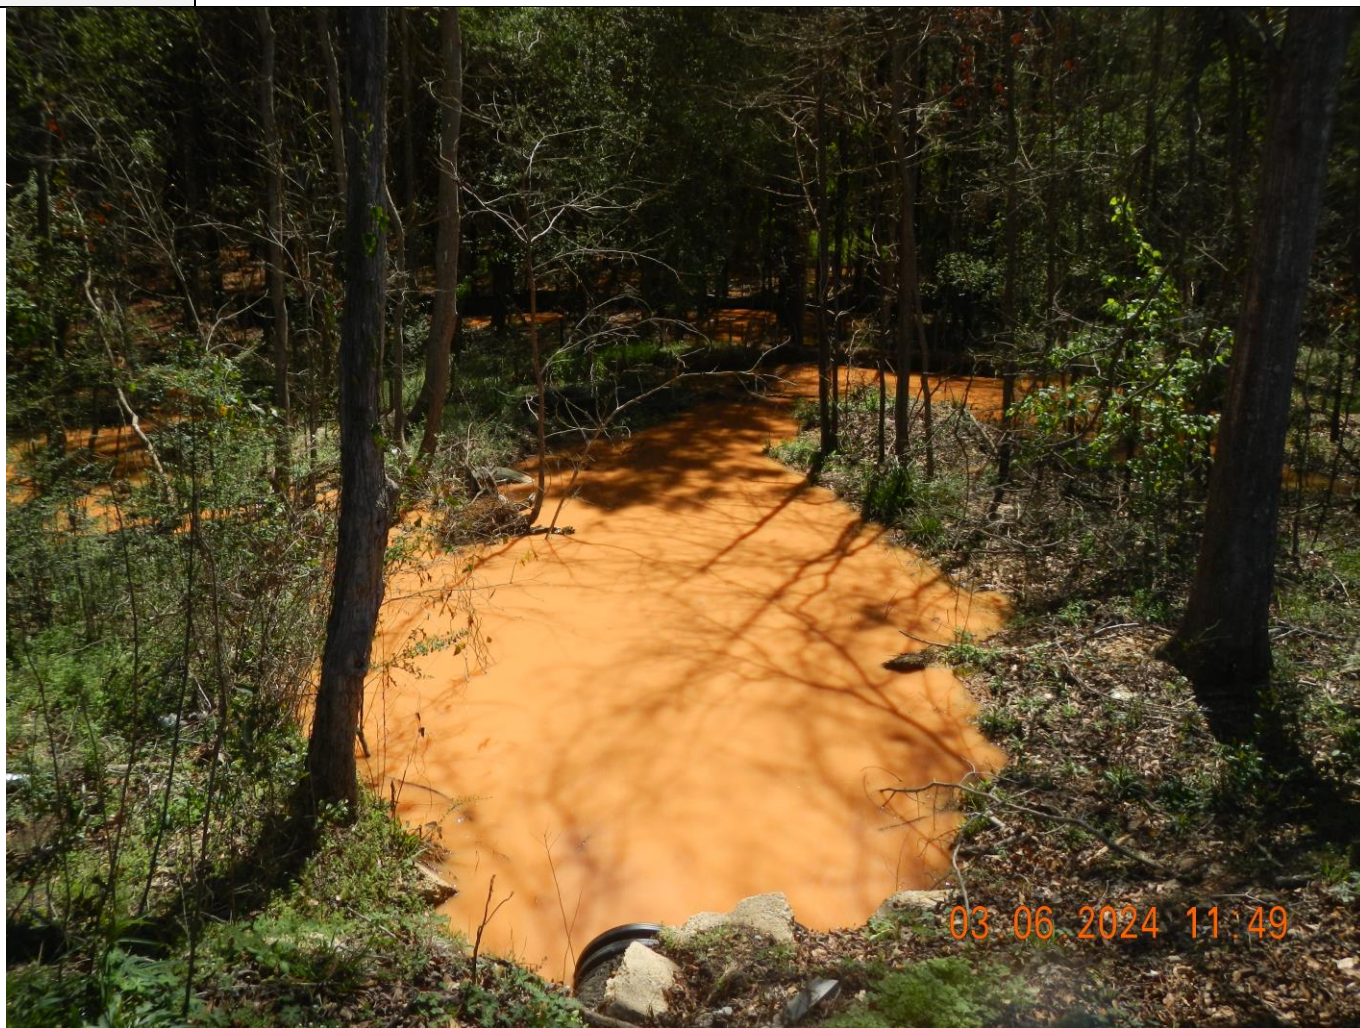
| <b>Photo ID:</b> | DSCN2946.JPG |

| <b>Description:</b> | Looking downgradient at the outfall and discharge from Pond #1 |

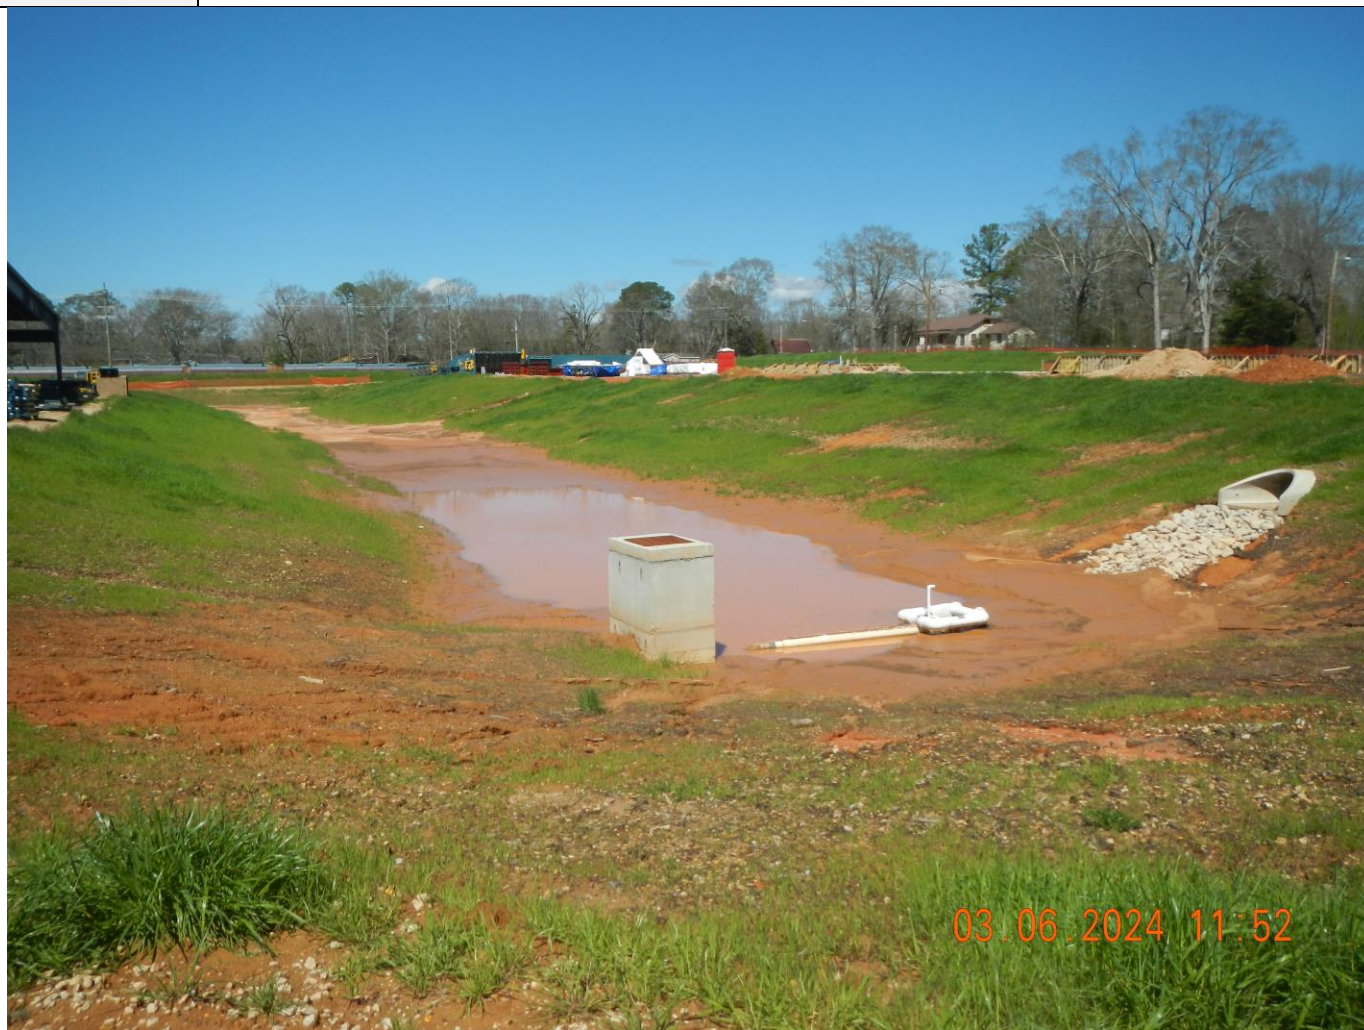
| <b>Photo ID:</b> | DSCN2947.JPG |

| <b>Description:</b> | View of Pond #1A. Riser structure discharges into Pond #1. Pond #1B discharges into this pond via the pipe on the right hand side of the photo. |

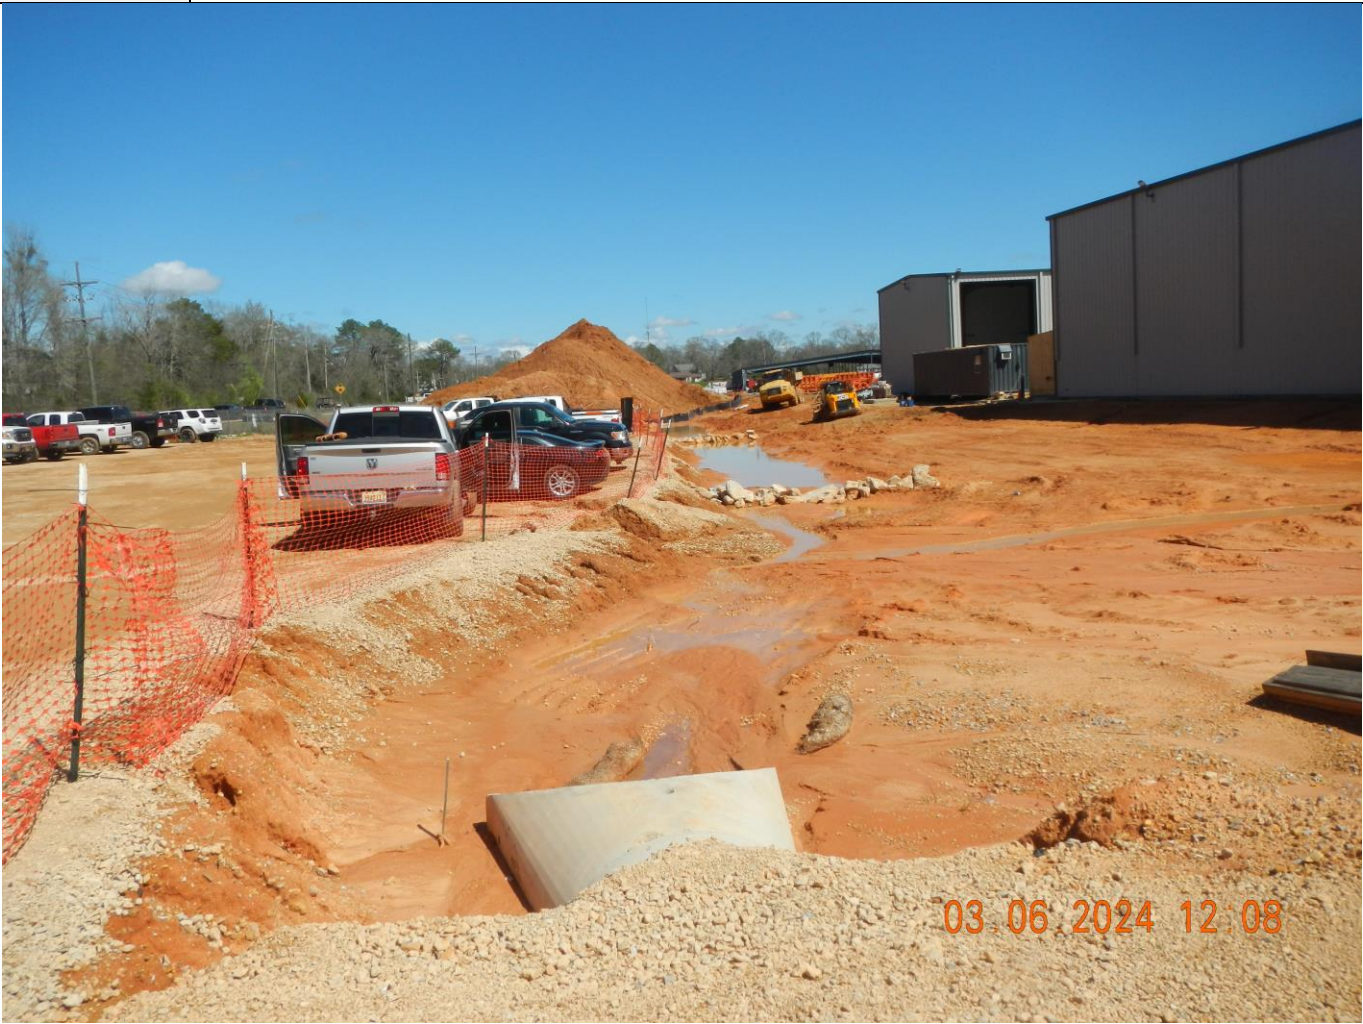
| <b>Photo ID:</b> | DSCN2952.JPG |

| <b>Description:</b> | Location of a drainage swale with rock check dams installed. |

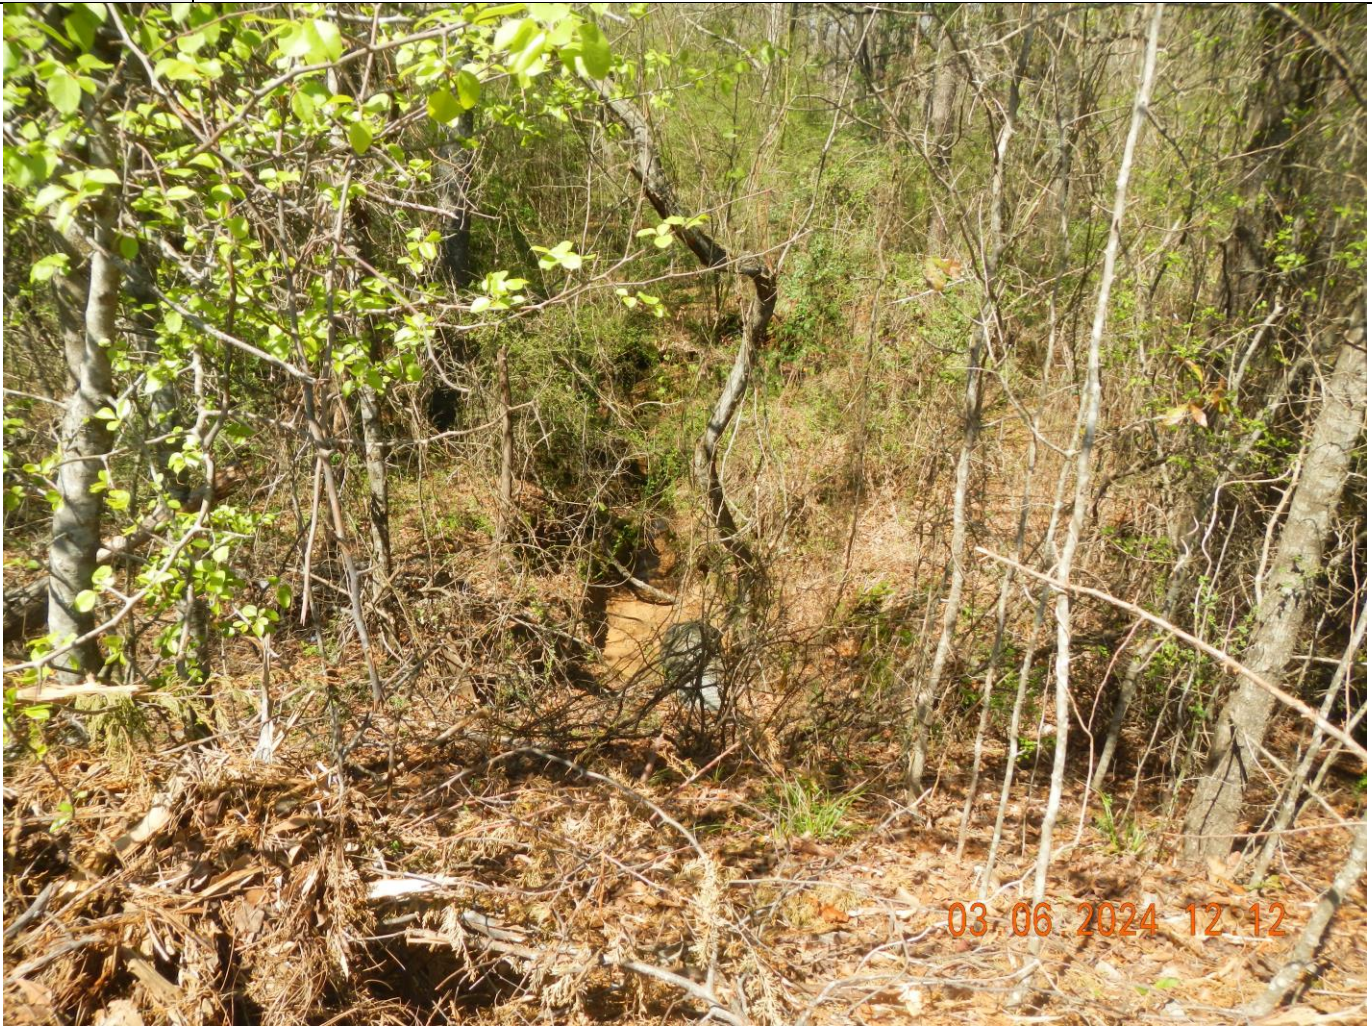
| <b>Photo ID:</b> | DSCN2953.JPG |

| <b>Description:</b> | Facility personnel identified this location as Outfall 002, which discharges runoff from the swale shown in photo DSCN2952. |

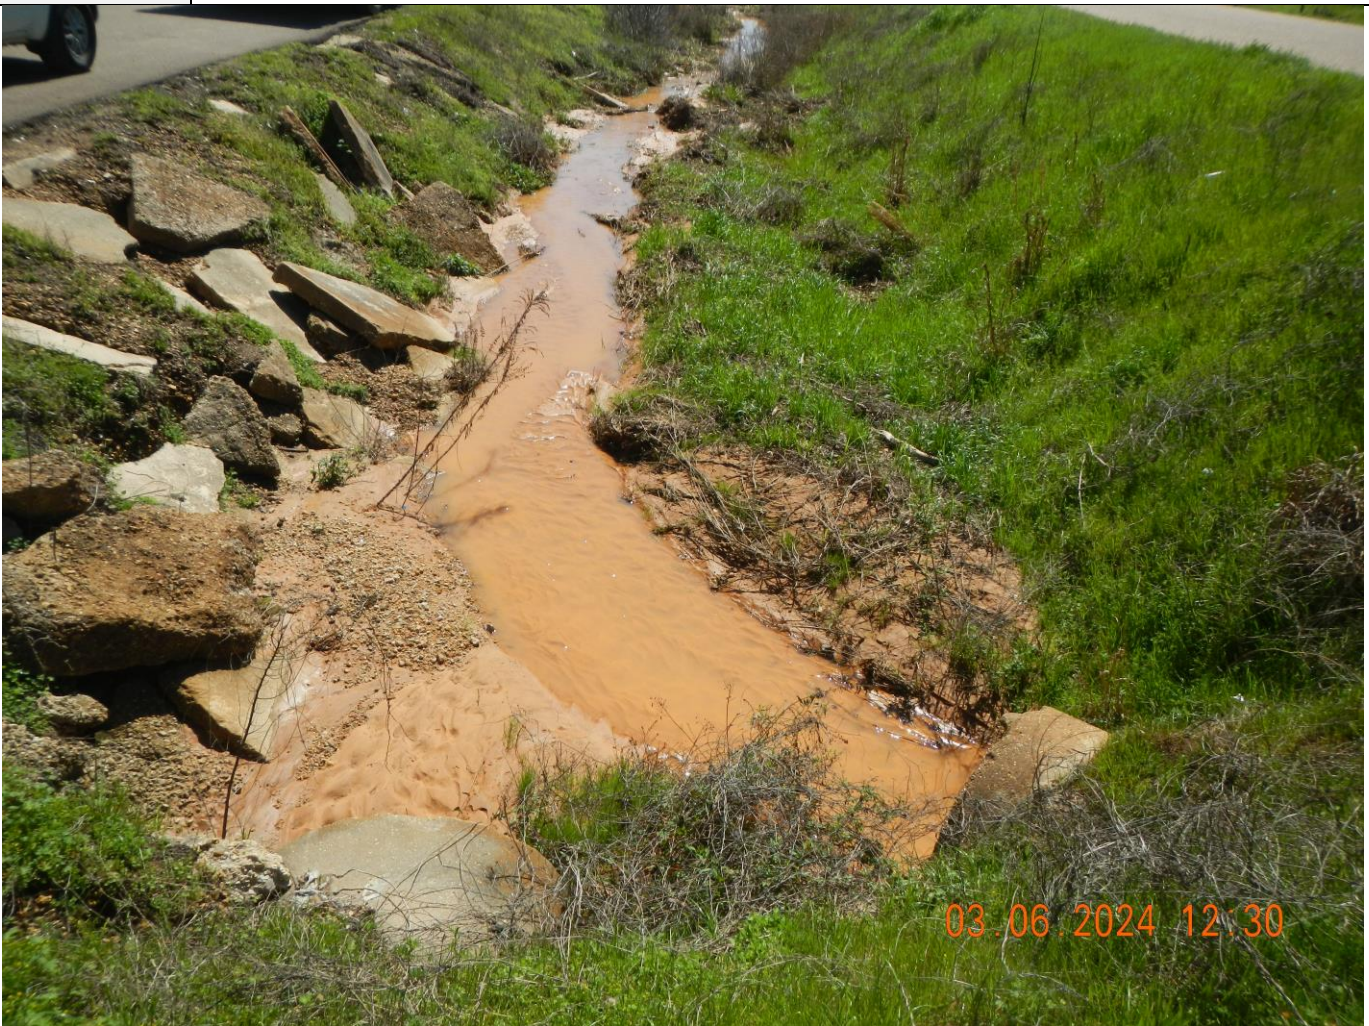
| <b>Photo ID:</b> | DSCN2954.JPG |

| <b>Description:</b> | Looking downgradient at the roadside ditch alongside E Frank Schuh Dr. The upgradient view is shown in photo DSCN2955. |

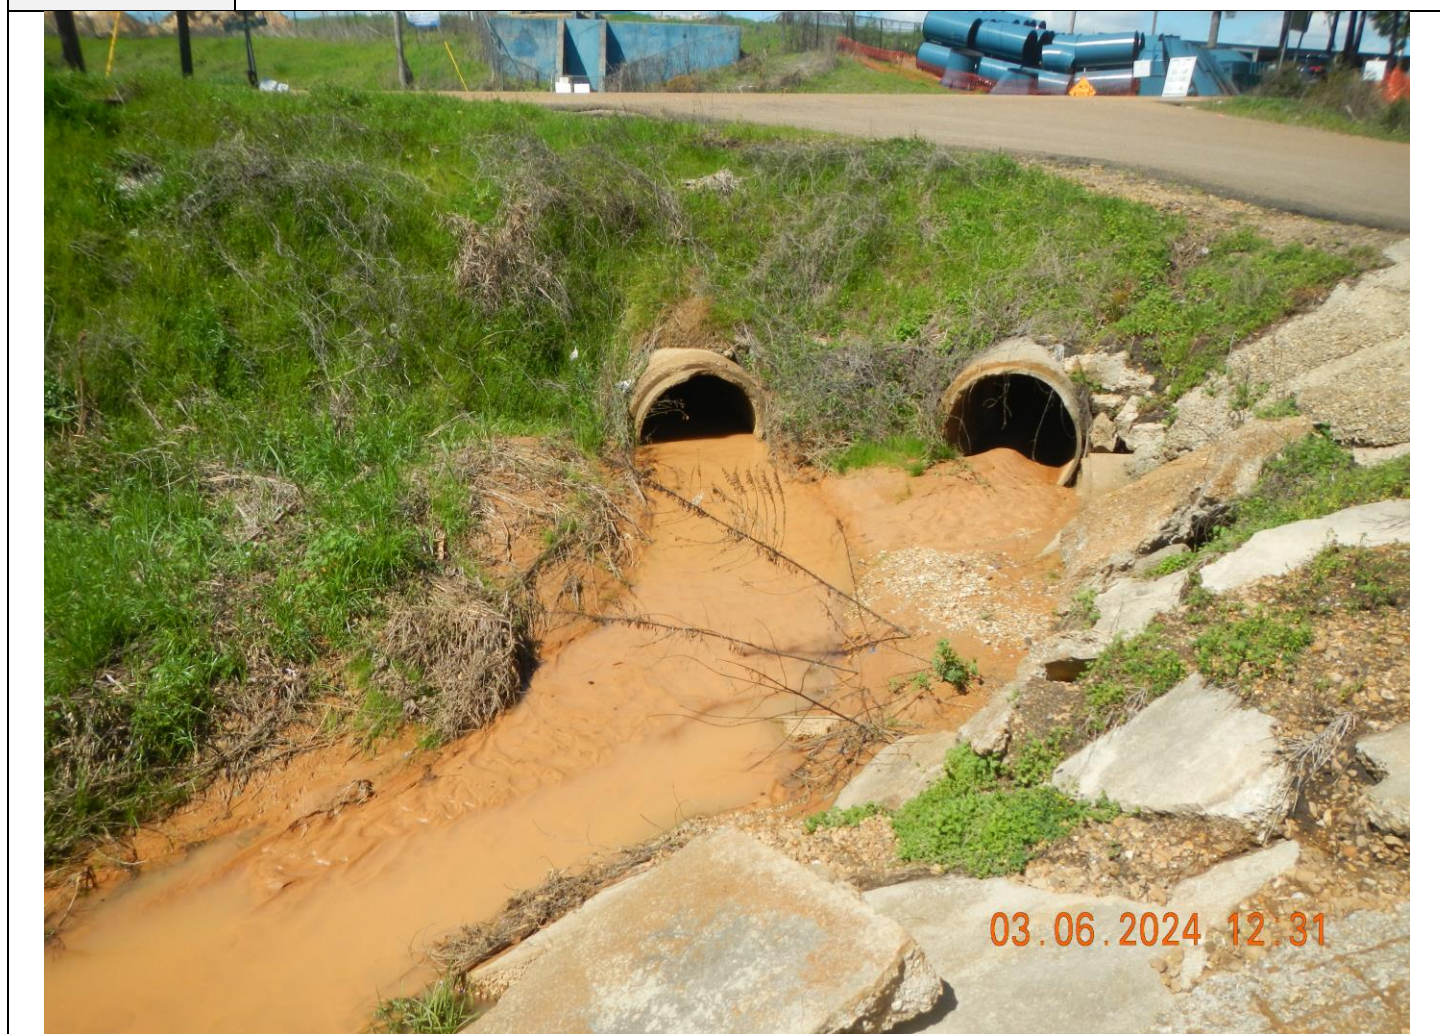
| <b>Photo ID:</b> | DSCN2955.JPG |

| <b>Description:</b> | Looking upgradient. Sediment deposition in the roadside ditch south of the site. See also photo DSCN2954 and 2956. |
