PHOTO LOG

| Facility Name: | Gloster Forest Products CSW |
| EPA Media: | Stormwater - Industrial |

| Date Stamp: | 3/6/2024 |

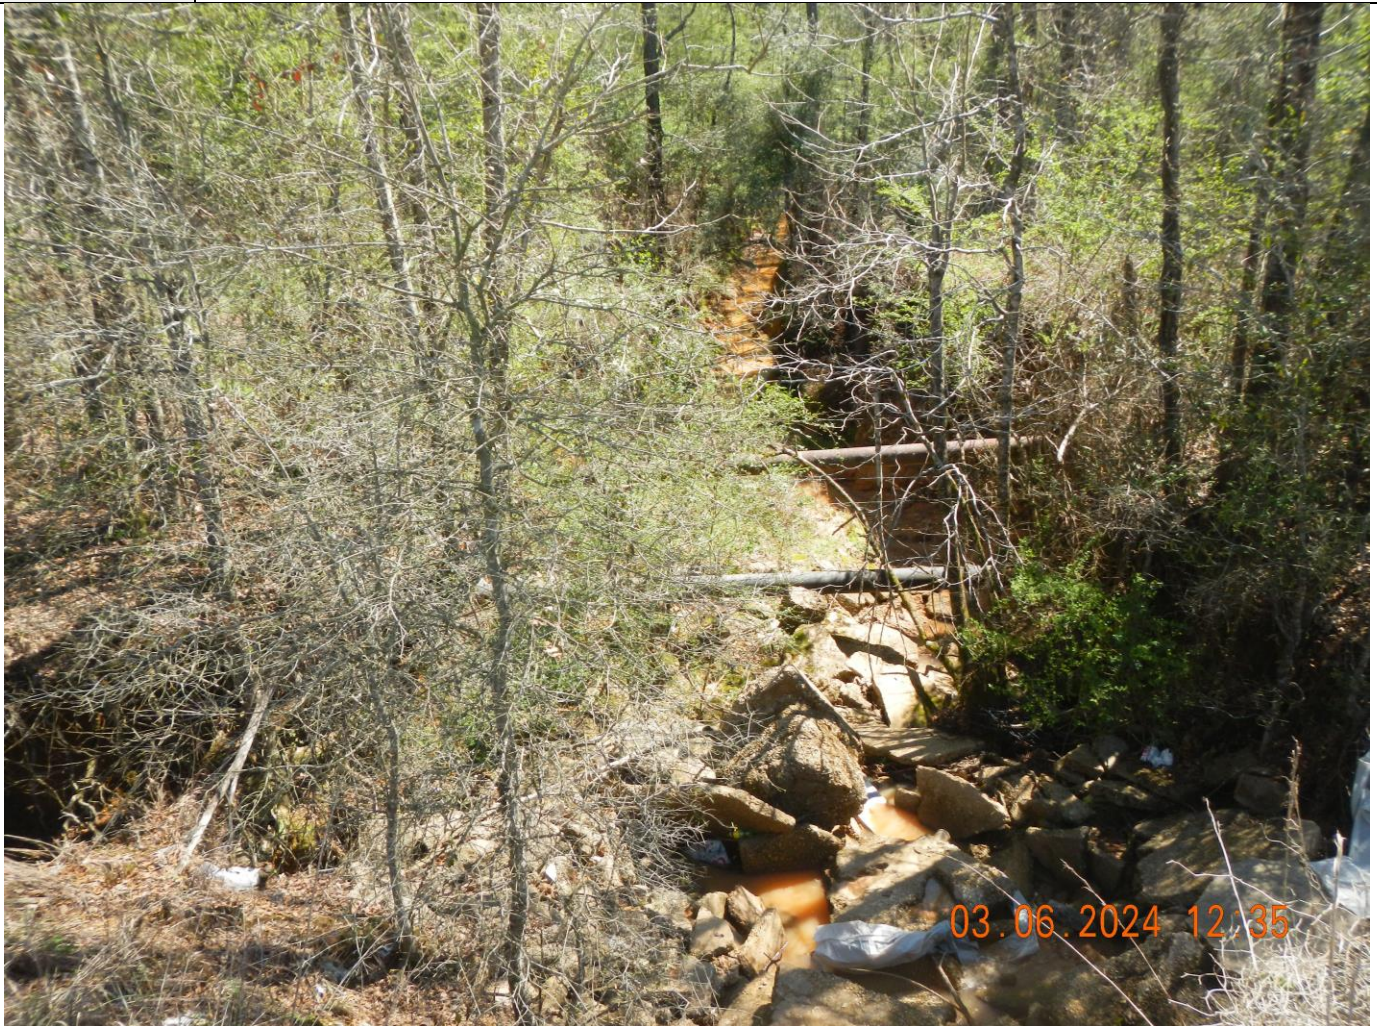
| <b>Photo ID:</b> | DSCN2956.JPG |

| <b>Description:</b> | Looking downgradient at the conveyance between the roadside drainage system shown in photo DSCN2954 and an unnamed tributary of Little Beaver Creek. |

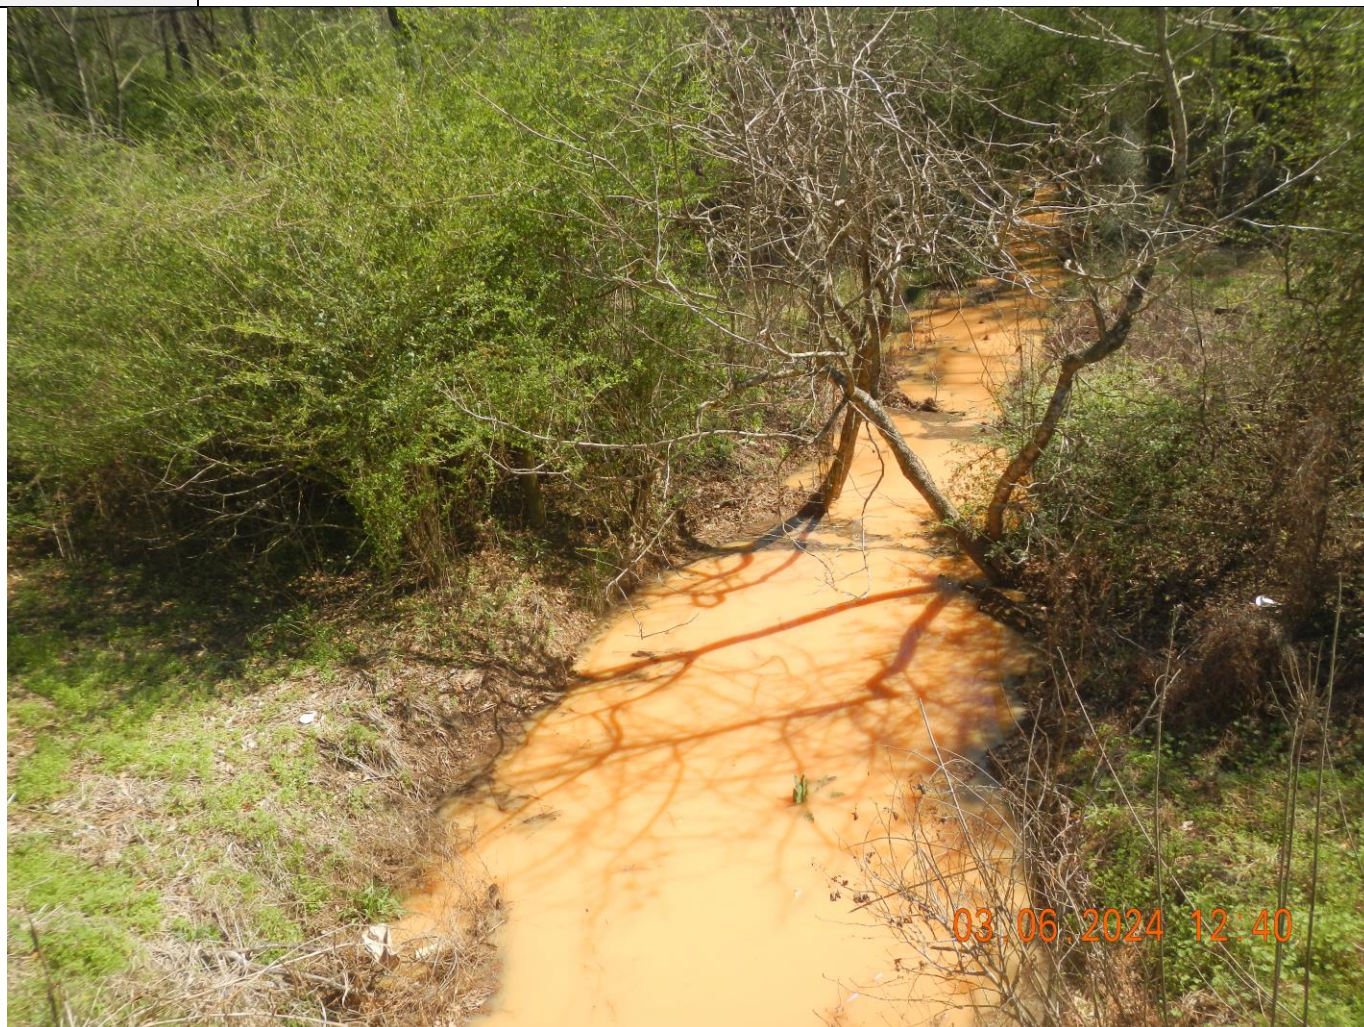
| <b>Photo ID:</b> | DSCN2957.JPG |

| <b>Description:</b> | Looking downgradient at the unnamed tributary of Little Beaver Creek, as viewed from Lower Gloster Rd/MS-24 immediately downstream of the dam of the adjacent pond (photo DSCN2938). For additional location information, please refer to the overview map on Page 1. |
