**Region 6 Compliance Assurance and Enforcement Division  
INSPECTION REPORT**

| Inspection Date(s): | 4/24 & 26/2024 | | |
| Company Name: | <b>Entergy Louisiana, LLC</b> | | |
| Facility Name: | <b>Sterlington Generating Plant</b> | | |

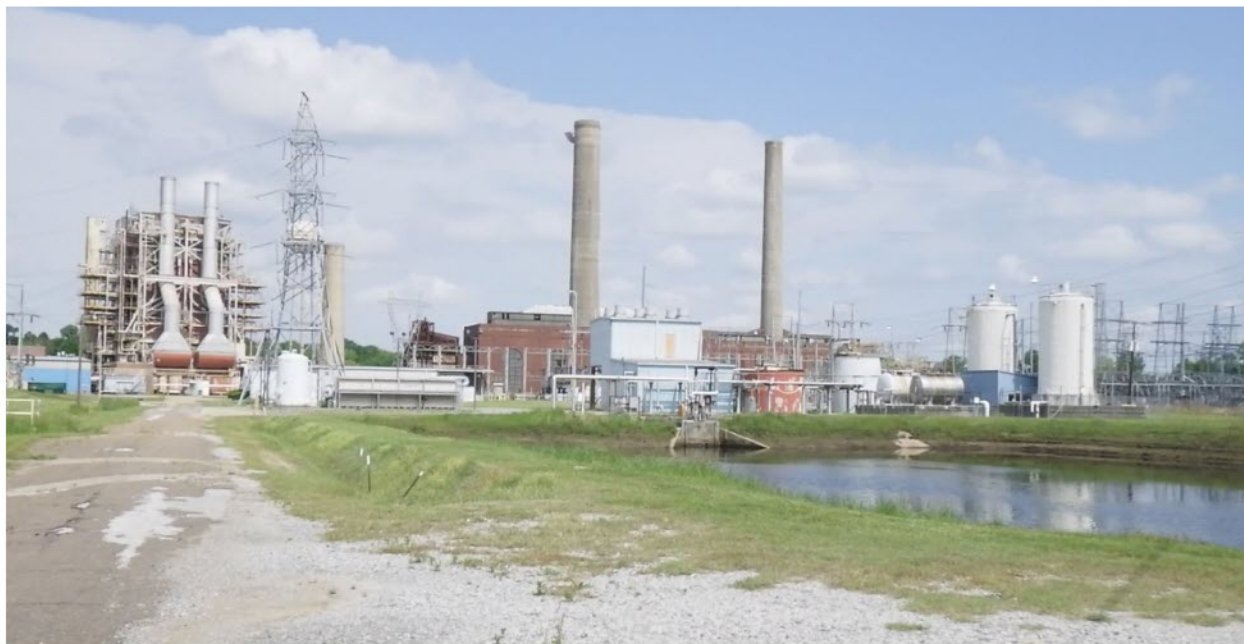
This outfall includes an intermittent discharge of overflow from the stormwater surge pond. This outfall is active. There was no flow or discharge at the time of the inspection (See Photo No. 1 in Appendix 1).

Photograph File Name: FacilitySiteOutfall007.JPG  
Date of Photograph: 04/24-26/2024  
Latitude and Longitude: 32.703151 -92.08103  
Orientation: N  
Map Datum: WGS-84  
Time of Photo: 09:00 AM  
Photographer: Jack Arias  
Description: This image shows the entrance of the facility.

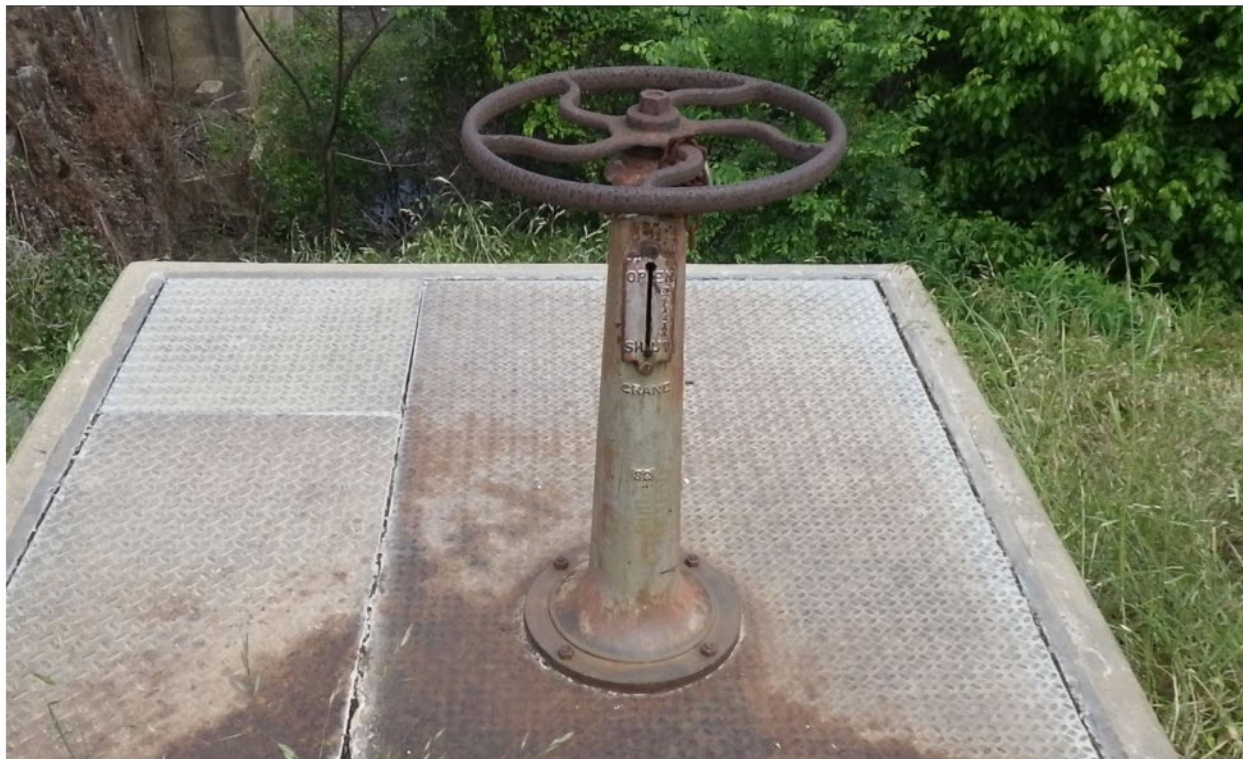
Photo No. 2

The Sterlington Generating Plant (SGP) is not active or in operation. SGP is retiring operations and stopped intake of river water (see Photo Nos. 2 - 3 in Appendix 1).

Description: This image shows the outfall 003 and water intake pump that intake fresh water from Quachita River for the cooling and industrial processes at the facility.

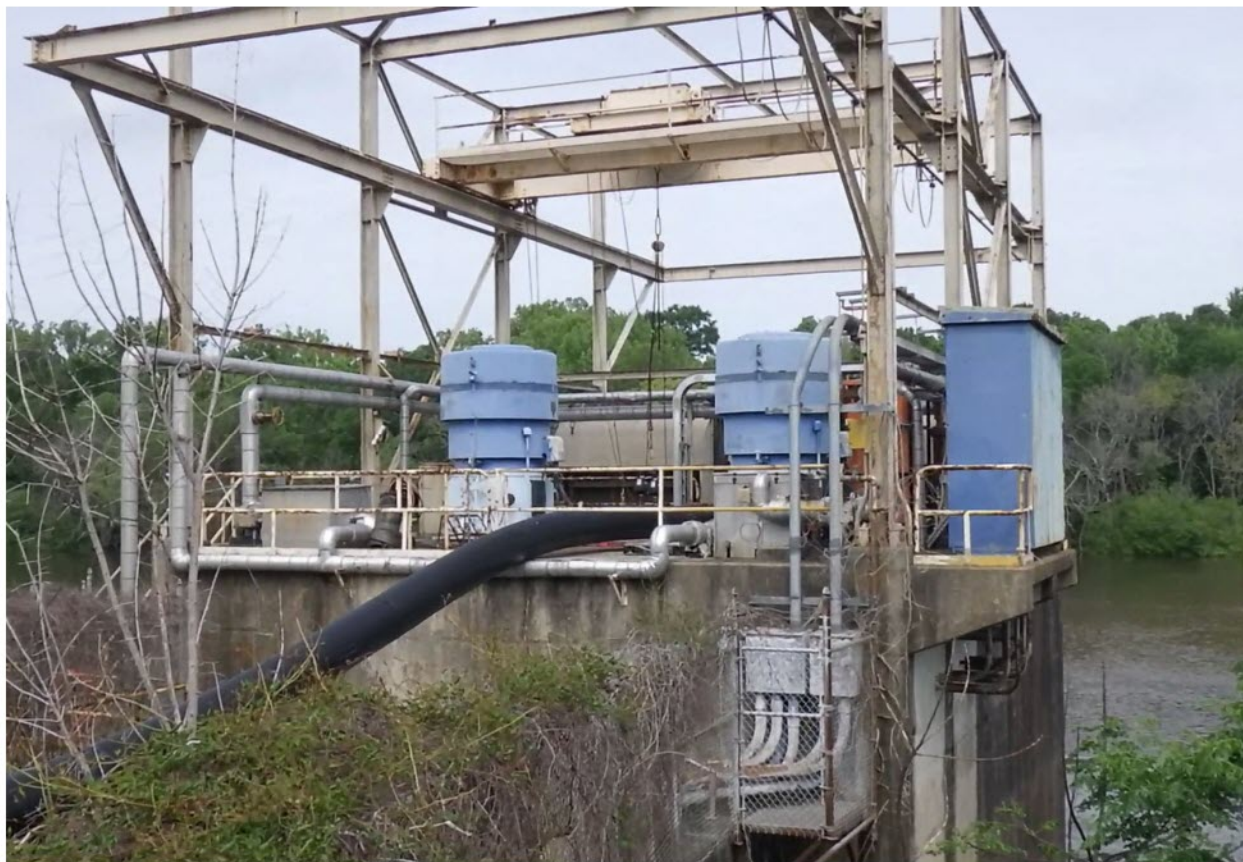
This outfall includes an intermittent discharge of low contamination potential storm water runoff from an area located southwest of the generating station administrative building. Outfall 003 is only used during emergency storm events to discharge accumulated stormwater runoff from the western portion of the plant to the Ouachita River. Discharges from this area must be released manually through the opening of hand wheel valves. Discharge area is routinely routed to the Oily Waste Pond that discharges through Outfall 005. This outfall is active. There was no flow or discharge at the time of the inspection (see Photo No. 3 in Appendix 1).

Photograph File Name: PumpsIntake.JPG  
Date of Photograph: 04/24-26/2024  
Latitude and Longitude: 32.703973 -92.080971  
Orientation: W  
Map Datum: WGS-84  
Time of Photo: 9:30 AM  
Photographer: Jack Arias  
Description: This image shows the water pumps that are used to intake fresh water from Quachita River. Not in operation.

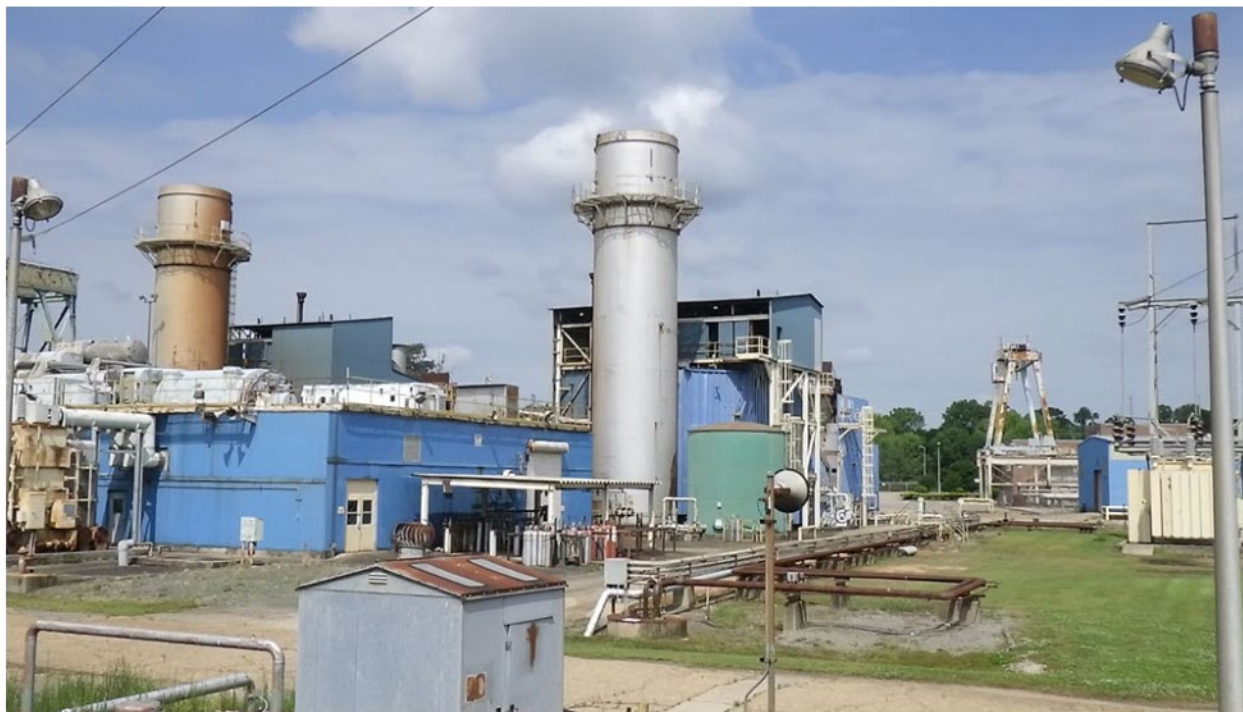
Photo No. 4

Description: This image shows the combustion area and unit 7 at the facility. Not in operation.

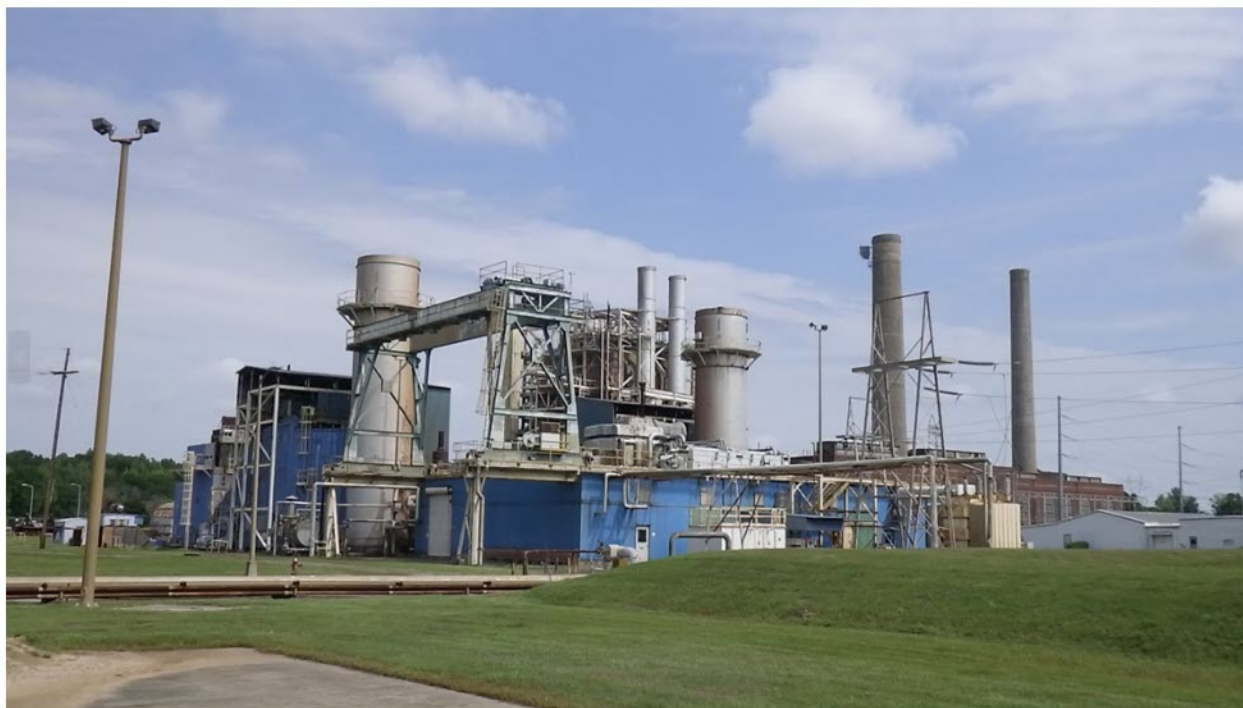
Photo No. 5

The Sterlington Generating Plant (SGP) is not active or in operation. SGP is retiring operations and stopped cooling and combustion activities at the facility (see Photo Nos. 5 - 6 in Appendix 1).

Photograph File Name: CombustionArea.JPG  
Date of Photograph: 04/24-26/2024  
Latitude and Longitude: 32.703609 -92.080025  
Orientation: NE  
Map Datum: WGS-84  
Time of Photo: 10:00 AM  
Photographer: Jack Arias  
Description: This image shows the combustion area, stacks, and unit 7 at the facility. Not in operation.

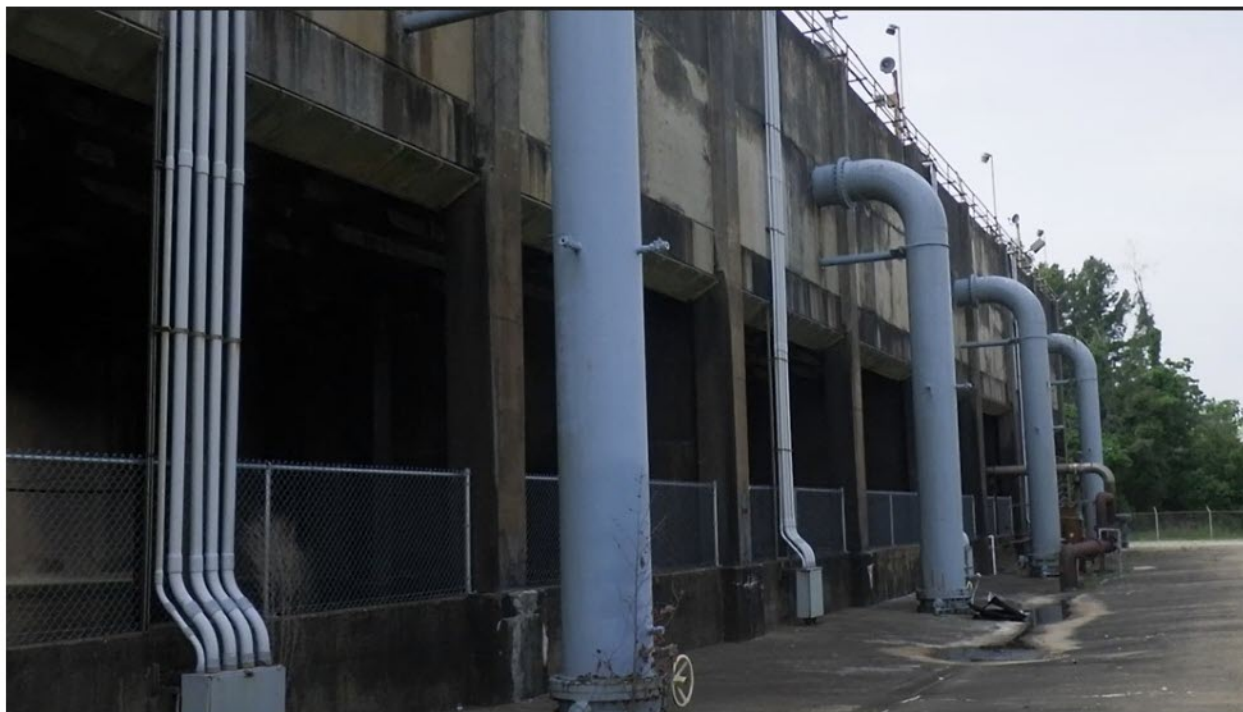
Photo No. 6

Photograph File Name: CoolingArea.JPG  
Date of Photograph: 04/24-26/2024  
Latitude and Longitude: 32.701138 -92.080326  
Orientation: SE  
Map Datum: WGS-84  
Time of Photo: 10:07 AM  
Photographer: Jack Arias  
Description: This image shows the cooling towers system. Not in operation.

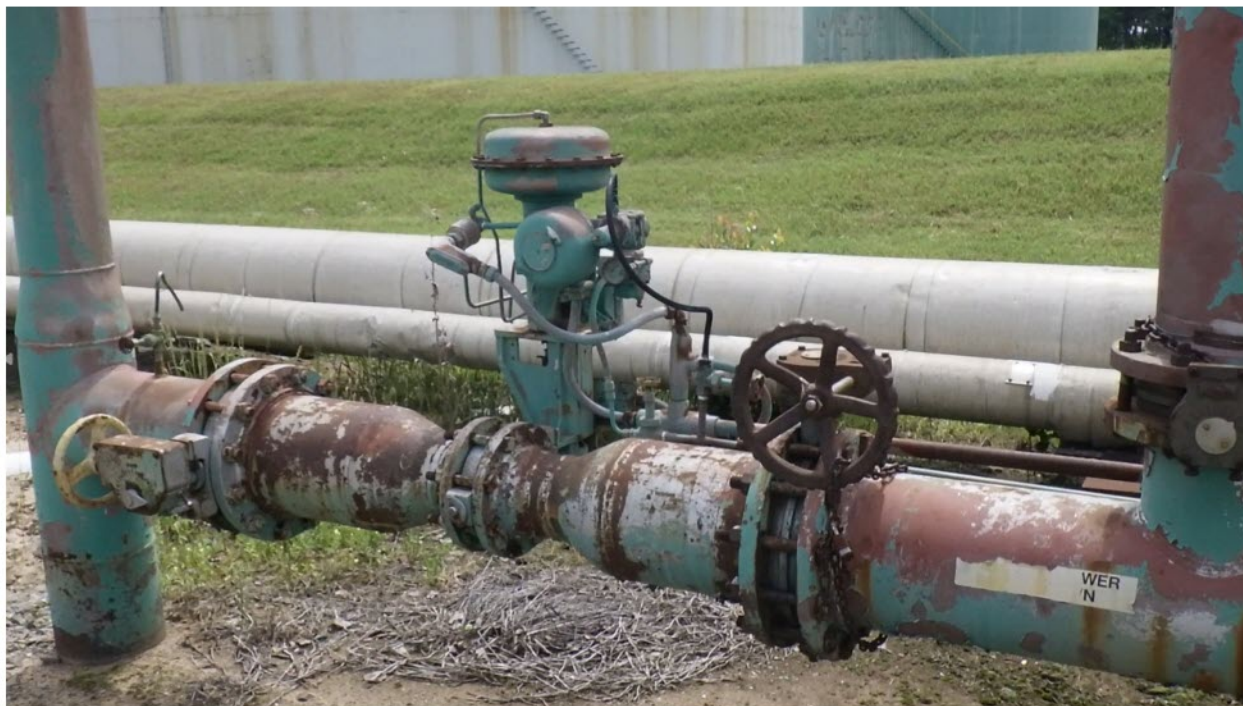
This outfall includes an intermittent discharge of hydrostatic test wastewater from hydrostatic tests conducted on various pipes, tanks, vessels, and/or equipment. This outfall is not active. There was no flow or discharge at the time of the inspection (See Photo No. 7 in Appendix 1).

Photograph File Name: Outfall205.JPG  
Date of Photograph: 04/24-26/2024  
Latitude and Longitude: 32.701721 -92.079981  
Orientation: E  
Map Datum: WGS-84  
Time of Photo: 10:15 AM  
Photographer: Jack Arias  
Description: This image shows the outfall 001 system.

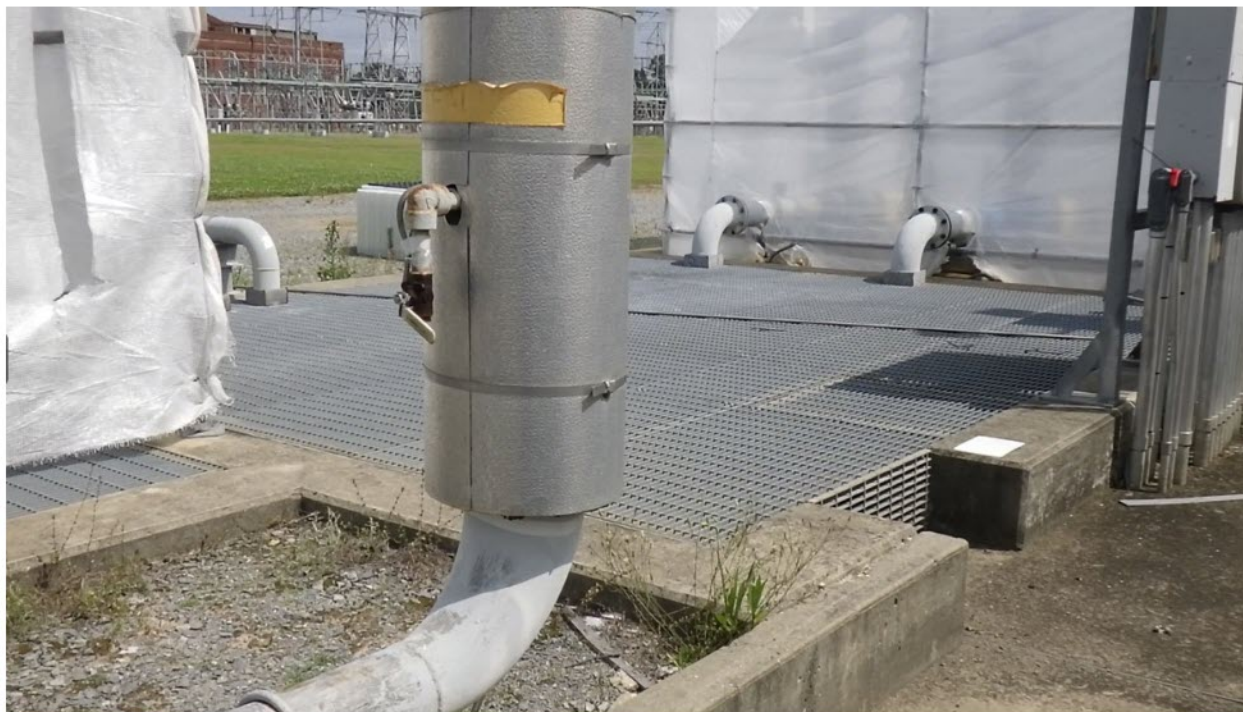
This outfall includes an intermittent discharge of first flush stormwater from the oil/water separator (Internal Outfall 305) and post first flush stormwater from the main plant area including low volume wastewaters as defined by 40 CFR 423, together with wastewater from boiler blowdown, spent acid, spent caustic, ammonia, and rinse water from demineralizer/regeneration system, laboratory drains, clarifier blowdown, contracted water treatment equipment, and seal water leak off; low contamination potential purged groundwater; maintenance wastewaters, including but limited to, pressure washing of floors, vehicle and building rinse waters (without the use of biodegradable detergents); fire system test wastewater; decommissioning waters; Unit 7 cooling tower drift and minimal flow control valve leakage; previously monitored hydrostatic test wastewater (Internal Outfall 205); and previously monitored metal cleaning and chemical metal cleaning wastewater (Internal Outfall 105). This outfall is not active. There was no flow or discharge at the time of the inspection (See Photo No. 8 in Appendix 1).

Photograph File Name: Outfall005.JPG  
Date of Photograph: 04/24-26/2024  
Latitude and Longitude: 32.70208 -92.079829  
Orientation: E  
Map Datum: WGS-84  
Time of Photo: 10:20 AM  
Photographer: Jack Arias  
Description: This image shows the outfall 005 system.

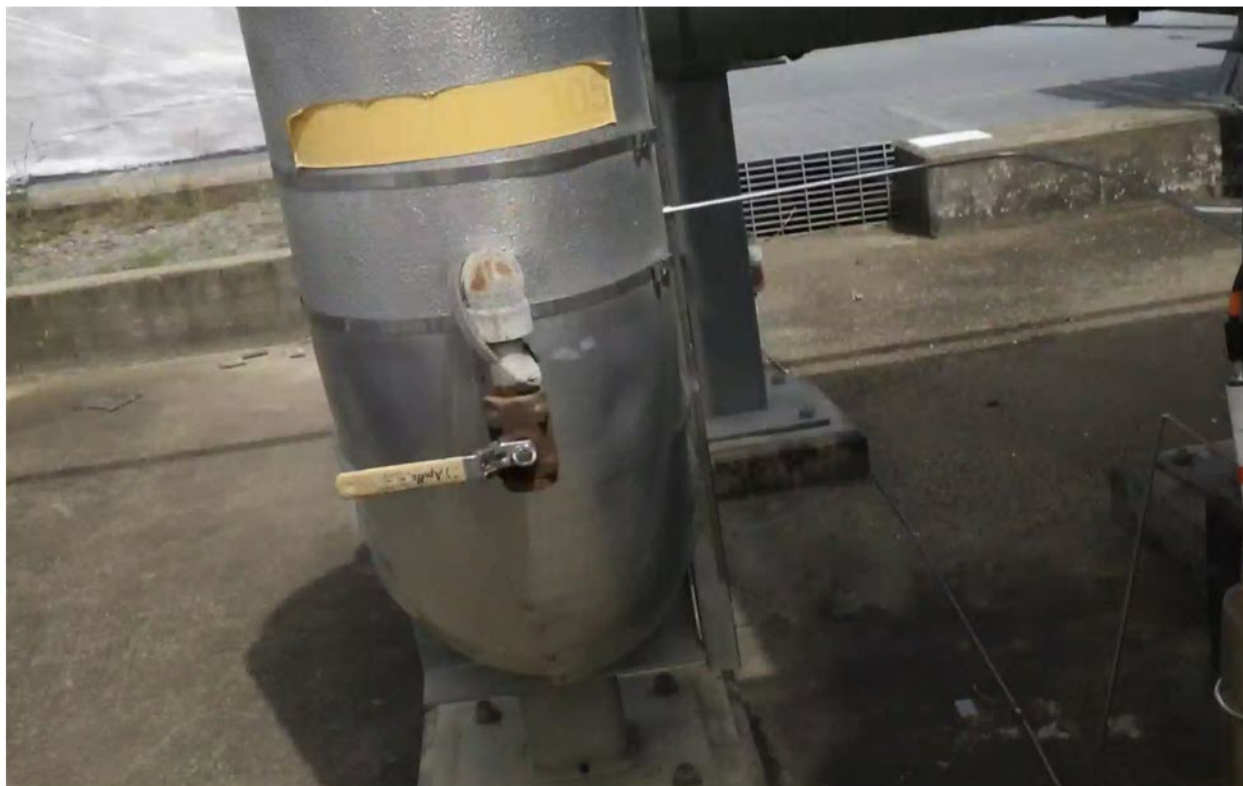
This outfall includes an intermittent discharge of first flush stormwater and process water from the main plant area and the switchyard including low volume wastewaters; low contamination potential purged groundwater: miscellaneous non-process wastewaters; fire system test wastewater; decommissioning waters; unit 7 cooling tower drift and minimal flow control valve leakage: previous monitored discharge from internal outfalls 105 and 205. This outfall is not active. There was no flow or discharge at the time of the inspection (see Photo No. 9 in Appendix 1).

Photograph File Name: Outfall305.JPG  
Date of Photograph: 04/24-26/2024  
Latitude and Longitude: 32.70208 -92.079829  
Orientation: E  
Map Datum: WGS-84  
Time of Photo: 10:30 PM  
Photographer: Jack Arias  
Description: This image shows the outfall 305 system.

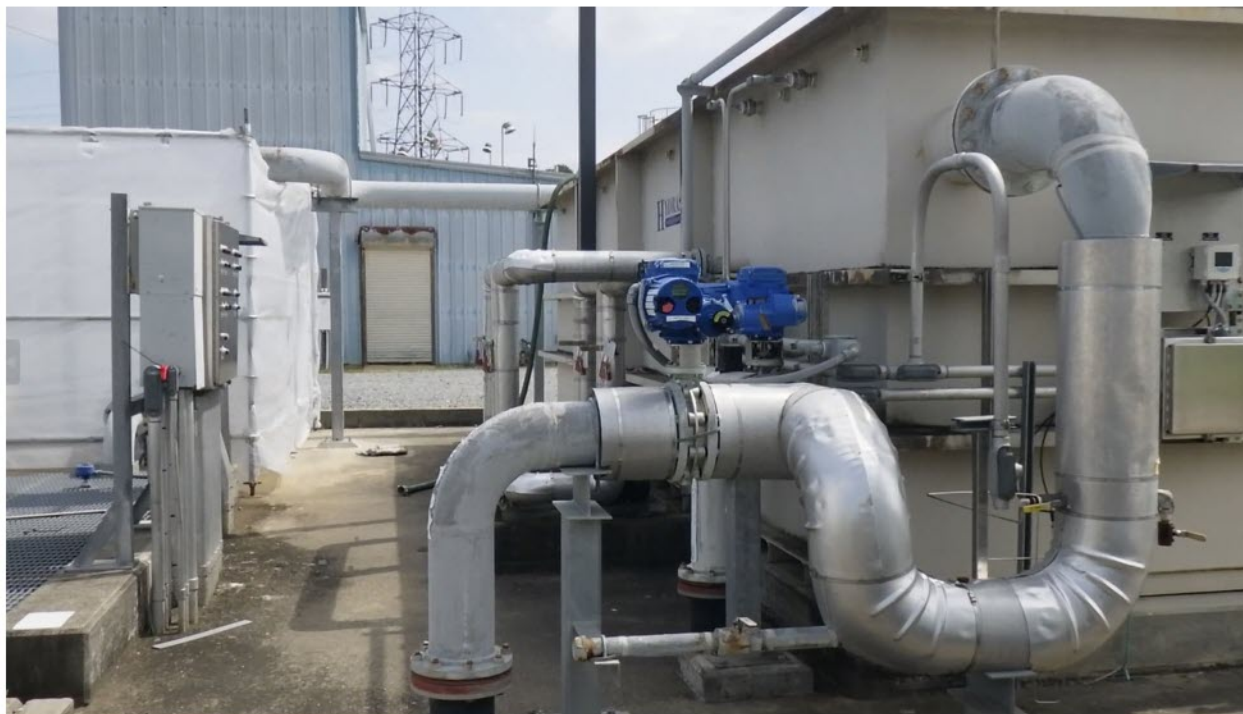
This outfall includes an intermittent discharge of decommissioning wastewaters and metal cleaning and metal chemical cleaning wastewaters, including but not limited to, chemical cleaning washwater, fireside washwater, and air preheater washwater. This outfall is not active. There was no flow or discharge at the time of the inspection (see Photo No. 10 in Appendix 1).

Photograph File Name: Unit 7Outfall105.JPG  
Date of Photograph: 04/25/2024  
Latitude and Longitude: 32.689569 -92.017883  
Orientation: E  
Map Datum: WGS-84  
Time of Photo: 10:40 AM  
Photographer: Jack Arias  
Description: This image shows unit 7 and outfall system.

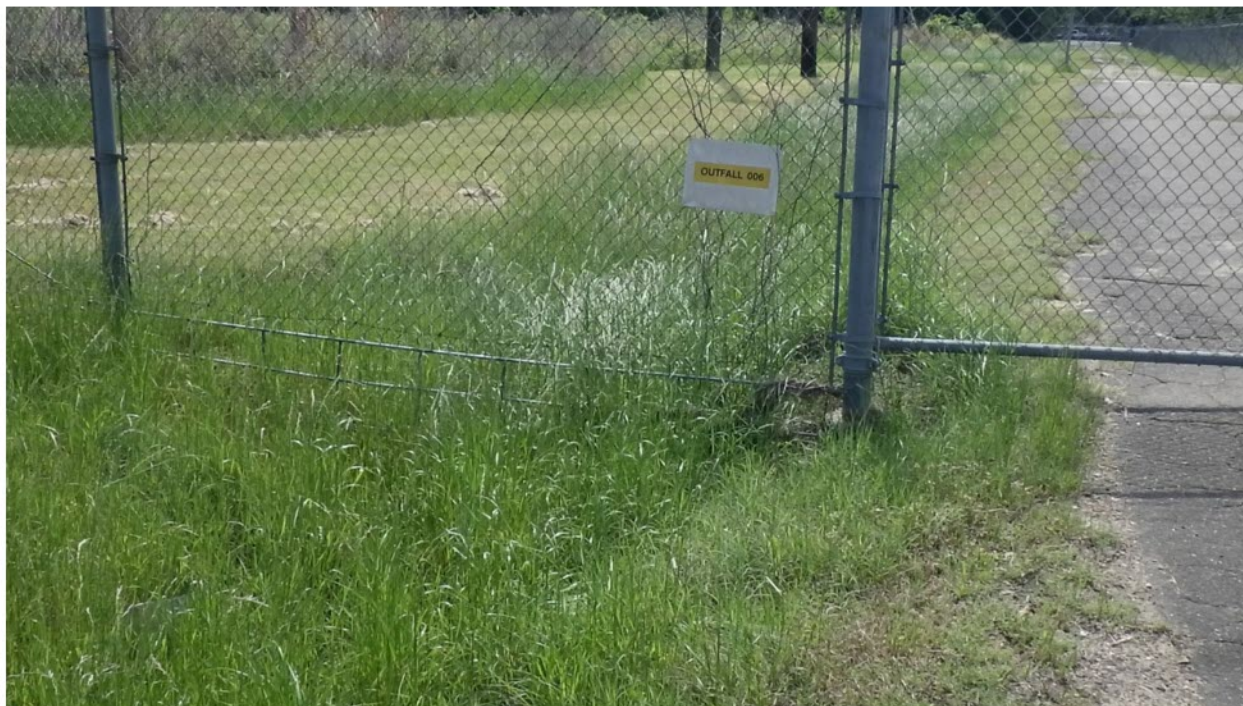
This outfall includes an intermittent discharge flow contamination potential stormwater runoff. This outfall is active. There was no flow or discharge at the time of the inspection (see Photo No. 11 in Appendix 1).

Photograph File Name: Outfall006.JPG  
Date of Photograph: 04/24-26/2024  
Latitude and Longitude: 32.701337 -92.077996  
Orientation: SE  
Map Datum: WGS-84  
Time of Photo: 10:50 AM  
Photographer: Jack Arias  
Description: This image shows outfall 006.

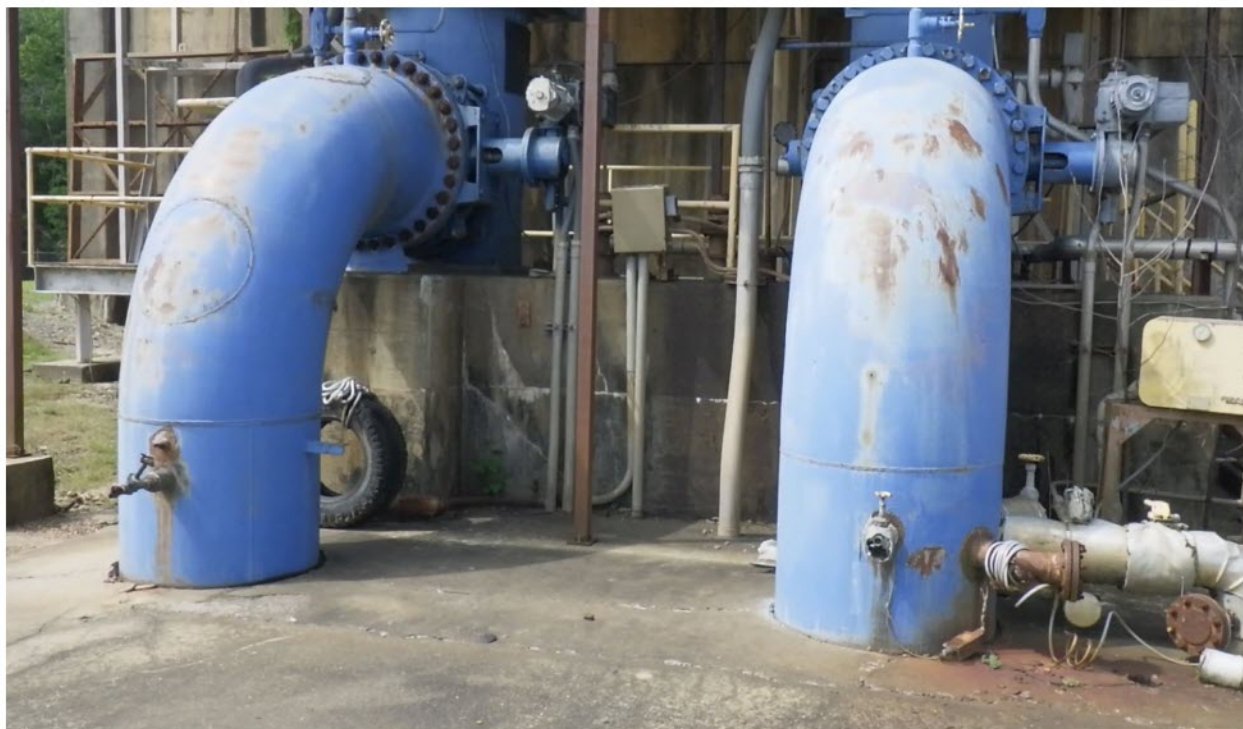
This outfall includes an intermittent discharge of cooling tower blowdown from unit 7, dust control and equipment washdown (without soaps and detergents) and decommissioning wastewaters. This outfall is not active. There was no observed flow or discharge at the time of the inspection (see Photo No. 13 in Appendix 1).

Photograph File Name: Outfall001.JPG  
Date of Photograph: 04/24-26/2024  
Latitude and Longitude: 32.701329 -92.080034  
Orientation: SE  
Map Datum: WGS-84  
Time of Photo: 11:20 AM  
Photographer: Jack Arias  
Description: This image shows the outfall 001.

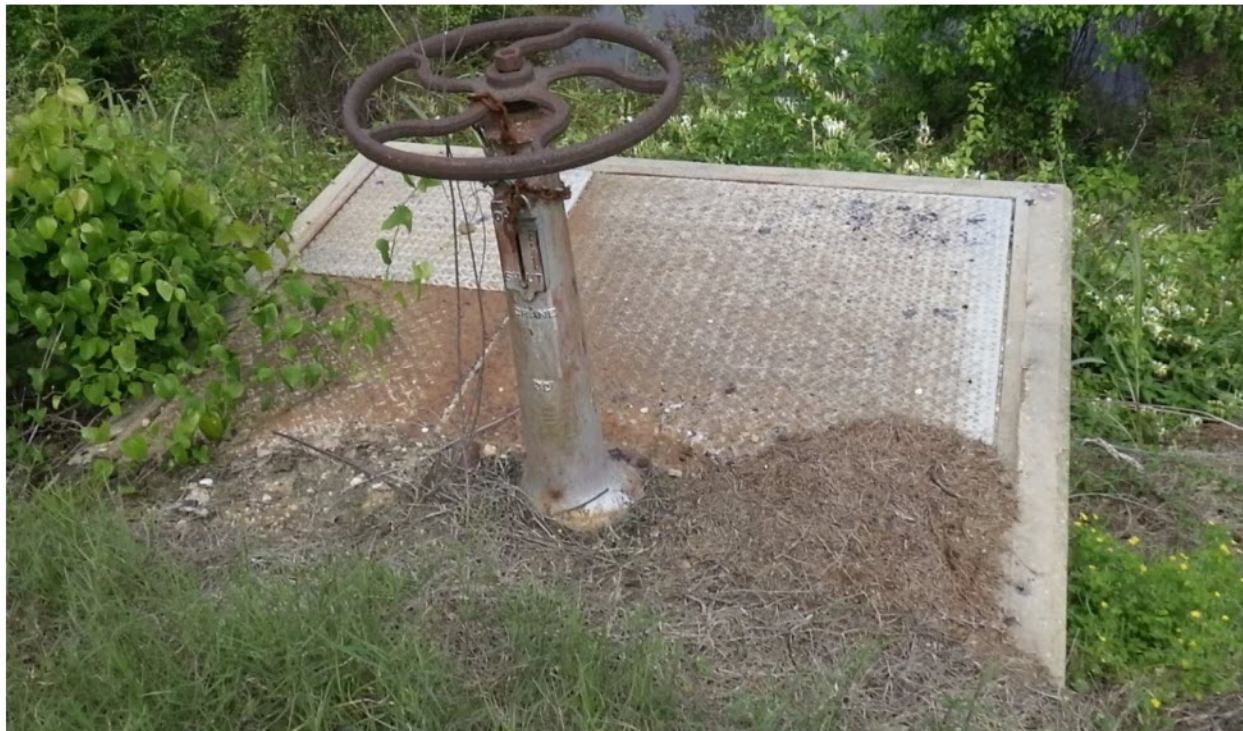
This outfall includes an intermittent discharge of low contamination potential stormwater from an area located west northwest of the generating station administrative building, only used during emergency storm events to discharge accumulated stormwater runoff from the western portion of the plant to the Ouachita River. Discharges from this area must be released manually through the opening of hand wheel valves. This discharge is routinely routed to the Oily Waste Pond that then discharges through Outfall 005. This outfall is active. There was no flow or discharge at the time of the inspection (see Photo No. 14 in Appendix 1).

Photograph File Name: Outfall004.JPG  
Date of Photograph: 04/24-26/2024  
Latitude and Longitude: 32.703878 -92.080712  
Orientation: SE  
Map Datum: WGS-84  
Time of Photo: 11:30 AM  
Photographer: Jack Arias  
Description: This image shows the outfall 004.
