## Region 6 Compliance Assurance and Enforcement Division

### INSPECTION REPORT

| Company Name: | <b>Graphic Packaging International, LLC</b> | | |
| Facility Name: | <b>West Monroe Paper Mill</b> | | |

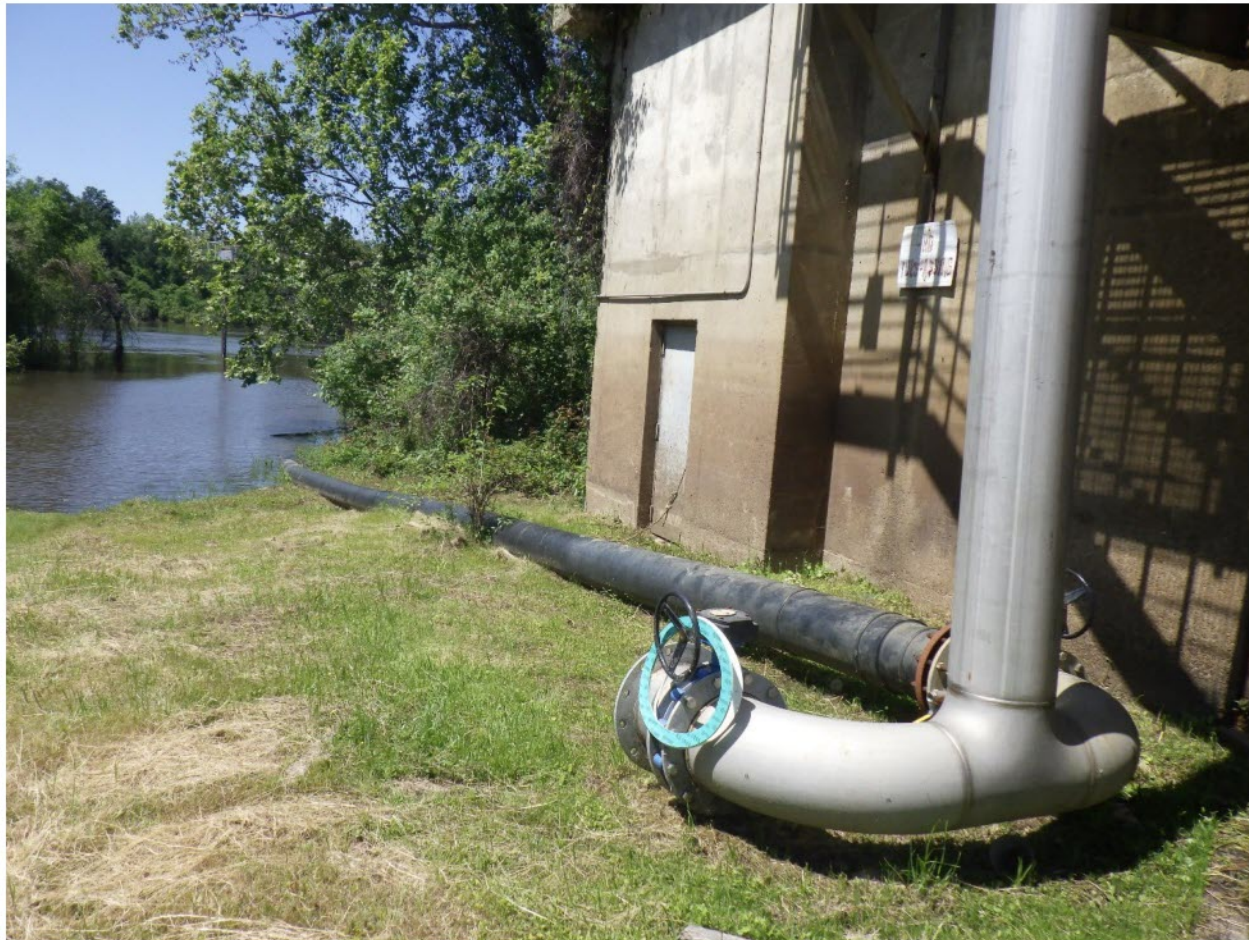
Photo No. 2

intake structure) because it was covered by water. The permit requires the design and construction of a screen with an intake velocity of 0.5 ft/s).

This image shows the Water Intake Structure that intake fresh water from Quachita River for the cooling and industrial processes at the facility. The facility actual intake inflow and withdraws from a freshwater river (Quachita River) is 8.7 MGD.

1. Facility should provide information that describes the design and operation of the closed-cycle recirculating system and addresses the potential adverse environmental impact and impingement reduction by the closed-cycle recirculating system.

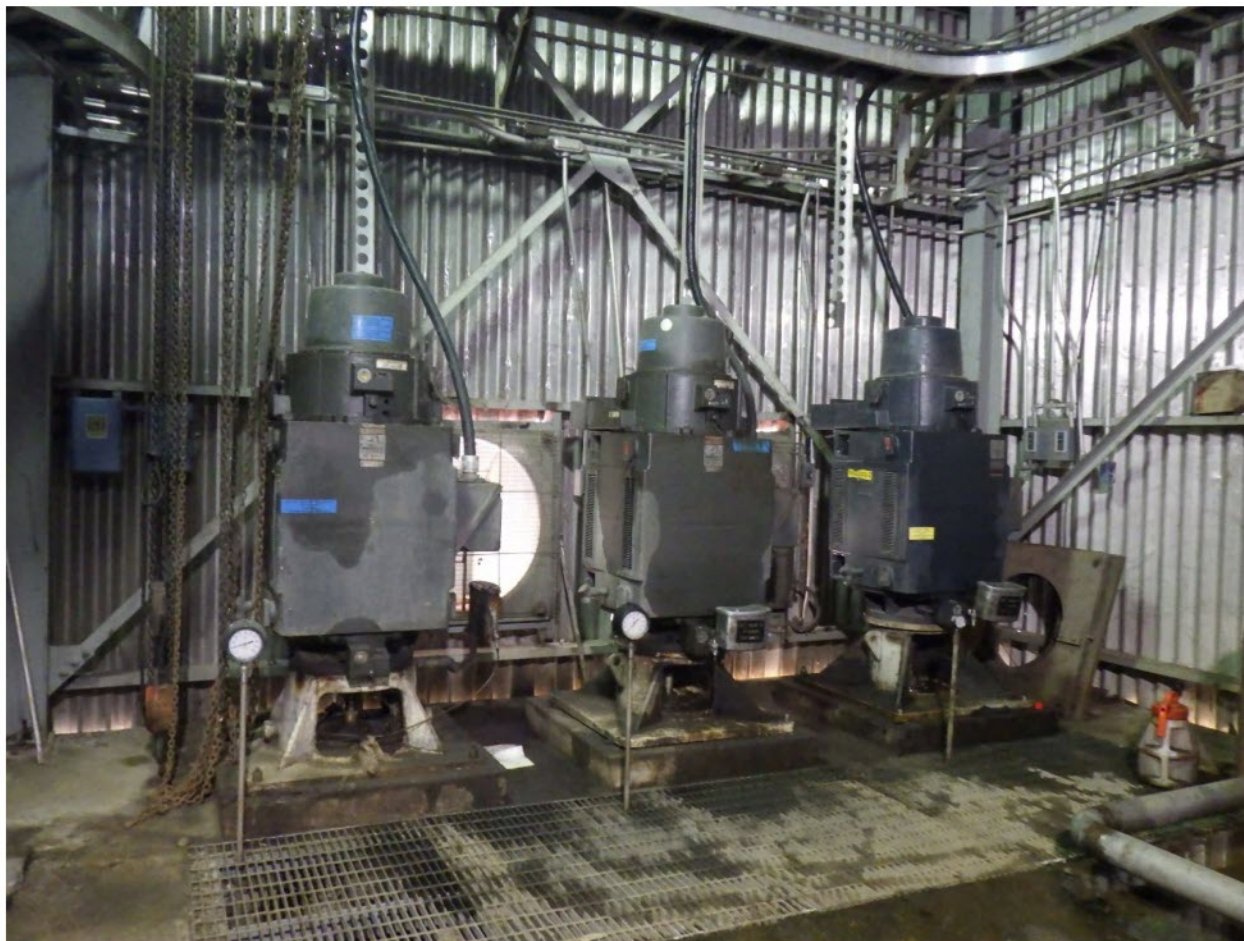
Photo No. 3

This image shows the water pumps #1, #2, and #3 that are used to intake fresh water from Quachita River for the cooling and industrial processes at the facility. The water passes through intake units through traveling pipes and screens (approximately 3/8-inch square steel mesh each) being pumped by circulating water pumps.

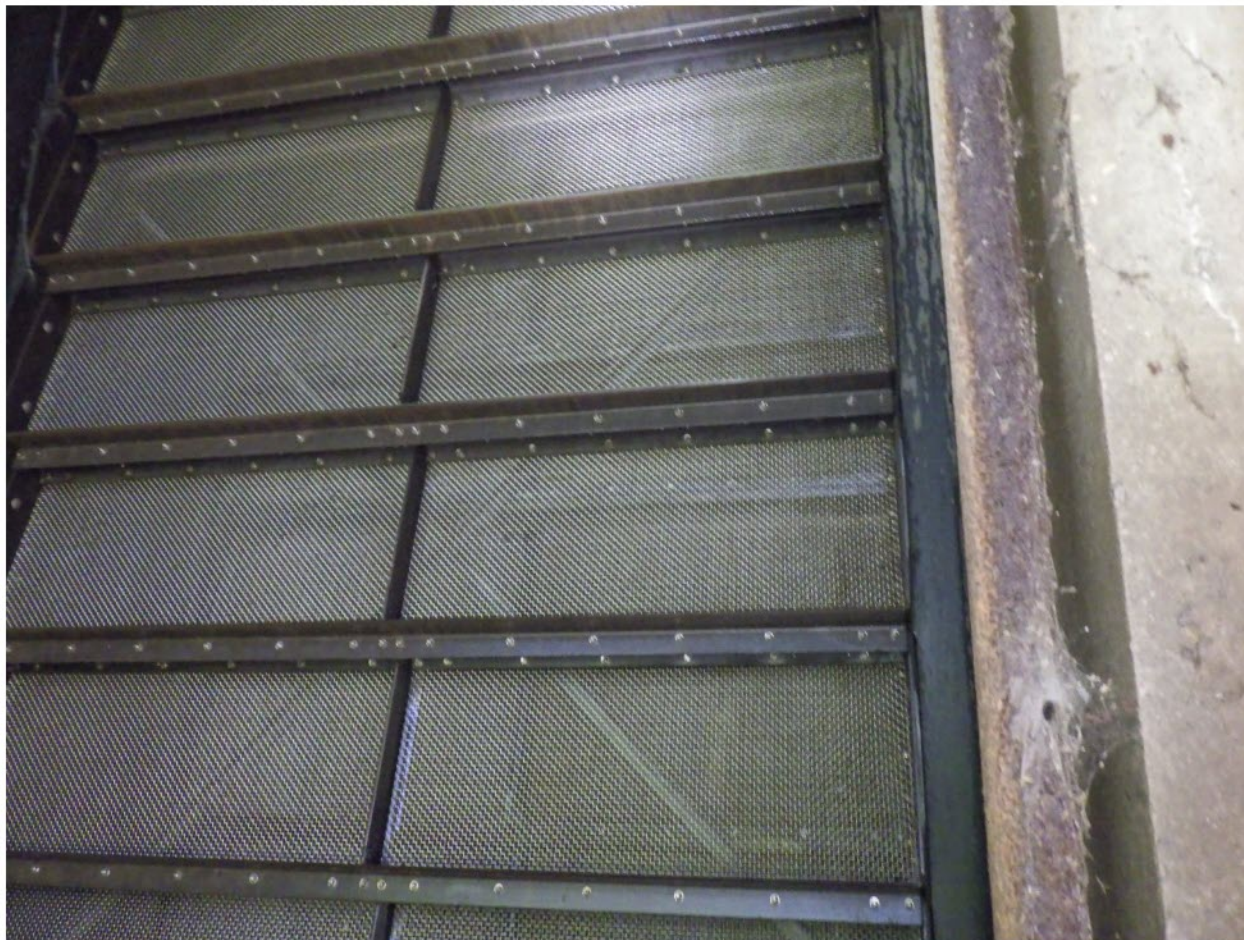
Photo No. 4

Photograph File Name: R0010833.JPG  
Date of Photograph: 04/23/2024  
Latitude and Longitud: 32.488572 -92.125388  
Orientation: E  
Map Datum: WGS-84  
Time of Photo: 11:41 AM  
Photographer: Jack Arias  
Description: This image shows screens (approximately 3/8-inch square steel mesh each) being pumped by circulating water pumps at the Water Intake Structure.

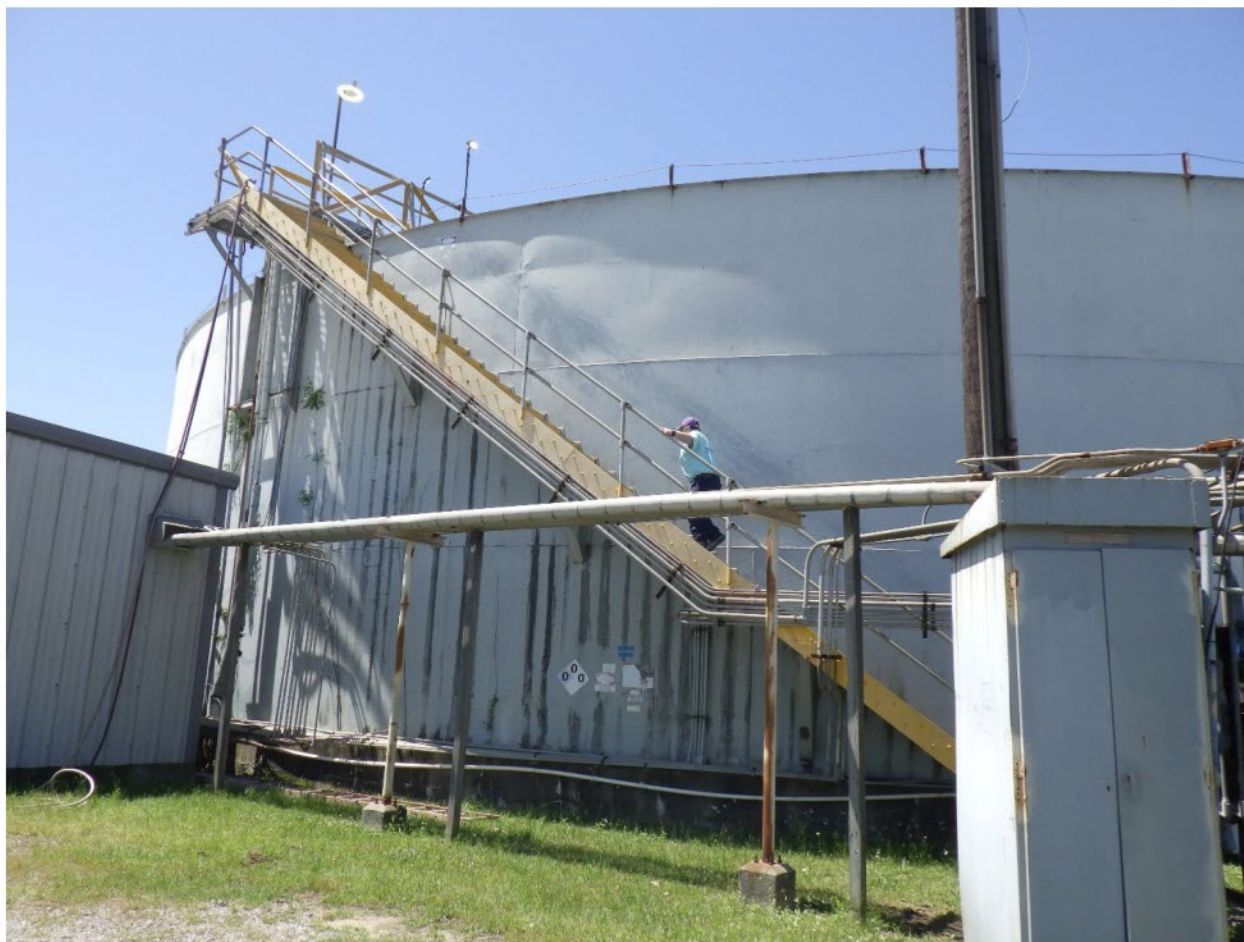
Photo No. 5

Description: This image shows the Mill River Water Clarifier Tank system (primary and secondary clarification treatment). This system removes solids/sludge from the river water (water intake procedure from Quachita River) prior to mill operations.

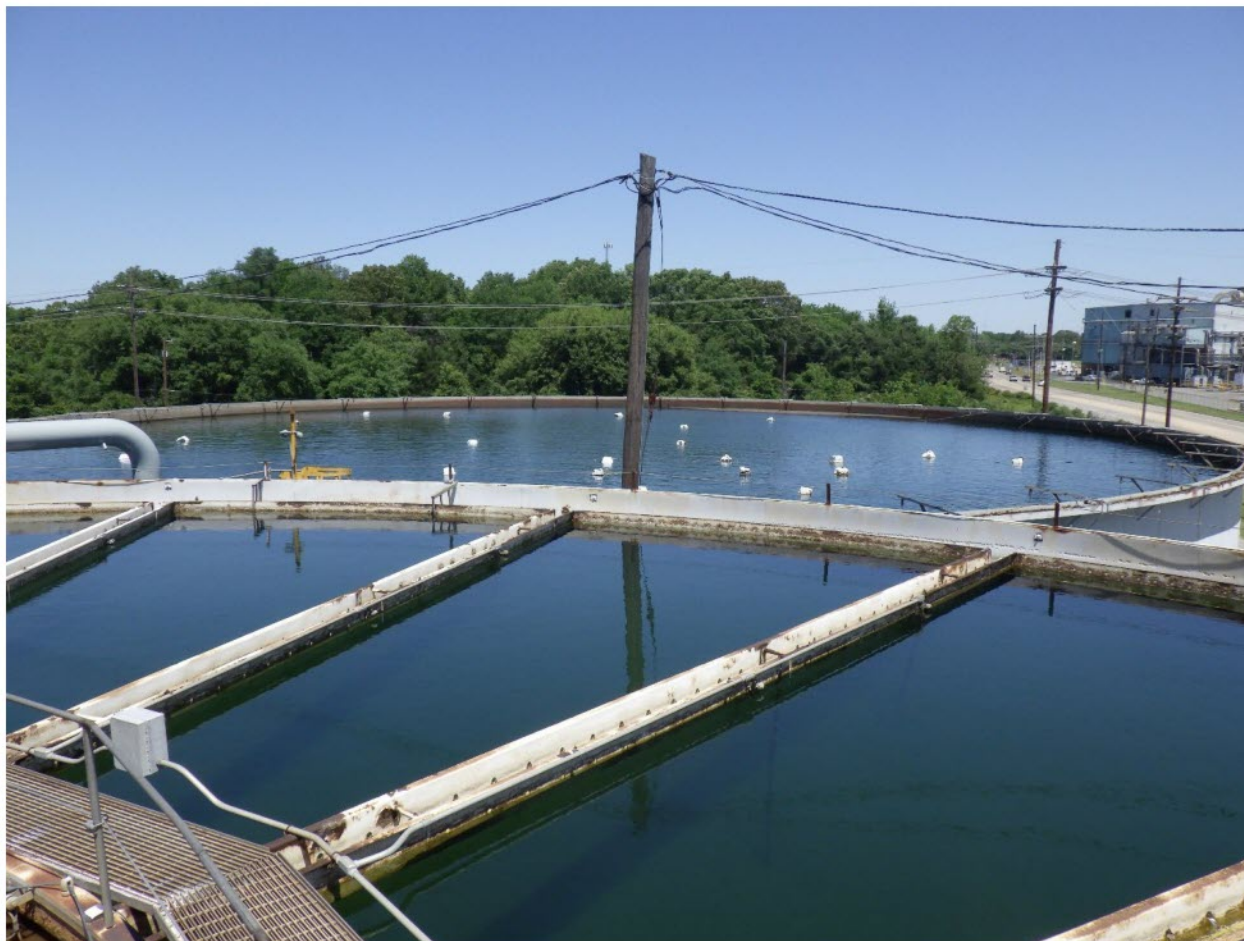
Photo No. 6

Photograph File Name: R0010846.JPG  
Date of Photograph: 04/23/2024  
Latitude and Longitude: 32.481707 -92.155541  
Orientation: W  
Map Datum: WGS-84  
Time of Photo: 12:24 PM  
Photographer: Jack Arias  
Description: This image shows inside the Mill River Water Clarifier tank system (primary clarification treatment).

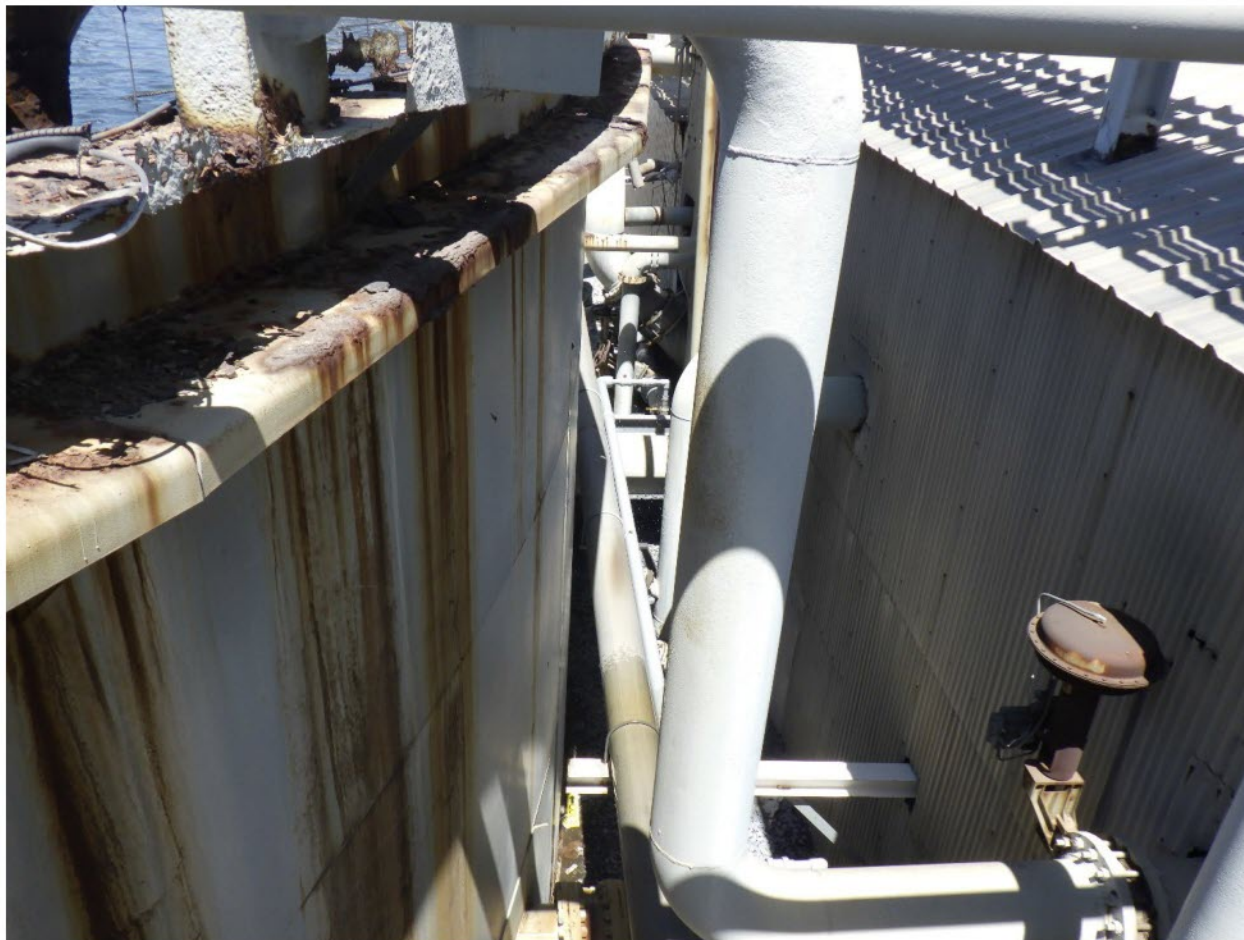
Photo No. 7

The mill water reservoir is a 1.25-million-gallon capacity holding tank for process water (river, well, and treated City of West Monroe wastewater). Its purpose is to provide capacity water to maintain mill operations for specific period of times. The reservoir provides process water in case of any temporary loss of the primary water source(s). At the time of the inspection, I observed water leaks on the containment wall of the tank and over a water valve that form part of the transfer system of process water. Also, I observed corrosion on the tank's wall and pipes as well as vegetation on the surface water of the tank. The facility needs to improve maintenance of the tank and resolve leaks, corrosion, and vegetation on the reservoir tank and structures (See Photo Nos. 7 – 9 in Appendix 1).

Description: This image shows the Mill Water Tank Reservoir. Also, this shows a water leak on the containment wall of the tank.

2. Facility should improve maintenance and resolve leaks, corrosion, and vegetation on the mill water reservoir tank and structures.
3. Facility will provide additional information (180 days after permit approval) connected to the public comments (colors in effluents discharged from outfalls 002, 003, 004, and 005 and results above the MQL for Total Aluminum outfall 401) regarding the impact of discharges on water quality from Graphic Packing new permit 2024 approval requirements.

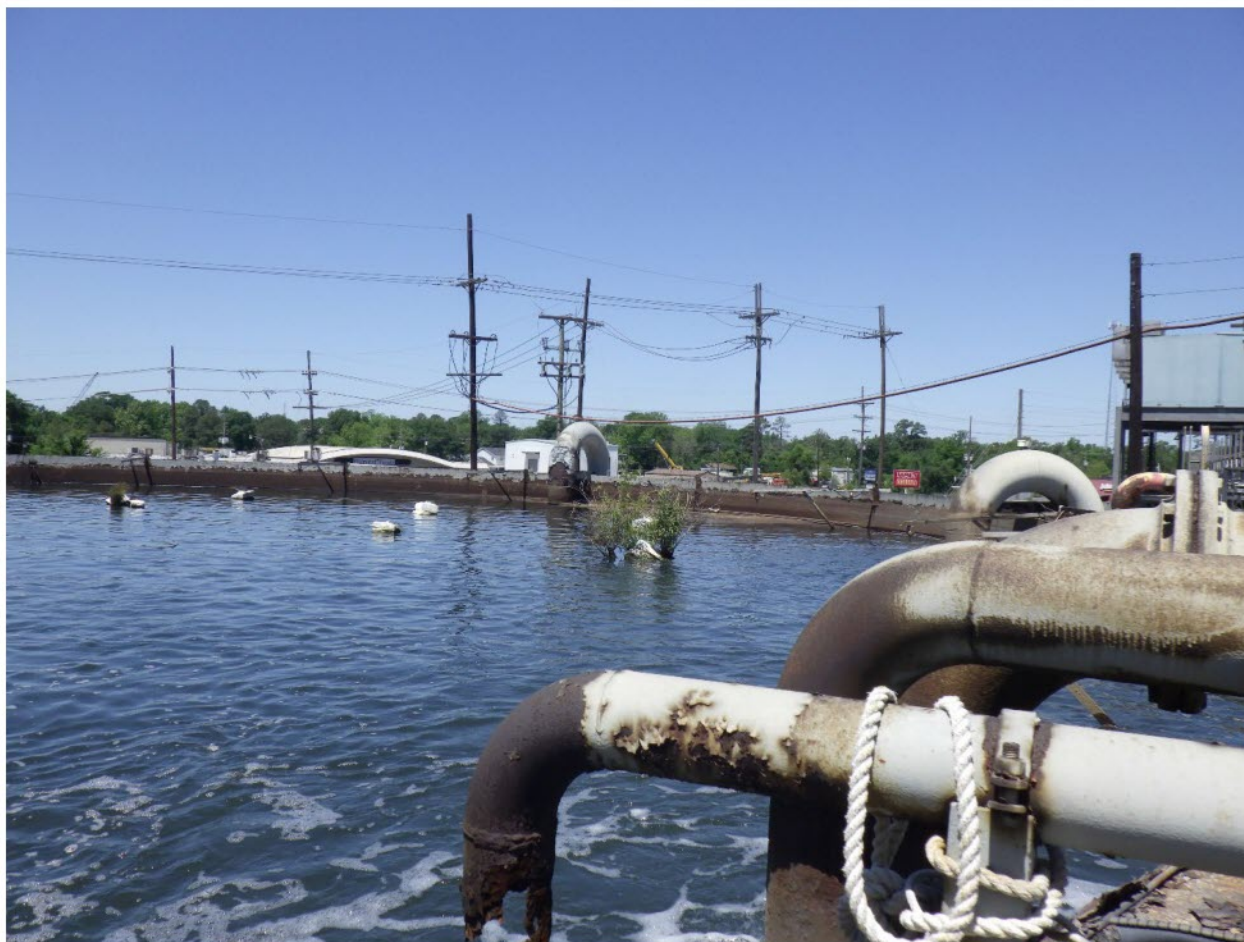
Photo No. 8

Photograph File Name: R0010851.JPG  
Date of Photograph: 04/23/2024  
Latitude and Longitude: 32.483716 -92.15419  
Orientation: NW  
Map Datum: WGS-84  
Time of Photo: 12:34 PM  
Photographer: Jack Arias  
Description: This image shows corrosion on tank structures and growing plants on surface water of the reservoir tank.

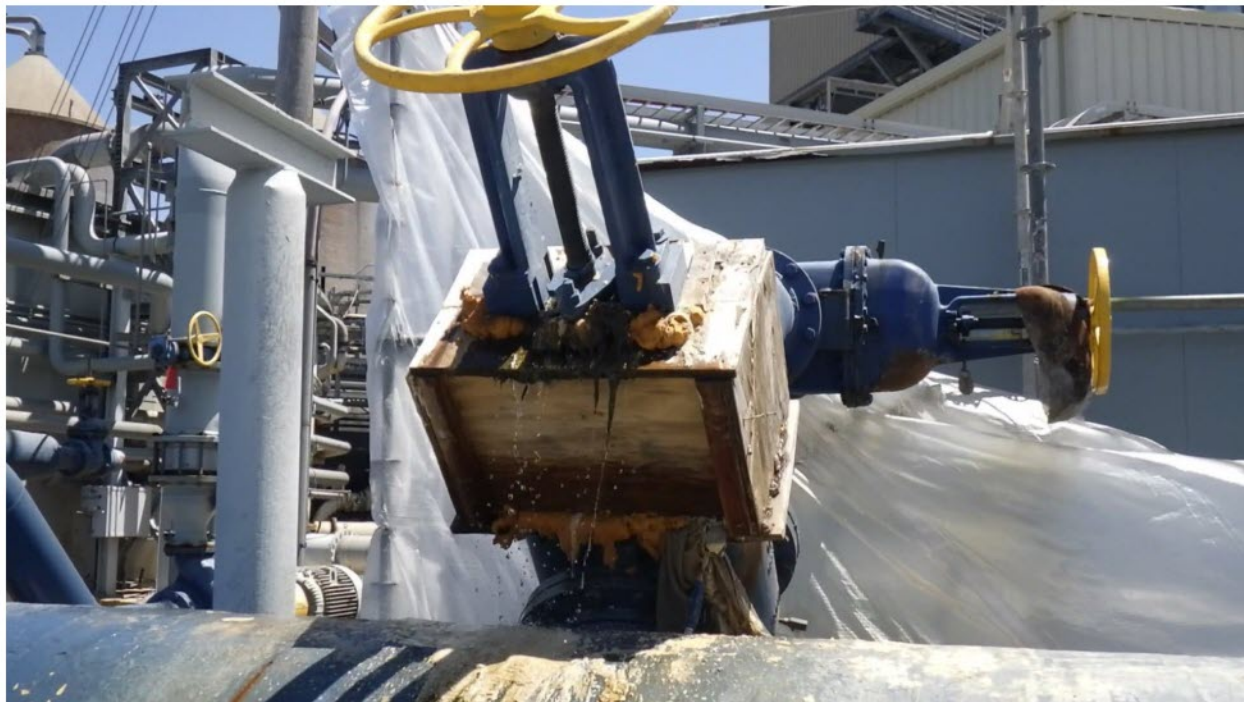
Photo No. 9

Photograph File Name: WaterValve.JPG  
Date of Photograph: 04/23/2024  
Latitude and Longitude: 32.483563 -92.154557  
Orientation: NW  
Map Datum: WGS-84  
Time of Photo: 12:45 PM  
Photographer: Jack Arias  
Description: This image shows a water valve's leak that form part of the transfer system of process water at the resevoir tank.

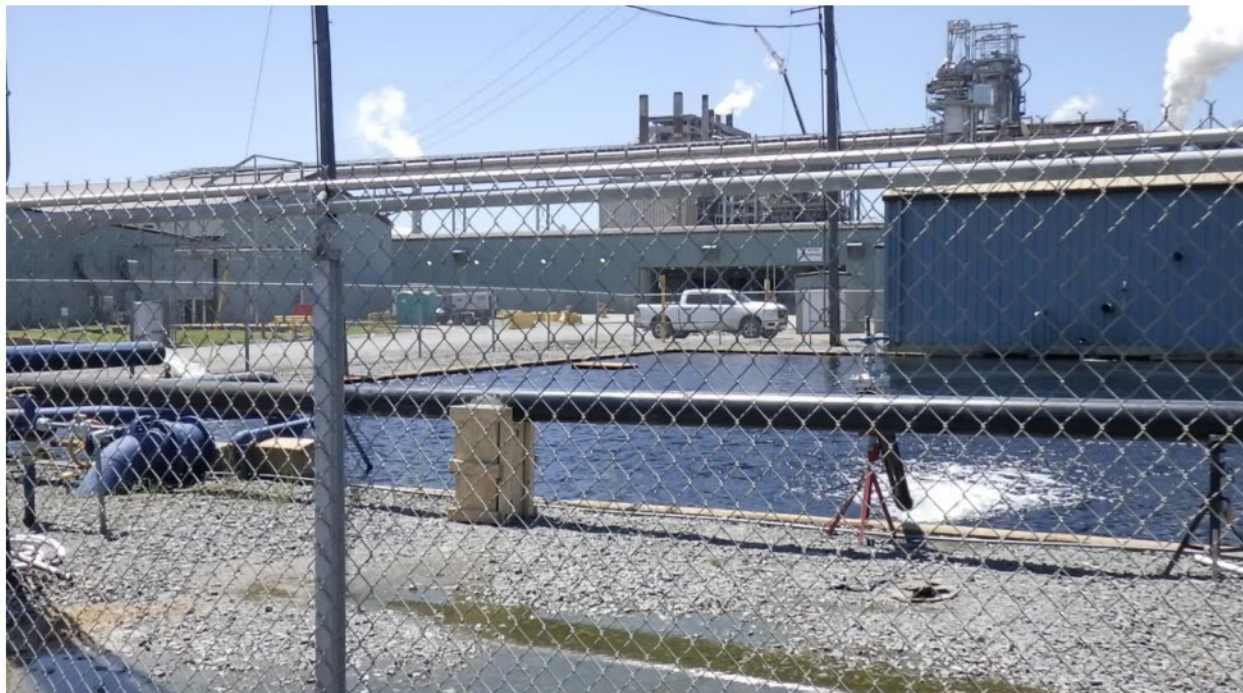
This is a concrete holding pond referred to as the "swimming pool" that is filled with chlorinated well water that feeds various mill process operations. I did not observe any issues including any malfunctions on the intake, flow, and transfer at the time of the inspection (See Photo No. 10 in Appendix 1).

Description: This image shows a concrete holding pond referred to as the "swimming pool" is filled with chlorinated well water that feeds various mill process operations.

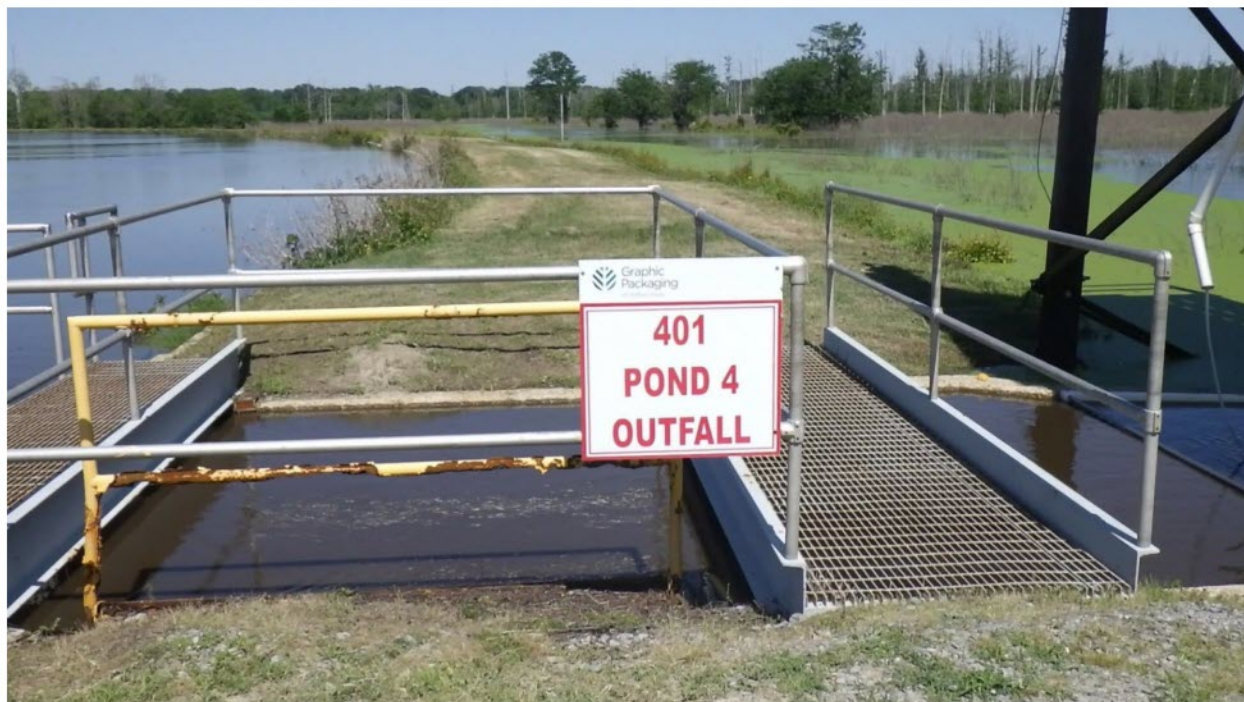
Photo No. 18

This outfall includes continues discharge of process area storm water in addition to excess storm water from the wet deck recirculation system at the West Monroe Chip Mill. Flows are routed to the wastewater treatment plant (including primary clarification, aerobic biological oxidation, sedimentation, and polishing ponds) which discharges to Outfall 401. Outfall 401 discharges to an unnamed tributary, thence to Outfall 001, thence to the Quachita River. Outfall 401 is located at the discharge point from the polishing ponds. There was flow and discharge at the time of the inspection and the water was observed to have a brown tint (See Photo Nos. 18 – 19 in Appendix 1).

Description: This image shows outfall 401. This outfall includes continuous discharge of process area storm water, excess storm water, and settleable solids from settling ponds.

4. Facility will update labels and provide any needed photos above the missing labels at the facility outfalls.
5. Facility will provide updates (180 days after permit approval) about the SWPP3 and SPCC plans.

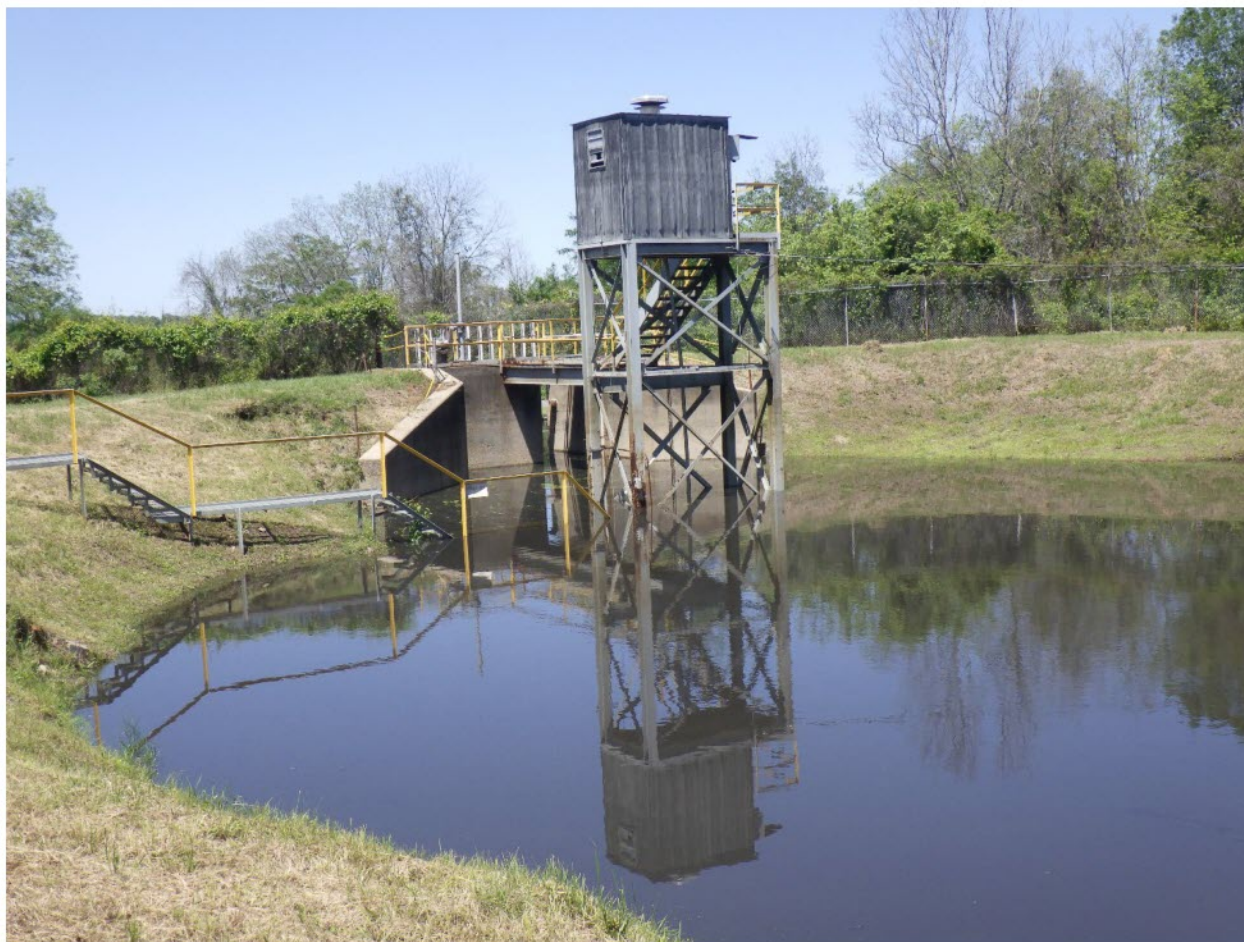
This outfall receives and includes intermittent discharge of previously monitored combined treated mill wastewater from Internal Outfall 401, treated municipal and parish sanitary wastewater from a public owned treatment works serving the City of West Monroe (LPDES permit LA0043982), and non-process stormwater runoff. Outfall 001 is in the southern portion of the property (32.45243, -92.121169) prior to discharge into the Quachita River. I observed outfall 001. There was flow and discharge at the time of the inspection and the water had a brown tint (See Photo No. 20 in Appendix 1).

Description: This image shows outfall 001 which receives and includes an intermittent discharge of previously monitored combined treated mill wastewater and settleable solids from settling ponds from Internal Outfall 401 and unnamed tributary.

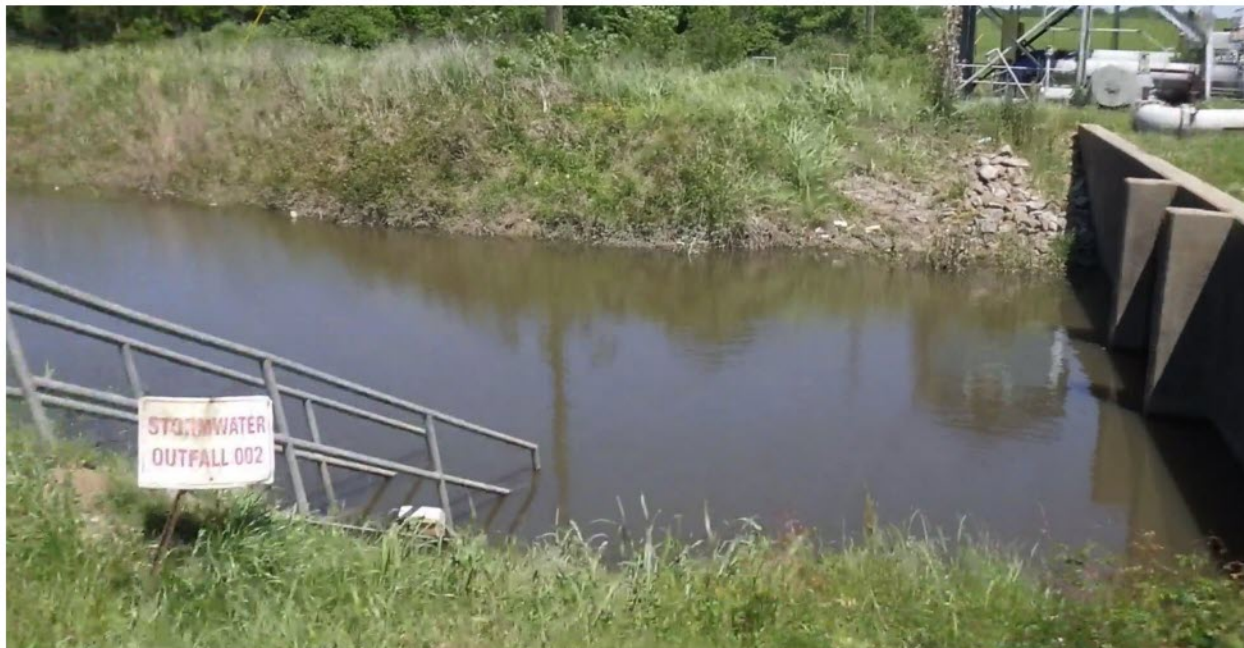
This outfall includes intermittent discharge of runoff from the rail car and tank truck loading and unloading areas, chips, plat roads, employee parking lots, solid waste and scrap metal containers, maintenance shop, storage tanks, partial roof from the N6 and N7 paper machine building, the contractor area north of the N6 and N7 paper machine buildings, roof runoff from plant 70 and natural areas southeast of the rail car switchyard and treated sanitary wastewater. Outfall 002 is centrally located (32.477947, -92.147732) within the facility and discharges into Judy Slough, thence to Toney Bayou, then Quachita River. I observed outfall 002. There was no flow or discharge at the time of the inspection and the water had a green or brown tint (See Photo No. 21 in Appendix 1).

Description: This image shows outfall 002 which receives and includes intermittent discharges of runoff from the rail car and tank truck loading, unloading areas, chips, plat roads, employee parking lots, solid waste and scrap metal containers, maintenance shop, storage tanks, roof run offs, and treated sanitary wastewater.

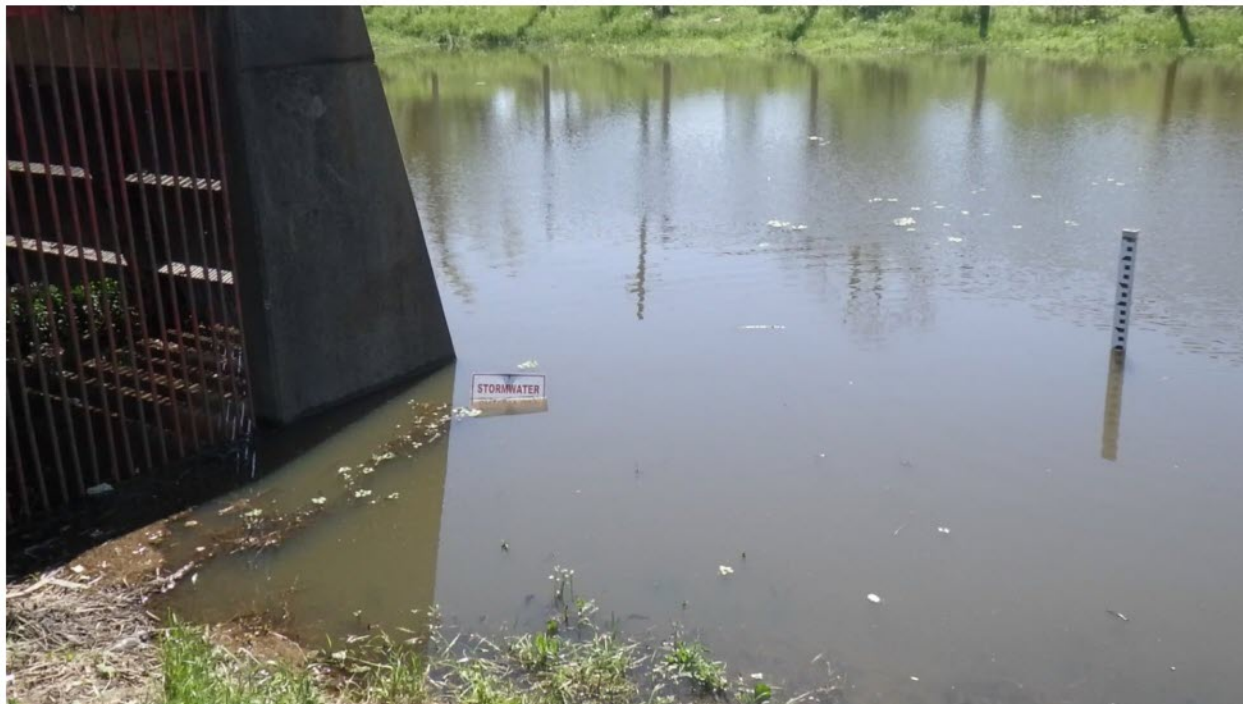
This outfall includes an intermittent discharge of non-process area stormwater runoff (including, but not limited to, stormwater runoff from roads and railroads), and storm water that accumulates within the undeveloped wooded area in the southernmost portion of the West Monroe Paper Mill. Parking, scales, and solid waste and scrap metal containers are also located within this drainage area. Additionally, the facility's wood-fired power boiler sluiced ash line traverses the outfall 003 drainage area. There is also a sanitary treatment plant located within the outfall 003 drainage area. Outfall 003 (32.47546, -92.149779) is in a surface drainage ditch that drains to Judy Slough, thence to Toney Bayou, thence to the Quachita River. There was no flow and discharge at the time of the inspection and the water was brown tint (See Photo No. 22 in Appendix 1).

This image shows outfall 003 which receives and includes intermittent discharges of non-process area stormwater runoff, and storm water that accumulates within the undeveloped wooded area in the southernmost portion of the West Monroe Paper Mill site discharges.

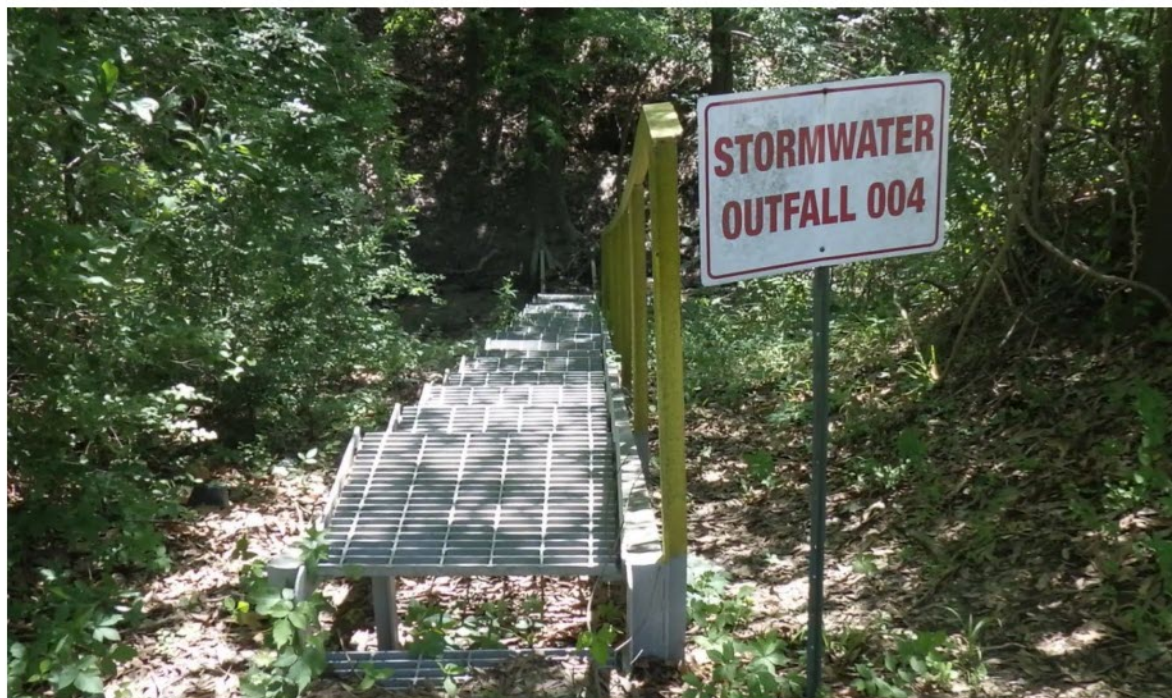
This outfall includes an intermittent discharge of non-process area stormwater runoff from the Plant 70 area and warehouse areas including roof runoff and employee parking, and solid waste and scrap metal containers. Outfall 004 is in the northeast corner of the site (32.485181 -92.14545), immediately south of Outfall 005. Outfall 004 discharges into Black Bayou, thence to Toney Bayou, thence to the Quachita River. There was not flow and discharge at the time of the inspection and the water (pool of water) was brown tint (See Photo No. 23 in Appendix 1).

Description: This image shows outfall 004 which receives and includes intermittent discharge of non-process area stormwater runoff from the Plant 70 area and warehouse areas including roof runoff and employee parking, and solid waste and scrap metal containers.

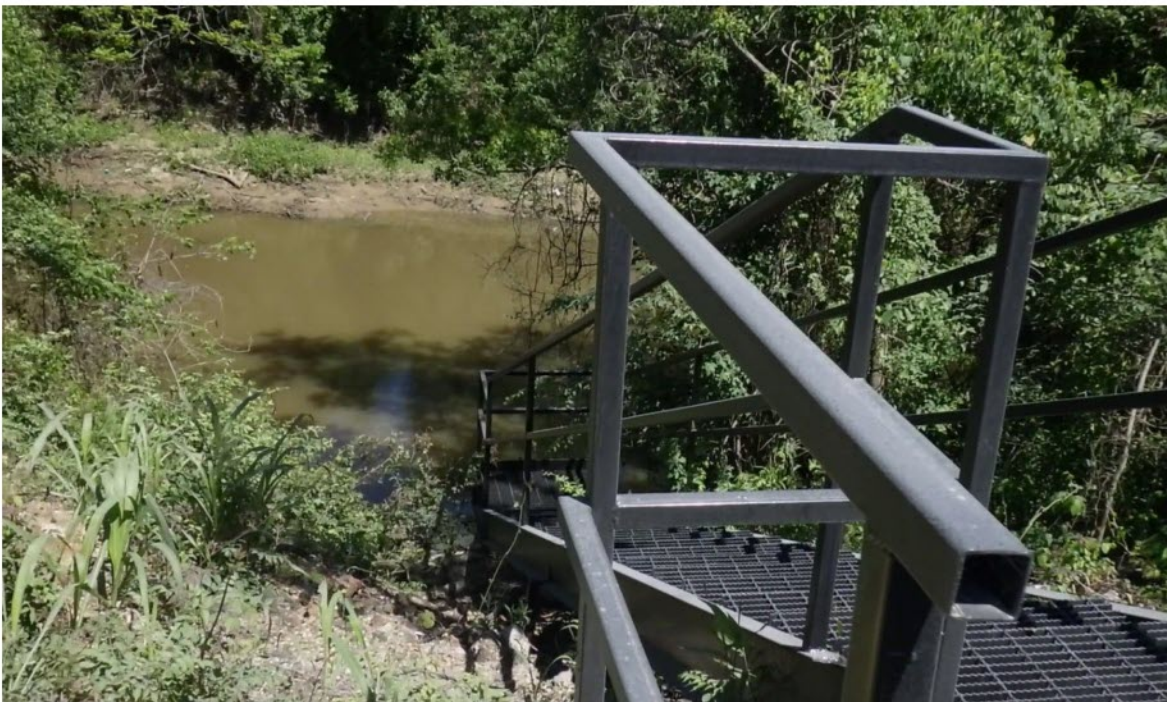
This outfall includes an intermittent discharge of non-process area stormwater runoff from the Plant 70 area and warehouse areas including roof runoff, employee parking, and solid waste and scrap metal containers. Outfall 005 is in the northeast corner of the site adjacent to a paved drive and discharges into Black Bayou, thence to Toney Bayou, thence to the Quachita River. There was not flow and discharge observed at the time of the inspection and the water had a brown tint (See Photo No. 24 in Appendix 1).

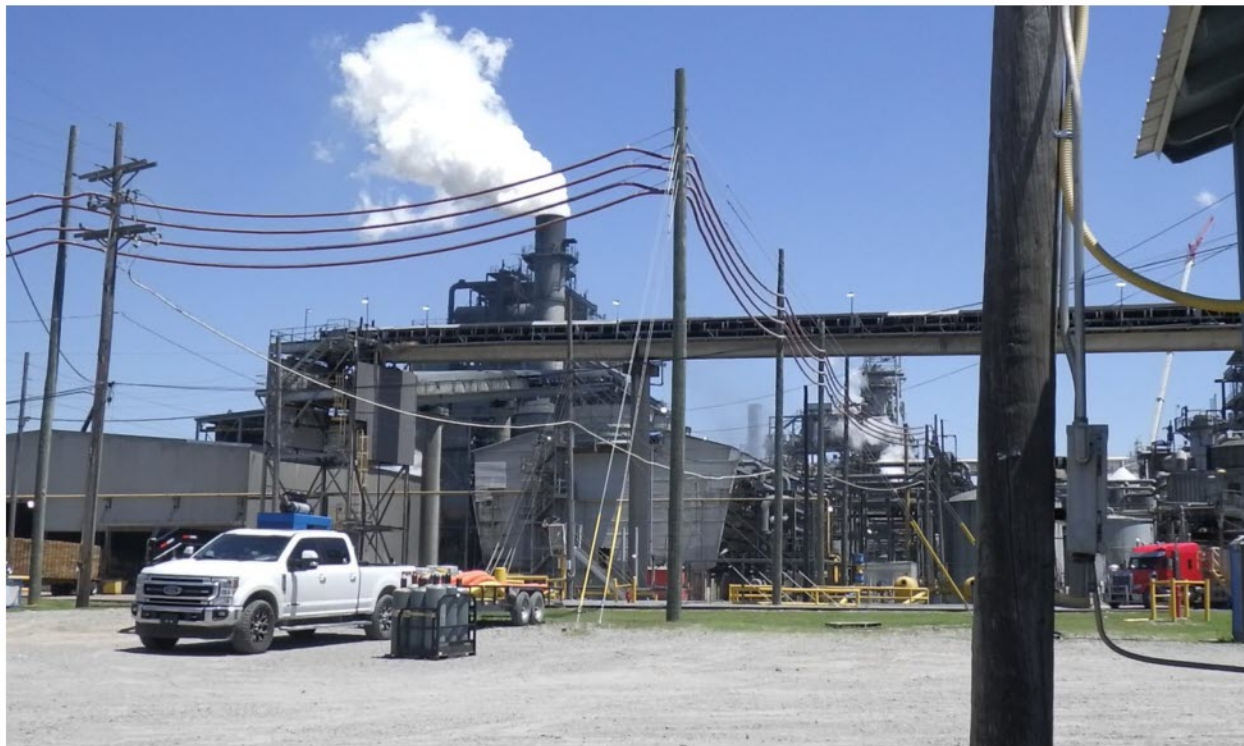
The Cooling Water Systems (GPI) operates several cooling tower systems; two of which are for recovery evaporators/concentrators. They are evaporative cooling designs, fan-induced upward draft with water falling over high surface area poly/fiberglass fill. The water is cooled in tower and circulated to the surface condensers, inter coolers, and after coolers on #3 and #5 evaporator trains and #5 and #6 concentrators. Water is then returned to the cooling tower. The water is recirculated for multiple cycles for water conservation. Water make-up is added, as needed, to account for blowdown and evaporation. There was no problem or malfunctions observed on the recirculating system at the time of the inspection (See Photo No. 25 in Appendix 1).
