**Region 6 Compliance Assurance and Enforcement Division  
INSPECTION REPORT**

| Inspection Date(s): | March 28, 2018 | | |
| Company Name: | <b>Polk Operating, L.L.C.</b> | | |
| Facility Name: | <b>Polk R 3 Facility</b> | | |

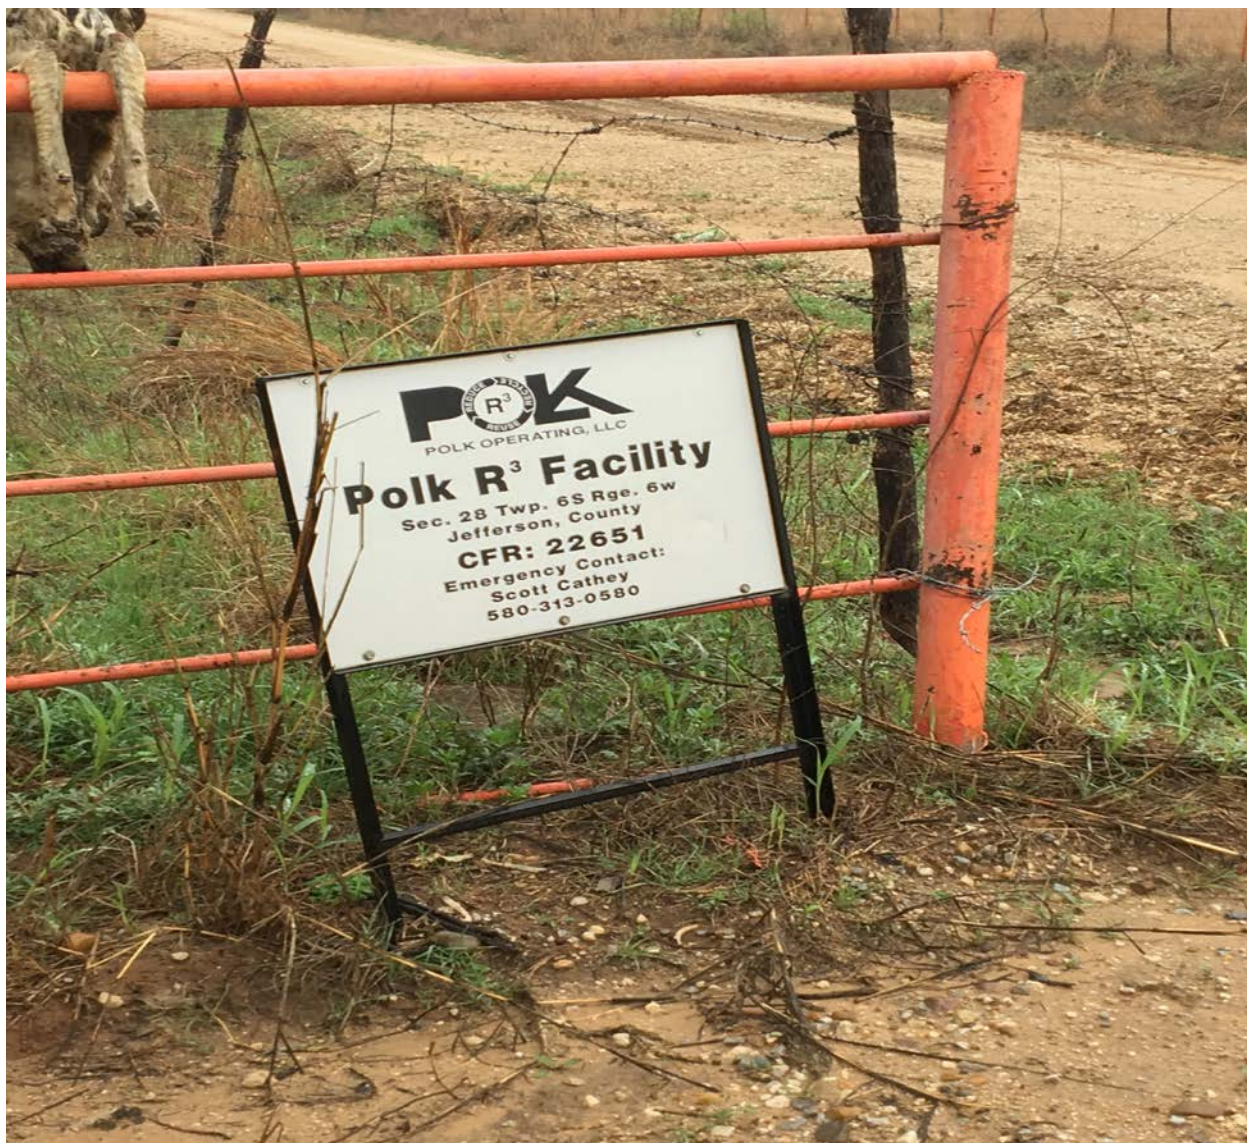
Photo No. 1

Description: This photo shows the sign of the facility and the location of the facility from where a discharge of brine and drilling mud fluids flowed from the site to the tributary of Red Creek.

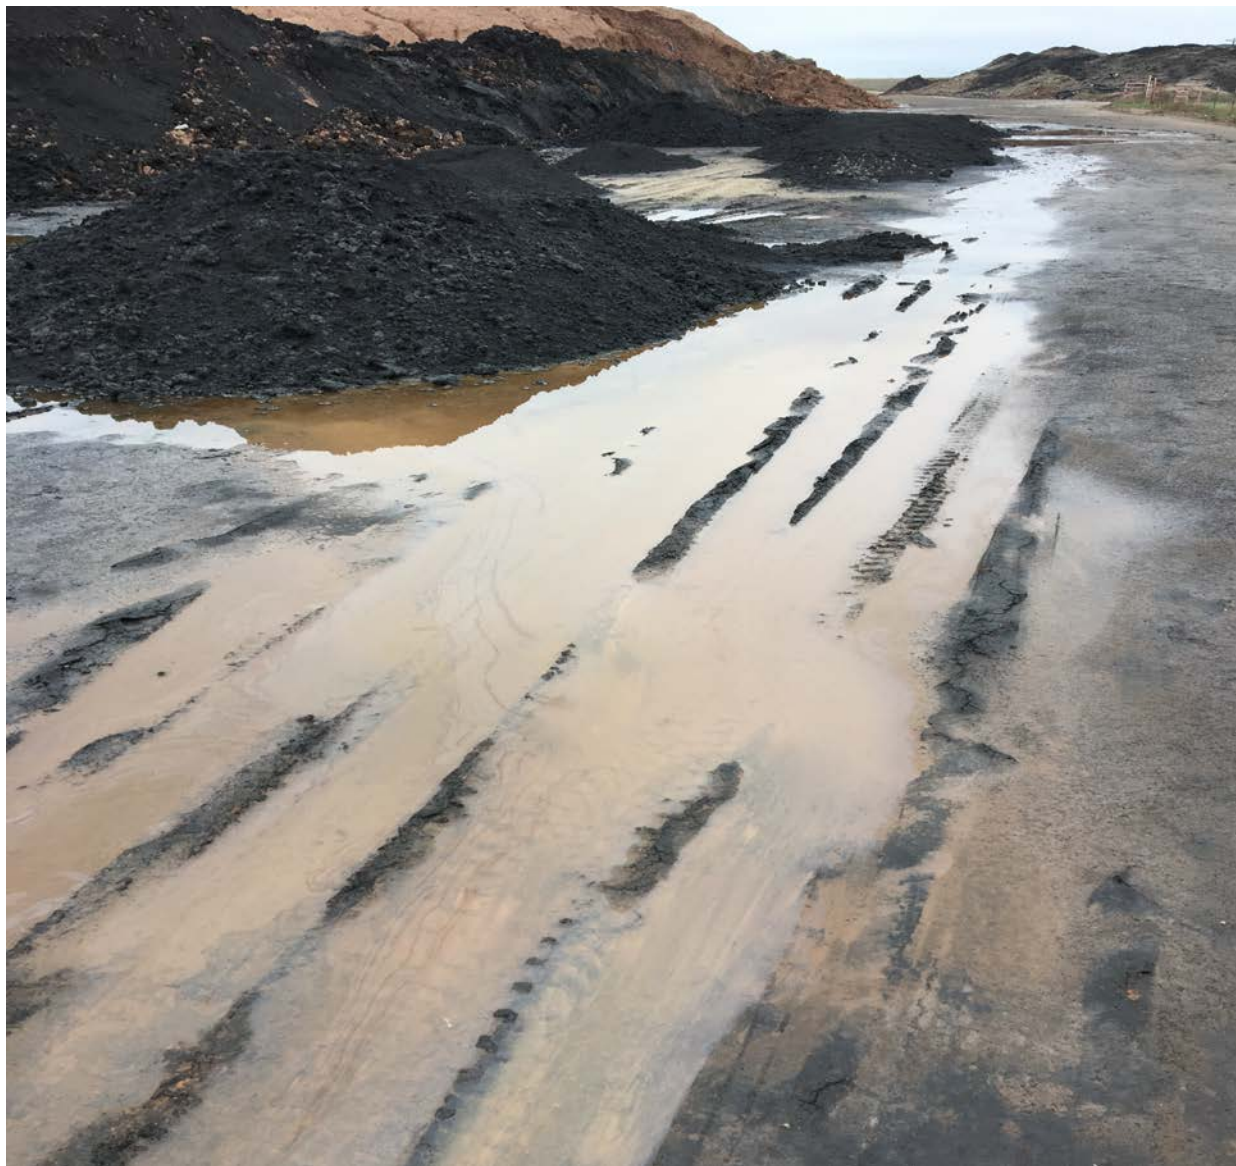
Photo No. 2

Description: This photo shows that rainfall caused runoff from these waste piles and brine fluids and oil flowed from the facility towards the tributary of Red Creek.

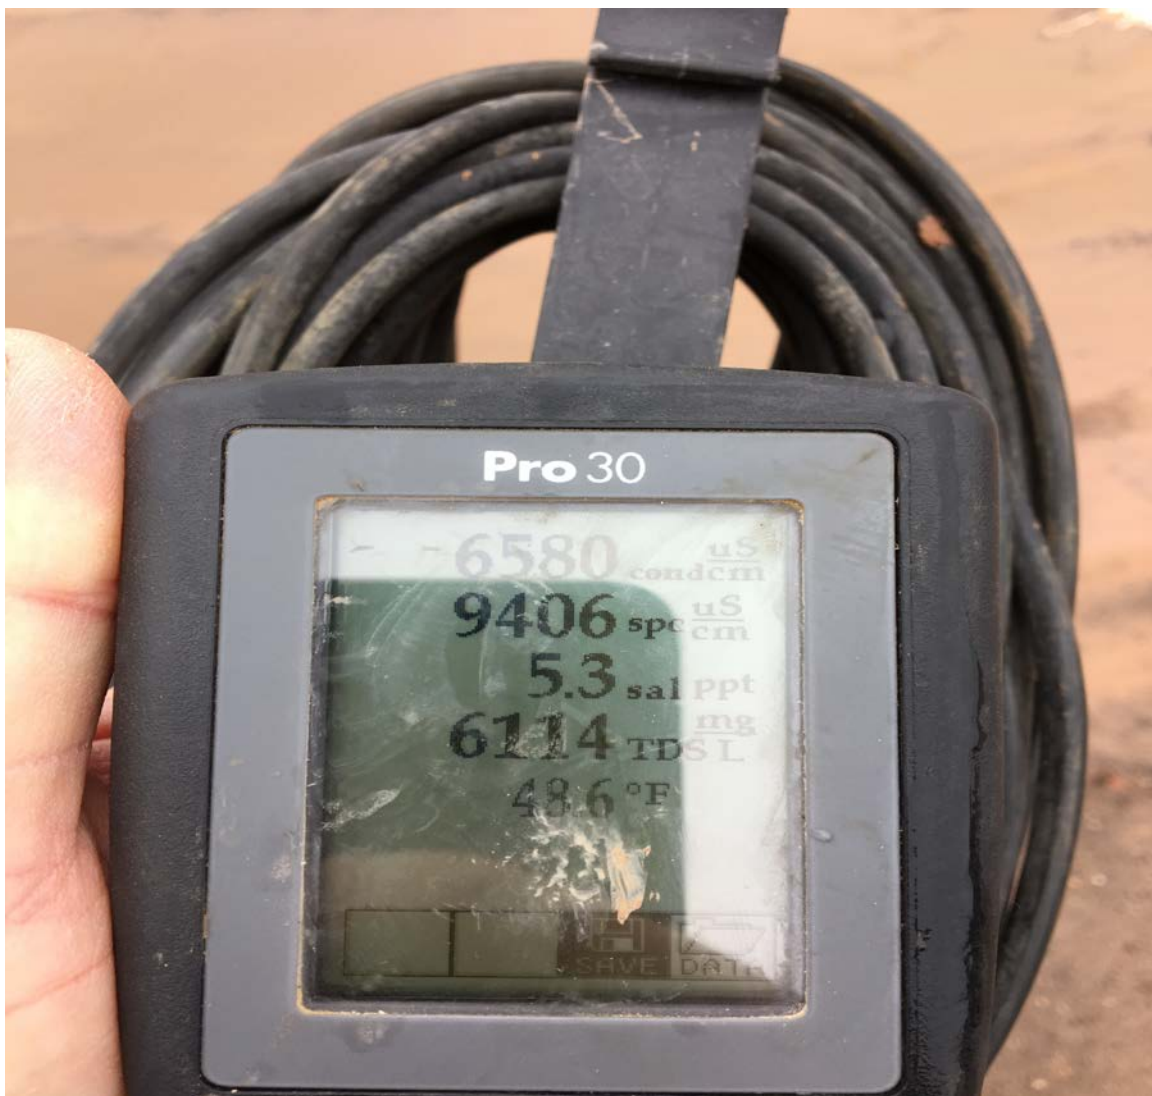
Photo No. 3

Description: This photo shows that at the point of discharge from the facility, the Total Dissolved Solids (TDS) reading was taken with a calibrated YSI Pro 30 Conductivity Meter where fluids, including brine and oil sheen, were leaving the mud piles. A TDS reading of 6,114 milligrams per liter (mg/L) was taken at this location. The flow of the fluids was south of the facility towards the tributary of Red Creek.

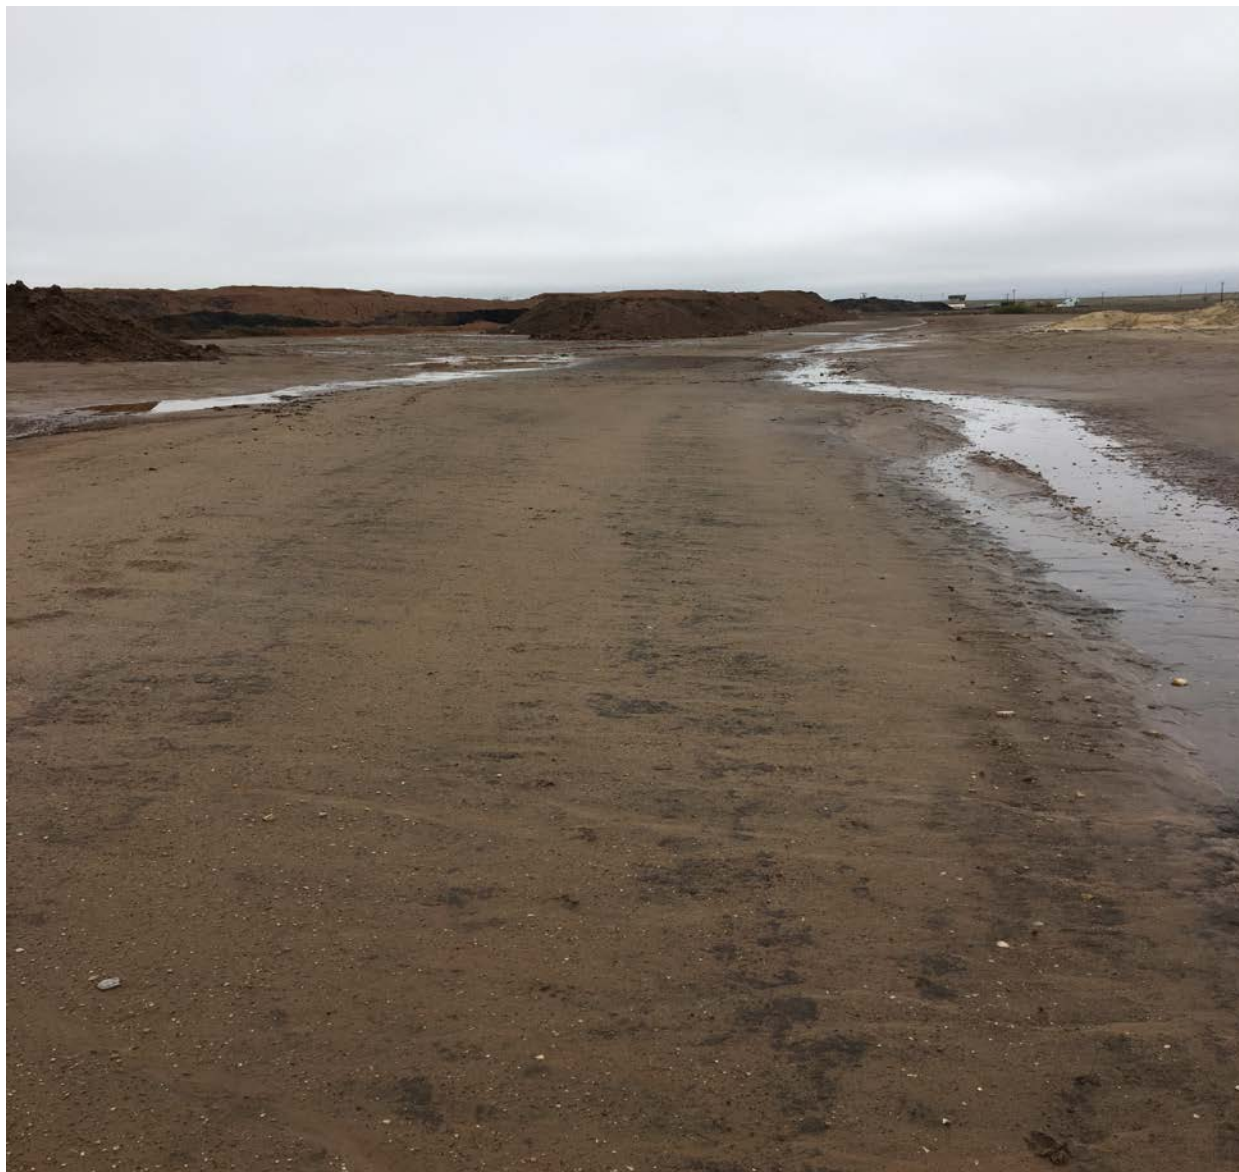
Photo No. 4

Description: The flow path from the facility where there were piles of drilling mud waste flowed from the facility south along a road ditch towards the tributary of Red Creek.

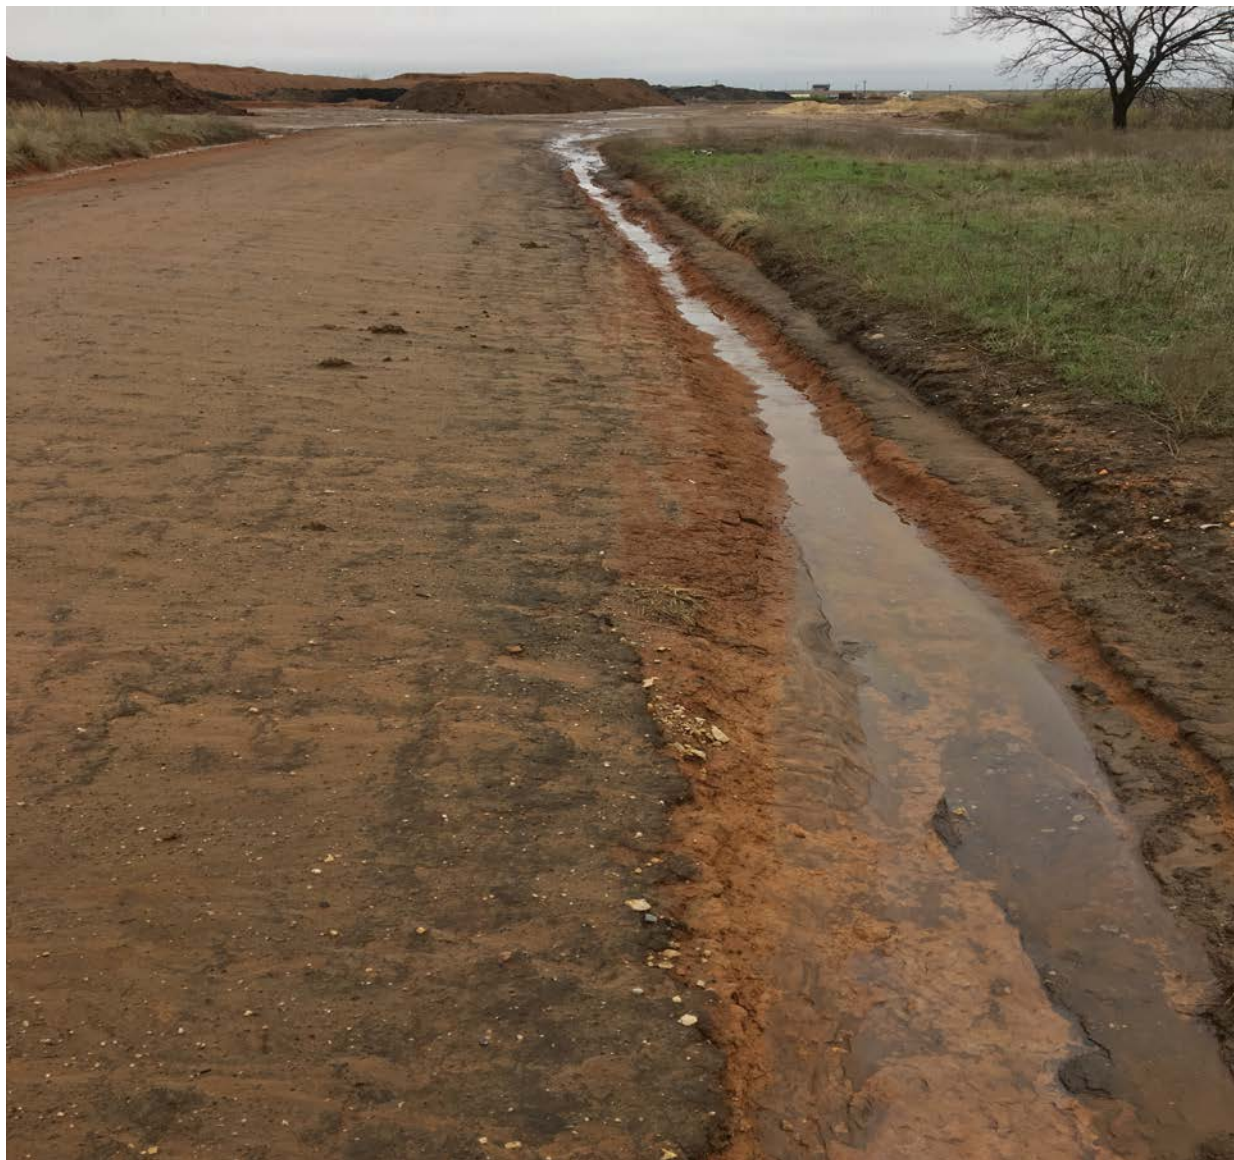
Photo No. 5

Description: This photo shows that the brine and drilling mud fluids flowed south from the facility and continued towards a pond and then a tributary of Red Creek.

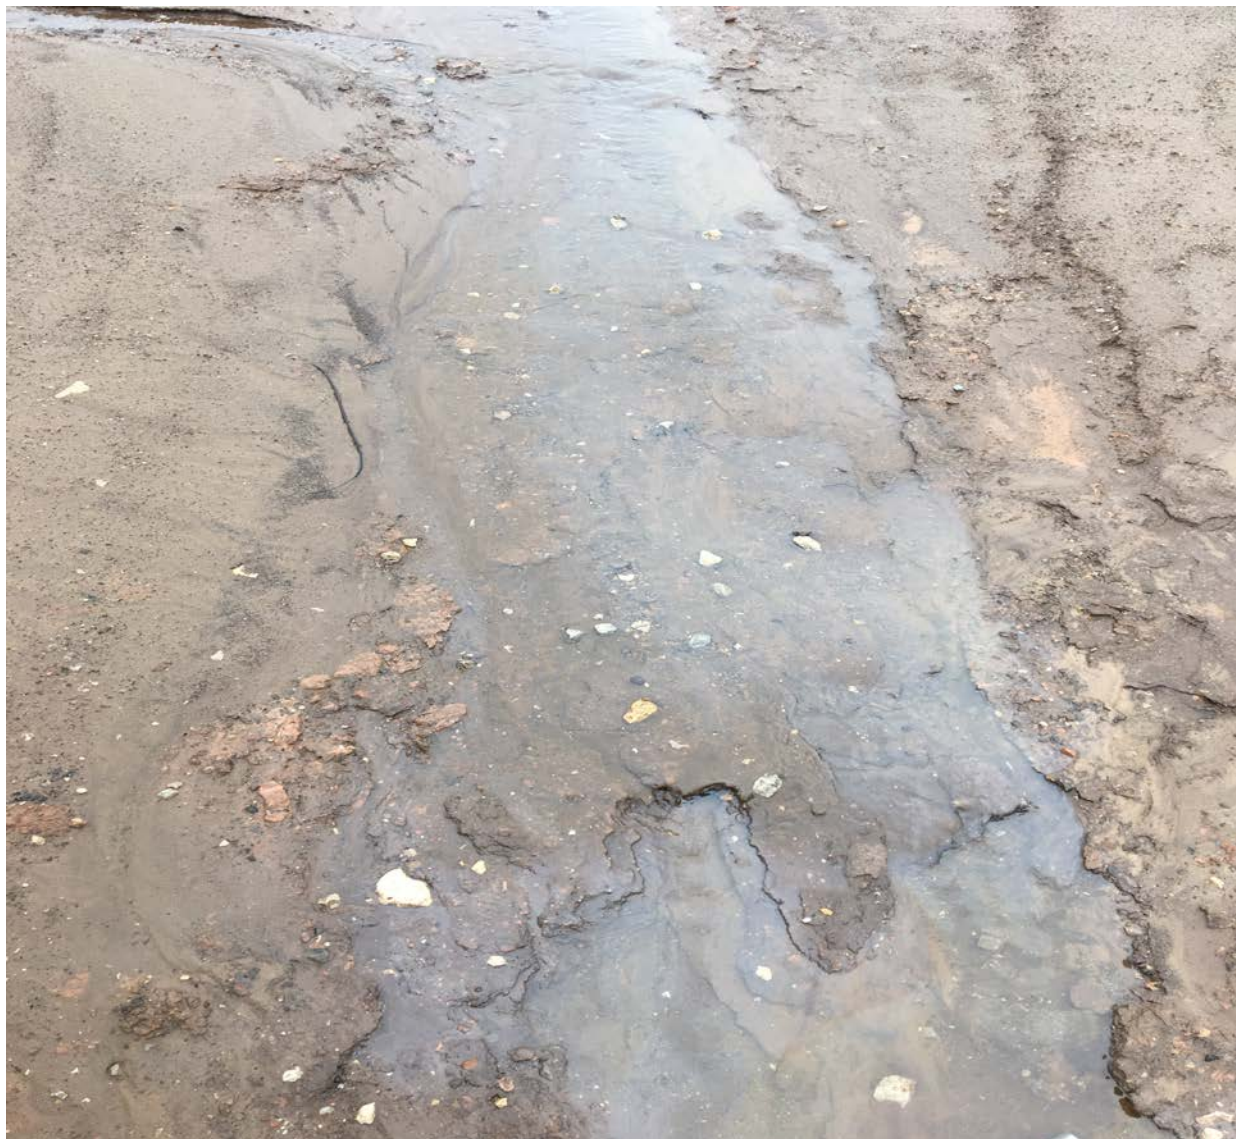
Photo No. 6

Description: This photo shows the oil sheen I observed that flowed south from the facility along the road side ditch towards the tributary of Red Creek. Additionally, brine was flowing along the flow path.

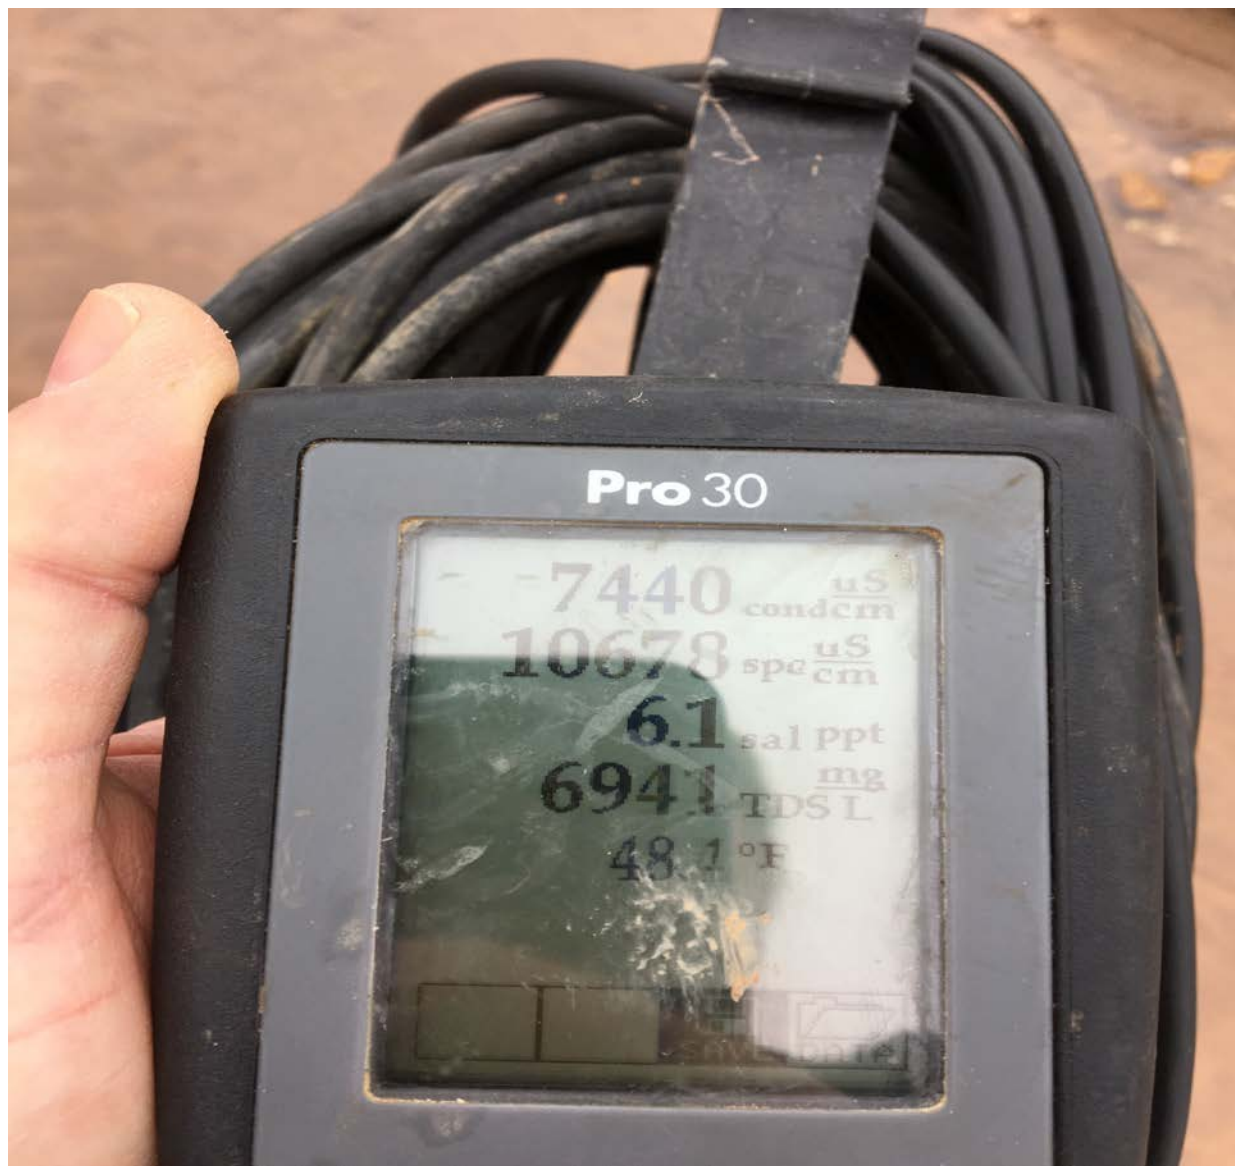
Photo No. 7

Description: TDS of the fluids in the ditch shown in Photo 5 was 6,941 mg/L. The flow was south towards the tributary of Red Creek.

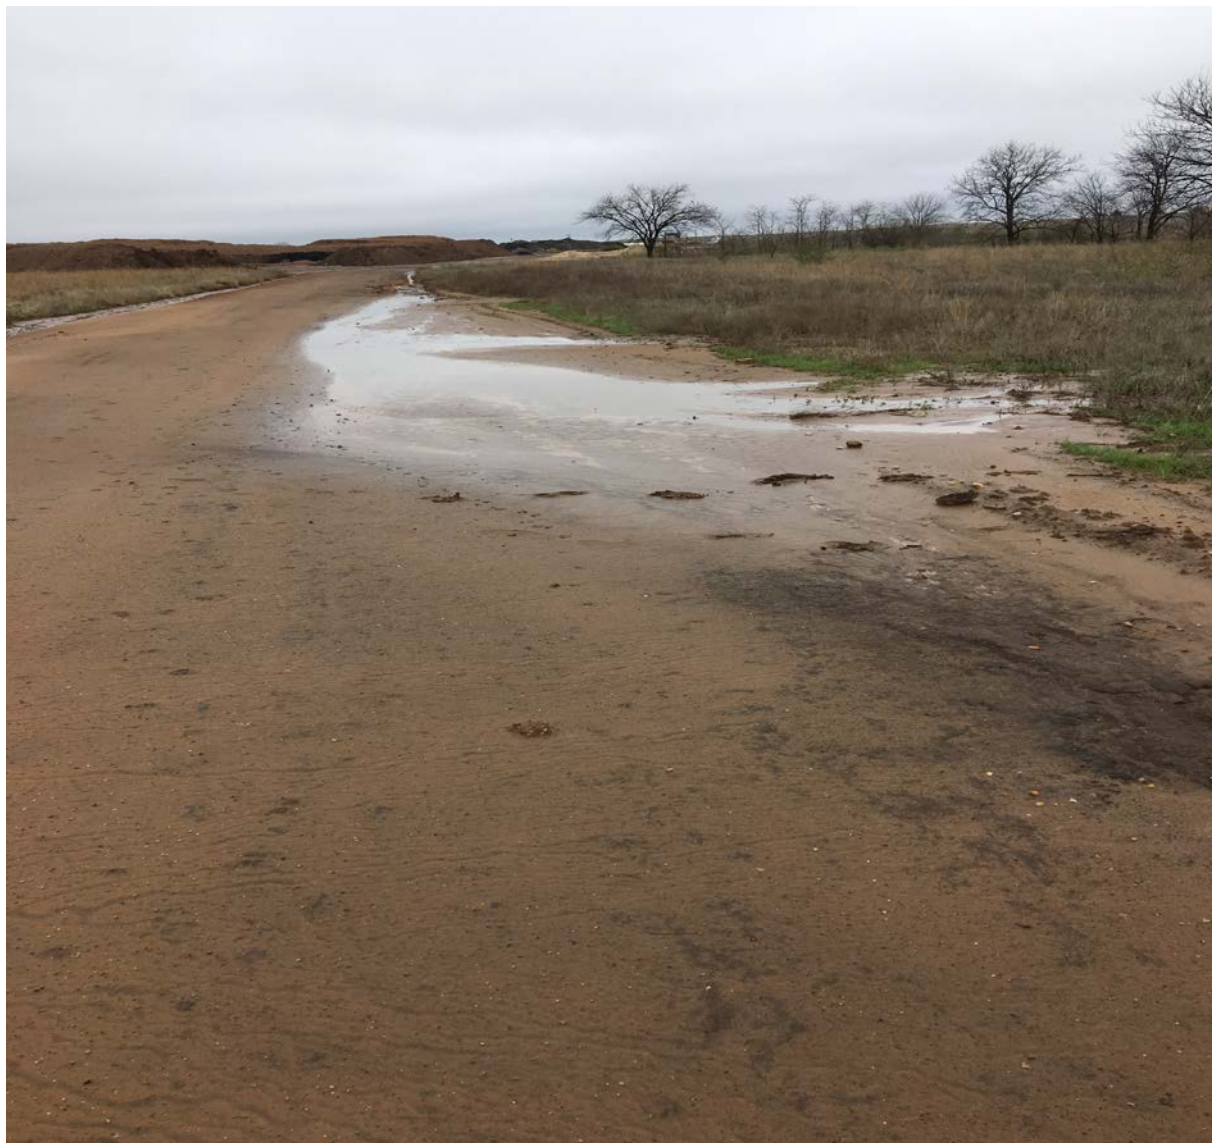
Photo No. 8

Description: This photo shows the flow path. The flow in the ditch flowed east, into a field show in this photo, and continued along the flow path away from the road ditch towards a tributary of Red Creek.

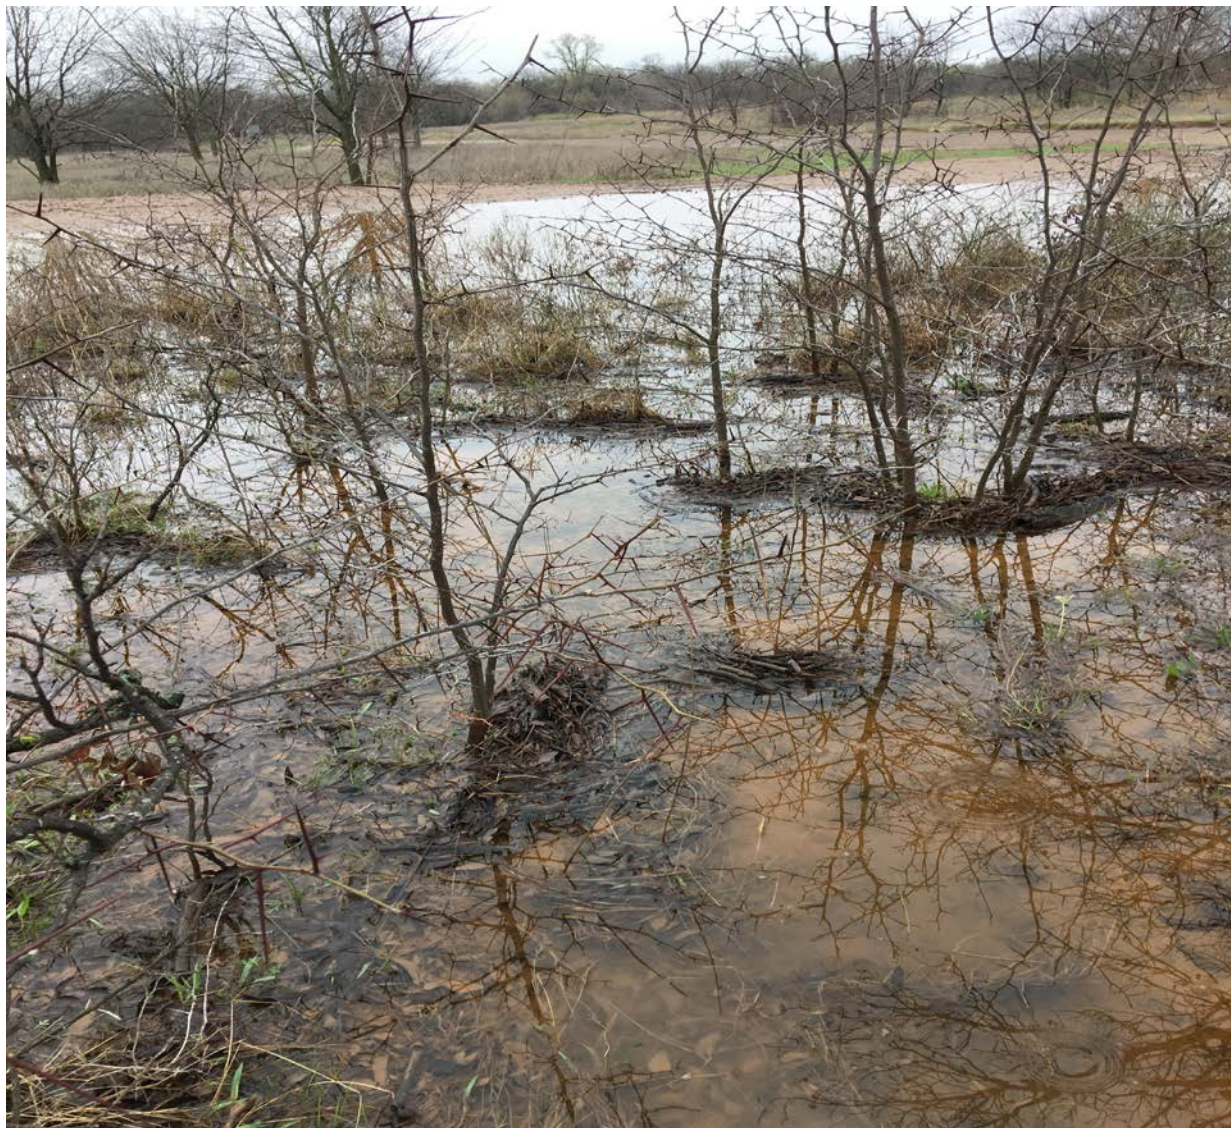
Photo No. 9

Description: The small tributary had pooled up at this location, near recent construction of the area south of the facility. This pooled up area was along the flow path of fluids from the facility towards the tributary of Red Creek.

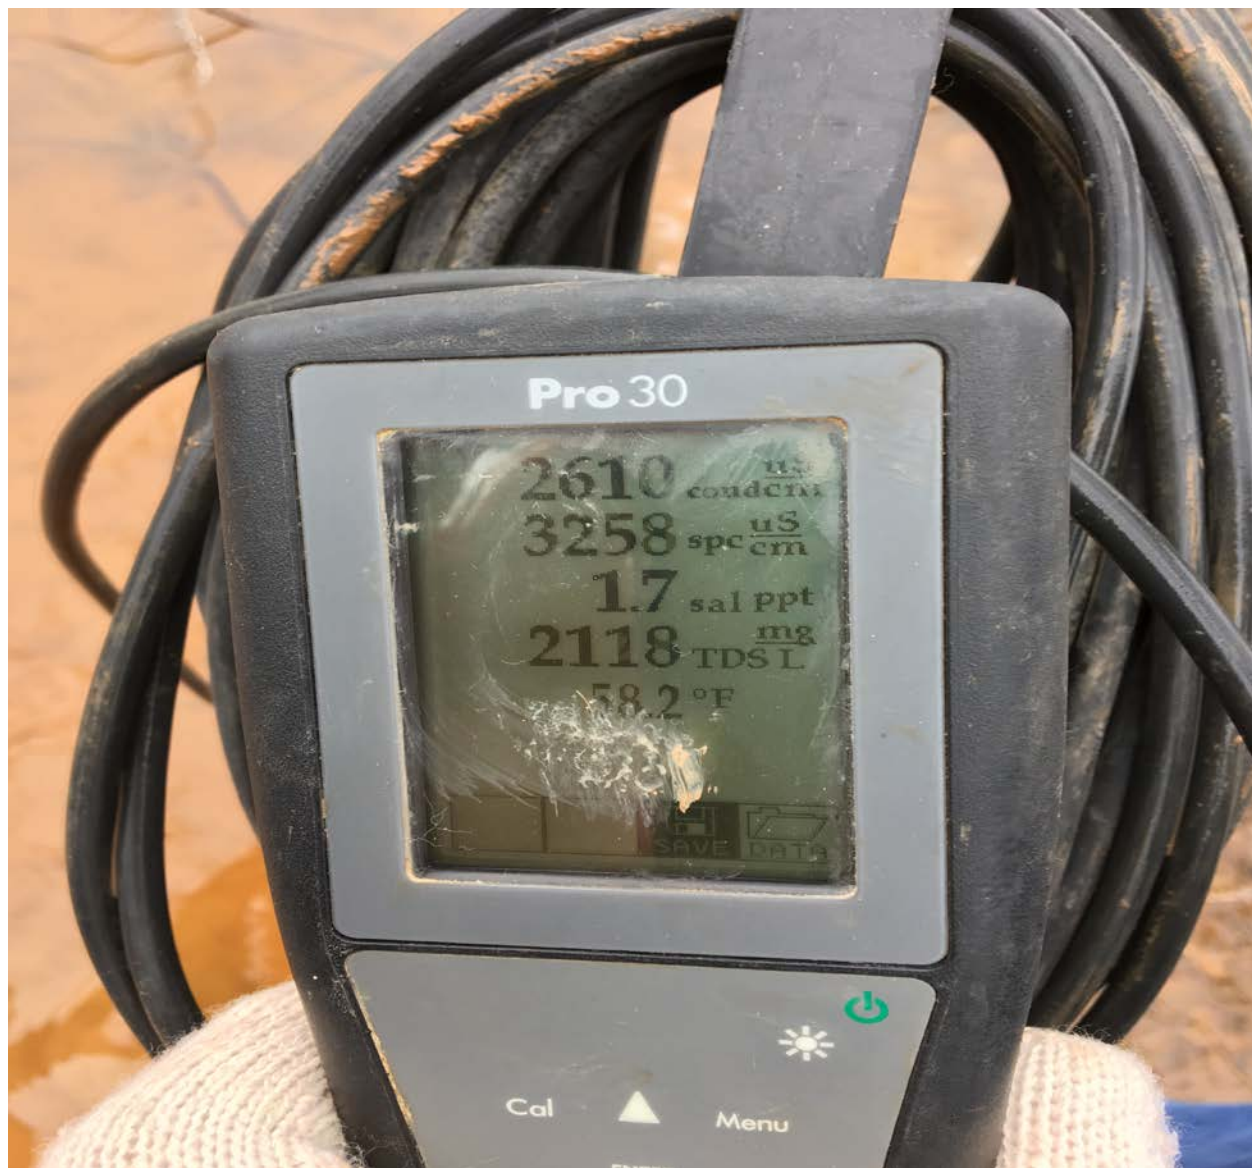
Photo No. 10

Description: This photo shows the TDS at the tributary location of Photo 9 and the TDS reading was 2,118 mg/L.

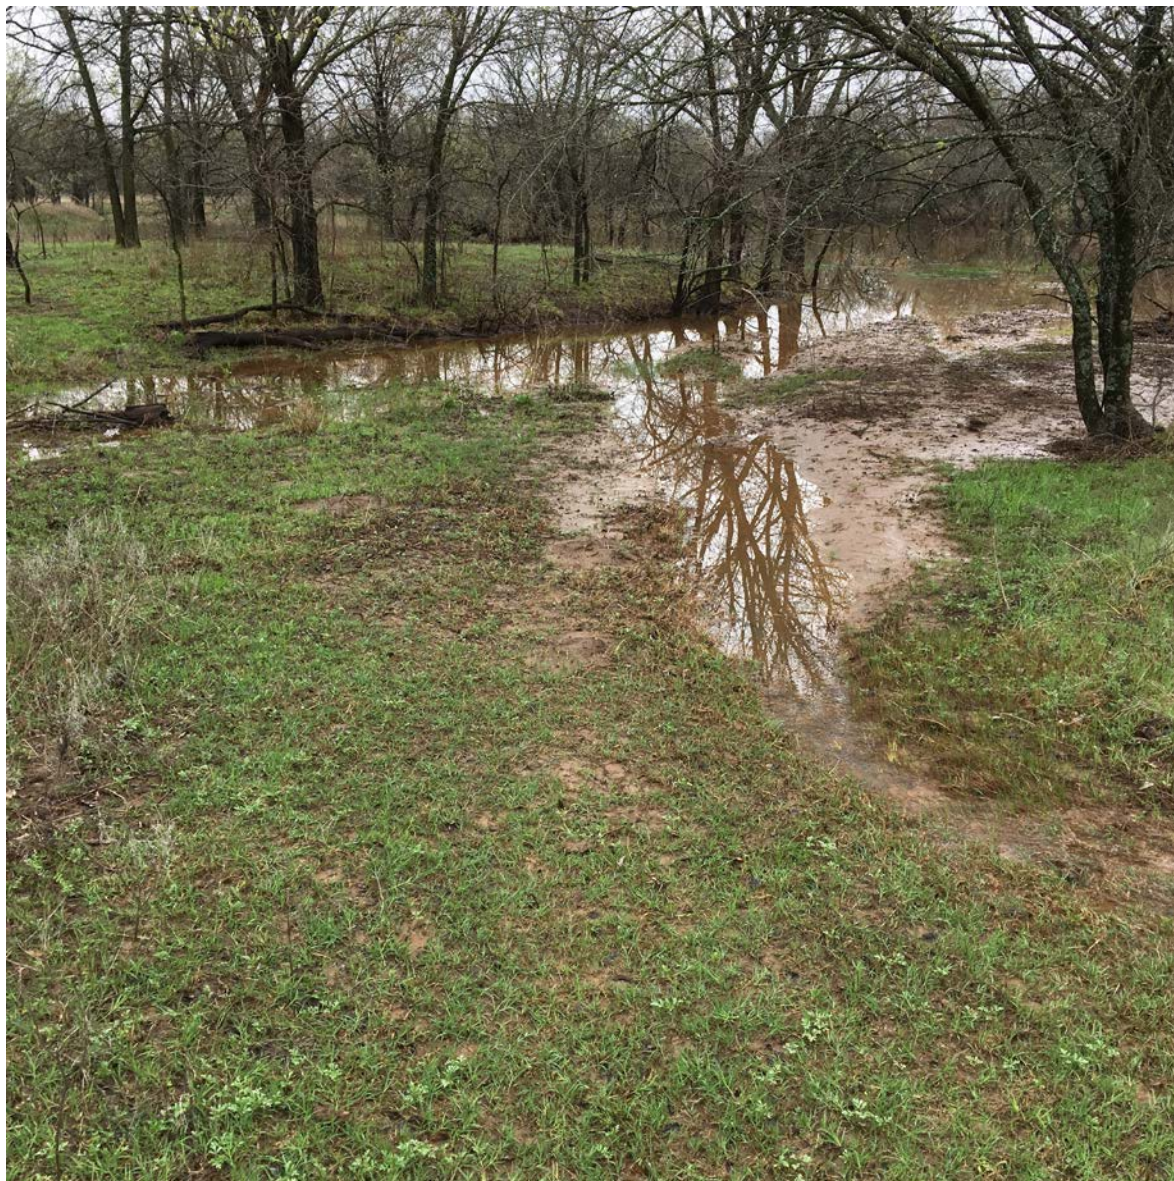
Photo No. 11

Description: The flow path entered a small pond prior to entering the tributary of Red Creek, and the brine and other fluids flowed to this location.

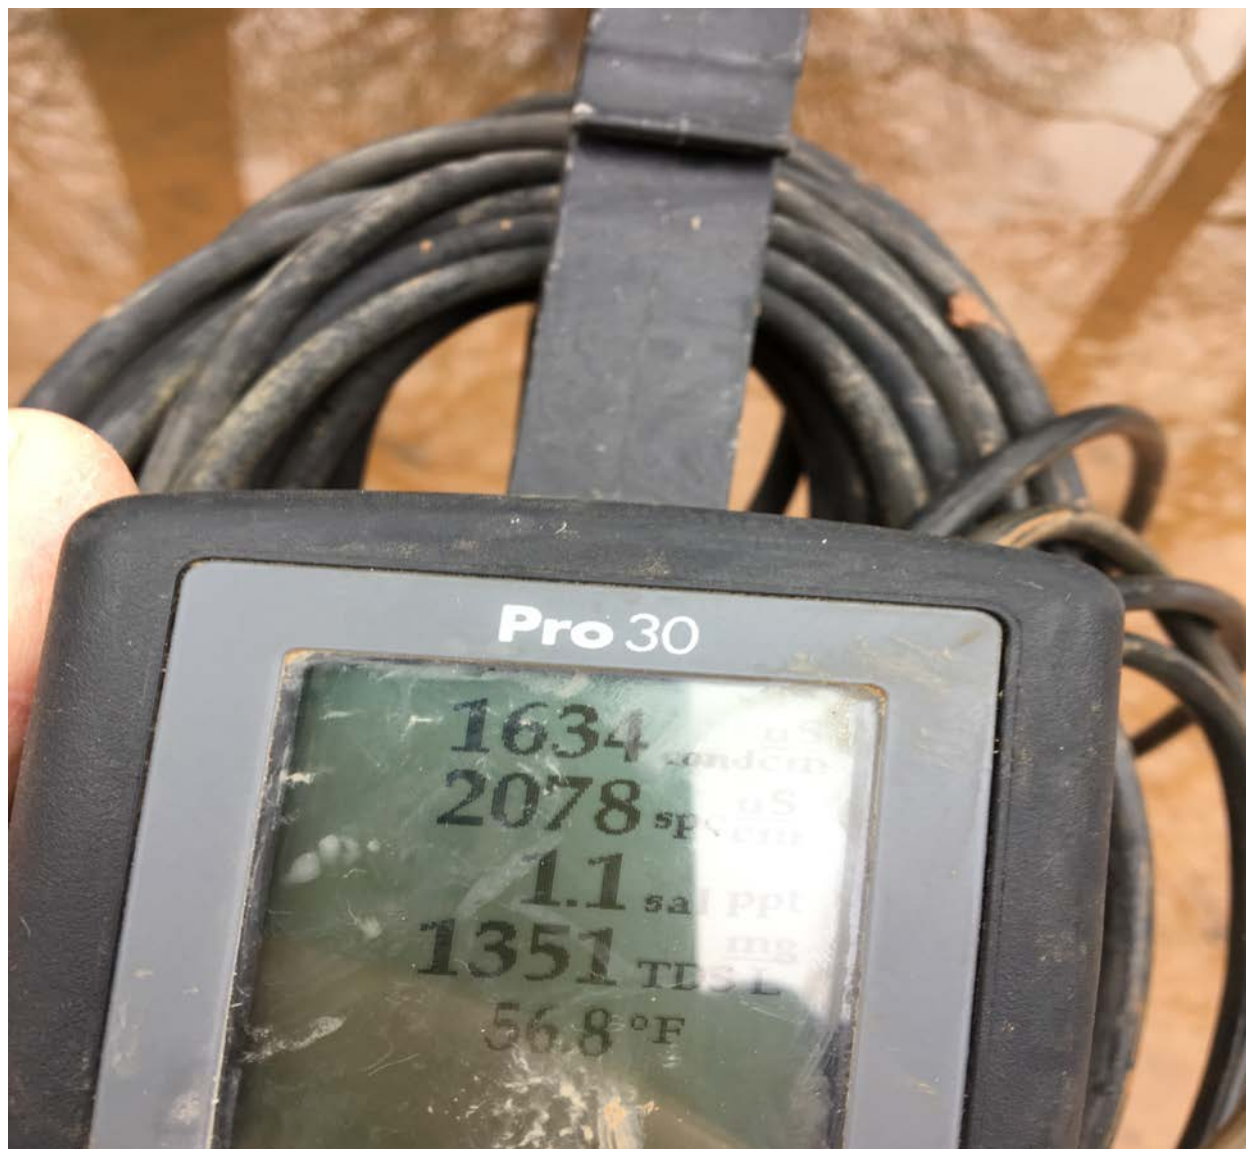
Photo No. 12

Description: TDS at the entry to the pond was 1,351 mg/L. The flow path of fluids enters this pond on the north side and exits on the southeast corner to a larger flow path area that leads to the tributary of Red Creek.

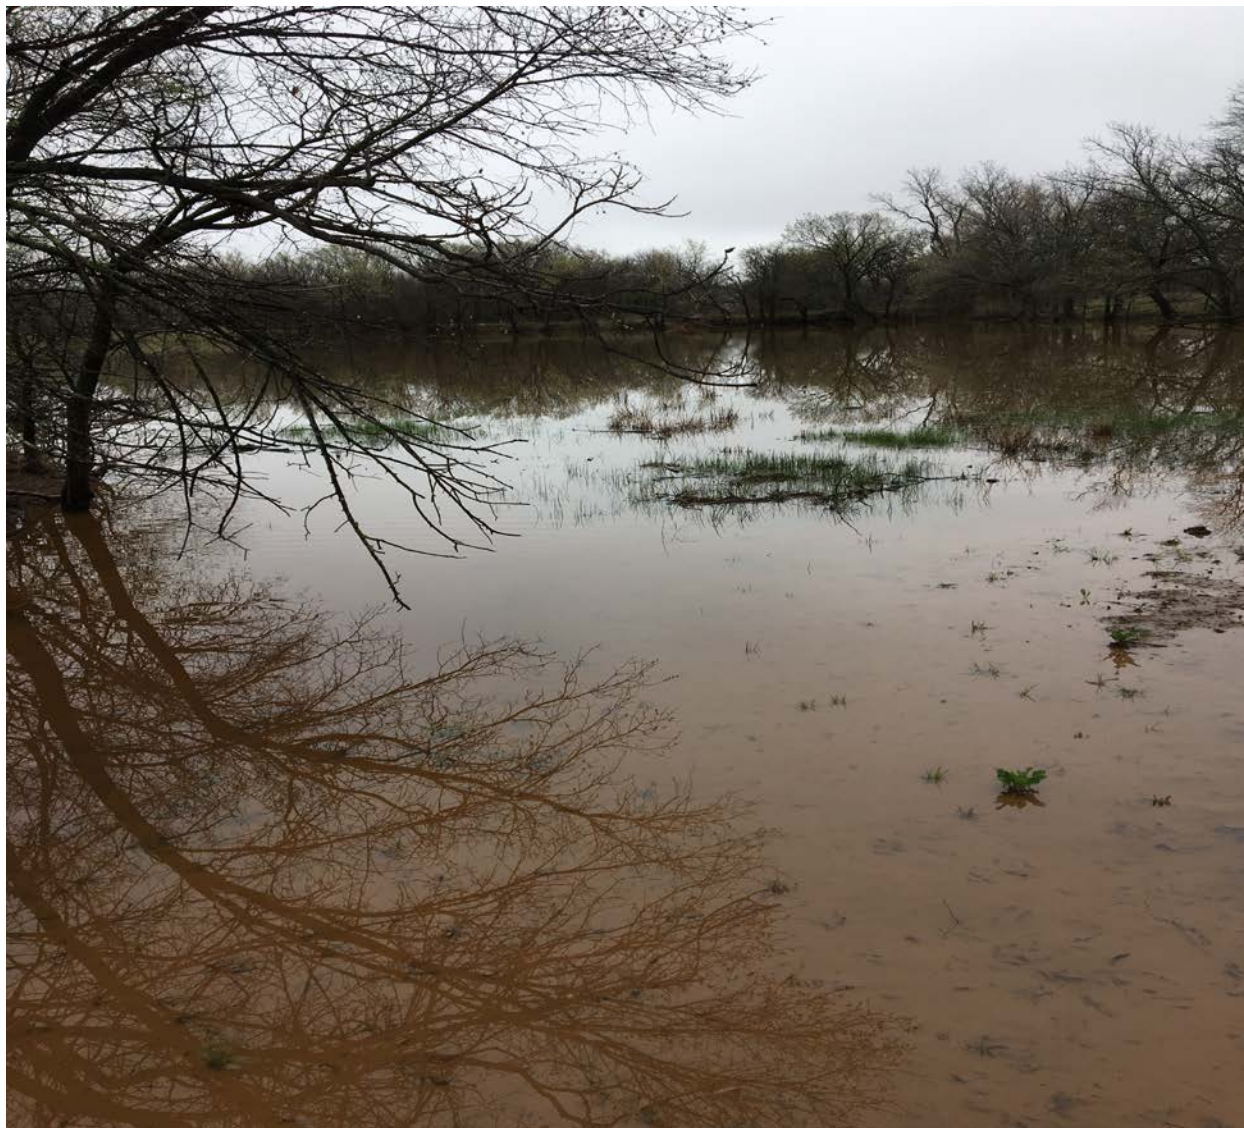
Photo No. 13

Description: The large pond area along the flow path and near the point of entry of the tributary of Red Creek was at this location. This pond has been flooded due to recent heavy rain.

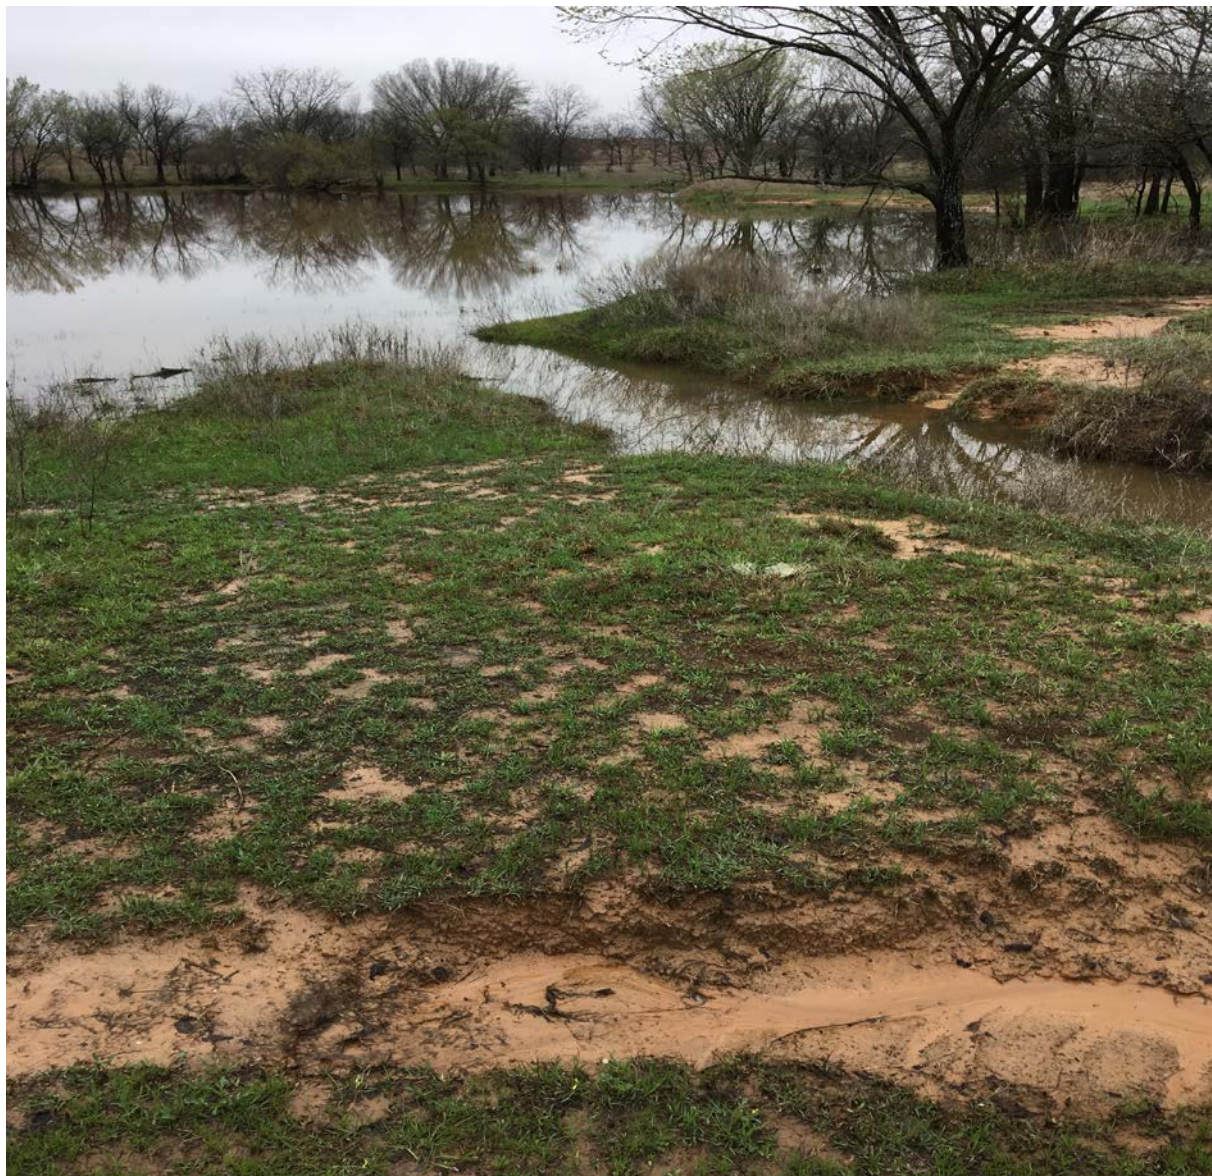
Photo No. 14

Description: The flow from the pond exited the flooded area at this location on the southeast side of the pond and flows towards a tributary of Red Creek.

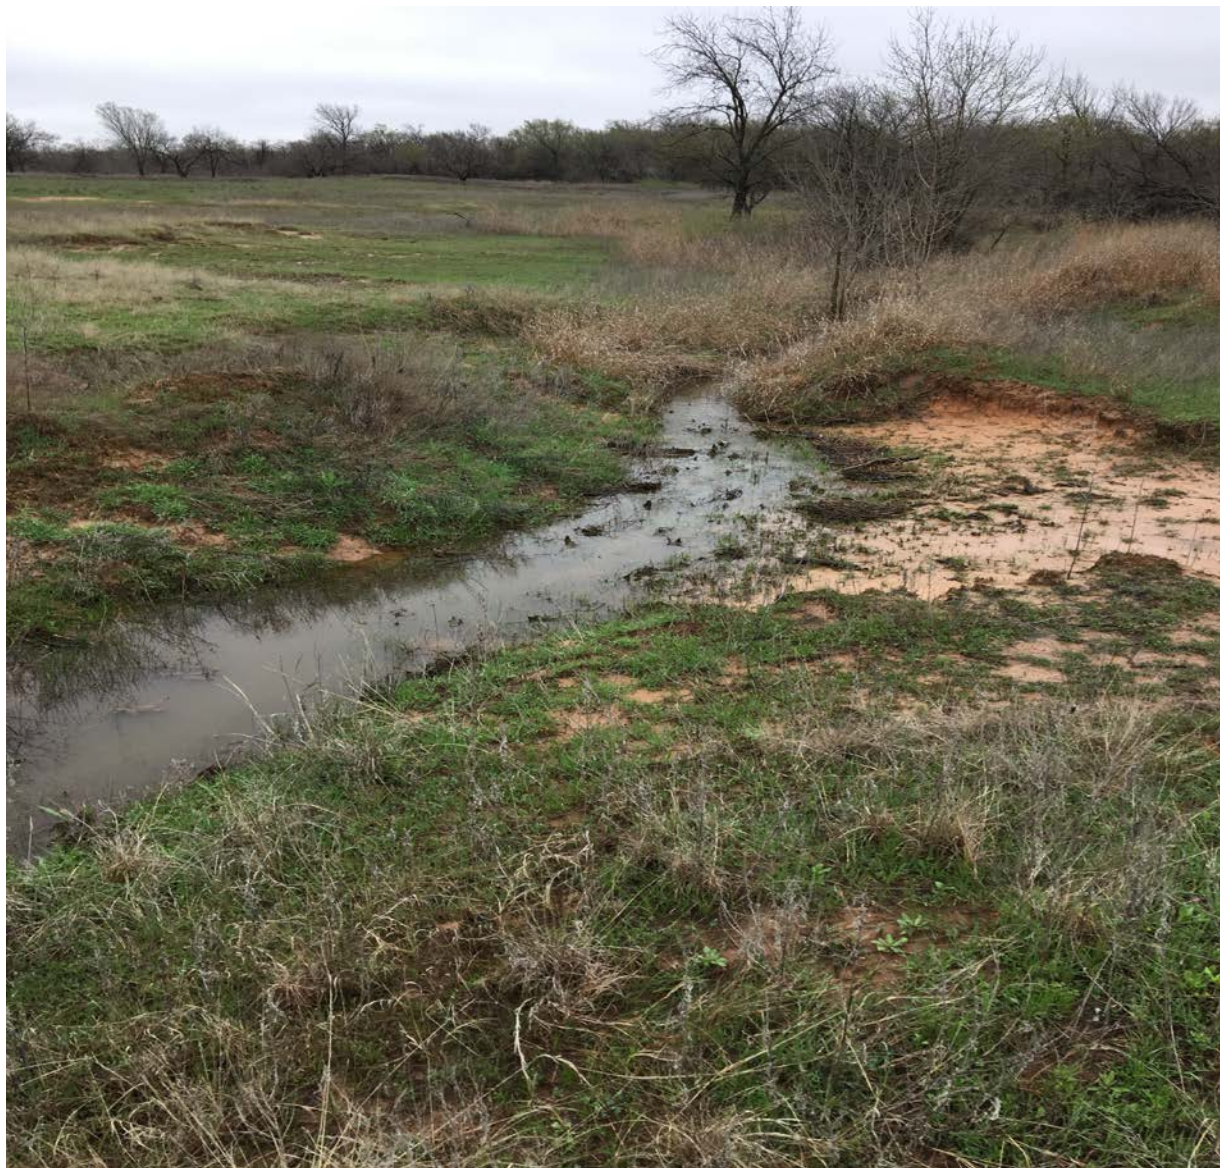
Photo No. 15

Description: This photo shows the flow path which continued east then southeast approximately 0.5 miles towards the tributary of Red Creek.
