**Region 6 Compliance Assurance and Enforcement Division  
INSPECTION REPORT**

| Inspection Date(s): | March 28, 2018 | | |
| Company Name: | <b>Polk Operating, L.L.C.</b> | | |
| Facility Name: | <b>Polk R 3 Facility</b> | | |

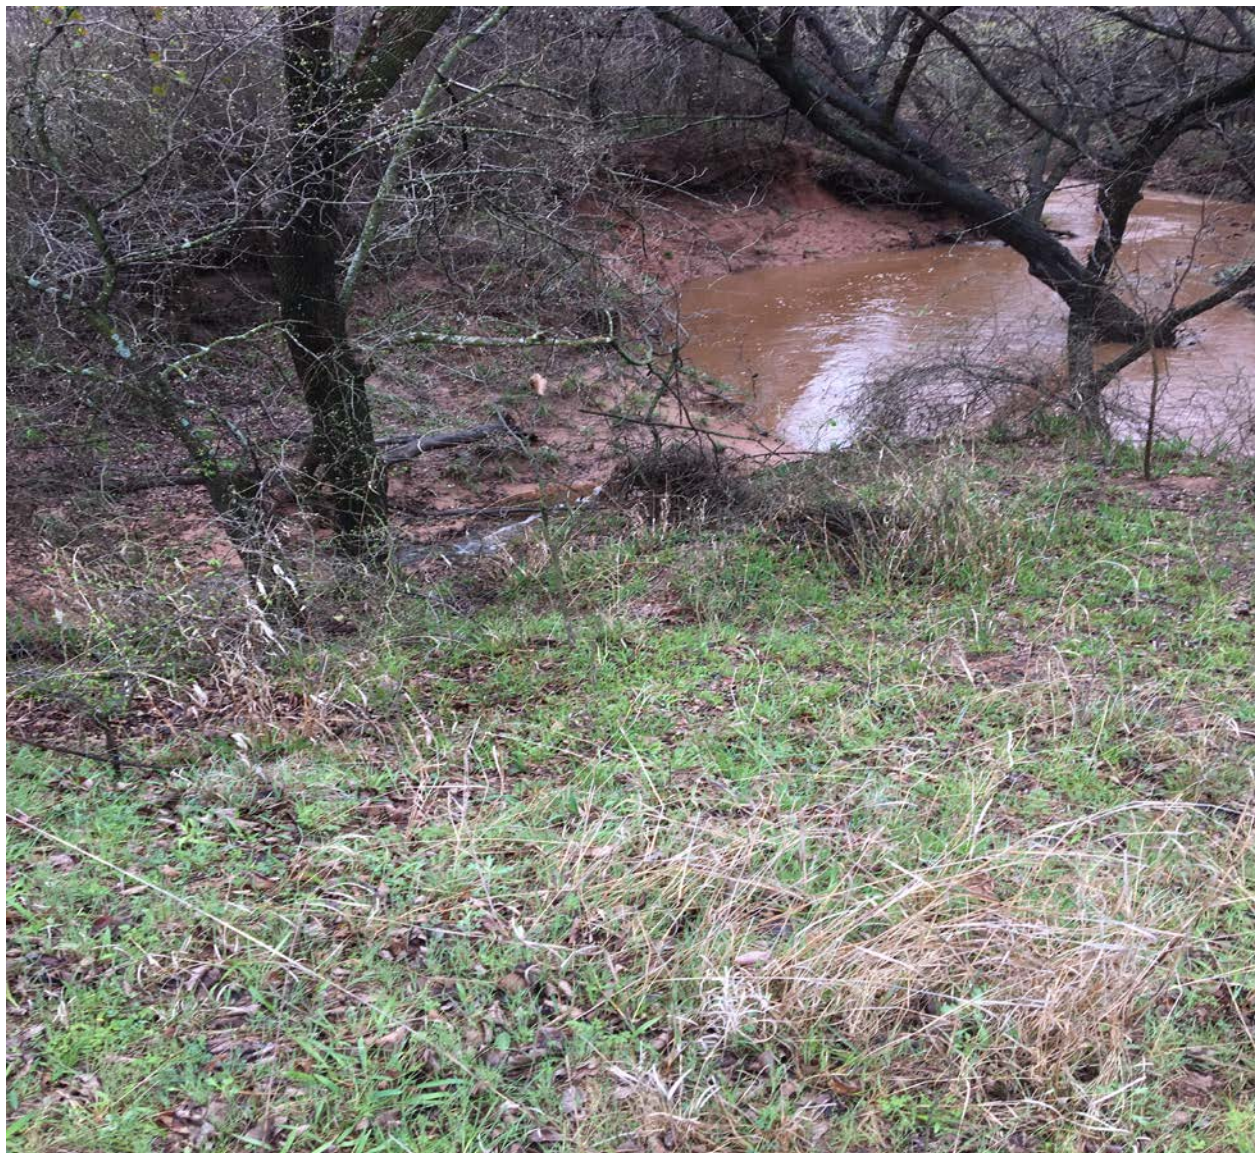
Photo No. 16

Description: The flow path entered the tributary of Red Creek at this location. I observed a strong flow in the tributary towards the east.

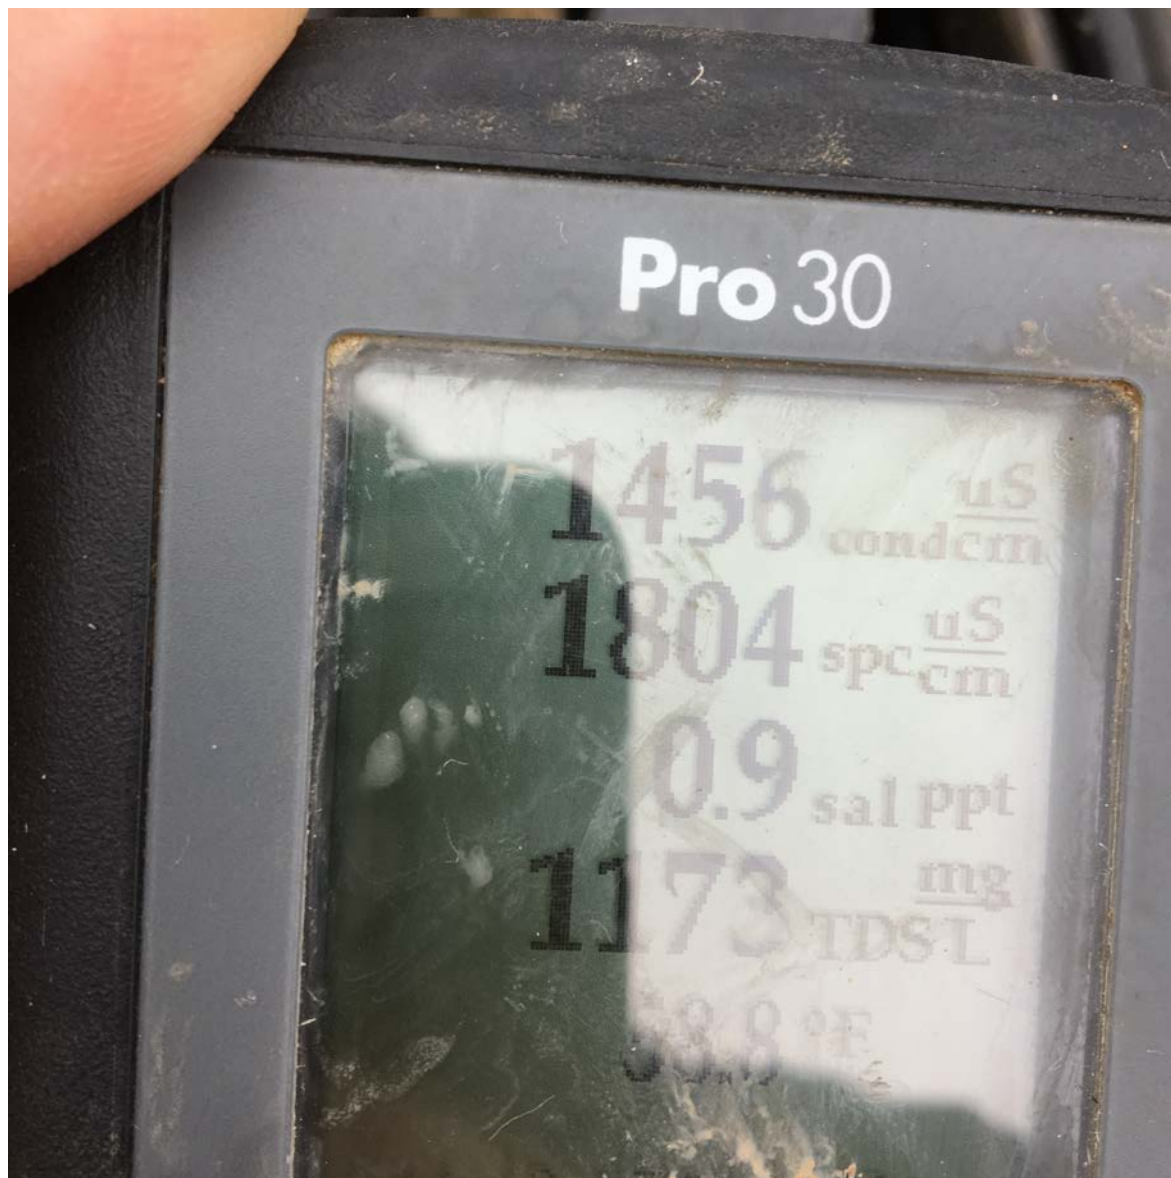
Photo No. 17

Description: The TDS of the tributary of Red Creek at the point of entry was 1,173 mg/L.

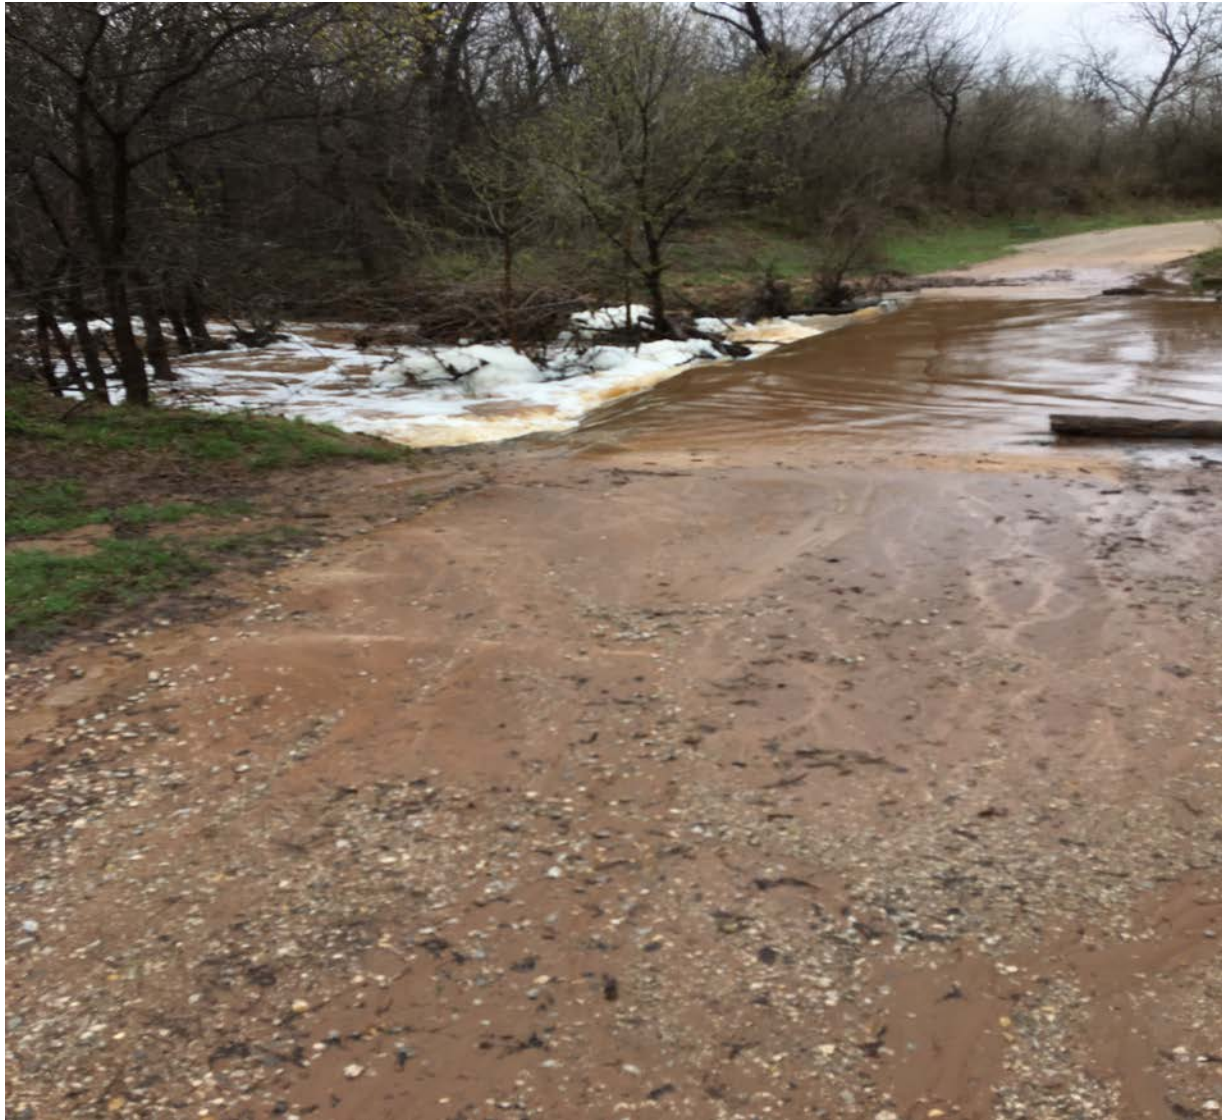
Photo No. 18

Description: This was a view of the tributary of Red Creek upstream of the discharge entry point. This photo shows that the tributary was flooding during the inspection.

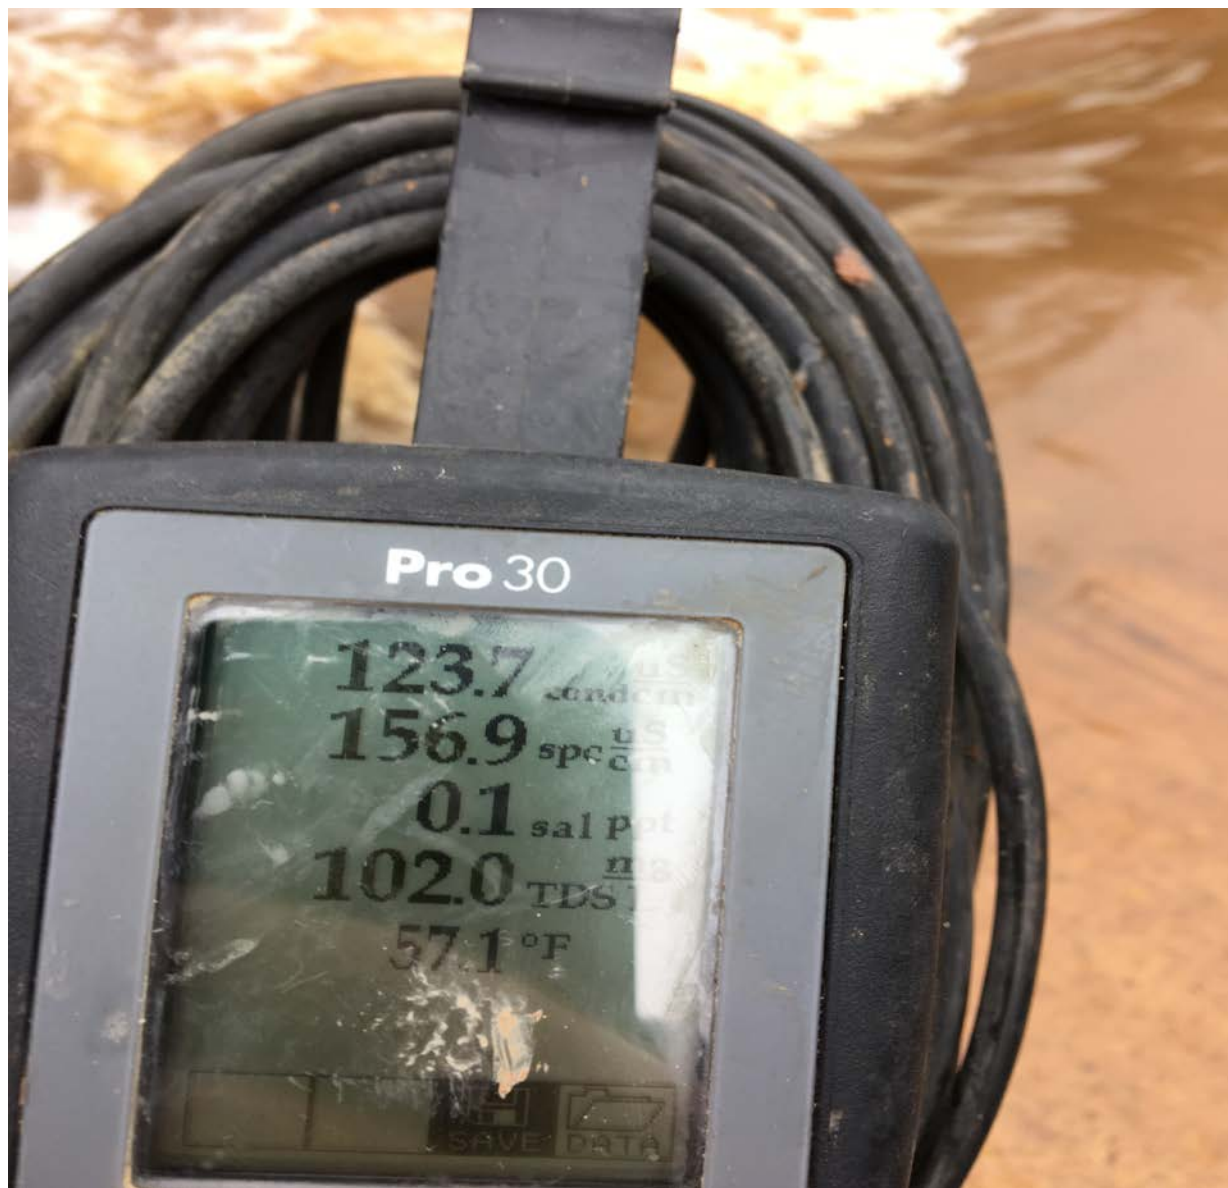
Photo No. 19

Description: The TDS upstream of the discharge entry point was 102 mg/L.

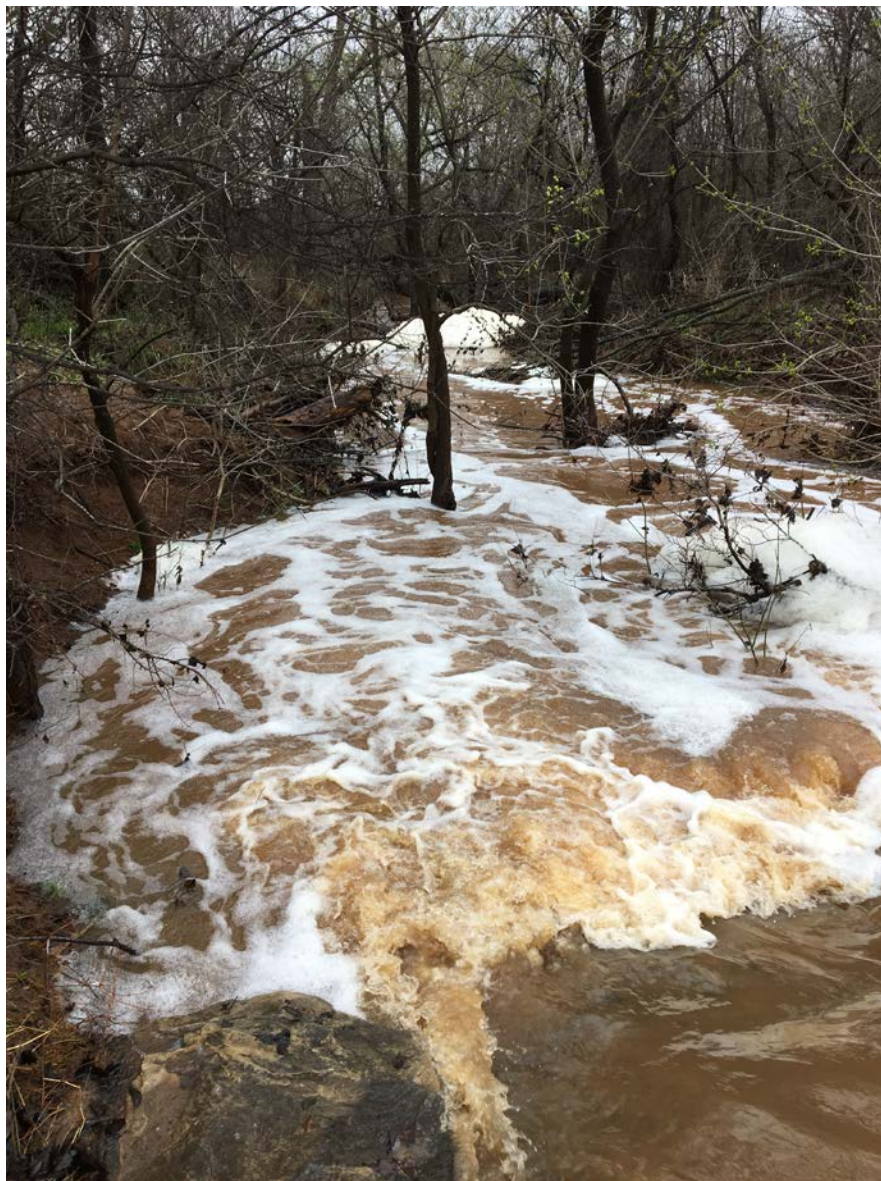
Photo No. 20

Description: This was the tributary of Red Creek flowing east near the point of entry of the flow path of brine and drilling mud fluids. I observed that heavy rain had caused flooding.
