**Region 6 Compliance Assurance and Enforcement Division**  
**INSPECTION REPORT**

| Inspection Date(s): | 07/21/2022 | | |
| Facility Name: | Town of Kinder Wastewater Treatment Facility | | |
| Identification/Permit Number: | LA0020605 | | |

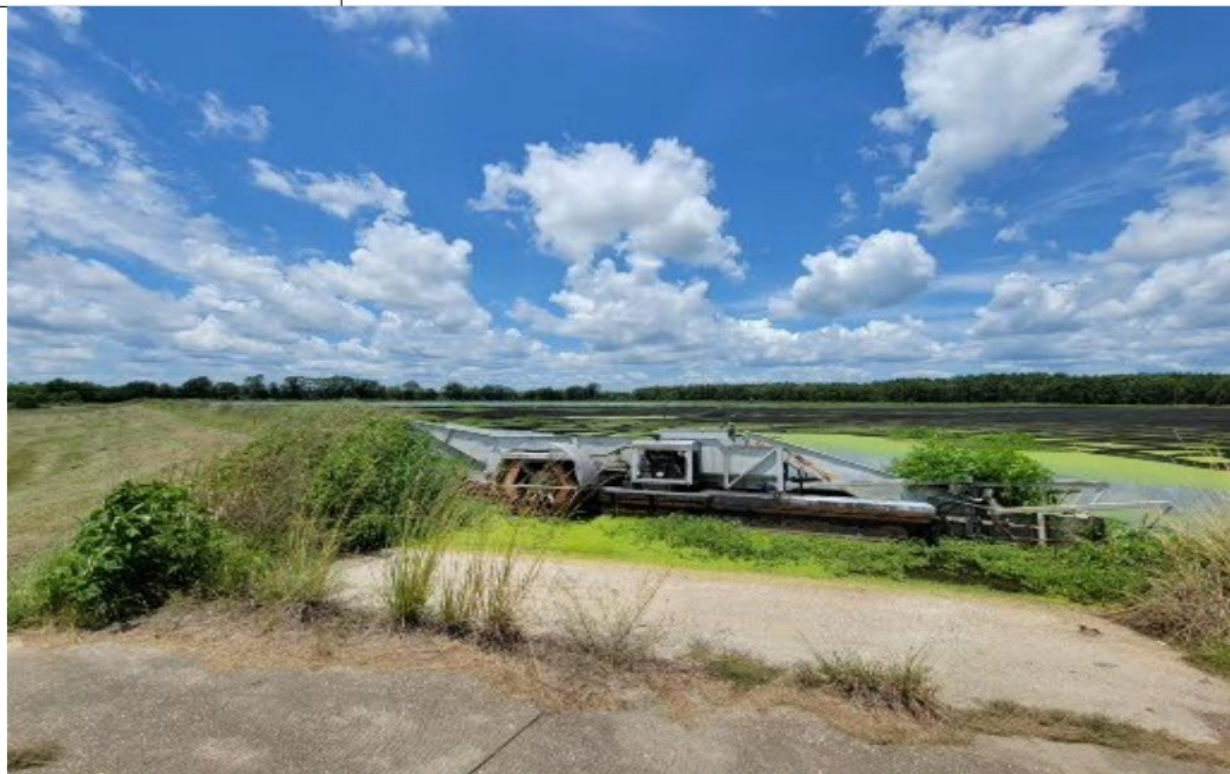
| Photo# | 1 | Date: | 7/21/2022 | Time: | 1:29 pm |

| Description | | Single Cell Lagoon | | | |

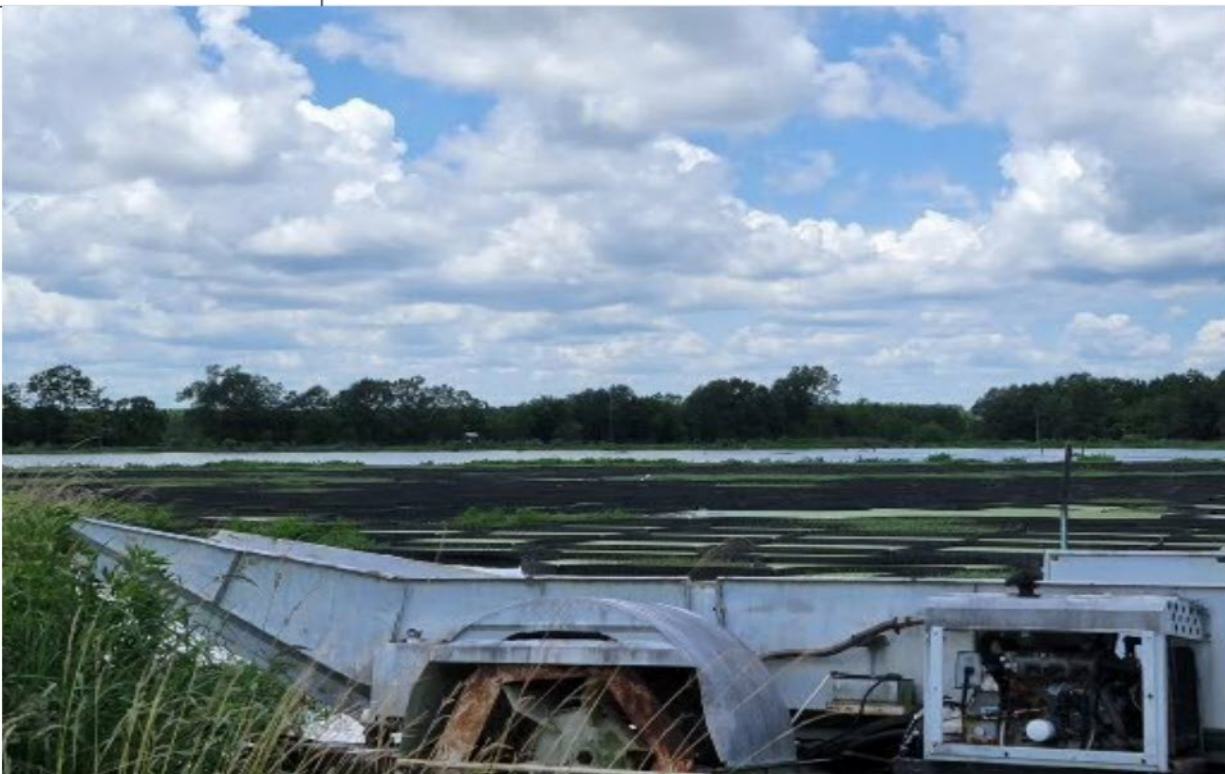
| Photo# | 2 | Date: | 7/21/2022 | Time: | 1:29 pm |

| Description | Single Cell Lagoon | | | | |

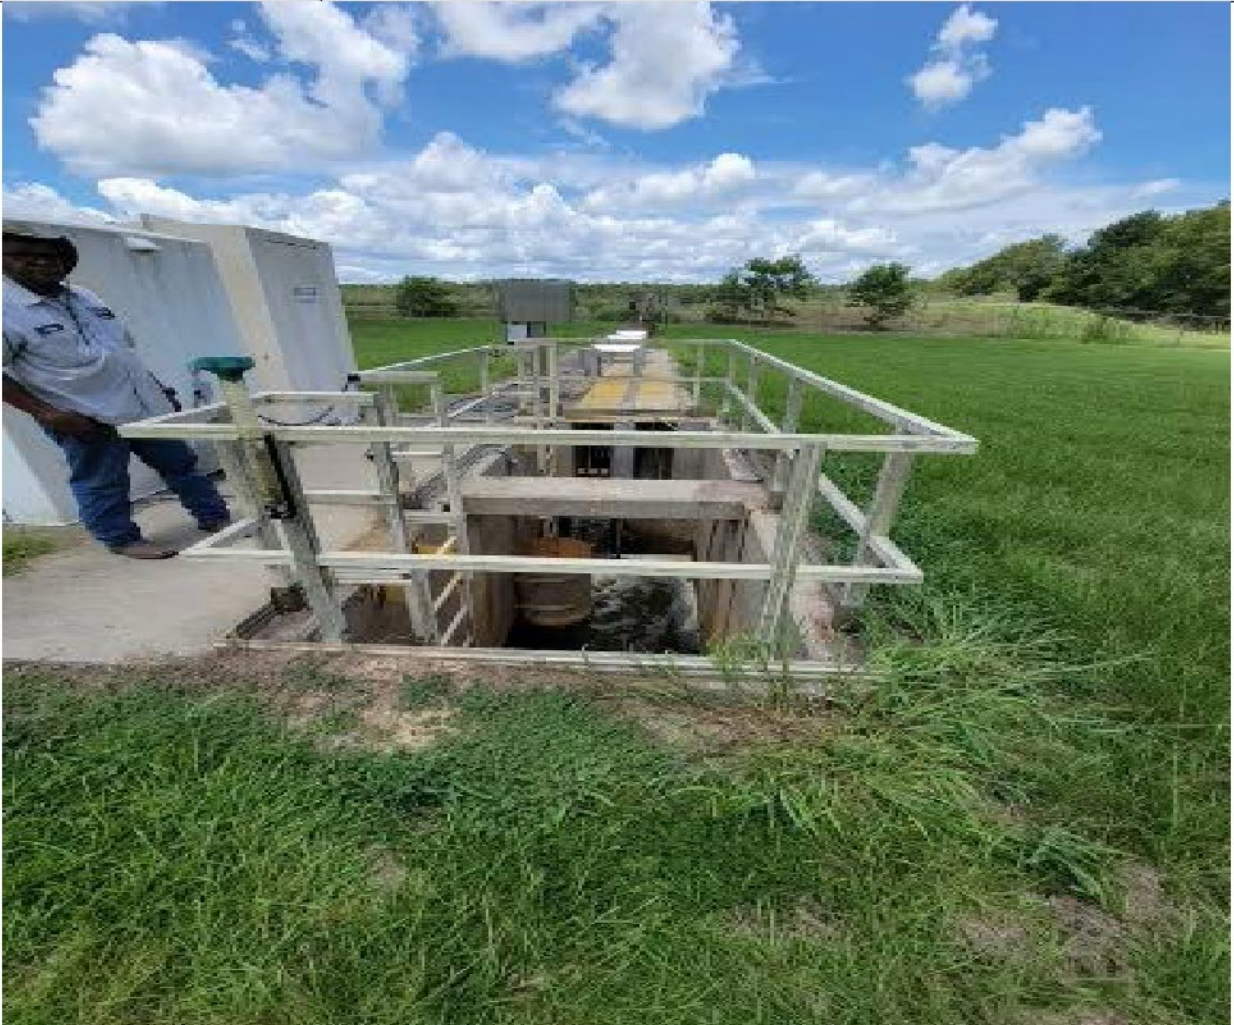
| Photo# | 3 | Date: | 7/21/2022 | Time: | 1:25pm |

| Description | Chlorine Contact Chamber | | | | |
