## Region 6 - Enforcement & Compliance Assurance Division

### INSPECTION REPORT

| Company Name: | CapturePoint, LLC | |
| Facility Name: | South Burbank Unit (SBU) R Battery | |

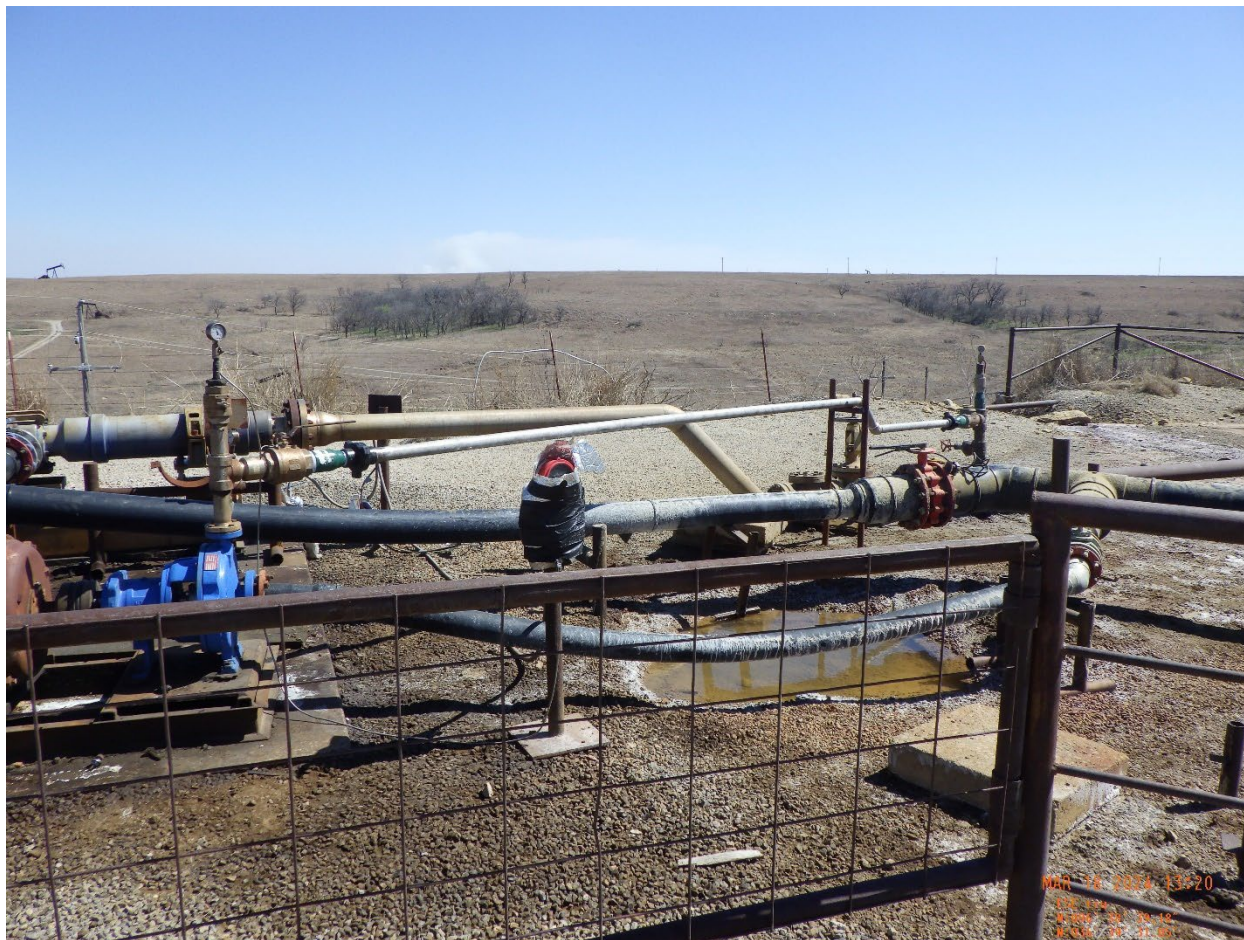
Photo No. 1

I observed the release point of the spill (see Appendix 1, Photo Log) Photo No. 1, which was a saltwater pumping station, where a saltwater flowline failed, releasing a company estimated 200 barrels of saltwater to the land surface. At the time of the inspection, the failed equipment had been replaced and the facility was operating as normal. For GPS location information and additional meta data, please see the photo log.

**Description:** This was the release point, a 2-inch steel line failed, releasing fluid to the land surface.

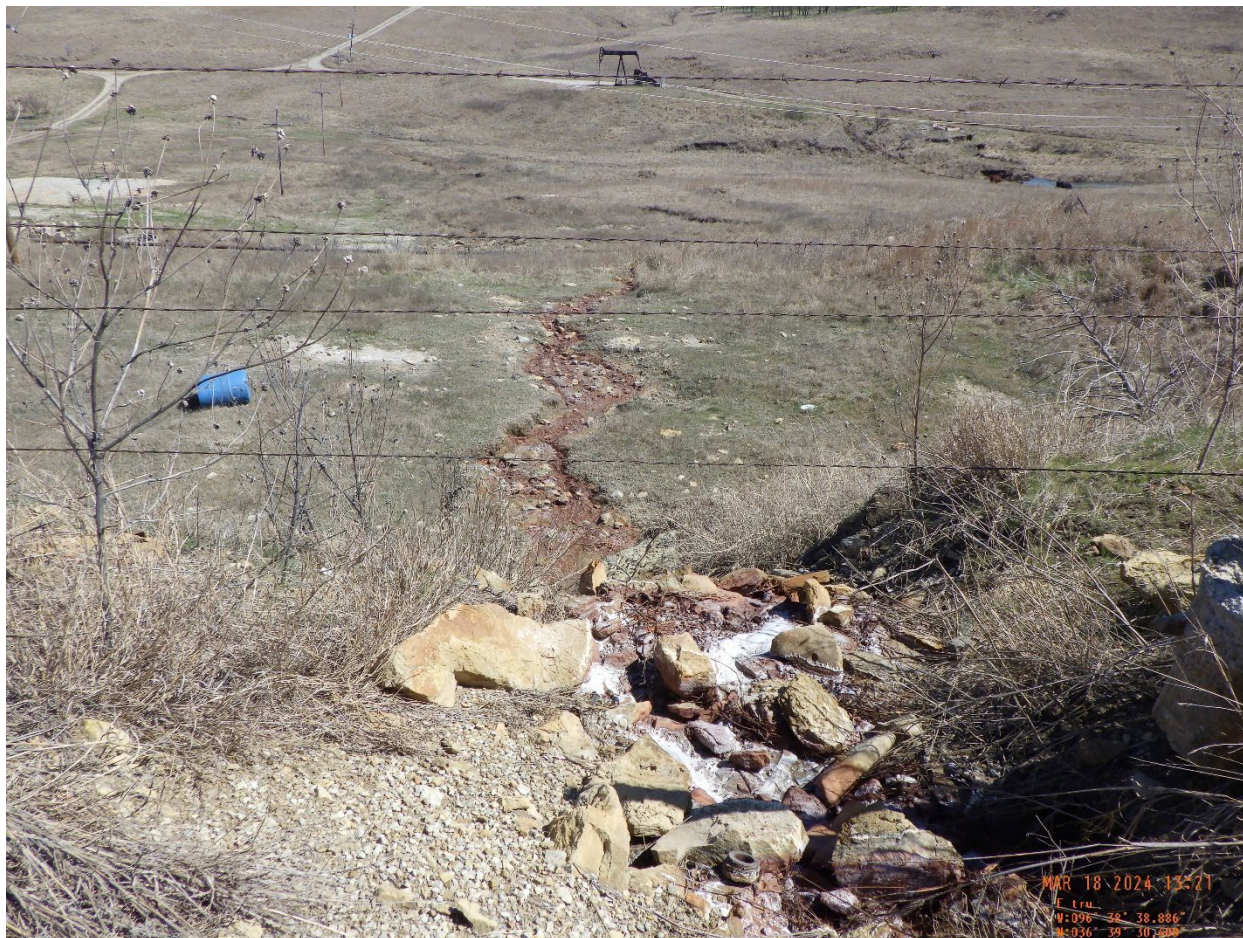
Photo No. 2

I observed the overland flowpath which migrated east from the facility along a drainage feature approximately 650 feet. The flowpath varied between 1 and 3 feet wide. The flowpath travelled across a significant downslope. See photo No. 2.

**Description:** This was the flowpath travelling east from the release point, down a significant grade. The flowpath averaged 2-3 feet in width.

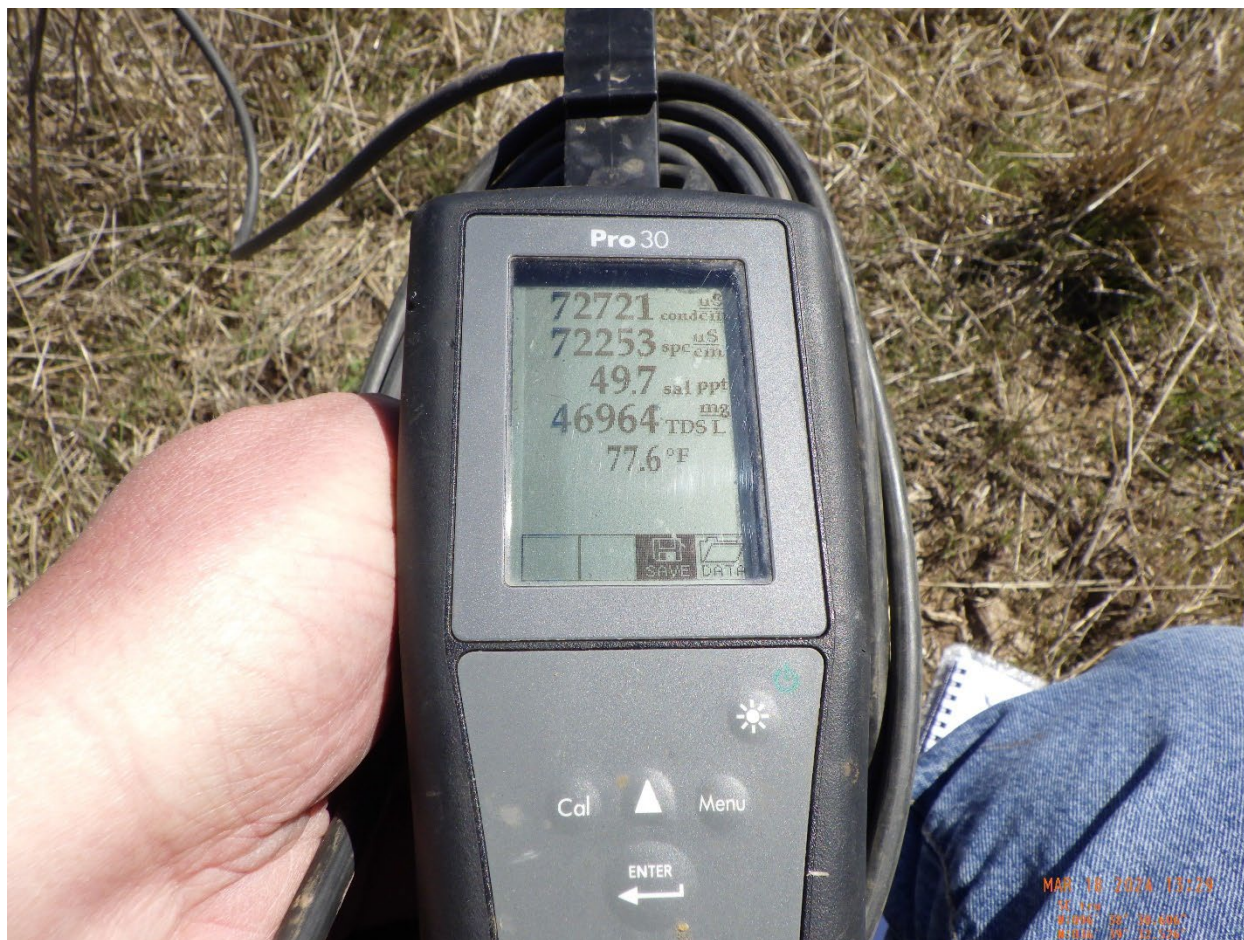
Photo No. 3

I observed the Point of Entry (POE) into an unnamed tributary of Little Chief Creek. At the POE, I observed an elevated TDS field reading of 46,964 mg/L. This was the highest TDS level observed throughout the inspection. The POE and associated TDS readings can be seen in Photos No. 3 and 4.

**Description:** This was an elevated TDS field reading of 46,964 mg/L taken at the Point of Entry (POE) into an unnamed tributary of Little Chief Creek. This was the highest TDS reading observed during the inspection.

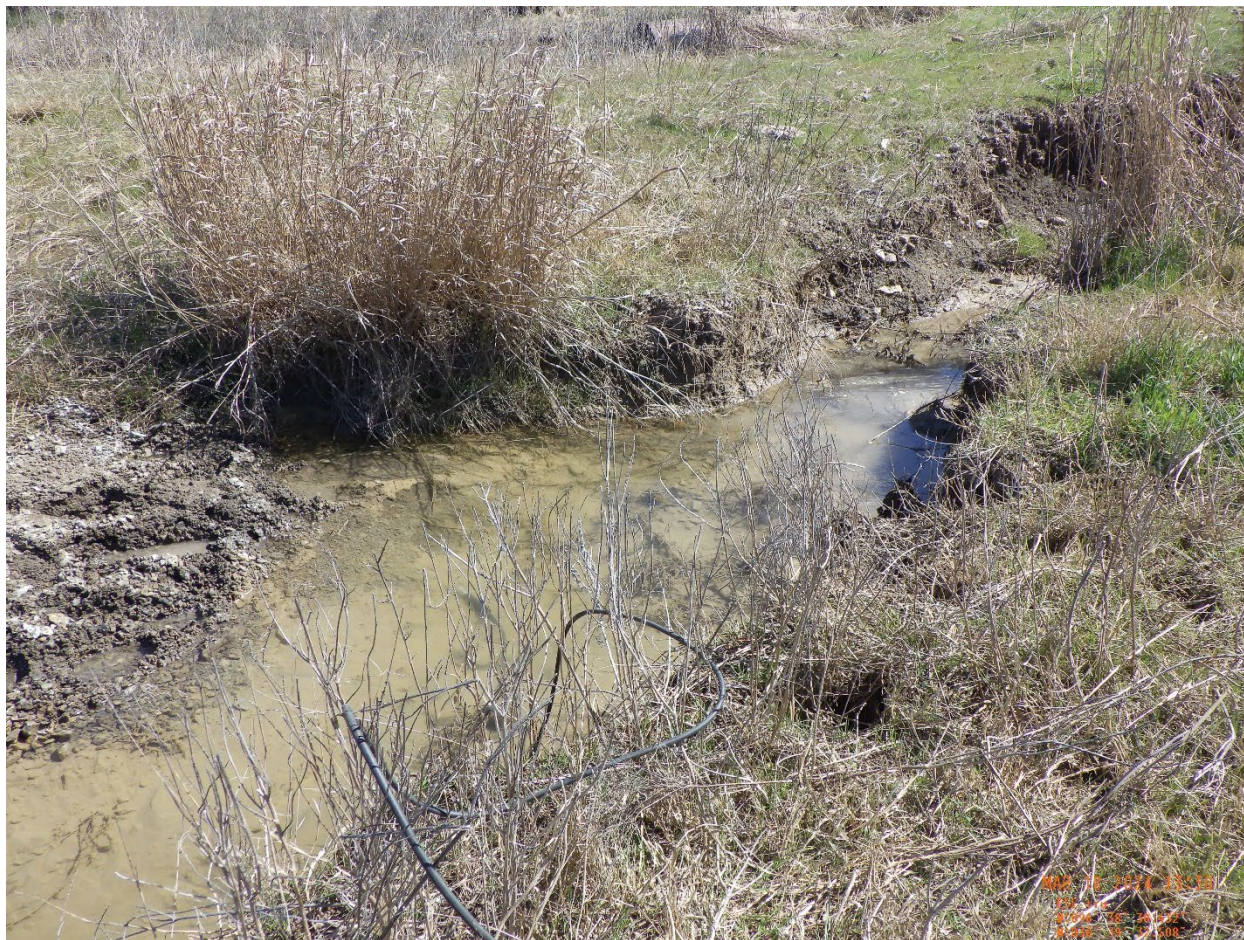
Photo No. 4

**Description:** This was the POE into the unnamed tributary of Little Chief Creek. At the time of the inspection, cleanup efforts had not yet reached this section of the impacted flowpath.

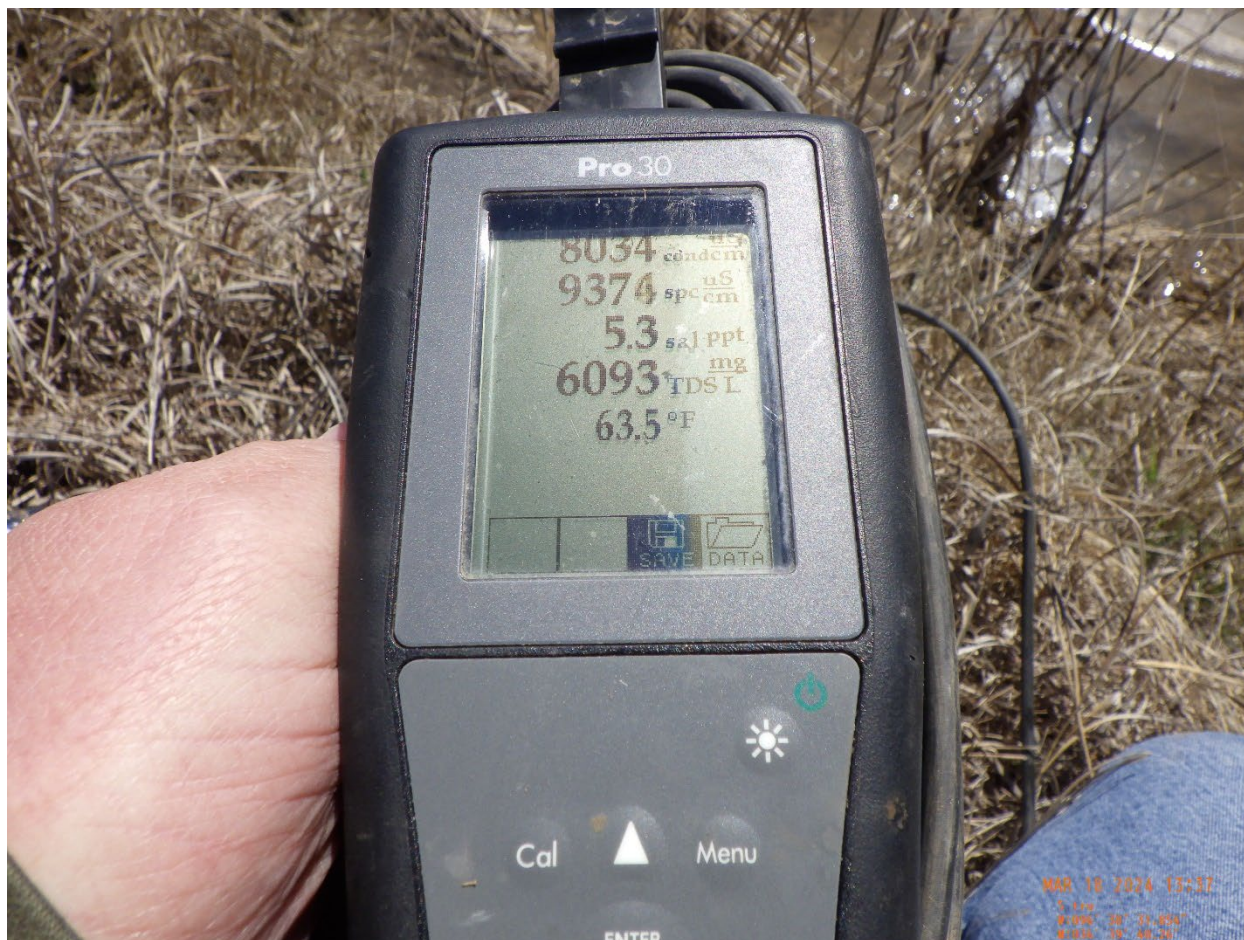
Photo No. 5

Continuing along the impacted tributary, I observed an elevated TDS field reading of 6,093 mg/L. This observation was made at the approximate midpoint of the flowpath along the tributary. This observation can be seen in Photo No. 5.

**Description:** This was an elevated TDS field reading of 6,093 mg/L taken at the approximate midway point of the impacted unnamed tributary. At the time of the inspection, this area had already been emptied and flushing operations were being conducted.

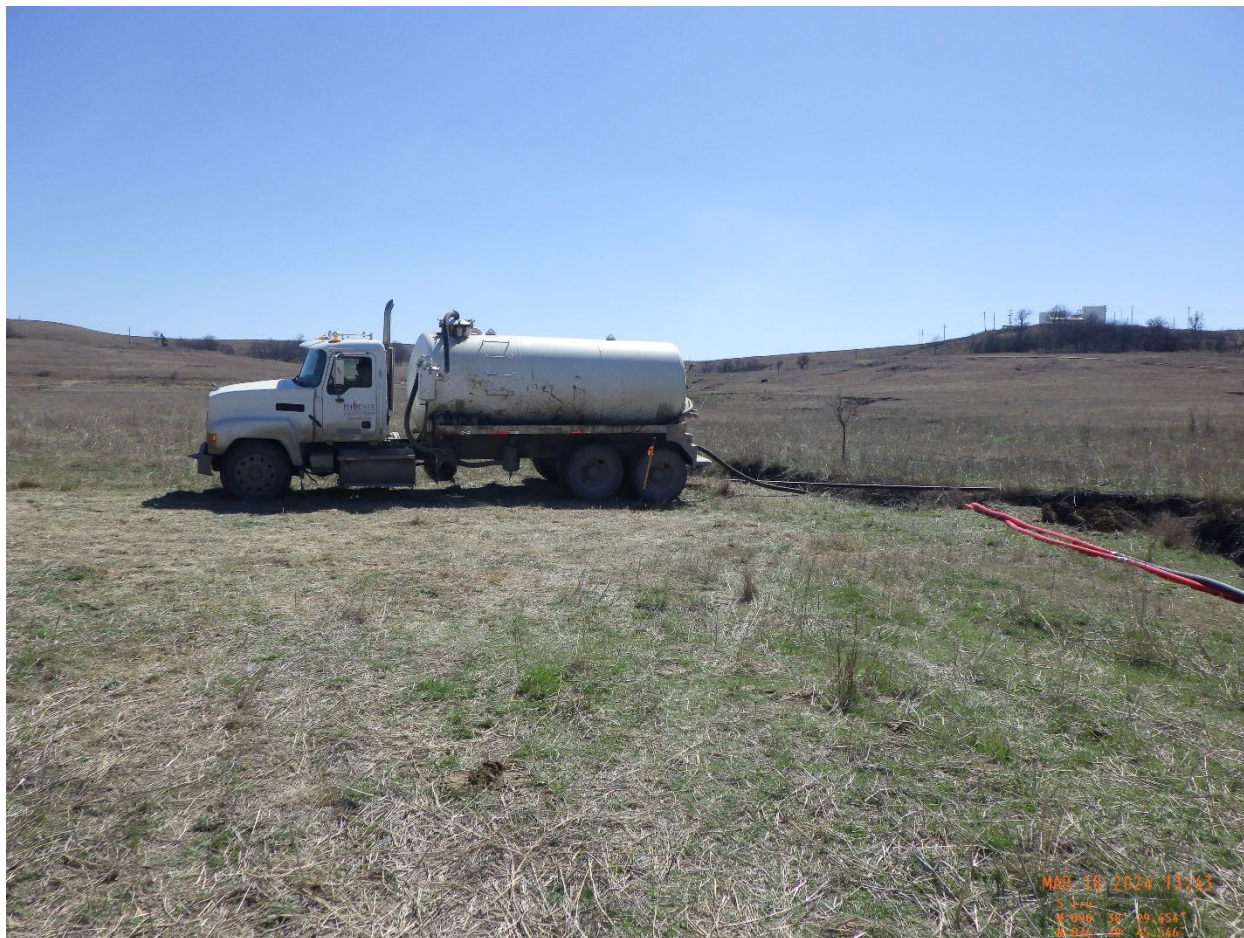
Photo No. 6

**Description:** This was a vacuum truck removing water from the impacted tributary of Little Chief Creek.

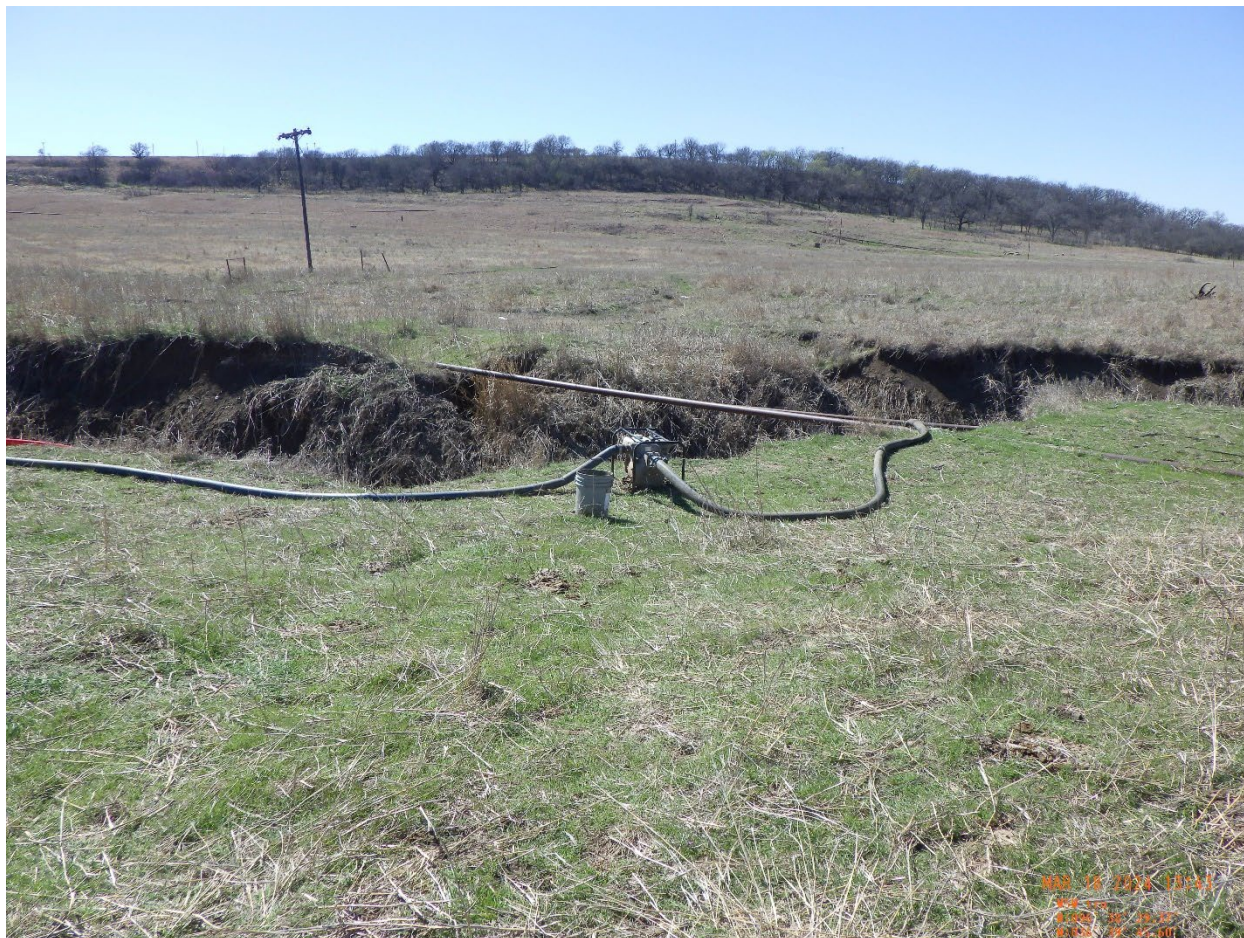
Photo No. 7

**Description:** This was a trash pump transferring water along the impacted tributary.

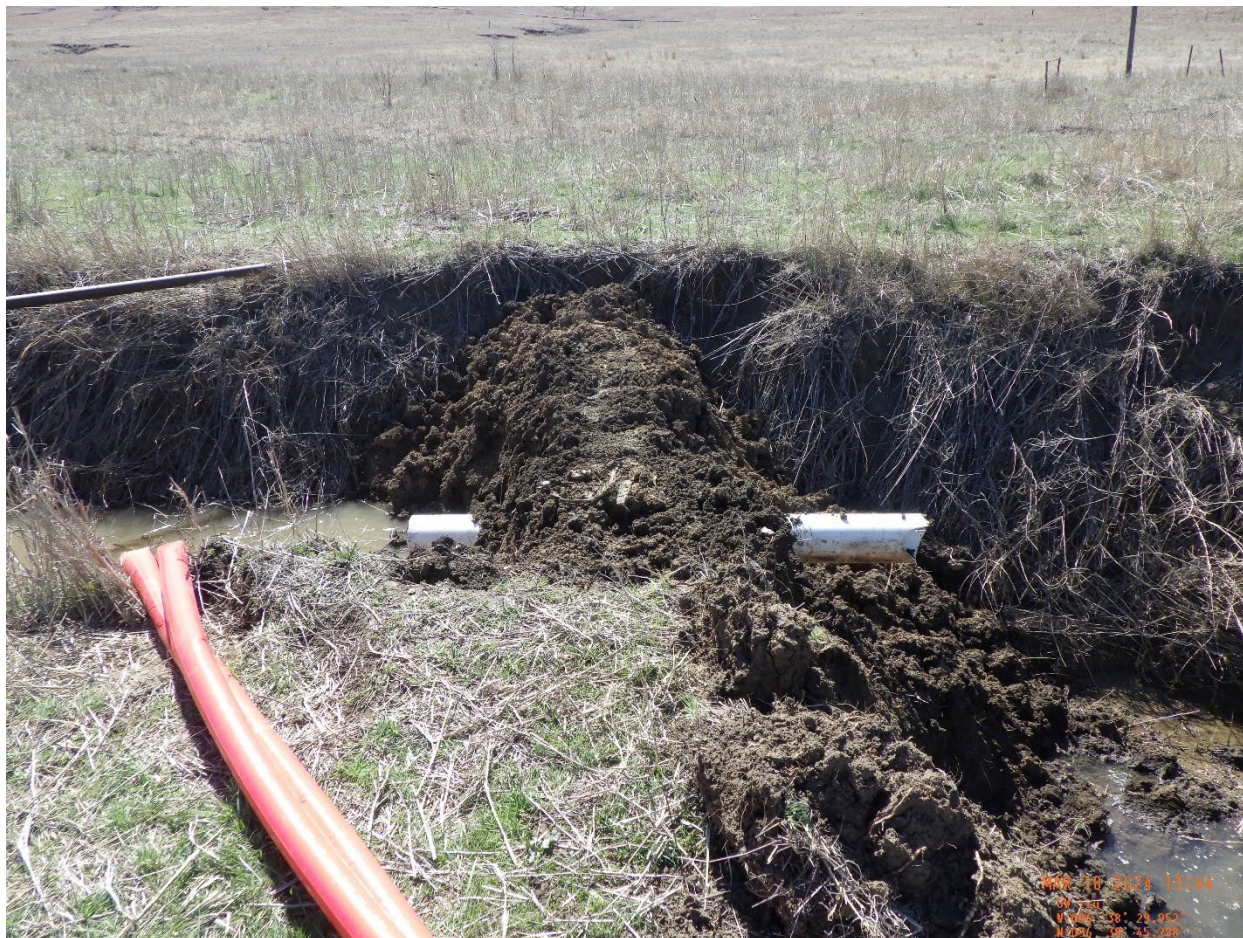
Photo No. 8

I observed a temporary containment dam which had been placed by the operator as part of the ongoing cleanup effort. The dam was placed to prevent further downstream migration of impacted waters. See photo No. 8.

**Description:** This was a temporary containment dam placed by the operator to prevent downstream migration of impacted waters.

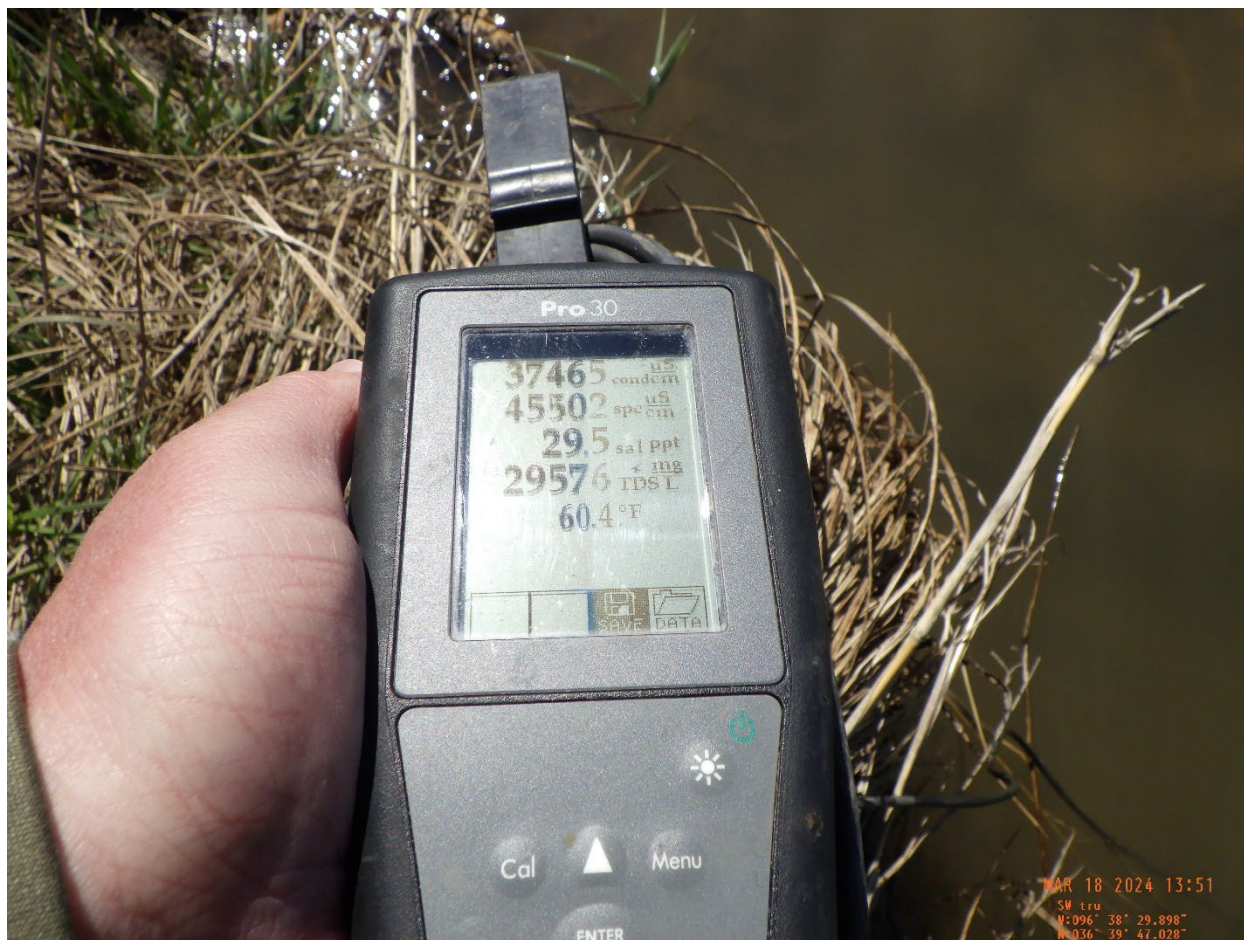
Photo No. 9

I observed the POE into Little Chief Creek. At the same location, I observed an elevated TDS field reading of 29,576 mg/L (Photo No. 9). This was the highest TDS level observed in Little Chief Creek throughout the inspection. I also observed the streams physical characteristics at the same location. These observations are documented in Photos No. 10, 11 and 12.

**Description:** This was an elevated TDS field reading of 29,576 mg/L taken at the POE into Little Chief Creek. This reading was observed in the main channel of Little Chief Creek. This was the highest TDS reading observed in Little Chief Creek during the inspection.

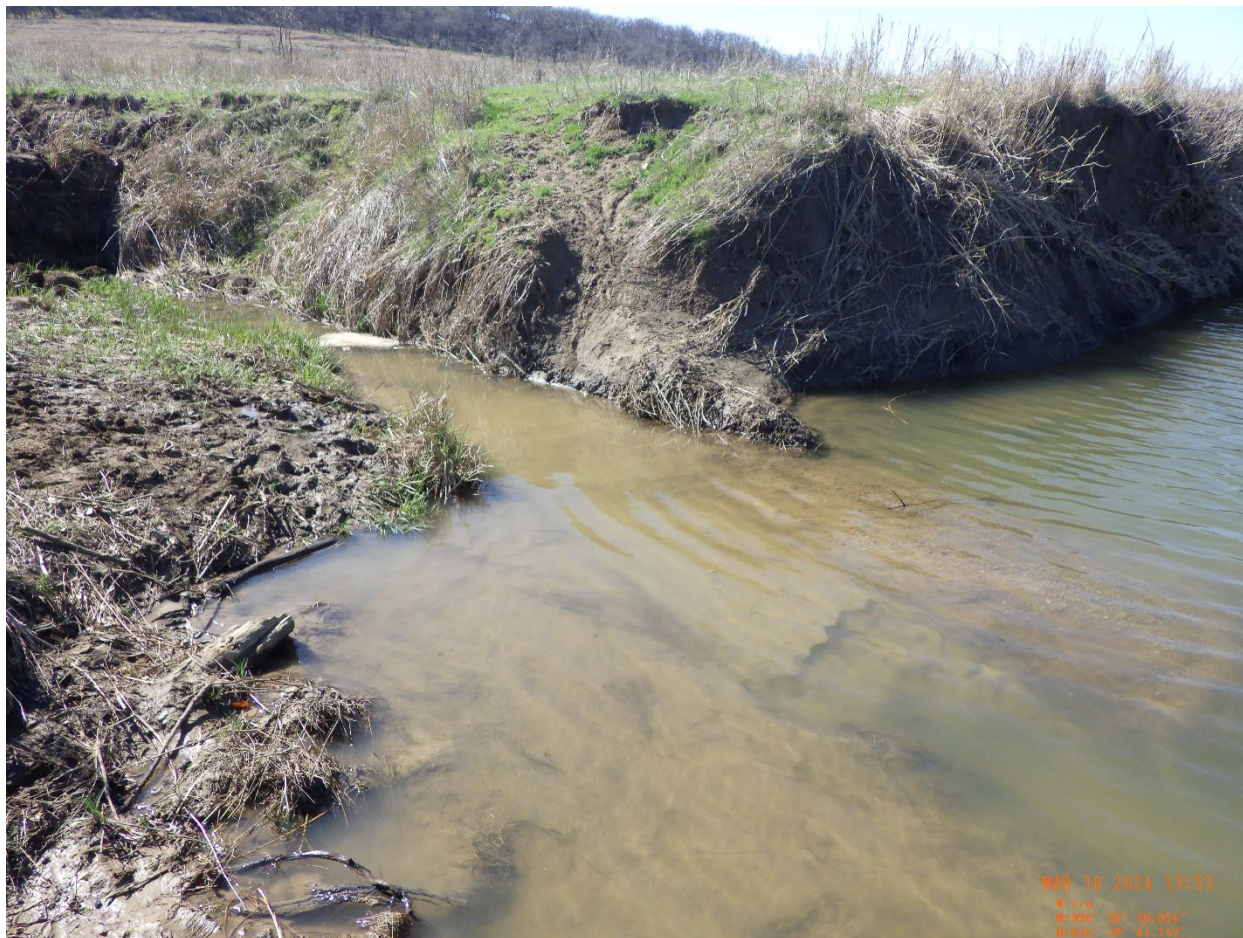
Photo No. 10

**Description:** This was the POE of the impacted unnamed tributary into Little Chief Creek. This is the same location where the TDS observation from photo No. 9 was taken.

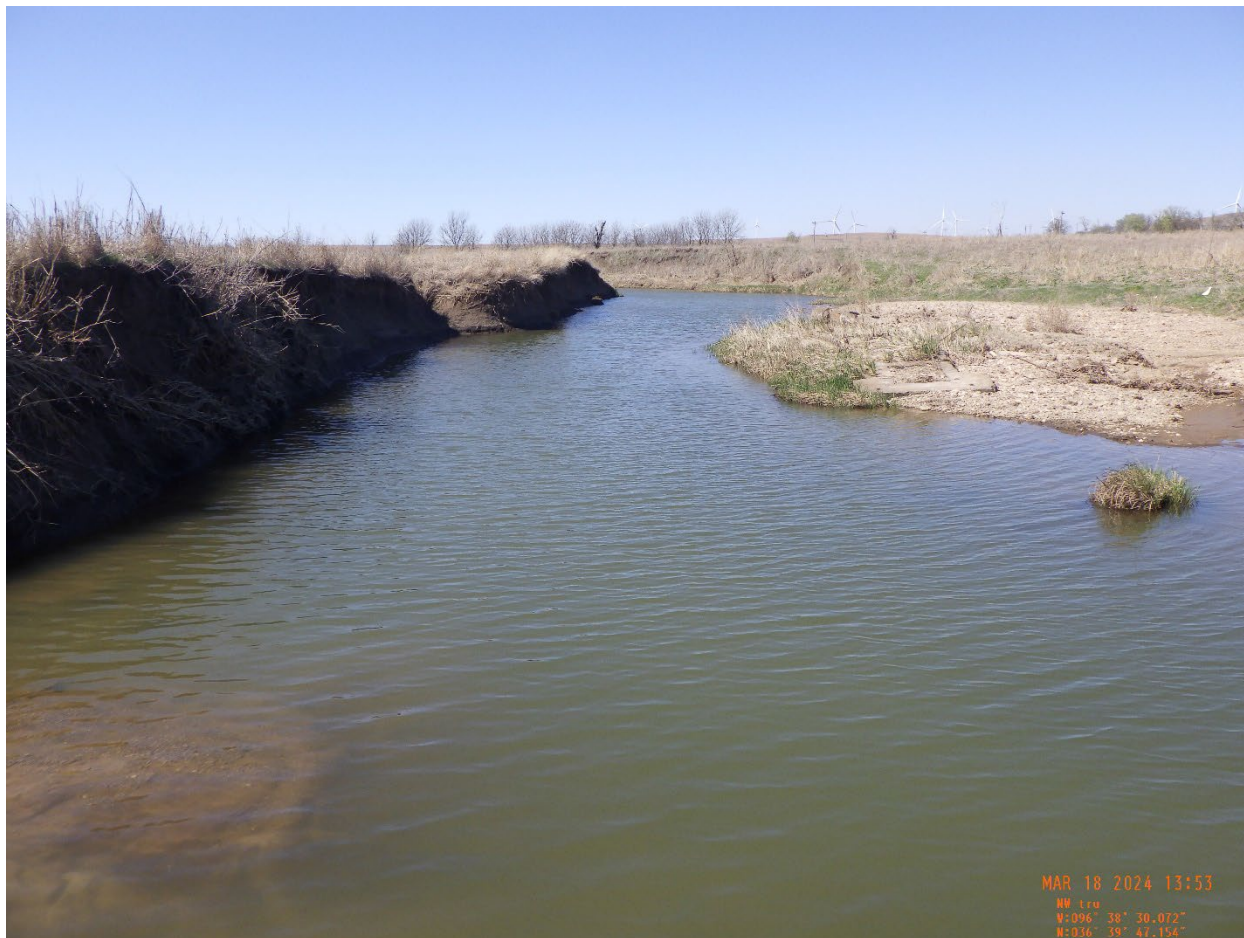
Photo No. 11

**Description:** This was a view from the POE looking downstream along Little Chief Creek.

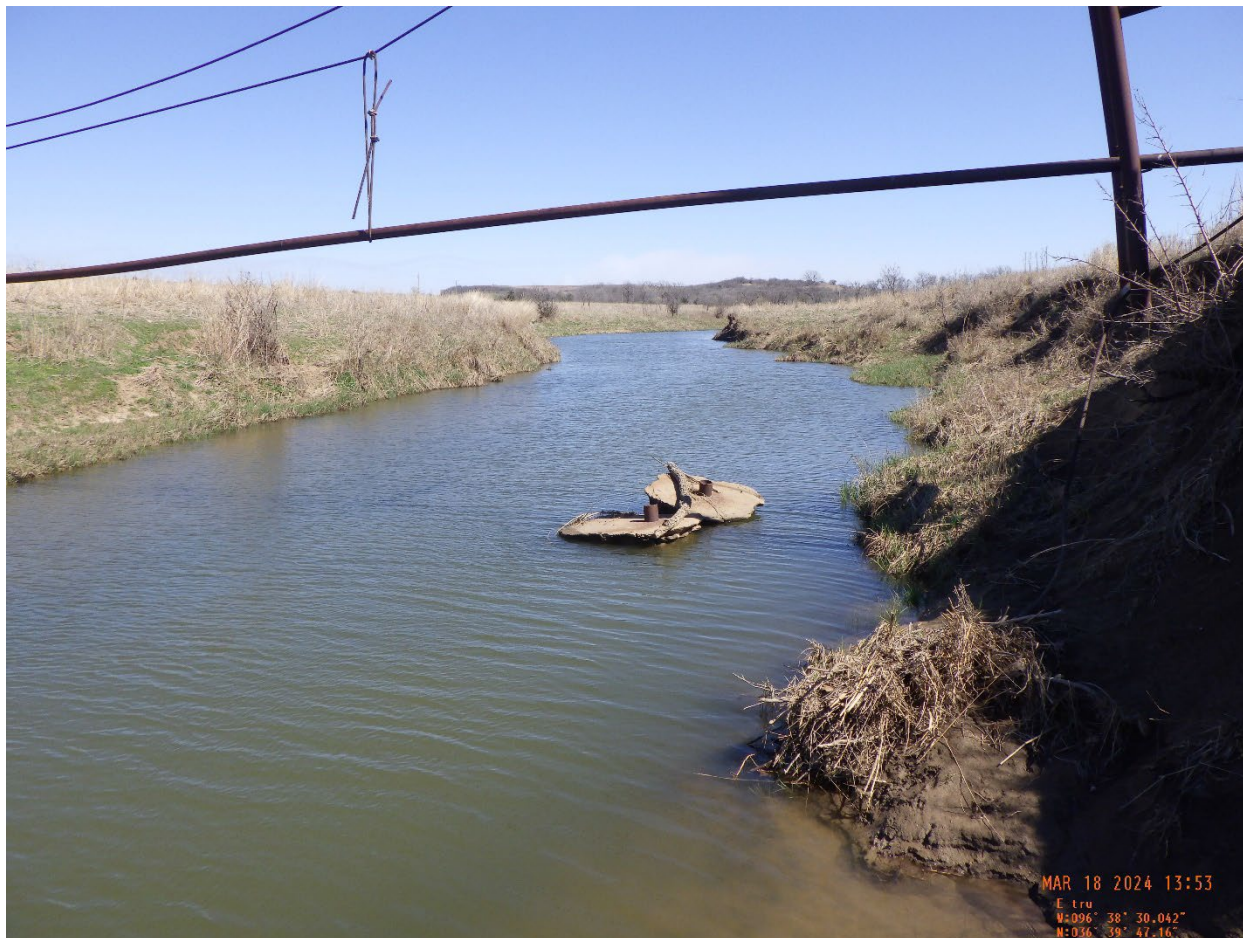
Photo No. 12

**Description:** This was an upstream view along Little Chief Creek from the POE.

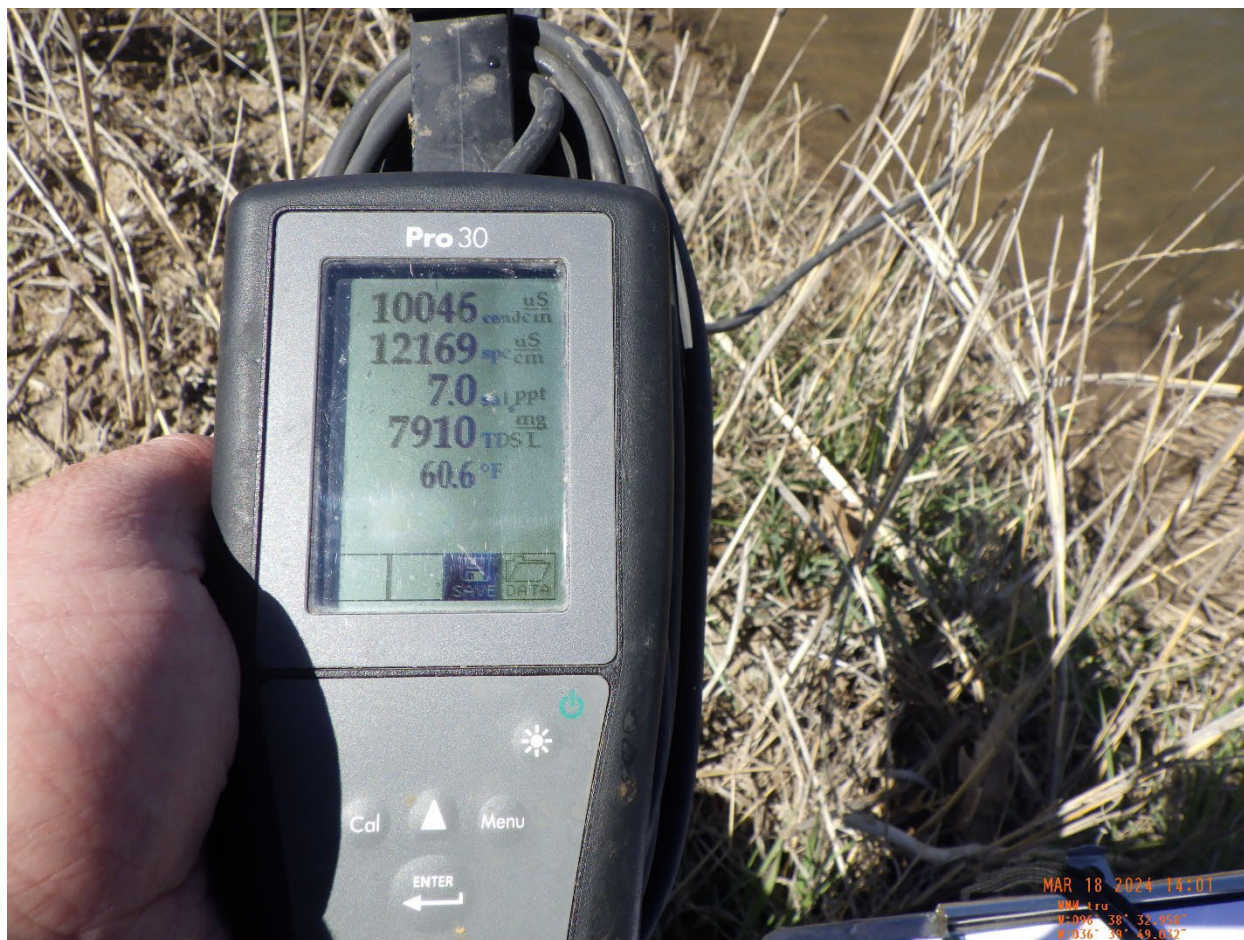
Photo No. 13

Approximately 350 feet downstream from the POE, in the main channel of Little Chief Creek I observed the furthest downstream spill impact. This was in the form of an elevated TDS field reading of 7,910 mg/L, which can be seen in Photo No. 13. At this same location I observed the physical stream characteristics (bed and bank features) which can be seen in the downstream and upstream photos pictured in Photos No. 14 and 15.

**Description:** This was an elevated TDS field reading of 7,910 mg/L taken downstream from the POE in the main channel of Little Chief Creek. This reading was observed approximately 350 feet downstream from the POE. This reading was taken just upstream from a shallow area of the creek which was preventing further downstream migration of impacted waters. This was the final observation of spill impact in Little Chief Creek.

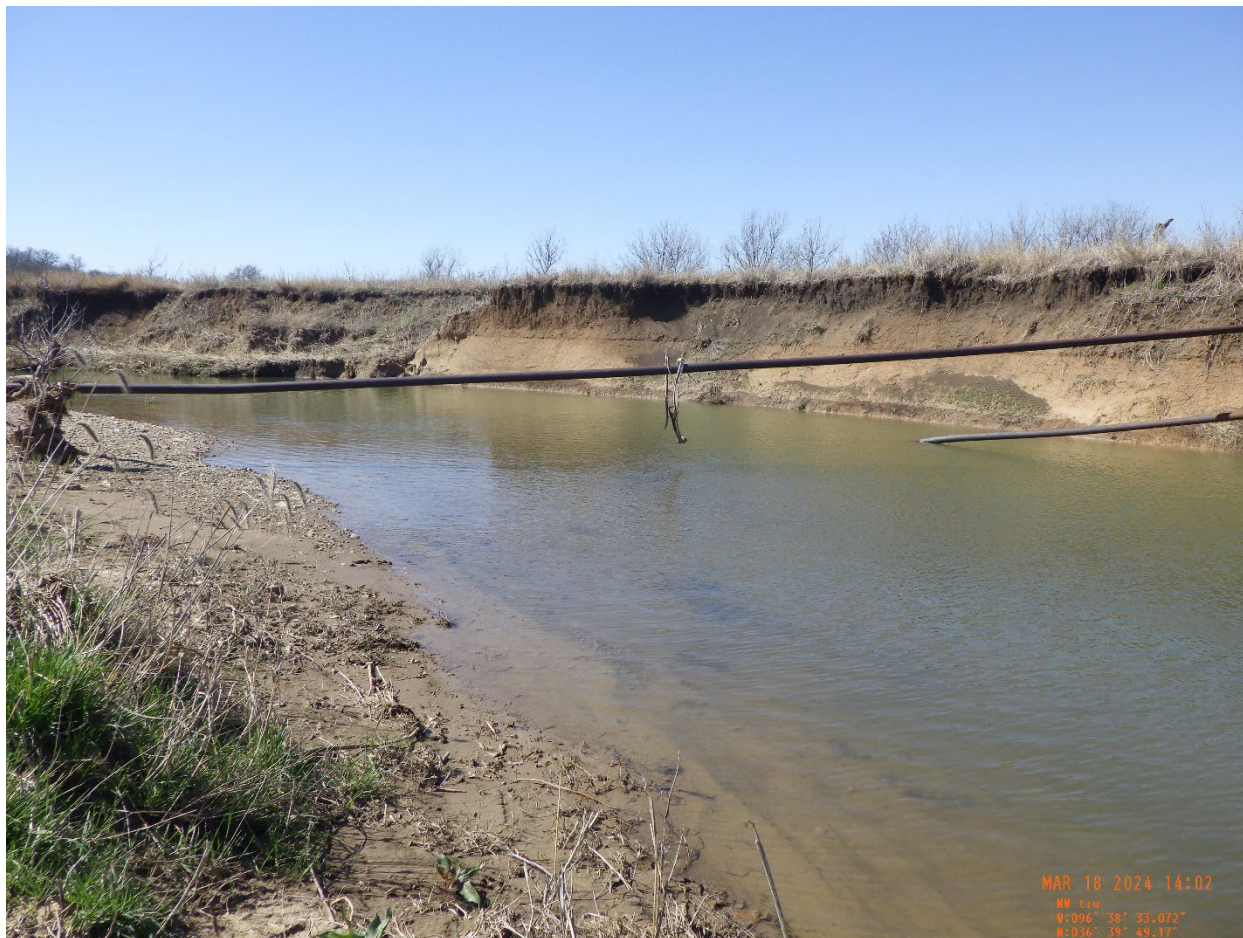
Photo No. 14

**Description:** This was a downstream view along Little Chief Creek. This photo was taken at the same location as the TDS reading from Photo No. 13.

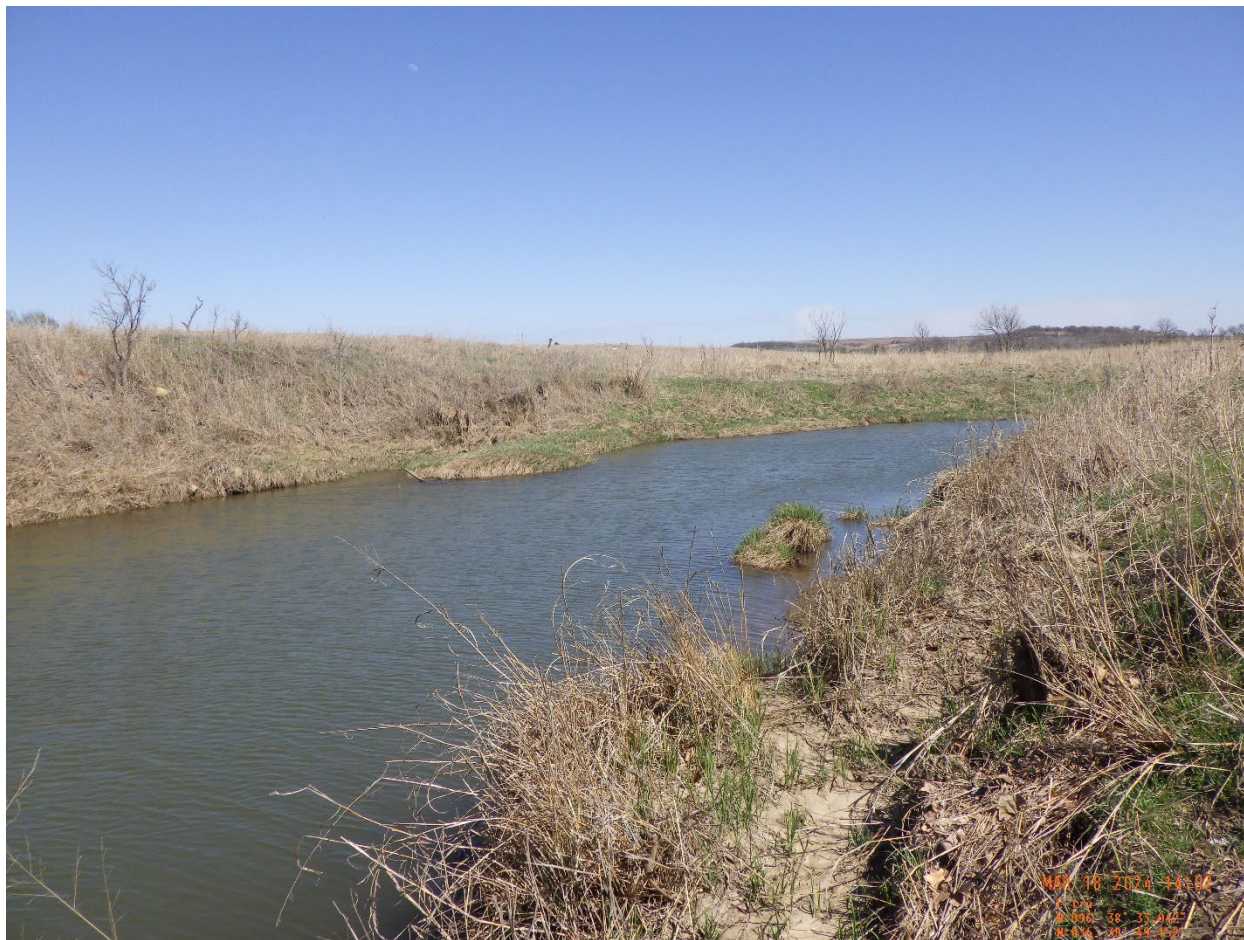
Photo No. 15

**Description:** This was an upstream view along Little Chief Creek. This photo was taken from the same location as Photos No. 13 and 14.

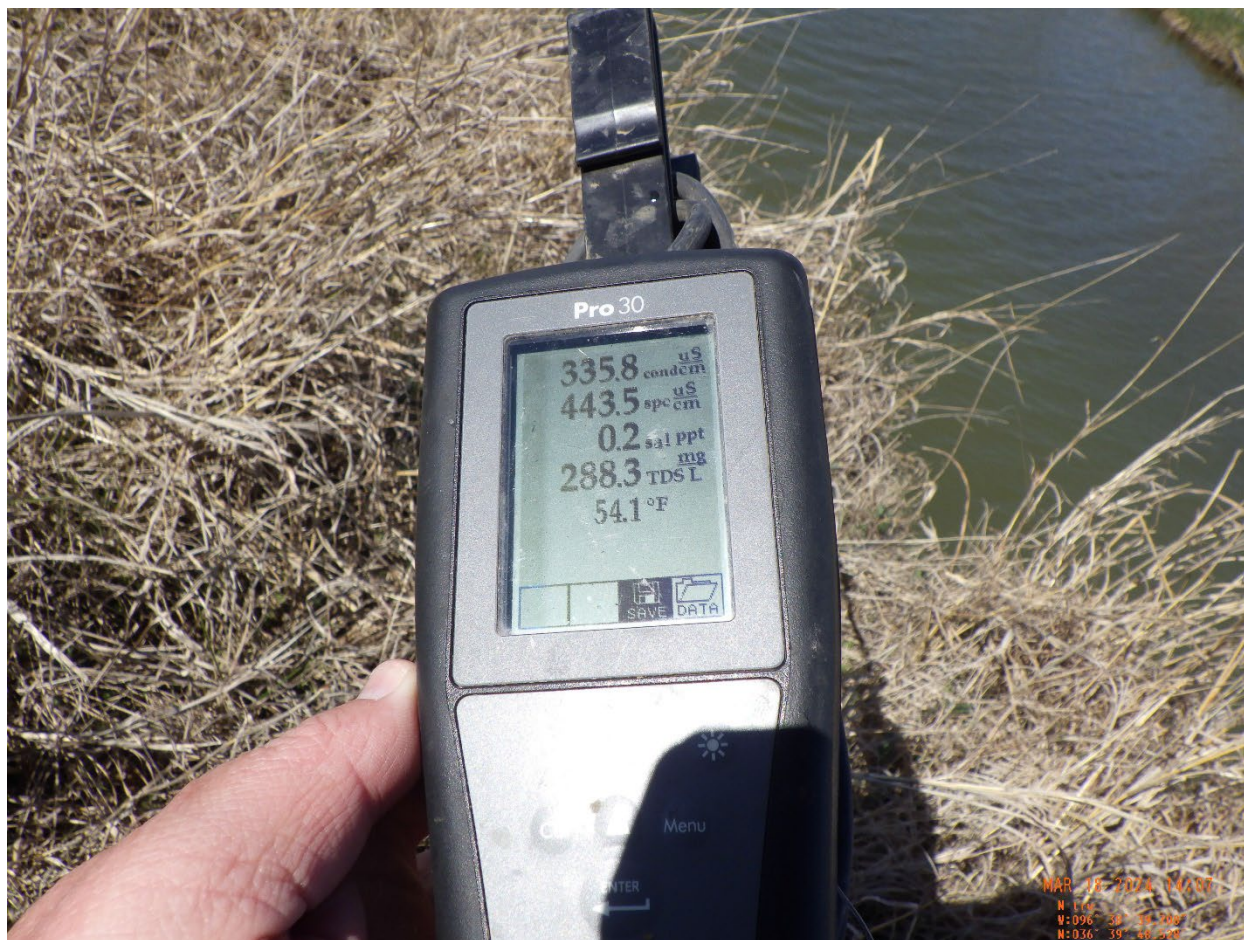
Photo No. 16

Continuing downstream I observed a TDS field reading of 288.3 mg/L. This indicated spill impacts had not travelled to this point downstream. This photo as well as GPS location and other metadata can be seen in Photo No. 16. At the same location I observed many turtles and fishes which were seemingly unaffected by the spill. Photos No. 17 and 18 provide a downstream and upstream view from the observation location. I did not observe any impacted fish or wildlife at any point during the inspection.

**Description:** This was a TDS field reading of 288.3 mg/L taken in the main channel of Little Chief Creek, downstream from the POE. This reading indicated there were no spill impacts present at this location.

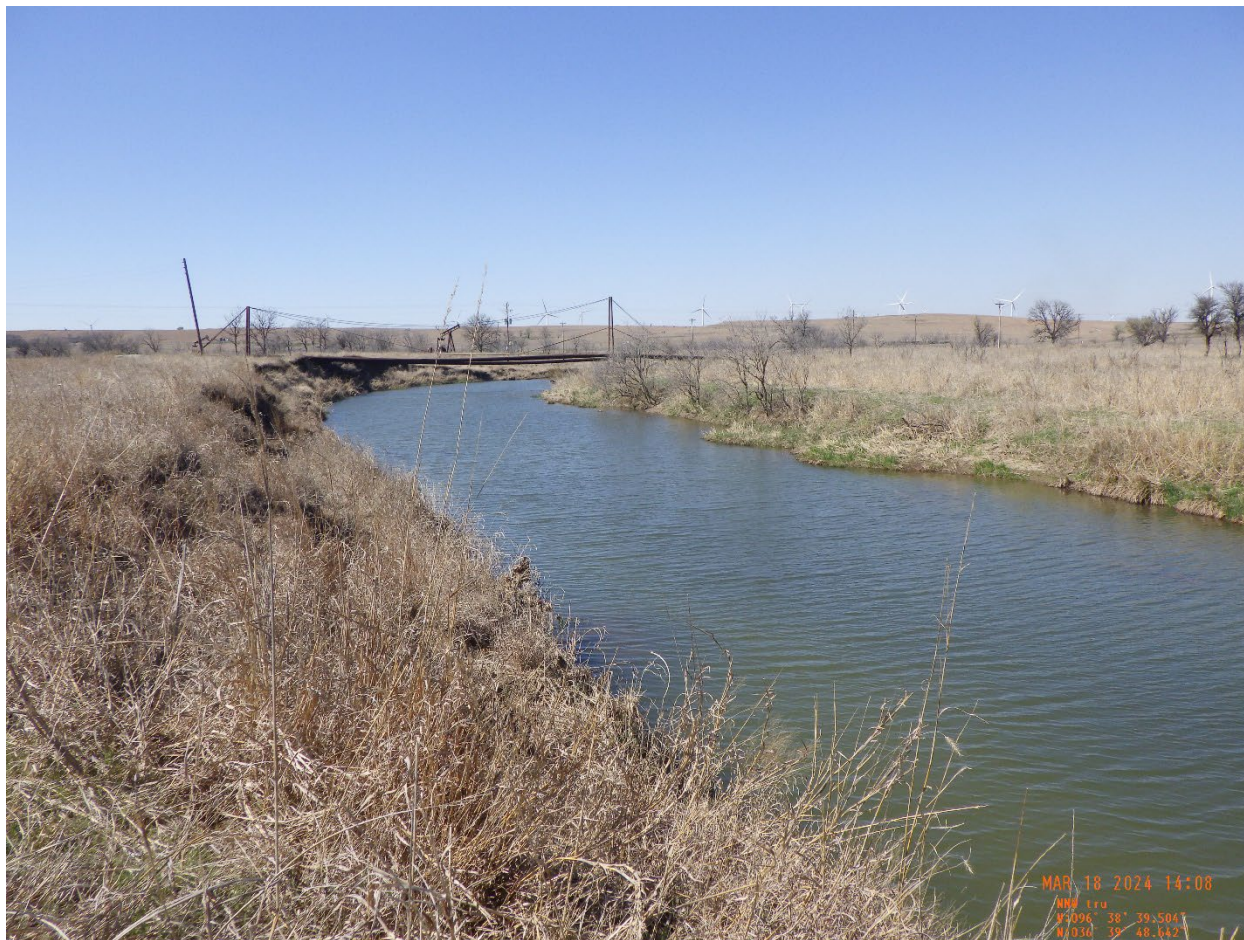
Photo No. 17

**Description:** This was a view downstream along Little Chief Creek. This photo was taken at the same location as the TDS reading from Photo No. 16.

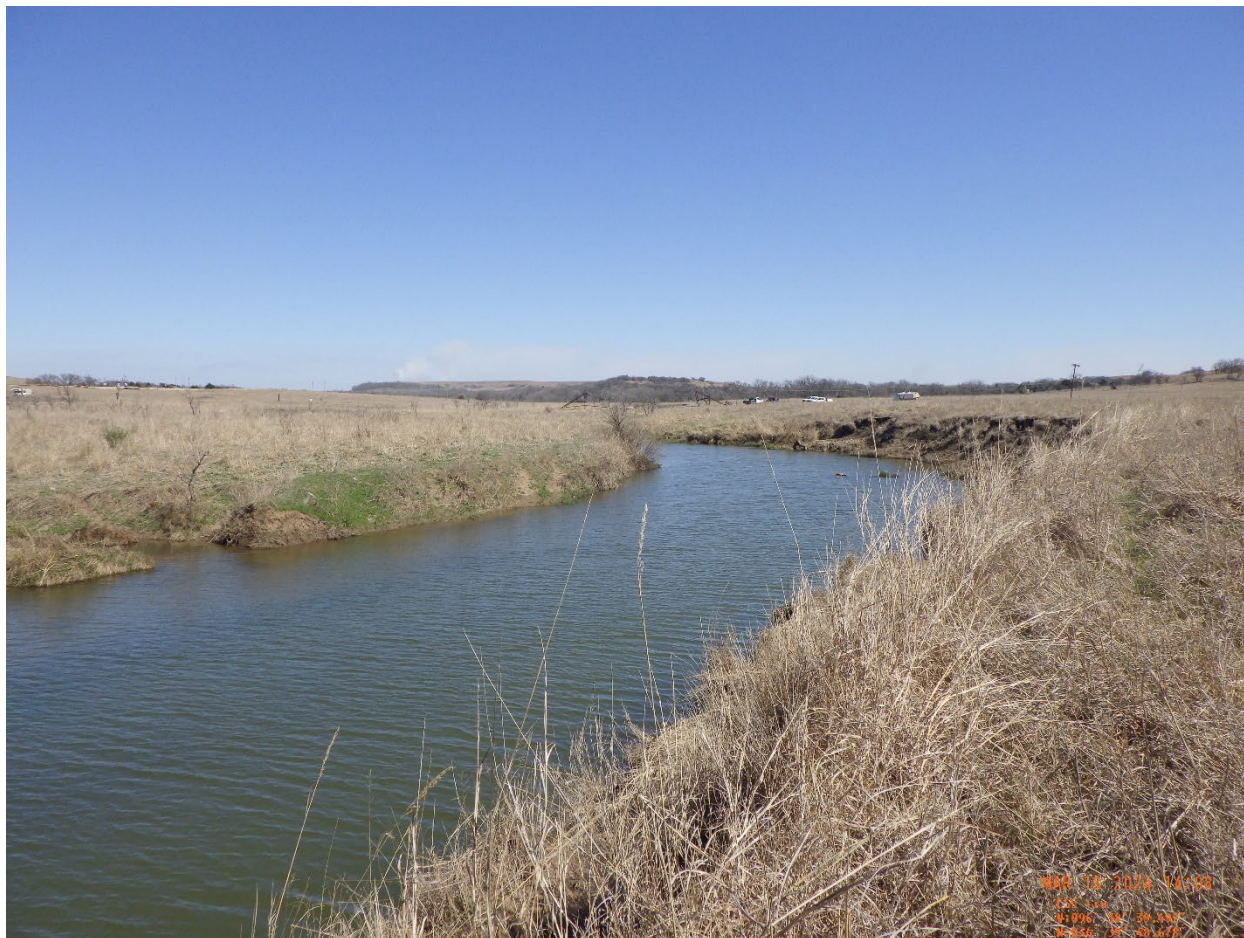
Photo No. 18

**Description:** This was a view upstream along Little Chief Creek. This photo was taken at the same location as the TDS reading from Photo No. 16.
