## Region 6 - Enforcement & Compliance Assurance Division

### INSPECTION REPORT

| Company Name: | CapturePoint, LLC | |
| Facility Name: | South Burbank Unit (SBU) R Battery | |

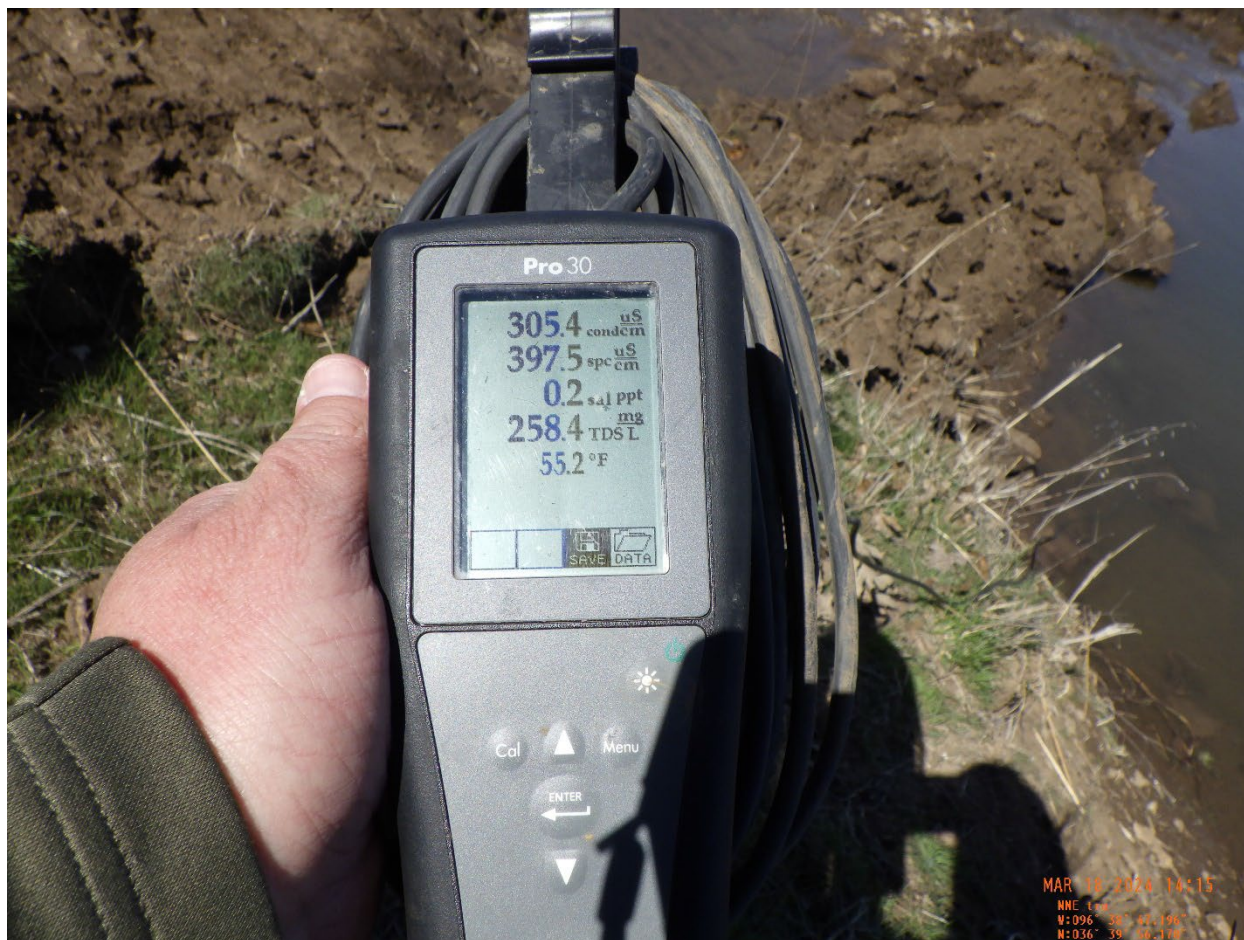
Photo No. 19

I observed the lowermost temporary containment dam, upstream and downstream views, and a TDS field reading of 258.4 mg/L. This was the furthest downstream point observed during the inspection. See Photos No. 19, 20, 21 and 22.

**Description:** This was a TDS field reading of 258.4 mg/L taken on the upstream side of the lowermost temporary containment dam which had been placed by the operator to contain any potential spill impacts. At the time of the inspection, water was flowing over the dam, but spill impacts were not observed at this location.

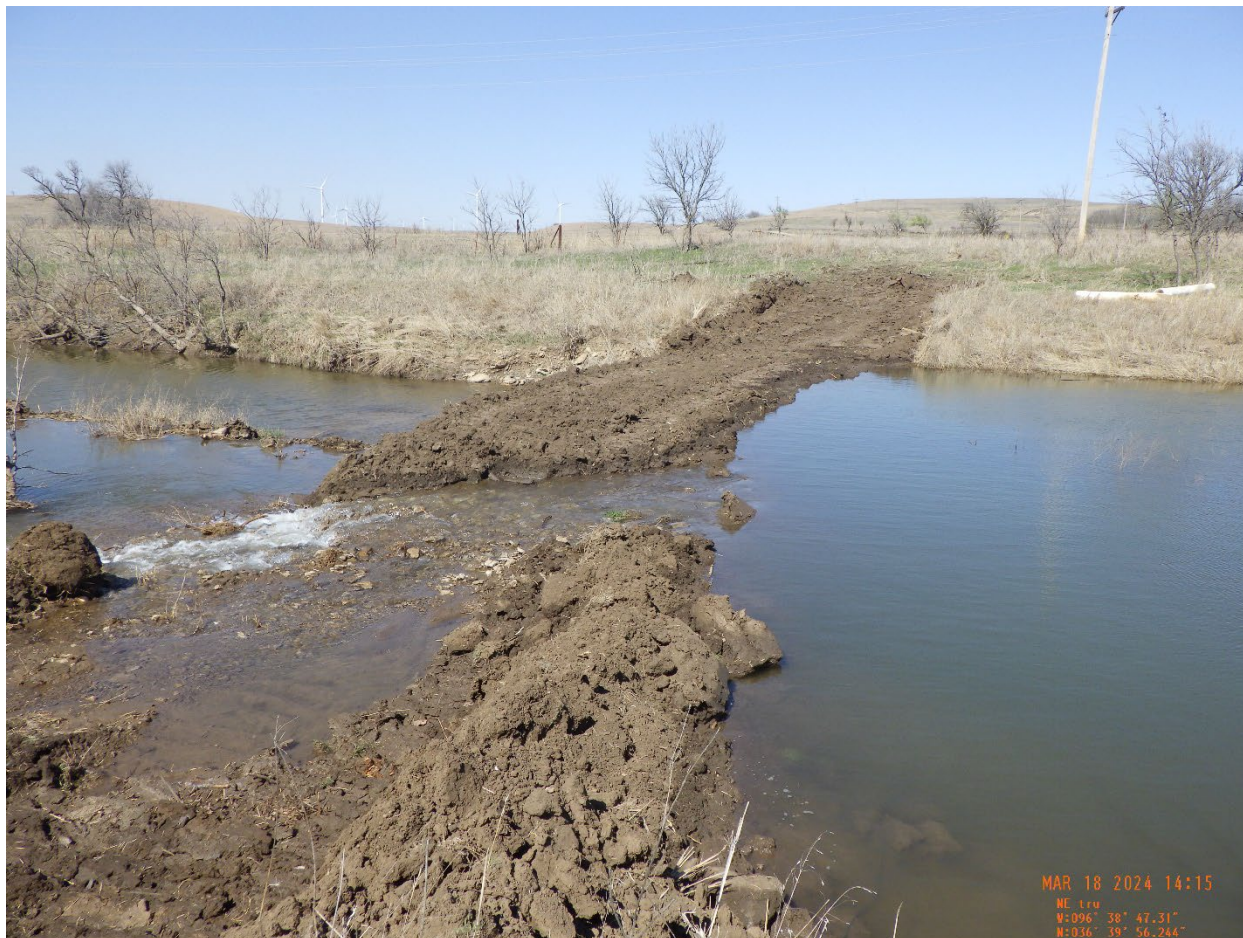
Photo No. 20

**Description:** This was the lowermost containment dam placed by the operator to prevent downstream migration of spill impacts.

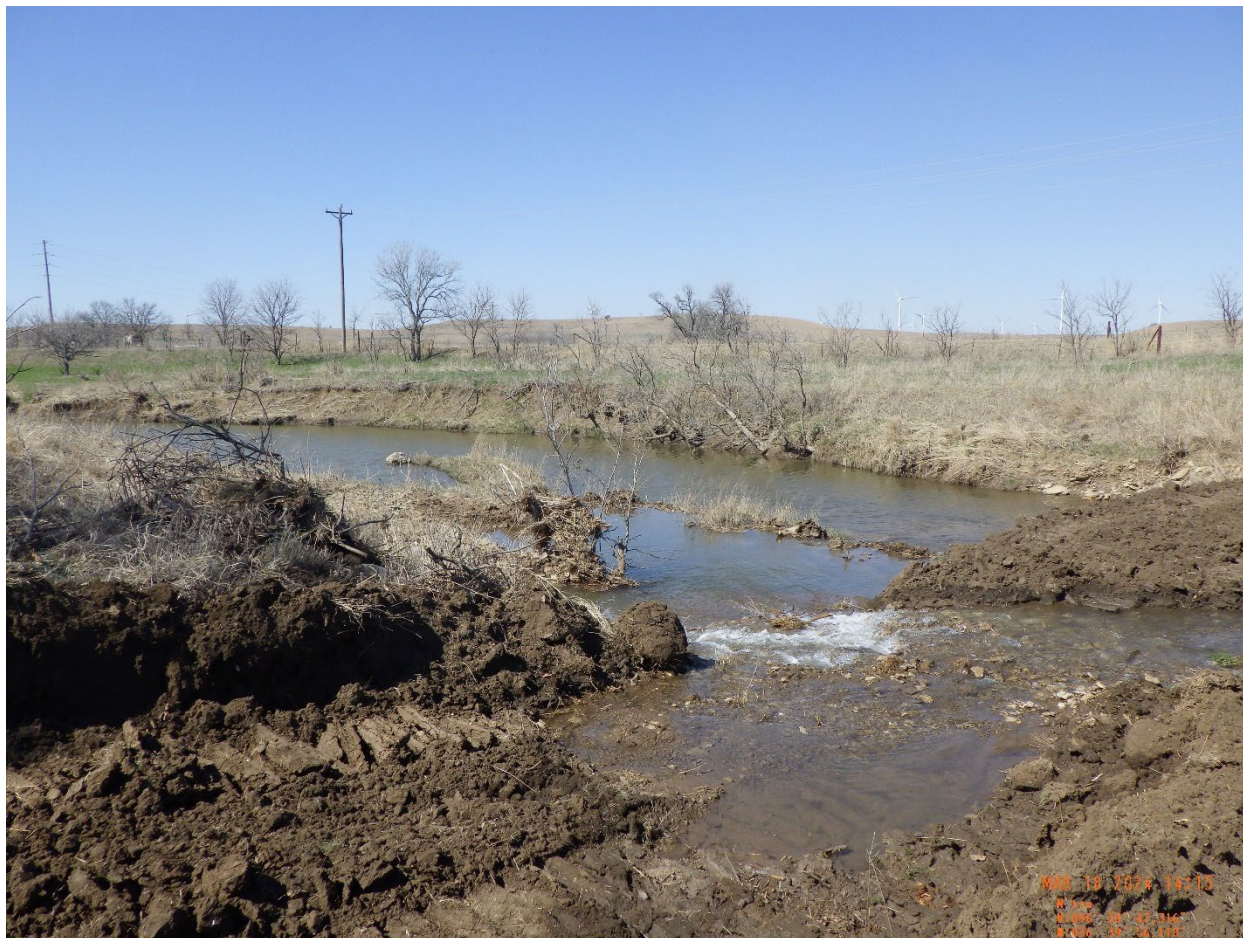
Photo No. 21

**Description:** This was a view downstream along Little Chief Creek from the lowermost containment dam.

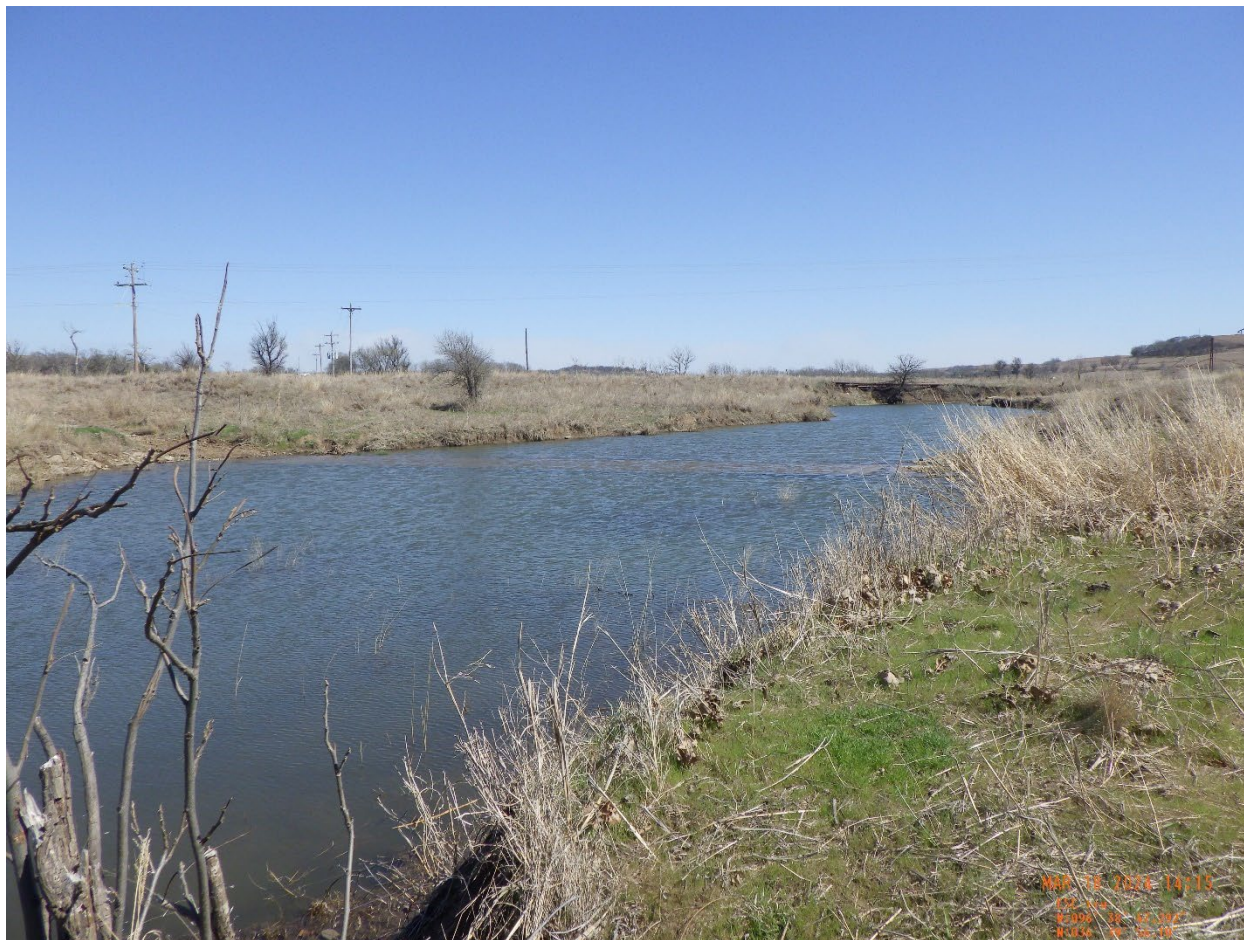
Photo No. 22

**Description:** This was a view upstream along Little Chief Creek from the lowermost containment dam.

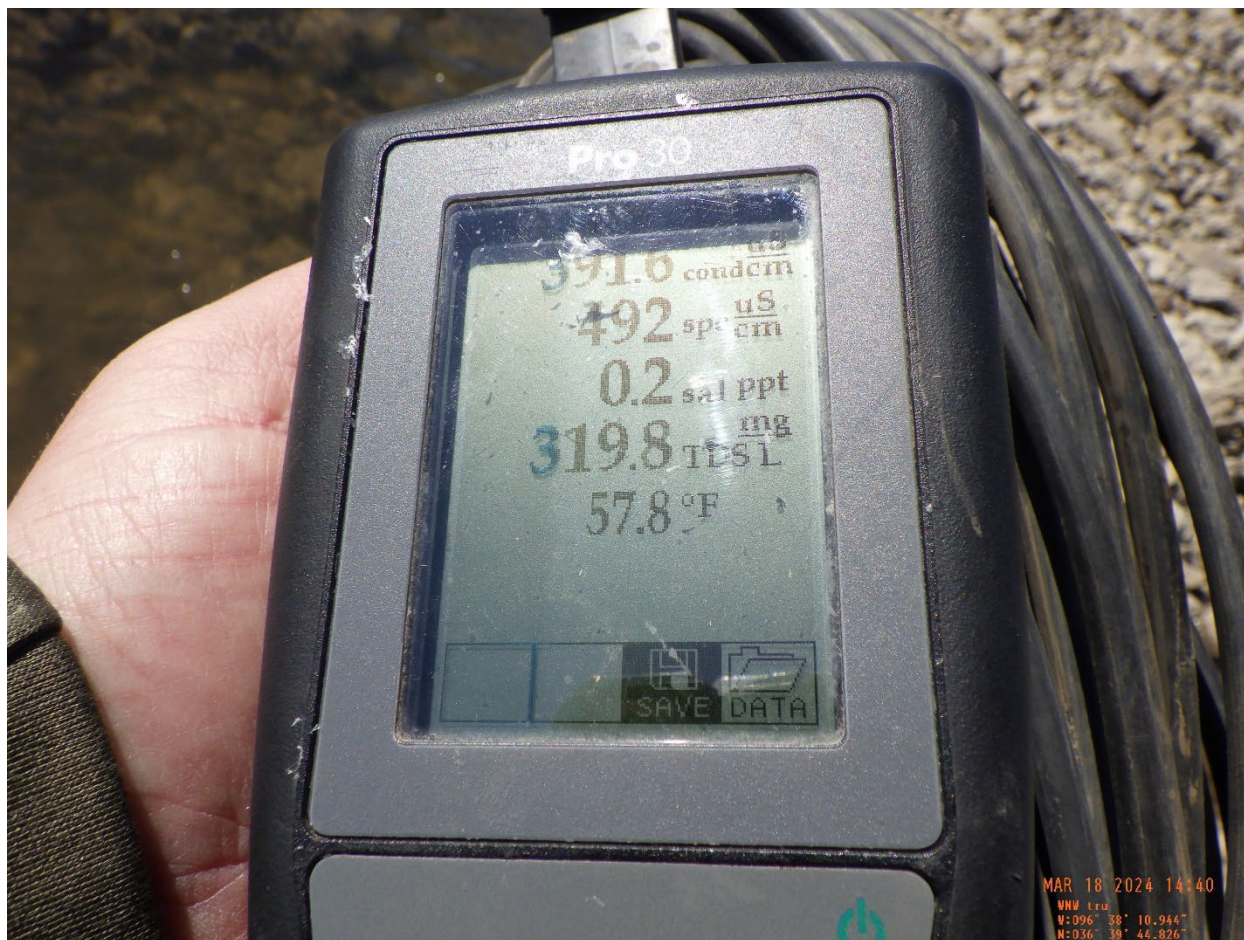
Photo No. 23

Approximately .3 miles upstream from the POE into Little Chief Creek, I observed a TDS field reading of 319.8 mg/L in the main channel of the creek which was not impacted by the spill. This observation should be used when considering the “background” TDS levels in the area. See Photo No. 23.

**Description:** This was a TDS field reading of 319.8 mg/L taken in the main channel of Little Chief Creek approximately .3 miles upstream from the POE. This reading was observed at the intersection of Little Chief Creek and county road 5818. This observation should be used to establish “background” TDS levels for the area.
