**Region 6 - Enforcement & Compliance Assurance Division**  
**INSPECTION REPORT**

| Inspection Date(s): | 12/23/2024 | |
| Facility Name: | <b>Rio Rancho WWTP-Lift Station -21</b> | |
| Identification/Permit Number: | NM0027987 | |

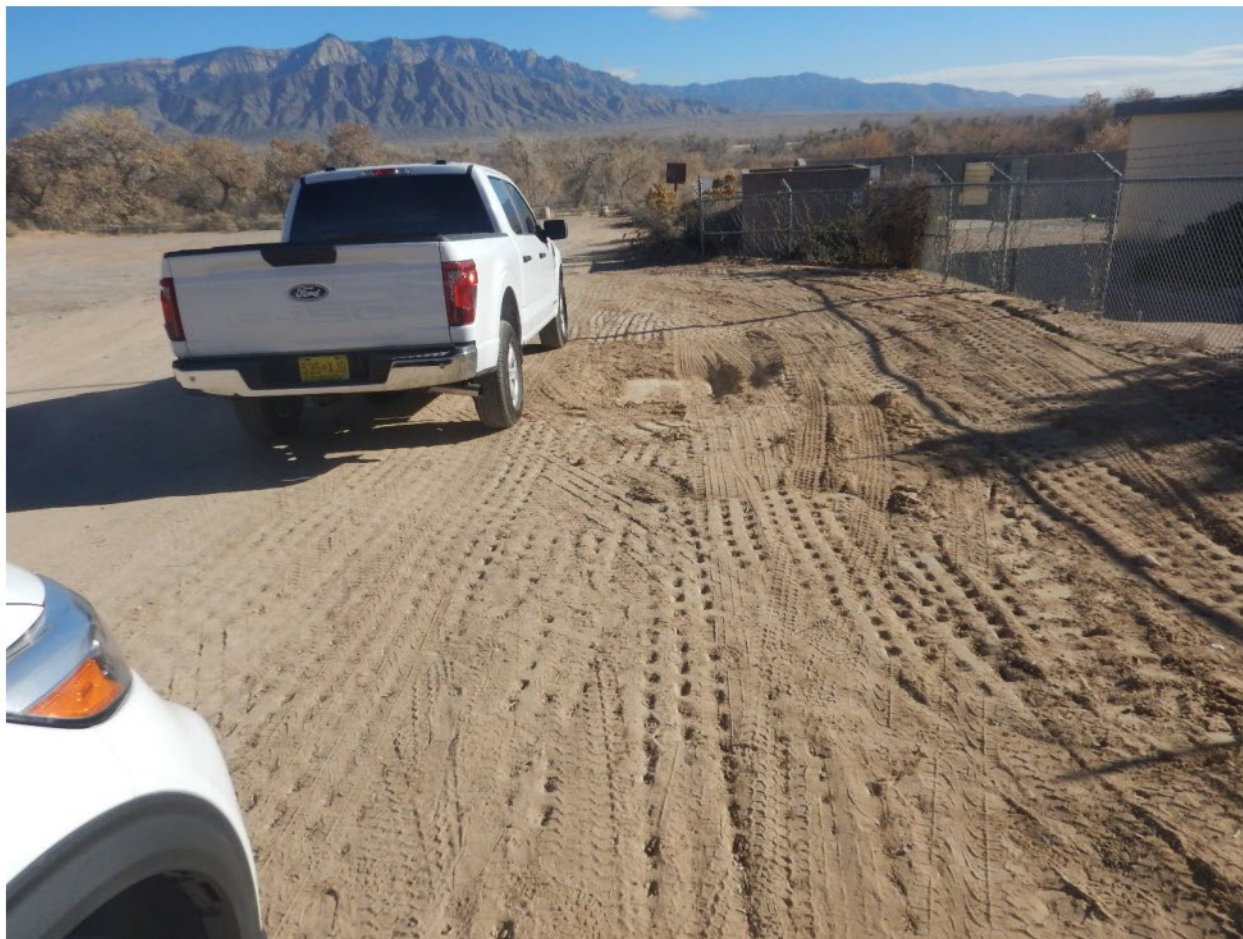
Photo No. 1

View looking approximately East adjacent to wire fabric perimeter fence of former WWTP #3 of the compacted land surface area where collapsed force was repaired. (DSCN2743) (12/23/2024) 2:43 PM. Photographed by D. Esparza

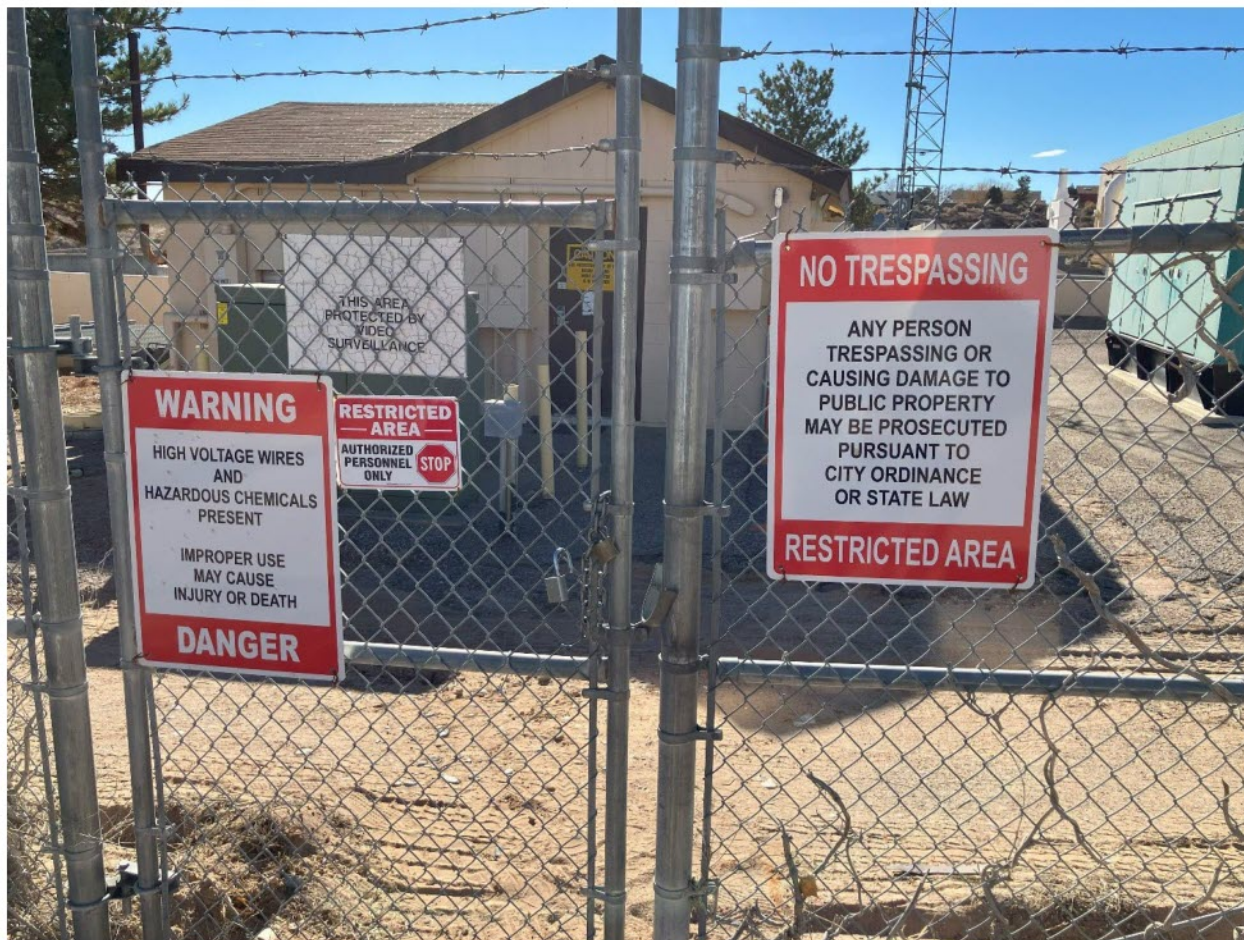
Photo No. 2

View of warning signage on outside of WWTP #3 and LS-#21 wire fabric perimeter fencing. (IMG\_0456)  
Photographed by N. Fuad

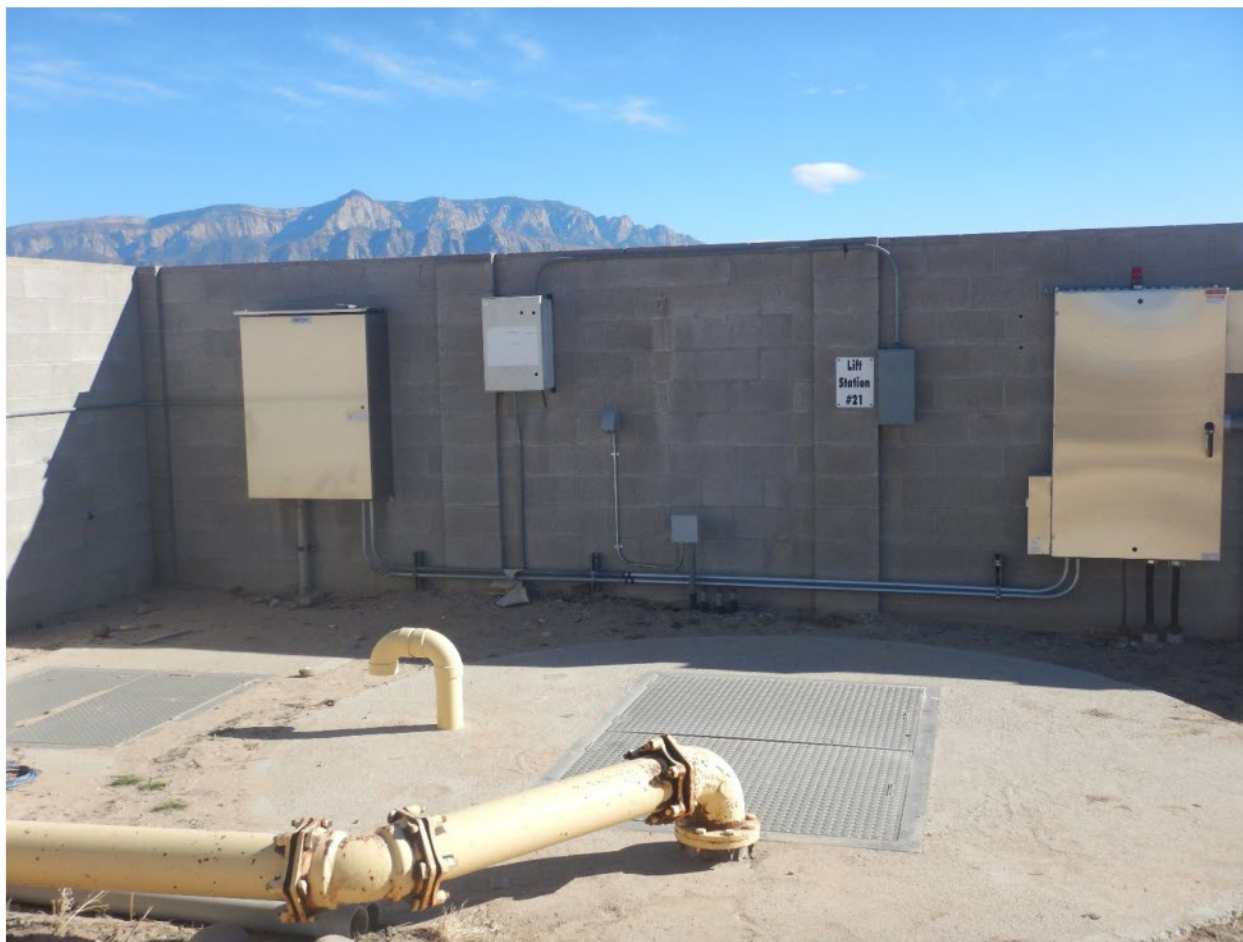
Photo No. 3

View of Lift Station #21 piping, electrical panels and wet well enclosures inside the former WWTP #3 perimeter fence. (DSCN2746) (12/23/2024) 2:44 PM. Photographed by D. Esparza

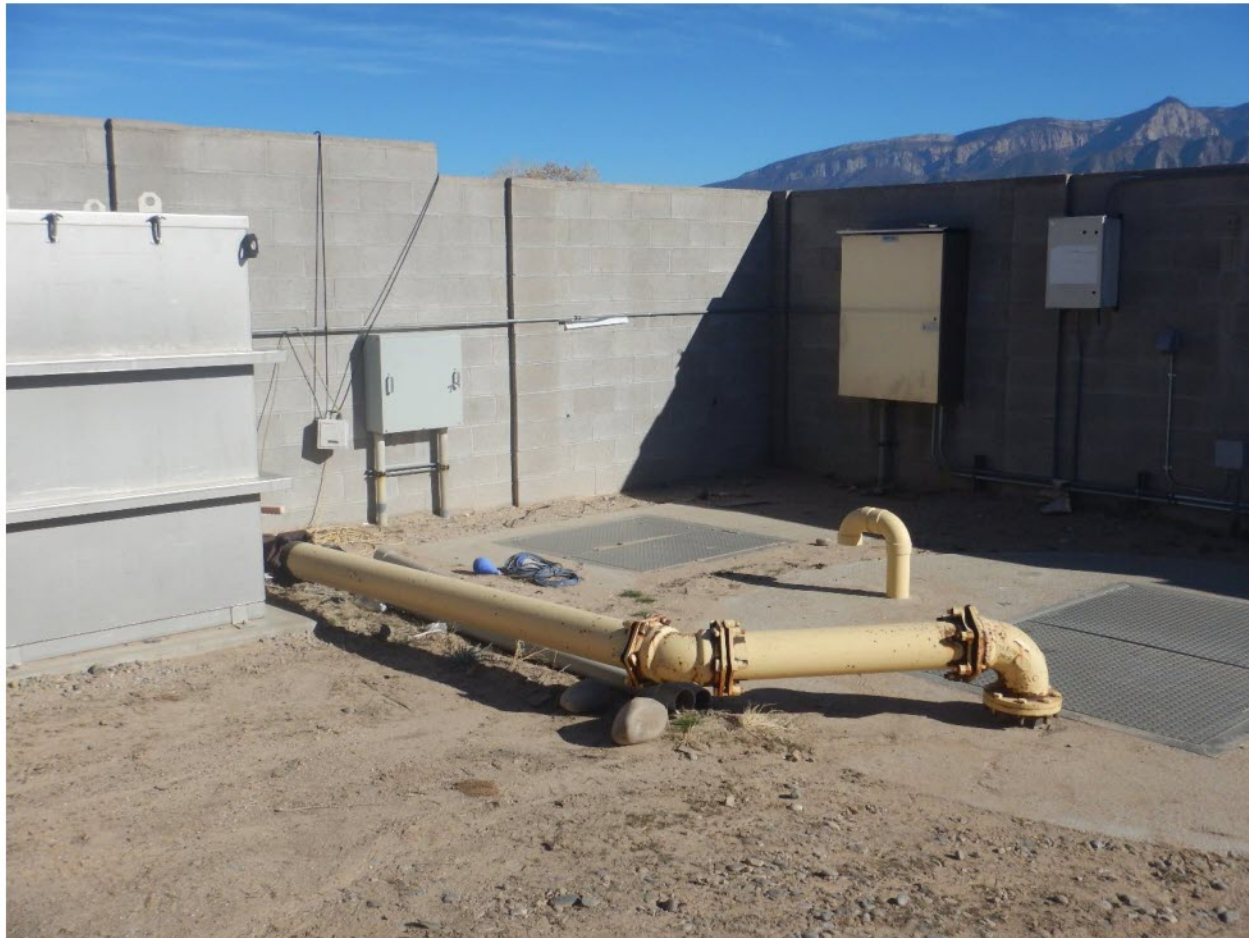
Photo No. 4

Another view of Lift Station #21 piping, electrical panels and wet well enclosures inside the former WWTP #3 perimeter fence. Note: the lack of piping support, fitting (flange) condition (corrosion/rust), visible corrosion near concrete masonry unit (CMU) wall penetration in an approximate Northerly direction and land surface debris. Additionally, this piping connects to the collapsed force main (located outside the CMU wall). (DSCN2747) (12/23/2024) 2:45 PM. Photographed by D. Esparza

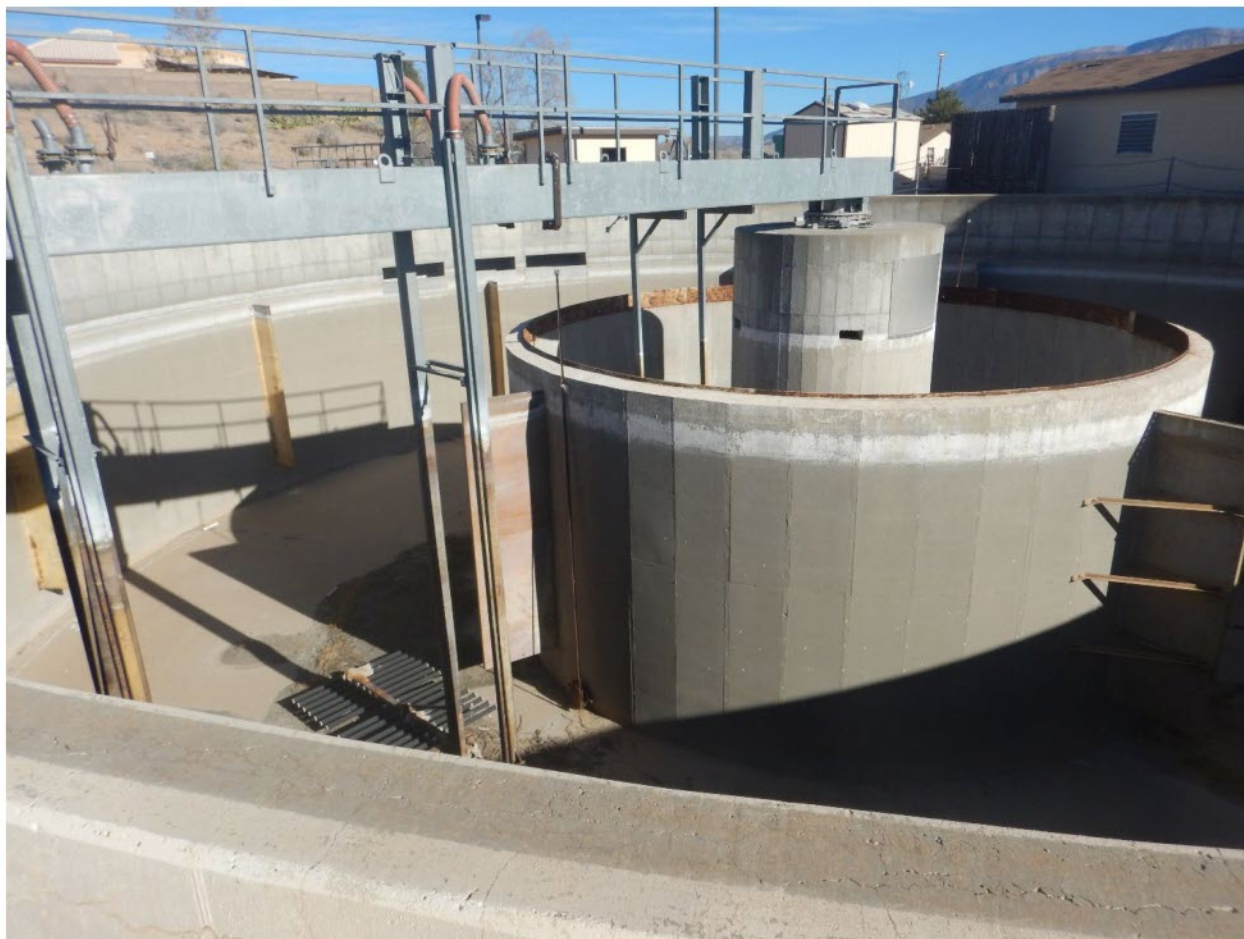
Photo No. 5

- The adjacent WWTP #3 (NPDES permit NM0029602, issued on June 6, 2016, and terminated March 24, 2021) was observed to confirm, previous treatment basins were not utilized as equalization (EQ) basins.

View of one of Rio Rancho's WWTP #3 (NPDES permit NM0029602, issued on June 6, 2016, and terminated March 24, 2021) clarifiers. This treatment process basin is located within the fenced perimeter and west of LS-#21. NOTE: the treatment basins and other appurtenant ancillary equipment were viewed to confirm they were not being utilized as EQ basins. (DSCN2749) (12/23/2024) 2:51 PM. Photographed by D. Esparza

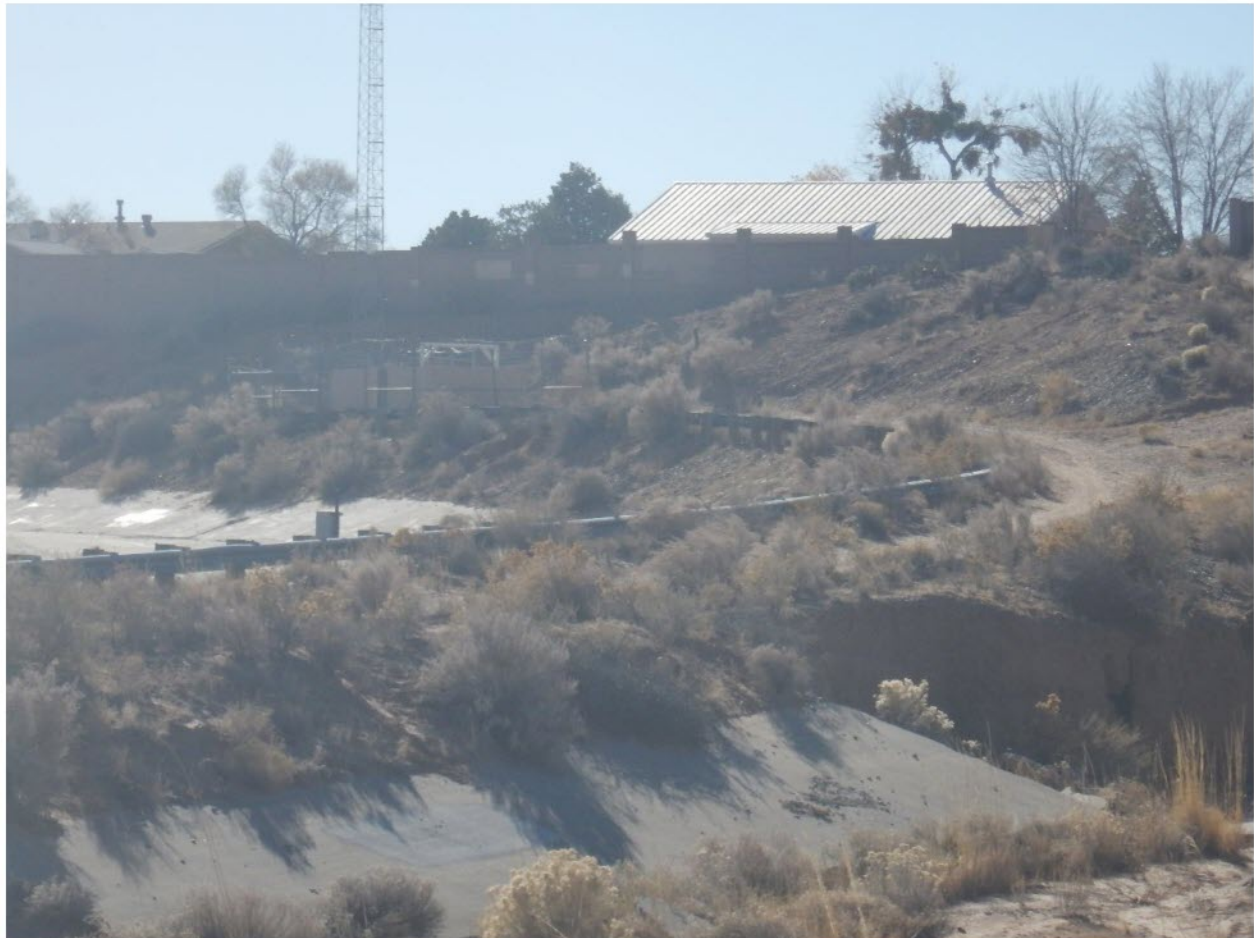
Photo No. 6

View of LS-#8 located approximately 900-feet Southeast of LS-#21. NOTE: LS-#8 collects the influent flows from Rivers Edge 1 subdivision and pumps via a closed conduit 6-inch force main to the LS-#21 wet well. (DSCN2751) (12/23/2024) 2:59 PM. Photographed by D. Esparza

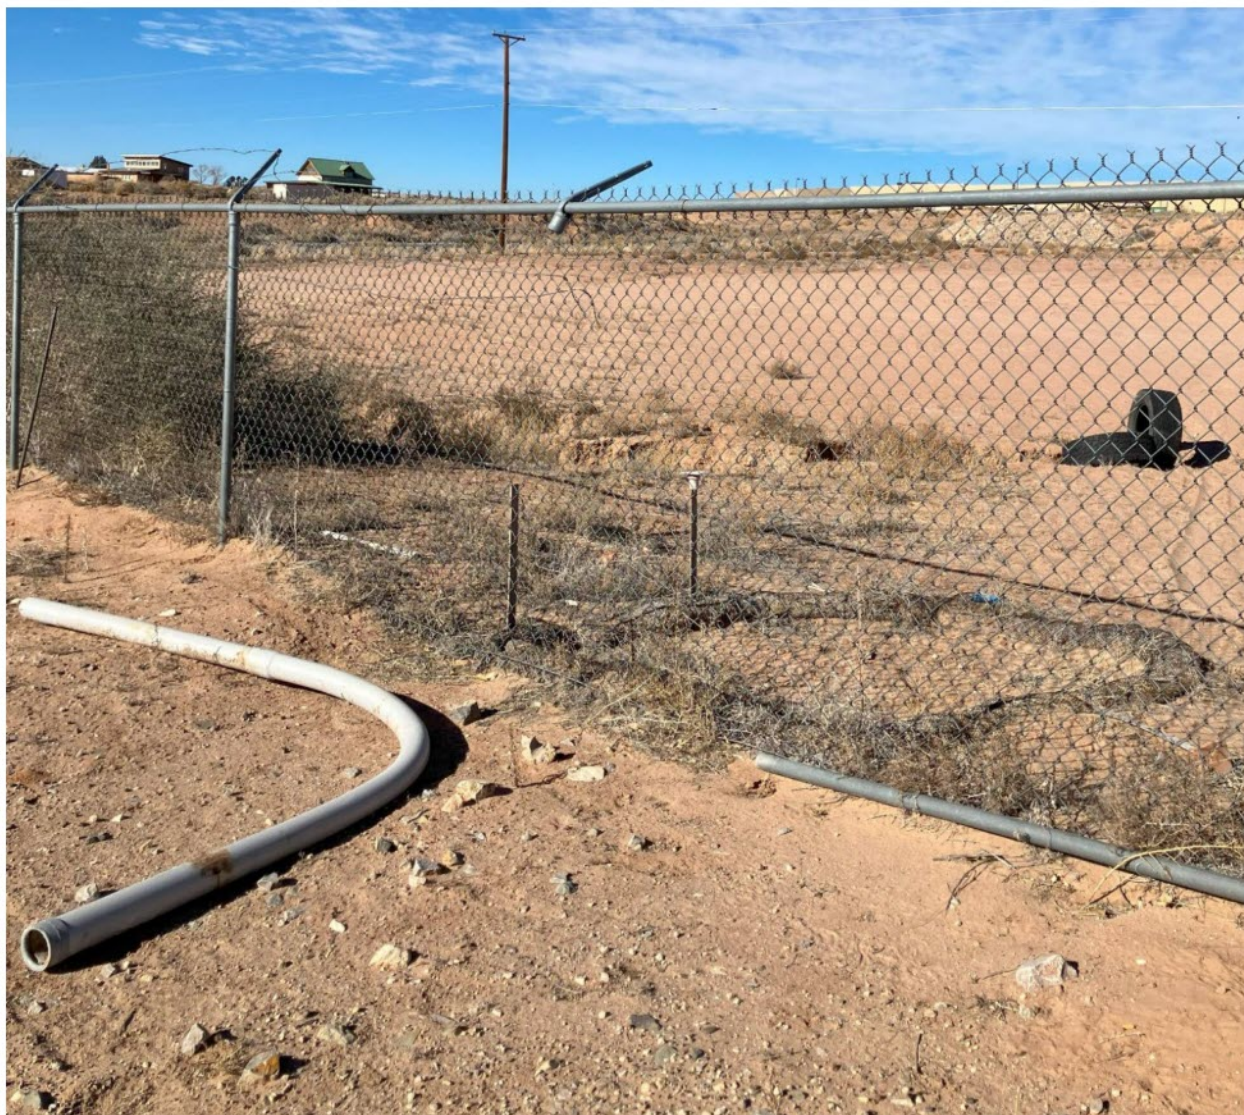
Photo No. 7

- Though some of the Lift Stations observed during this December onsite inspection-maintained perimeter fencing various areas of the fencing exhibited damage, others lacked secure site fencing at all, exhibited vagrant vegetive growth, had visible evidence of previous storm event erosion and/or lacked visible flashing lights or audible alarms. Additionally, visible notification signage was lacking.

View looking north of LS-#15 damaged wire fabric perimeter fencing. NOTE: stormwater wattles outside fencing. (IMG\_0537-cropped) Photographed by N. Fuad

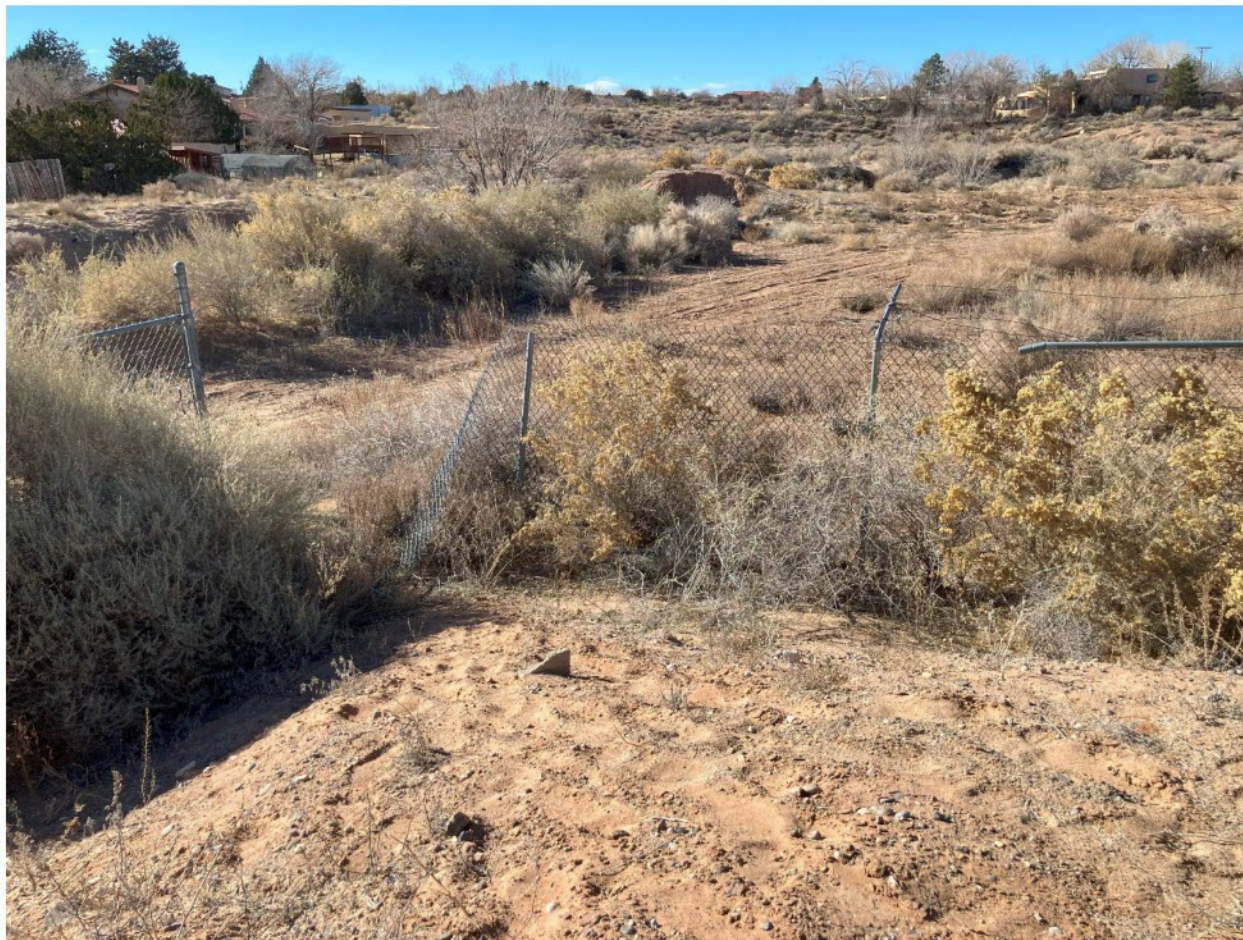
Photo No. 8

Another view of damaged perimeter wire fabric fencing of LS-#15. NOTE: the excessive vagrant vegetive growth inside and along fencing allows for perimeter degradation and vermin attraction. (IMG\_0543)  
Photographed by N. Fuad

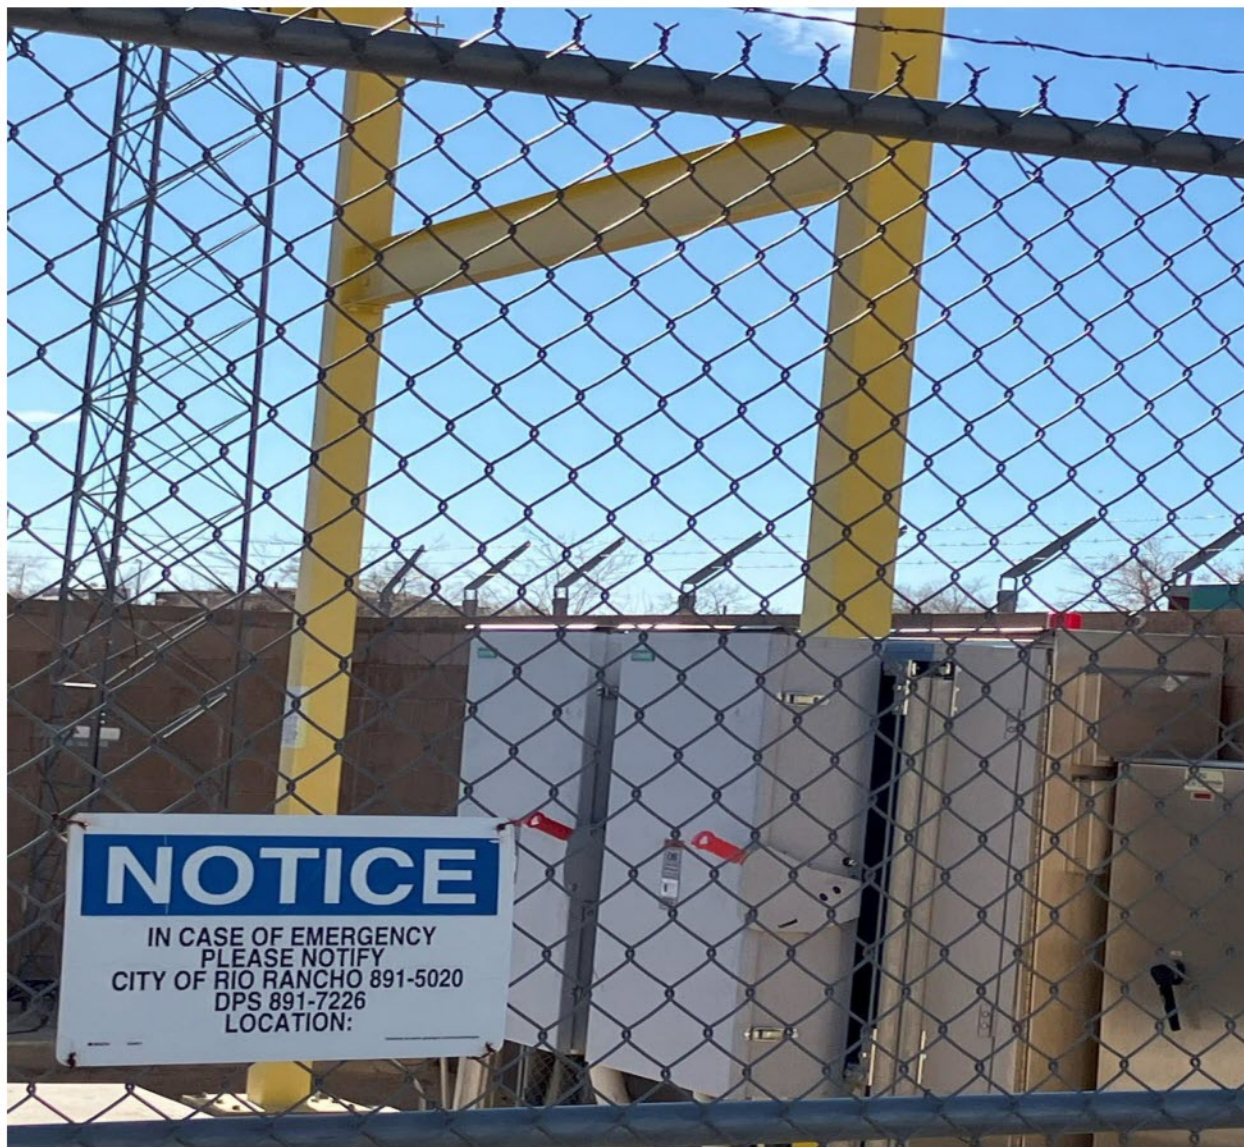
Photo No. 9

View of minimal warning or electrical hazard signage inside of LS-#15. NOTE: the appearance of a flashing light (alarm) in the center right of photograph located below enclosure. (IMG\_0545) Photographed by N. Fuad

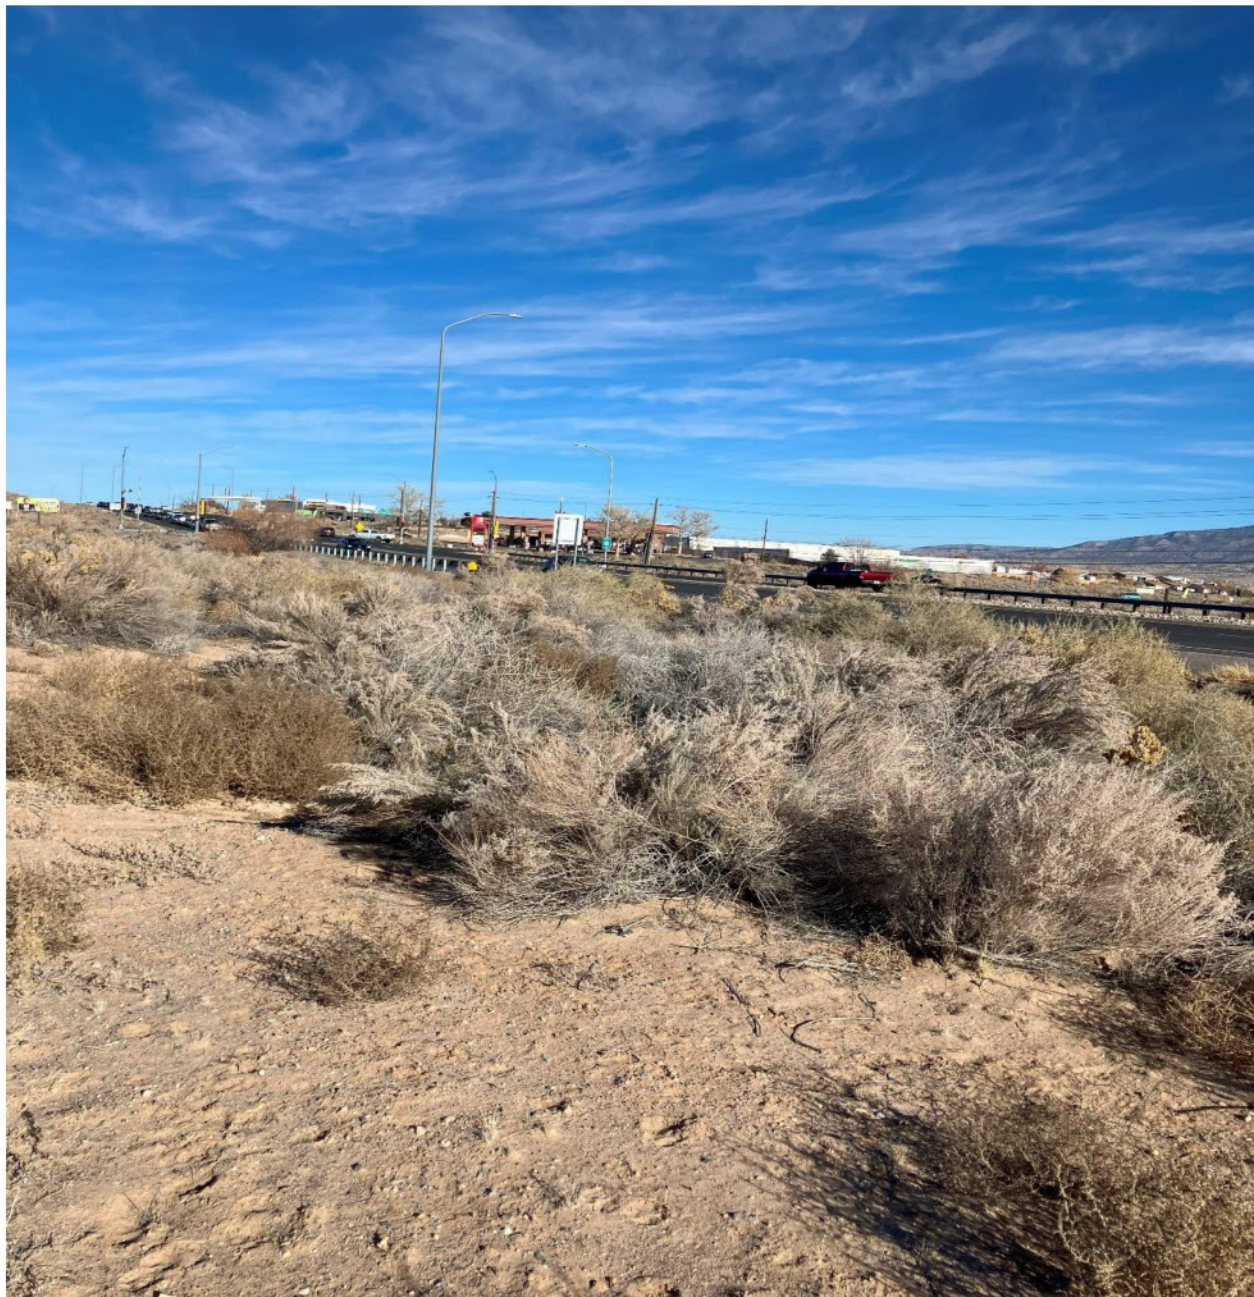
Photo No. 10

View looking from LS-#22 approximately northeast towards State Highway 528 (aka Pat D 'Arco Highway)  
NOTE: lack of perimeter fencing. (IMG\_0561) Photographed by N. Fuad

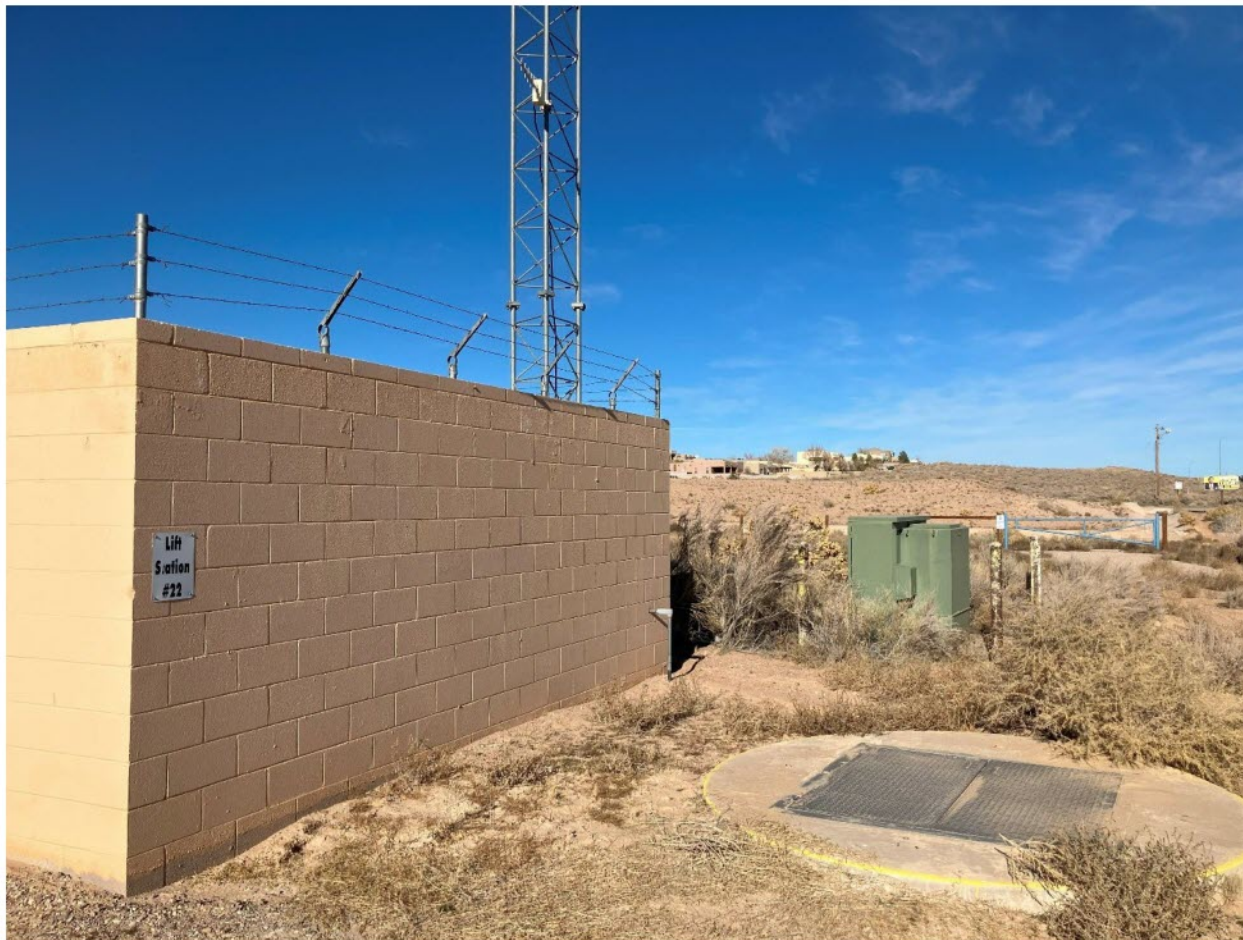
Photo No. 11

View of north side of LS-#22. NOTE: the lack of perimeter fencing adjacent to state highway 528 potentially allowing unauthorized access to the wet well and ancillary equipment. Additionally, the SCAFCA access gate is denoted in the upper right of the photograph. (IMG\_0562) Photographed by N. Fuad.

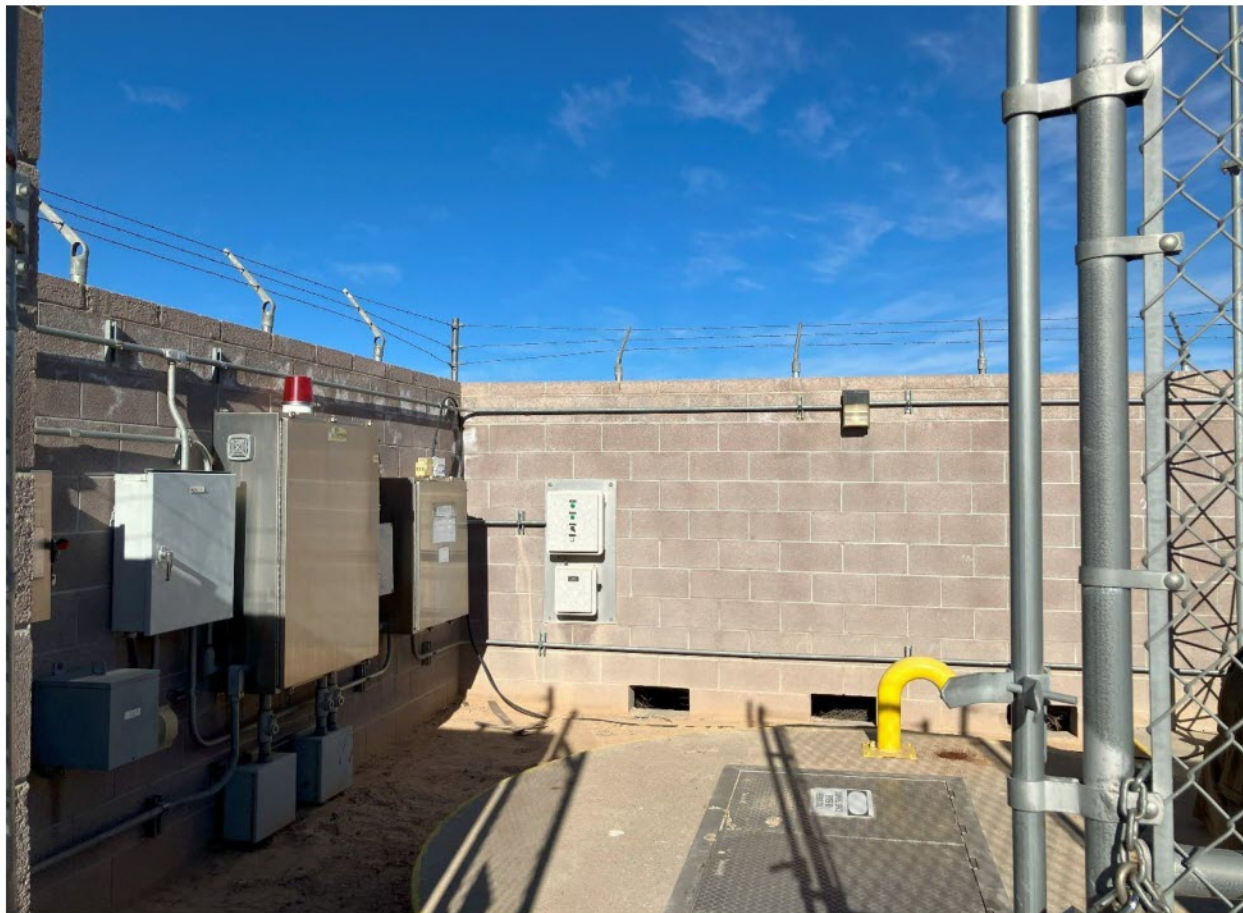
Photo No. 12

View inside of CMU enclosure of LS-#22 exhibiting electrical control panels and lift station vault. NOTE: the flashing light alarm below the top of the enclosure. (IMG\_0563) Photographed by N. Fuad.

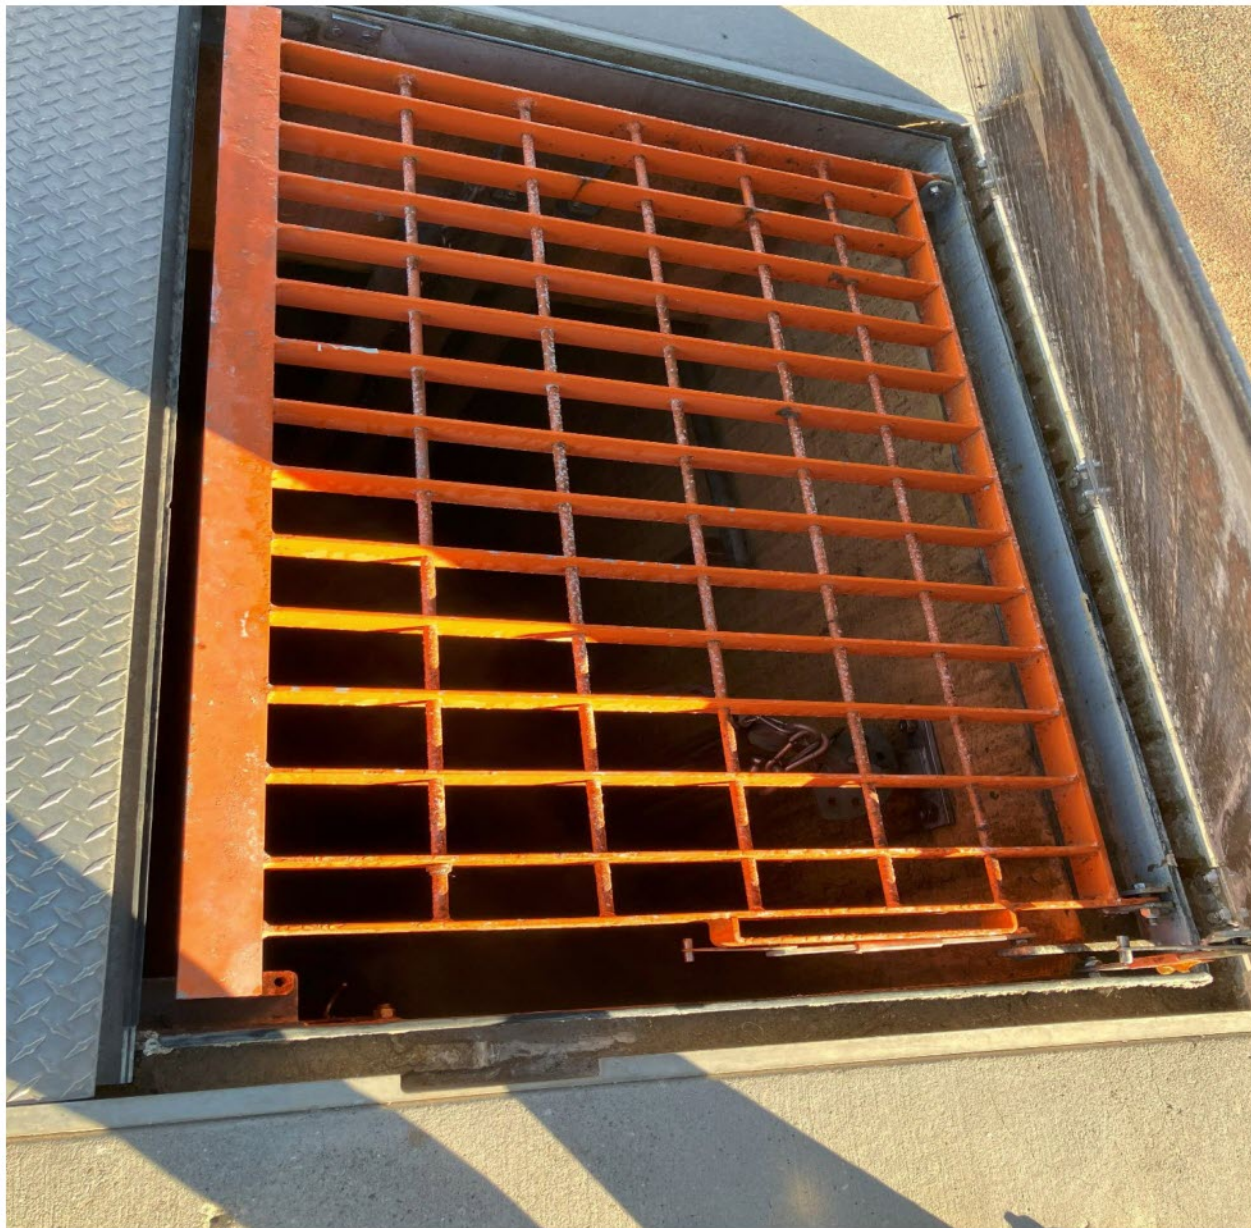
Photo No. 13

View of safety gate within locked hatchway of LS-#10 wet well. NOTE: LS-#10 is located within a secure CMU enclosure, maintains adequate perimeter lighting (elevated poles) and stated audible alarms. (IMG\_0566) Photographed by N. Fuad

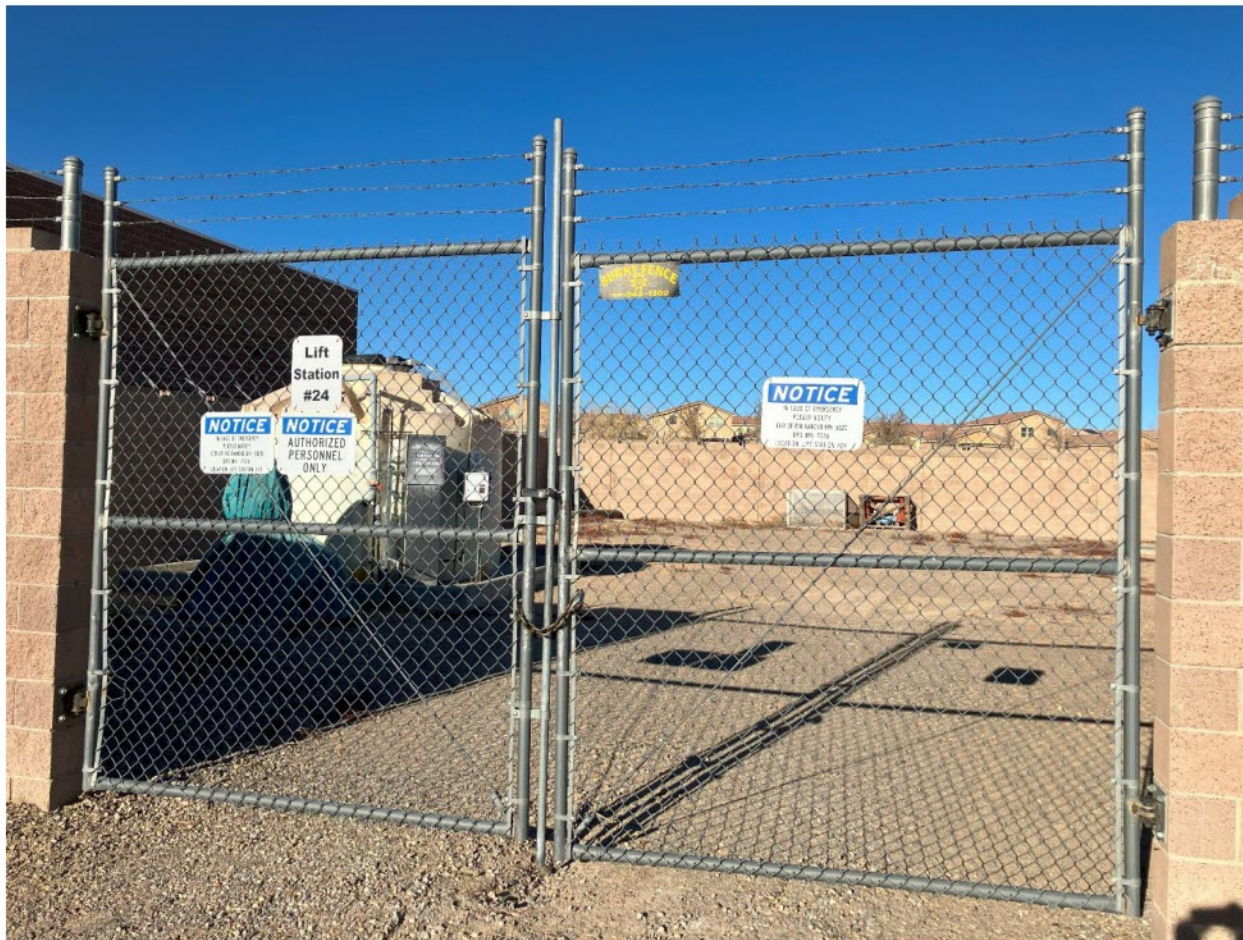
Photo No. 14

View of wire fabric gate and secondary CMU wall of LS-#24, located within Water Reclamation Facility (WRF) #6 (aka Cabezon WRF). NOTE: WRF #6 effluents are also pumped into an injection well authorized under New Mexico Environment Department (NMED) discharge permit DP-215. (IMG\_0571) Photographed by N. Fuad

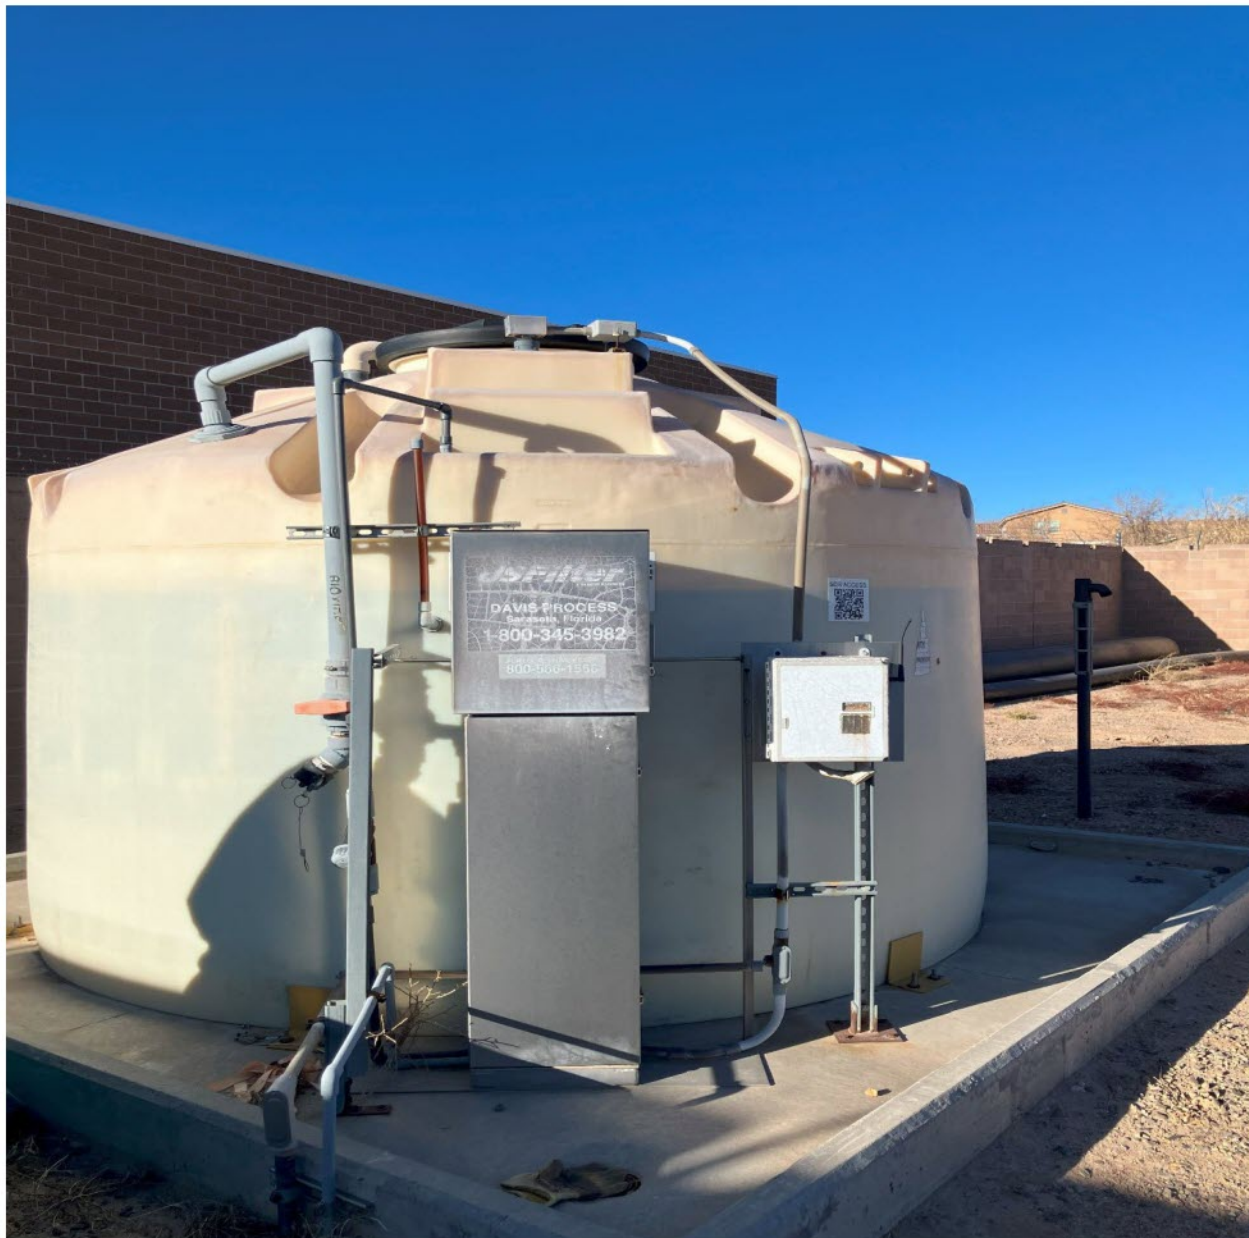
Photo No. 15

Bioxide tank located within LS-#24 is no longer in use. The tank contents are slowly being emptied to the wet well. NOTE: the degradation of the chemical safety signage. (IMG\_0576) Photographed by N. Fuad

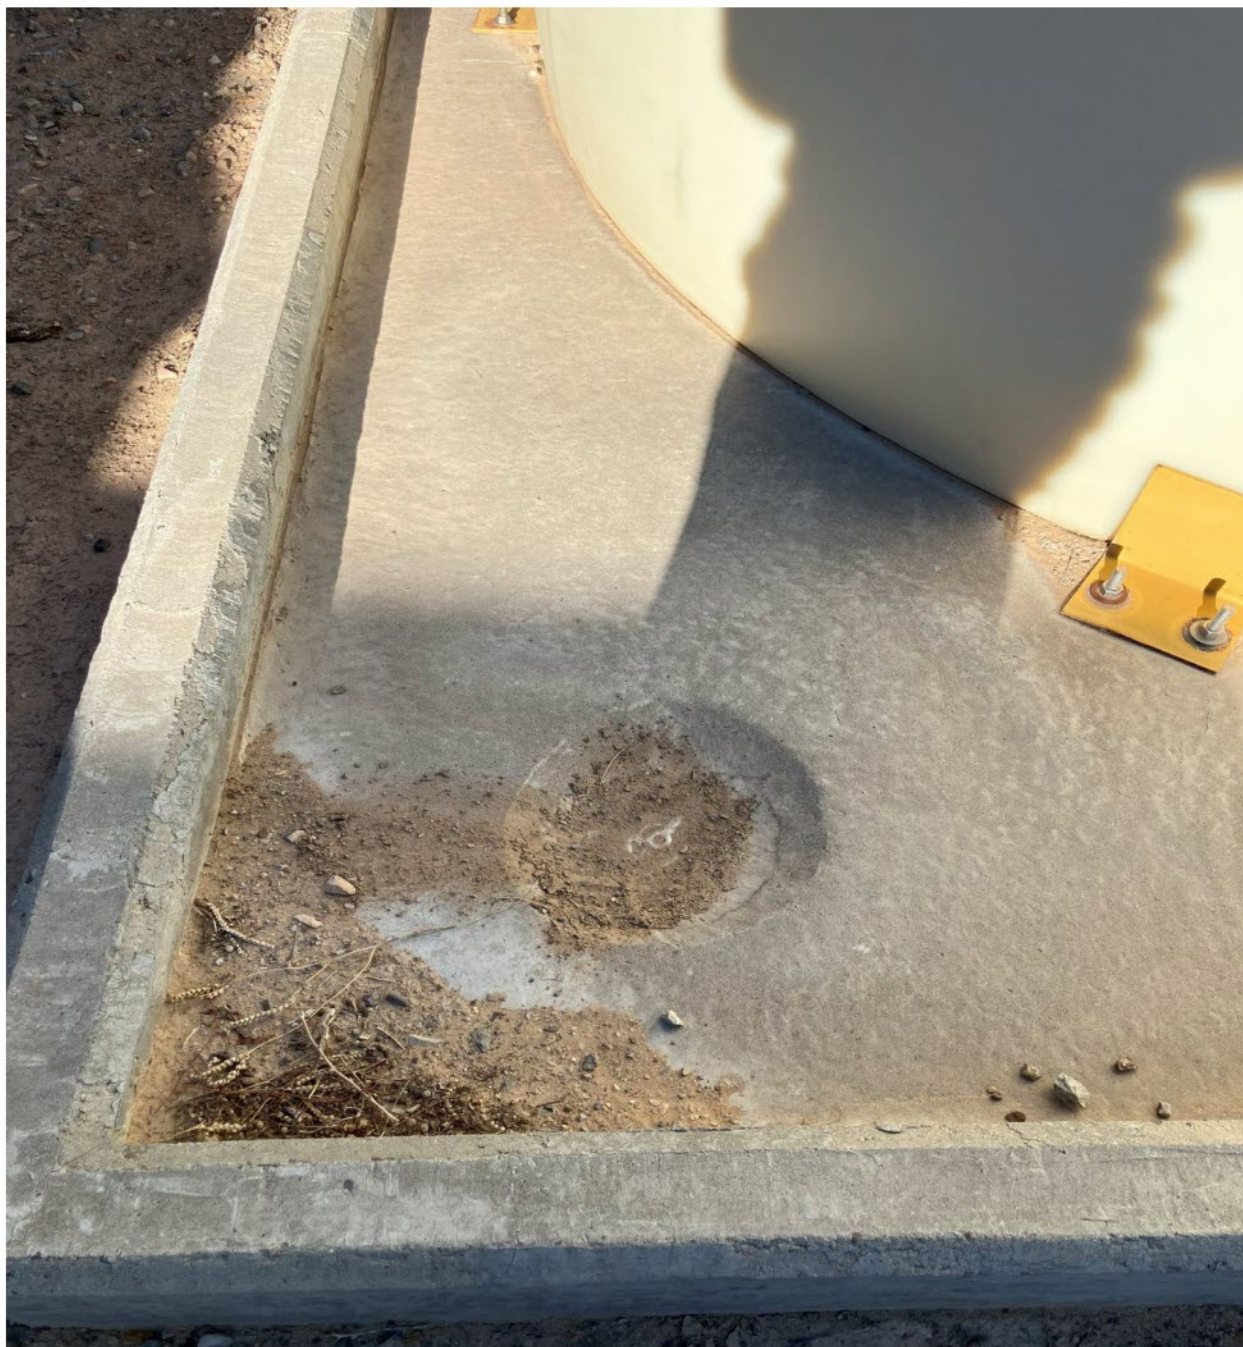
Photo No. 16

View of the secondary containment obstructed drop drain for the Bioxide tank at LS-#24. (IMG\_0576)  
Photographed by N. Fuad
