**Region 6 - Enforcement & Compliance Assurance Division**  
**INSPECTION REPORT**

| Inspection Date(s): | 12/23/2024 | |
| Facility Name: | <b>Rio Rancho WWTP-Lift Station -21</b> | |
| Identification/Permit Number: | NM0027987 | |

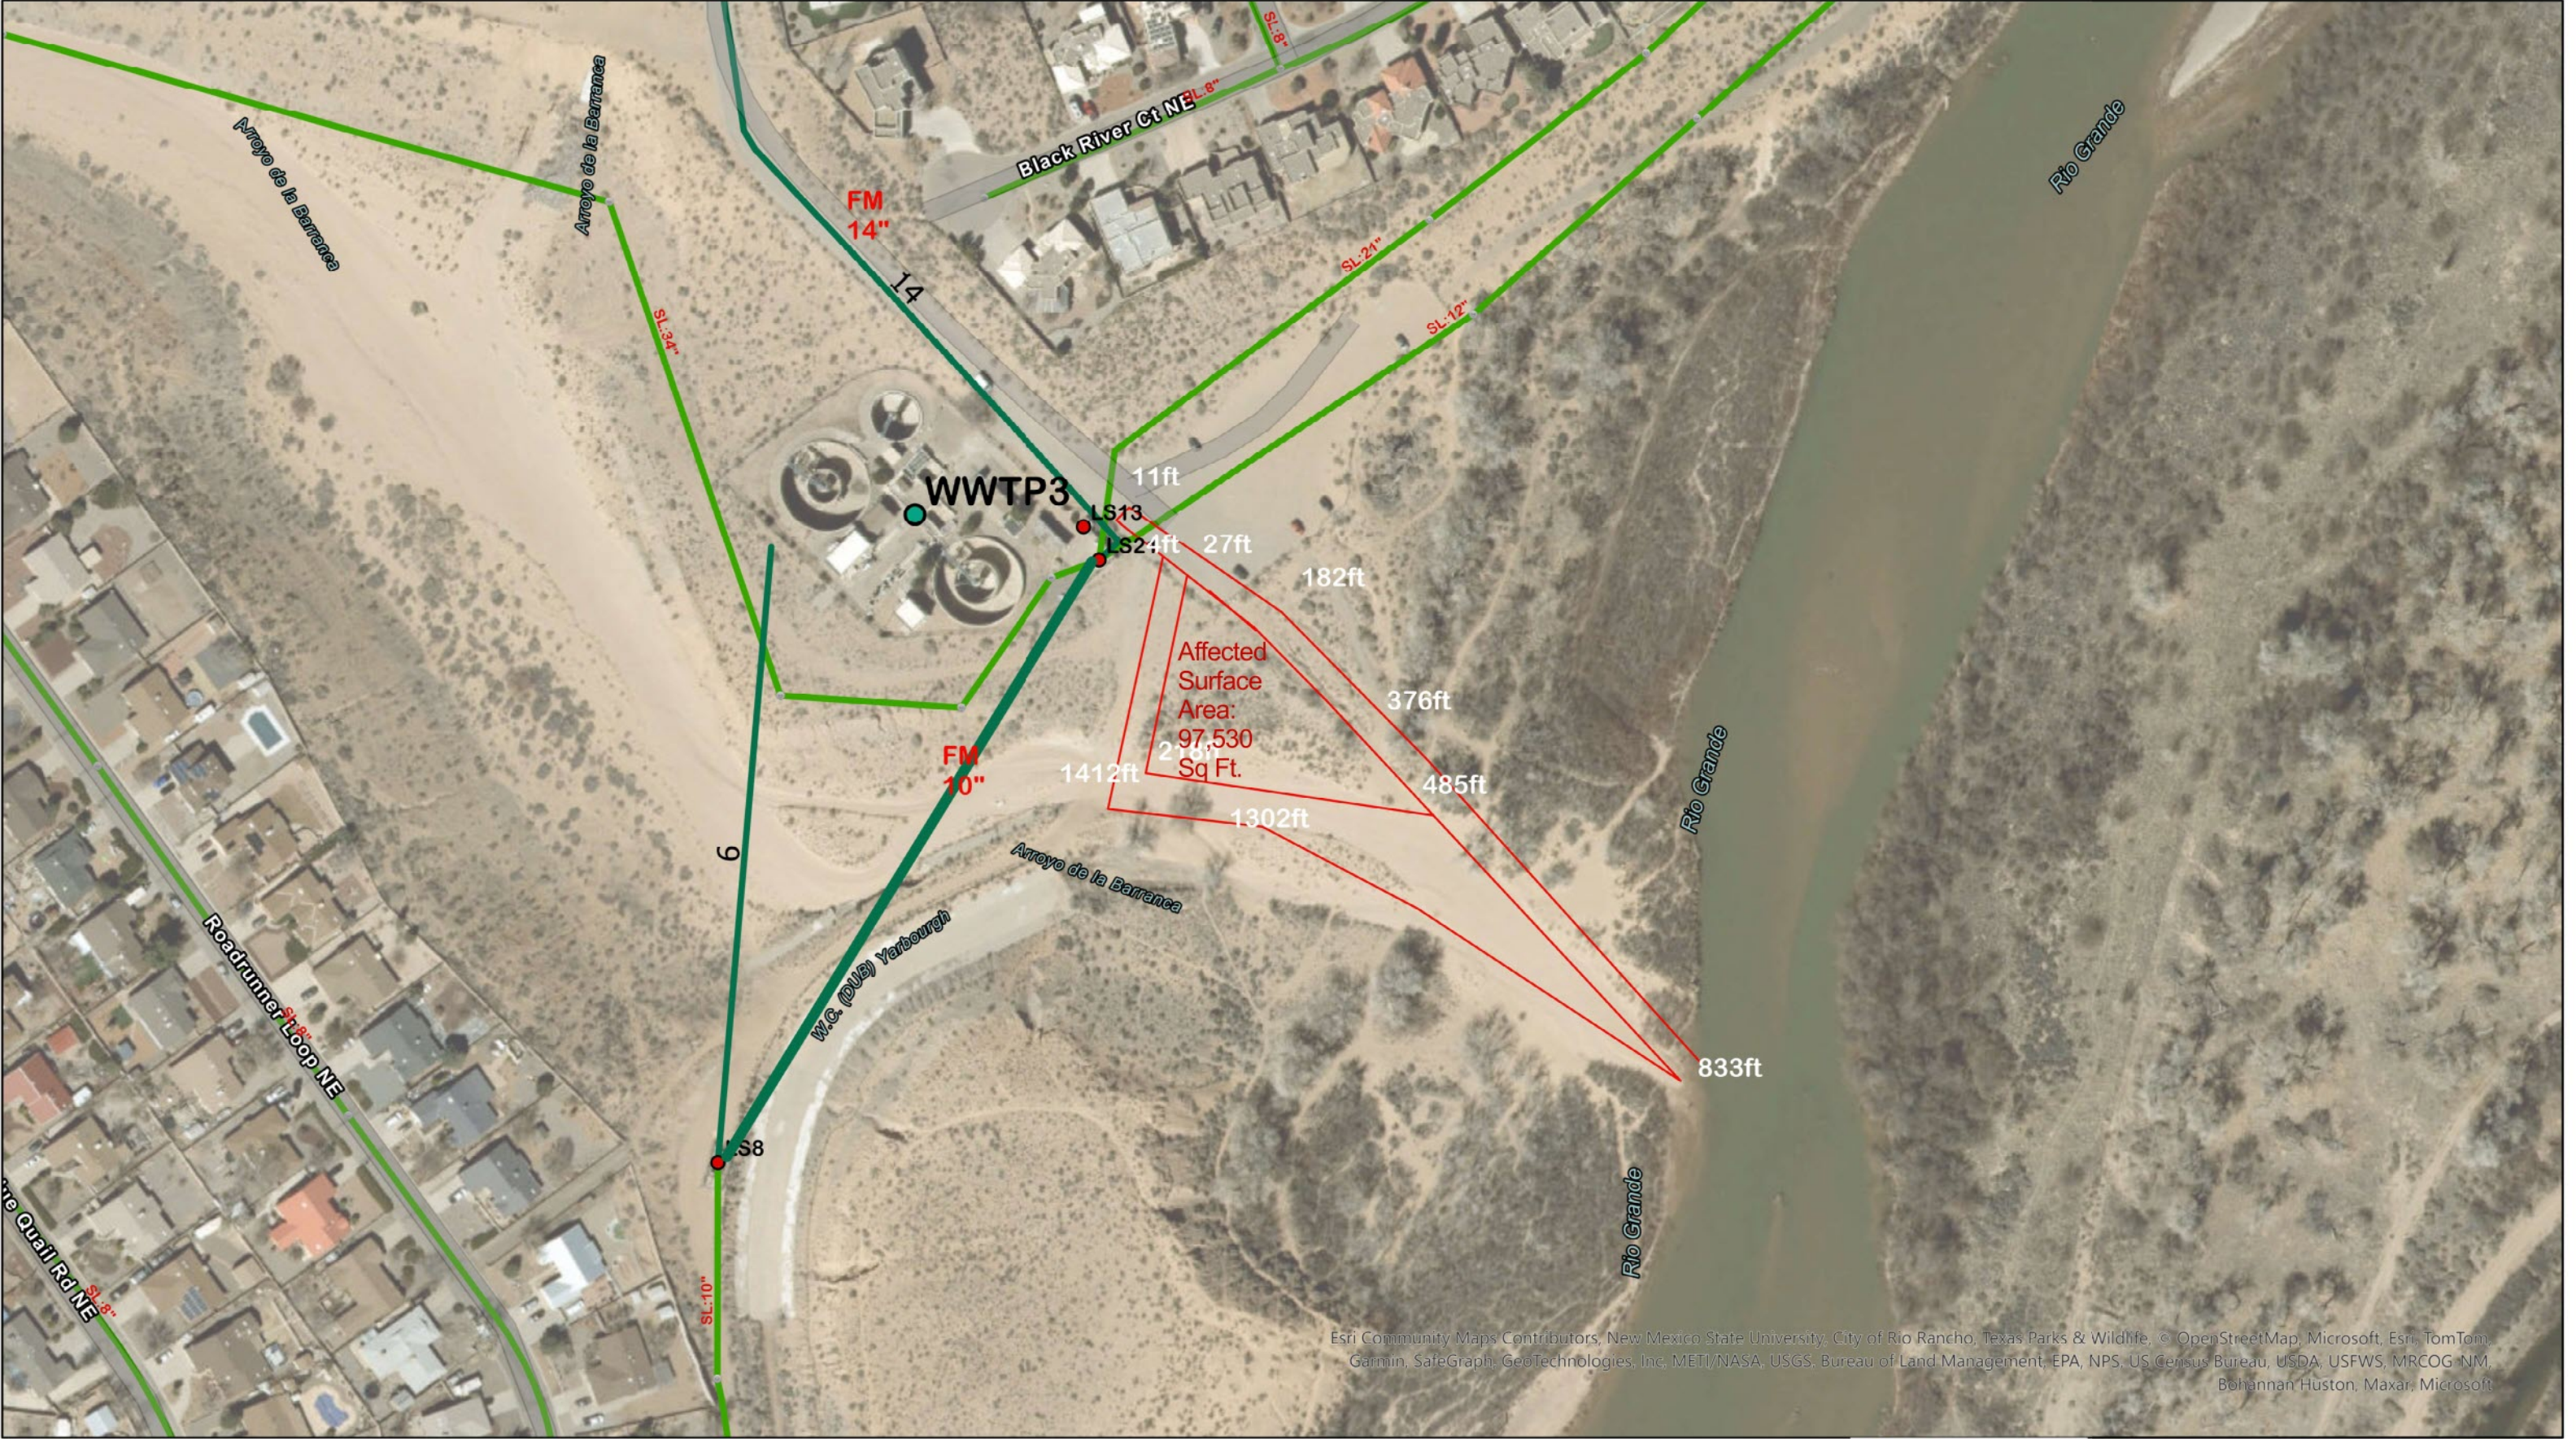
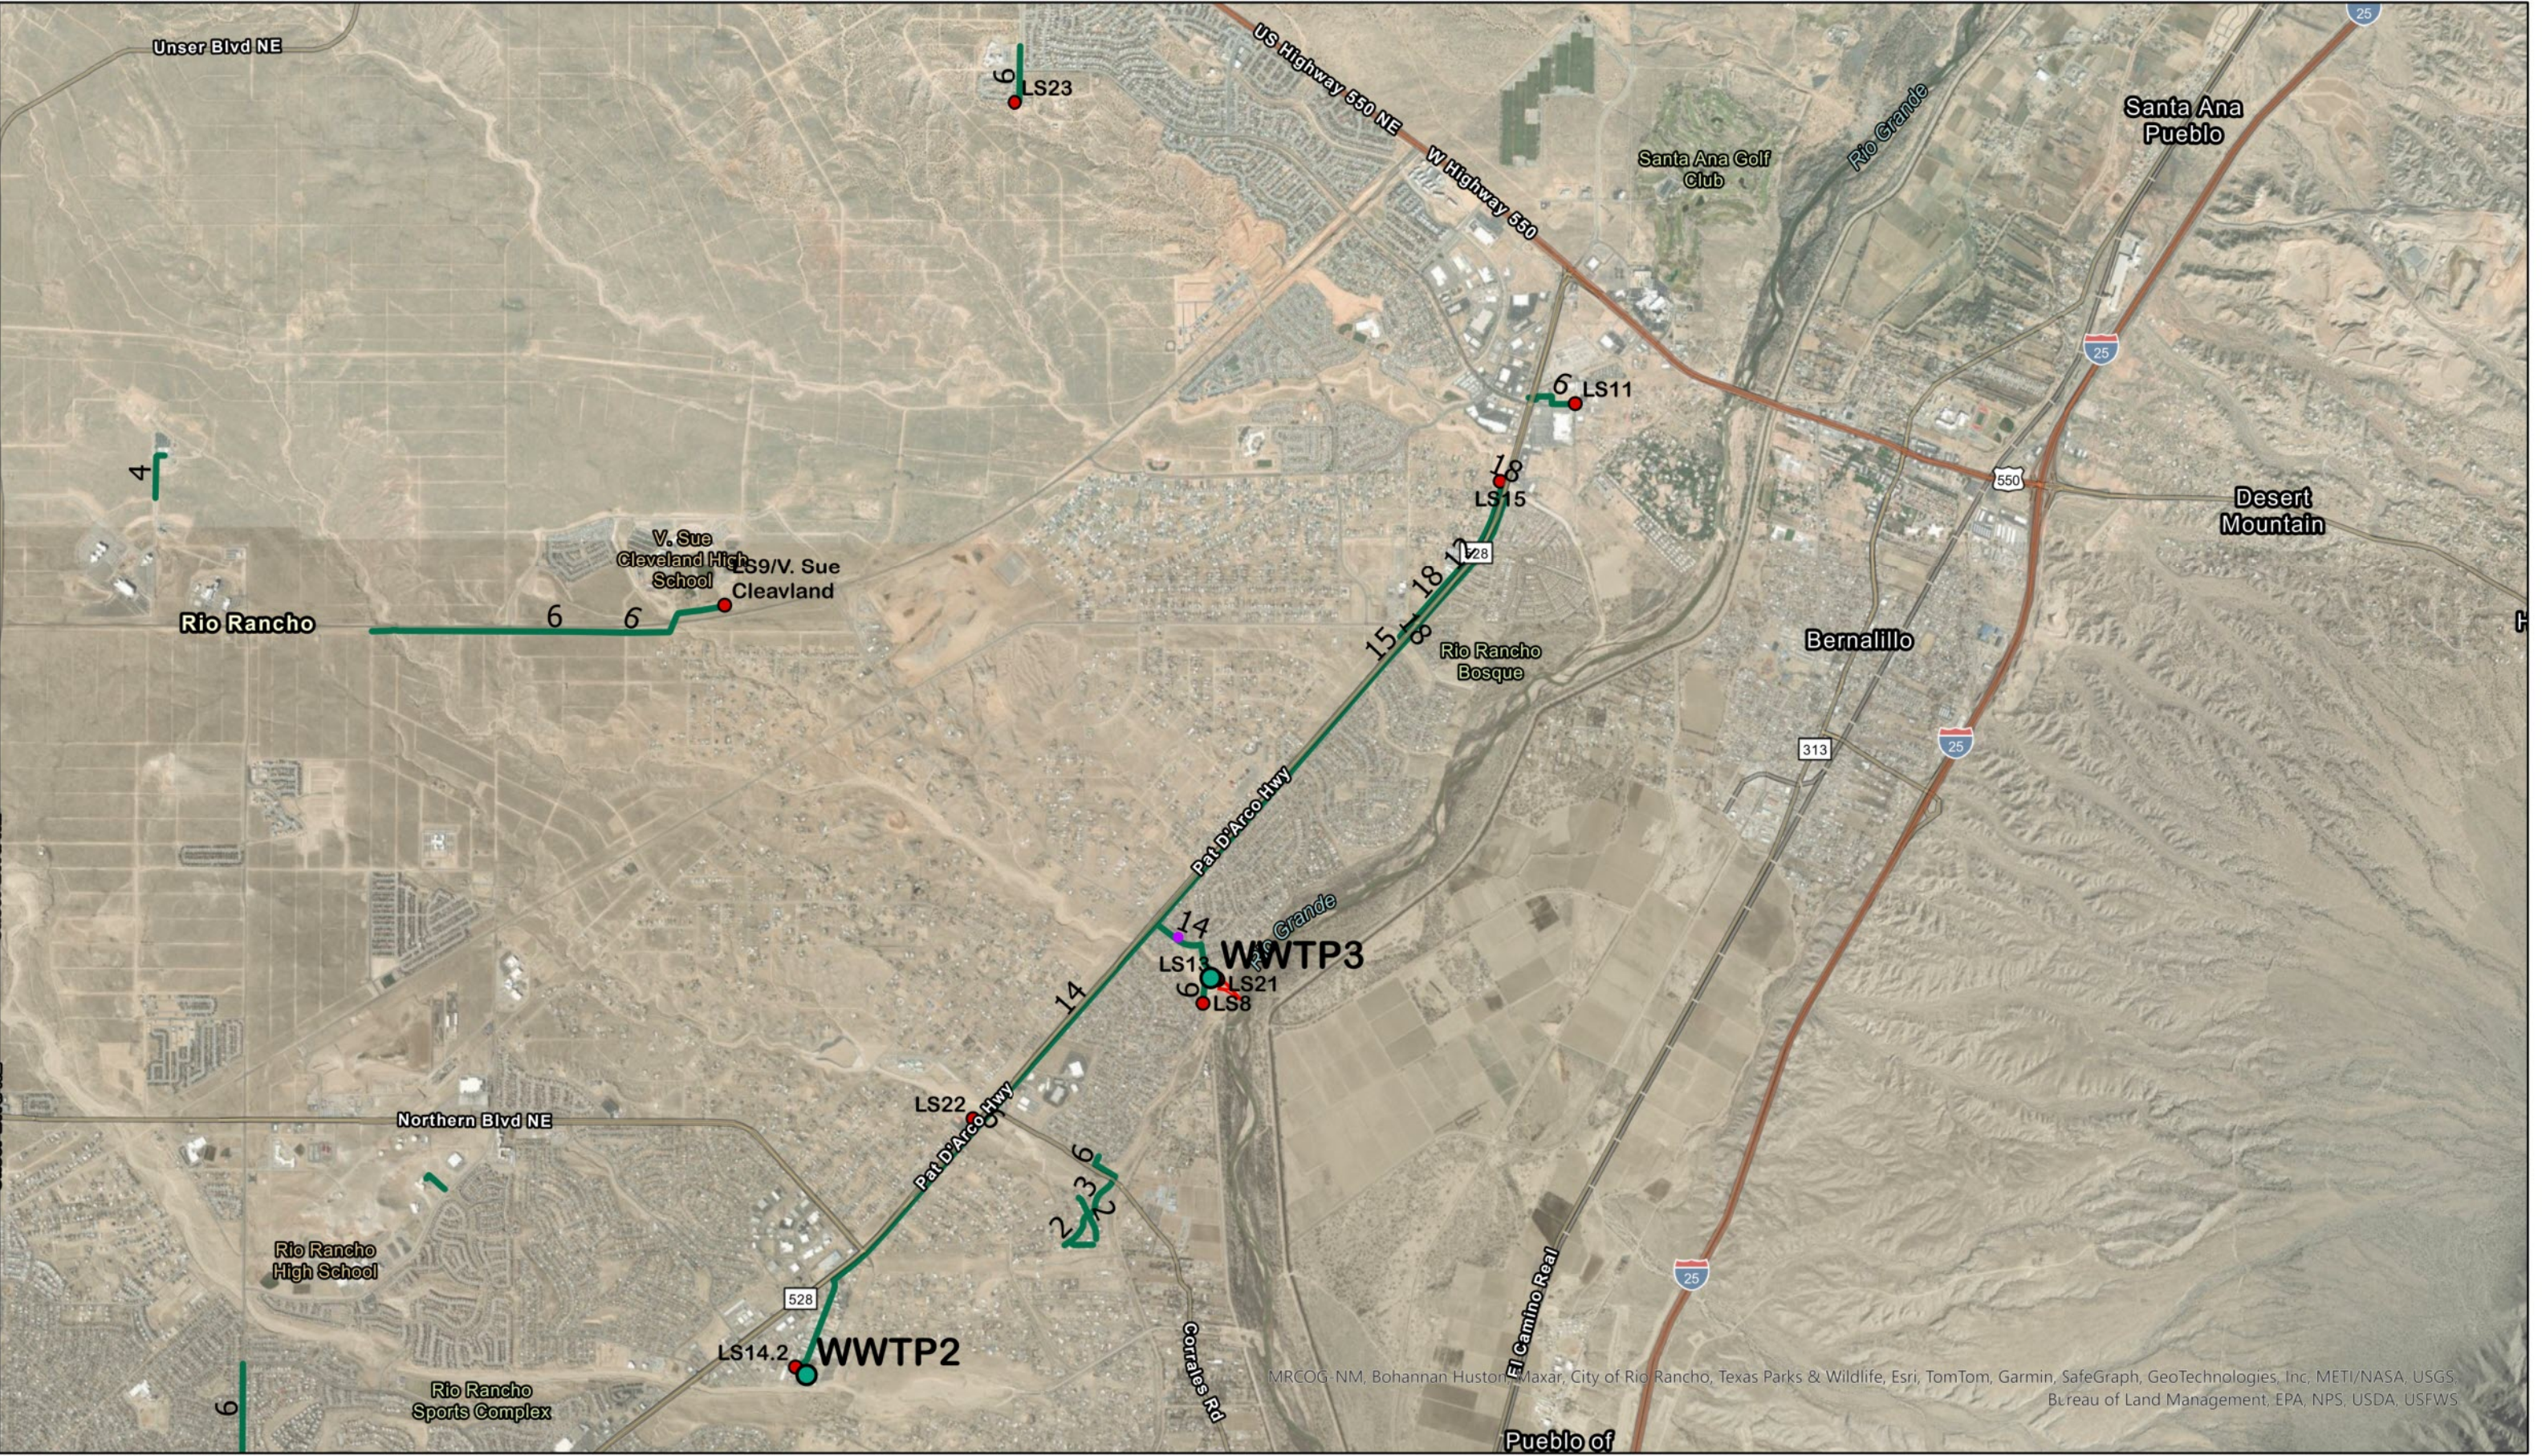
### LS-21 Gravity and Force Main- Impacted Area

See LS\_21 Gravity and FM on shared drive (**Appendix 4 LS-21 Gravity- Force Mains and Impacted Area**). The surface area was calculated through google maps, please see attached document (LS\_21 Gravity and FM\_4). A total area of 3,251 Ft was determined and multiplied by the arroyo size towards the entry into the Rio Grande, 30 Ft. This results in a surface area total of 97,530 Sq Ft.
