Former Frenchtown Mill	Observer: J. Peterson
Project 350.0065.001	Date / Time: 5/10/18 1340-1520
Clark Fork River Berm	Weather: Cloudy, 61 degrees F
Clark Fork Discharge at USGS Gage 12353000 (cfs): 45,200 – 42,700

**Clark Fork River Stage Monitoring Sites  
Former Frenchtown Mill Site  
Missoula County, Montana  
FIGURE 1**

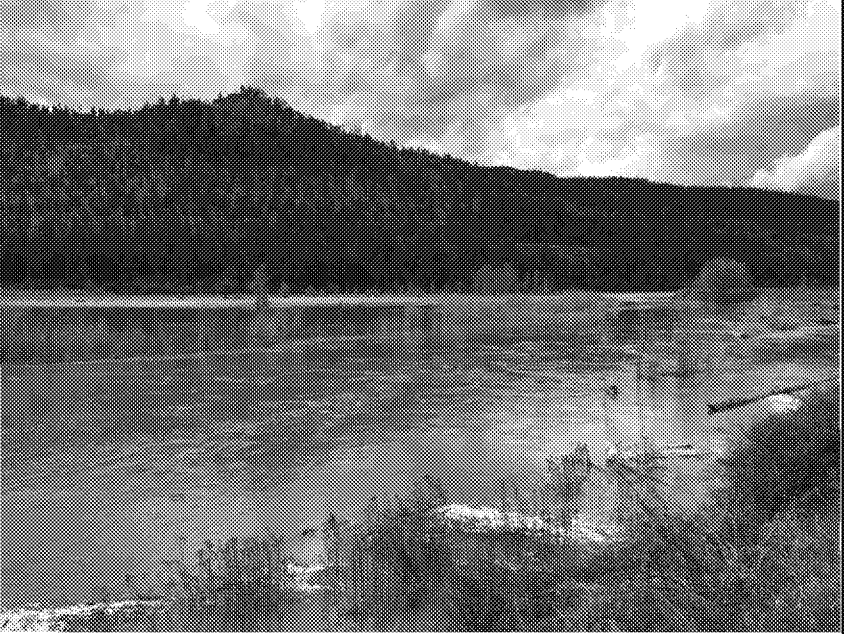
<p><b>Site: Photo Point 1</b></p> <p><b>Date/Time: 5/10/18 14:20</b></p> <p><b>Staff Gage (ft): N/A</b></p> <p><b>Location:</b> N 46.95066 W 114.20983</p> <p><b>Comments:</b> Looking northwest. Southwest corner of HP2.</p>

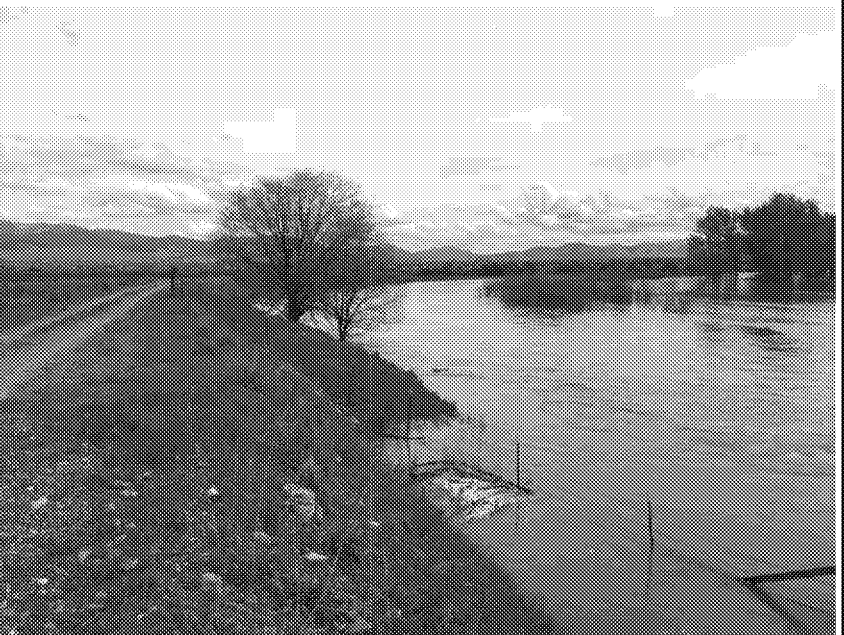
<p><b>Site: Photo Point 2</b></p> <p><b>Date/Time: 5/10/18 14:25</b></p> <p><b>Staff Gage (ft): N/A</b></p> <p><b>Location:</b> N 46.951097 W 114.213278</p> <p><b>Comments:</b> Looking east. South of HP2.</p>

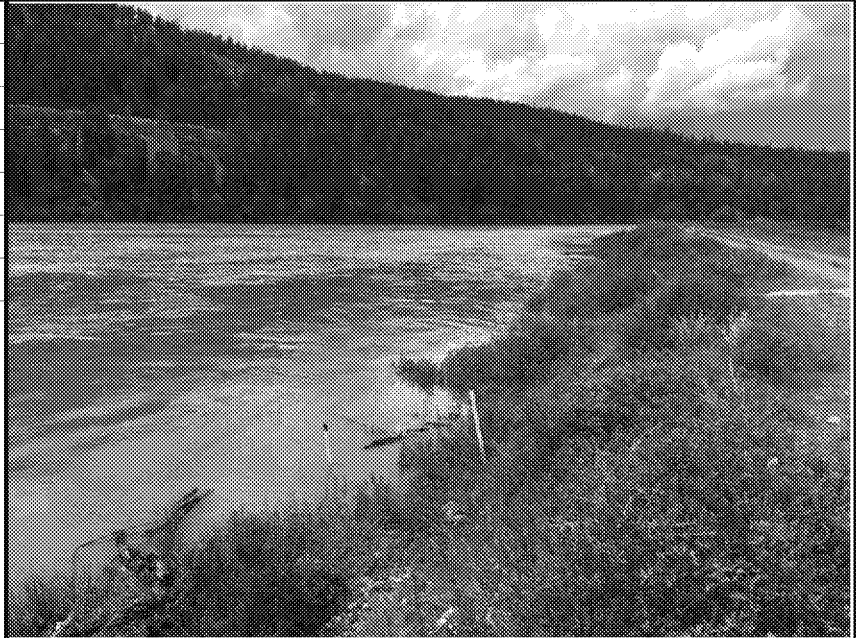
**Site: Photo Point 3**  
**Date/Time: 5/10/18 14:25**  
**Staff Gage (ft): 1.65**  
**Location:**  
N 46.95146  
W 114.21378  
**Comments:**  
Looking northwest. West side of HP2, second staff gage. River is turbid.

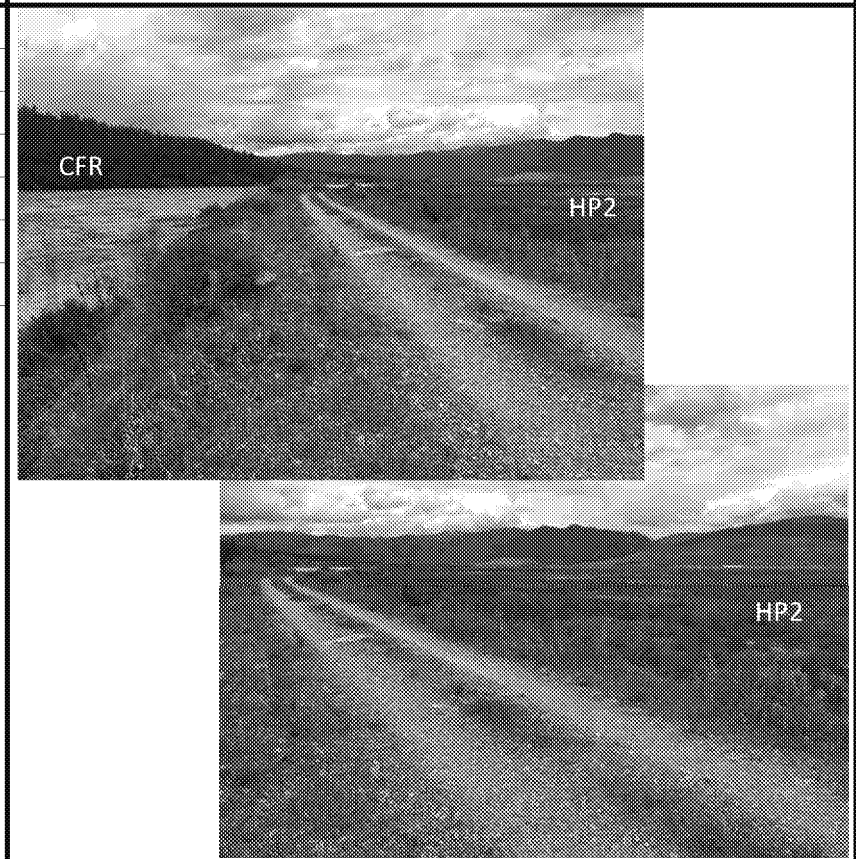
**Site: Photo Point 4**  
**Date/Time: 5/10/18 14:35**  
**Staff Gage (ft): N/A**  
**Location:**  
N 46.95341  
W 114.21720  
**Comments:**  
Looking north. West side of HP2.

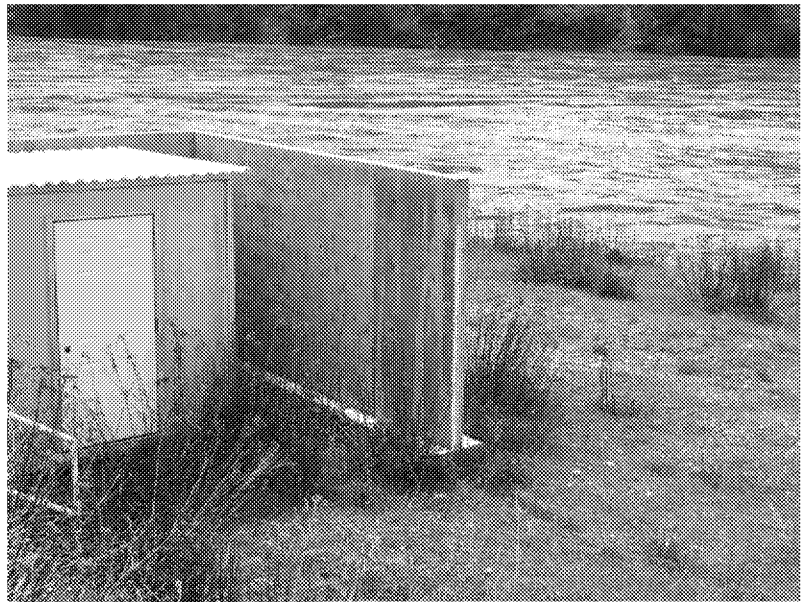
**Site: Photo Point 5**  
**Date/Time: 5/10/18 14:40**  
**Staff Gage (ft): Below gage**  
**Location:**  
N 46.95862  
W 114.21883  
**Comments:**  
Looking south. Located at outfall 1, west side of HP2/HP7. Gage installed on concrete structure on 7/27/17.

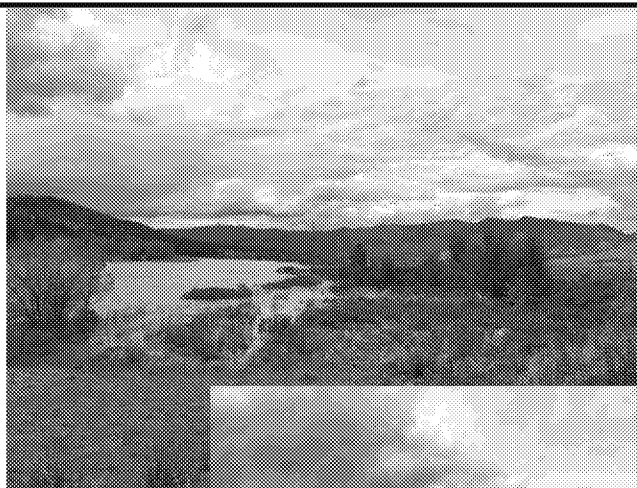
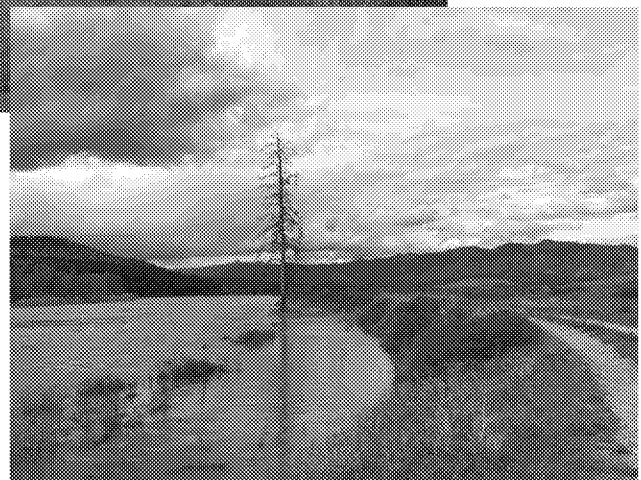
**Site: Photo Point 6**  
**Date/Time: 5/10/18 14:42**  
**Staff Gage (ft): N/A**  
**Location:**  
N 46.96022  
W 114.21975  
**Comments:**  
Looking north. Southwest side of HP11.

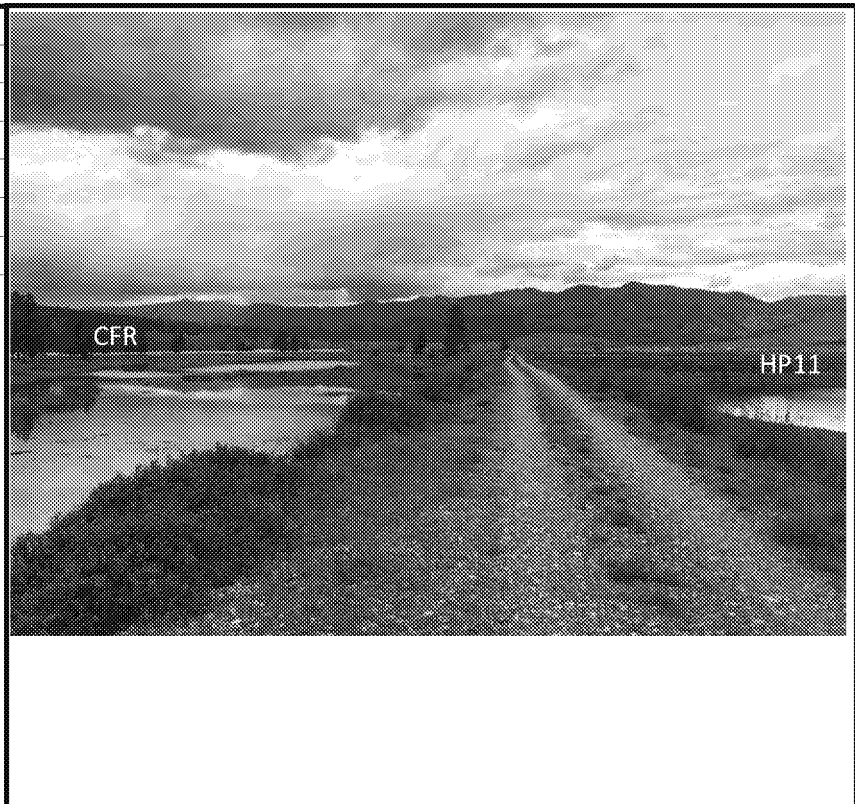
**Site: Photo Point 7**  
**Date/Time: 5/10/18 14:45**  
**Staff Gage (ft): N/A**  
**Location:**  
 N 46.96448  
 W 114.22173  
**Comments:**  
 Looking north. West side of HP11.

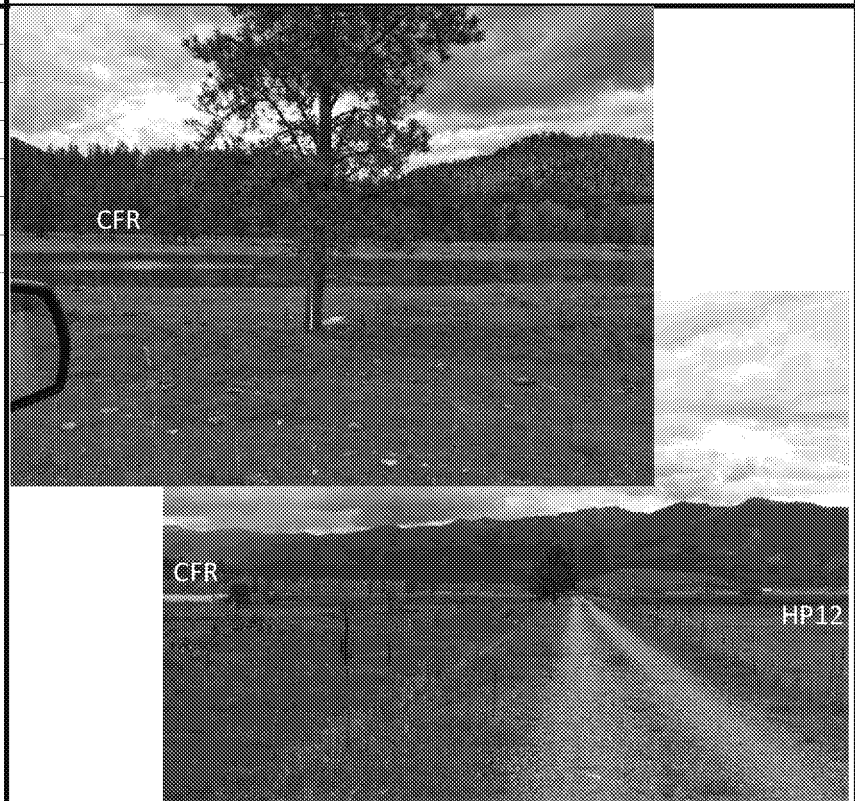
**Site: Photo Point 8**  
**Date/Time: 5/10/18 14:50**  
**Staff Gage (ft): Below gage**  
**Location:**  
 N 46.97270  
 W 114.22433  
**Comments:**  
 Looking north. West side of HP12.

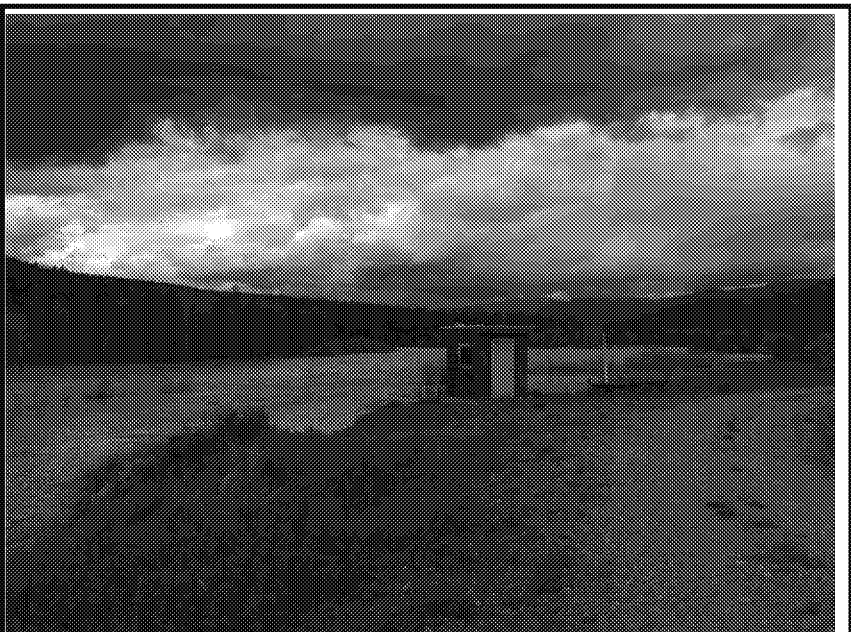
<b>Site:</b> Photo Point 9/CFR-2

<b>Date/Time:</b> 5/10/2018 15:00	
<b>Staff Gage (ft):</b> above gage	
<b>Location:</b>	
N 46.97682	
W 114.22689	
<b>Comments:</b>	
Looking north. West side of HP13a. River gage submerged. A transducer is present at this gage site and stage data will be collected when the gage becomes accessible.
