**NPDES COMPLIANCE EVALUATION INSPECTION**  
**Industrial Activities**

**BOVONI MUNICIPAL SOLID WASTE LANDFILL FACILITY**  
1-19 Estate Bovoni, St. Thomas, Virgin Islands 00802  
Latitude: 18° 31' 31.81" N; Longitude: 64° 88' 59.83" W  
Telephone Number: (340) 715-9100

**NPDES ID: VIU000019**

Inspection Dates: May 8 and 15, 2024

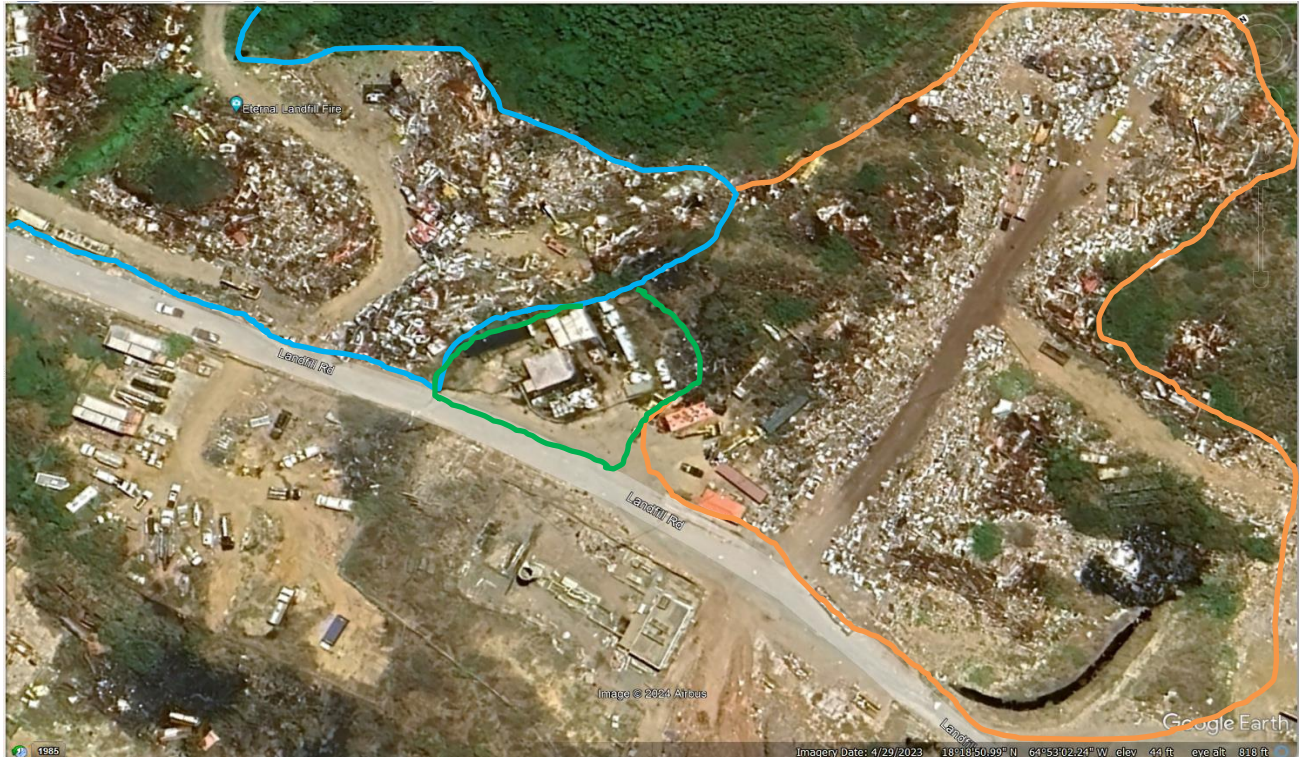
**Figure 3**

The sections of Facility visited, during the limited walkthrough are identified by color-coded outlines
