Clean Water Act Section 404: Site Visit/Case Development

Site Name	Super Café Randy Inc. (hereinafter as "The Site")	Start Date	December 11, 2024
		End Date	December 11, 2024
Inspection Purpose	Initial site visit		
Opening Conference			
<input checked="" type="checkbox"/> Presentation of Inspector Credentials			
Name and Title (Use N/A if owner/operator not available to join the inspection)			
Mr. Julio C. Cajigas and José A. Bechara - Representatives for NWF, LLC (Owners of the adjacent property)			
<input checked="" type="checkbox"/> Opening Conference			
Name of person authorizing access if applicable			
Randy González Alonso from Super Café Randy Inc. (Owner of segregated parcel where work took place). Access was provided via phone call on December 9, 2024.			
Mr. Julio C. Cajigas - Representative for NWF, LLC (Owners of the adjacent property). Access was provided via phone call and confirmed via email on December 9, 2024.			
Notes from Opening Conference

Super Café Randy Inc.
 Tax parcel number 003-077-067-63-001 (segregated parcel)
 in the Municipality of Isabela, Puerto Rico

Tax Parcel No. 003-077-067-63-001 at
Francisco Camacho St., Guayabos Ward, Isabela,
Puerto Rico

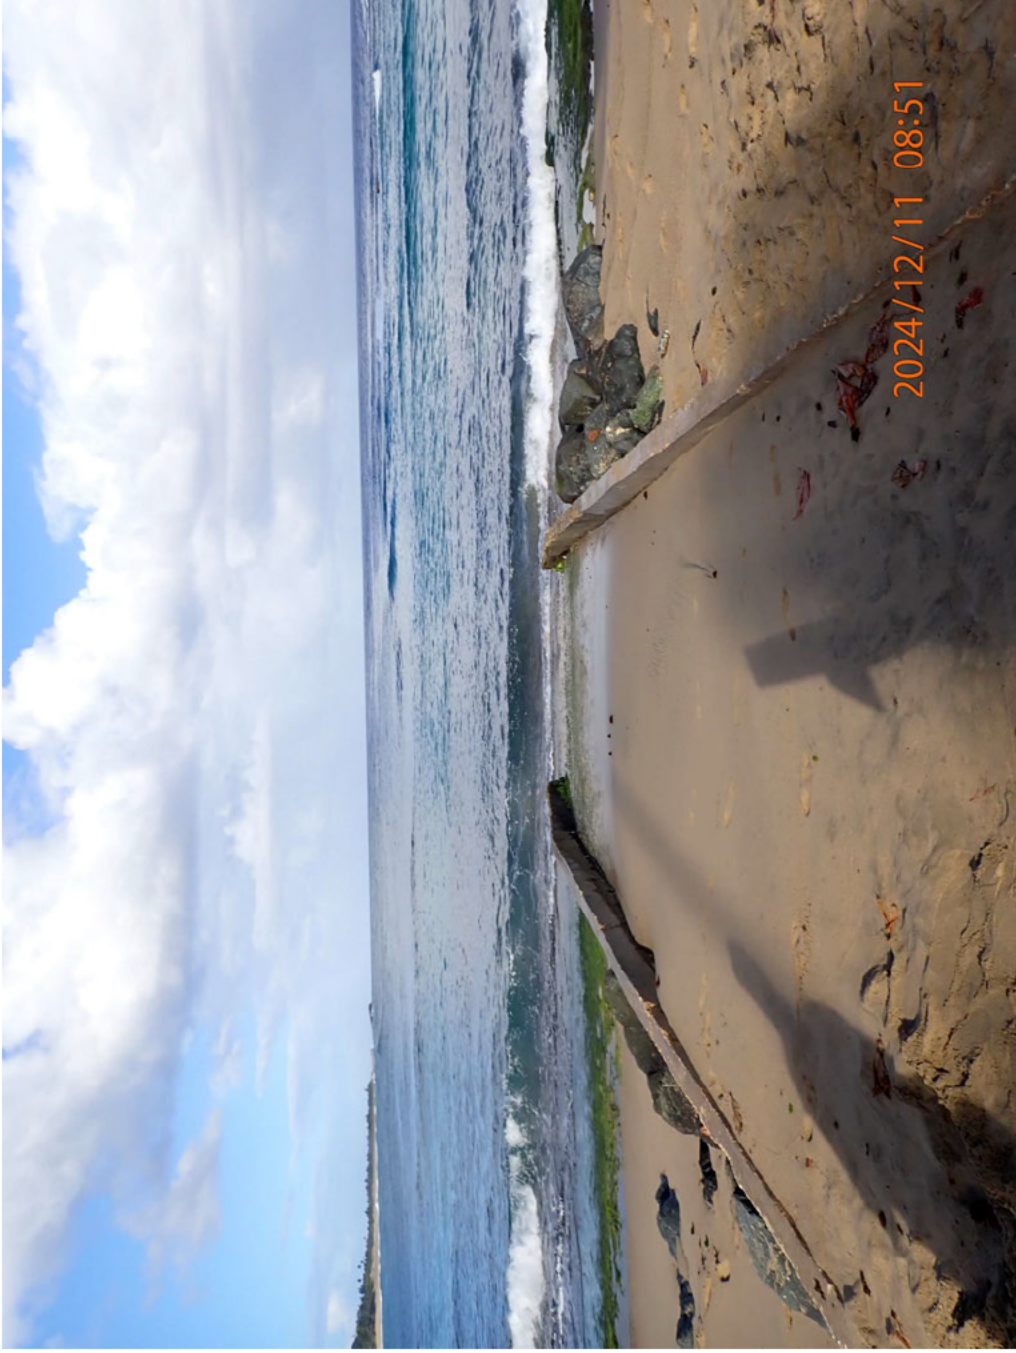
Date: 12/11/2024
Time: 8:51 AM
Photographer: SOL
Photo ID: PC1111146

Boat ramp looking to the west
to the Atlantic Ocean

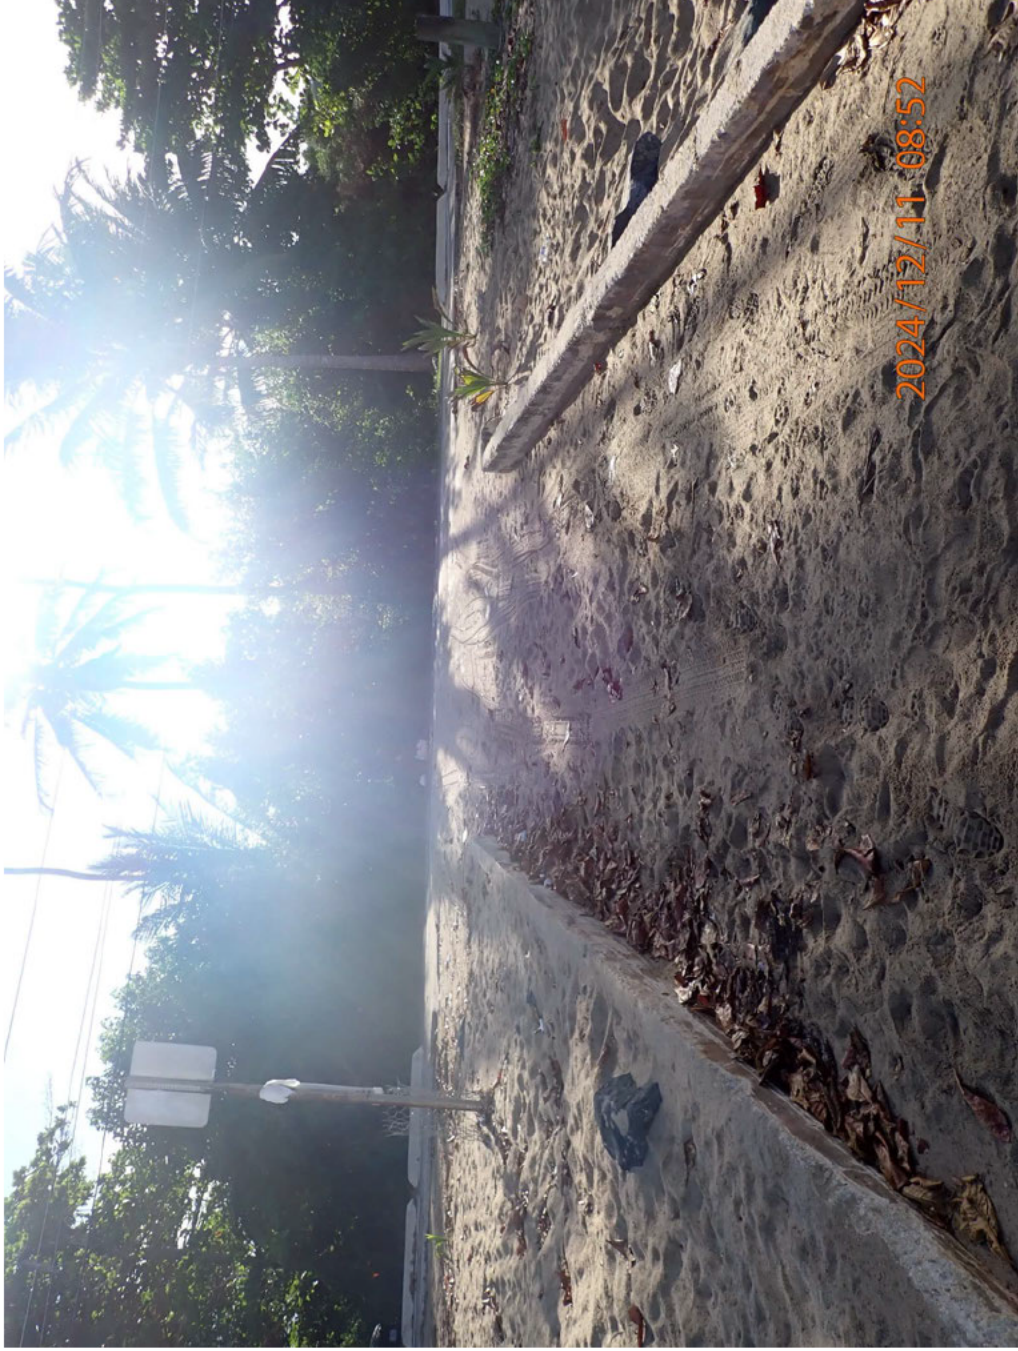
Date: 12/11/2024
Time: 8:52 AM
Photographer: SOL
Photo ID: PC11147

Boat ramp looking to the east, up the berm and municipal road, and the wetland on the other side of the road.

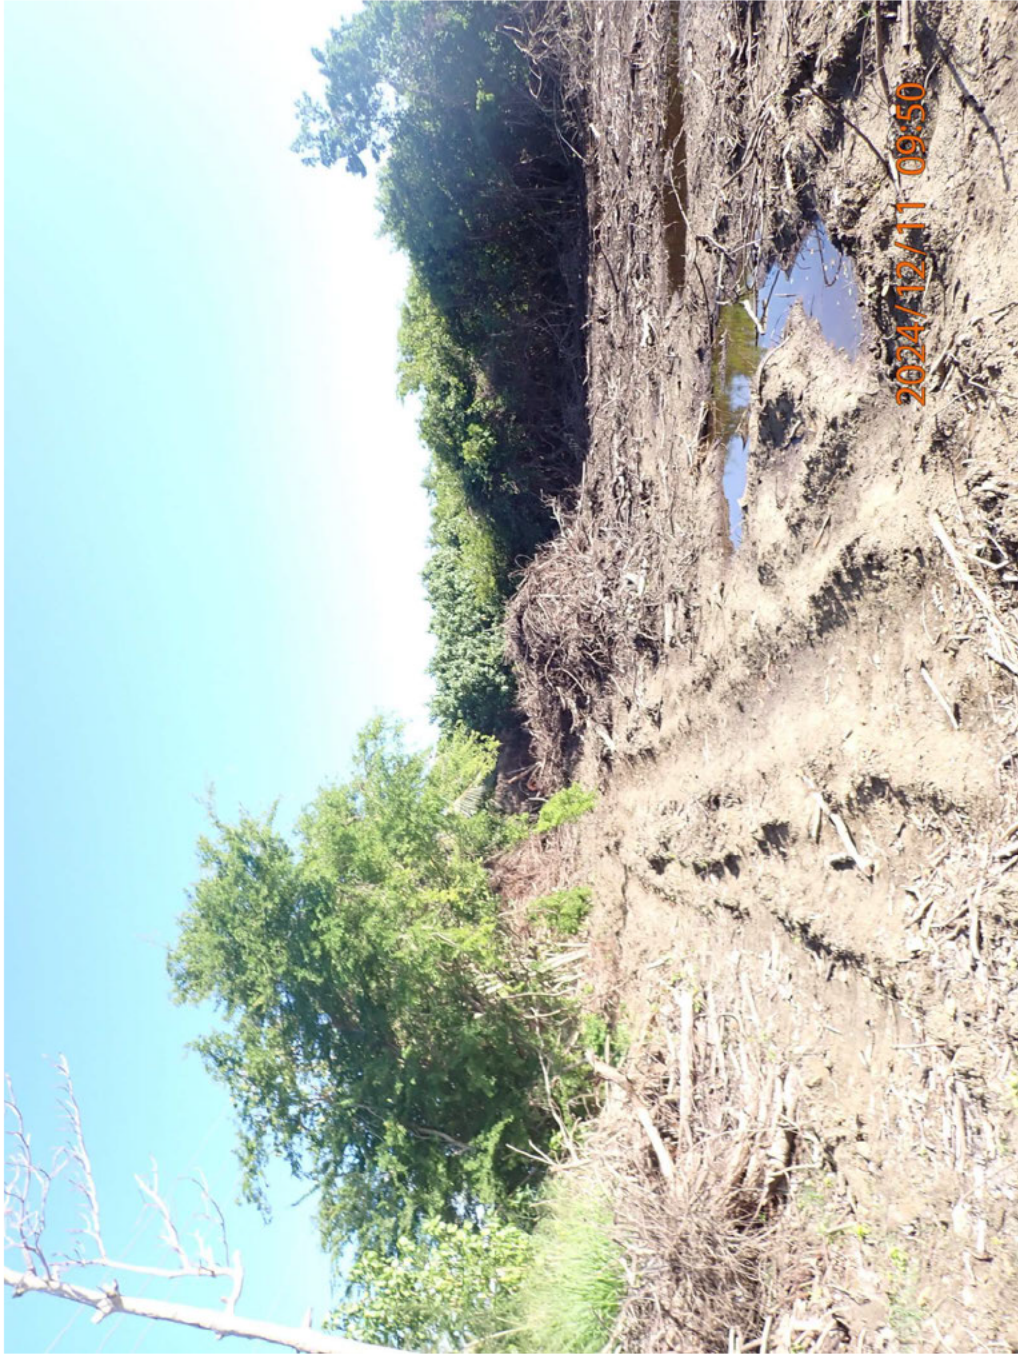
Date: 12/11/2024
Time: 9:50 AM
Photographer: JLF
Photo ID: PC-111153

Access point to site
(18.5091968, -67.0210335)
looking north

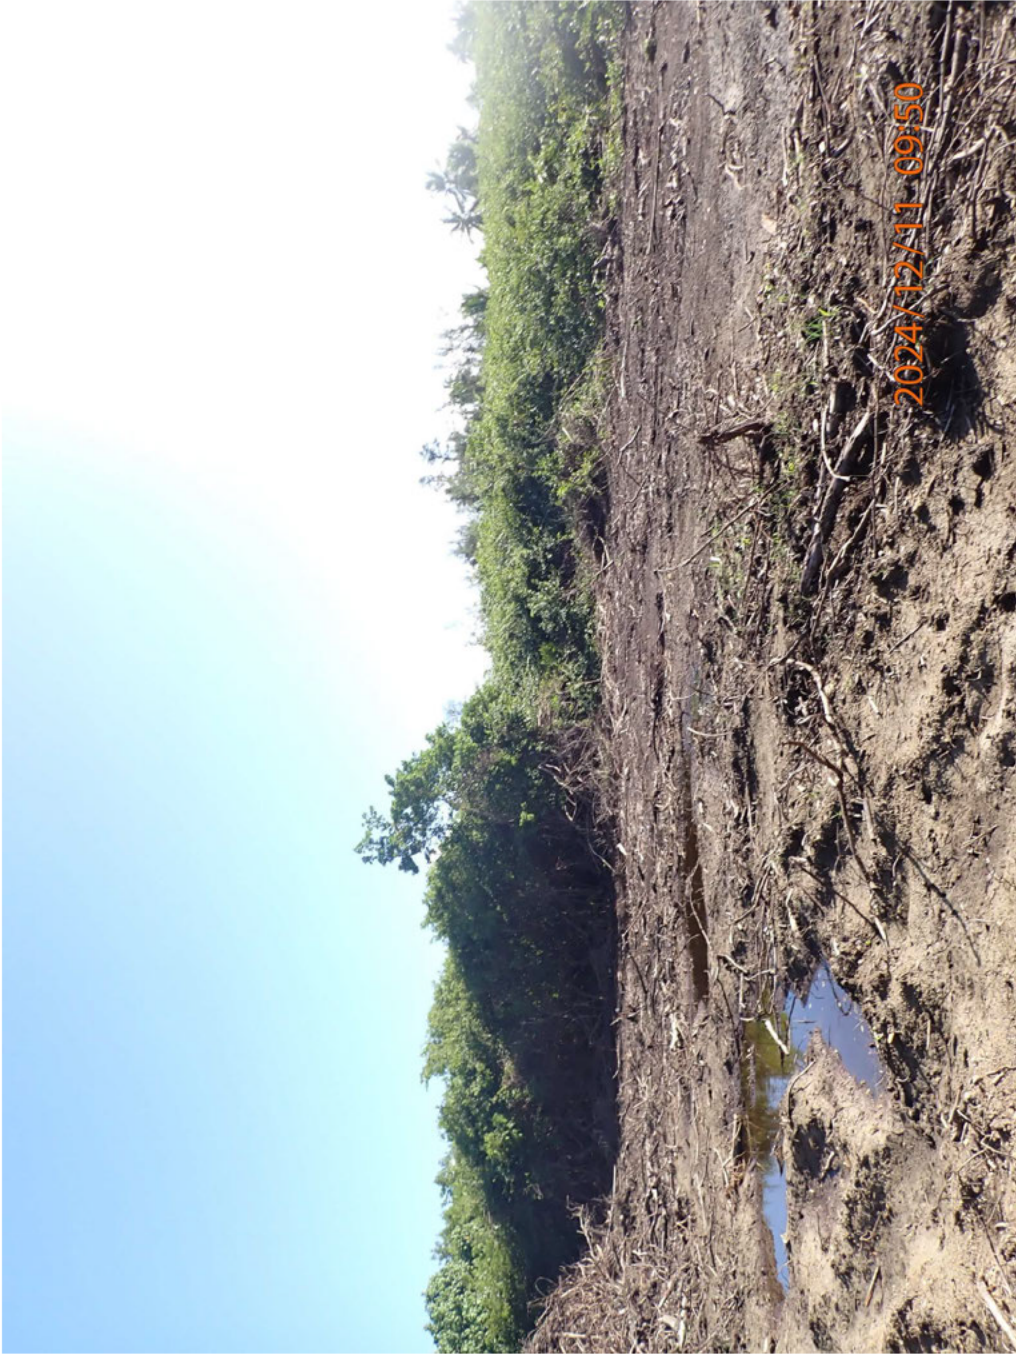
Date: 12/11/2024
Time: 9:50 AM
Photographer: JLF
Photo ID: PC-111154

Access point to site
(18.5091968, -67.0210335)
looking east

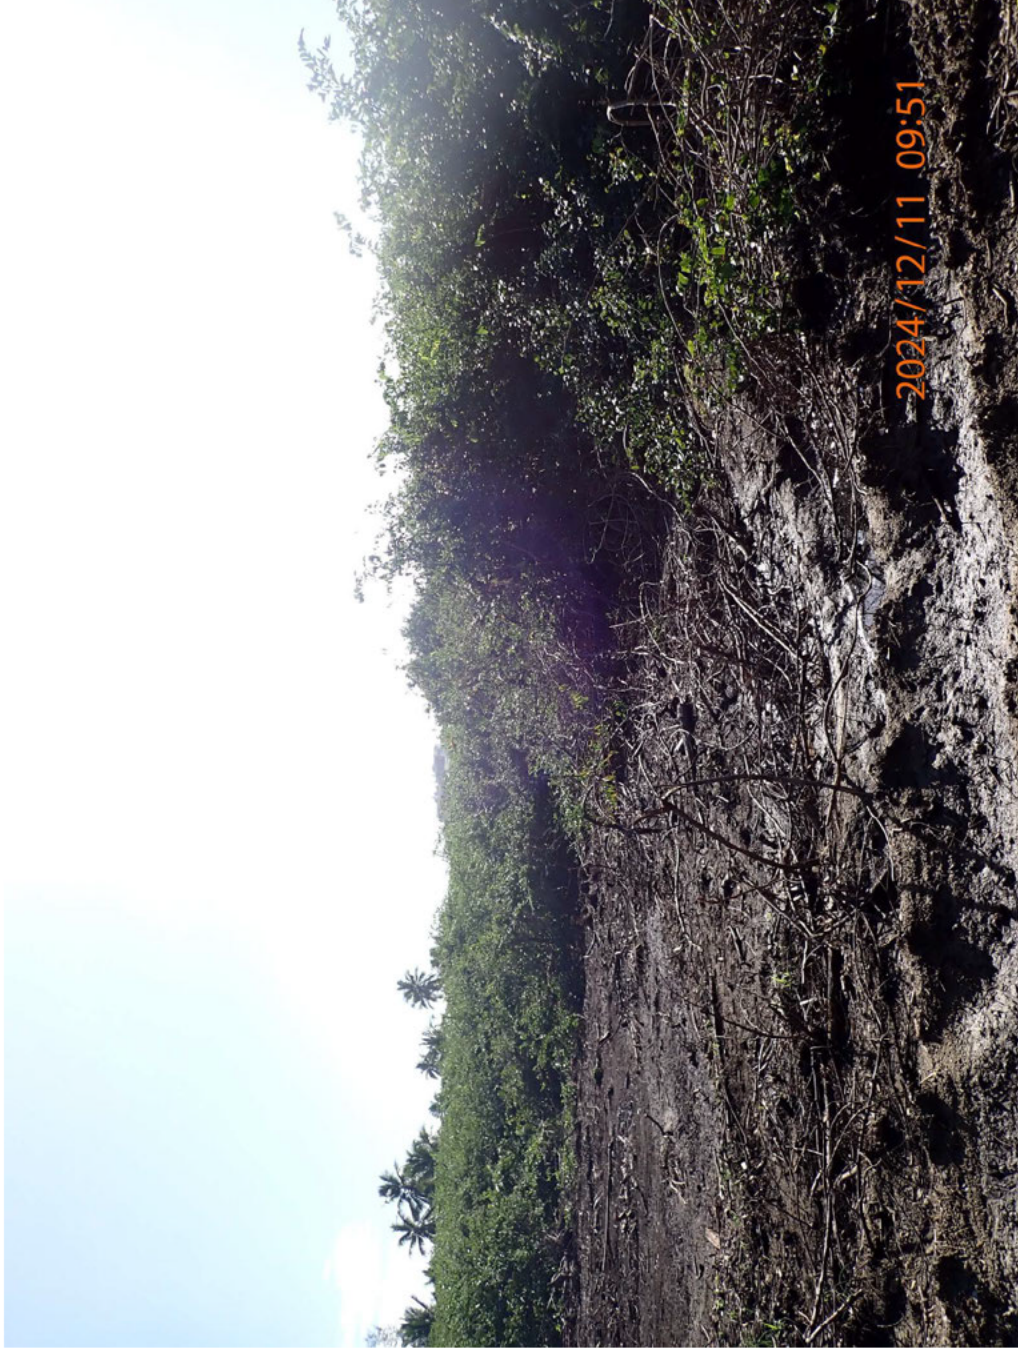
Date: 12/11/2024
Time: 9:51 AM
Photographer: JLF
Photo ID: PC-111155

Access point to site
(18.5091968, -67.0210335)
looking west

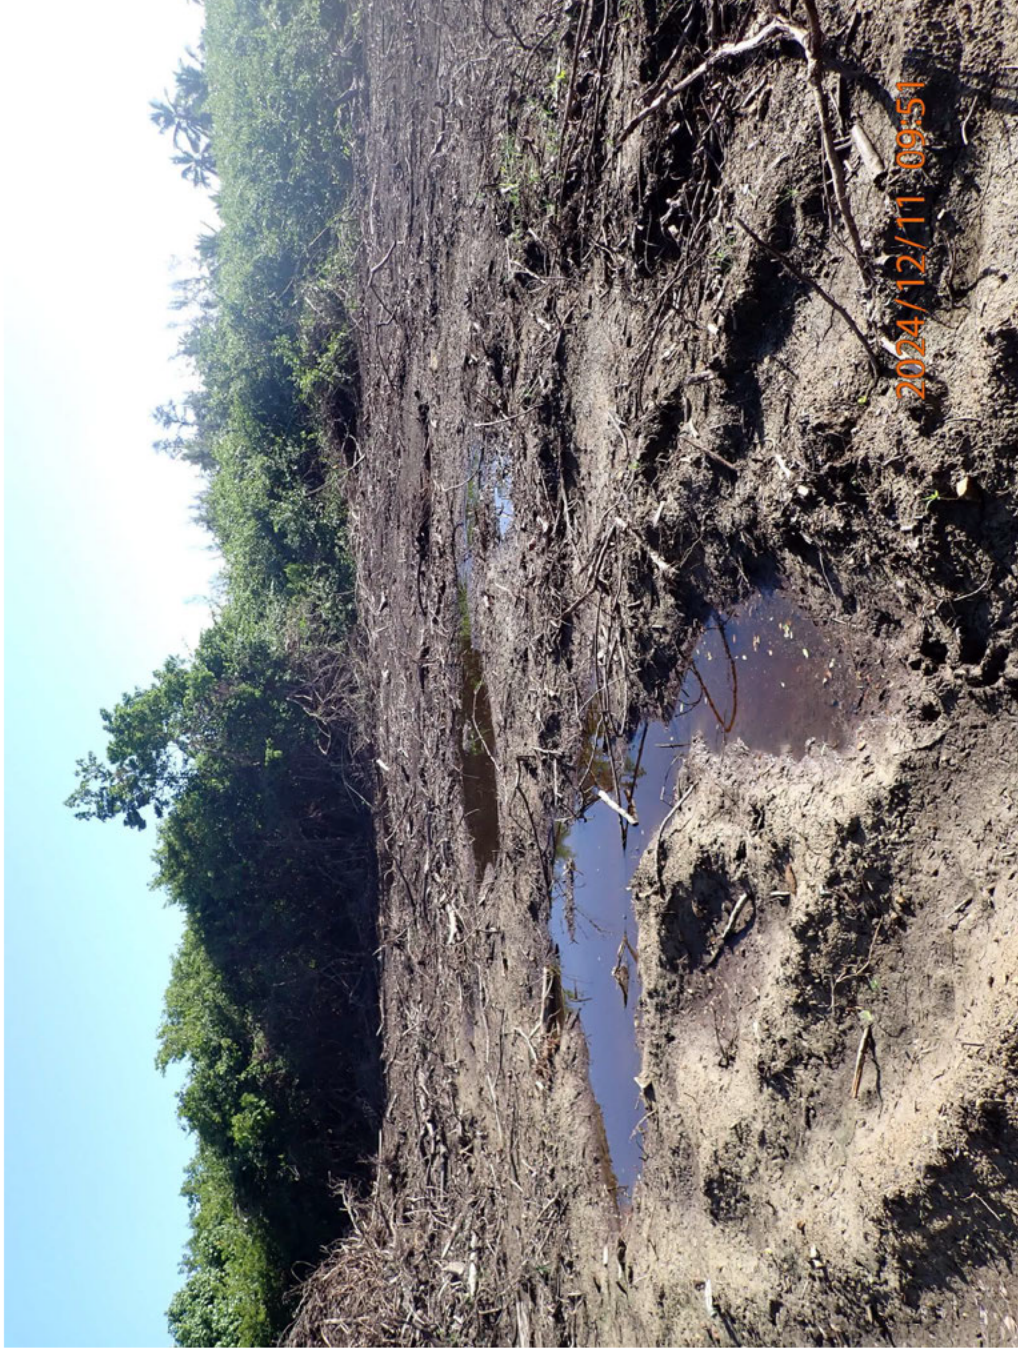
Description:
Standing water.

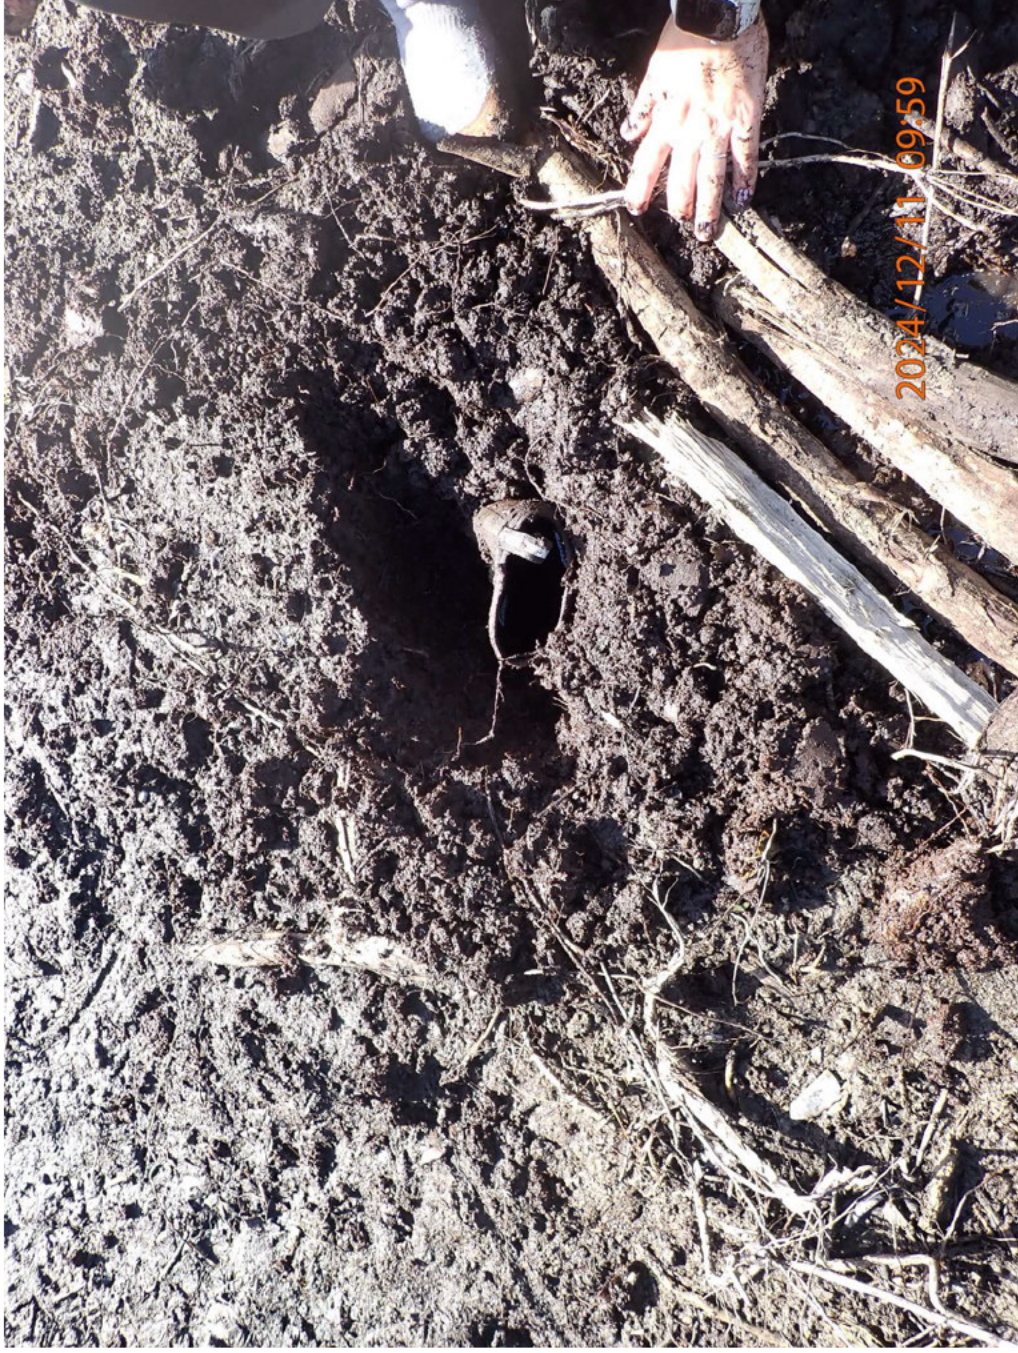
Date: 12/11/2024
Time: 9:59 AM
Photographer: JLF
Photo ID: PC-111157

One of two photos (PC-111157 -
PC-111158) of EPA inspector
boot stuck in mucky soil
(18.5092748, -67.0207408)

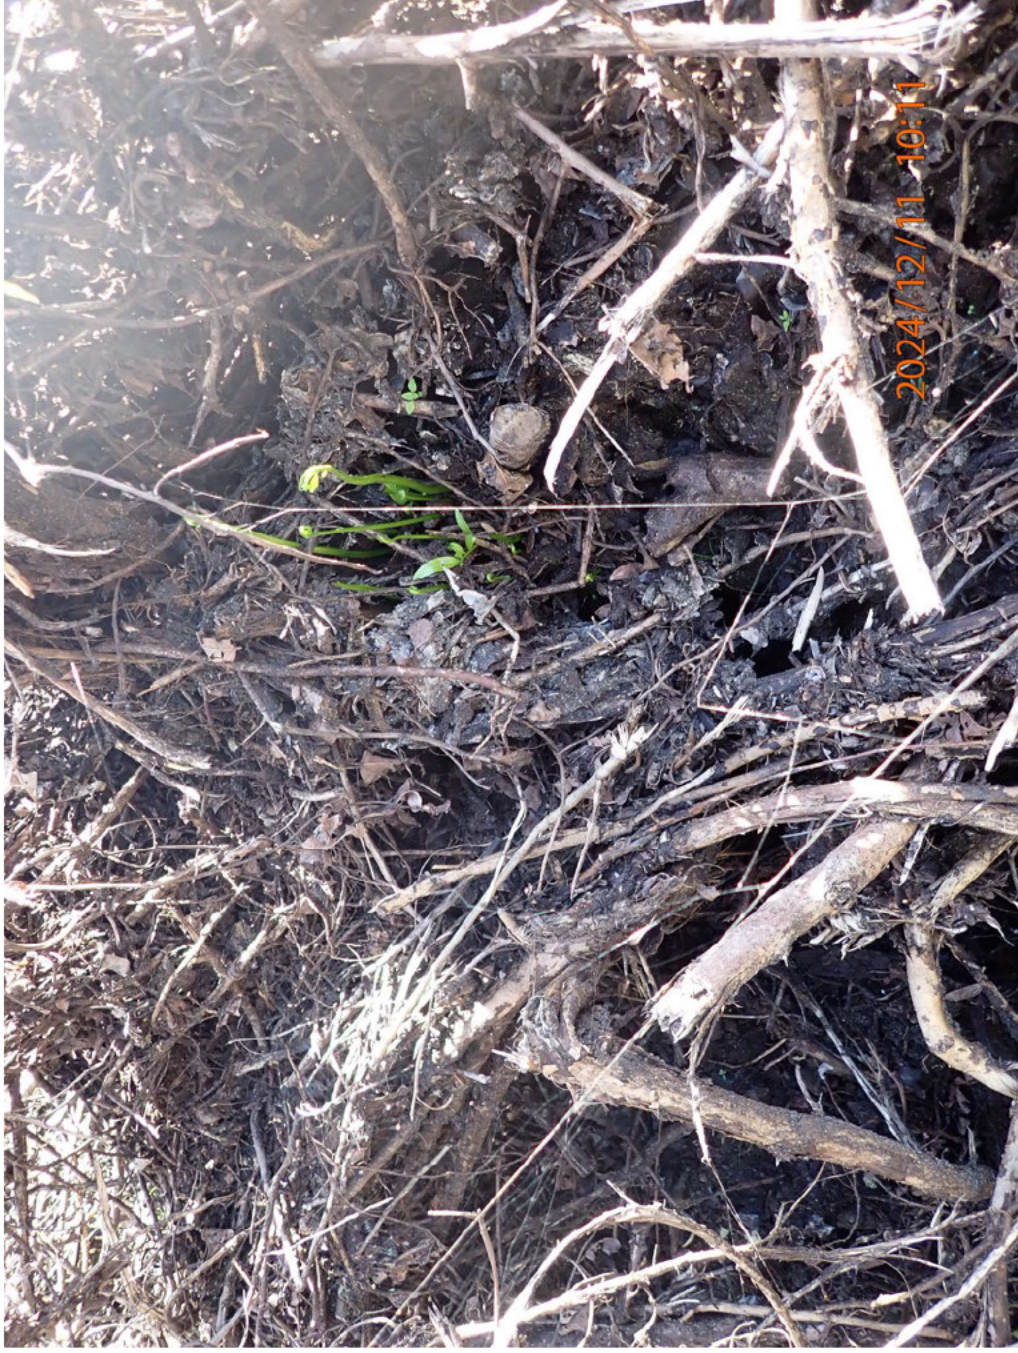
Date: 12/11/2024
Time: 9:51 AM
Photographer: JLF
Photo ID: PC-111159

(1/2) Fill pile materials containing bulldozed soils and vegetation. Mangrove sprouts can be observed in the pile.

Remarks:
 Vegetation was removed and piled. Species included *Annona glabra* (OBL), *Thespesia populnea* (FAC), *Acrosticum* spp. (OBL), *Dalbergia ecastaphyllum* (FACW), and *Conocarpus erectus* (FACW).

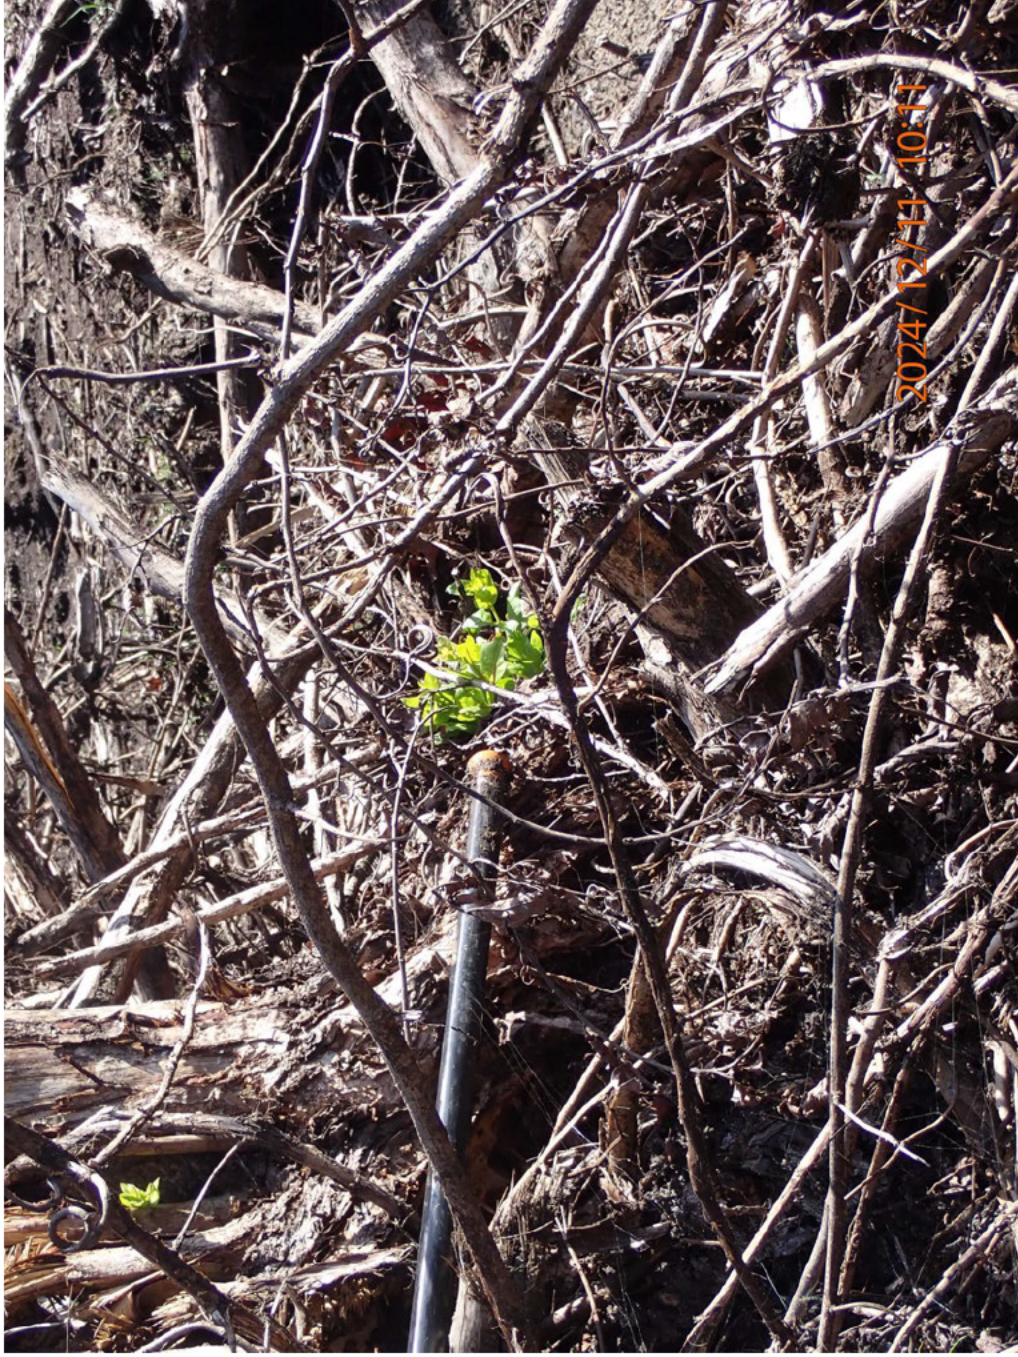
Date: 12/11/2024
Time: 10:11 AM
Photographer: JLF
Photo ID: PC-111160

(2/2) Fill pile materials containing bulldozed soils and vegetation. Mangrove sprouts can be observed in the pile.

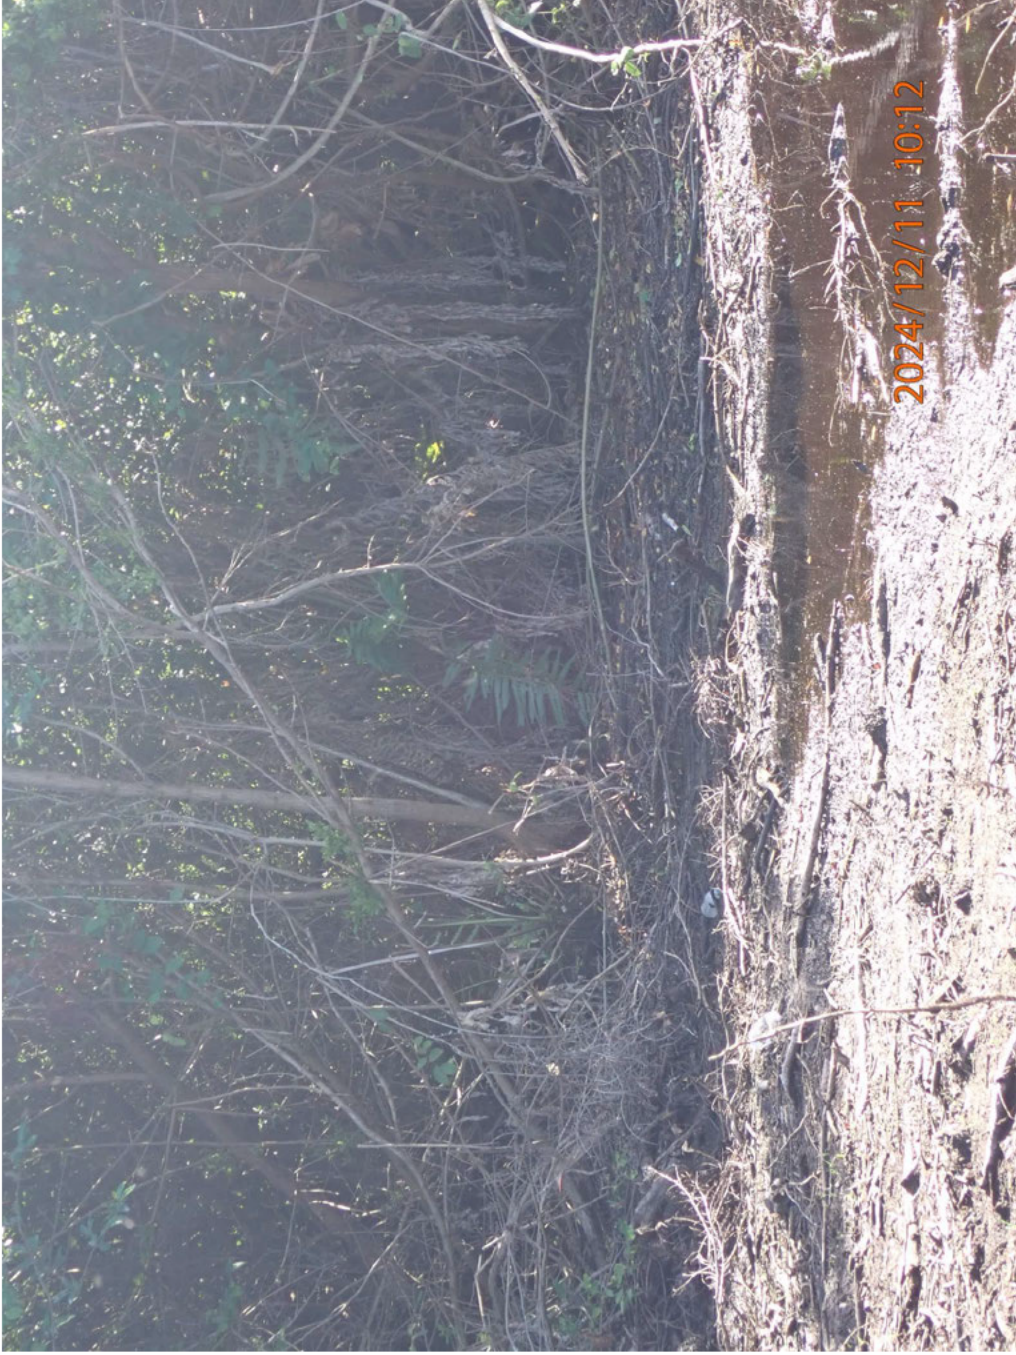
Date: 12/11/2024
Time: 10:12 AM
Photographer: JLF
Photo ID: PC-1111160

View of *Achrosticum* sp. (obligate) at the periphery of impacted area next to standing water.

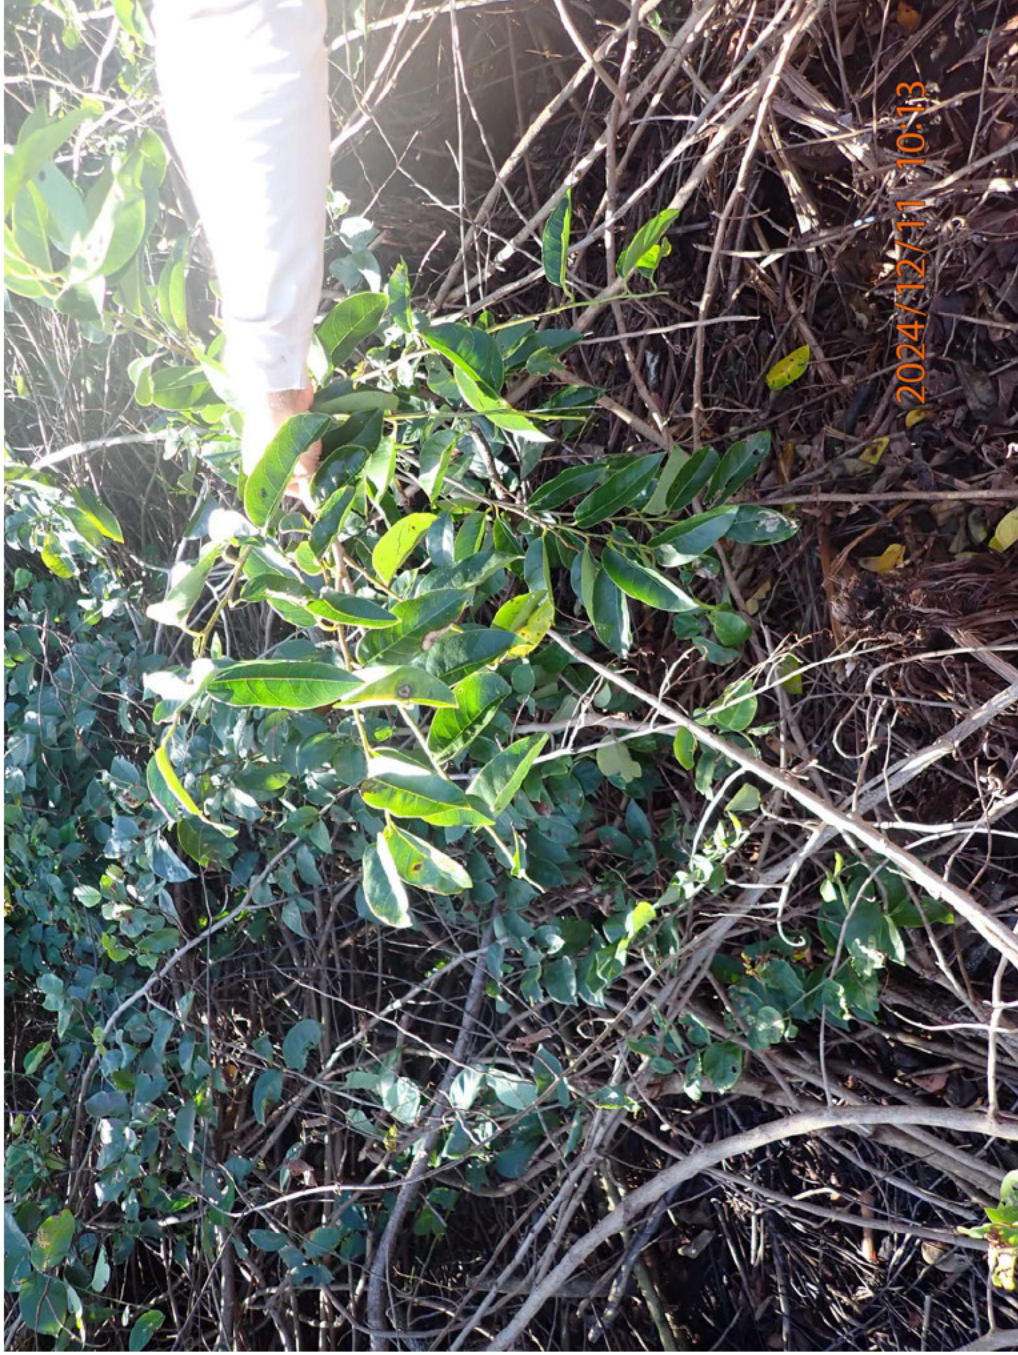
Date: 12/11/2024
Time: 10:13 AM
Photographer: JLF
Photo ID: PC-111162

One of three photos (PC-111162
-PC-111164) of *Annona glabra*
(obligate) at the periphery of
impacted area.

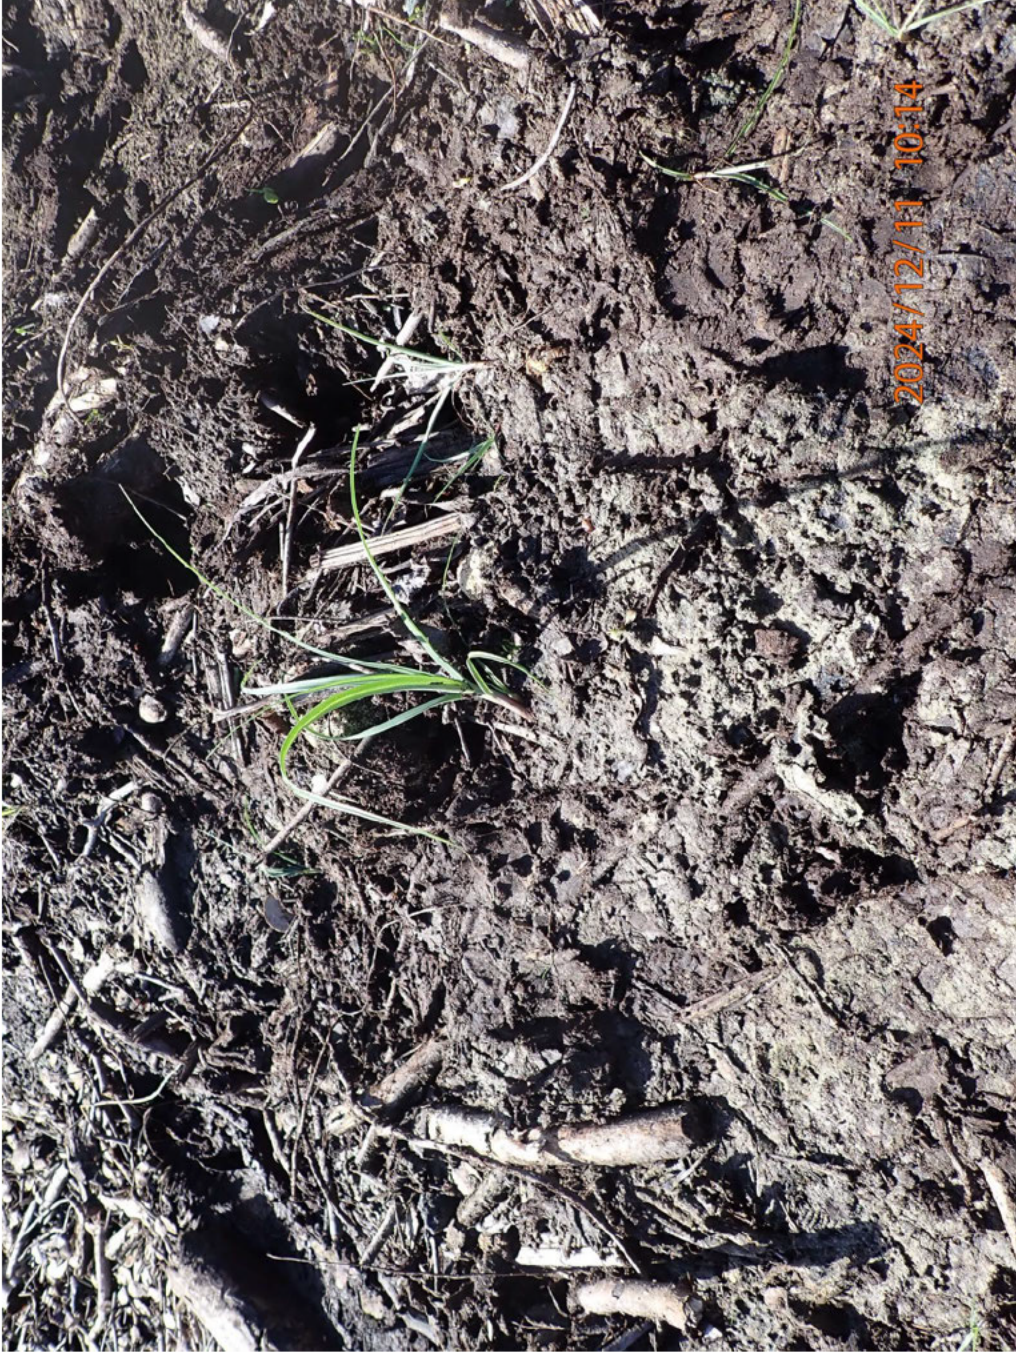
Description:
Unidentified Cyperaceae
growing on impacted site.

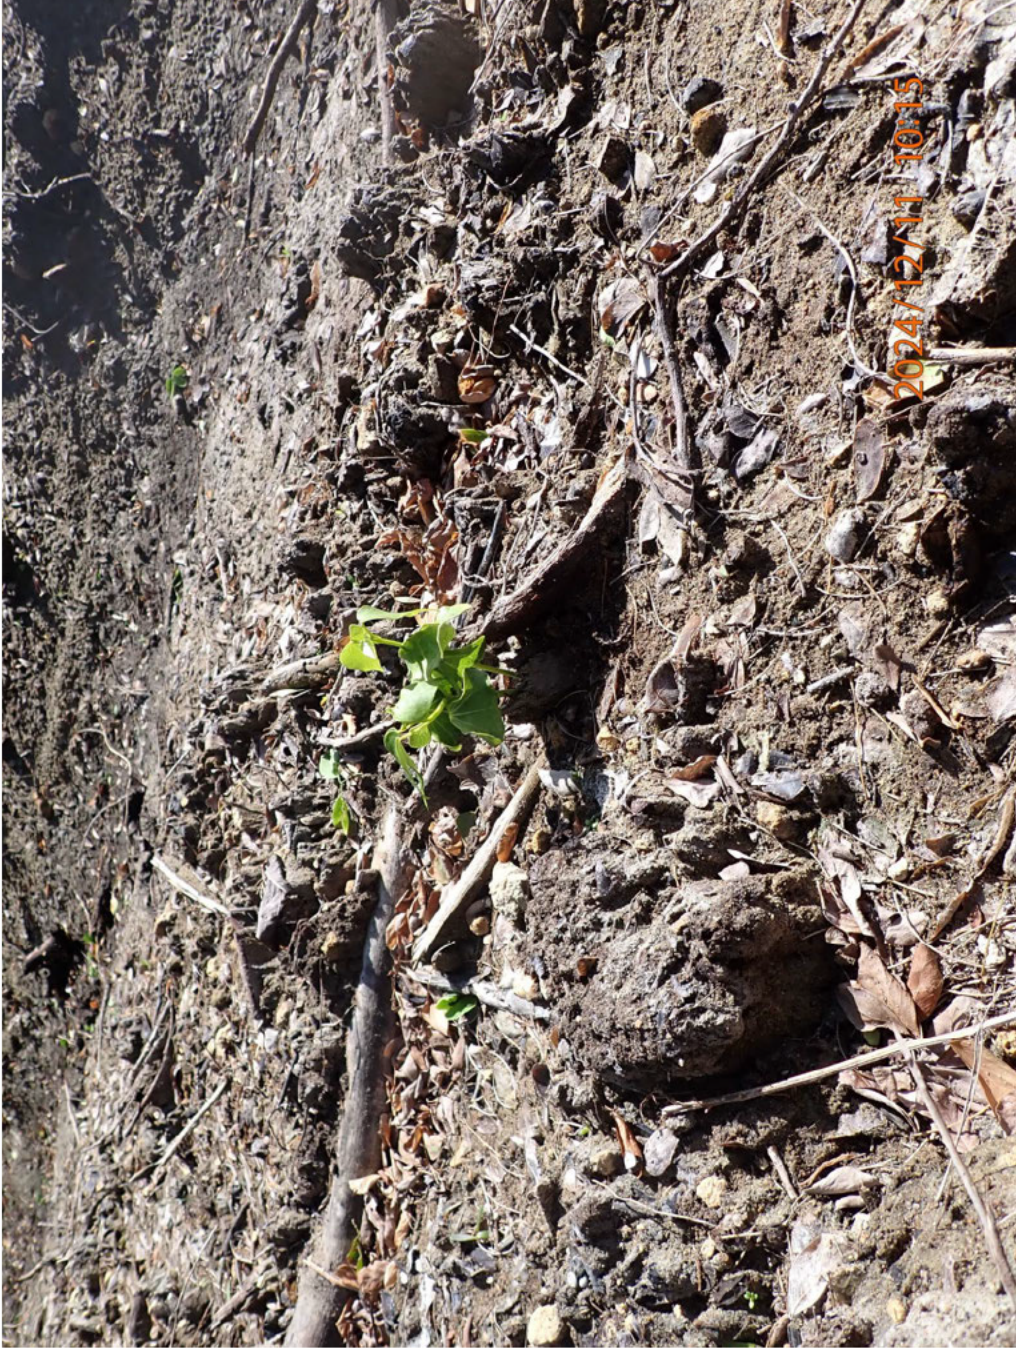
Date: 12/11/2024
Time: 10:14 AM
Photographer: JLF
Photo ID: PC-1111166

Thespesia populnea (FAC)
sprouting on site.

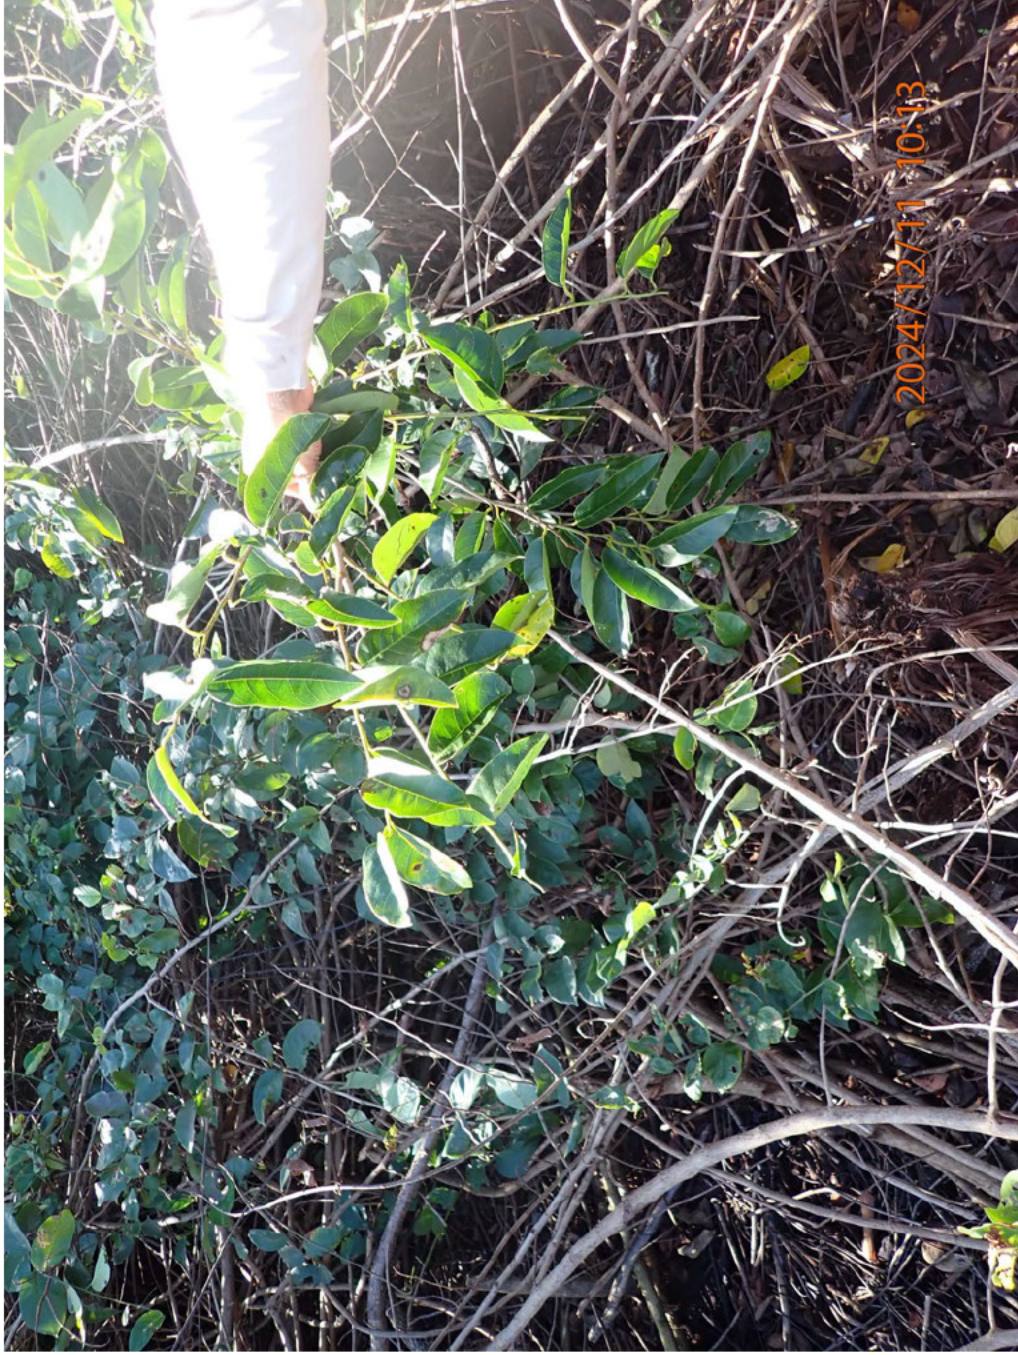
Date: 12/11/2024
Time: 10:13 AM
Photographer: JLF
Photo ID: PC-111162

One of three photos (PC-111162
-PC-111164) of *Annona glabra*
(obligate) at the periphery of
impacted area.

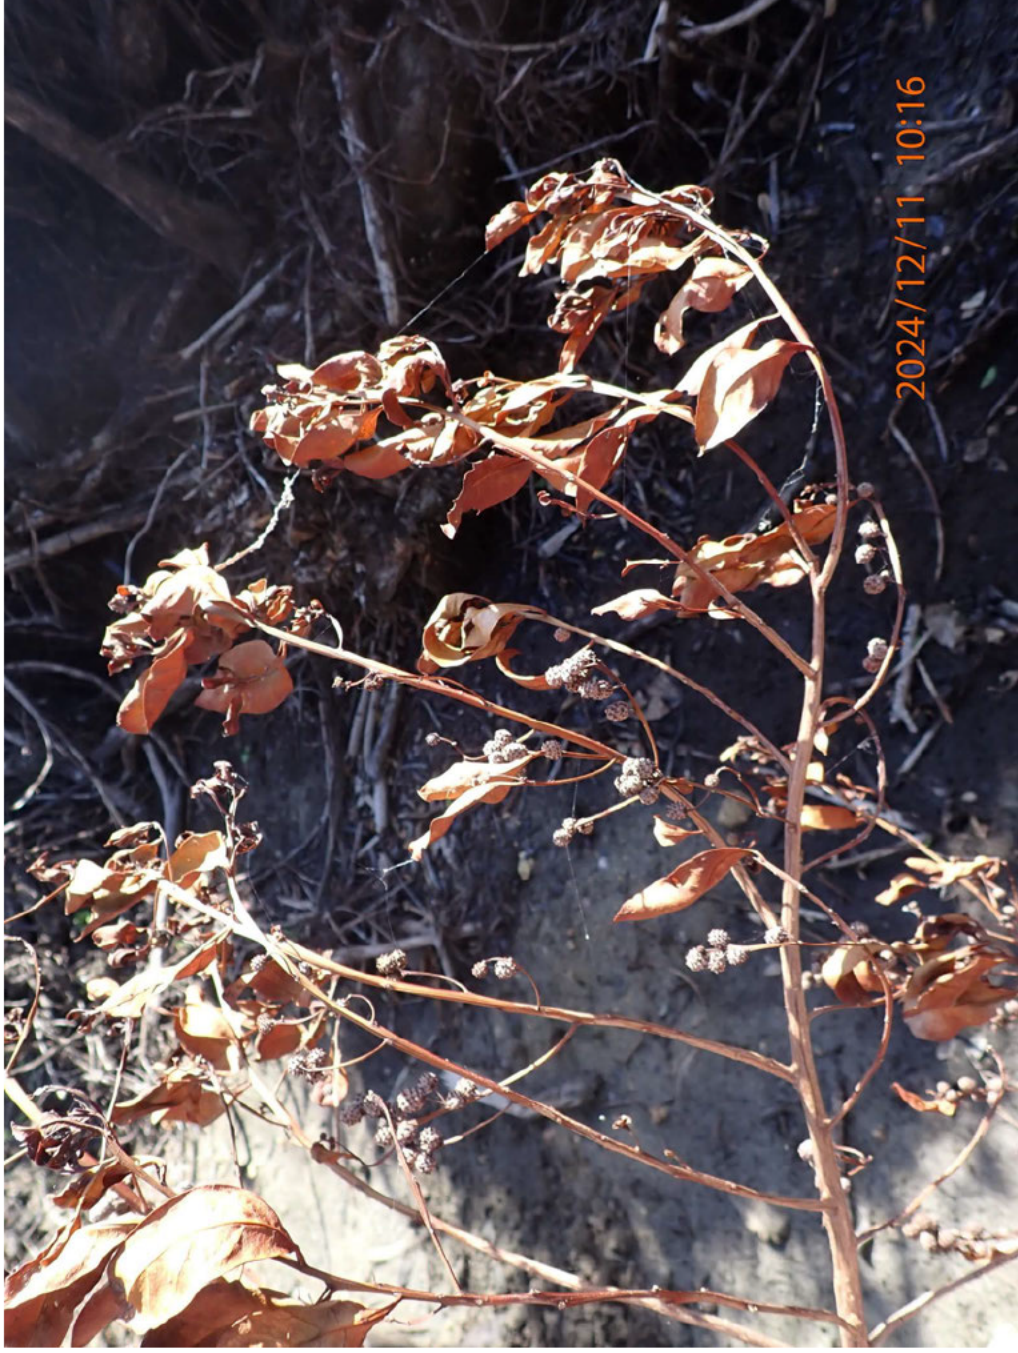
Date: 12/11/2024
Time: 10:16 AM
Photographer: JLF
Photo ID: PC-1111167

Dried branch of *Conocarpus erectus* (obligate) with fruits retrieved from the fill pile.

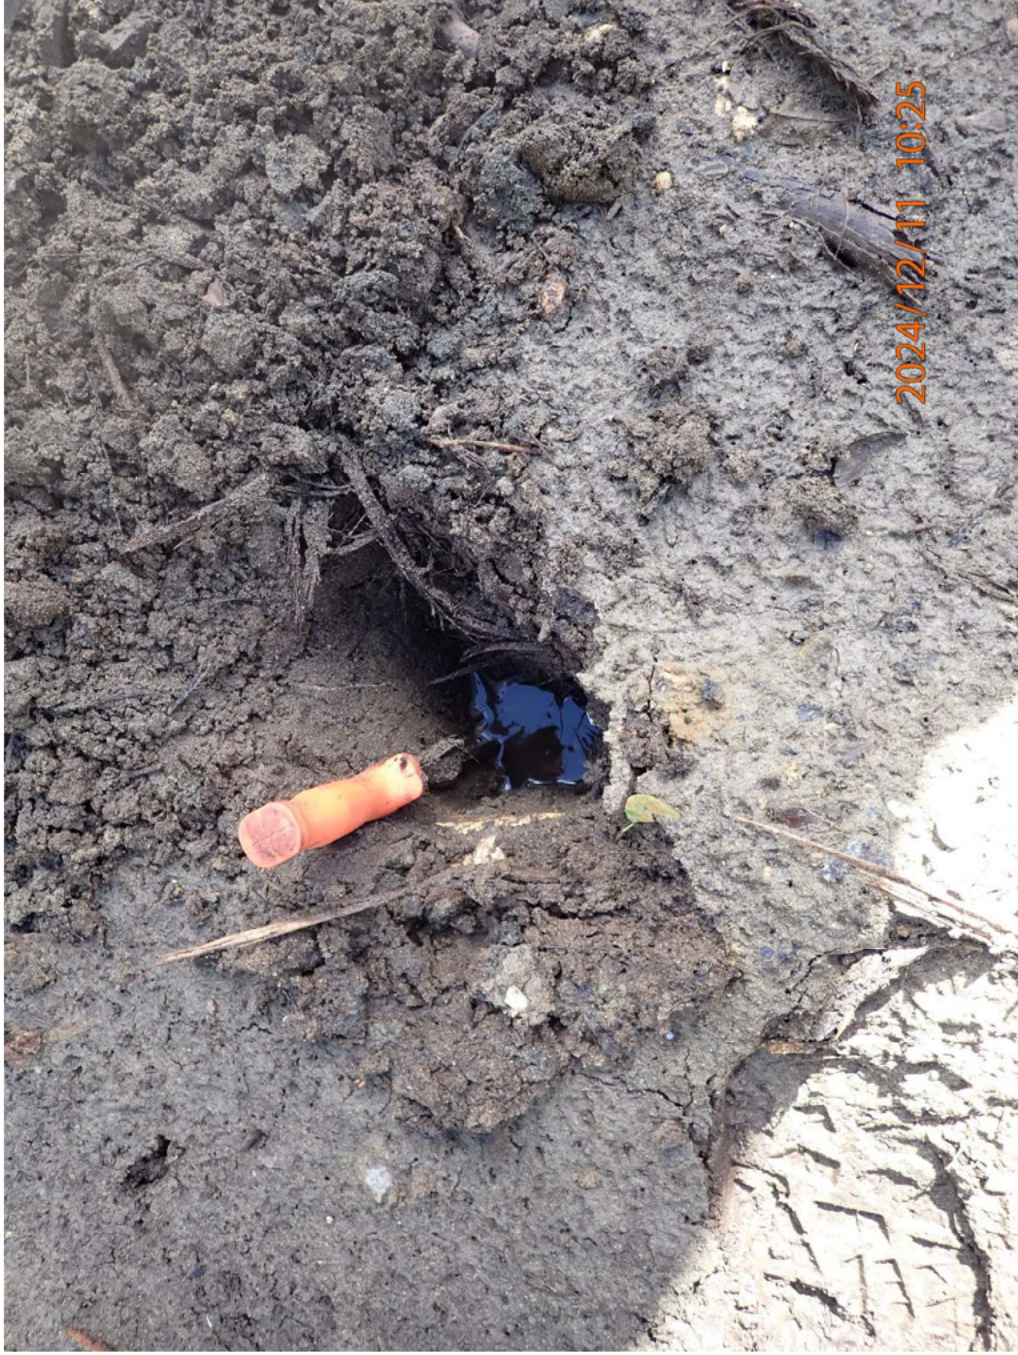
Date: 12/11/2024
Time: 10:25 AM
Photographer: JLF
Photo ID: PC-1111168

Soil pit (18.5093975, -
67.0207770)

Profile Description: (Describe to the depth needed to document the indicator or confirm the absence of indicators.)								
Depth (inches)	Matrix		Redox Features				Texture	Remarks
	Color (moist)	%	Color (moist)	%	Type ¹	Loc ²		
0-20	10YR 3/2	100					Mucky Sand

Remarks:
Very faint Hydrogen sulfide odor.
