Clean Water Act Section 404: Site Visit/Case Development

Site Name	Super Café Randy Inc. (hereinafter as "The Site")	Start Date	December 11, 2024
		End Date	December 11, 2024
Inspection Purpose	Initial site visit		
Opening Conference			
<input checked="" type="checkbox"/> Presentation of Inspector Credentials			
Name and Title (Use N/A if owner/operator not available to join the inspection)			
Mr. Julio C. Cajigas and José A. Bechara - Representatives for NWF, LLC (Owners of the adjacent property)			
<input checked="" type="checkbox"/> Opening Conference			
Name of person authorizing access if applicable			
Randy González Alonso from Super Café Randy Inc. (Owner of segregated parcel where work took place). Access was provided via phone call on December 9, 2024.			
Mr. Julio C. Cajigas - Representative for NWF, LLC (Owners of the adjacent property). Access was provided via phone call and confirmed via email on December 9, 2024.			
Notes from Opening Conference

Super Café Randy Inc.
 Tax parcel number 003-077-067-63-001 (segregated parcel)
 in the Municipality of Isabela, Puerto Rico

Tax Parcel No. 003-077-067-63-001 at
Francisco Camacho St., Guayabos Ward, Isabela,
Puerto Rico

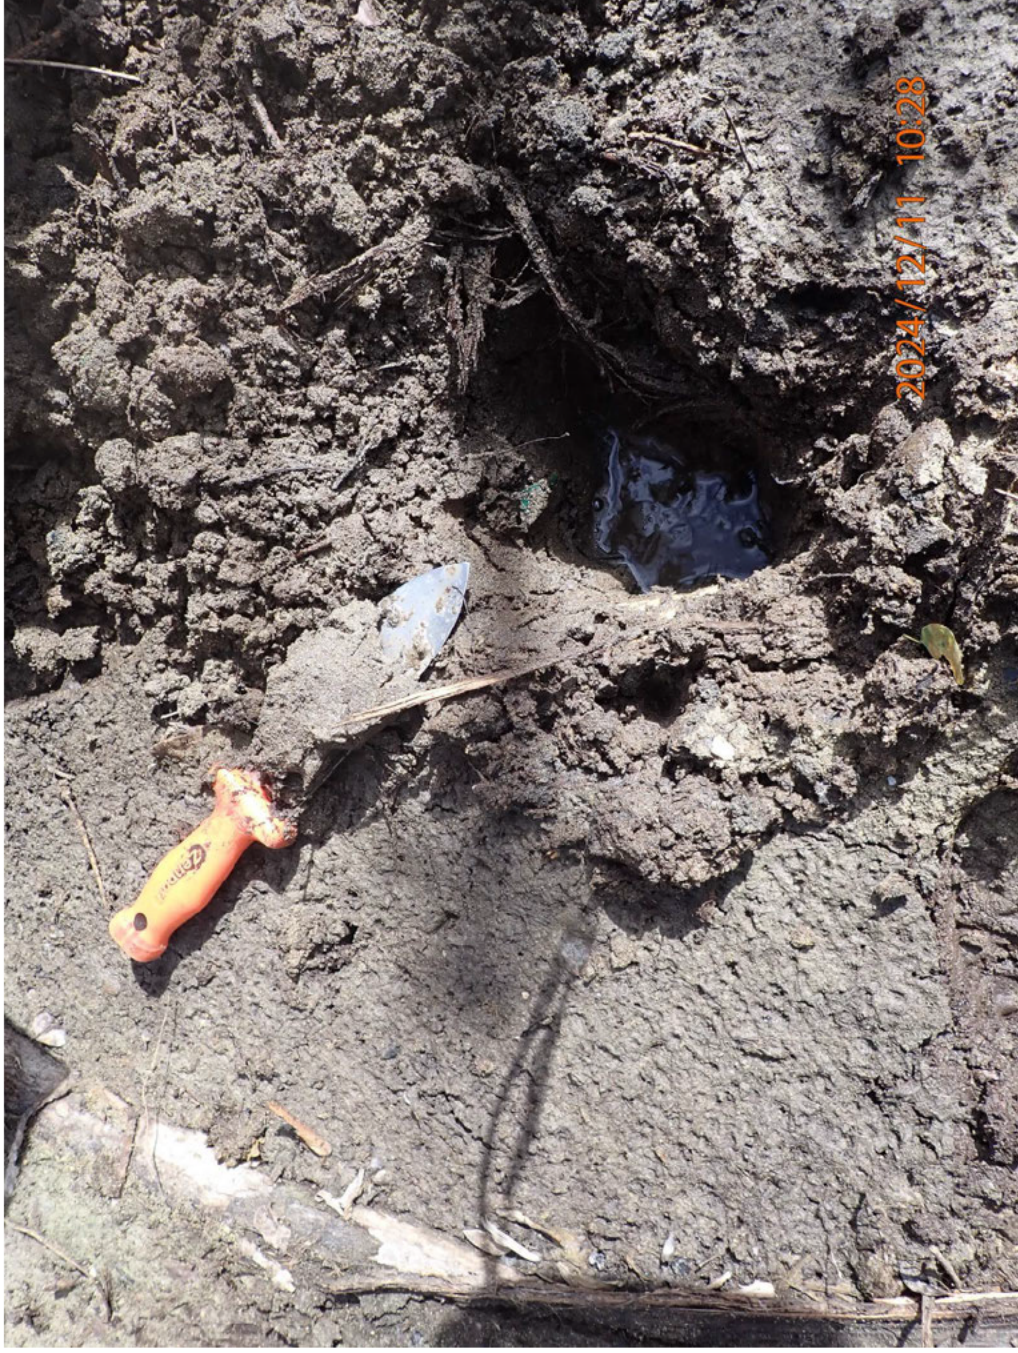
Description:
Soil pit (18.5093975, -
67.0207770)

Profile Description: (Describe to the depth needed to document the indicator or confirm the absence of indicators.)								
Depth (inches)	Matrix		Redox Features				Texture	Remarks
	Color (moist)	%	Color (moist)	%	Type ¹	Loc ²		
0-20	10YR 3/2	100					Mucky Sand
