INSPECTION REPORT

| <b>Type of Inspection</b> | Industrial Stormwater Inspection (ISI) | | |
| <b>Permittee Name</b> | Mondelēz Global LLC | | |
| <b>Facility or Site Name</b> | Mondelēz Toledo Ohio Facility (fka Kraft Foods Global Inc) | | |

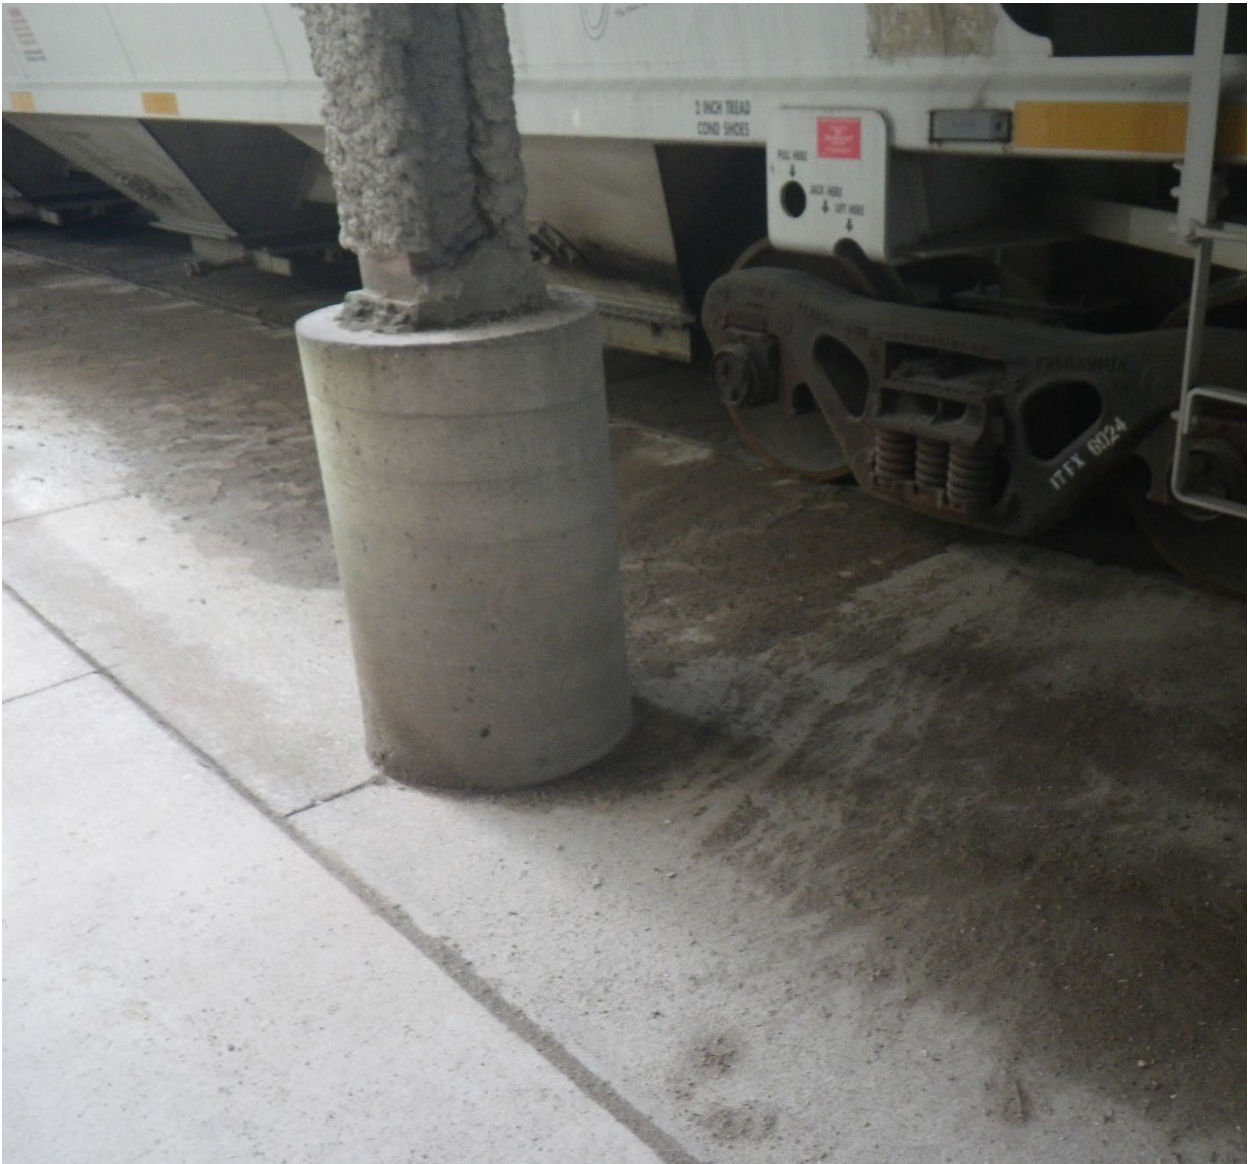
| Location: Hopper cars area | | |
|---|---|---|
| US EPA observed sediment on the ground near the hopper cars and storm drain inlets. | | |

- US EPA documented areas of concern around Track 2 and the contractor roll off area. Sediment was observed on the concrete by the hopper cars and around the storm drain inlets. Dust was also observed on the ground by the dust collector. See photograph 24.

| Photograph 1. Ground alongside of the track where the hopper cars were. Sediment can be seen on the ground by the hopper car. This is the track 2 loading area. | | | IMGP0001.JPG |

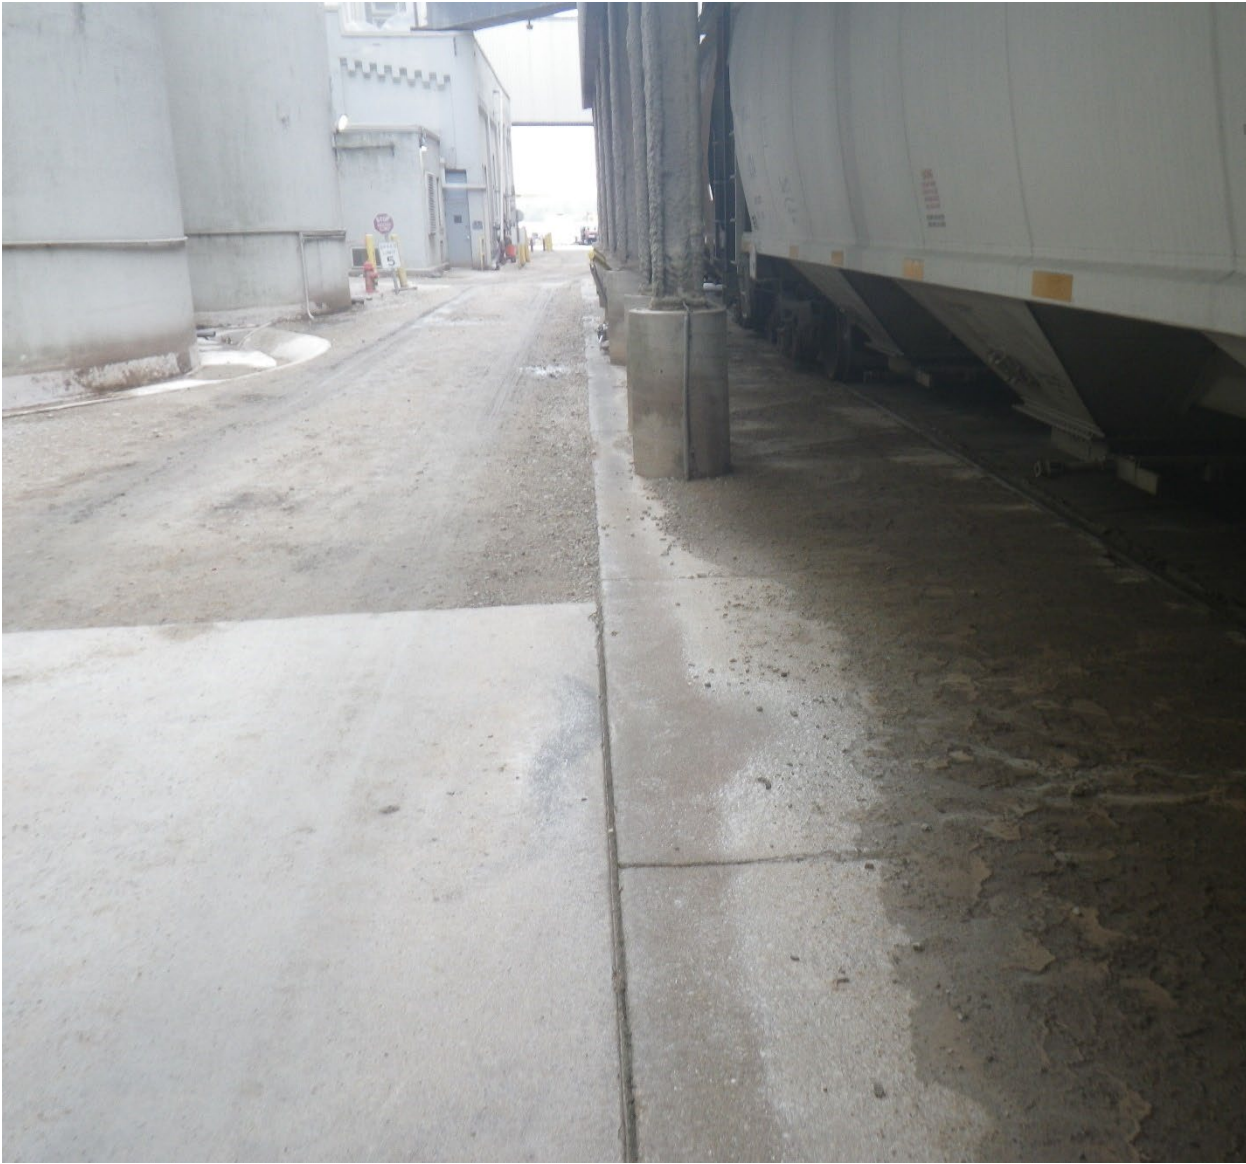
| Photograph 2. Ground alongside of the track where the hopper cars were. Sediment can be seen on the ground by the hopper car. | | | IMGP0002.JPG |

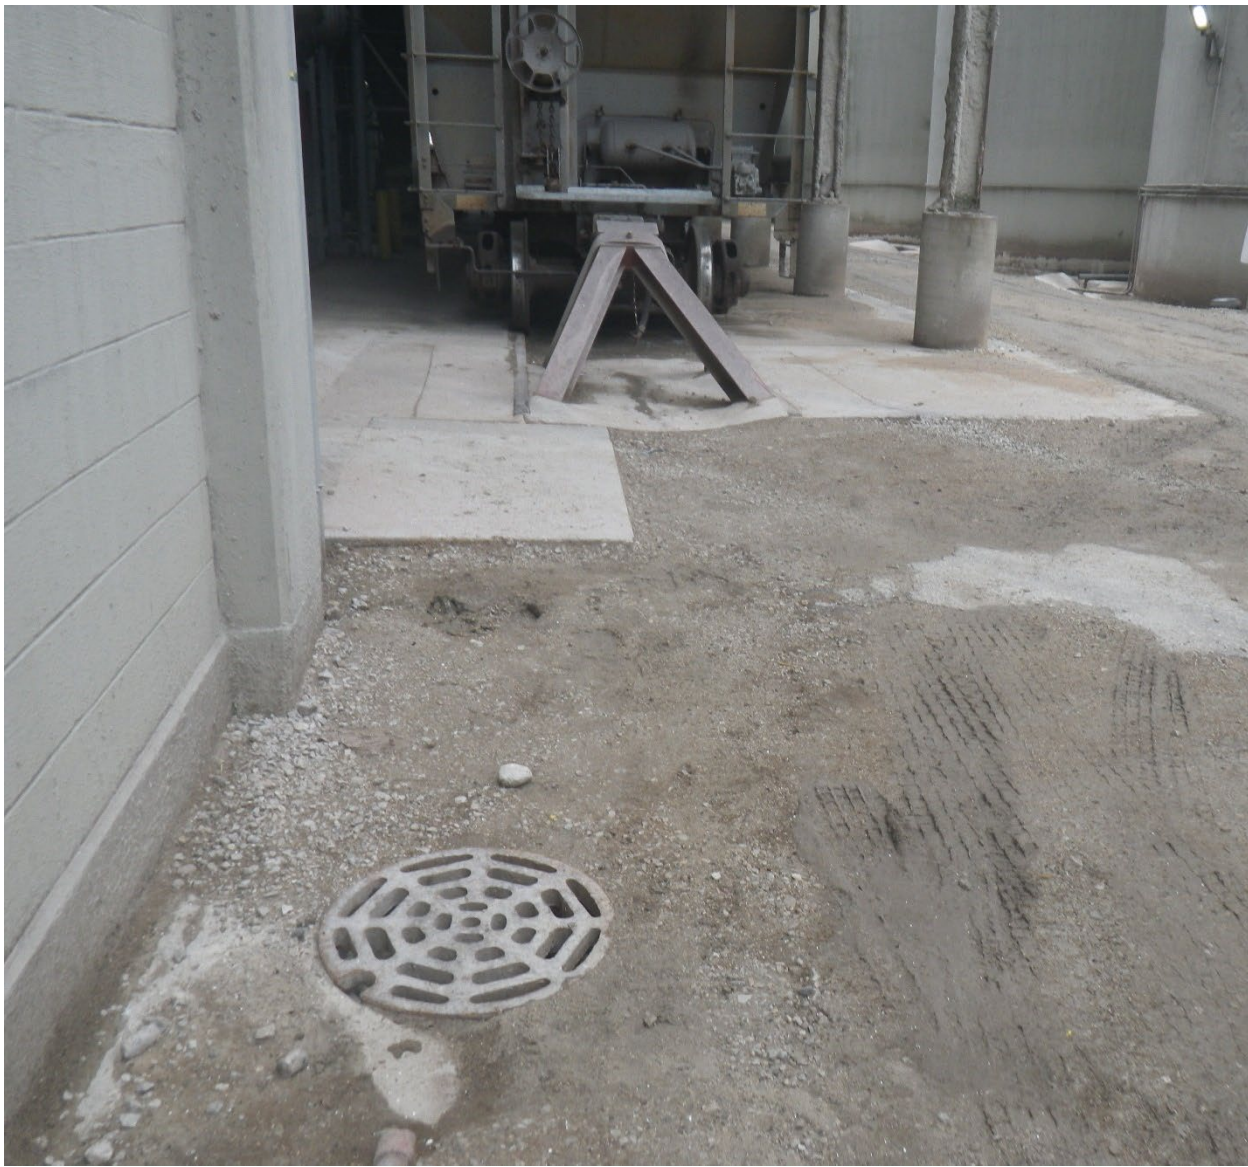
- US EPA documented exposed areas not stabilized. See photographs 3, 6, 8, 17, 19, 25, and 29.
- Section 2.1.2.11 Waste, Garbage and Floatable Debris: “You shall ensure that waste, garbage, and floatable debris are not discharged to receiving waters by keeping exposed areas free of such materials or by intercepting them before they are discharged.”

| Photo 3. View of outfall near hopper cars shown in photographs 1 and 2. This unstabilized area drains to outfall 001. | | | IMGP0003.JPG |

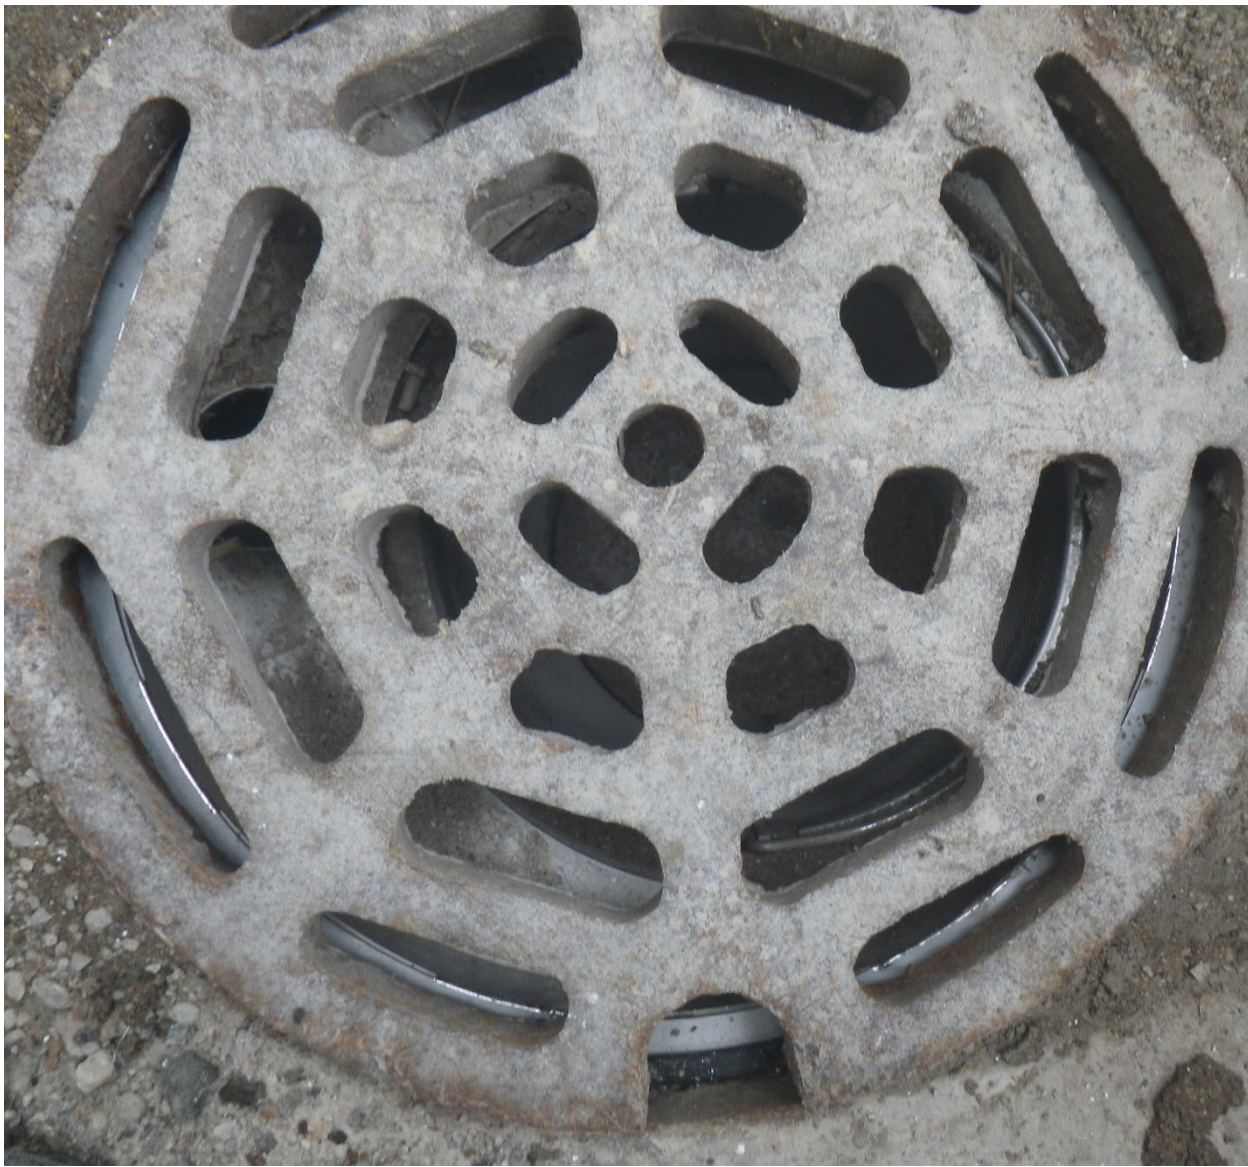
| Photograph 4. Closeup of inlet shown in photograph 3. | | | IMGP0004.JPG |

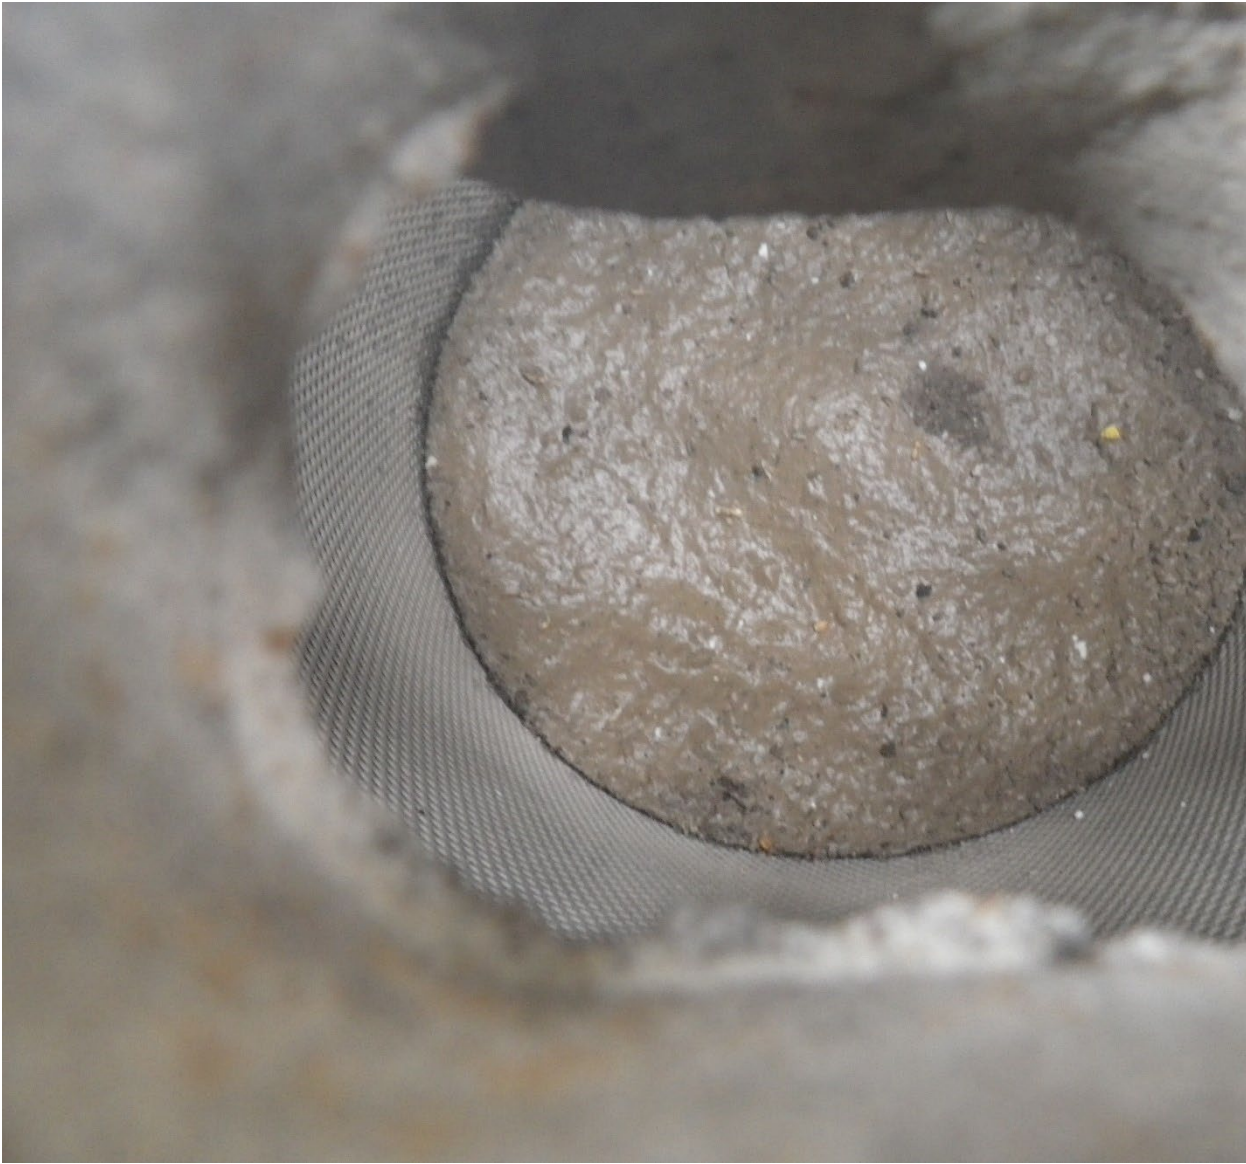
| Photo 5. View through hole of manhole lid shown in photograph 4. Sediment can be seen at the bottom of the inlet protection. | | | IMGP0005.JPG |

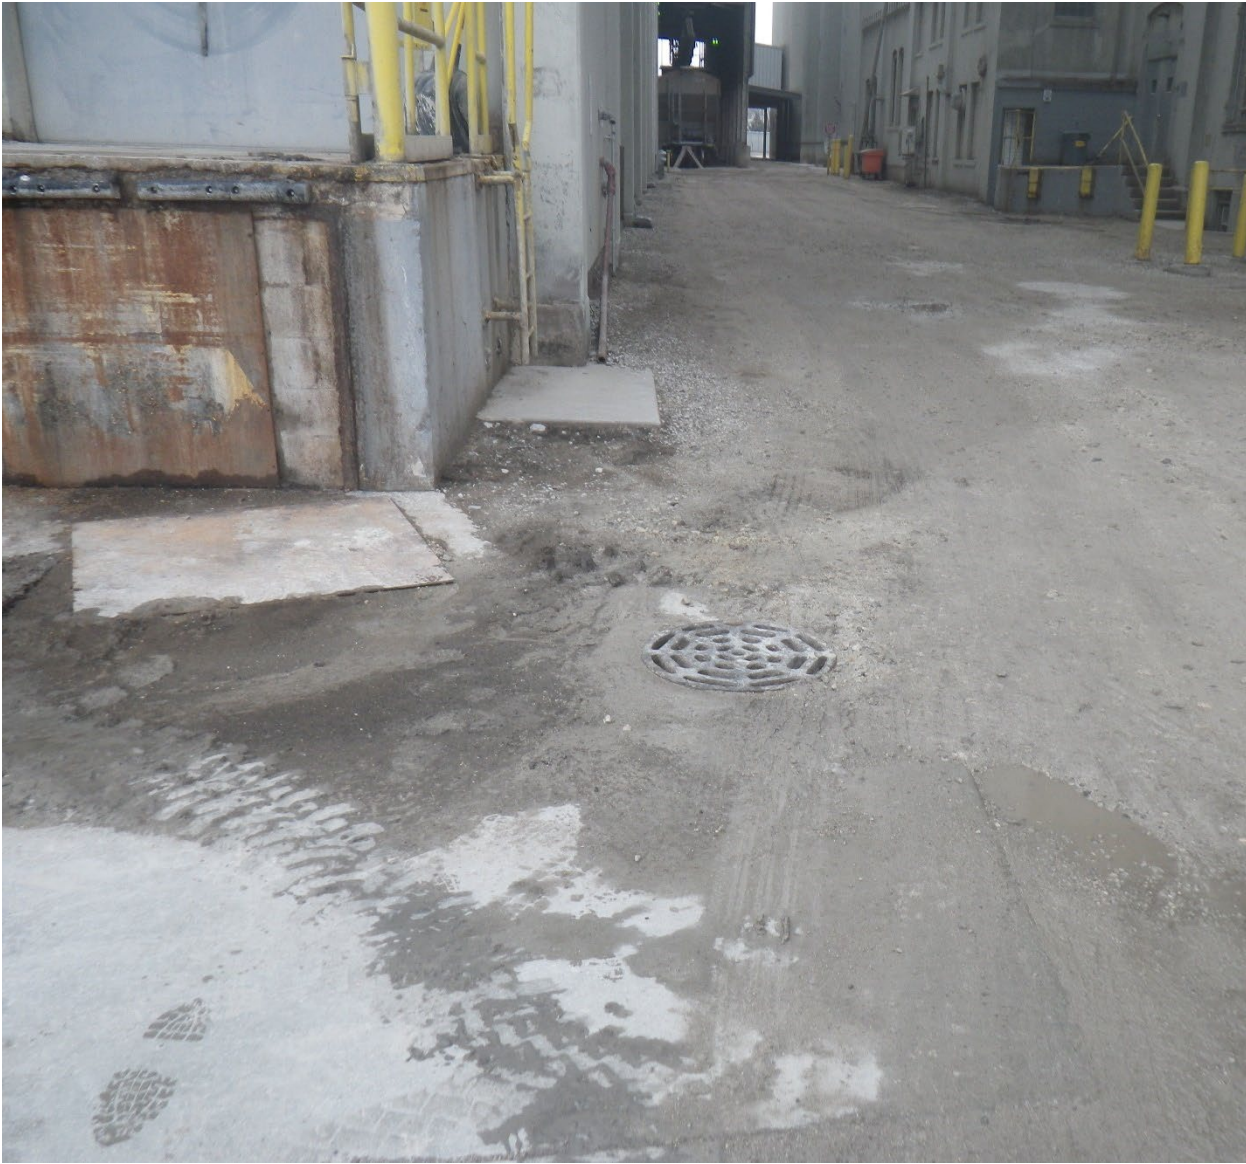
| Photograph 6. Second mahole leading to outfall 001 | | | IMGP0006.JPG |

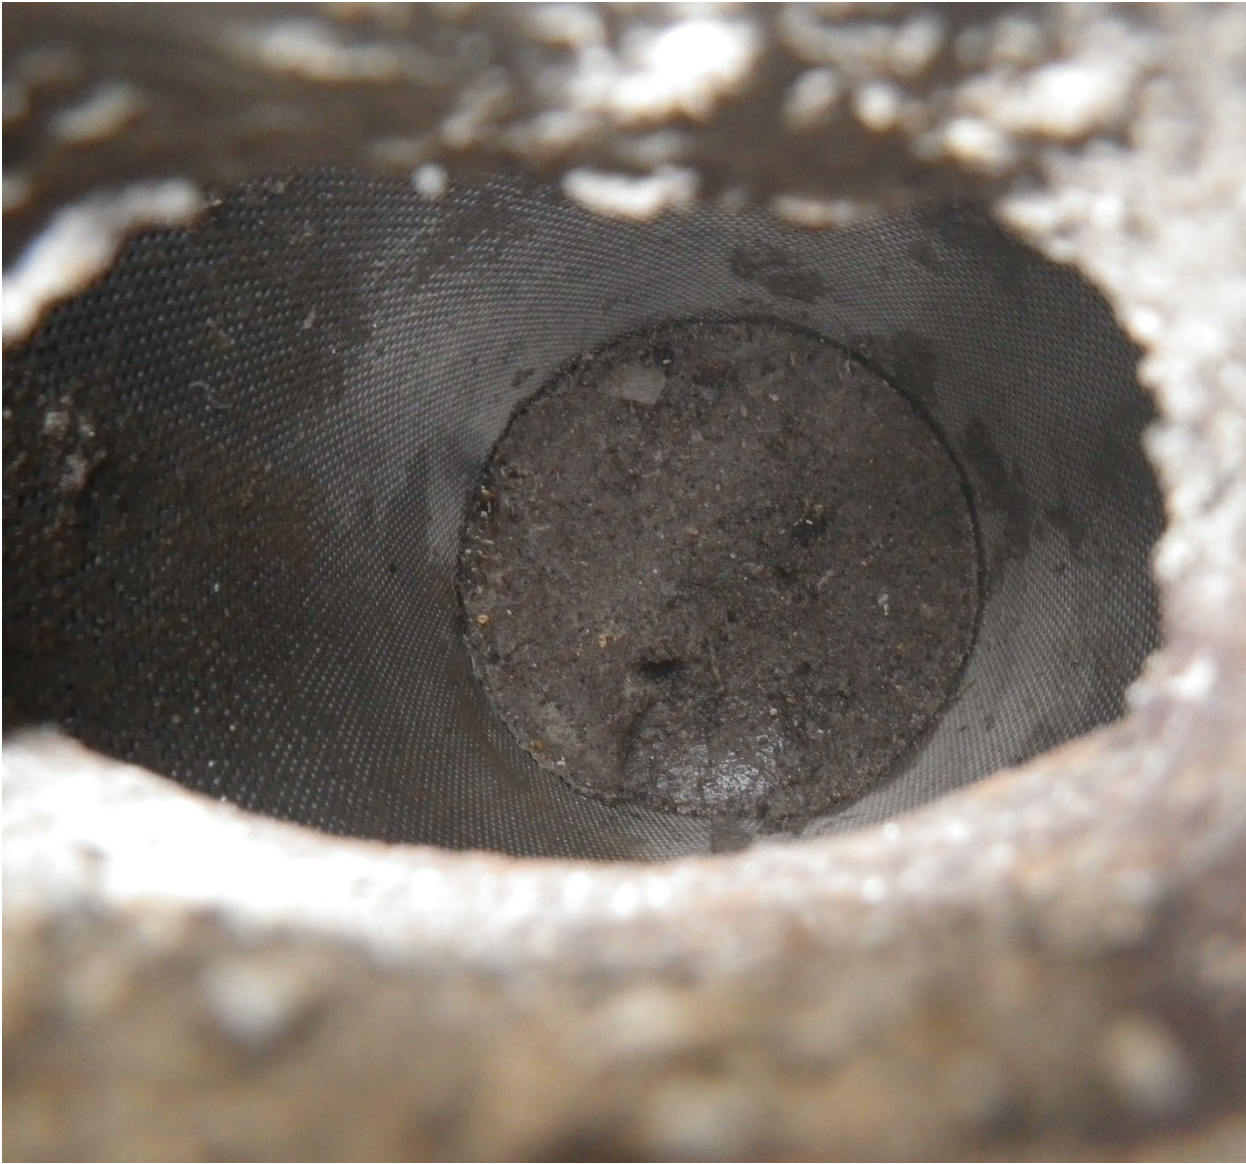
| Photograph 7. Close view through hole in manhole lid shown in photograph 6. Sediment can be seen in the inlet protection. | | | IMGP0007.JPG |

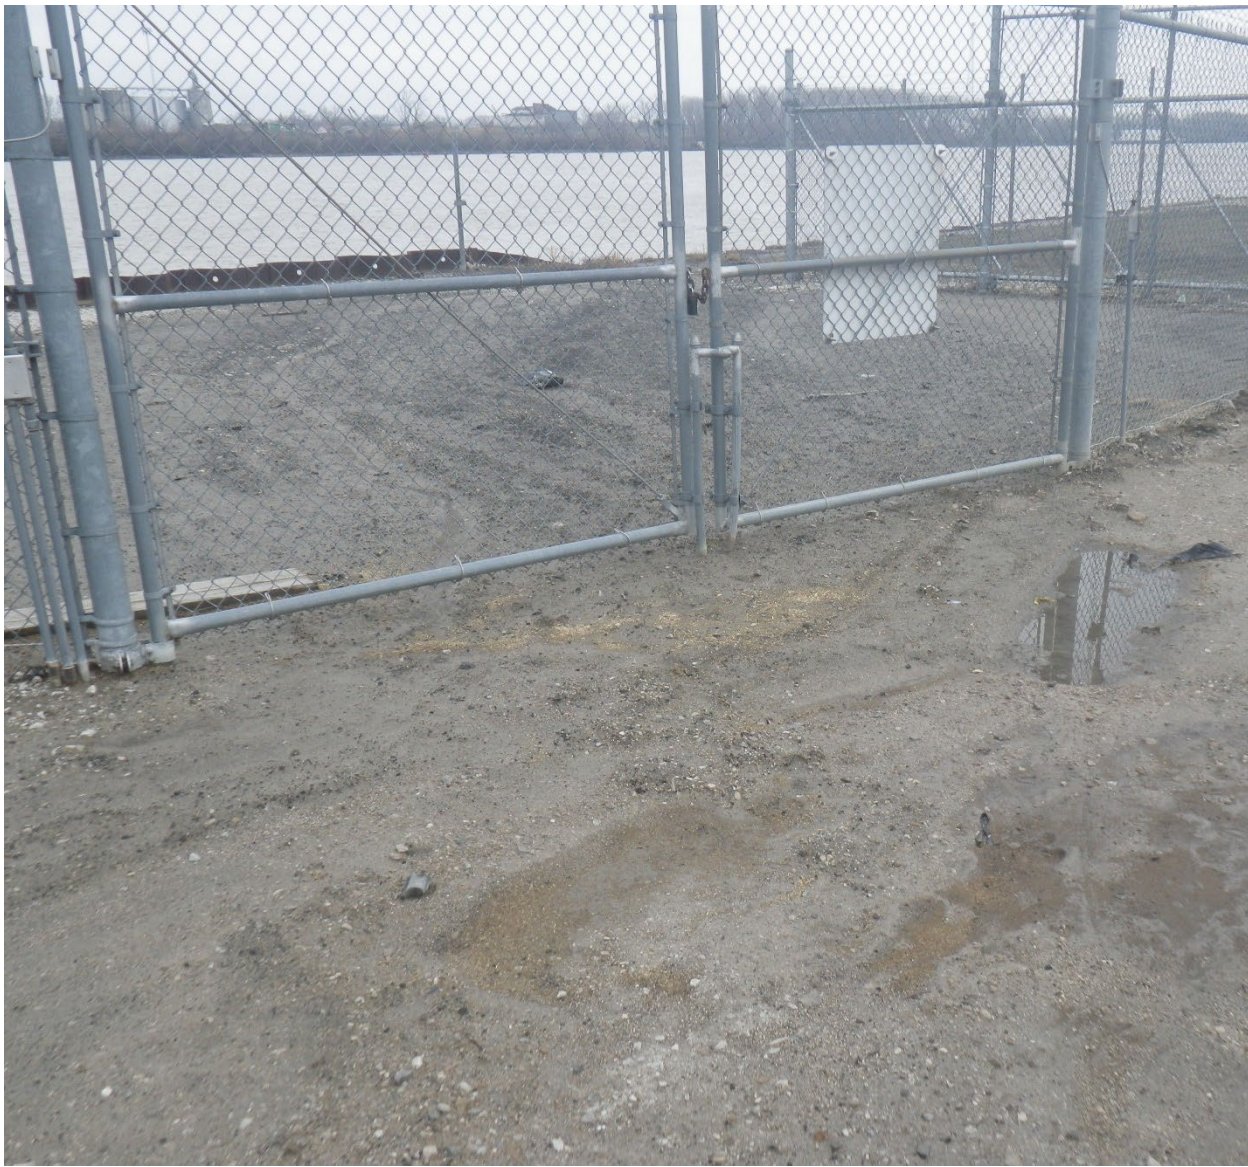
| Location: Dock area | | |
|---|---|---|
| US EPA observed accumulations of grain along the dock area near holes in the sheet piling, and erosion along the fence line. | | |

- US EPA documented grain accumulation near the waterway /dock area. US EPA also documented sediment build up to the top of the sheet pilings in some areas. See photographs 8-10, 25, and 27-31.

| Photograph 8. Fence with dock area beyond fence | | | IMGP0008.JPG |

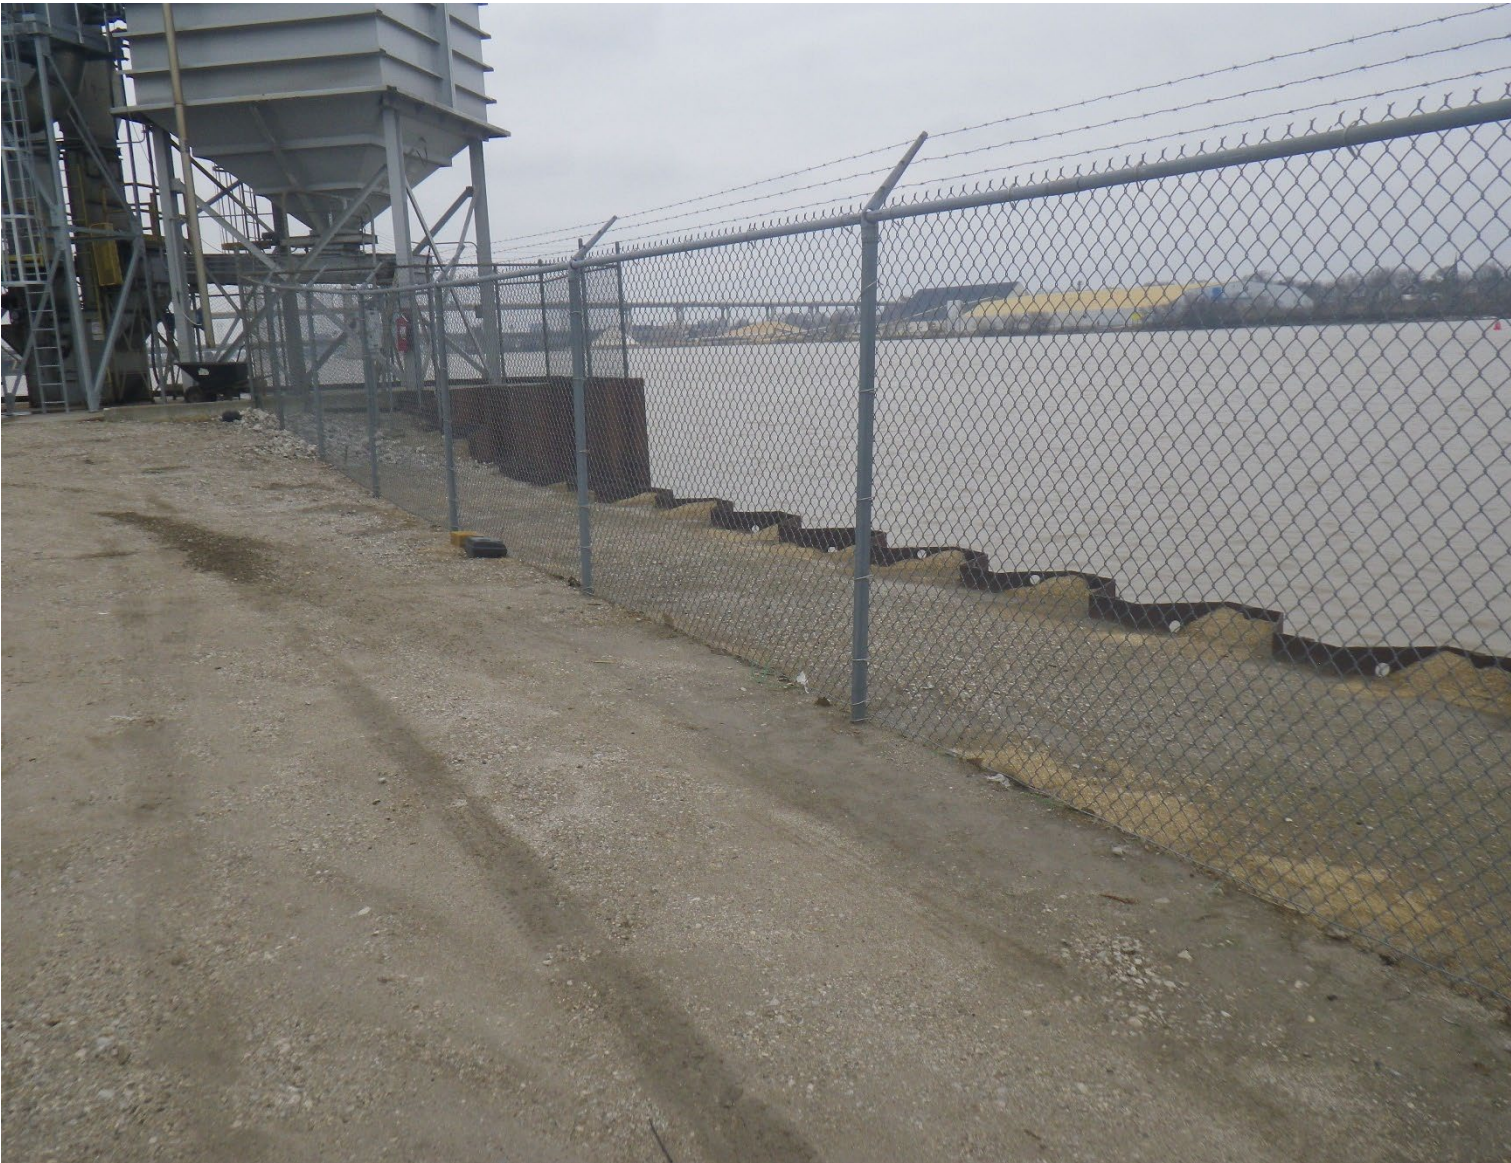
| Photograph 9. Fence dock area next to area shown in photograph 8. Grain can be seen accumulating at the edge of the dock against the sheet pilings. Holes can be seen in the sheet pilings. | | | IMGP009.JPG |

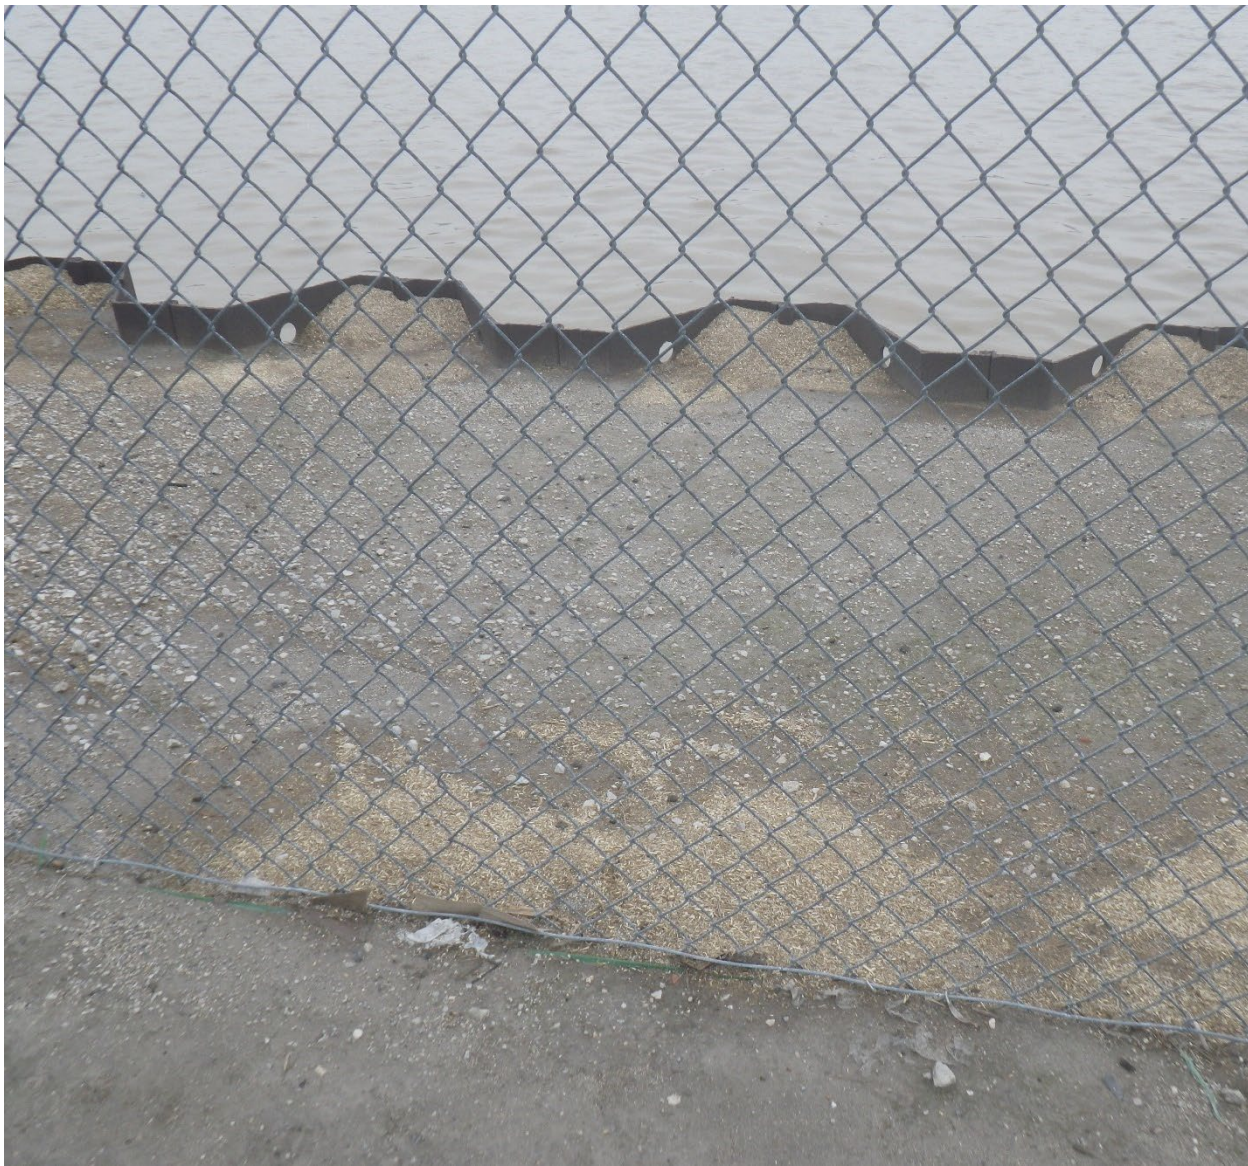
| Photograph 10. Closer view of dock area shown on the right side of photograph 9. Grain can be seen just on the other side of the fence. Grain has also accumulated along the sheet pilings at the edge of the water. Holes can be seen in the sheet pilings where the grain has accumulated. | | | IMG0010.JPG |

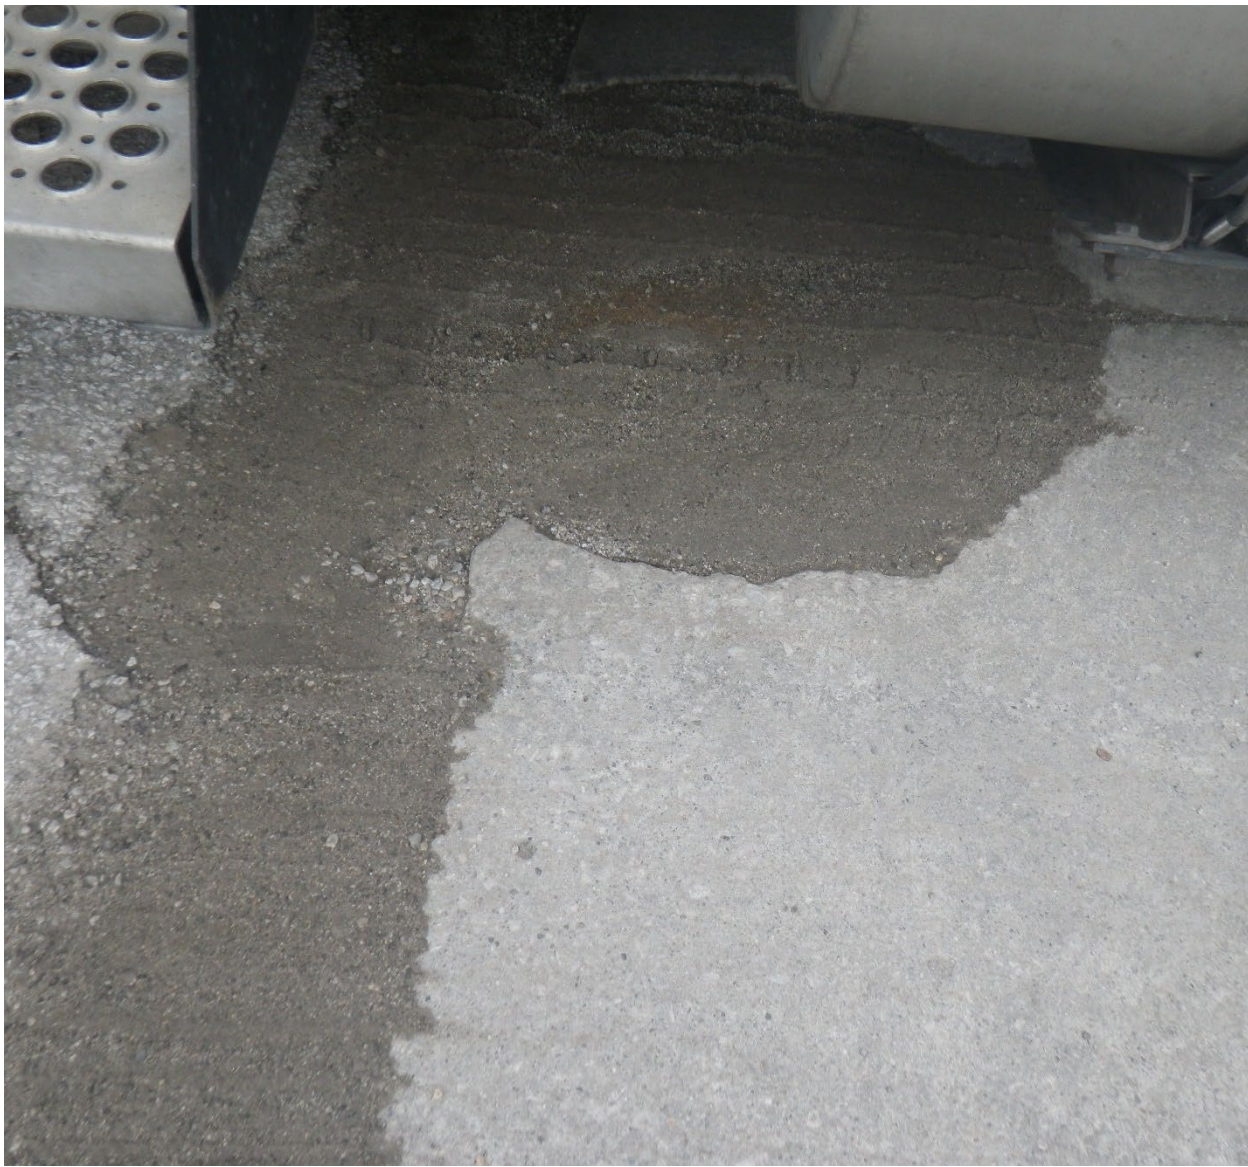
| Photograph 13. Pavement damp from liquid under truck close to dock area | | | IMGP0013.JPG |

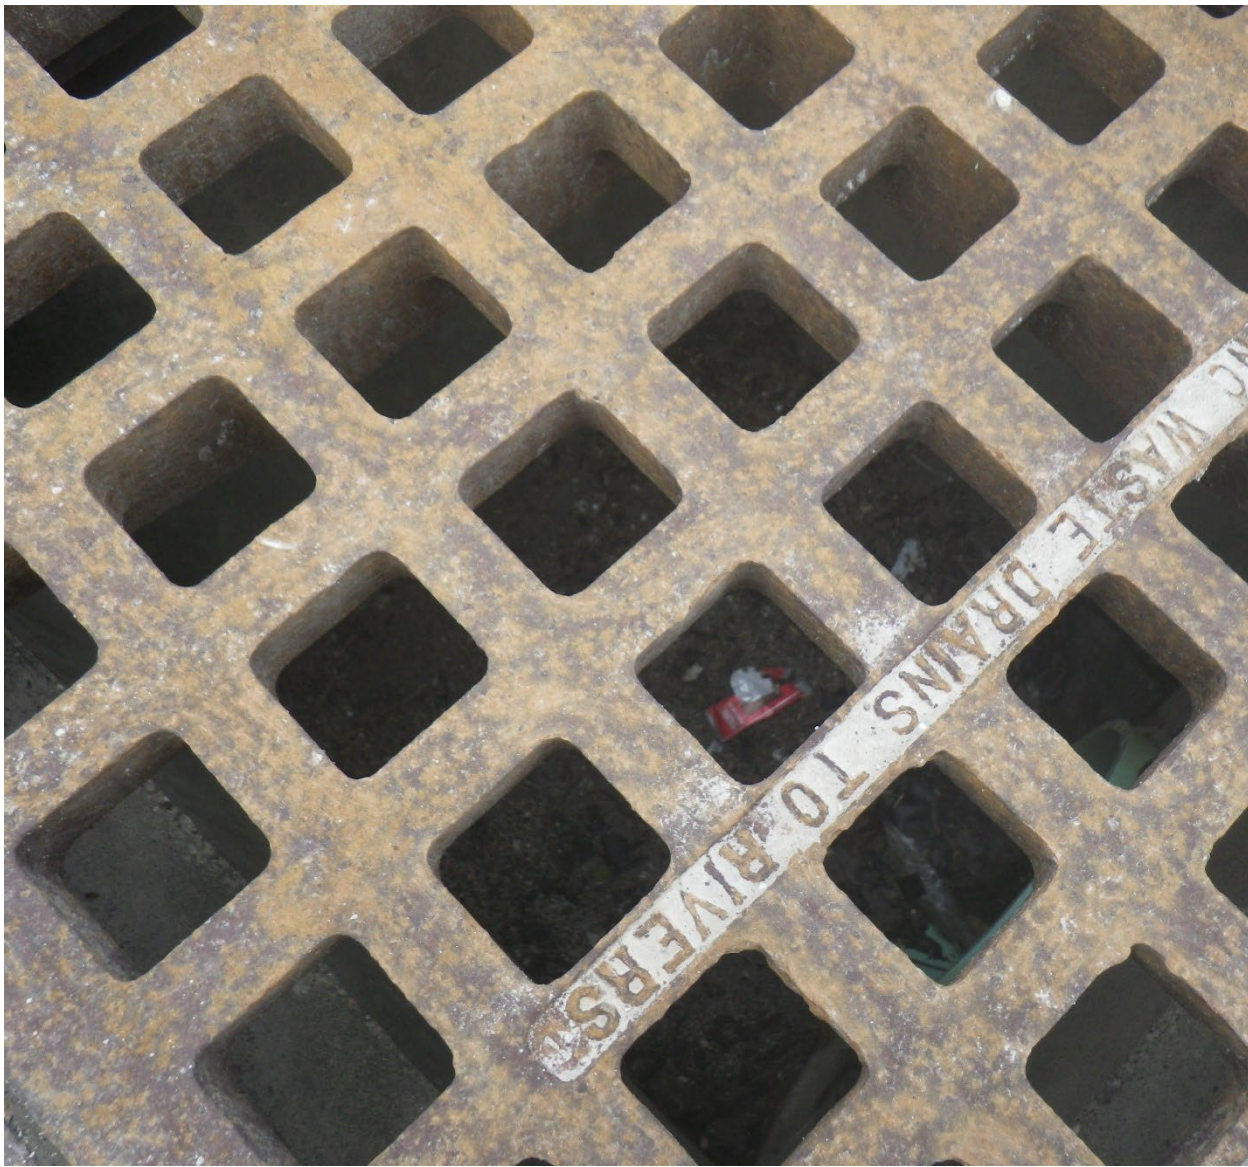
| Location: Dock area | | |
|---|---|---|
| US EPA observed sediment in storm drains and unstabilized ground. | | |

- US EPA documented areas of concern in the Outfall 5 area. The area has a patch of unstabilized black dirt near an outfall. See photograph 17. Inside a storm sewer shown in photographs 15 and 16, US EPA documented sediment and trash accumulation inside the structure leading into the storm water pipe.

- See photographs 15 and 16 for documentation of garbage and floatable material inside sewer.
- SWPPP: US EPA noted that the SWPP is not up to date. US EPA also documented holes in the sheet piling along the dock, which was not identified in the SWPPP.

| Photograph 15. Storm sewer inlet that leads to outfall3/4. | | | IMGP0015.JPG |

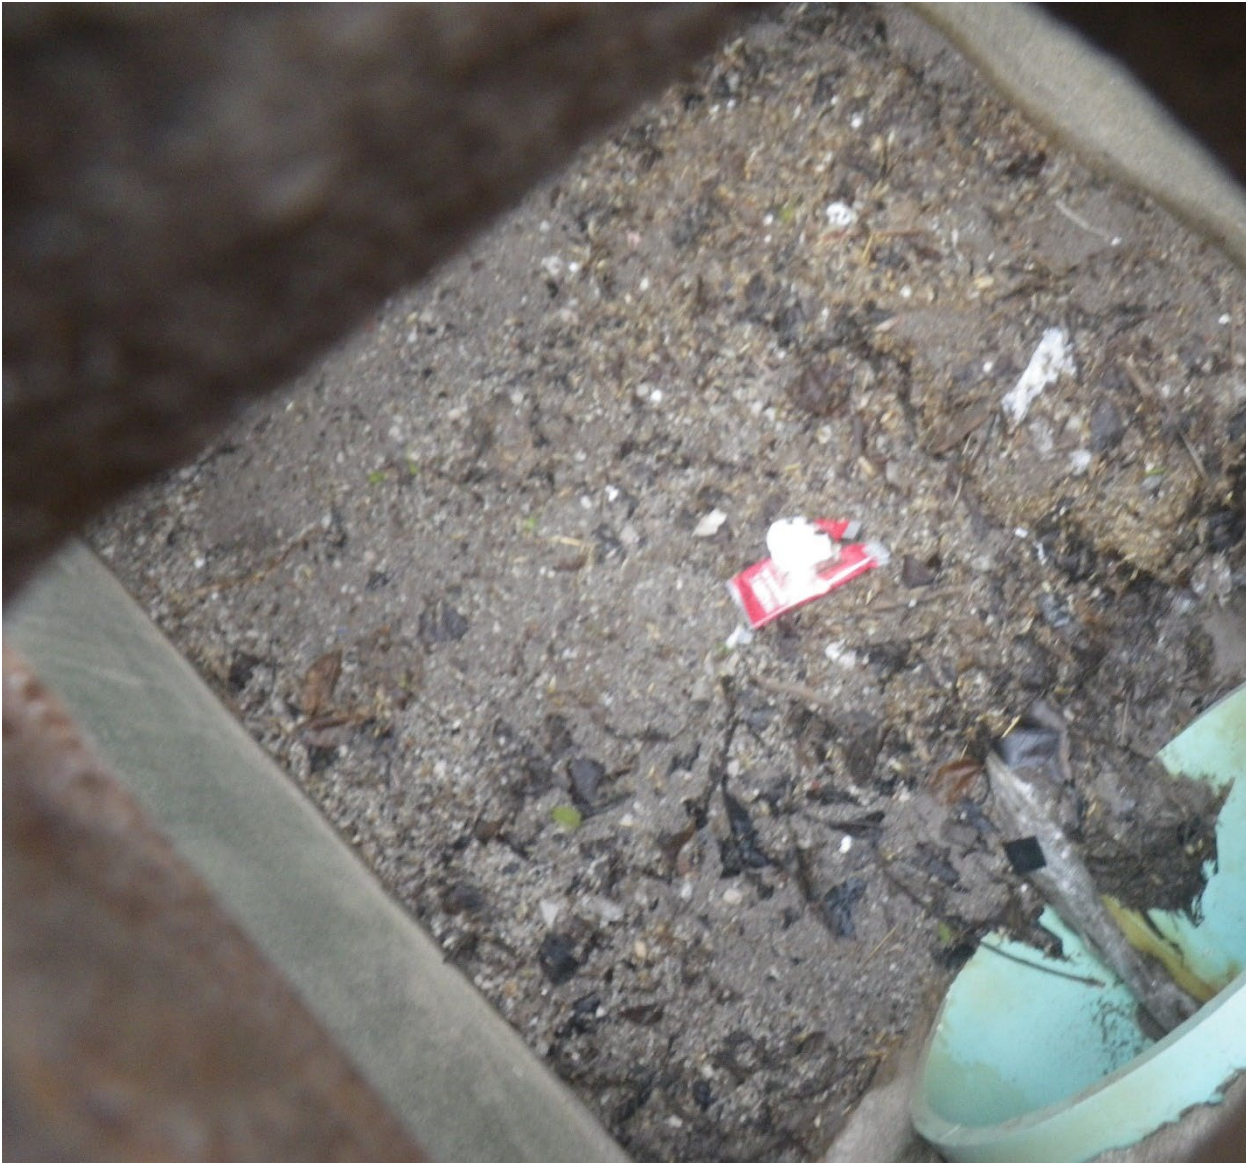
| Photograph 16. Close up through the grate shown in photograph 15. | | | IMGP0016.JPG |

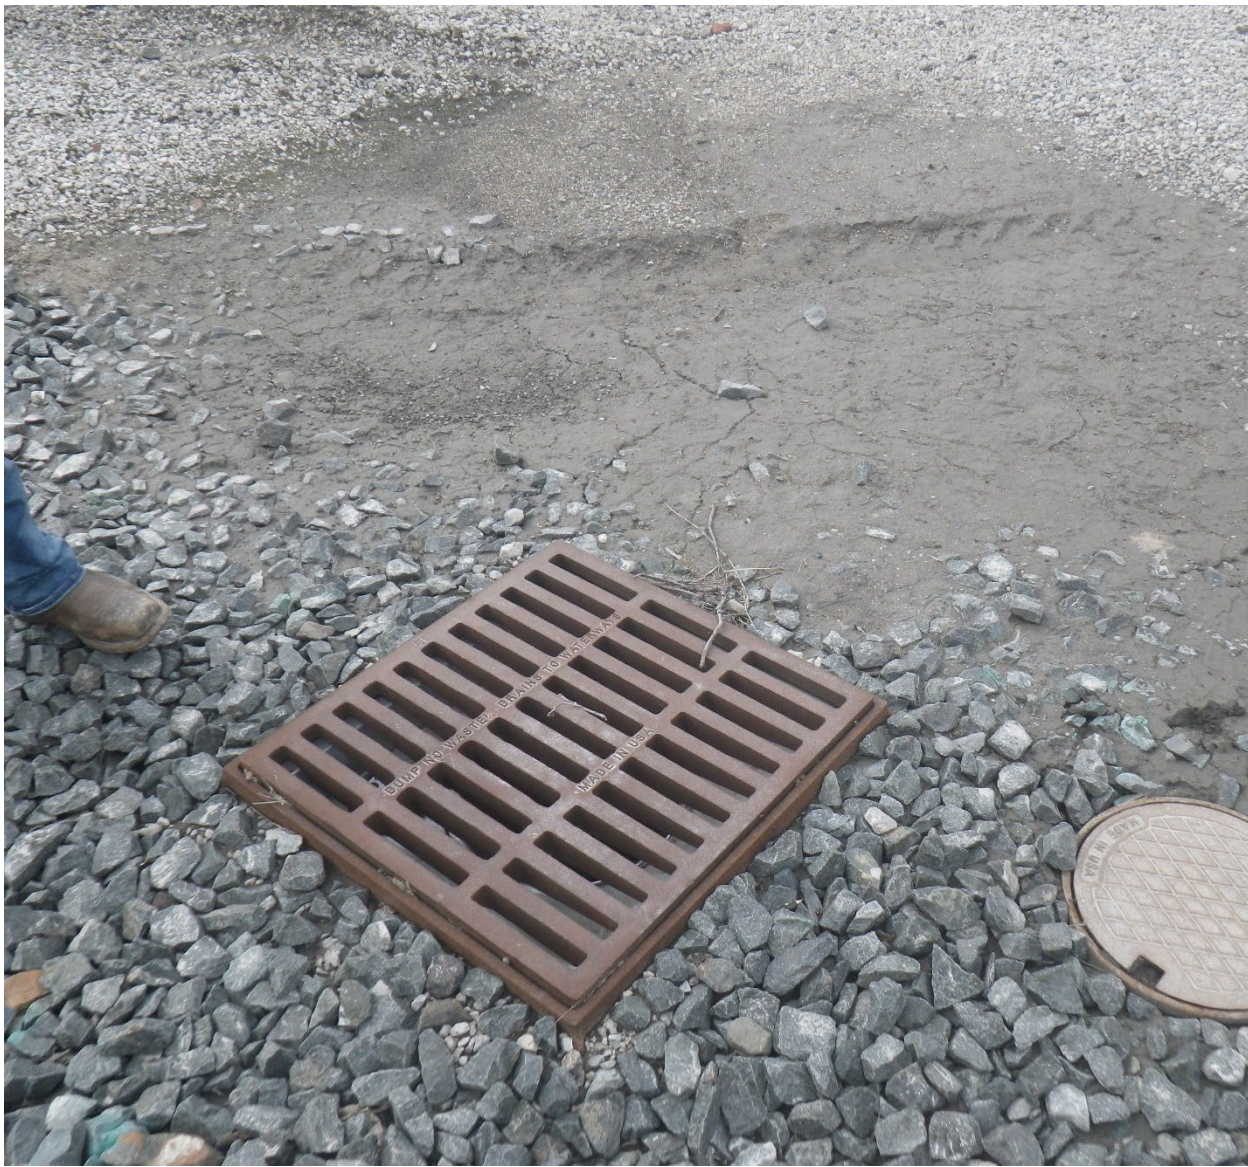
| Photograph 17. Storm water inlet leading to outfall 005. This is near the truck grain unloading area. | | | IMGP0017.JPG |
