INSPECTION REPORT

| <b>Type of Inspection</b> | Industrial Stormwater Inspection (ISI) | | |
| <b>Permittee Name</b> | Mondelēz Global LLC | | |
| <b>Facility or Site Name</b> | Mondelēz Toledo Ohio Facility (fka Kraft Foods Global Inc) | | |

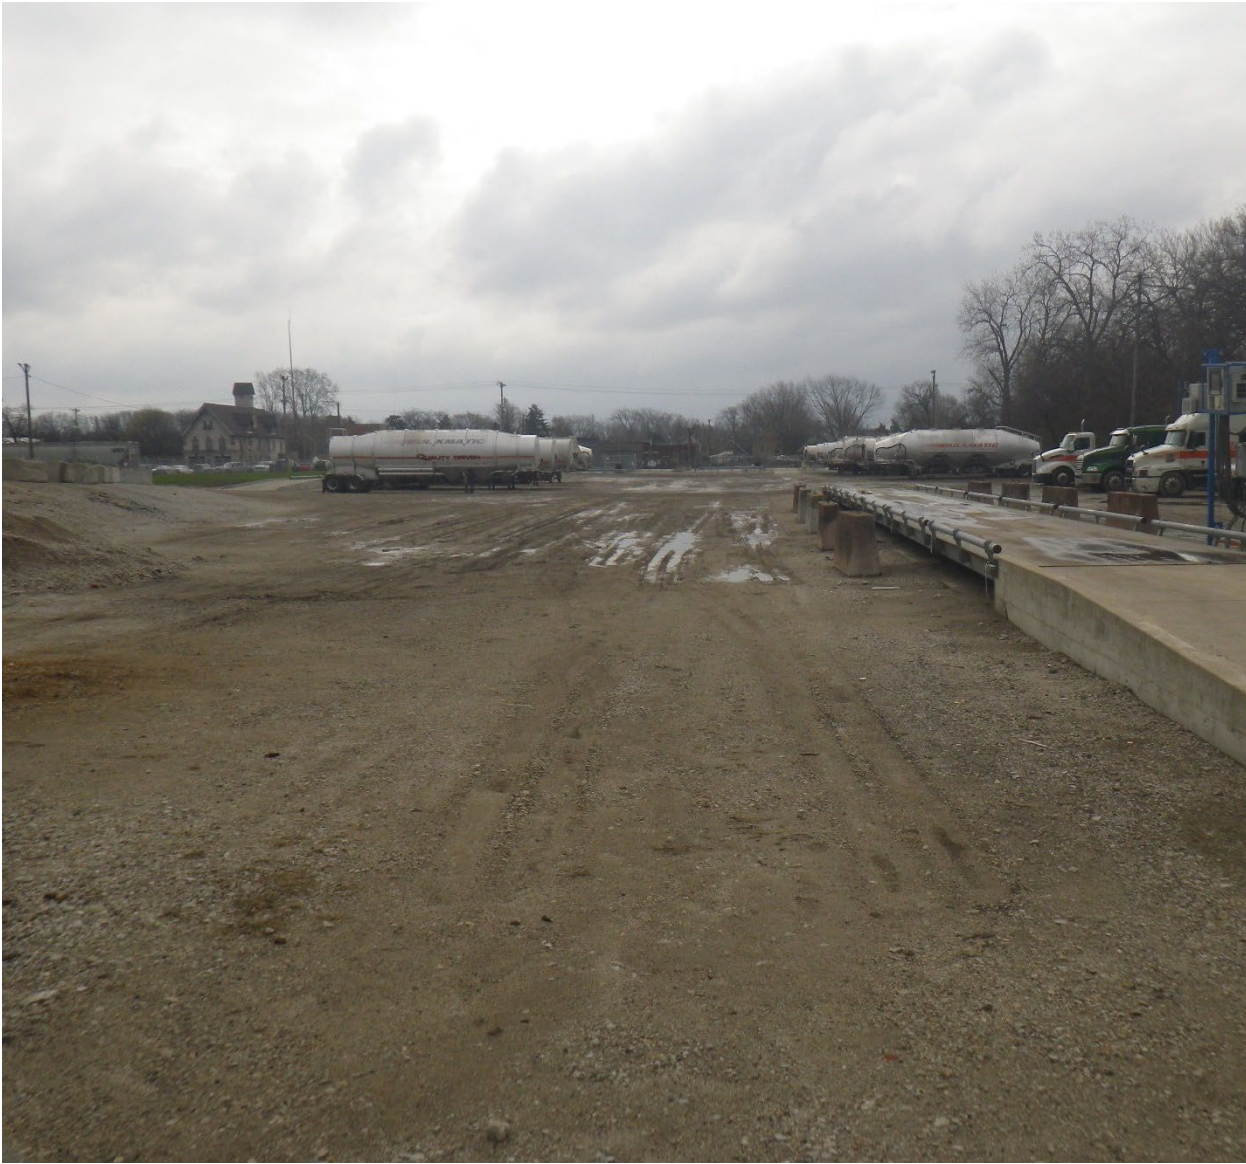
| Location: Dock area | | |
|---|---|---|
| US EPA observed sediment in storm drains and unstabilized ground. | | |

- US EPA documented exposed areas not stabilized. See photographs 3, 6, 8, 17, 19, 25, and 29.
- Section 2.1.2.11 Waste, Garbage and Floatable Debris: “You shall ensure that waste, garbage, and floatable debris are not discharged to receiving waters by keeping exposed areas free of such materials or by intercepting them before they are discharged.”

| Photograph 19. Area east of truck unloading area.<br>Unstabilized area east of the scales. | | | IMGP0019.JPG |

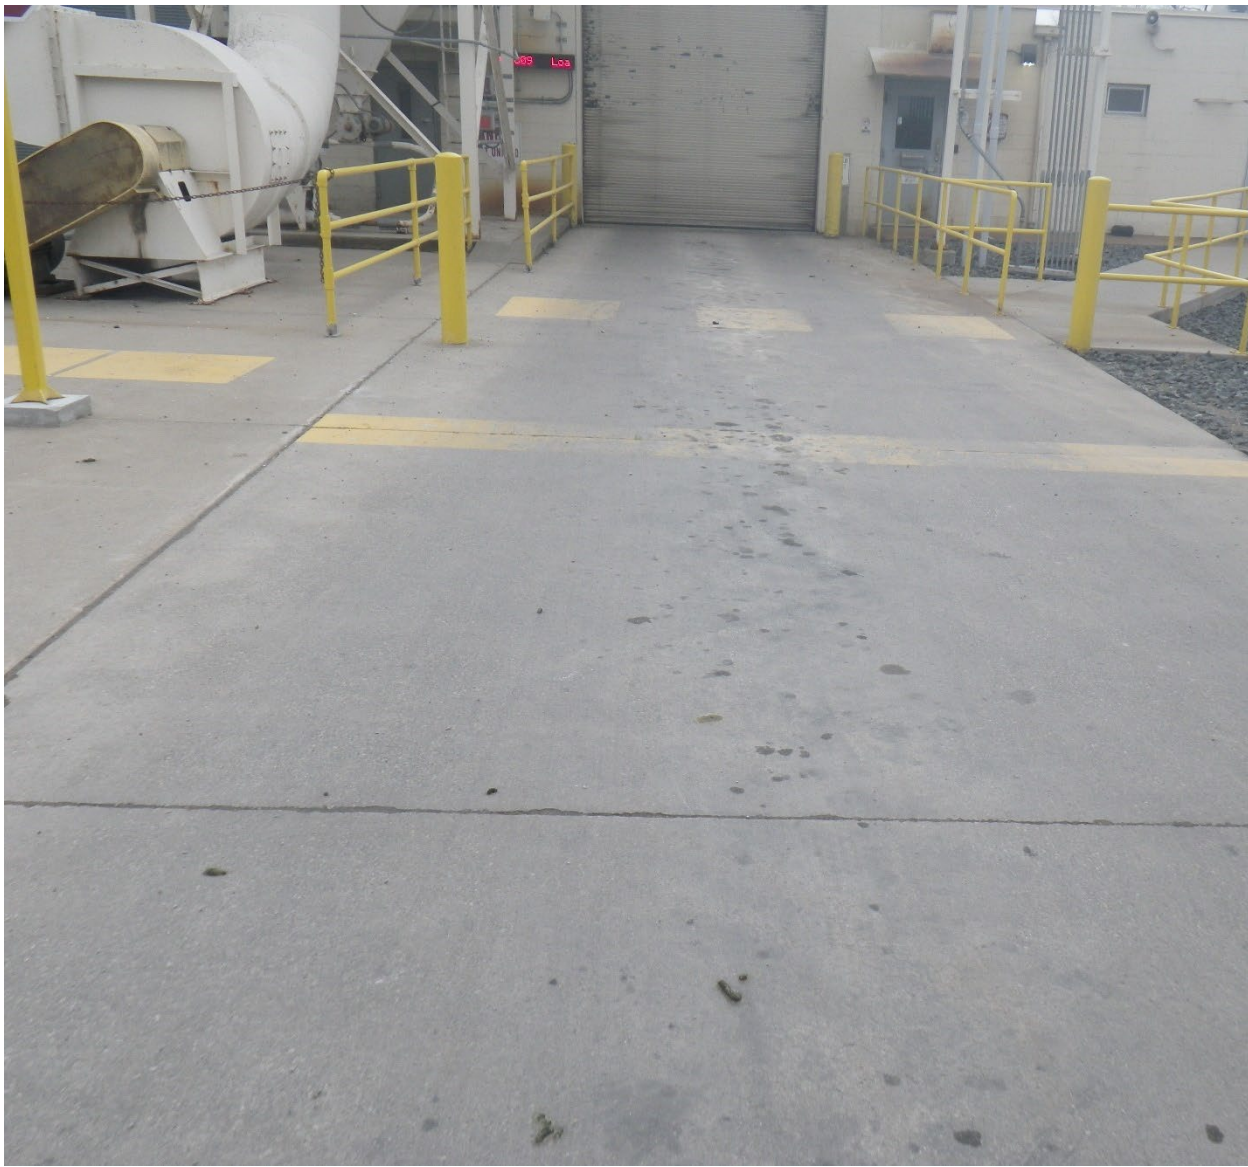
| Photograph 20. Hydraulic fluid staining on the pavement by the truck unloading area. | | | IMGP0020.JPG |

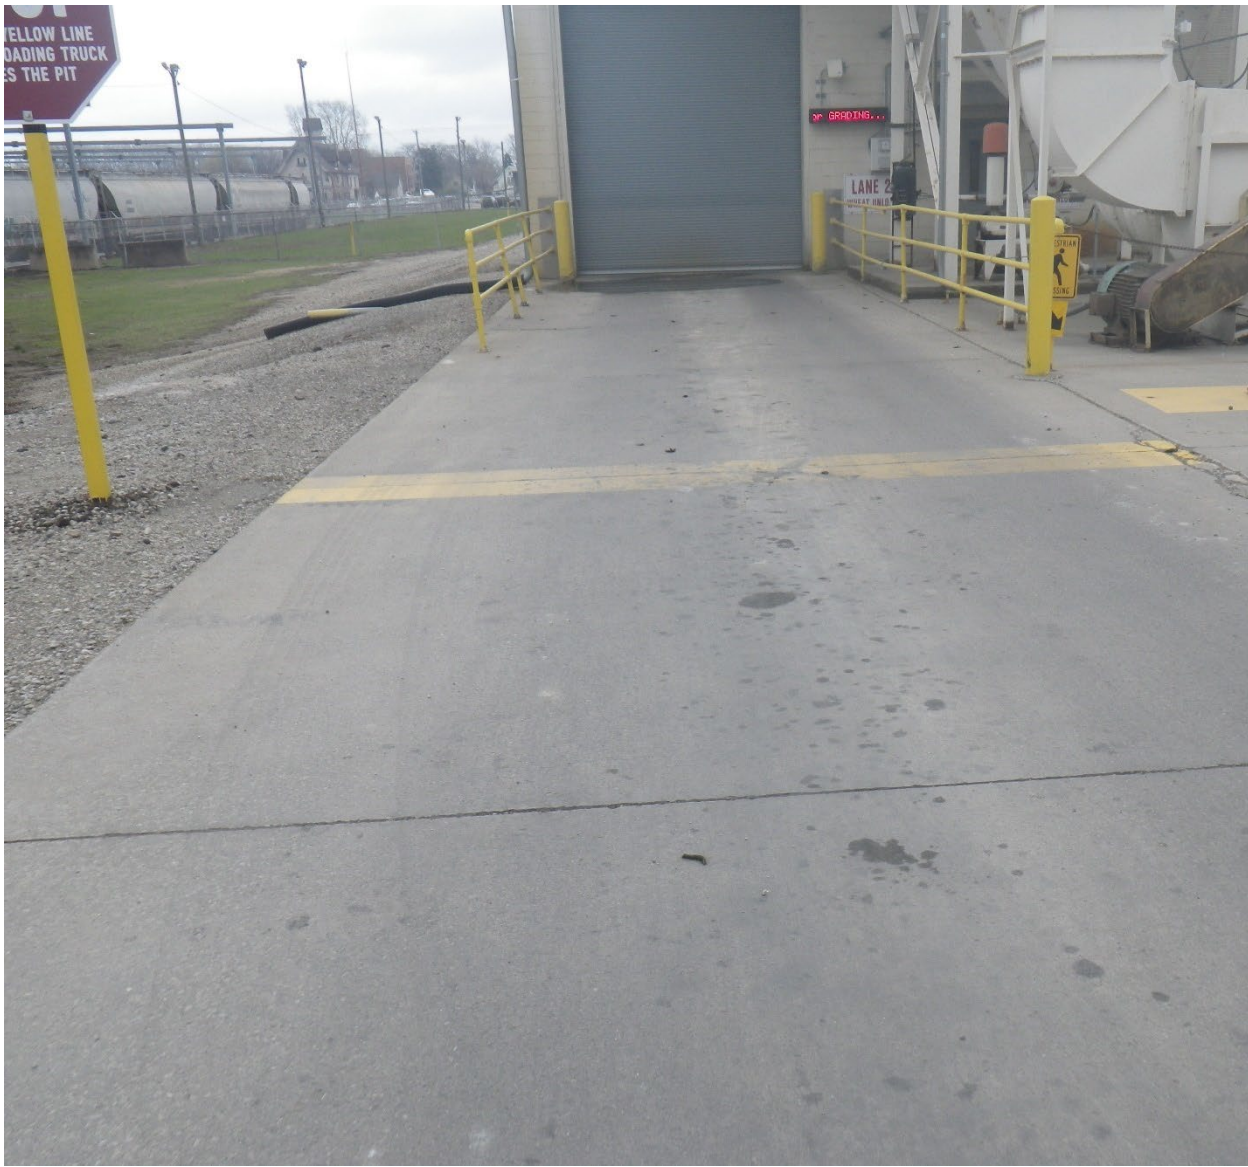
| Photograph 21. Staining on the pavement by the truck unloading area. | | | IMGP0021.JPG |

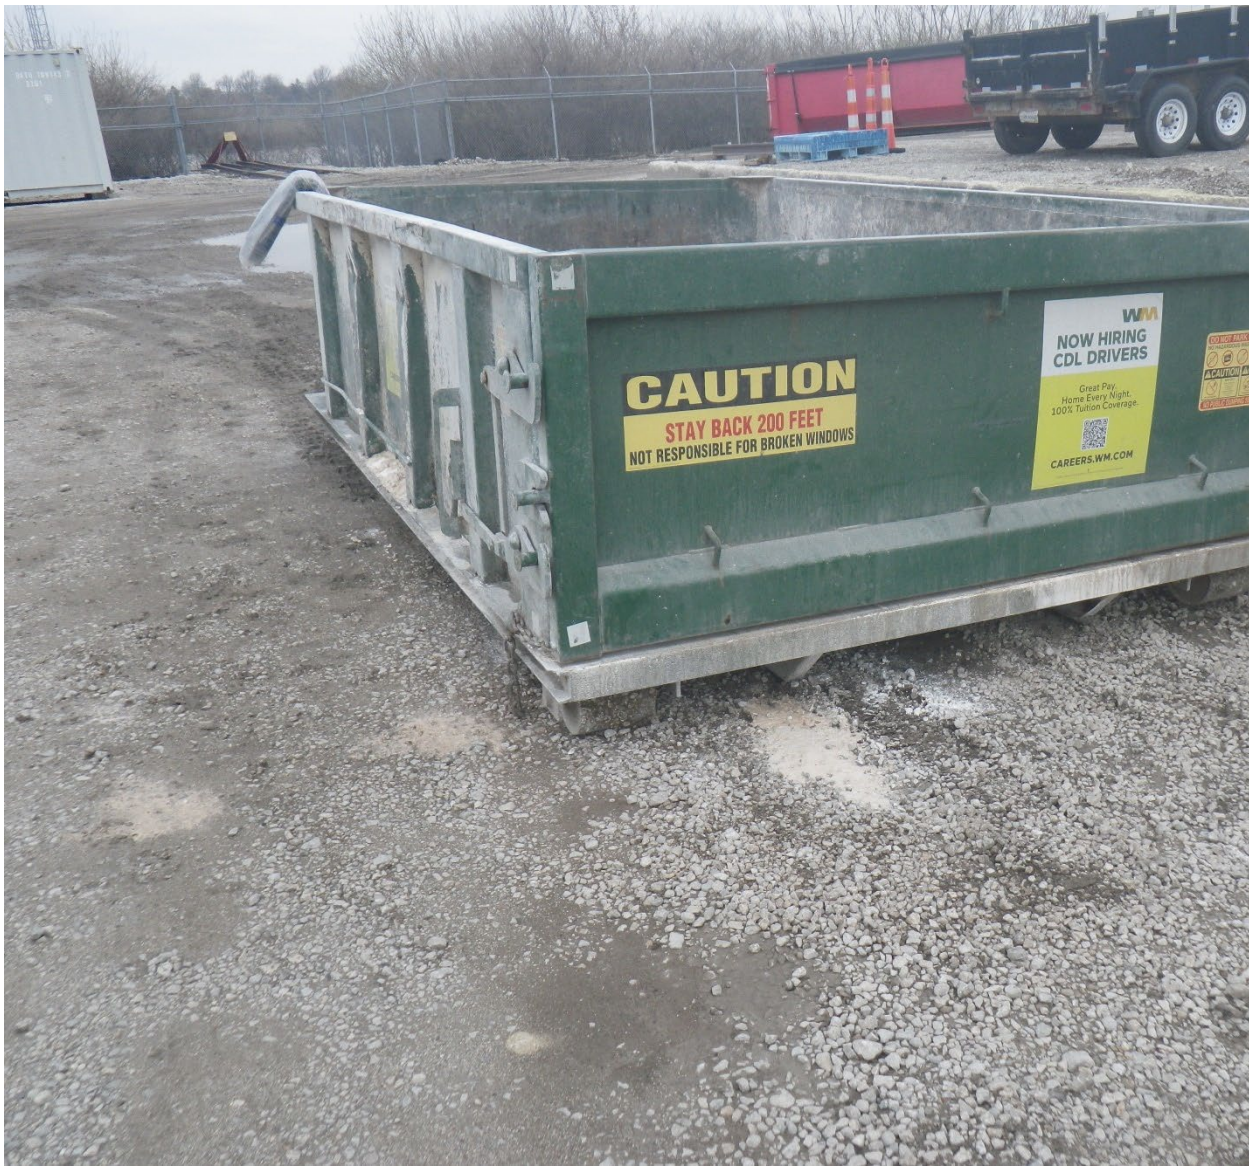
| Photograph 22. Roll off container for dust collector. Some is spilled on the ground. | | | IMGP0022.JPG |

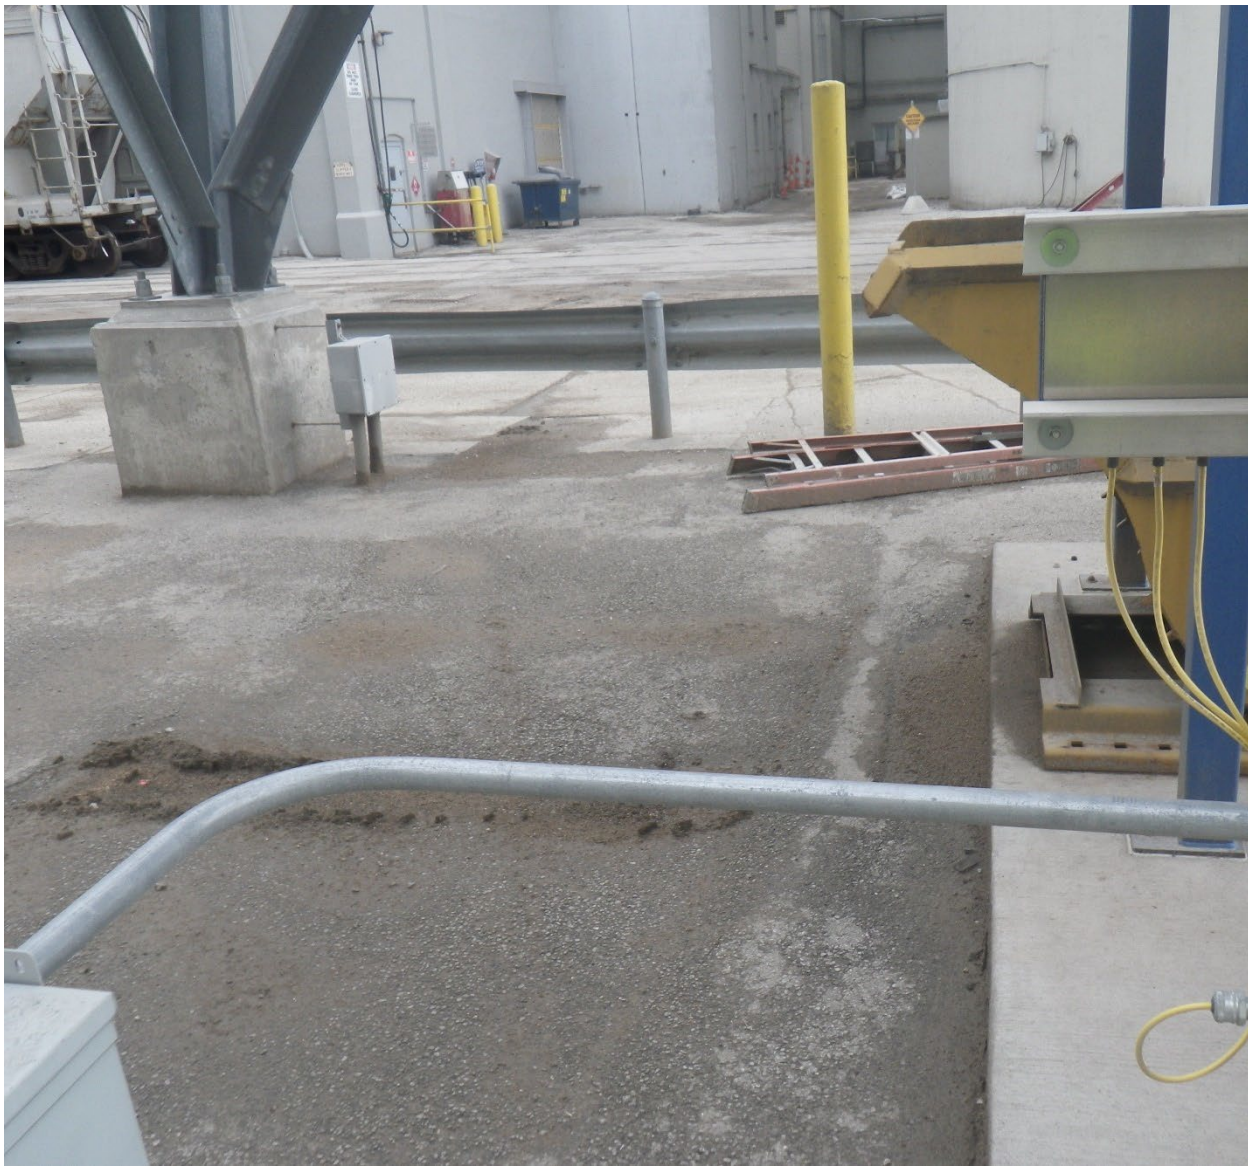
| EPA observed dust on the ground by the dust collector | | |

- US EPA documented areas of concern around Track 2 and the contractor roll off area. Sediment was observed on the concrete by the hopper cars and around the storm drain inlets. Dust was also observed on the ground by the dust collector. See photograph 24.

| Photograph 24. Dust collector and dust buildup | | | IMGP0024.JPG |

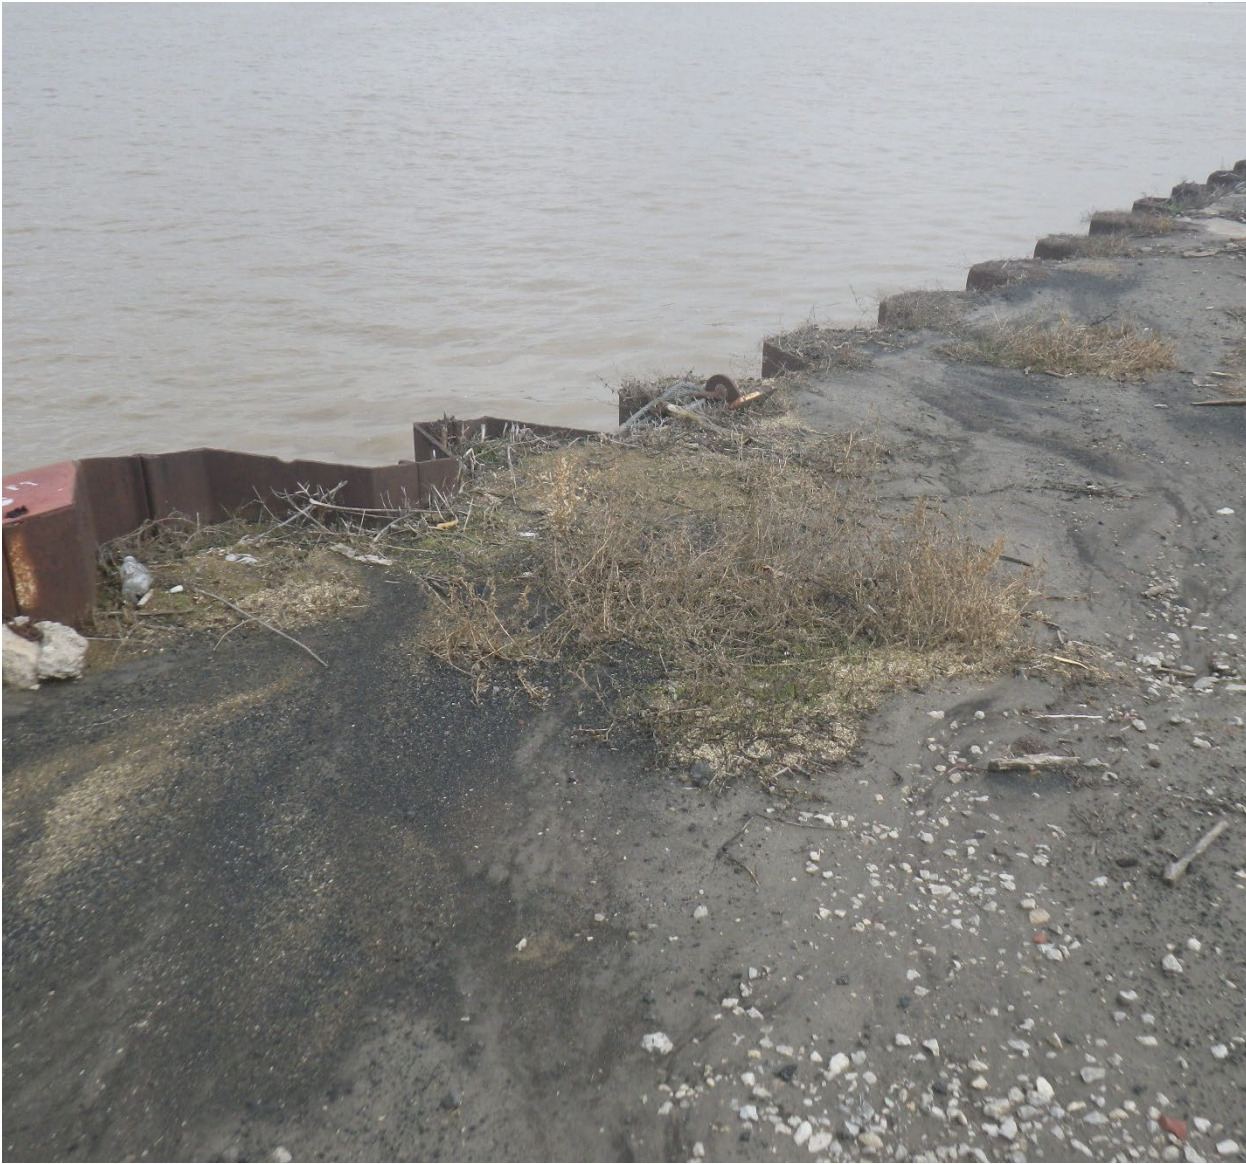
| Location: Dock area | | |
|---|---|---|
| US EPA observed accumulations of grain along the dock area near holes in the sheet piling, and erosion along the fence line. | | |

- US EPA documented grain accumulation near the waterway /dock area. US EPA also documented sediment build up to the top of the sheet pilings in some areas. See photographs 8-10, 25, and 27-31.

| Photograph 25. Dock area with sediment buildup along sheet pilings. | | | IMGP0025.JPG |

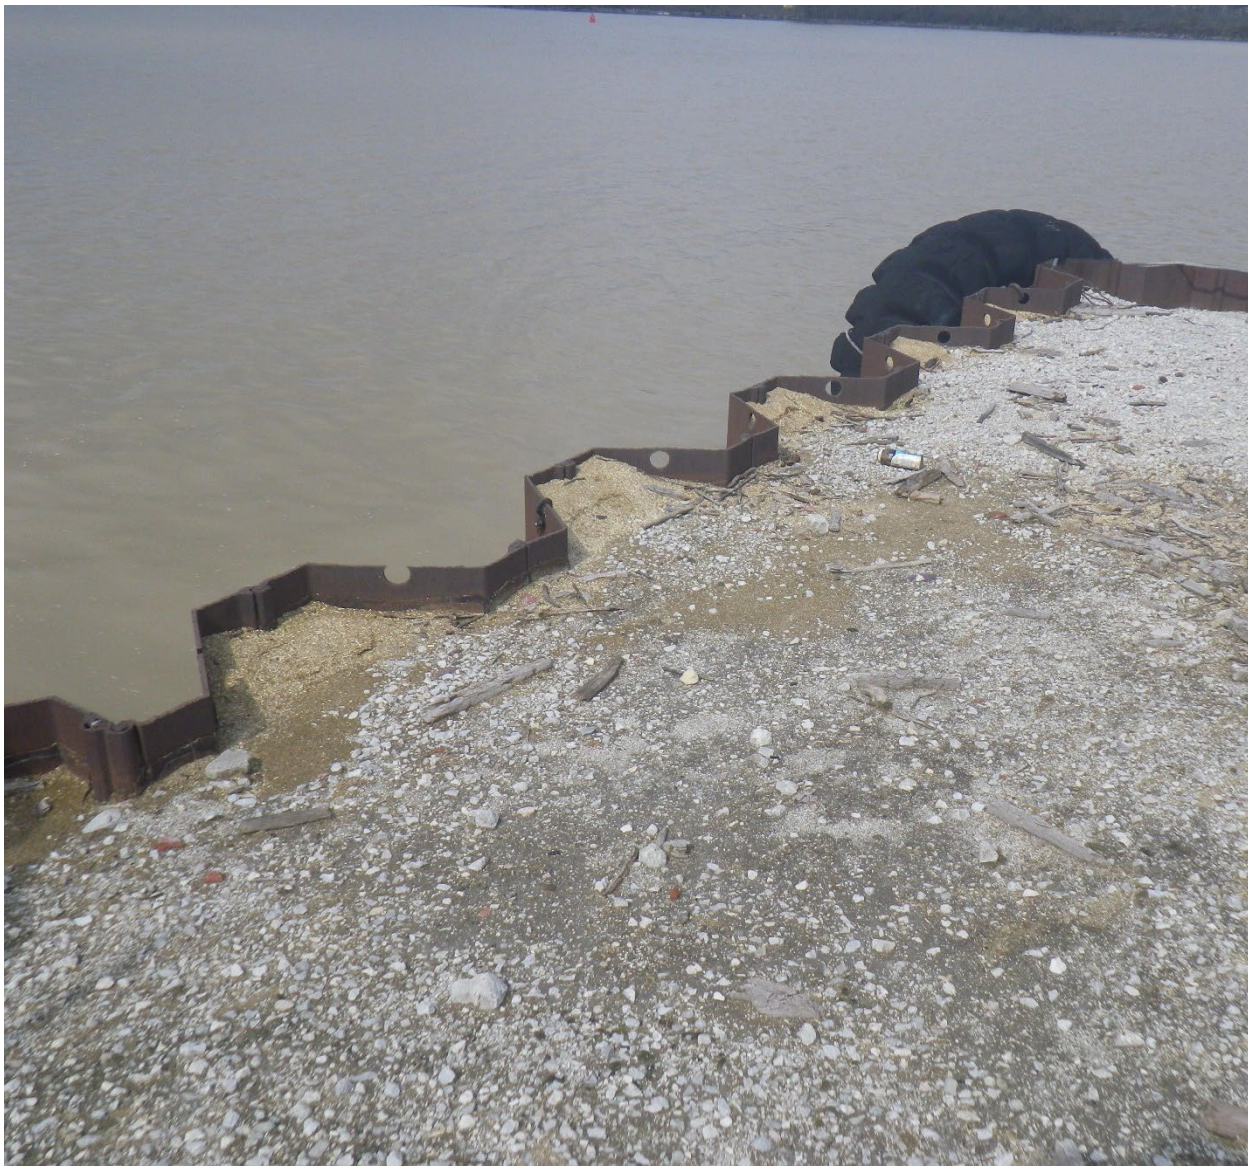
| Photograph 27. Dock area showing the grain build up along the sheet pilings | | | IMGP0027.JPG |

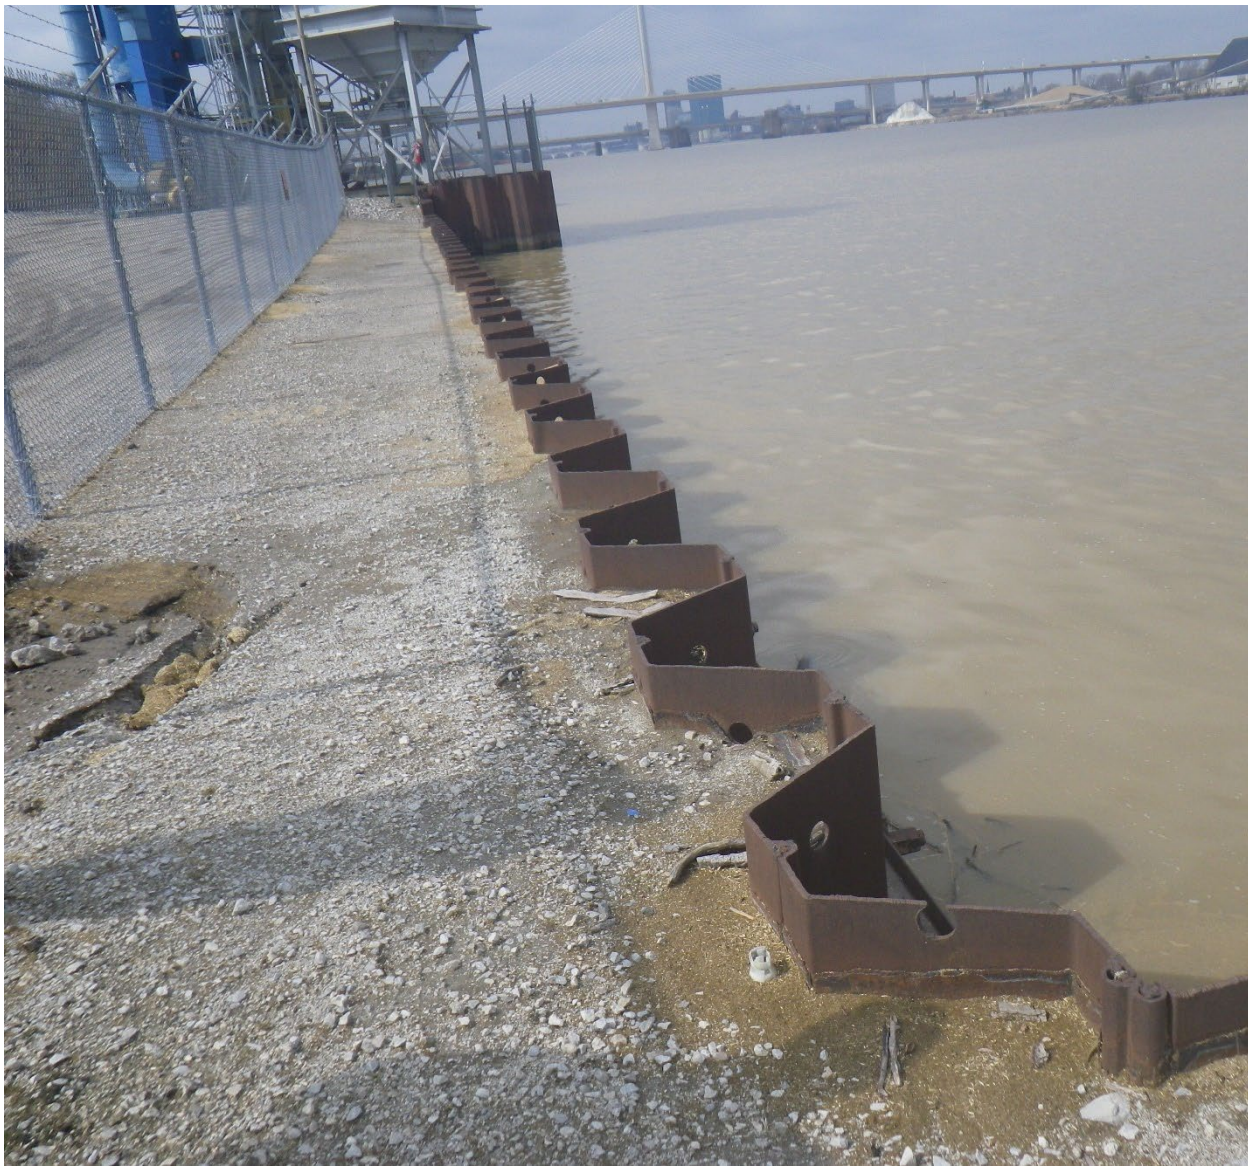
| Photograph 28. Dock area showing the sheet pilings and grain along the pilings. | | | IMGP0028.JPG |

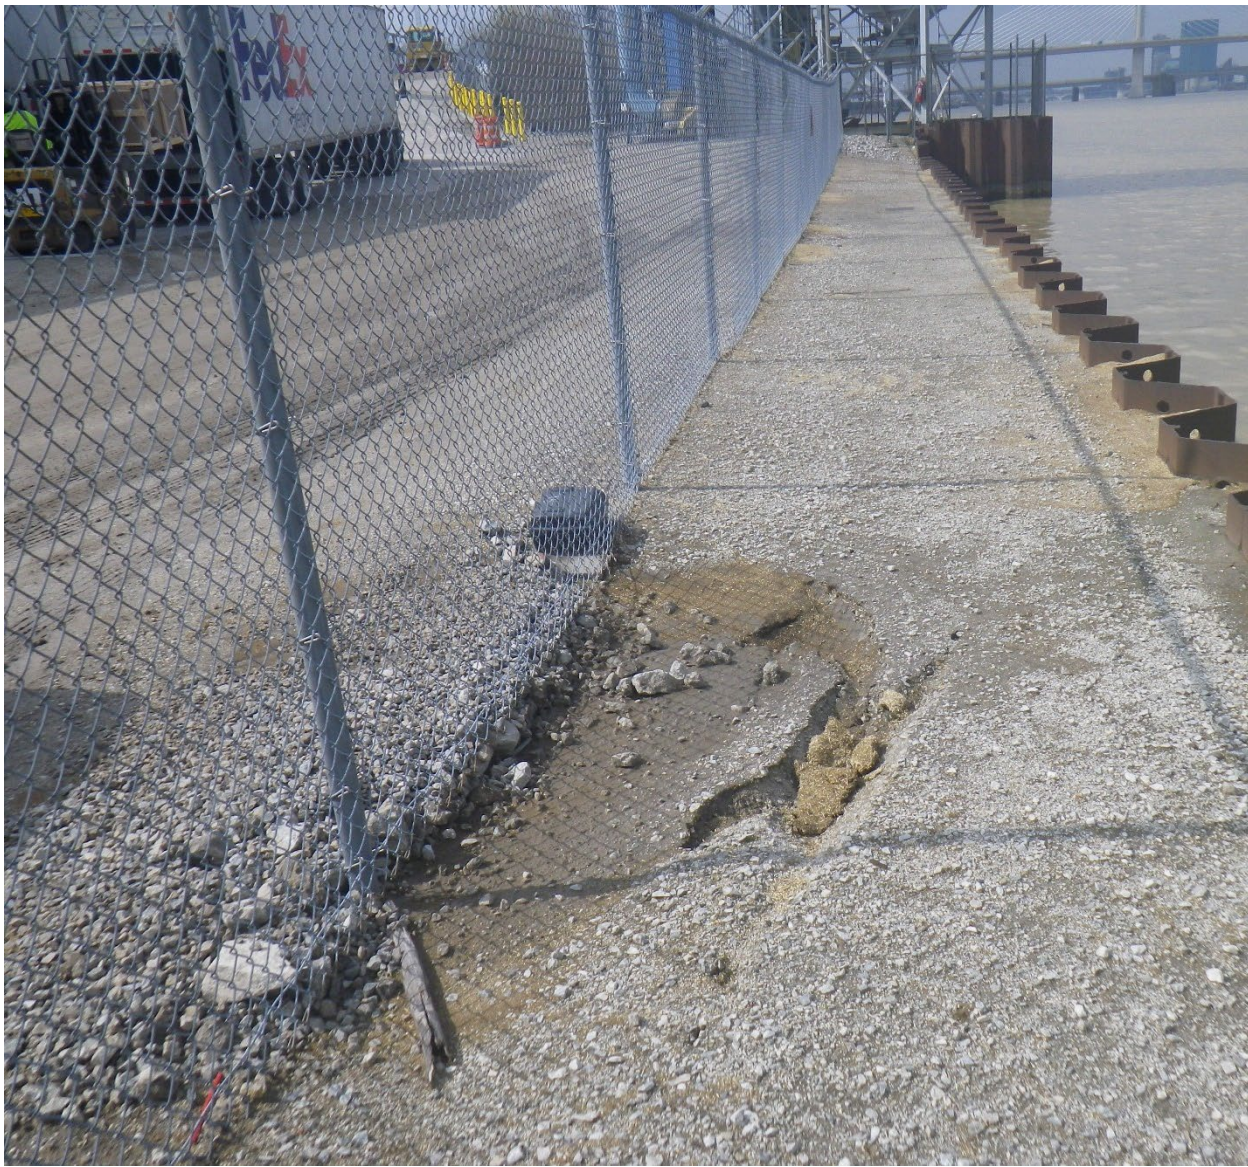
| Photograph 29. Dock area shown in photograph 28. Near the middle of the photograph can be seen erosion and grain accumulation | | | IMGP0029.JPG |

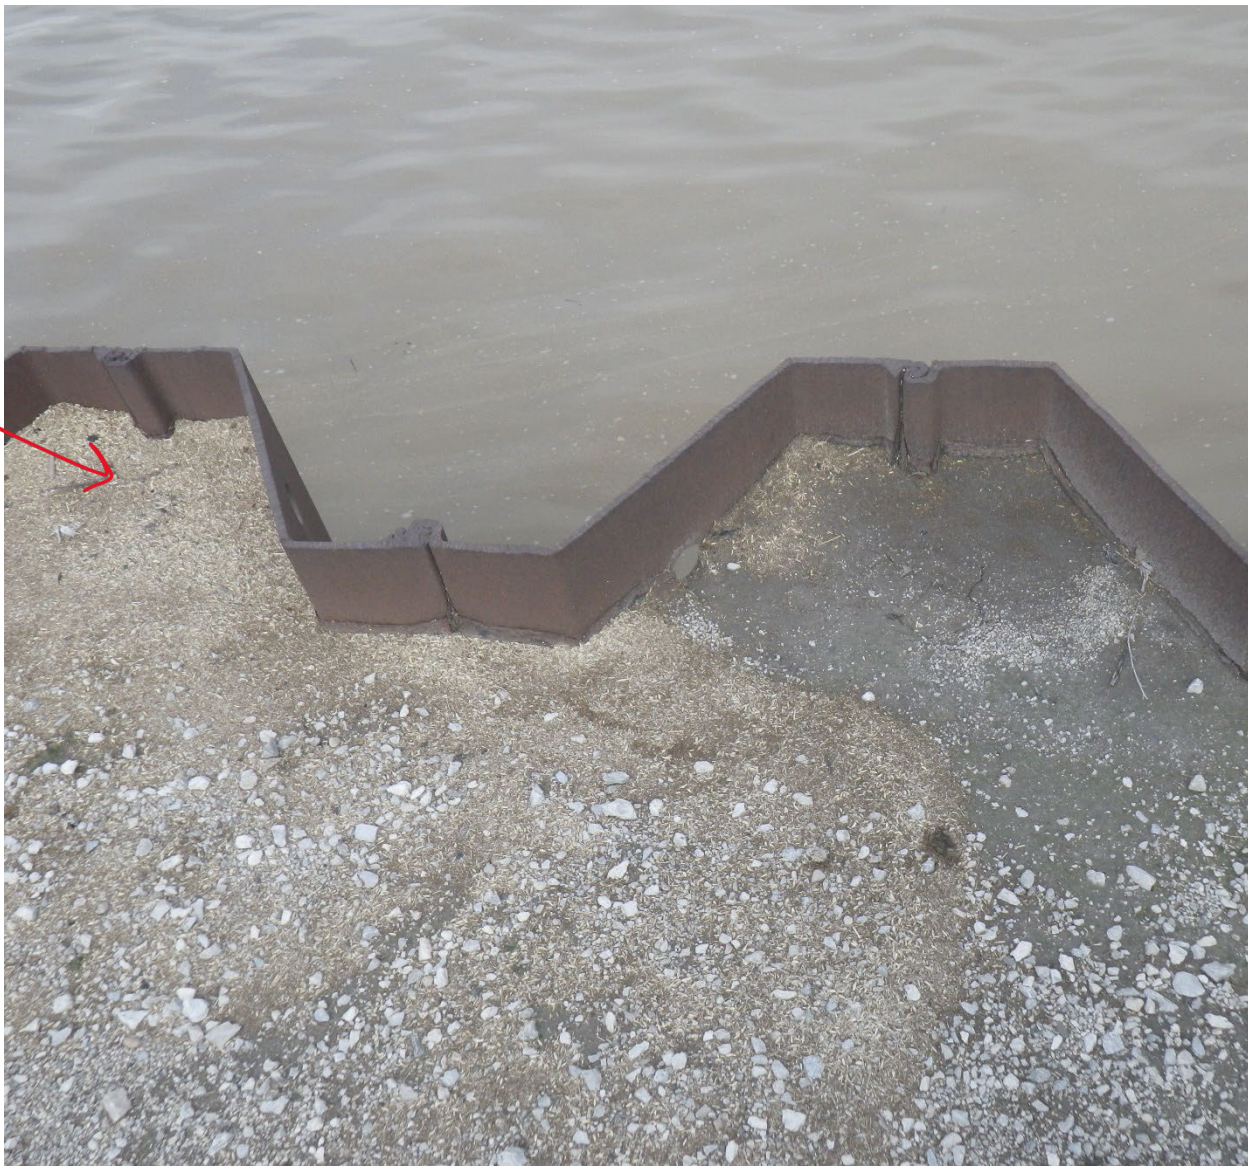
| Photograph 30. Grain can be seen accumulating along the sheet pilings on the edge of the dock. The red arrows point to the grain. | | | IMGP0030.JPG |

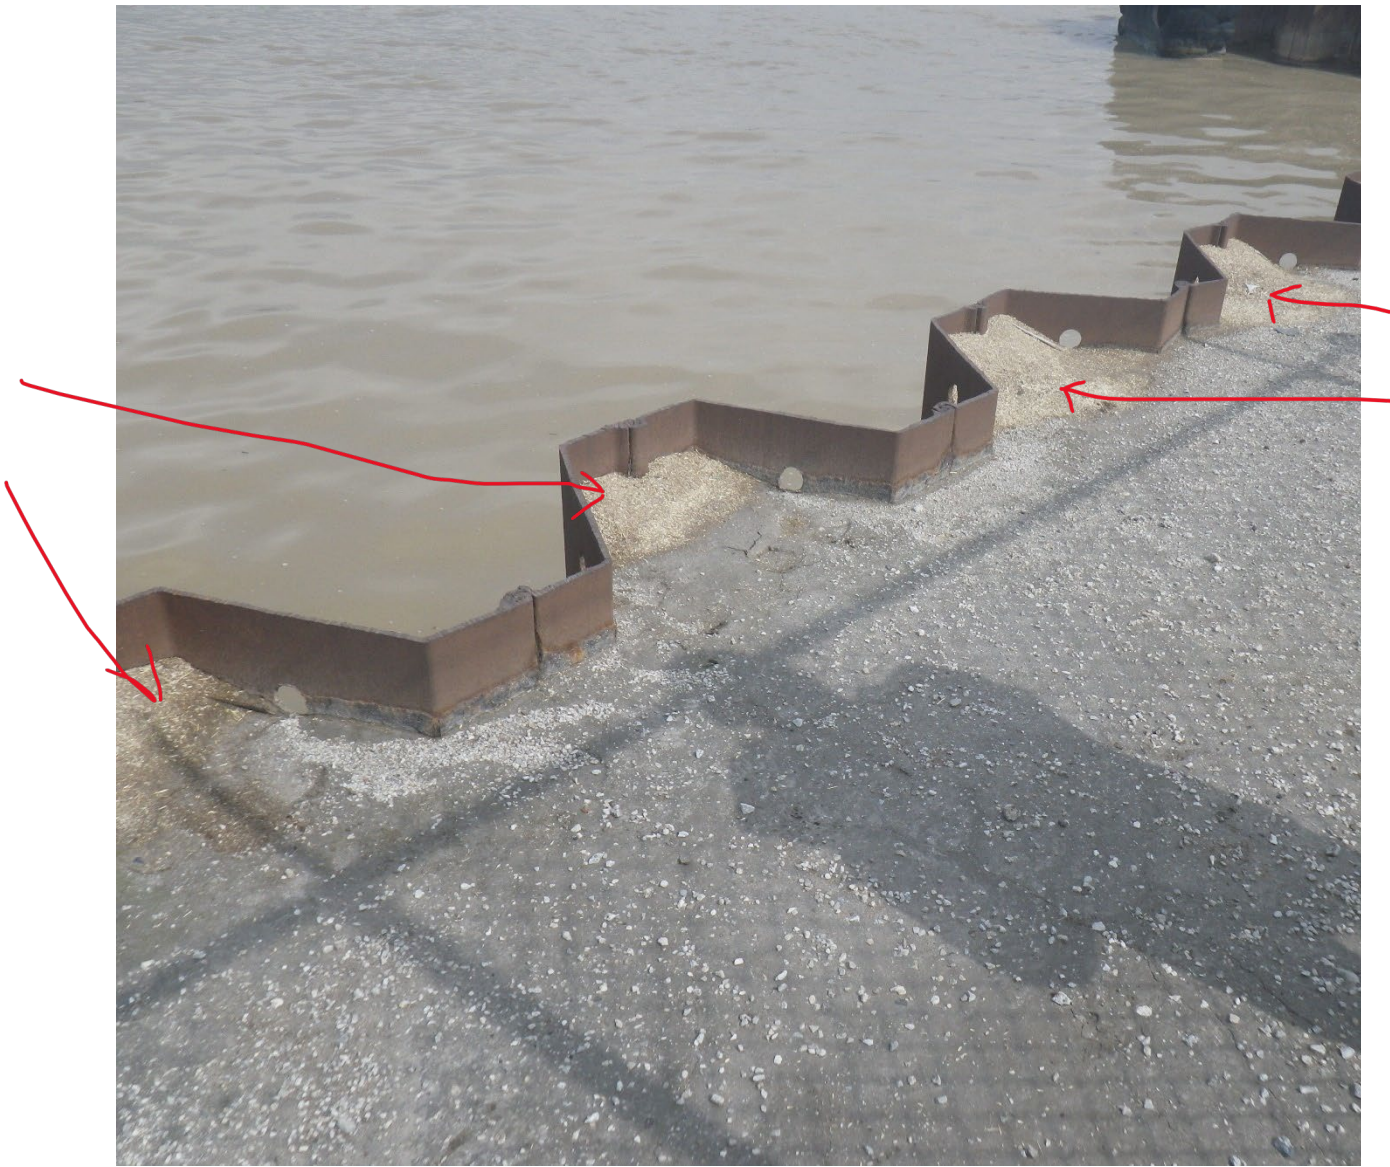
- See photographs 15 and 16 for documentation of garbage and floatable material inside sewer.
- SWPPP: US EPA noted that the SWPP is not up to date. US EPA also documented holes in the sheet piling along the dock, which was not identified in the SWPPP.

| Photograph 31. Grain can be seen accumulating along the sheet pilings on the edge of the dock at ground level. The red arrows point to the grain. Holes can be seen in the sheet piling. | | | IMGP0031.JPG |
