**UNITED STATES ENVIRONMENTAL PROTECTION AGENCY, REGION 2**  
**Enforcement and Compliance Assurance Division**  
**Water Compliance Branch**  
**Clean Water Act (CWA) Inspection Report**

<b>Program:</b> Industrial Stormwater (5G2)	<b>Inspection Type:</b> Compliance Evaluation Inspection
<b>Site Name:</b> Tri-State Quikrete	<b>NJPDES/ICIS No.:</b> NJG167789
<b>Inspection Entry Date:</b> 09/04/2024 <b>Inspection Entry Time:</b> 9:40 AM	<b>Inspection Exit Date:</b> 09/04/2024 <b>Inspection Exit Time:</b> 11:00 AM
<b>Facility Inspected:</b> Tri-State Quikrete 150 Gold Mine Road Flanders, NJ 07836	
<b>Lat, Long:</b> 40.88045, -74.71525 <b>NAICS / SIC Code:</b> 3272 - Concrete Products, Except Block and Brick	
<b>EPA Representative(s):</b> Christina Palmrose-Krieger, EPA Region 2, 212-637-4049, <a href="mailto:Palmrosekrieger.Christina@epa.gov">Palmrosekrieger.Christina@epa.gov</a>	
<b>State Representative(s):</b> N/A	
<b>On-site Facility Representative(s):</b> Tony Miceli, Operations Manager, <a href="mailto:Tony.Miceli@quikrete.com">Tony.Miceli@quikrete.com</a>	
<b>Name and Address of Responsible Official:</b> Tony Miceli 150 Gold Mine Road Flanders, NJ 07836

Attachment 1 – CEI Phot

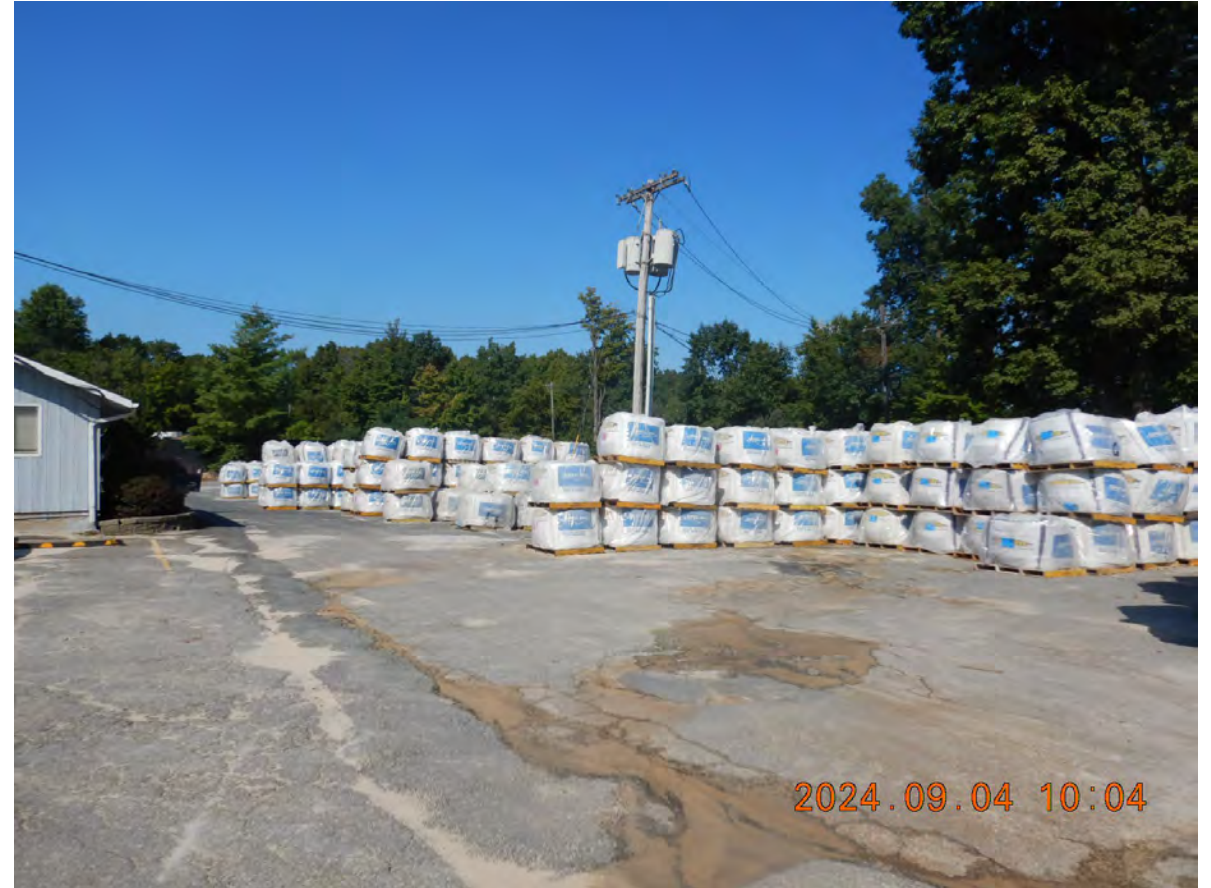
DSCN3681 – Final product stored outside next to office building; stormwater and source material on pavement

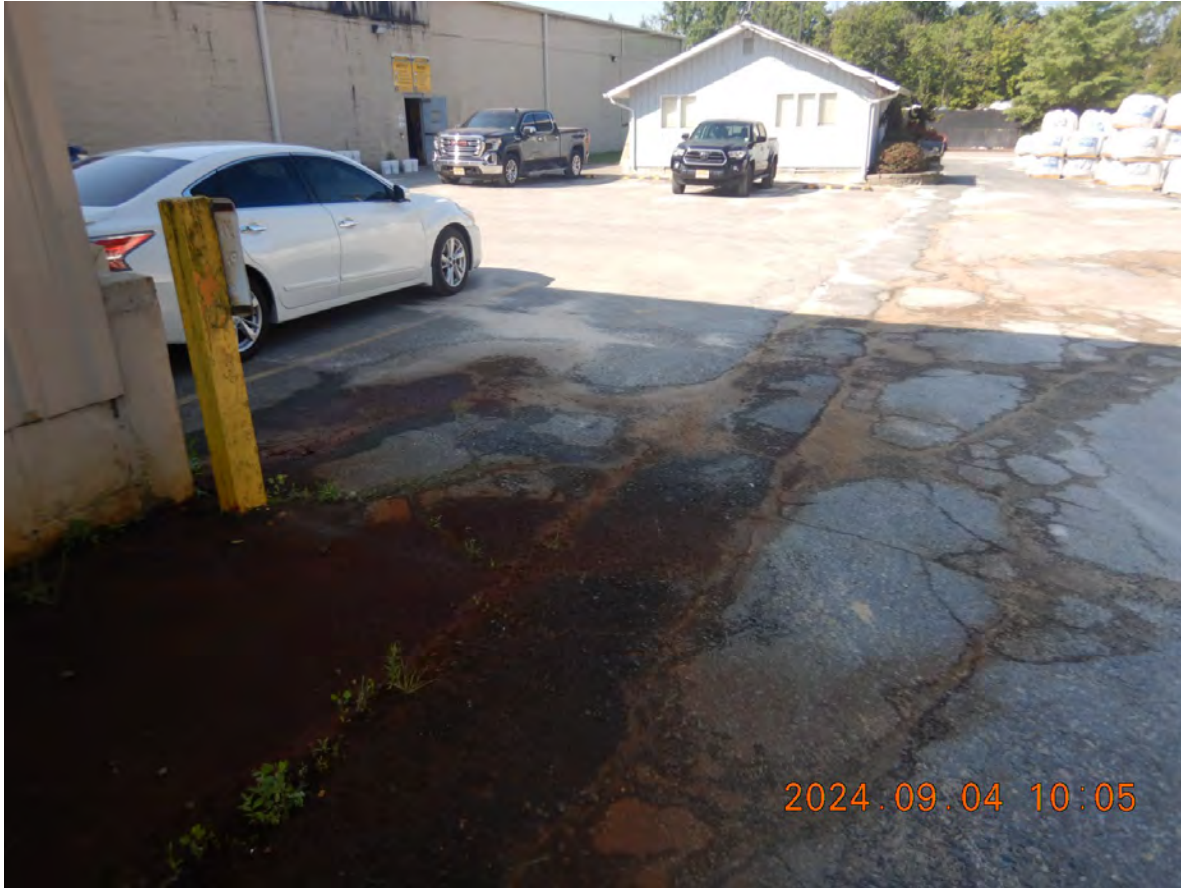
DSCN3682 - Stormwater and source material on pavement in employee parking lot

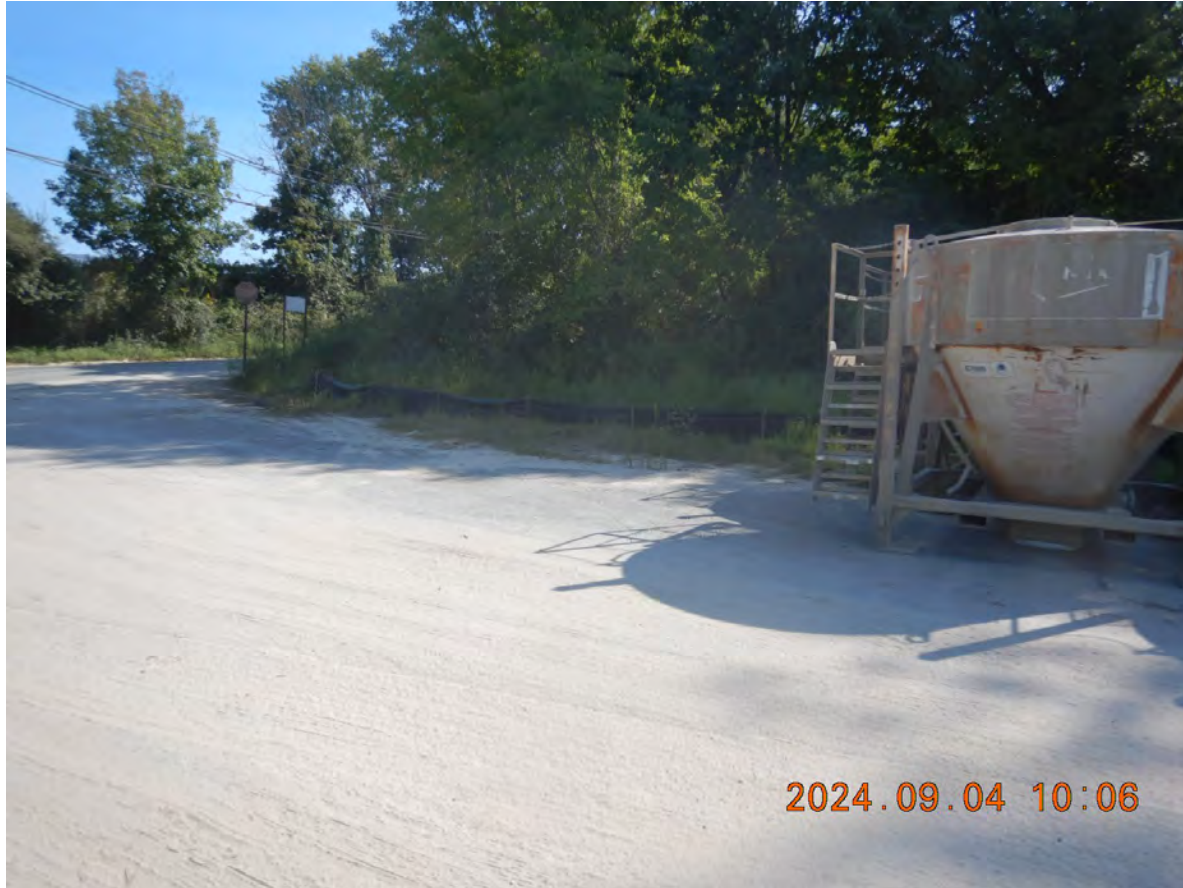
Mr. Miceli stated that the catch basins discharge to the other side of Gold Mine Road. At the time of the CEI, due to the limited shoulder along the Gold Mine Road, embankment and vegetation, this outfall was not able to be accessed or observed. Mr. Miceli also stated that there is an issue with flooding in this area of Gold Mine Road. Source material was observed along Gold Mine Road (Attachment 1; DSCN3684, DSCN3691, DSCN3692, and DSCN3694).

DSCN3684 – North entrance to the Site; significant source material over pavement

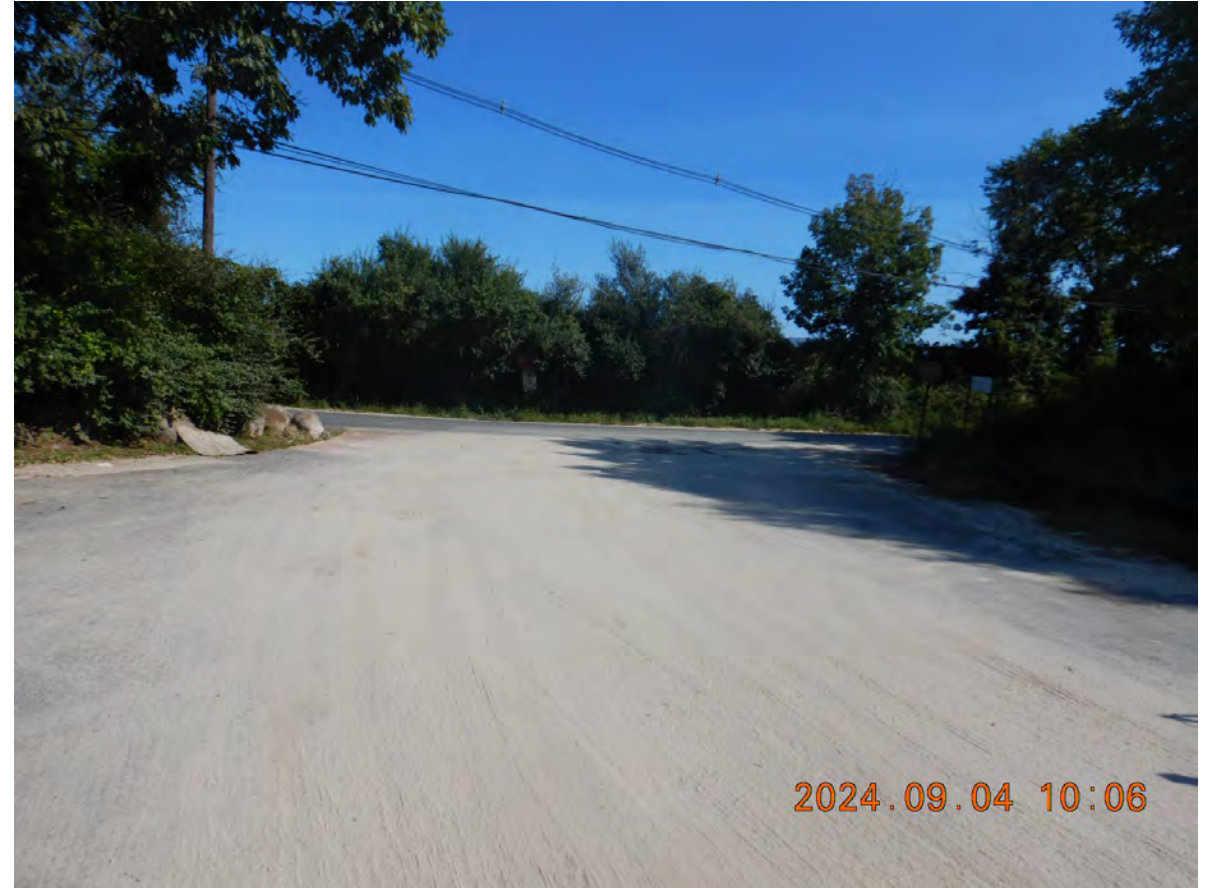
DSCN3685 - North entrance to the Site; significant source material over pavement; catch basin located at the end of driveway and Gold Mine Rd

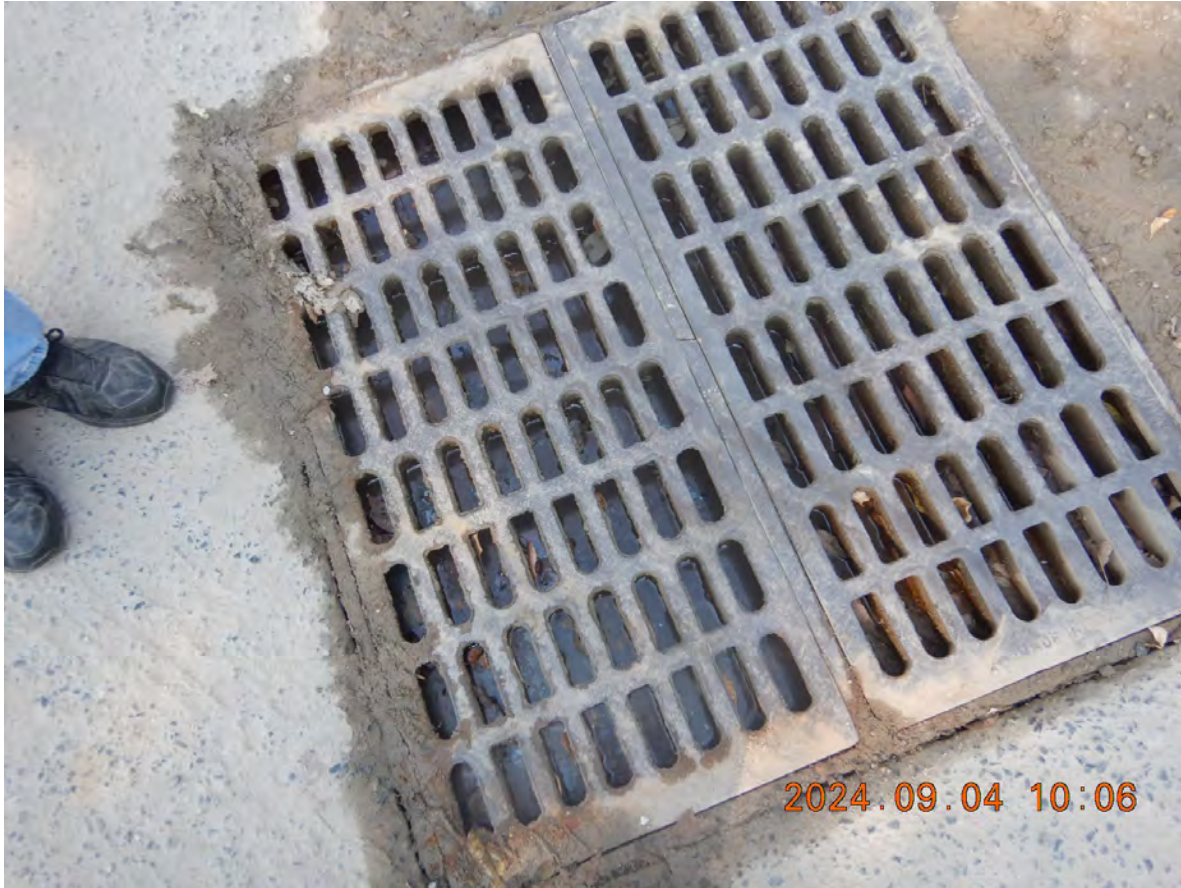
- d. EPA observed a significant amount of source material build up and sheen on catch basin screens (Attachment 1; DSCN3688, DSCN3689, DSCN3706, and DSCN3705)

DSCN3688 - Catch basin located at the end of driveway and Gold Mine Rd

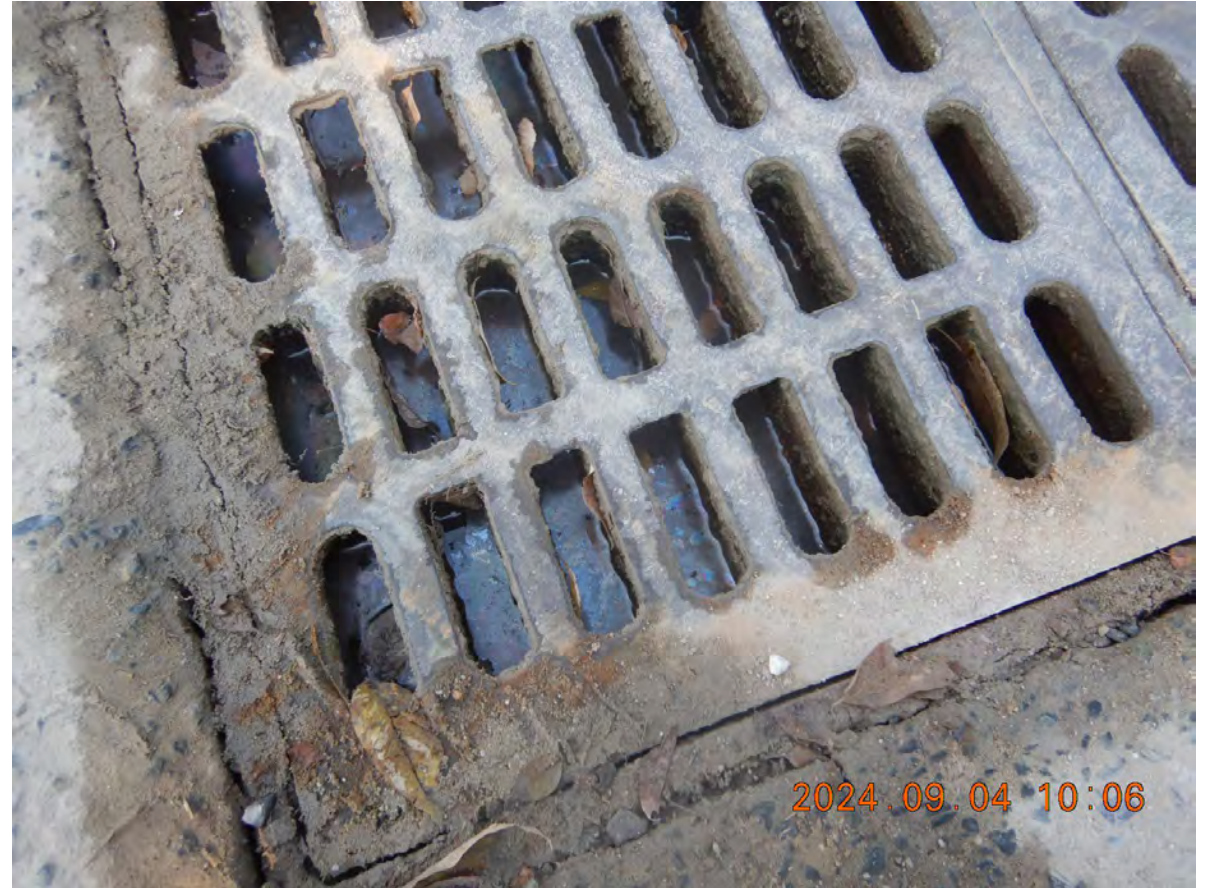
DSCN3689 – Source material, debris, and sheen inside basin

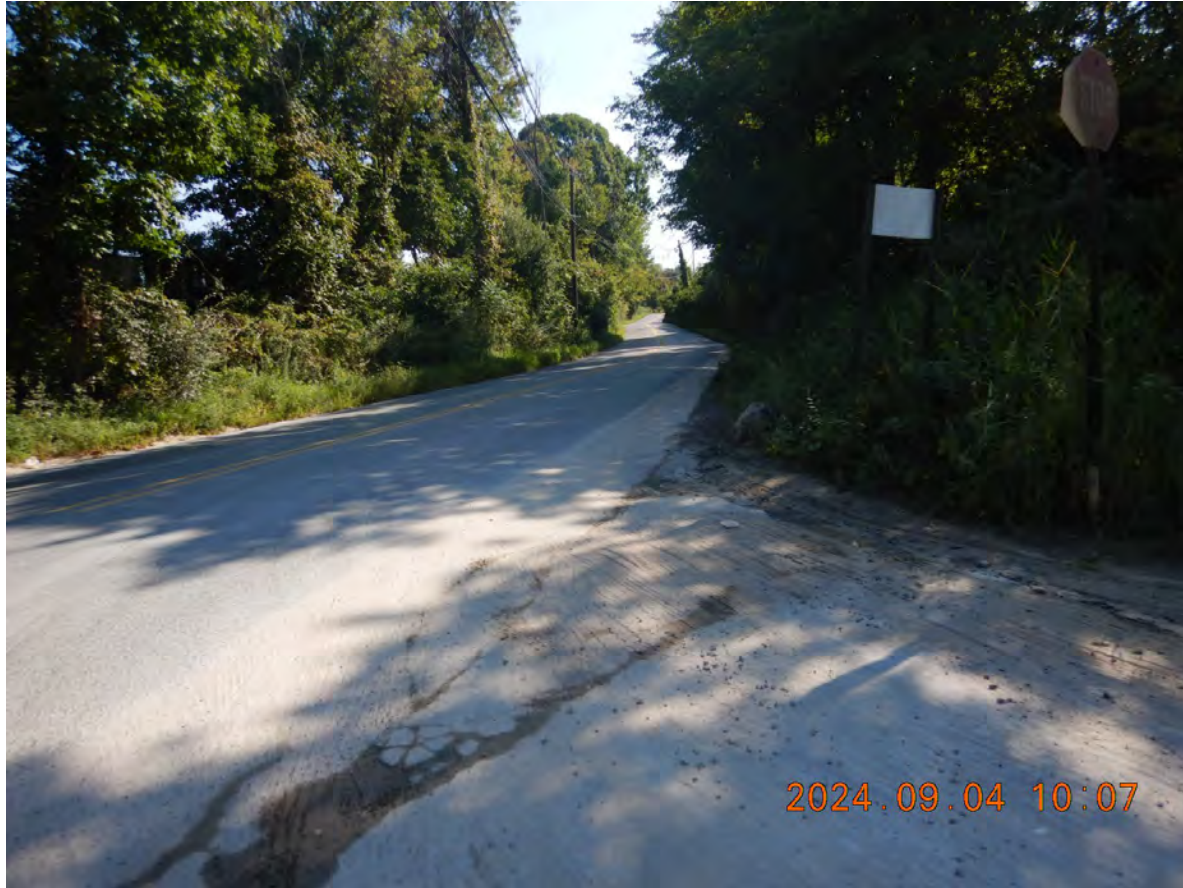
DSCN3691 – Source material tracked out onto Gold Mine Rd looking east

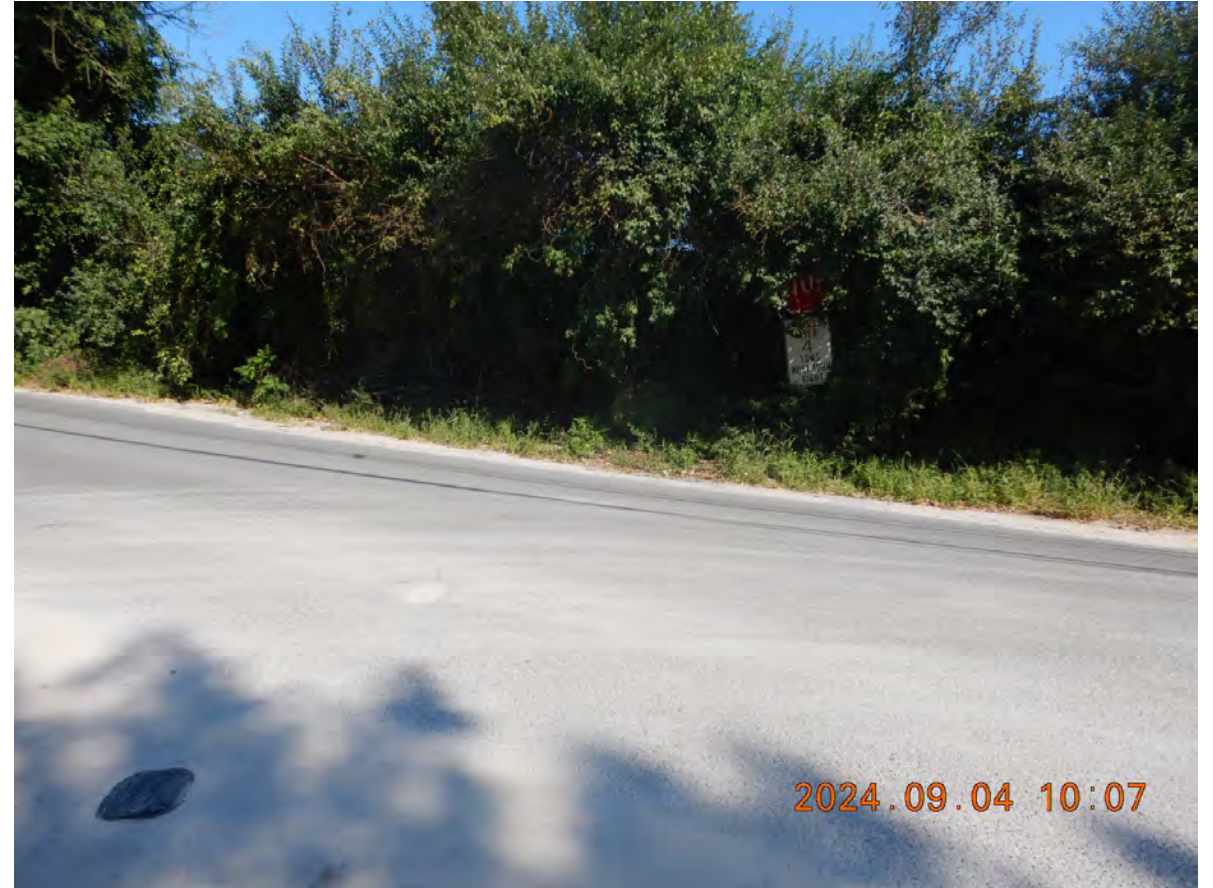
DSCN3692 – Source material can be seen on the north side of Gold Mine Rd.

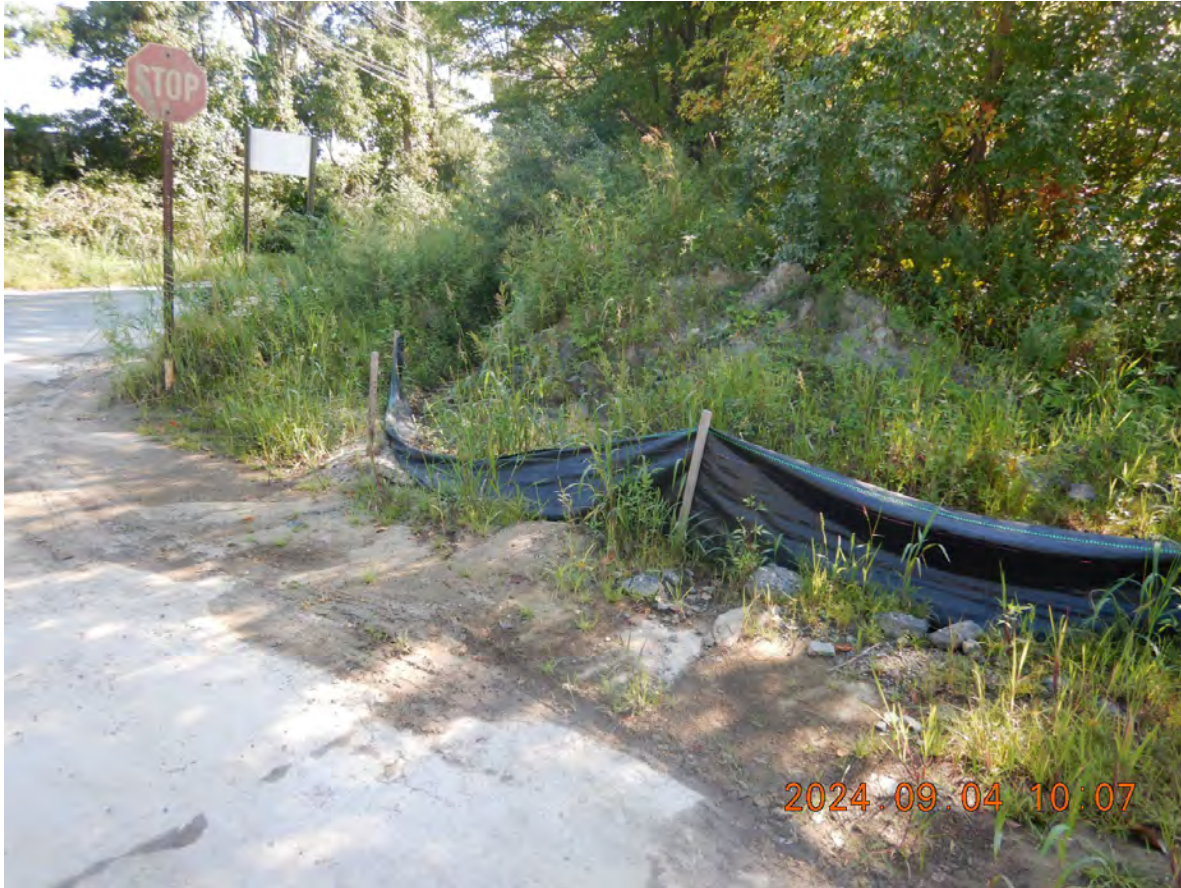
- c. EPA observed significant amounts of source material on pavement along the main drive, loading and unloading areas, and onto Gold Mine Road (Attachment 1; DSCN3694, DSCN3700, DSCN3711, DSCN3755, and DSCN3767)

DSCN3694 – Stormwater and source material along entrance and Gold Mine Rd.

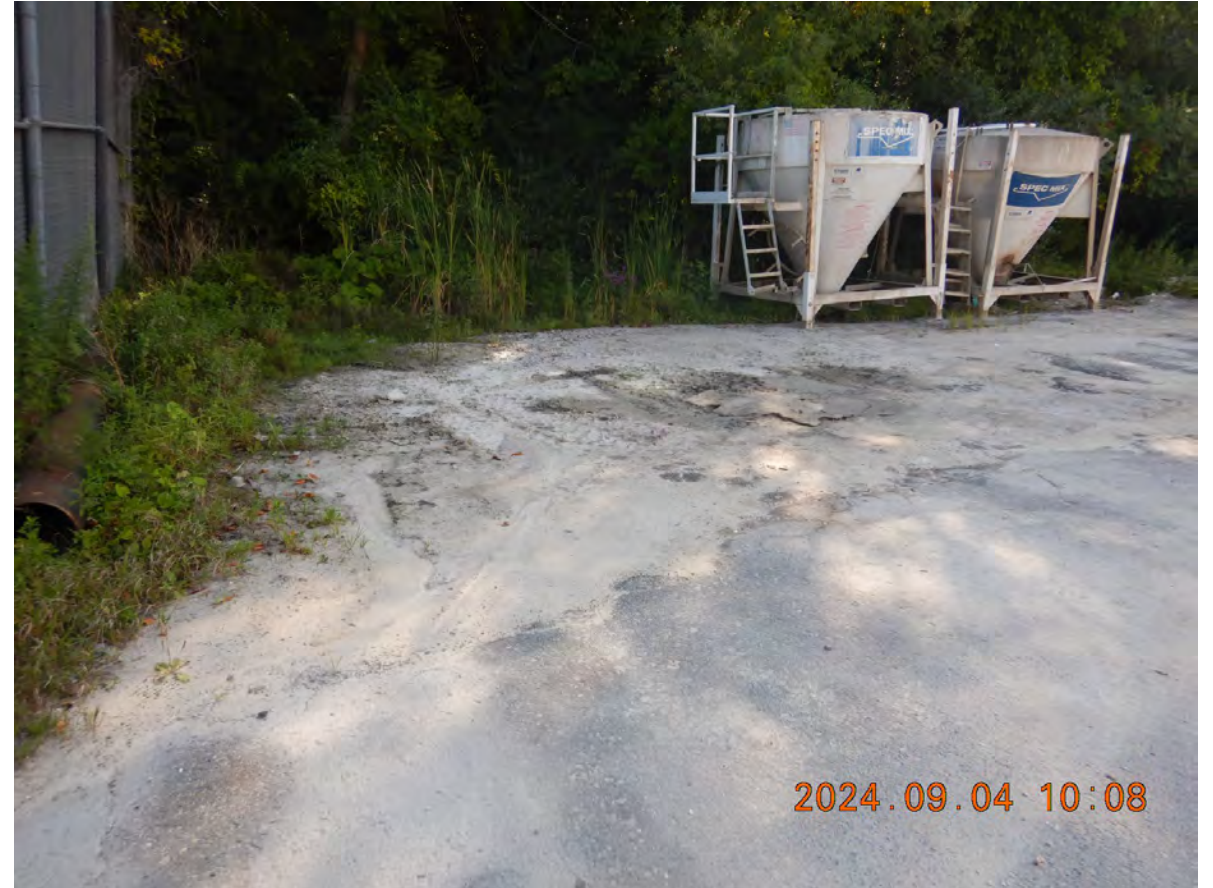
DSCN3700 - Stormwater and source material along entrance and Gold Mine Rd.

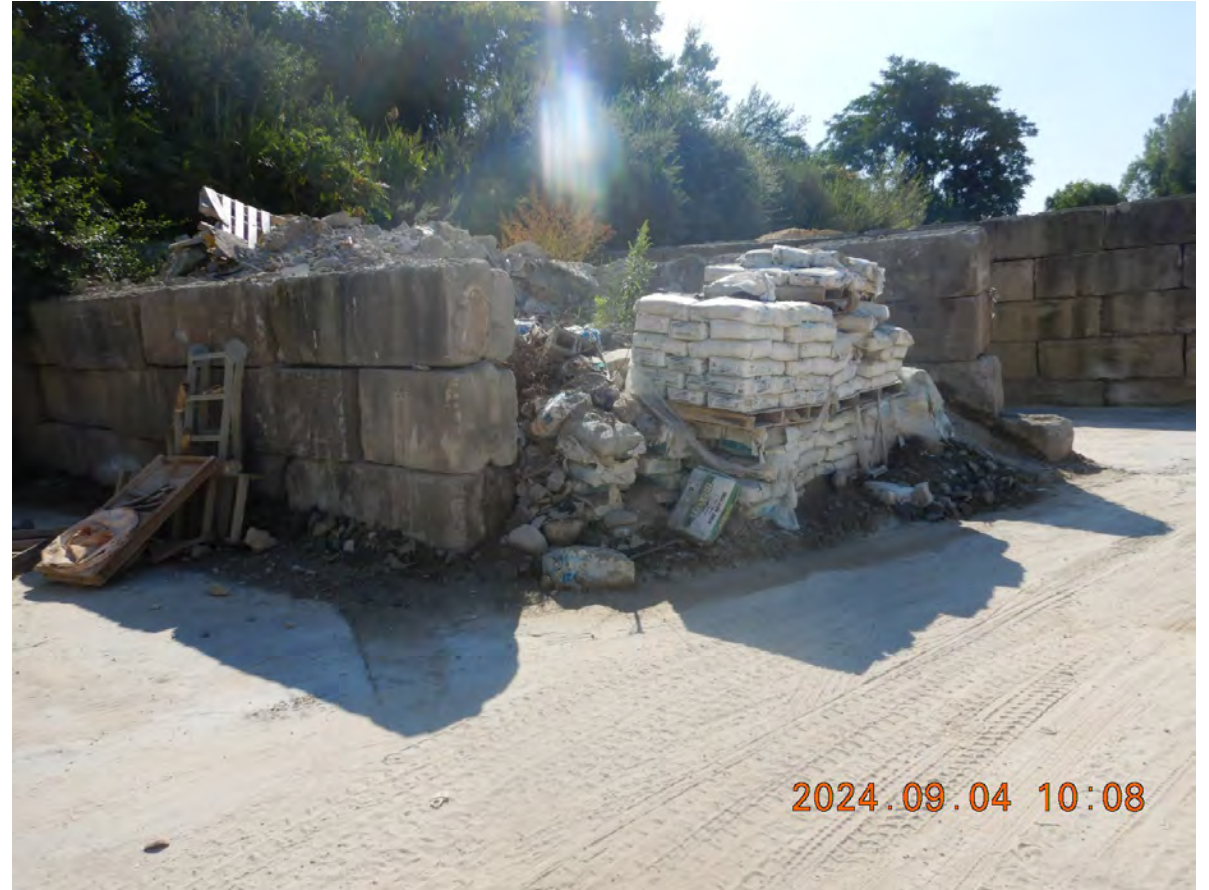
- b. EPA observed stormwater collecting and flowing downhill from waste storage, uncovered dumpsters, and recyclable material areas (Attachment 1; DSCN3725, DSCN3731, DSCN3702, and DSCN3723)

DSCN3702 – Stormwater collected at the base of outdoor of waste and materials storage

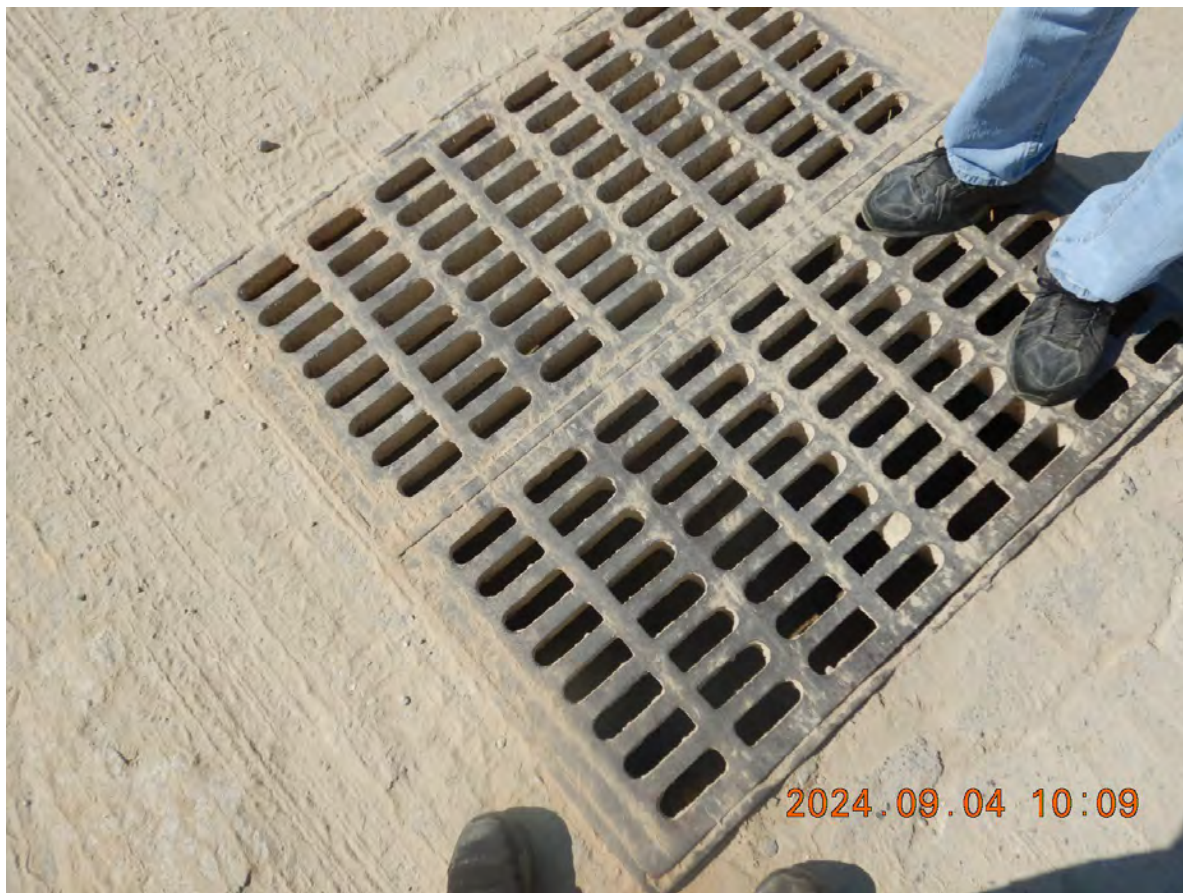
EPA continued the Inspection along the eastern side of the Site to the second catch basin. Stormwater and source material was observed in and around the catch basin (Attachment 1; DSCN3703, DSCN3705, and DSCN3706). Waste and materials to be recycled were also stored along the eastern edge of the Site (Attachment 1; DSCN3701 and DSCN3702). EPA continued the Inspection to the South side of the Site

DSCN3703 – Catch basin in the central east portion of the Site

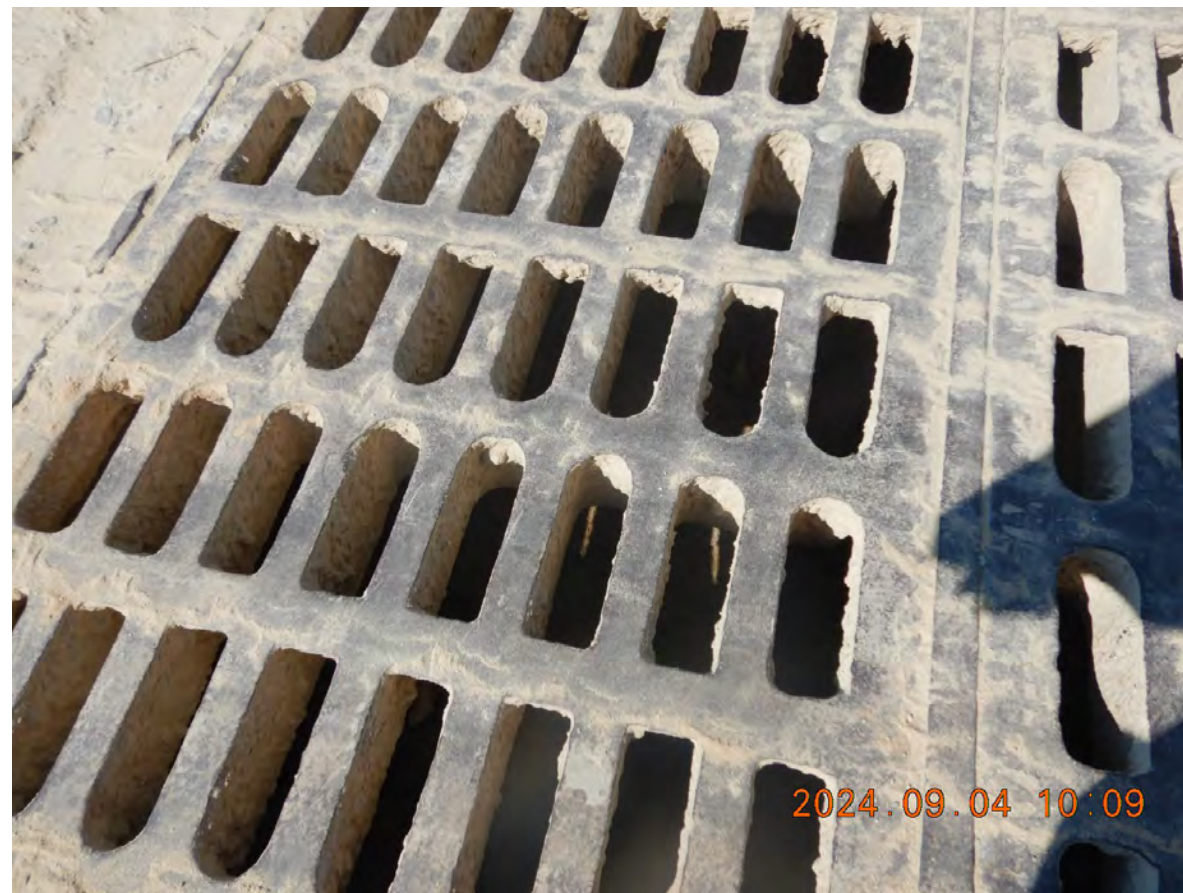
DSCN3705 – Source material inside catch basin

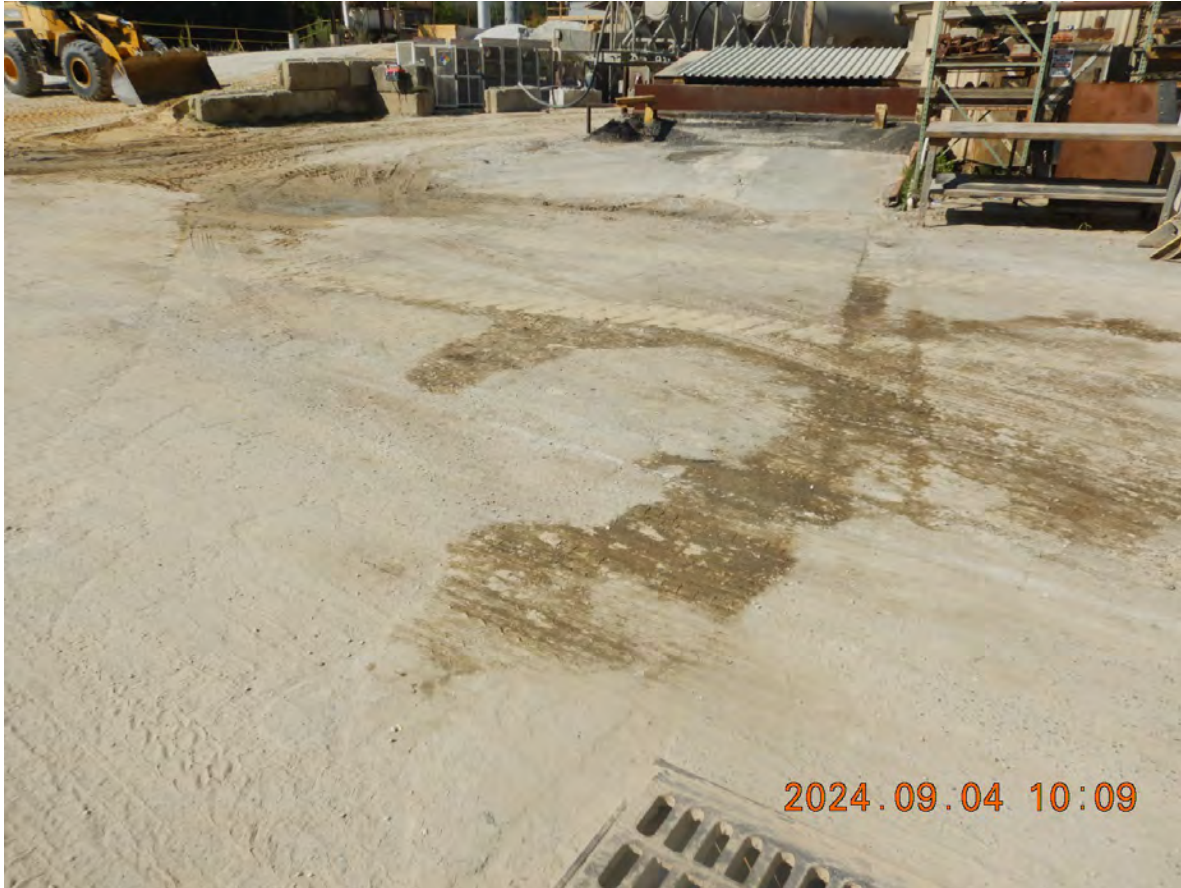
DSCN3706 – Catch basin near east central area;  
Stormwater collecting in the area

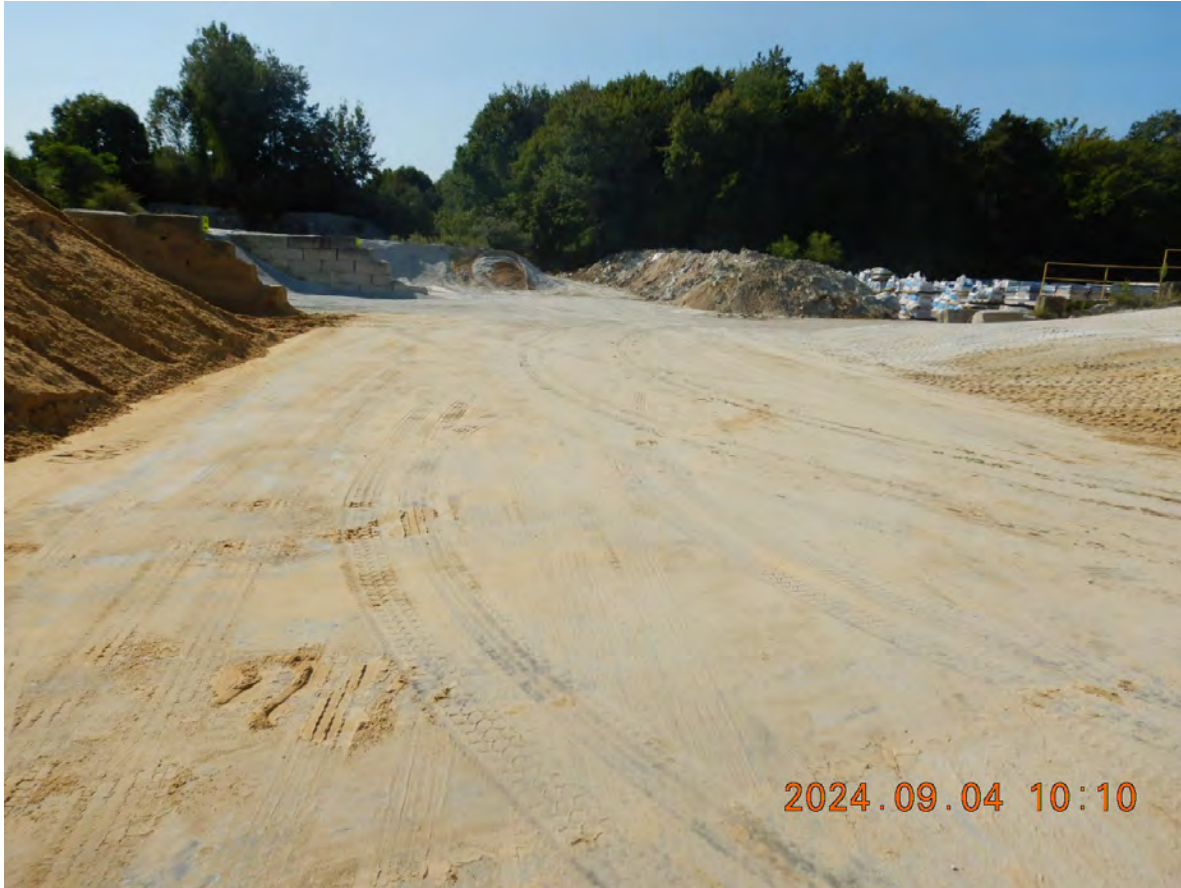
DSCN3711 – East driveway facing south; aggregate bunks, and materials to be recycled

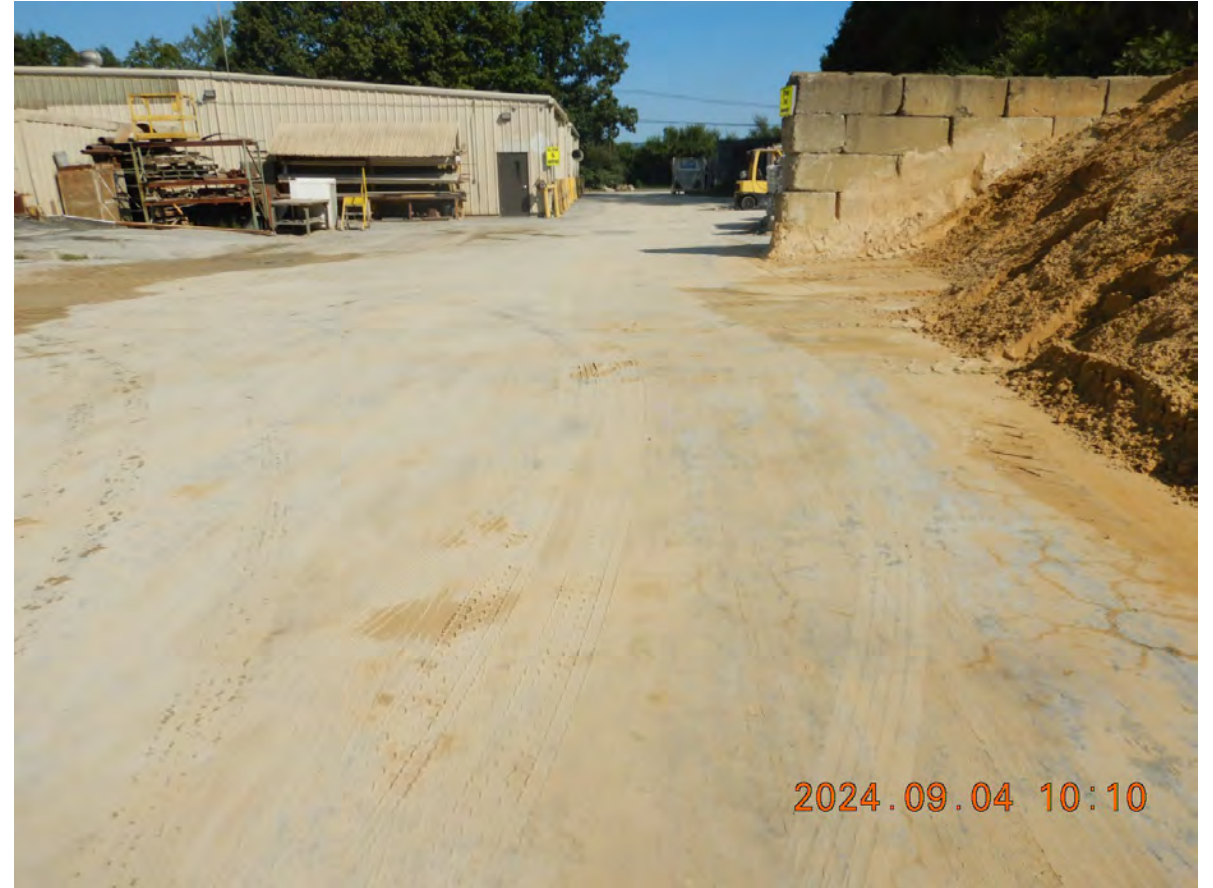
- a. At the time of the CEI, the EPA inspector observed stormwater freely collecting and flowing downhill and a lack of structural or stabilization methods to prevent or minimize contact with pollutants and/or erosion methods for controlling sediment and pollutants around aggregate storage (Attachment 1; DSCN3712, DSCN3719)

DSCN3712 – Stormwater and source material along drive facing north

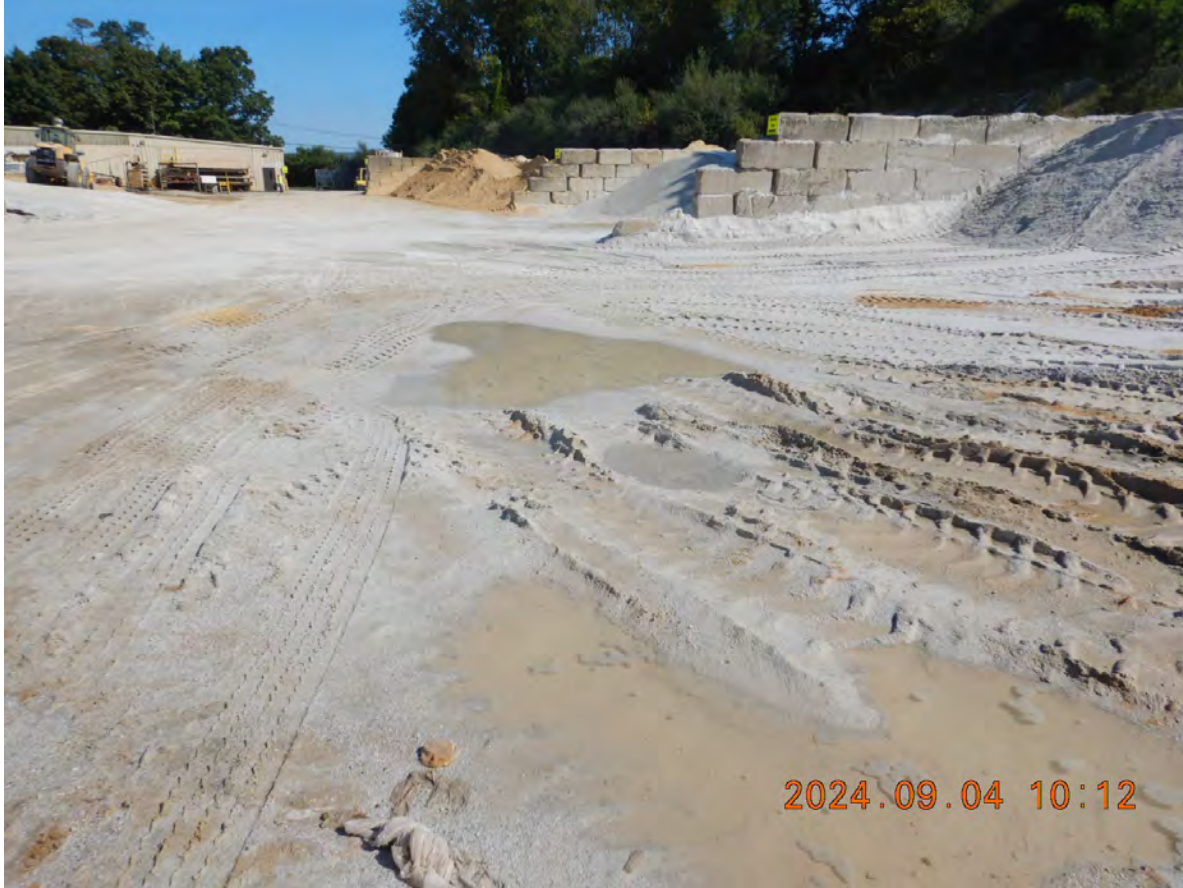
DSCN3719 – Stormwater collecting and pooling on source material; facing north; upgrade of catch basins

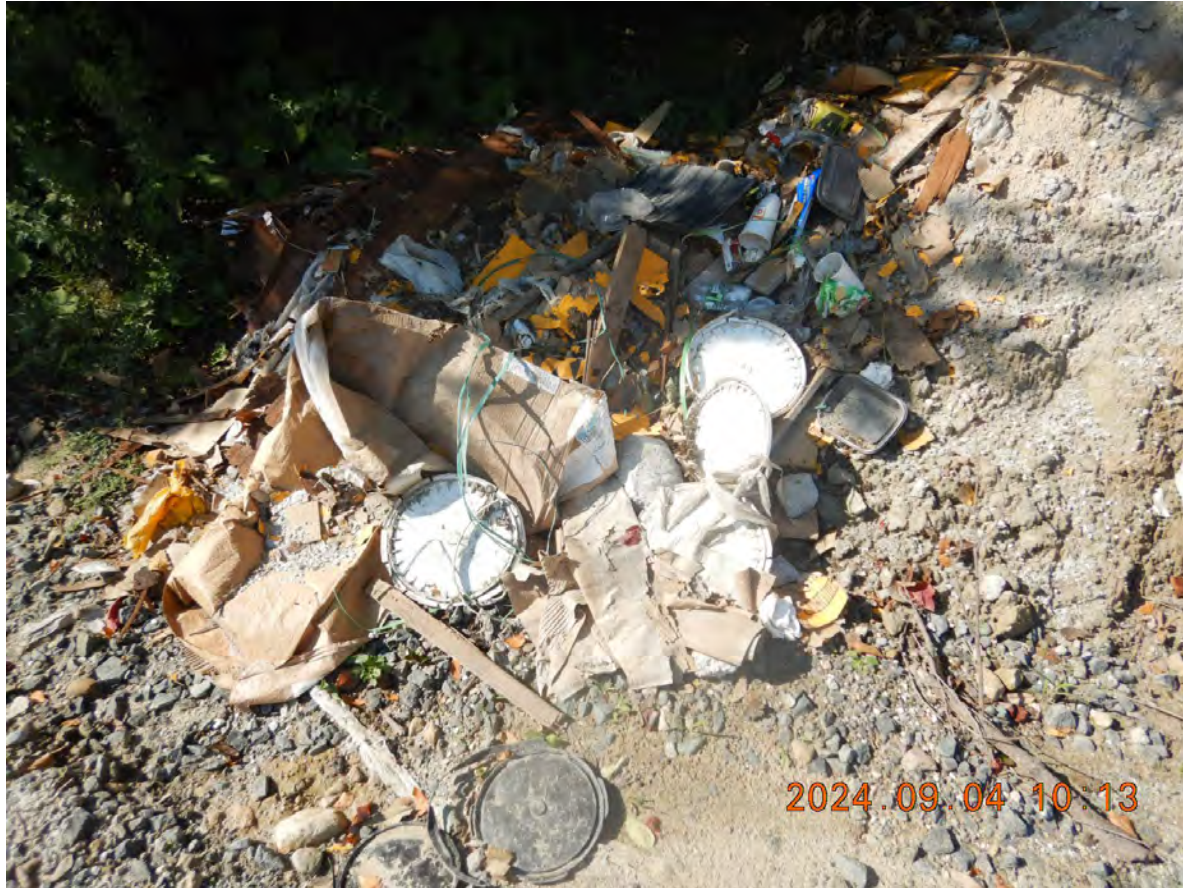
DSCN3723 – Trash and waste materials next to materials to be recycled

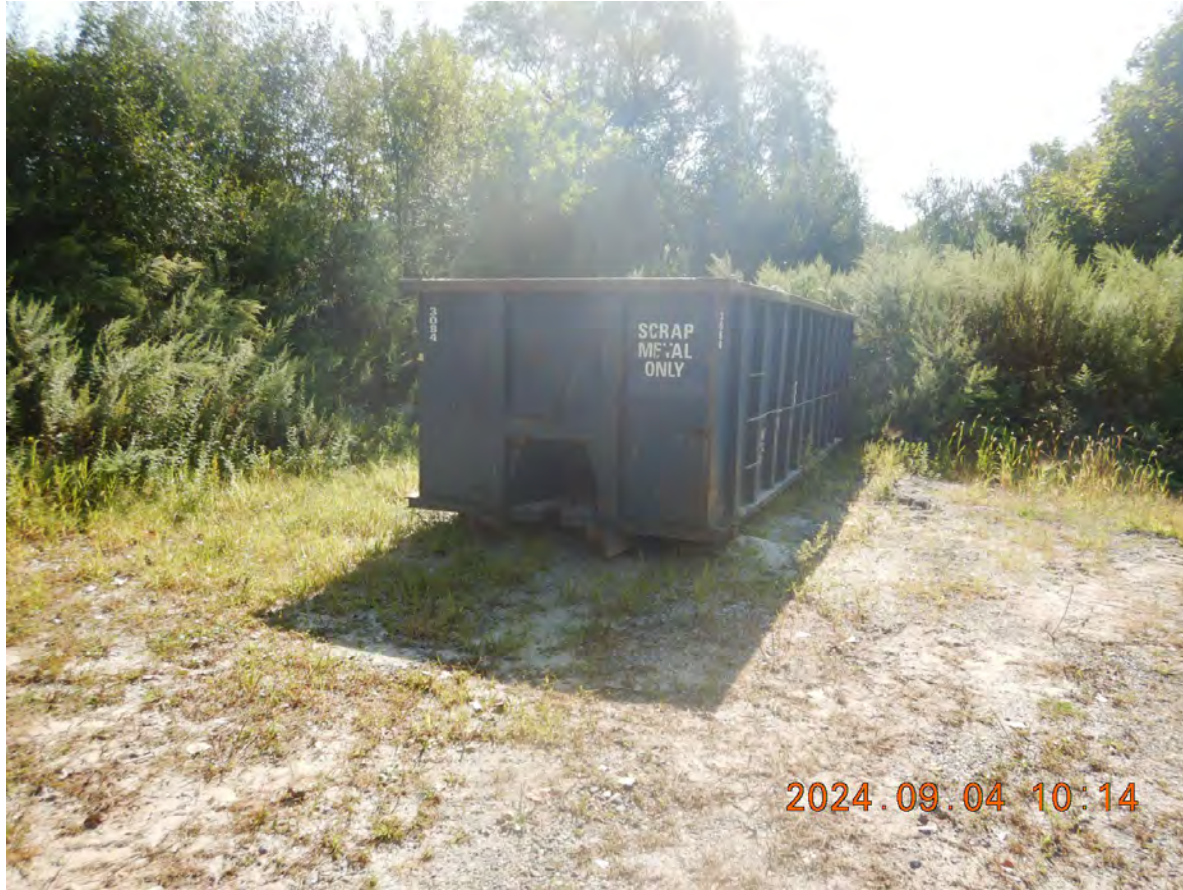
DSCN3725 – Uncovered scrap metal dumpster in southwest area of the Site; upgrade of catch basins

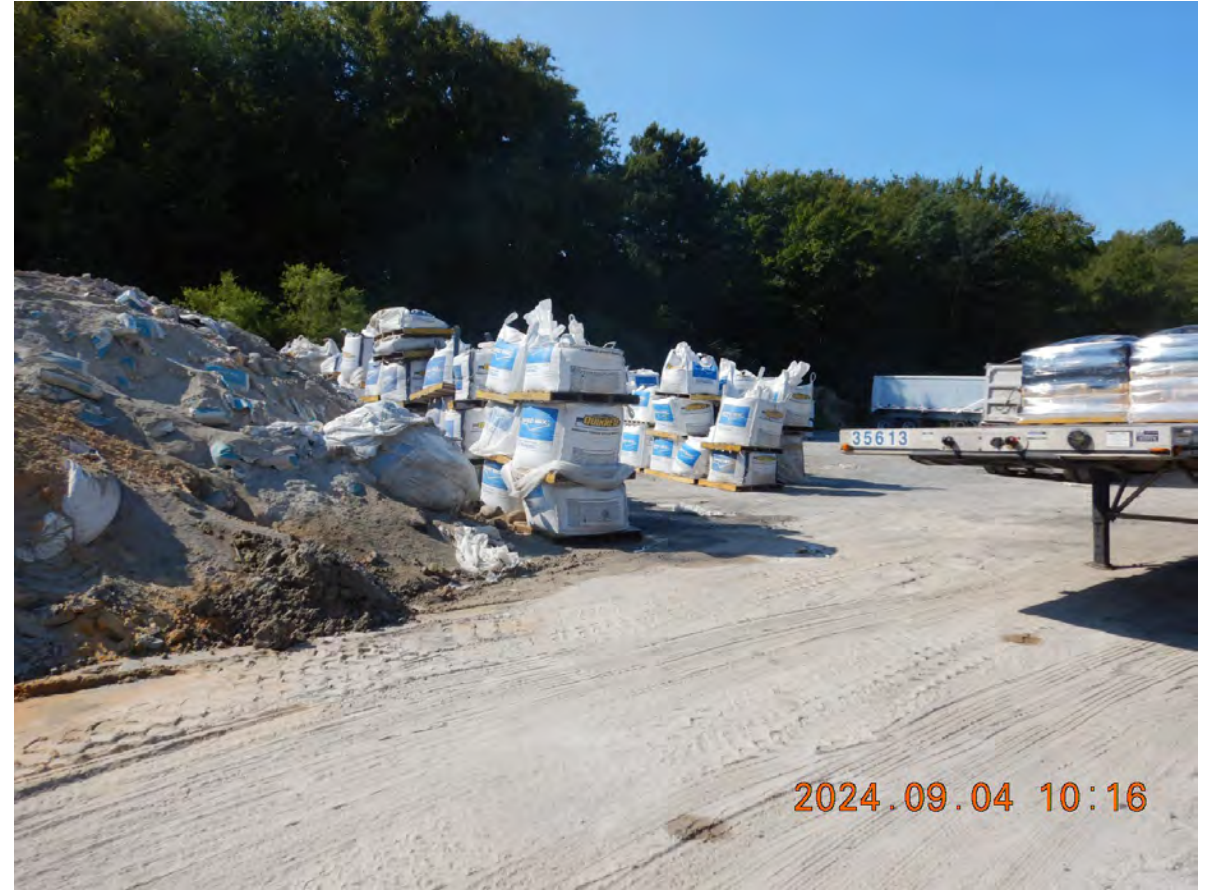
DSCN3730 – Stormwater collecting around material to be recycled
