**UNITED STATES ENVIRONMENTAL PROTECTION AGENCY, REGION 2**  
**Enforcement and Compliance Assurance Division**  
**Water Compliance Branch**  
**Clean Water Act (CWA) Inspection Report**

<b>Program:</b> Industrial Stormwater (5G2)	<b>Inspection Type:</b> Compliance Evaluation Inspection
<b>Site Name:</b> Tri-State Quikrete	<b>NJPDES/ICIS No.:</b> NJG167789
<b>Inspection Entry Date:</b> 09/04/2024 <b>Inspection Entry Time:</b> 9:40 AM	<b>Inspection Exit Date:</b> 09/04/2024 <b>Inspection Exit Time:</b> 11:00 AM
<b>Facility Inspected:</b> Tri-State Quikrete 150 Gold Mine Road Flanders, NJ 07836	
<b>Lat, Long:</b> 40.88045, -74.71525 <b>NAICS / SIC Code:</b> 3272 - Concrete Products, Except Block and Brick	
<b>EPA Representative(s):</b> Christina Palmrose-Krieger, EPA Region 2, 212-637-4049, <a href="mailto:Palmrosekrieger.Christina@epa.gov">Palmrosekrieger.Christina@epa.gov</a>	
<b>State Representative(s):</b> N/A	
<b>On-site Facility Representative(s):</b> Tony Miceli, Operations Manager, <a href="mailto:Tony.Miceli@quikrete.com">Tony.Miceli@quikrete.com</a>	
<b>Name and Address of Responsible Official:</b> Tony Miceli 150 Gold Mine Road Flanders, NJ 07836

Attachment 1 – CEI Phot

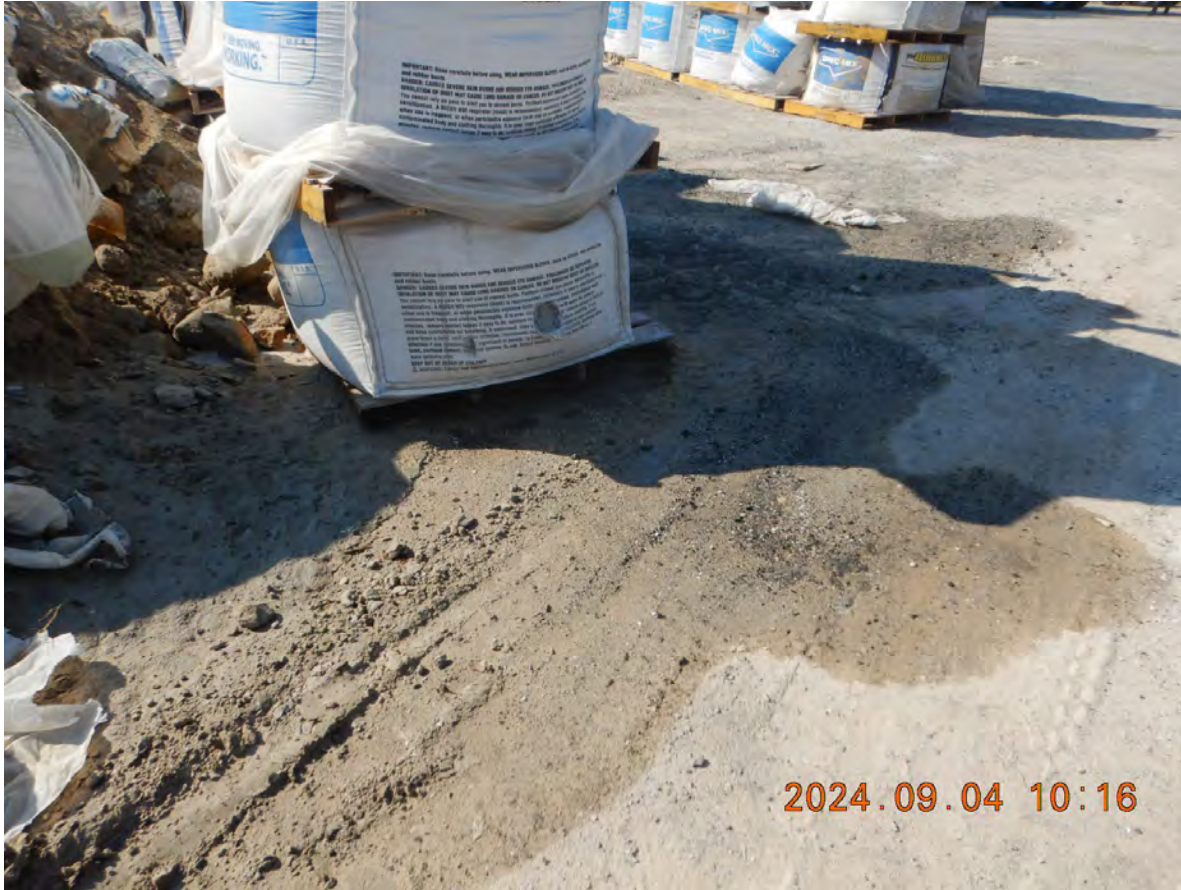
- b. EPA observed stormwater collecting and flowing downhill from waste storage, uncovered dumpsters, and recyclable material areas (Attachment 1; DSCN3725, DSCN3731, DSCN3702, and DSCN3723)

DSCN3731 - Stormwater collecting around material to be recycled

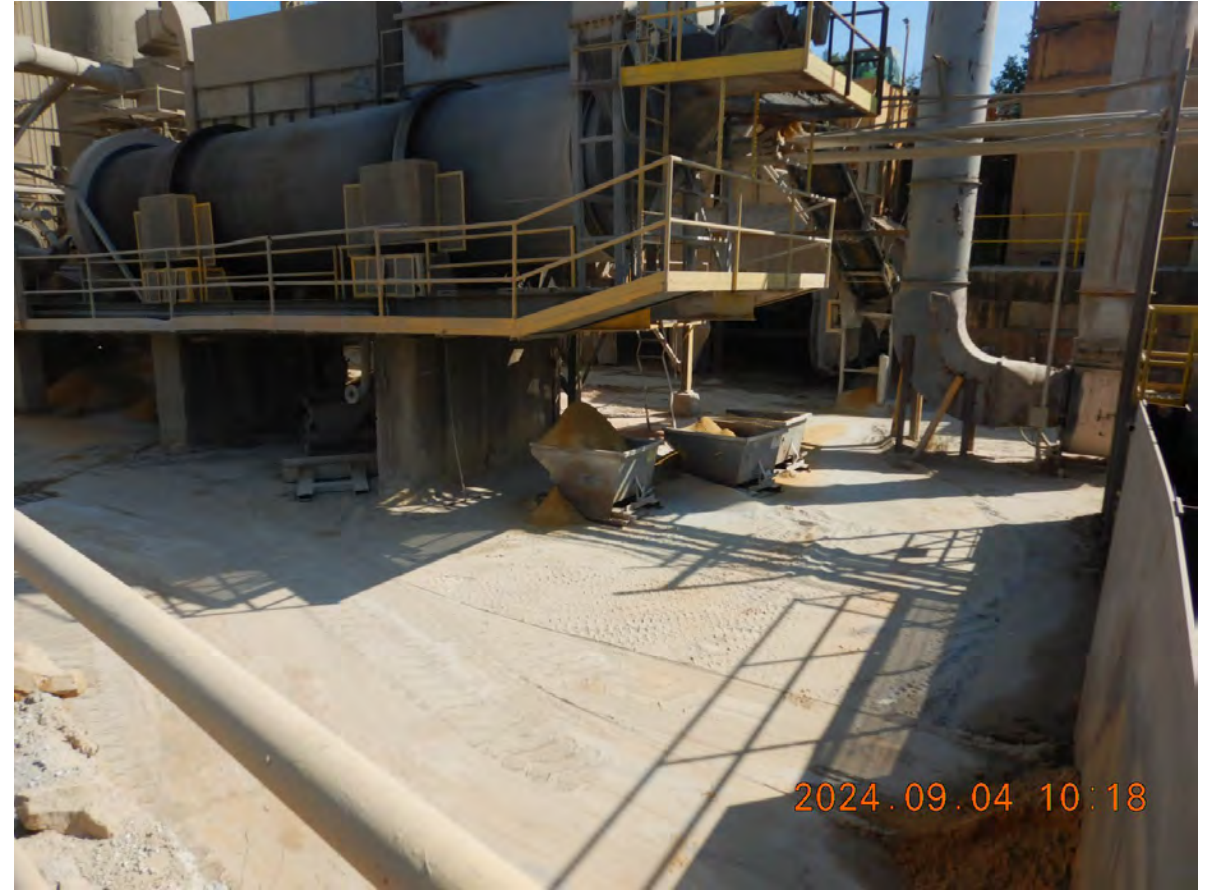
- f. Dust collector bins were overflowing with collected materials (Attachment 1; DSCN3739)
6. Part I.F.4.a of the Permit states that the SPPP is required to include a plan that ensures regular, preventative maintenance and appropriate repairs, including replacement of all structural BMPs and the updating of non-structural BMPs such as Standard Operating Procedures (SOPs). At the time of the CEI, the Facility's provided SPPP did not include a sufficient narrative description of the structural BMP maintenance repairs and or/replacement nor the updating of non-structural BMPs to ensure that the Facility does not discharge any unpermitted wastewaters (Attachment 3.b).

DSCN3739 – Central area of Site near silos; material collected to be recycled; material overflowing dust collectors

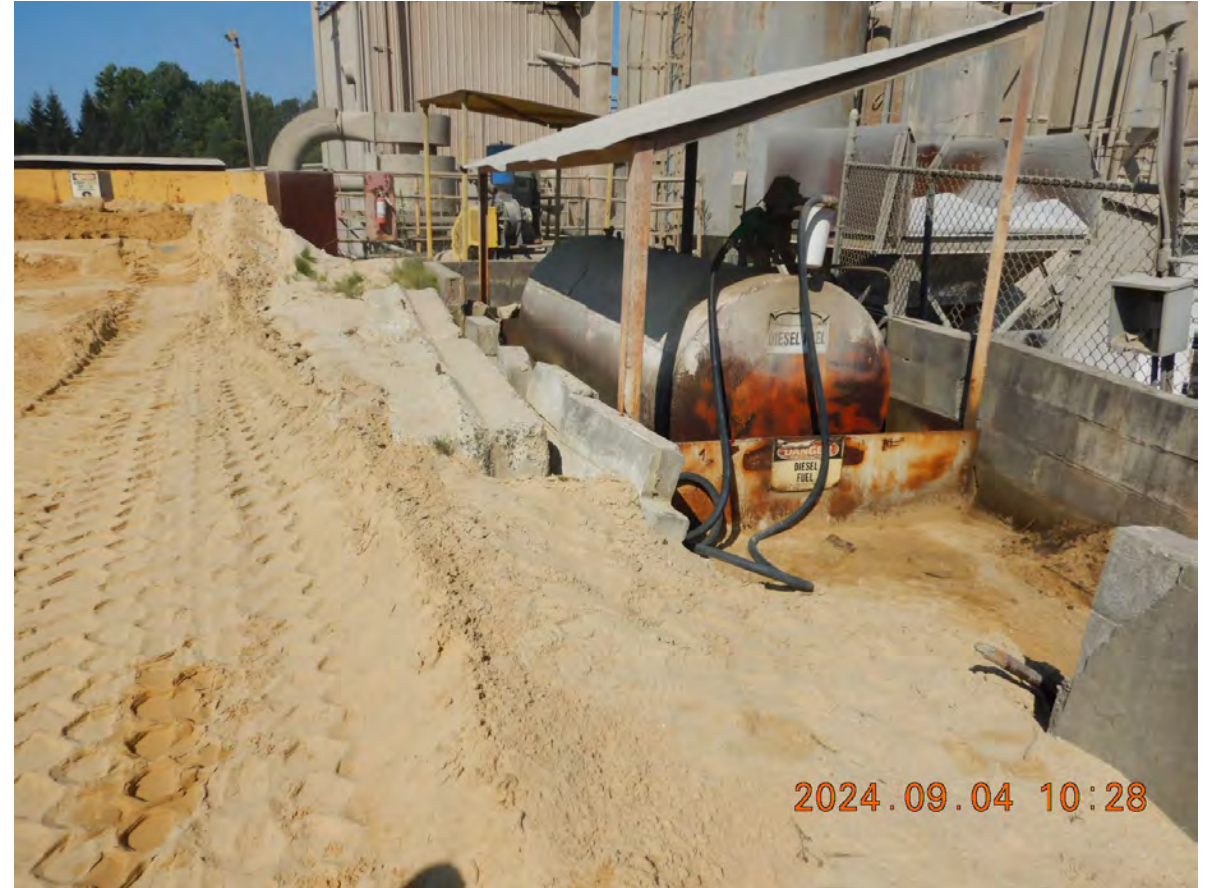
- e. EPA observed secondary containment of the diesel tank was in need of repair and staining was visible on the source material near the fueling hose (Attachment 1; DSCN3752)

DSCN3752 - Diesel fuel storage used for front end loader; secondary containment in need of repair

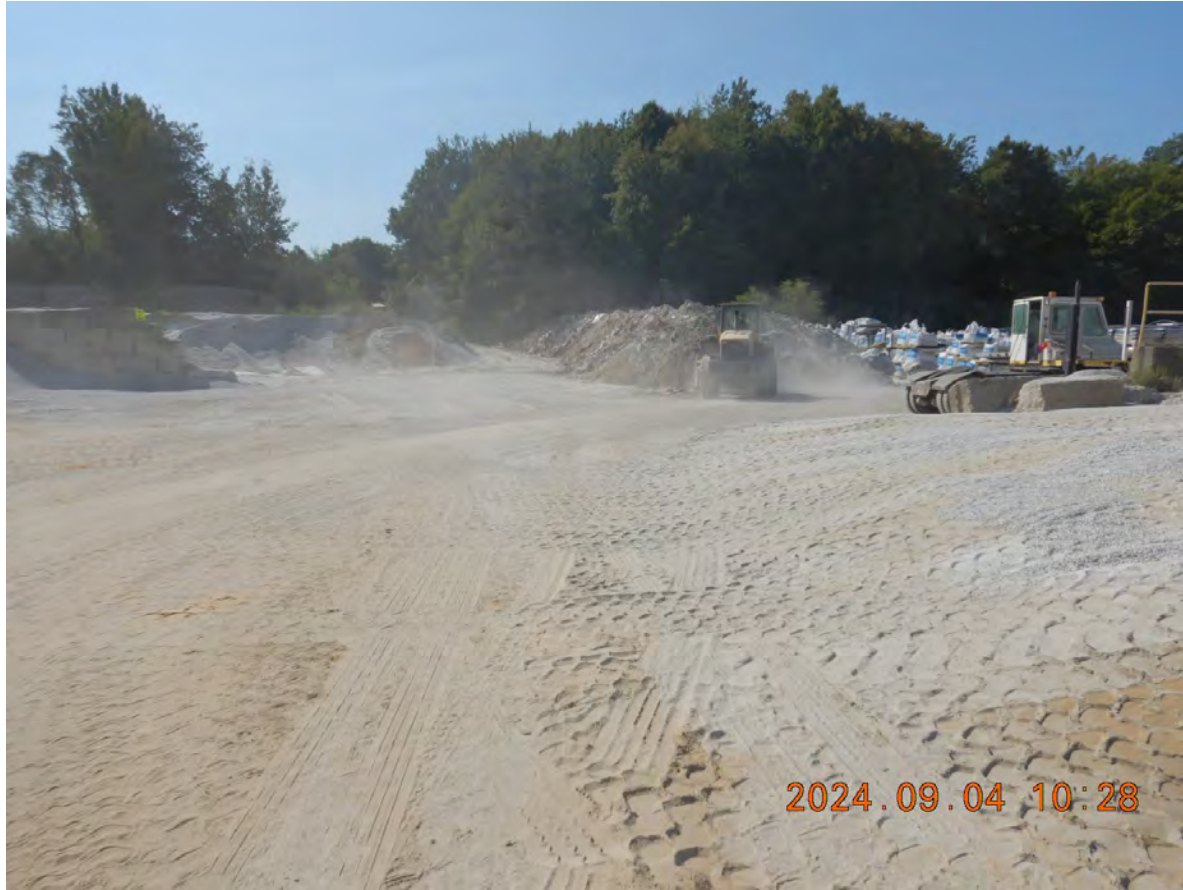
- c. EPA observed significant amounts of source material on pavement along the main drive, loading and unloading areas, and onto Gold Mine Road (Attachment 1; DSCN3694, DSCN3700, DSCN3711, DSCN3755, and DSCN3767)

DSCN3755 – Front end loader moving source material

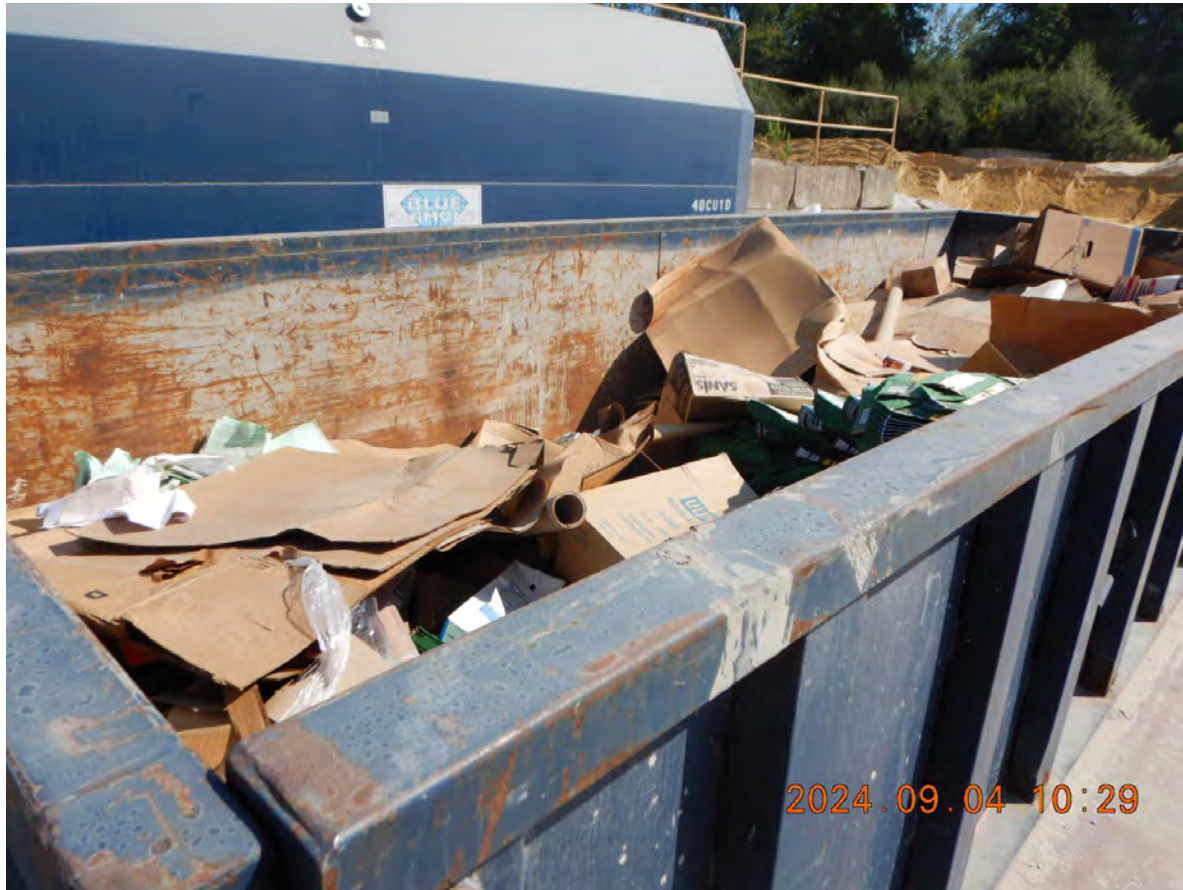
DSCN3762 – Uncovered dumpster near trash compactor

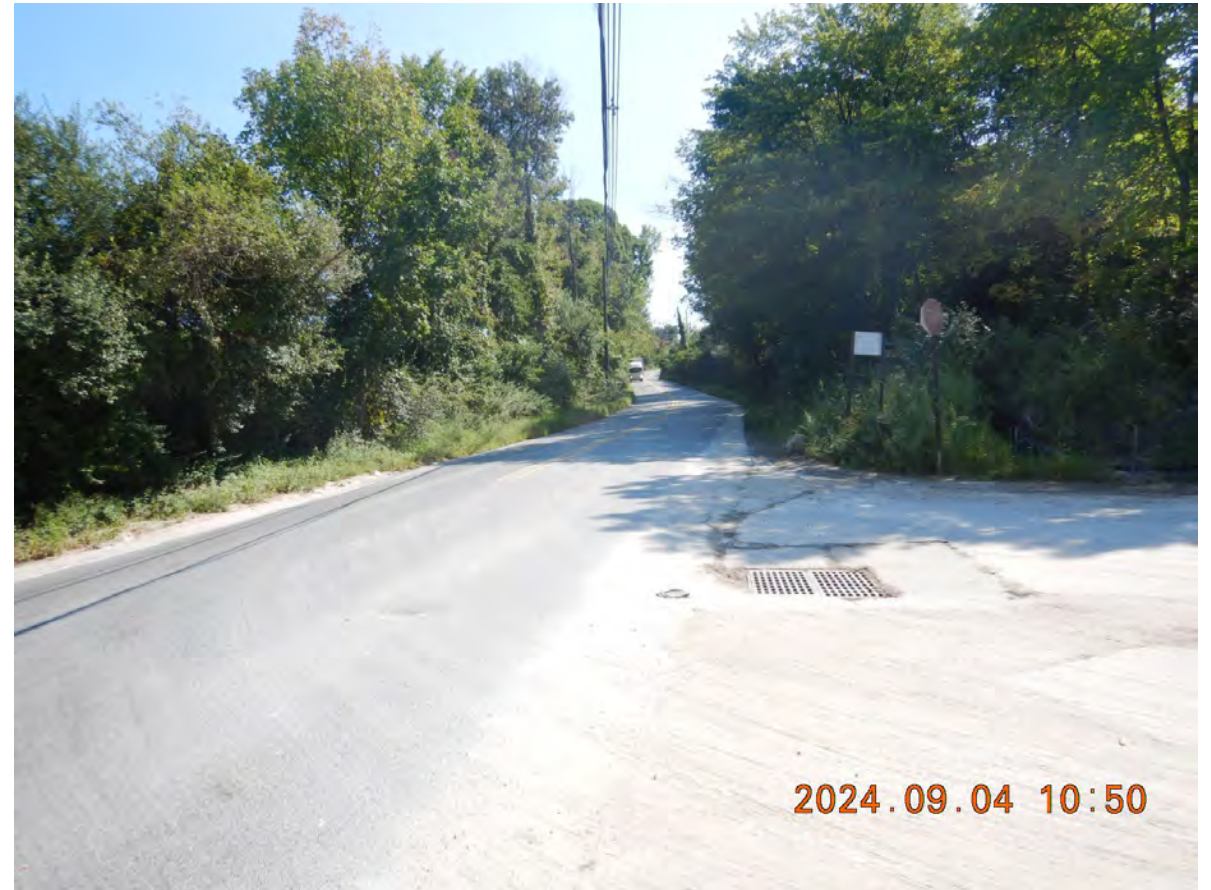
DSCN3767 – Catch basin near entrance; source material along road and driveway

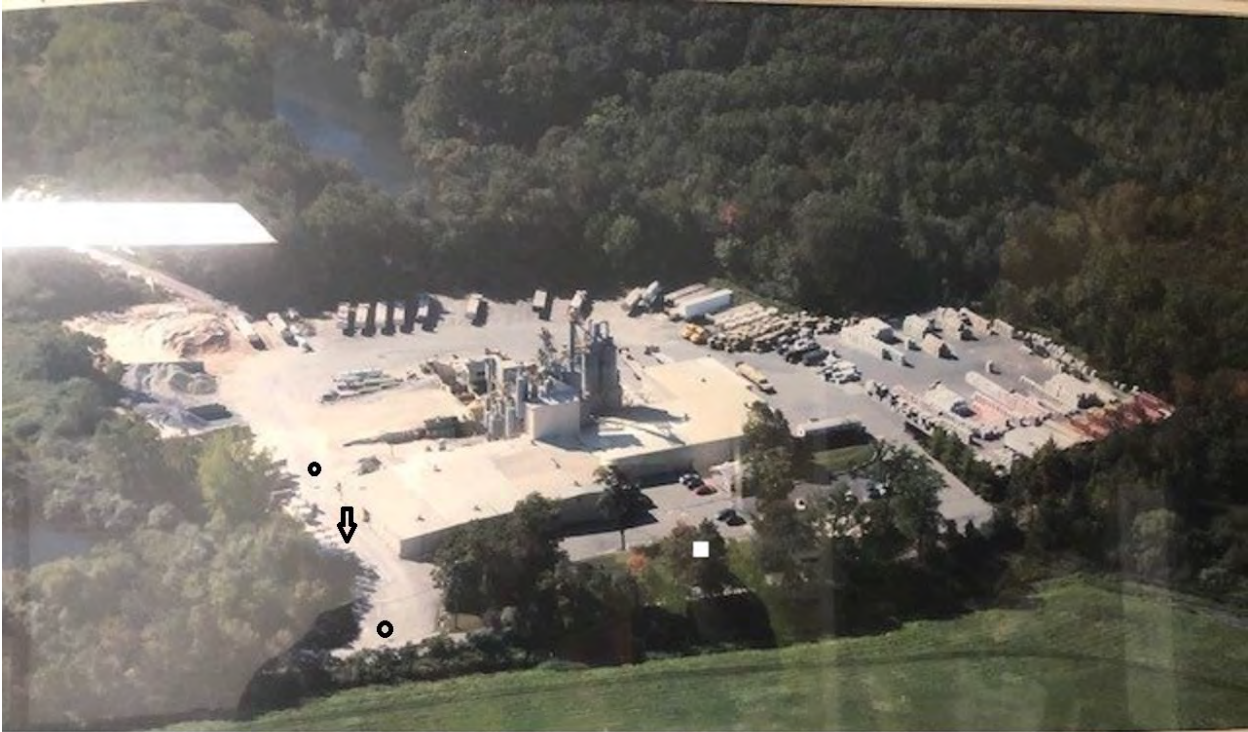
*General Location Map / Site Map*

The map provided by the Facility did not include all required elements listed in Part I.F.2 of the Permit (Attachment 3.b).

2. The Facility representative stated, and the provided Facility SPPP indicates, that there are two (2) catch basins located at the Facility. However, the provided SPPP map of the Facility is not clearly labeled. The previous inspection report provided by NJDEP indicates that there are five (5) stormwater catch basins that discharge off-site. Clarification is needed on how many catch basins are located at the Facility.
