### INSPECTION REPORT

| Media Program: | RCRA Compliance Evaluation Inspection | |
| Company Name: | Invista Houston | |

Appendix 1 – Photo Log – 3 photos taken on 10/6/2022

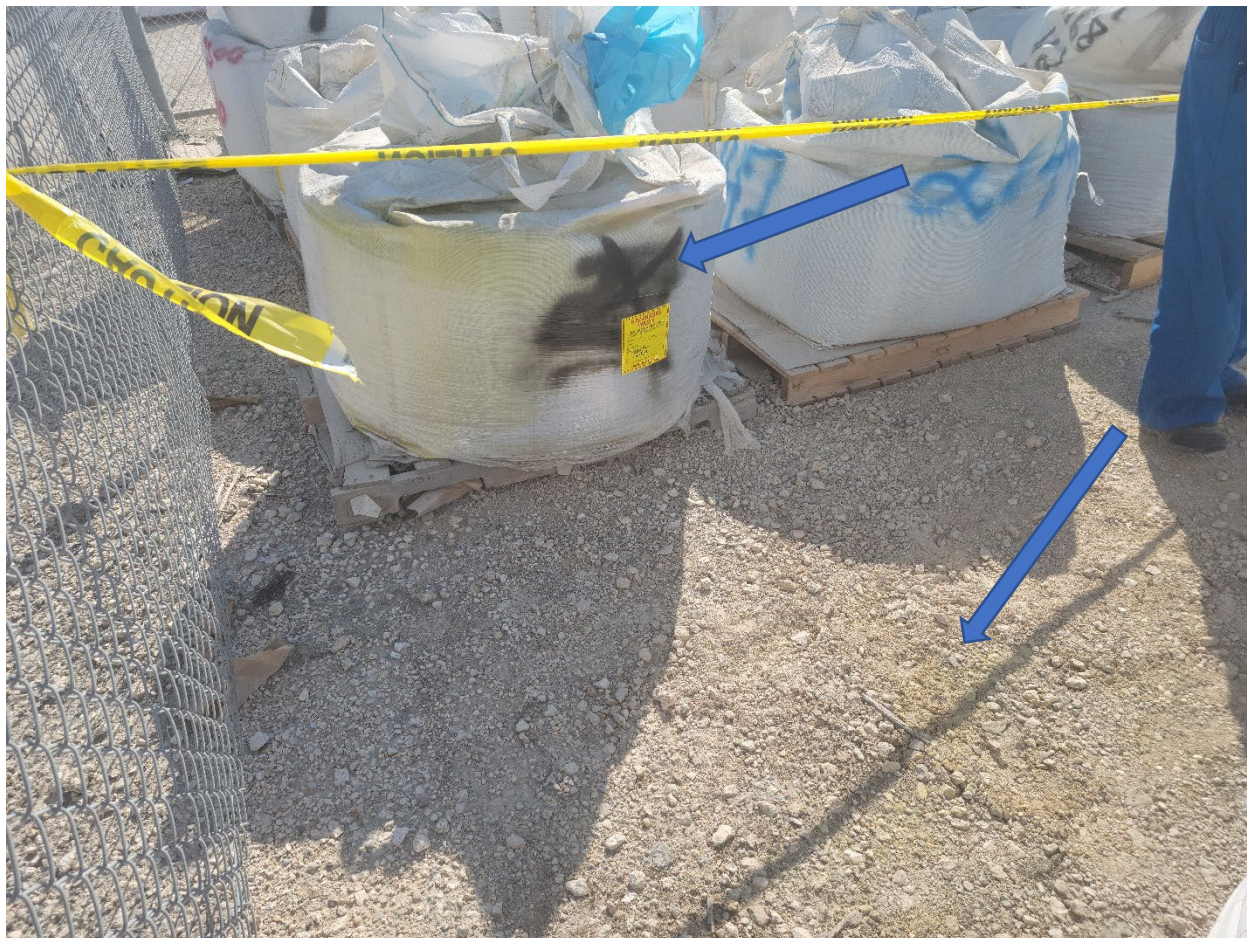
Photo No. 1

inspection. I saw yellowish-green discoloration on the ground near the super sack and green discoloration on the bag. See Appendix 1. Since constituent of concern is chromium, the facility will need to evaluate this as a potential spill of waste. Catalyst support media was seen on the ground in the area, but I did not identify any catalyst. All the containers were labeled and dated at WMU 41.

- Based on my observation, the facility needs to evaluate the possible spill of hazardous waste material at WMU 41 40 CFR 262.17 (a)(1).
- Facility weekly inspection require further review. I was unable to track inspection records for, WMU 39 and WMU 41, super sack storage area 40 CFR 262.17(a)(1)(v).

| Description: Spill located at WMU41- blue arrows added to photo to indicate area of contamination. | |

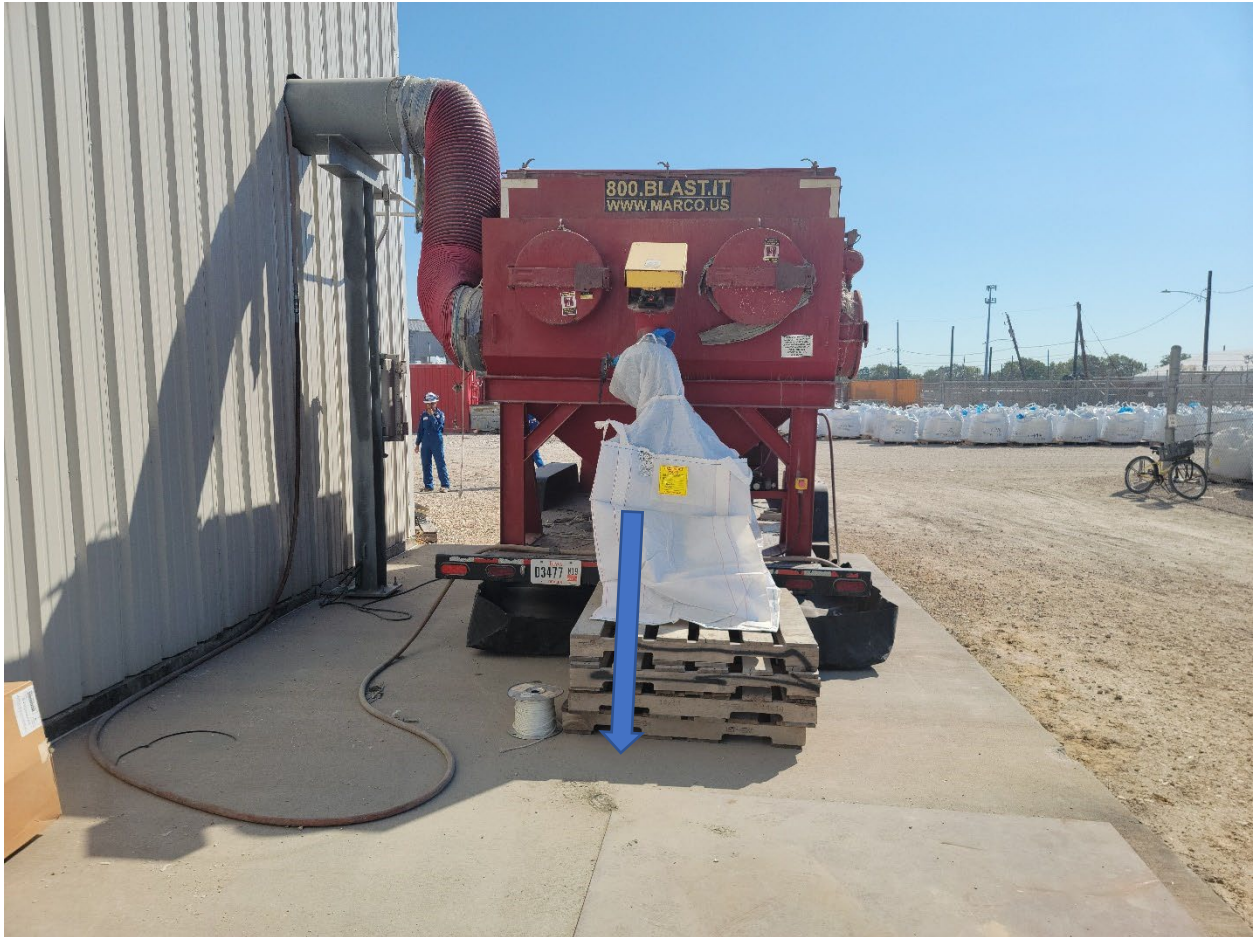
Photo No. 2

This system is located outside WMU 39. Dust from the catalyst process is controlled by a cartridge dust collector and accumulates in an attached super sack. I observed a small spill of dust near the dust collector on the concrete pad. See Appendix 1.

| Description: Dust collection system outside WMU 39, blue arrow added to photo to indicate spill on the concrete pad. | |

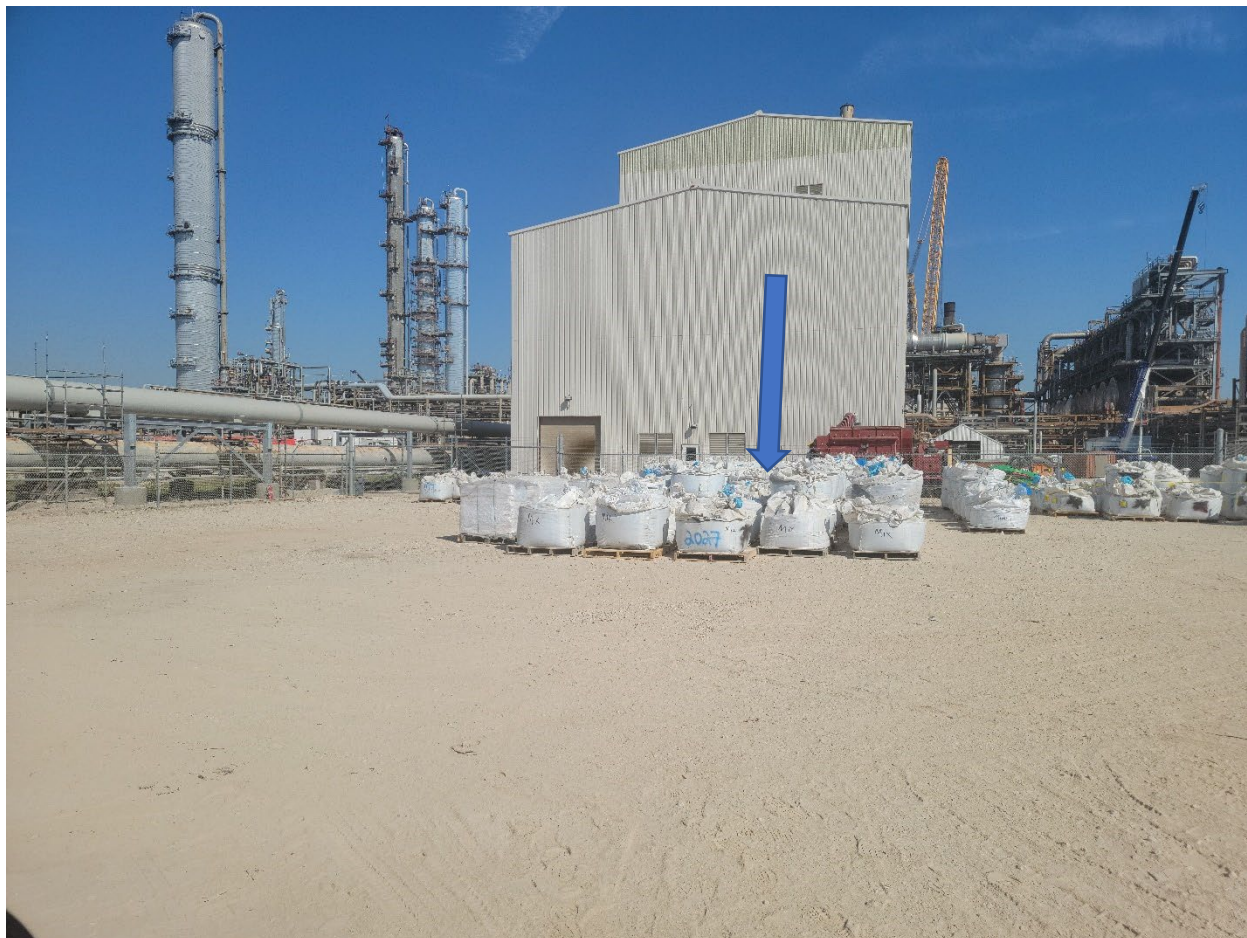
Photo No. 3

WMU 41 contains a super sack staging area and roll off containers used for storage of waste catalysts. I noticed the super sack staging area lacks aisle spacing to fully access material and conduct proper

| Description: Overview of WMU 41- blue arrow added to photo to indicate lack of aisle spacing. | |

- A lack of aisle spacing prevents full access to the supersacks for a complete evaluation
- Catalyst support media was seen on the ground in the area but we did not identify any catalyst
