### INSPECTION REPORT

| Company Name: | <b>CapturePoint, LLC</b> | |
| Facility Name: | <b>North Burbank Unit (NBU) 83 Battery</b> | |

EPA conducted an inspection at the CapturePoint, LLC North Burbank Unit 83 Battery, where NBU well 92-2 released oil into a nearby, unnamed tributary of Salt Creek.

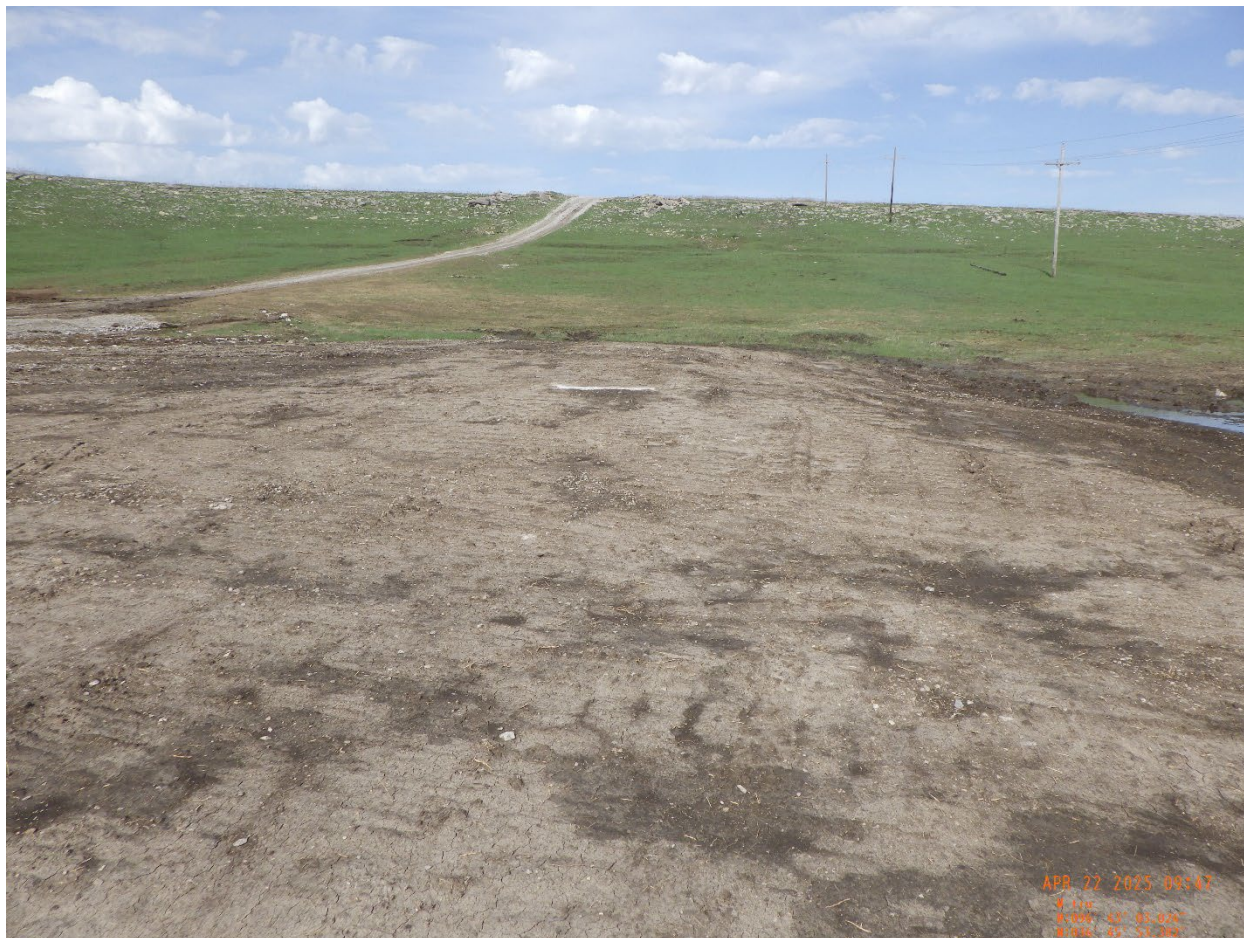
Photo No. 1

I observed the well location for well 92-2. At the time of the inspection, the well had been plugged and restored. See photo No. 1 and 2, Appendix 1 (photo log). For additional GPS location information and photo metadata, see the attached photo log.

**Description:** This was the well location where the spill originated, post plugging and restoration.

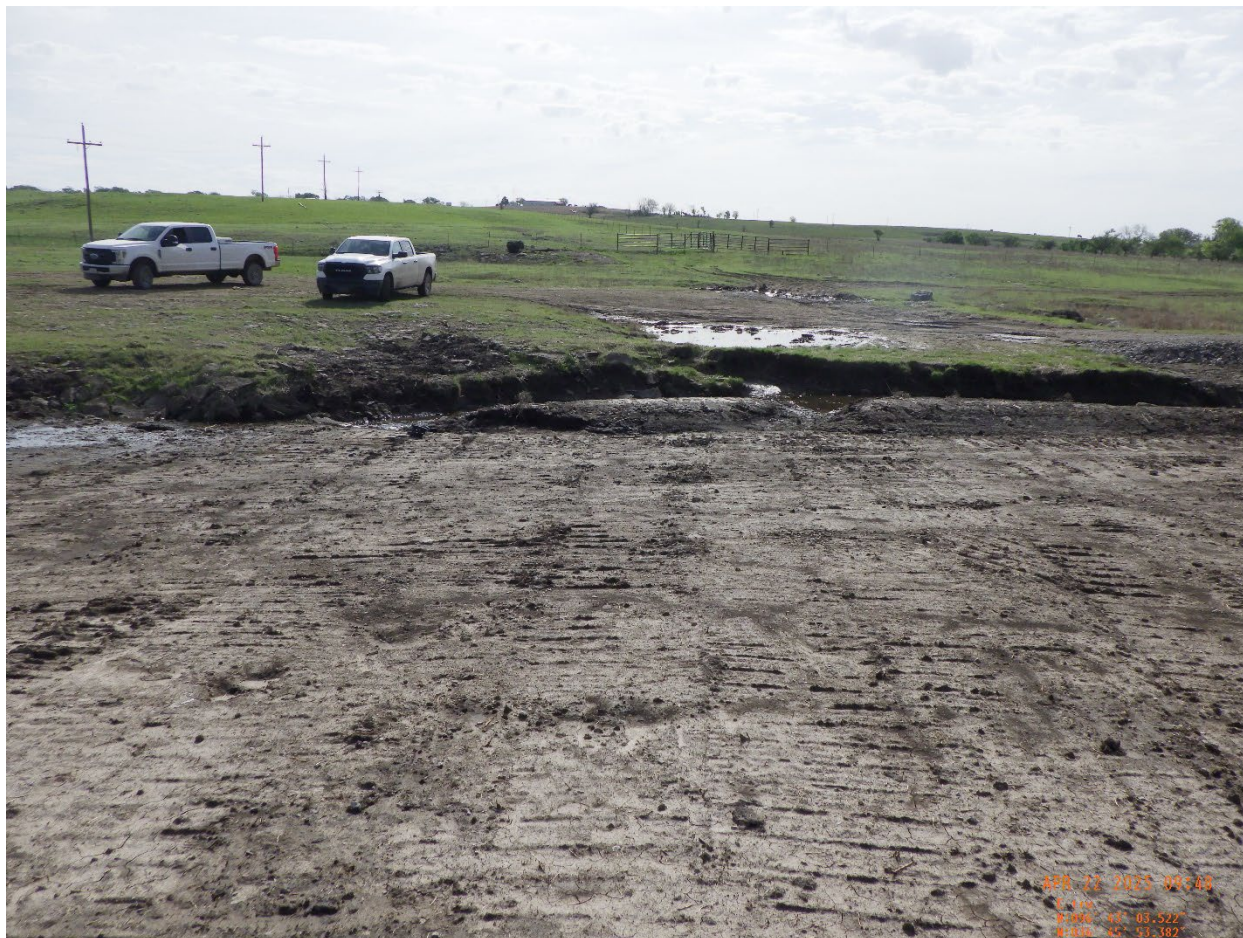
Photo No. 2

**Description:** This was a view toward the east, across the well location, looking toward the unnamed tributary of salt creek.

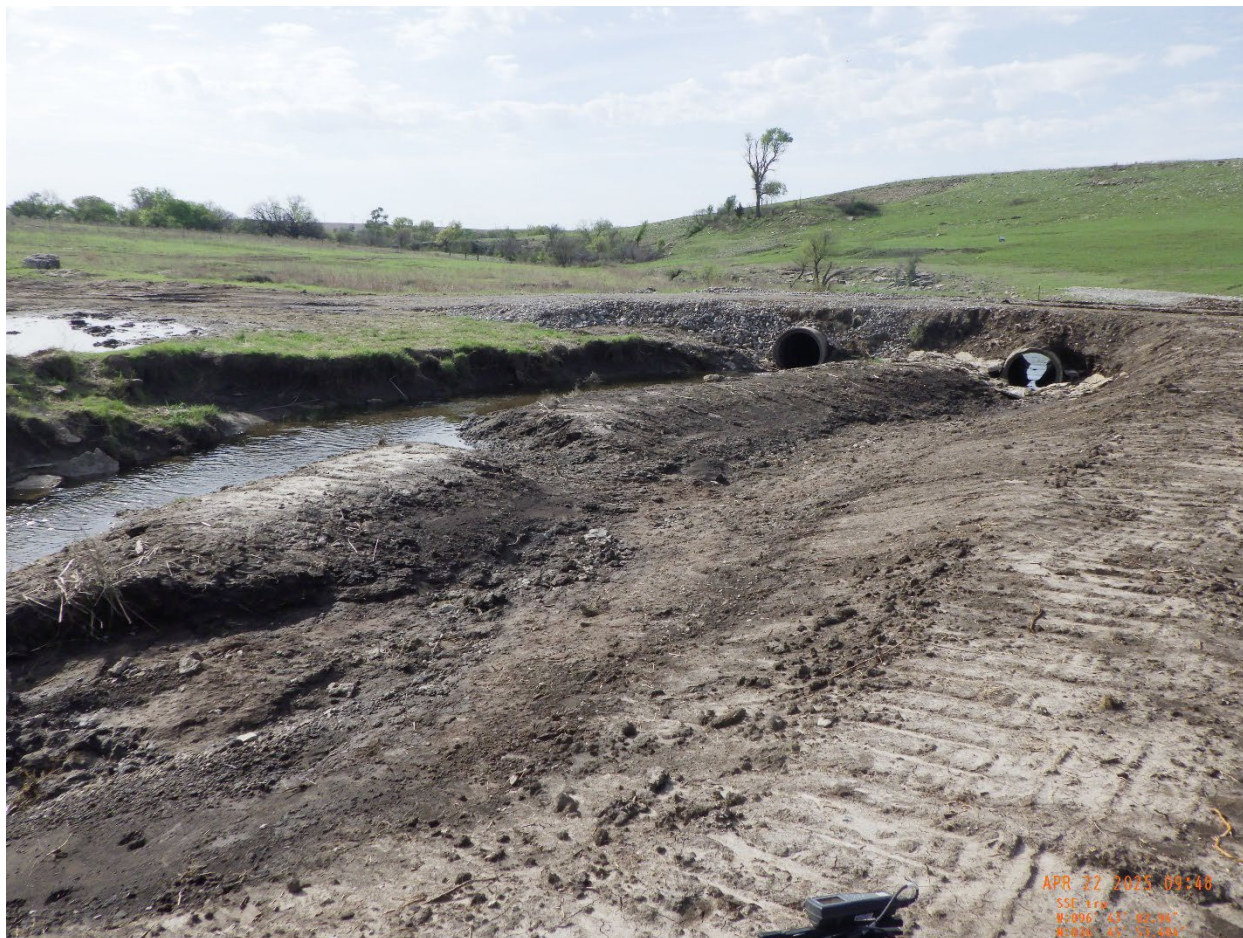
Photo No. 3

I observed the restored portion of the impacted tributary. See photo No. 3 and 5.

**Description:** This was a view of the restored area along the impacted tributary of Salt Creek.

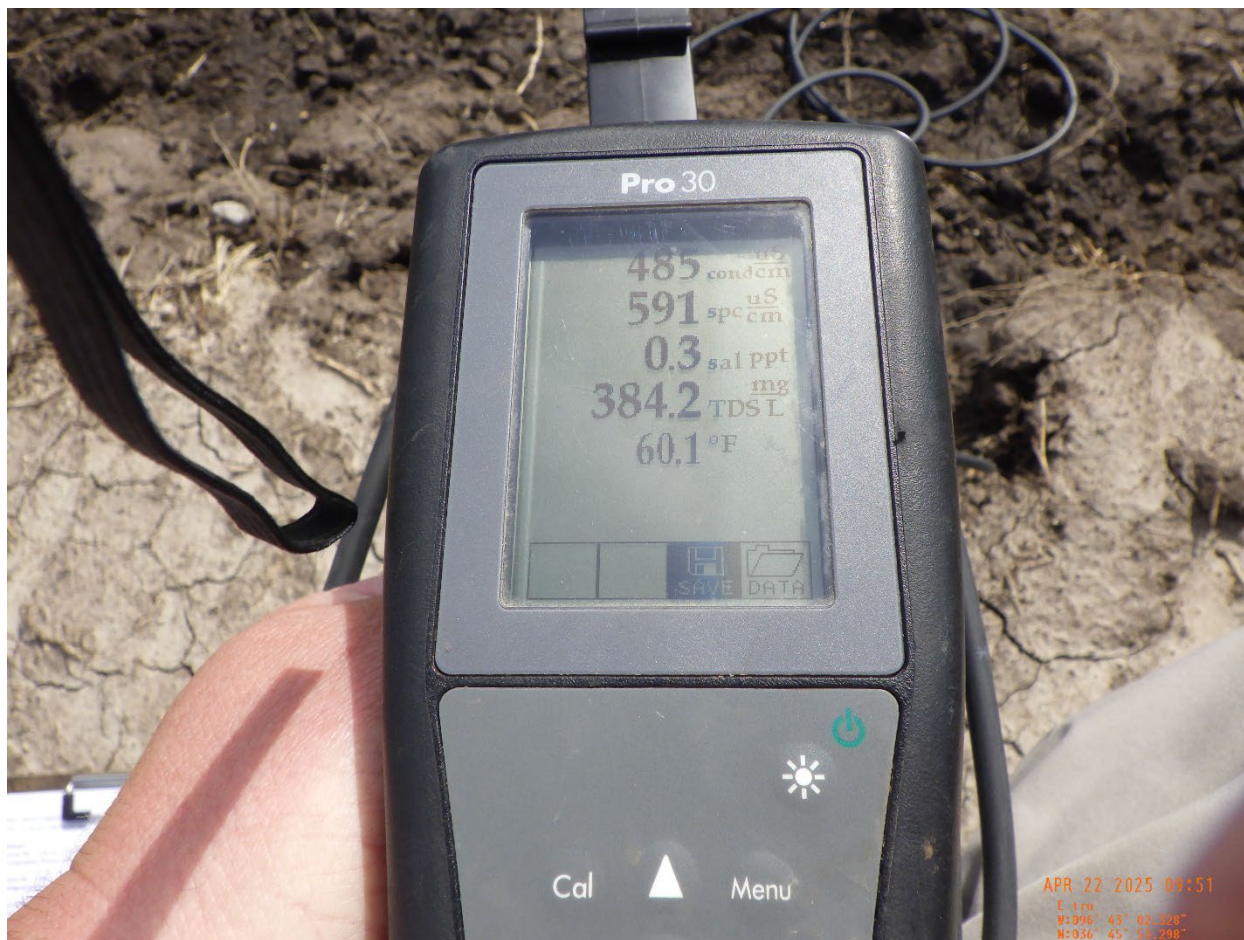
Photo No. 4

I observed a TDS field reading of 384.2 mg/L in the main channel of the impacted tributary. See photo No. 4.

**Description:** This was a TDS field reading of 384.2 mg/L taken in the main channel of the impacted tributary.

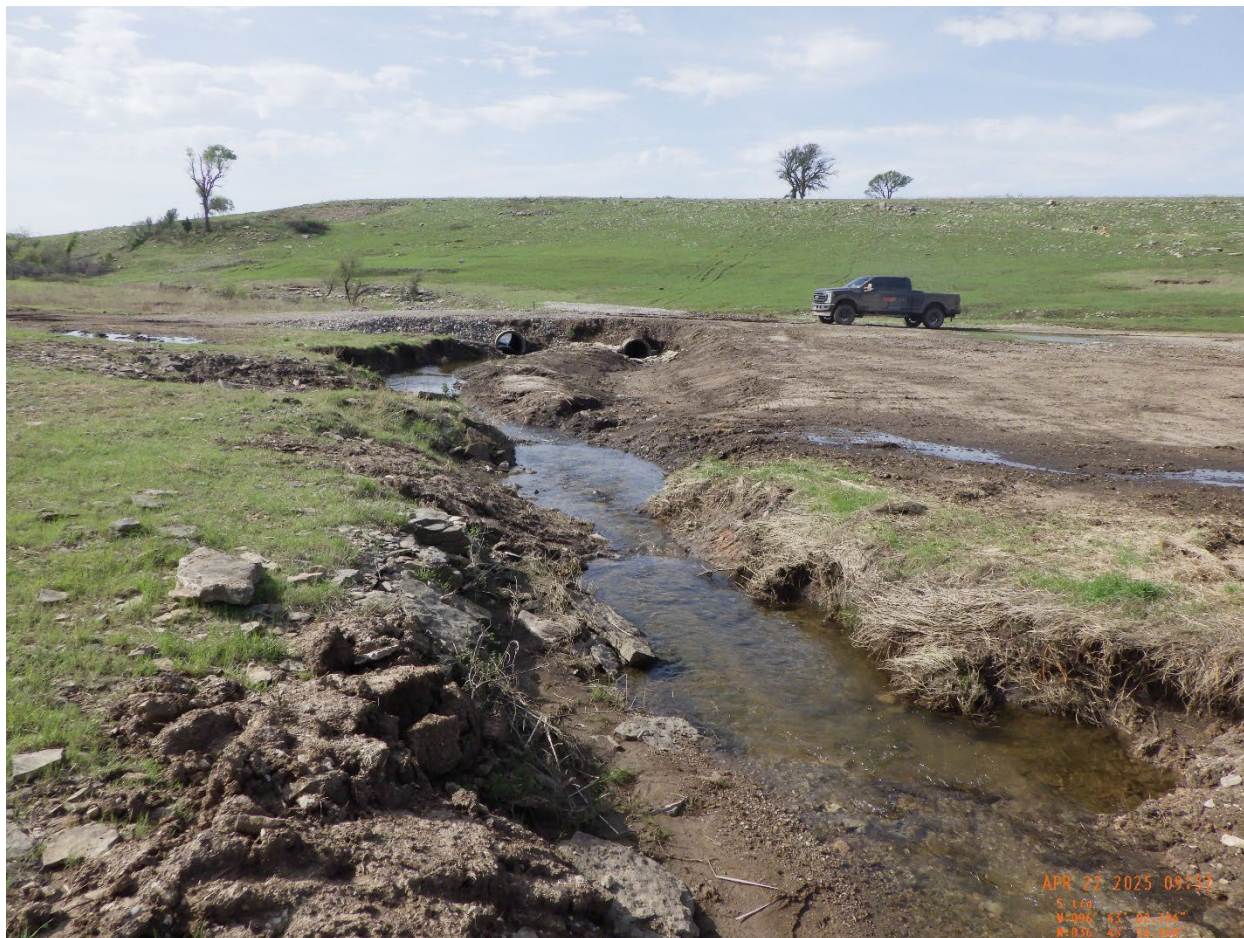
Photo No. 5

**Description:** This was an overview of the impacted portion of the unnamed tributary after the area was restored.
