**Region 6 - Enforcement & Compliance Assurance Division**  
**INSPECTION REPORT**

| Inspection Date(s): | 02/13/2024 | |
| Company Name: | Lion Elastomers, LLC | |
| Facility Name: | Port Neches Plant | |

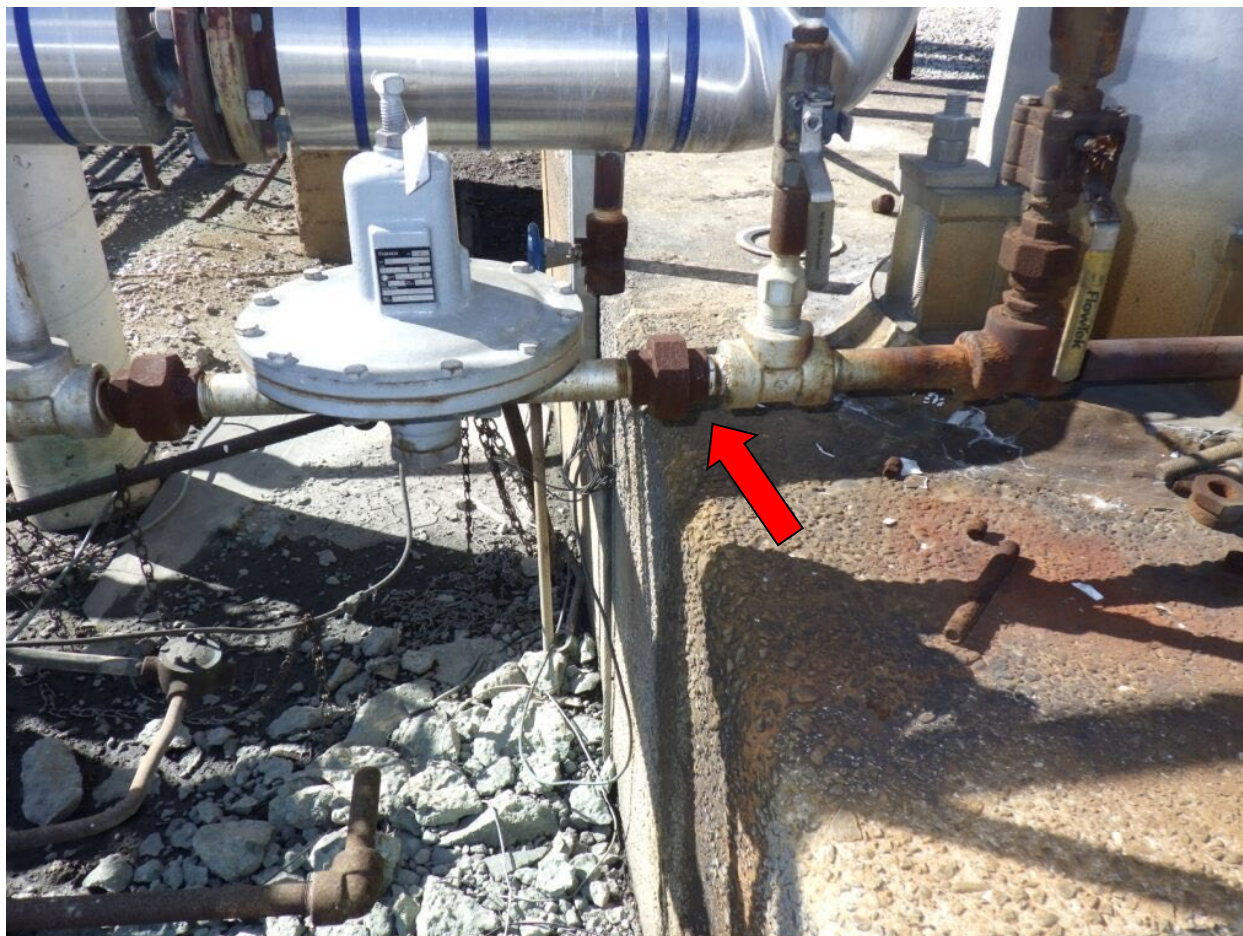
Photo No. 1

We proceeded to the southeast portion of the Facility to observe the railcar loading area, Main Flare, inactive styrene vent, and styrene unloading sump. We arrived at the Main Flare at 14:10 and visually observed a leaking steam line at the base of the flare. Mr. McPherson monitored components with the FID along the flare header and gas lines to the Main Flare. Mr. McPherson detected a measurement of 10,900 ppm VOC as methane ("VOC") along the natural gas line to the flare (see Photo 1 in Appendix 1). Inspectors also observed a potential open-ended line on the flare's knock-out drum. Inspectors noted that the Main Flare appeared to have excess steam based on visual observation. [AOC 1]

These observations indicate that the Main Flare may be operating with poor efficiency resulting in excess emissions. In addition to the observations at the flare tip, inspectors documented a natural gas leak from the Main Flare's natural gas line with a measurement of 10,900 ppm VOC. An observed steam leak and potential open-ended line at the flare knock-out drum indicate the Facility may not be conducting visual inspection of flare components.

Description: Natural gas line leak detected with a measurement of 10,900 ppm VOC. Arrow denotes where the measurement was detected.

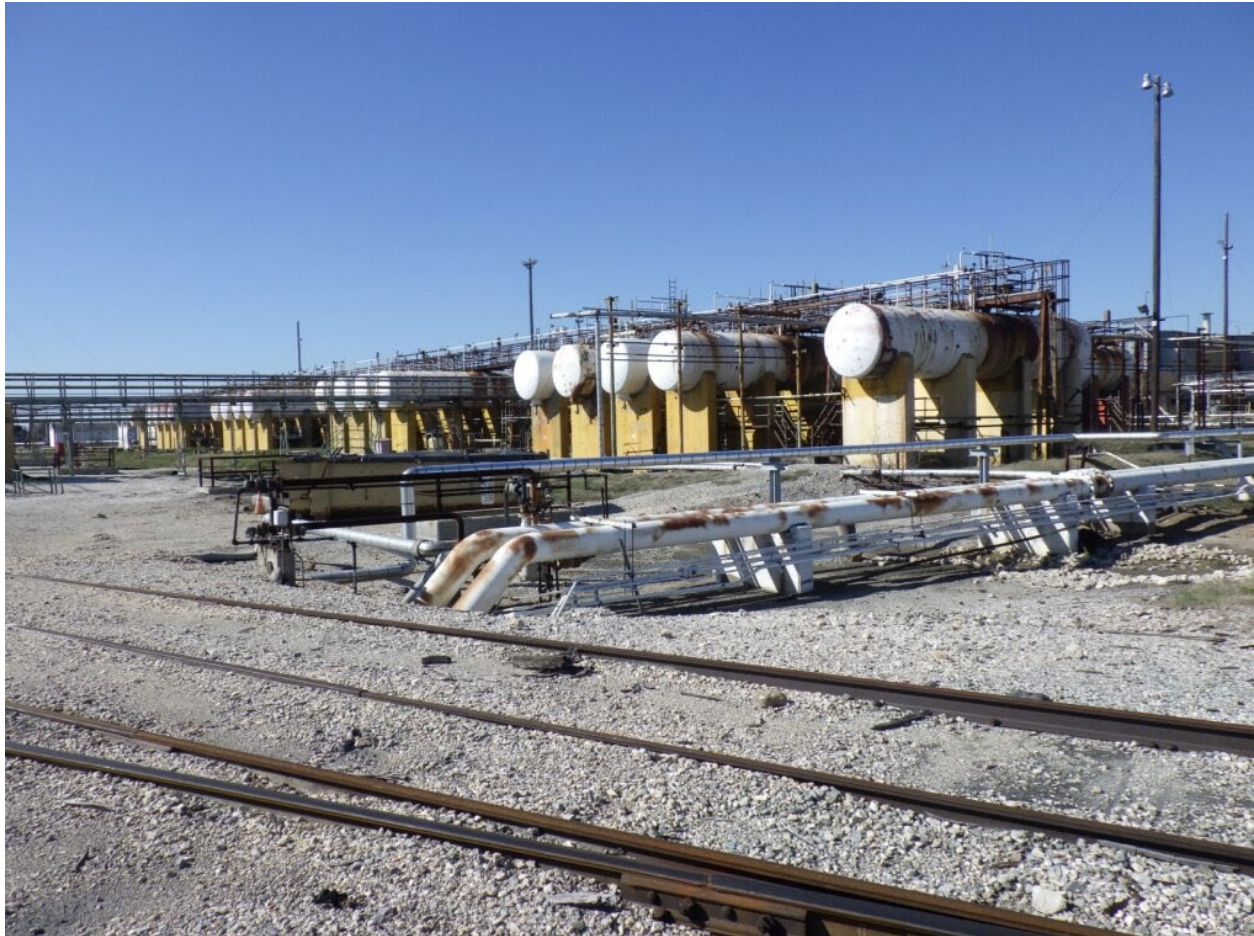
Photo No. 2

While near the Main Flare, I observed the inactive styrene vent with the OGIC and did not observe emissions. No active loading from railcars was occurring during the inspection but we were able to observe the railcar loading area and the tank farm to the north of the railcar loading area. The tanks were observed with rust and coating deterioration (Photo 2). [AOC 5]

- 5) EPA observed the tanks in the Facility tank farm with rust and coating deterioration.

Special Condition 19 of NSR Permit Number 9908 requires storage tanks' uninsulated tank exterior surfaces exposed to the sun to be white or unpainted aluminum except for labels, logs, etc. not to exceed 15 percent of the tank total surface area.

Description: Tank farm observed with rust and coating deterioration.

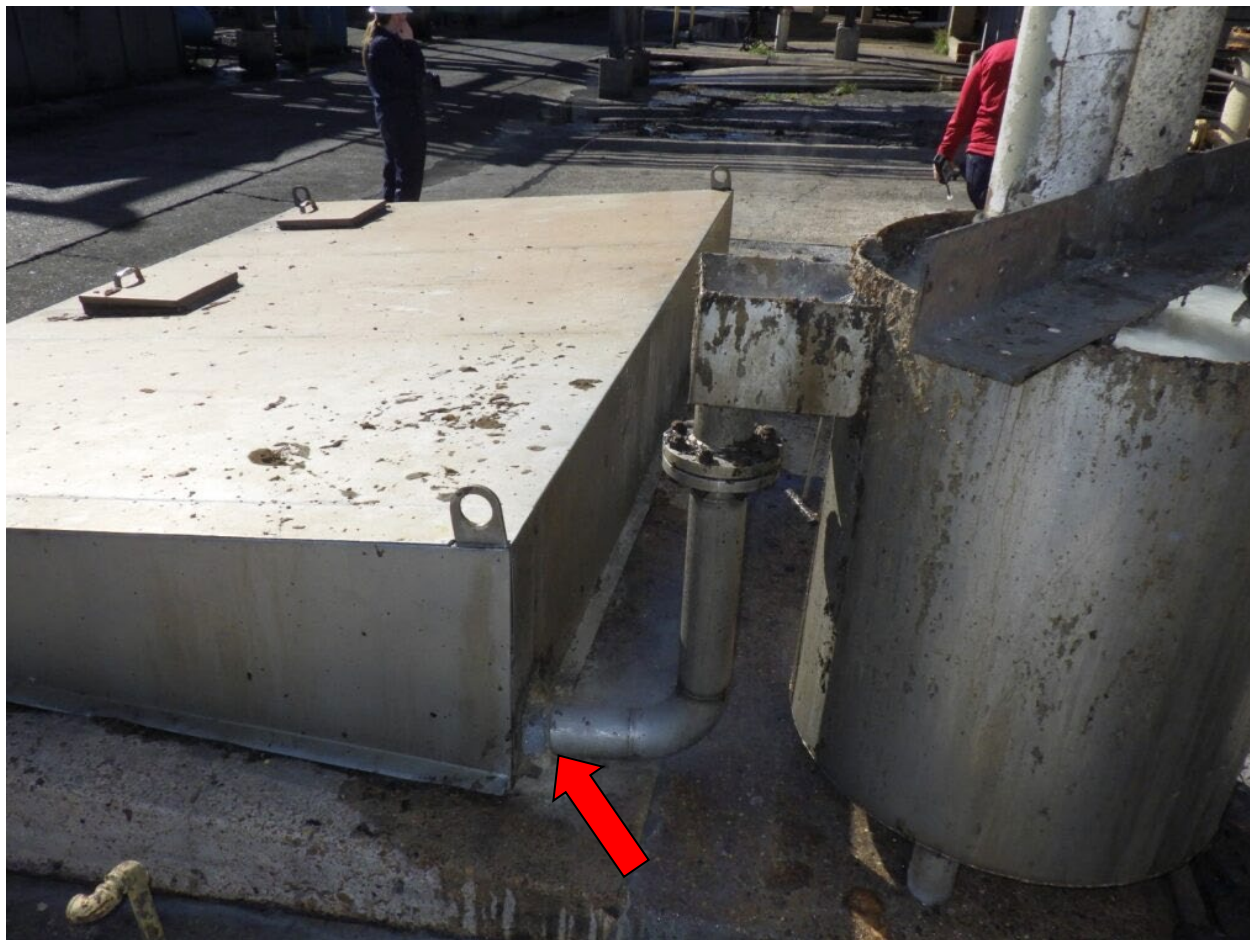
Photo No. 3

We also monitored the area with an FID. We detected up to 9,000 ppm VOC at the inlet to the wastewater sump from the "gumbo pot" (Photo 3). We detected a up to of 10,400 ppm VOC at the vent on the west side of the wastewater sump. [AOC 6,7] The background measurement on the FID while in the vicinity of the "gumbo pot" was measured between 100 and 200 ppm VOC. The Recommended Exposure Limits ("REL") designated by the National Institute for Occupational Safety and Health ("NIOSH") and Permissible Emissions Limits ("PEL") designated by the Occupational Safety and Health Administration ("OSHA") for styrene and BD are presented in Table 1. It is expected that styrene is the primary VOC detected in the area.

- 6) EPA detected elevated VOCs around the "gumbo pot" and 7C recovery area wastewater sump.

During the inspection, the FID measured a 100-200 ppm VOC background in the vicinity of the “gumbo pot” and wastewater sump. The FID also detected up to of 9,000 ppm VOC and 10,400 ppm VOC from the inlet of the gumbo pot to the wastewater sump and the vent on the west side of the wastewater sump cover, respectively. The Facility may not be identifying the “gumbo pot” or the wastewater sump as emission points. Additionally, the concentration of VOC and styrene may be exceeding exposure threshold limits, putting Facility employees at risk.

Description: "Gumbo Pot" observed on the right of image. Wastewater sump on the left of image. Arrow denotes where a measurement of 9,000 ppm VOC was detected.

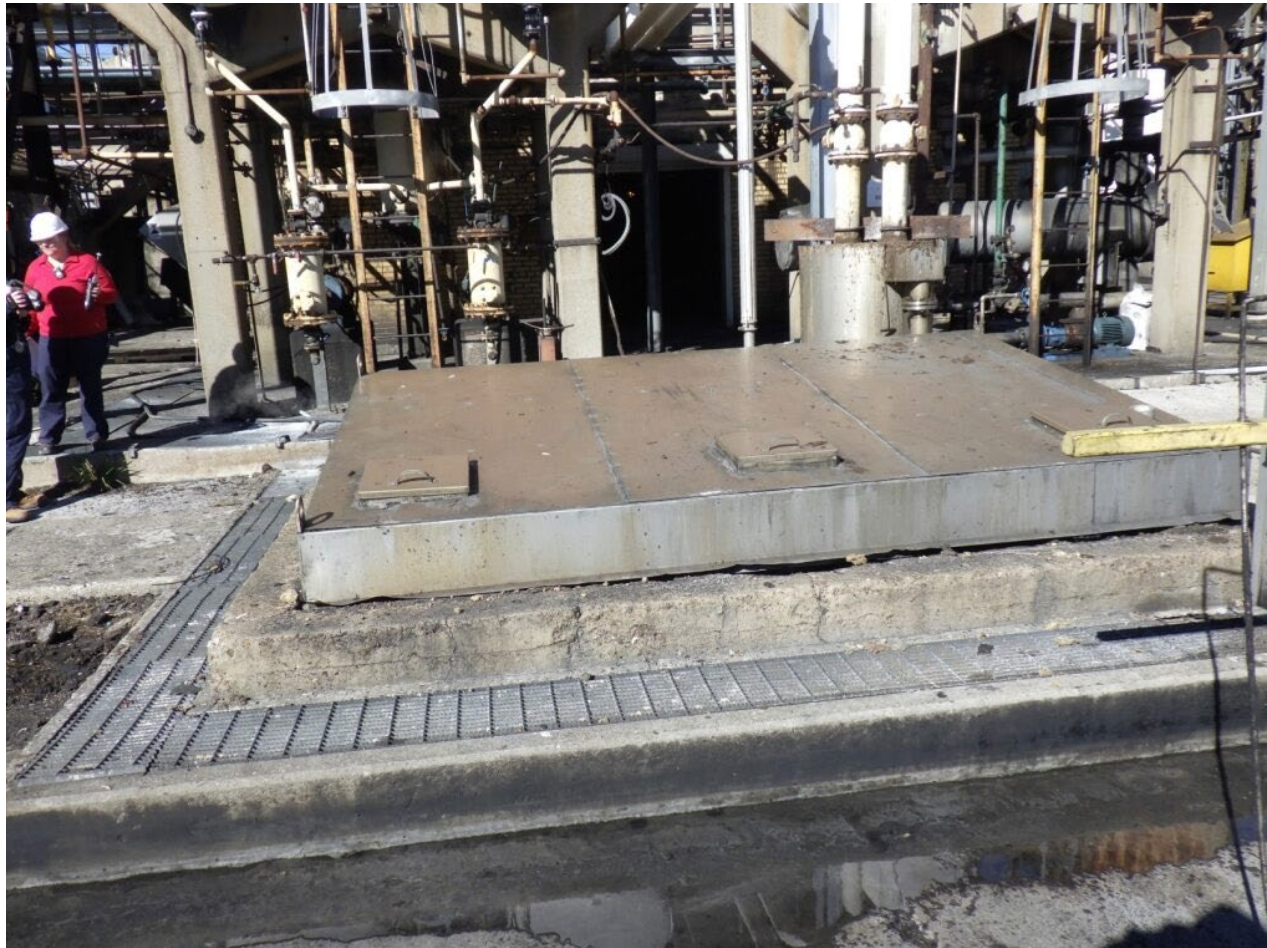
Photo No. 4

Description: Wastewater sump in 7C recovery area.

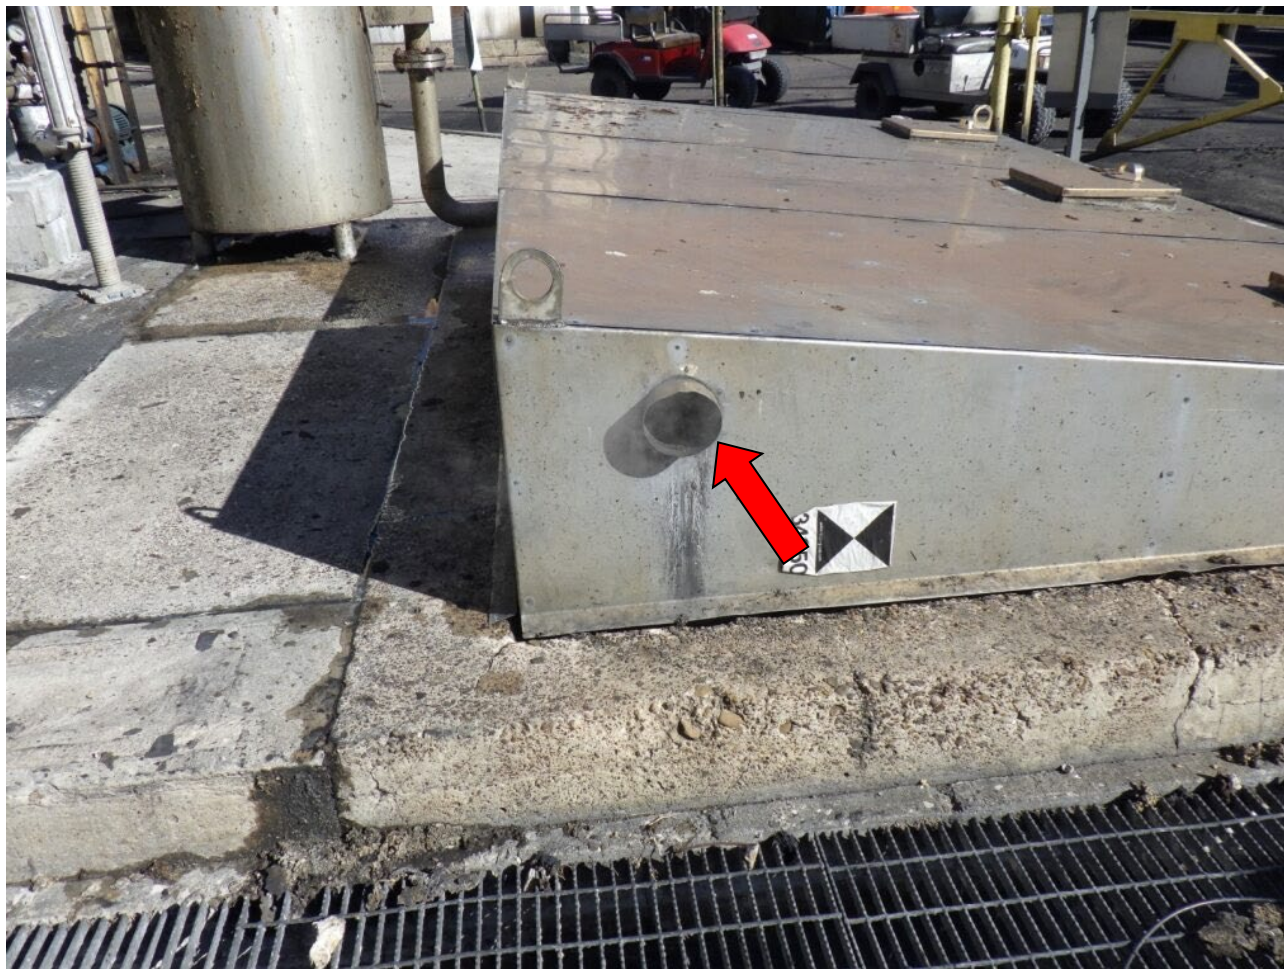
Photo No. 5

Description: Wastewater sump in 7C recovery area. Outlet vent observed on the western side of the sump cover. Arrow denotes where inspectors detected a measurement of 10,400 ppm VOC.

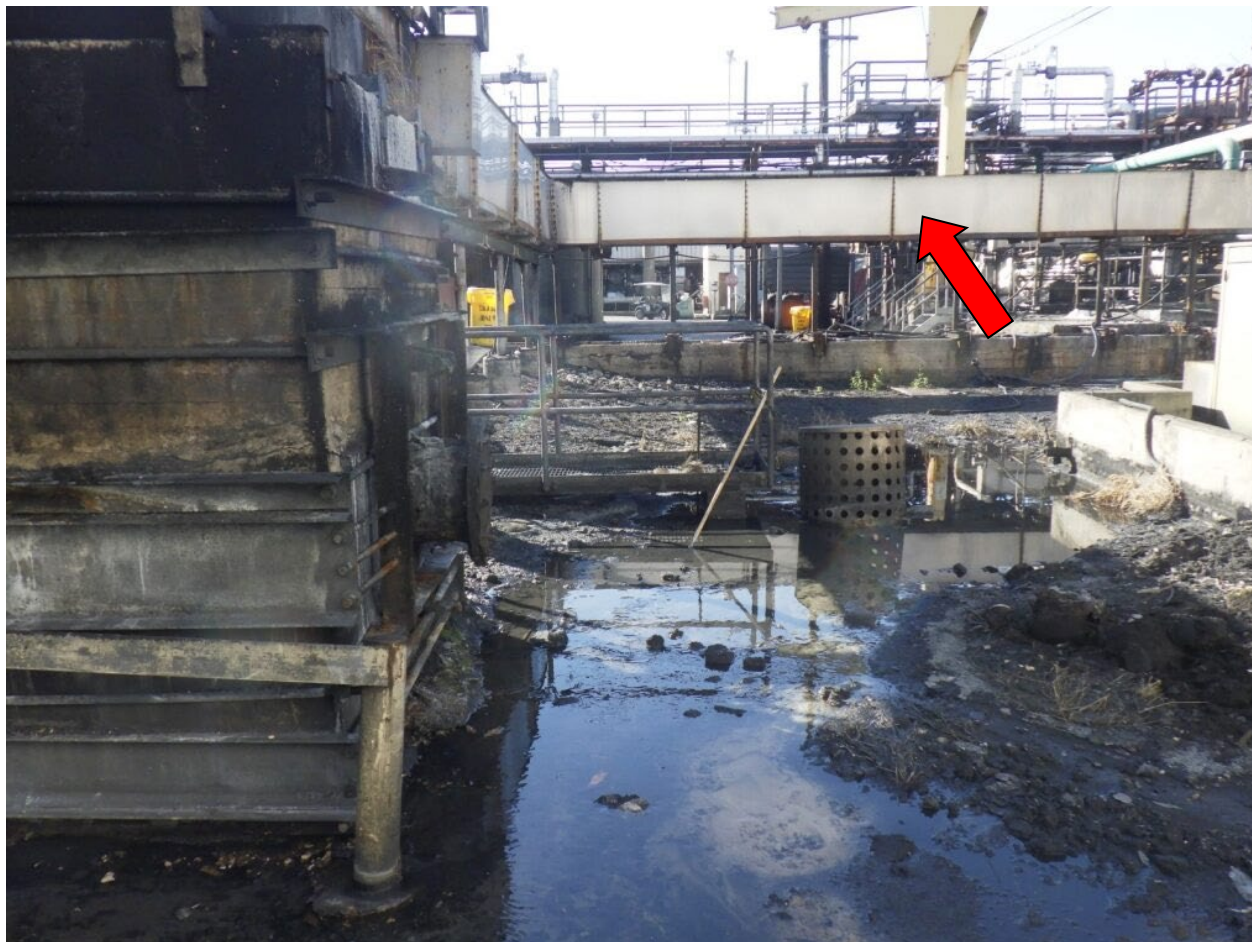
Photo No. 6

At 15:05, we walked to the main wastewater sump between the 6C and 6D buildings. The wastewater conveyance lines were open to atmosphere as was the main wastewater sump. Inspectors noted visible deterioration at the wastewater sump box (Photo 6). We returned to the conference room at 15:10.

Description: Photo taken south of the main wastewater sump. The arrow denotes wastewater conveyance line open to the atmosphere. Visual deterioration at the sump box.
