**Region 6 - Enforcement & Compliance Assurance Division**  
**INSPECTION REPORT**

| Inspection Date(s): | 03/12/2024 | |
| Company Name: | <b>Jerry Langley Oil Company, LLC</b> | |
| Facility Name: | <b>Tom #14</b> | |

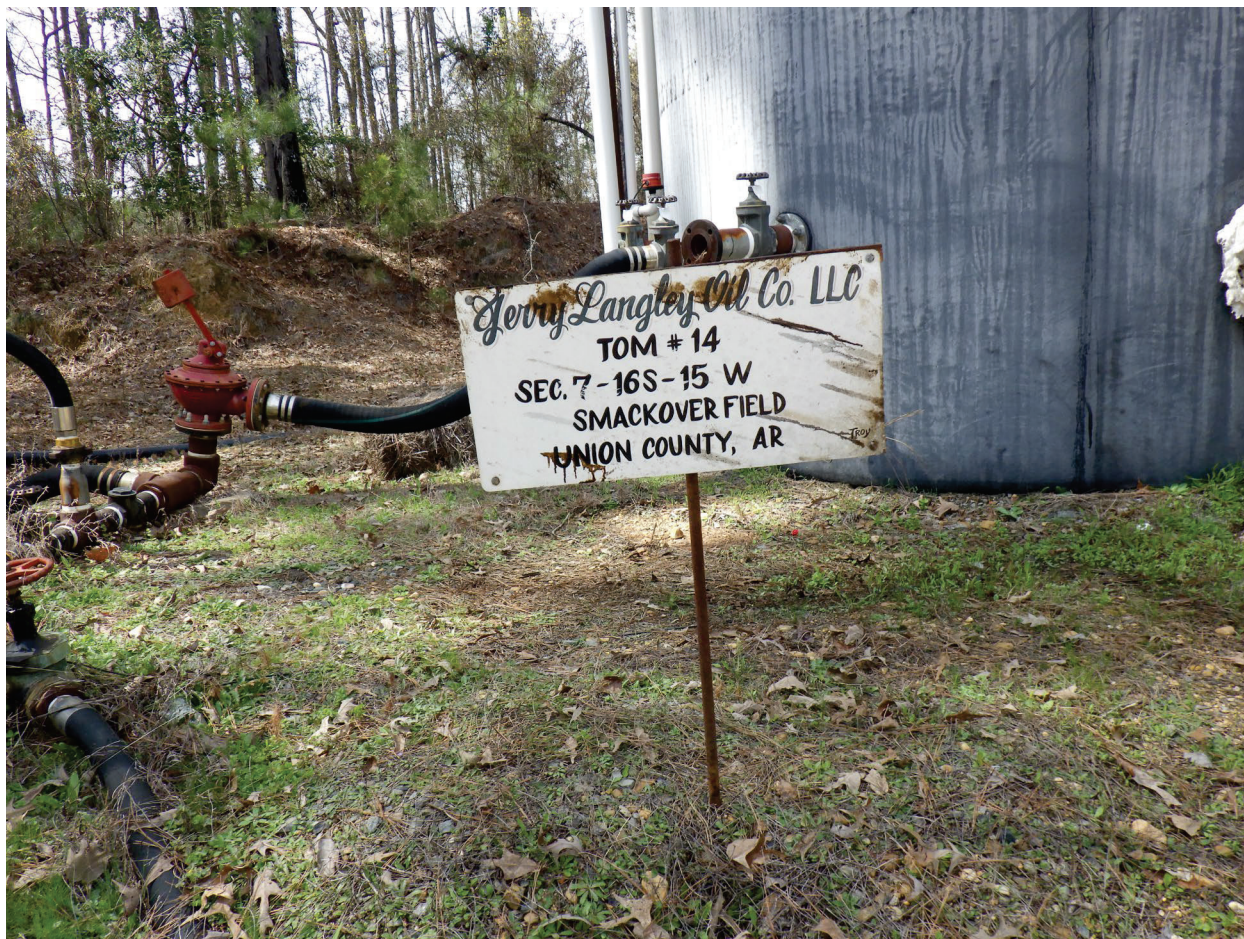
Photo No. 1

**Photo File Name:** R0010200**Orientation:** WNW**Date of Photo:** 03/12/2024**Time of Photo:** 2:11 PM**Latitude:** 33.34403**Longitude:** -92.68669**Photographer:** Uma Lad**Description:** This photo was taken looking west-northwest and shows the facility sign.

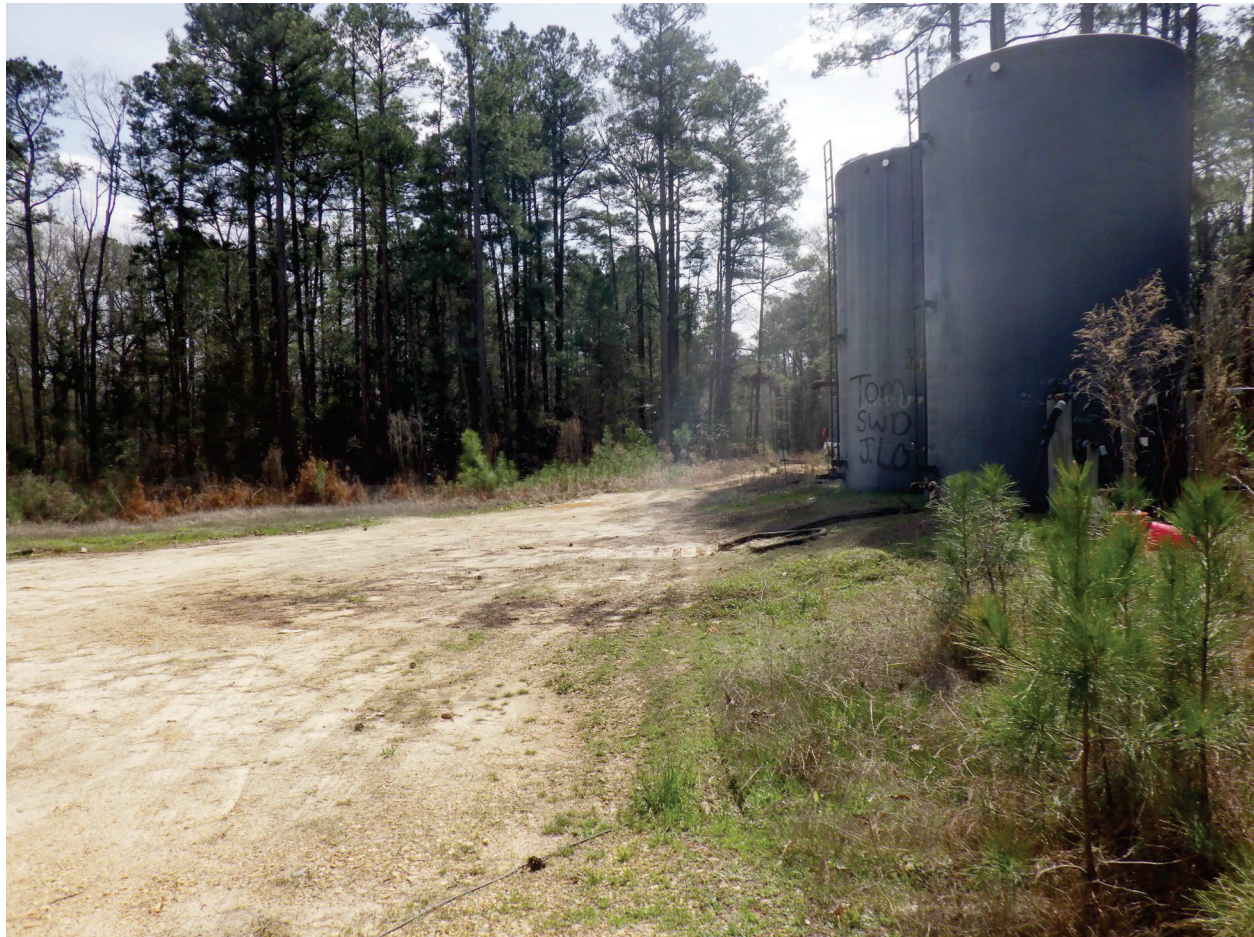
Photo No. 2

**Photo File Name:** R0010201**Orientation:** S**Date of Photo:** 03/12/2024**Time of Photo:** 2:12 PM**Latitude:** 33.34393**Longitude:** -92.68671**Photographer:** Uma Lad**Description:** This photo was taken looking south and shows an overview of the facility.

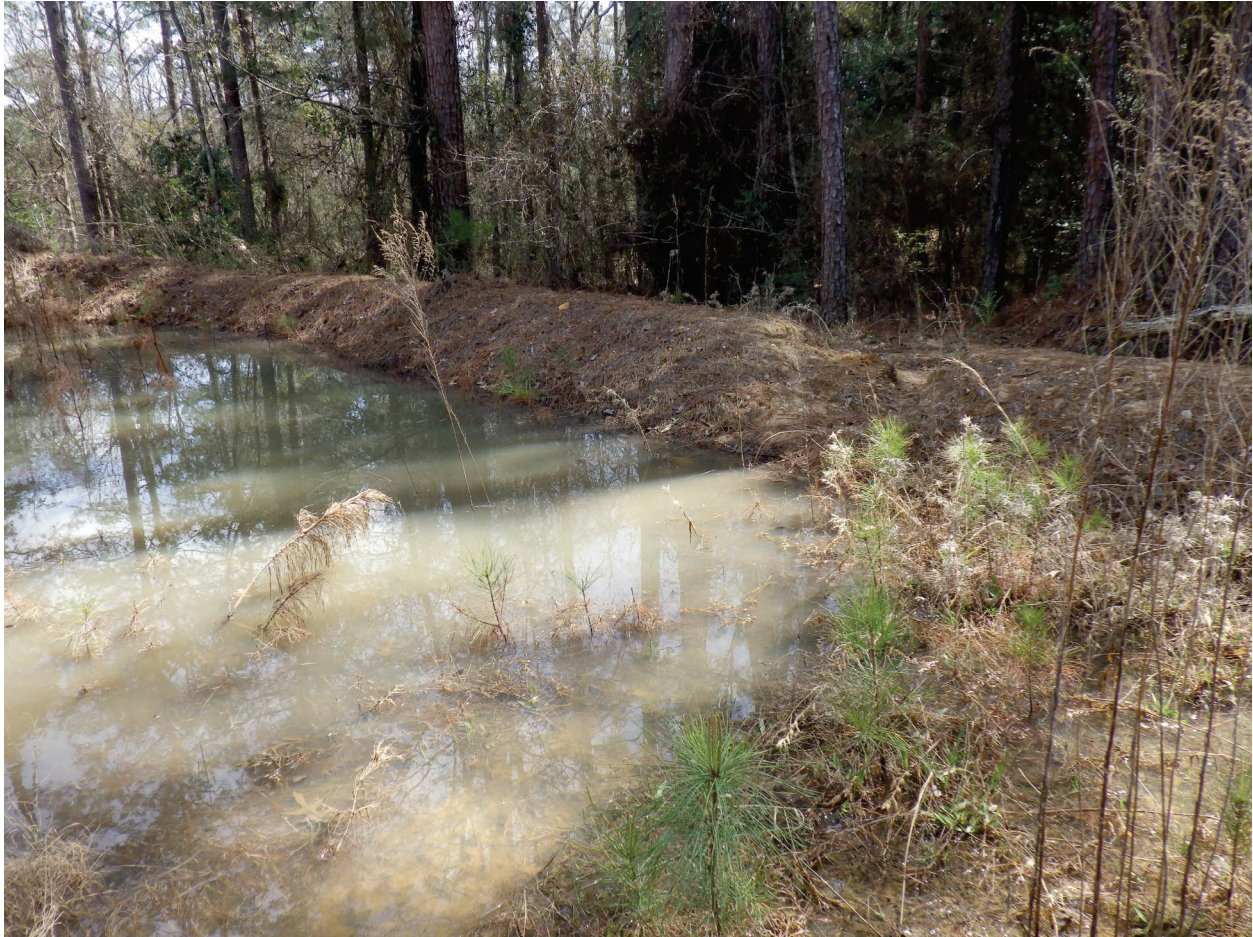
Photo No. 3

I observed a low point in the secondary containment berm, see photo No. 3. I observed a leak from a capped secondary containment drainage pipe, see photo No. 4.

No closing conference was held due to no Jerry Langley Oil Company, LLC staff being present during the inspection. Areas of concern at the time of the inspection include the low point on the secondary containment berm and the leak from the capped secondary containment drainage pipe.

**Photo File Name:** R0010202**Orientation:** SE**Date of Photo:** 03/12/2024**Time of Photo:** 2:14 PM**Latitude:** 33.34421**Longitude:** -92.686710**Photographer:** Uma Lad**Description:** This photo was taken looking southeast and shows low areas on the secondary containment.

Inspector will conduct follow-up phone calls with the company representatives over the coming weeks and months to ensure areas of concern are properly addressed.

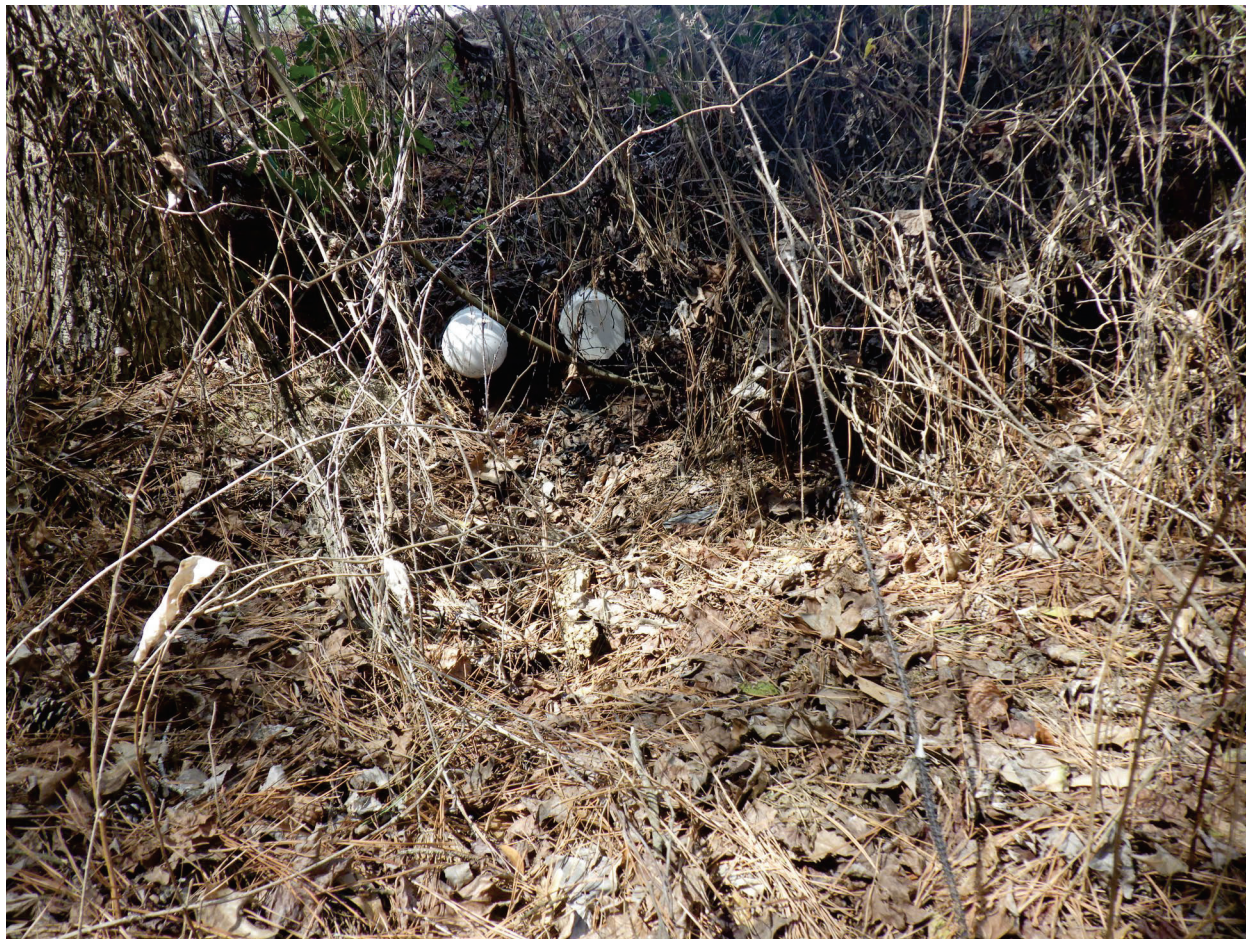
Photo No. 4

**Photo File Name:** R0010203**Orientation:** NW**Date of Photo:** 03/12/2024**Time of Photo:** 2:15 PM**Latitude:** 33.34376**Longitude:** -92.68644**Photographer:** Uma Lad**Description:** This photo was taken looking northwest and shows two (2) capped secondary containment drainage pipes. The drainage pipe on the left was leaking at the time the inspection.
