Re: EPA RCRA Compliance Evaluation Inspection – October 30, 2018; EPA ID#  
TXR000084812 – Henry Company – Garland, Texas

**Region 6 Compliance Assurance and Enforcement Division  
INSPECTION REPORT**

| NAICS: | 324122 Asphalt Shingle and Coating Materials Manufacturing | | |

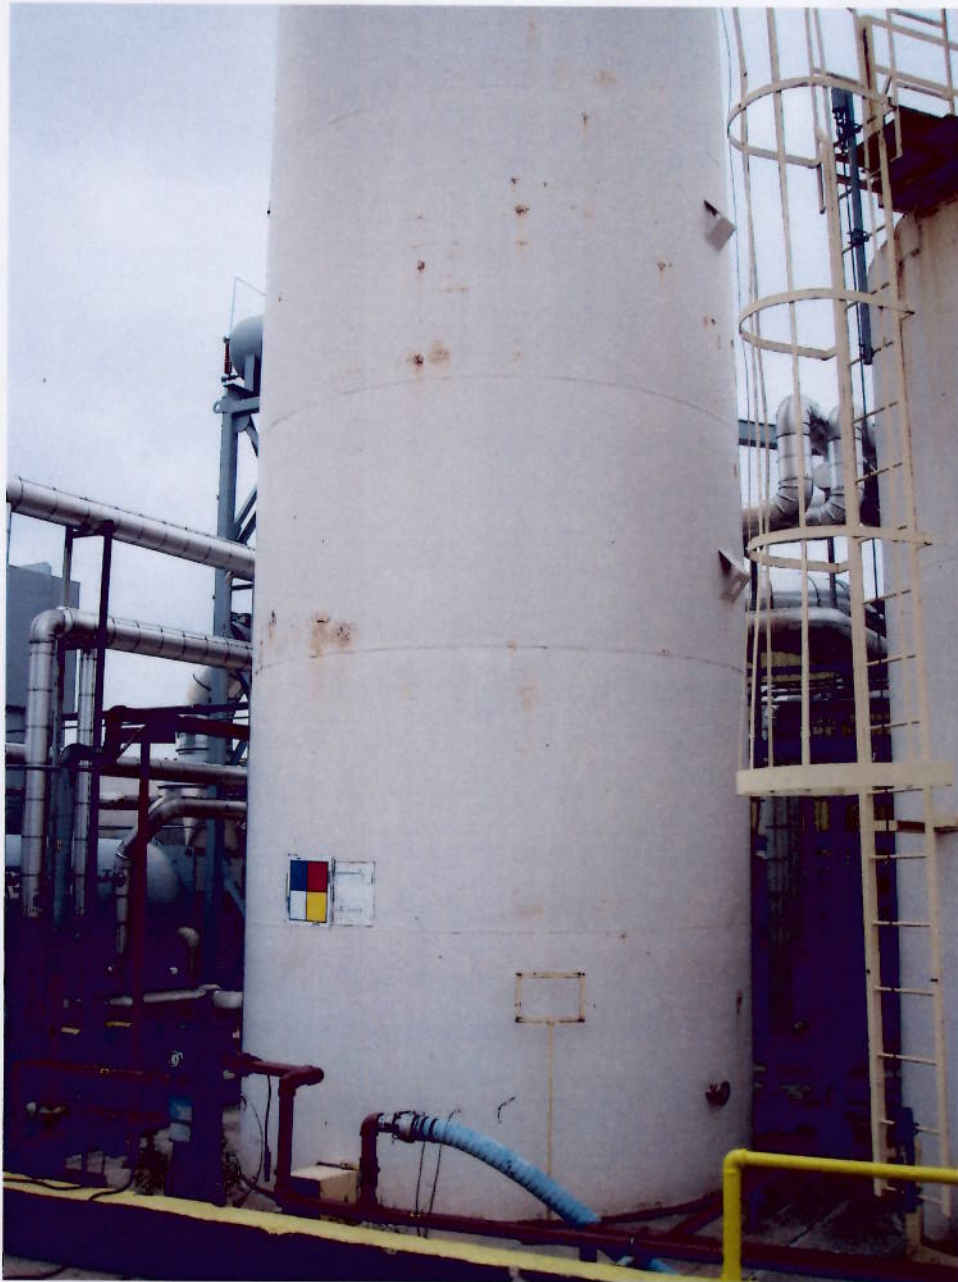
Photo No. 1

I observed tank T58 (Attachment 1, photo 2), which was the former reused mineral spirits tank and tank 61 (Attachment 1, photo 1), which is an oil tank. Reused mineral spirits were used to make products in the past, however the facility discontinued the use of reused mineral spirits in 2016 and tank T58 was empty during the inspection. I then observed 12 totes (Attachment 1, photo 3) containing a bad batch of product awaiting disposal as waste. Michael said they use process knowledge to determine the waste is non-hazardous and provided me with safety data sheets as part of the determination. Michael also said the facility produces a bad batch 3-4 times a year, which consists of 6 to 8, 275-gallon totes each time. I then observed drip buckets that collect asphalt leaks at pump connections. Michael said when the material in the buckets is dry, it is disposed of in the trash.

Description: T61 Oil tank

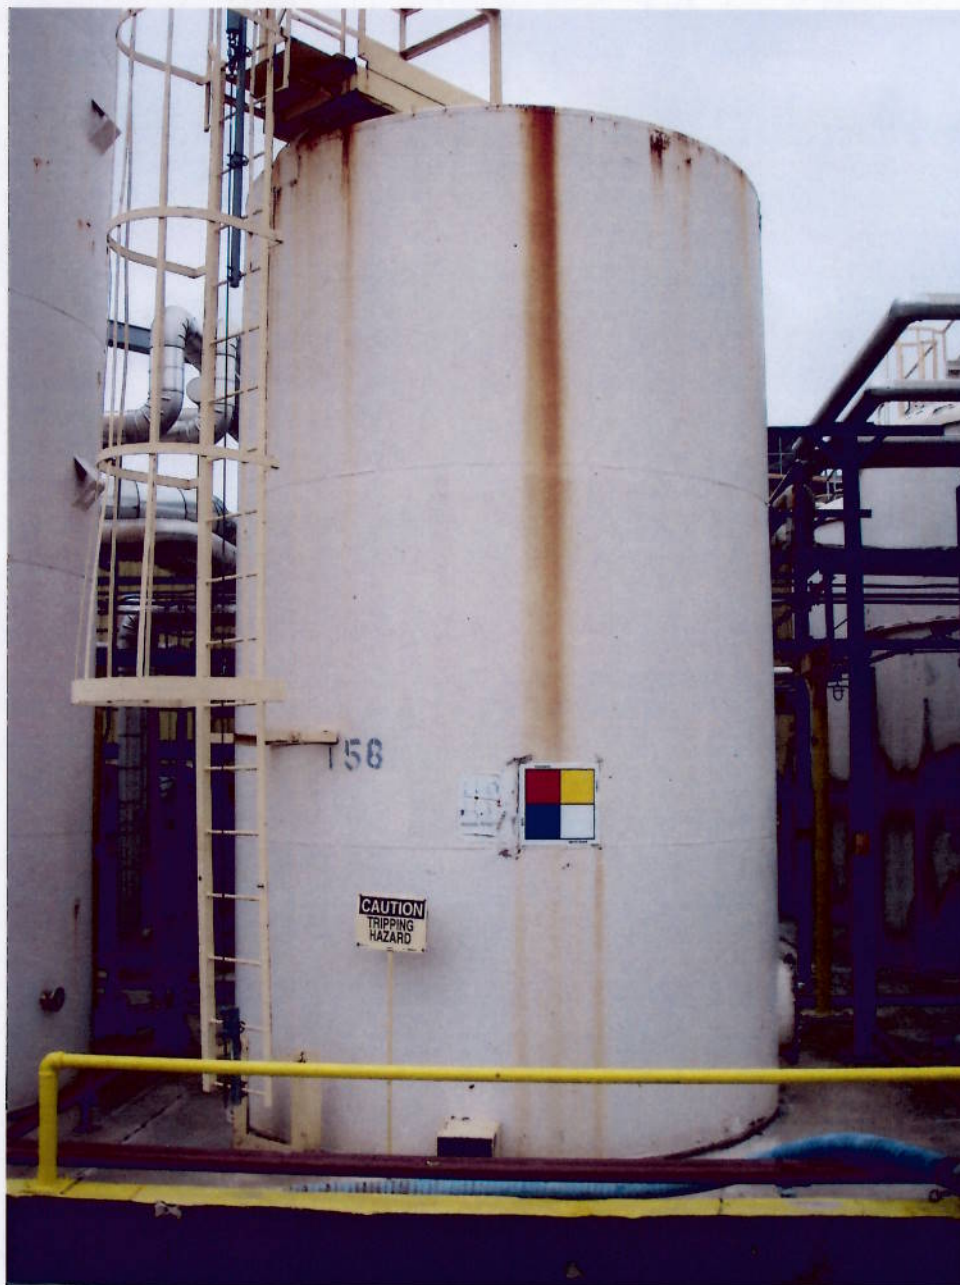
Photo No. 2

Description: Tank T58 former reused mineral spirits tank.

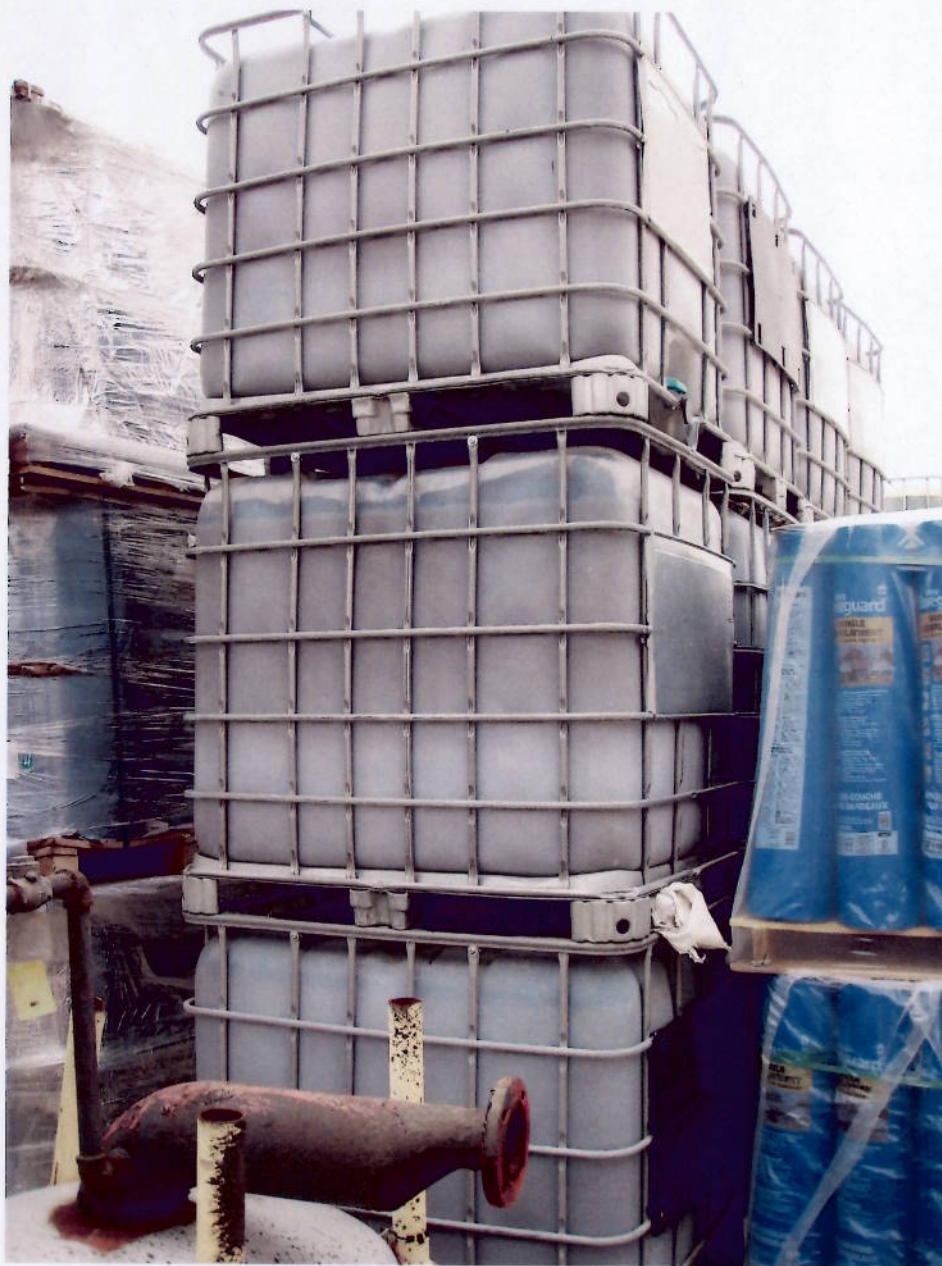
Photo No. 3

Description: 12 totes of bad batch of product awaiting disposal (non-hazardous per waste determination)
