Subject: PCB Capacitor Explosion in Finland

# ON THE BRINK OF CATAS

CAPACITOR FIRE IN A PAPER MILL AT IMATRA, FINLAND  
O.A.Elo and P. Vuojolahti

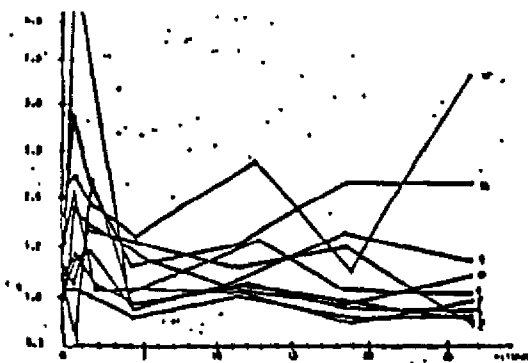
n:o 5 S-triglycerides

To follow the fatty metabolism the levels of cholesterol, triglycerides, and the electrophoresis of lipoproteins were measured from the serum. A clear increasing tendency was noted for triglycerides in the serum. For many of the exposed, the peak was reached a week after exposure; the peak was reached two weeks after exposure for the remainder. Four weeks after exposure the baseline values were attained again. The baseline value for the ten exposed persons from whom all four samples were collected was 1.39 mmol/l. For this group the mean peak level of triglycerides was 2.14 mmol/l; their mean level at four weeks was 1.13 mmol/l. At group level a 54 % increase was found (Figure 5).

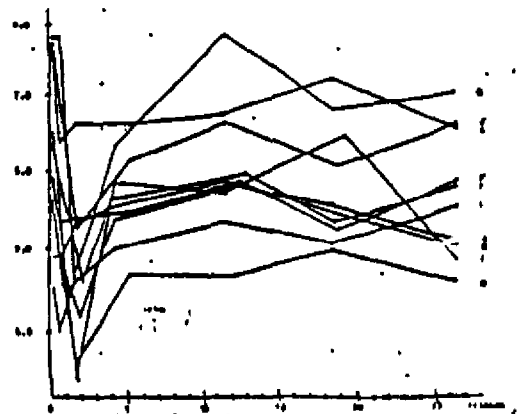
n:o 6 S-Cholesterols

A clear decreasing tendency in the level of cholesterol was observed for the same group. The lowest levels were attained, again, at either one or two weeks after exposure. The mean baseline value was 6.25 mmol/l, the mean of the lowest values was 4.62 mmol/l, and four weeks after exposure it was 5.69 mmol/l. Compared with its baseline value, a mean drop of 26 % occurred in the level of cholesterol (Figure 6).
