**Well Inspection**  
**Osage DNR / Environmental Protection Agency**  
**1201 Elm Street, Suite 500**  
**Dallas, Texas 75270**

| <b>Operator Info</b> | McCann Resources, Inc<br>1613 West 6th Street<br>Bartlesville, OK 740033404<br>Phone: 918-337-4747 | <b>Inventory ID</b> | OS2217000 | | |
| | | <b>Lease Name</b> | Parker | | |
| | | <b>Well ID</b> | W-85 | | |

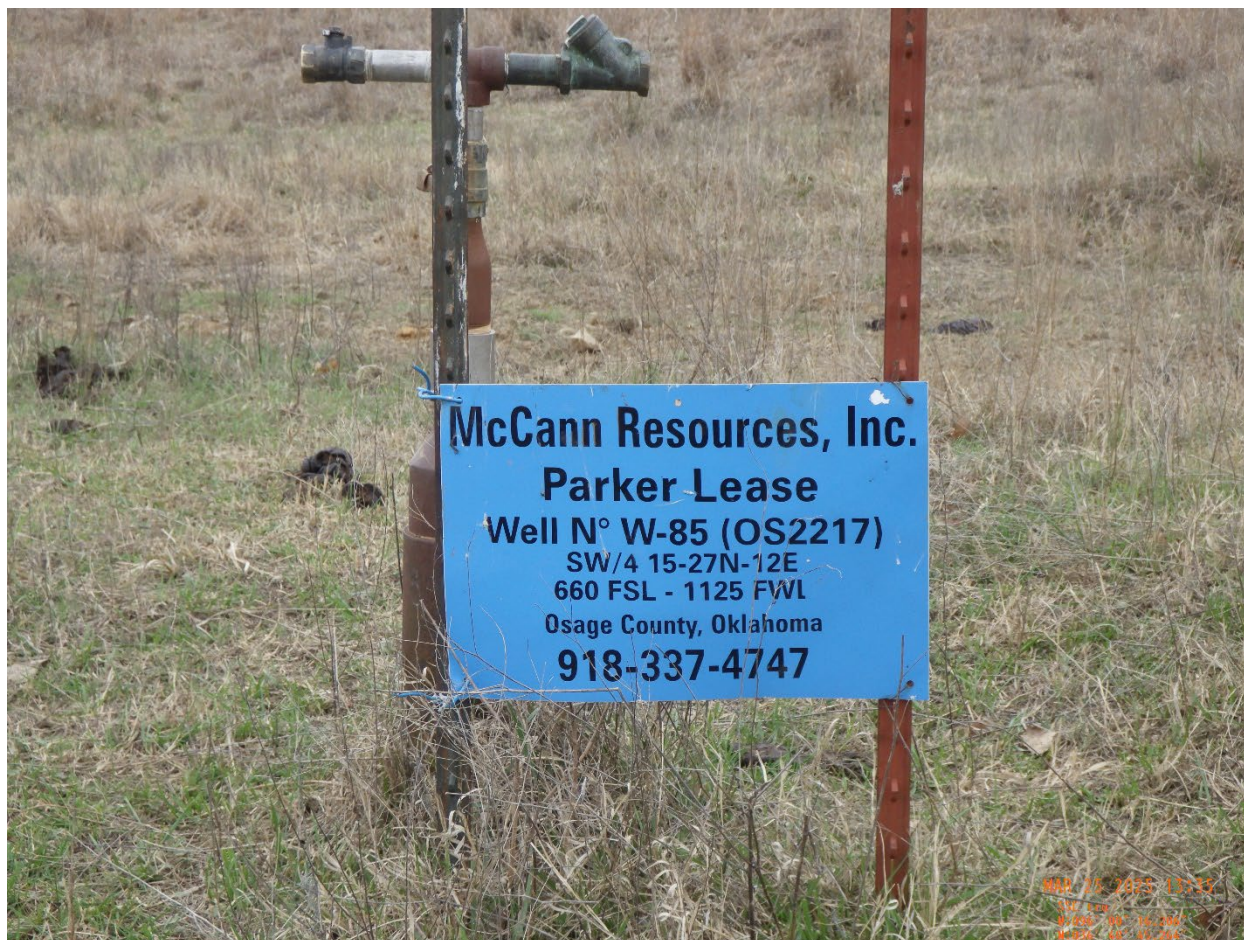
Photo No. 1

| <b>Inspection Comments</b> | Well inaccessible by vehicle at the time of the inspection. Inspector observed well OS2217000, at the time of the inspection the well was 4.5" casing reduced to 1" valves. Inspector contacted Mr. McCann at the time of the inspection to address the lack of access and the need to schedule the overdue MIT. | | | | |

**Description:** This was well OS2217000 at the time of the inspection. The well was casing reduced to 1-inch fittings. The road to the well was impassible by vehicle.
