**Region 6 - Enforcement & Compliance Assurance Division**  
**INSPECTION REPORT**

| Company Name: | NEW MEXICO WATER SERVICE | |
| Facility Name: | Rio Del Oro Wastewater Treatment Plant | |
| Identification/Permit Number: | NM0030414 | |

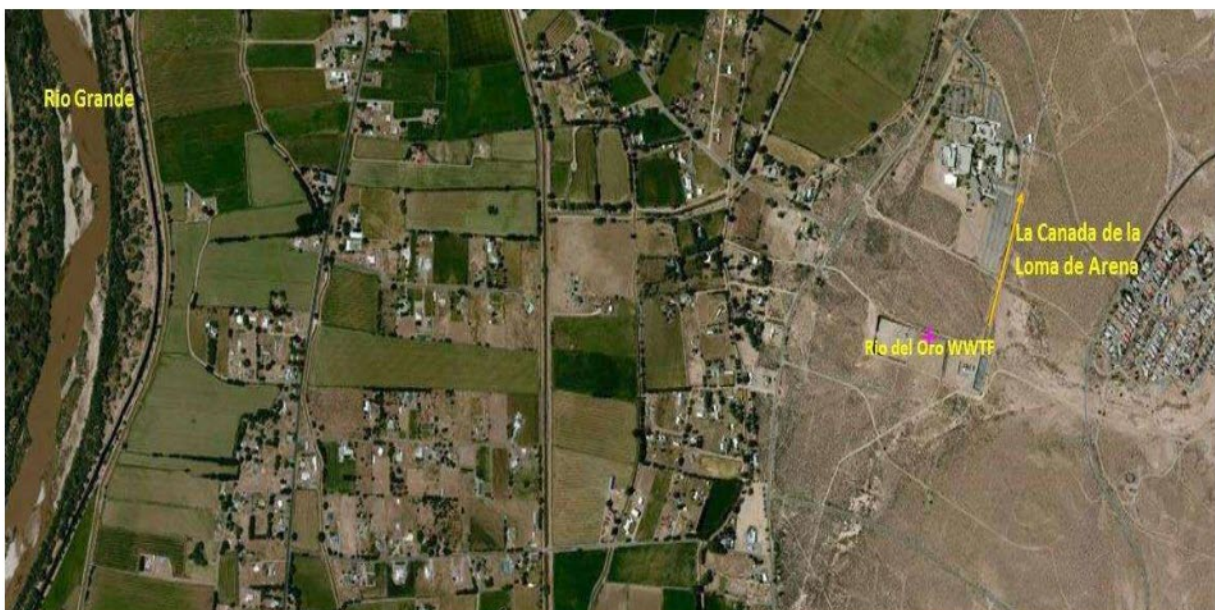
**Aerial Image #2** View of the Rio Del Oro WWTP and the permitted flow path from Outfall 001 into the La Cañada de la Loma de Arena arroyo

- The observed affixed thermometer within the sample storage refrigerator did not exhibit any visible evidence of proper and timely calibration of temperature recording devices (thermometers). In response to the Request for Information (RFI) dated December 7, 2023 (**Appendix 3 Request for Information (RFI)**). The WWTP simply responded “none”. Therefore, the integrity or stability of the collected samples cannot be guaranteed; thus, the results could be inaccurate or in error.
- The WWTP description of Outfall 001 states the discharge is to an arroyo named La Cañada de la Loma de Arena thence to La Constancia Ditch, and finally to Rio Grande (**Aerial Image #2**). However, if the statement of the closed conduit discharge to the Las Maravillas Homeowner’s Association lagoon is correct (**Aerial Image #3**) this is contrary to the permitted outfall location.

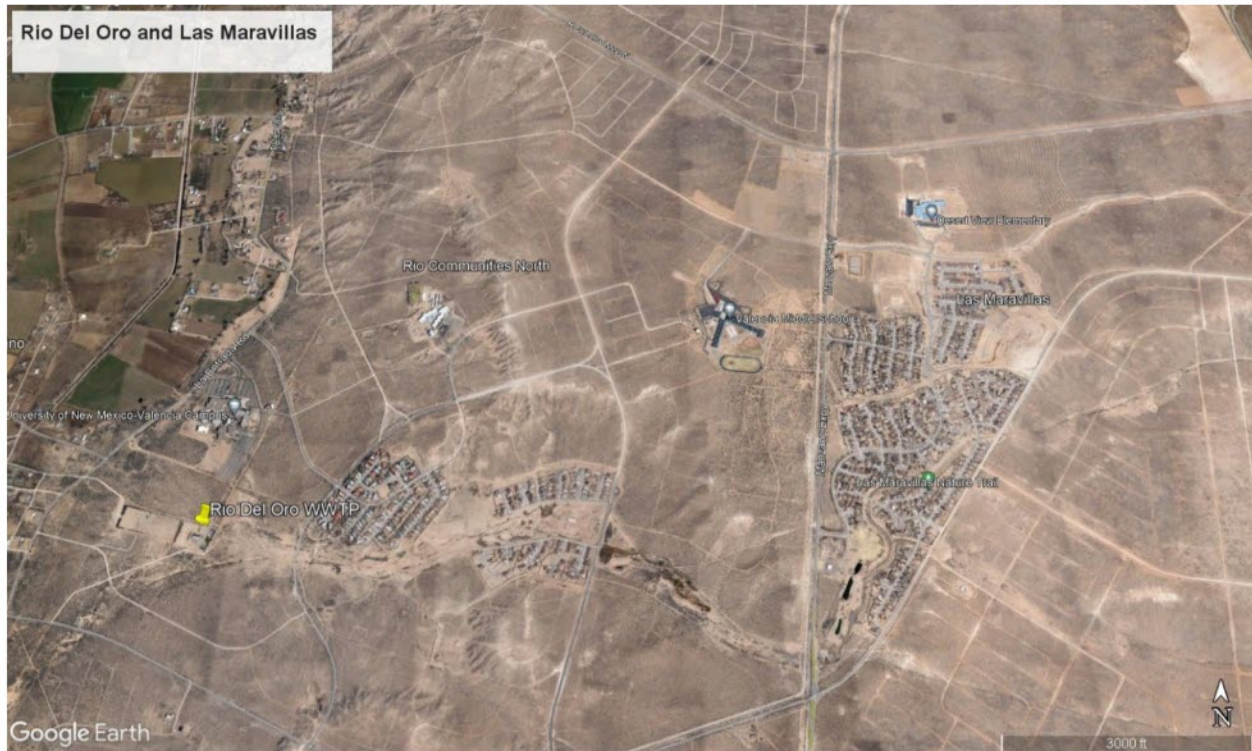
**Aerial Image #3** View of the Rio Del Oro WWTP (yellow pin) and the stated discharge to the Las Maravillas Subdivision (green pin) located approximately 1-mile east of the WWTP.

- It was stated that the WWTP typically discharges the disinfected effluent through a closed conduit pipe to the Las Maravillas Homeowners Association lagoon located approximately 1-mile east of the facility.

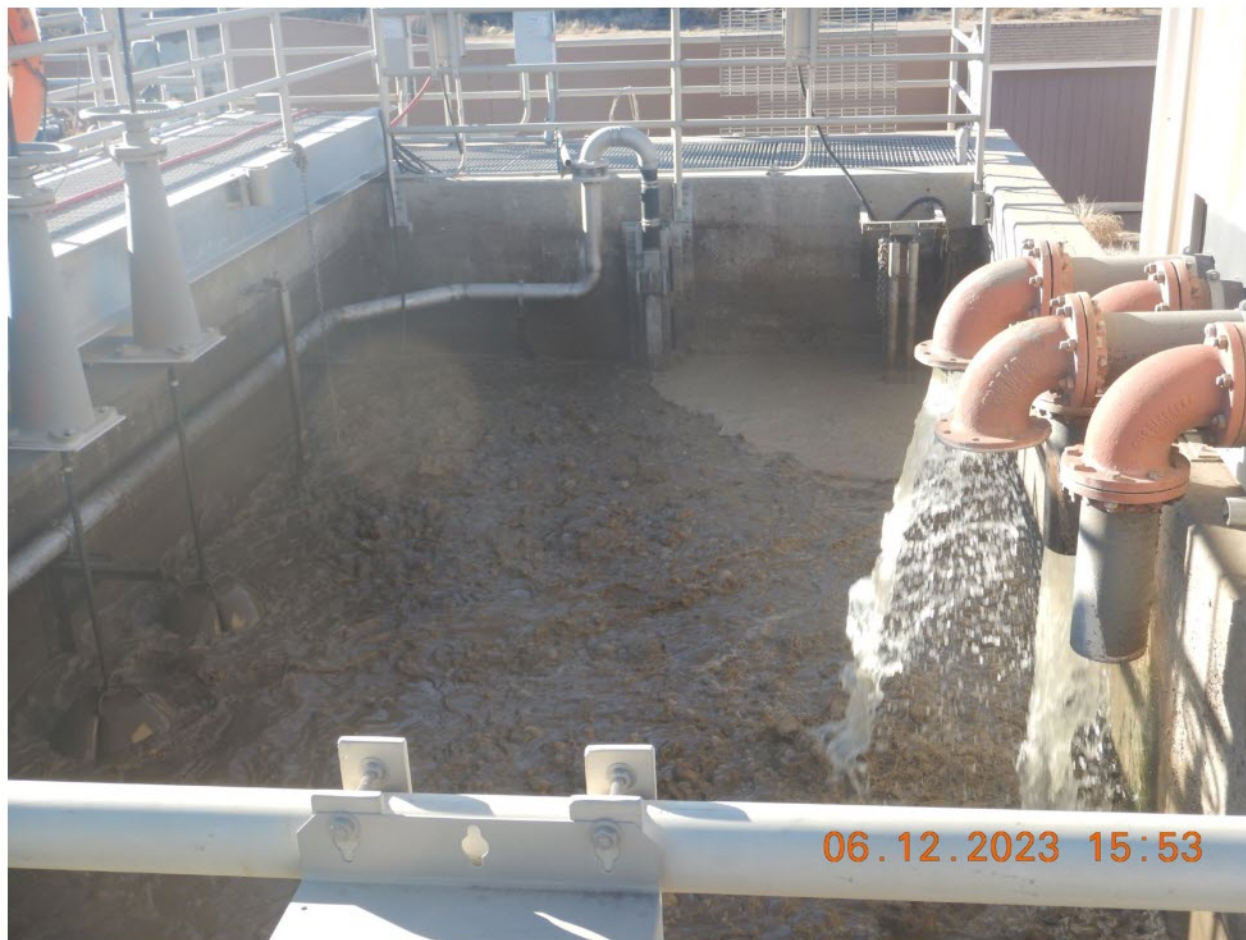
Photo No. 1

View of WWTP's pre-air basin. Bar screen and entrance headworks on right side of photograph. (DSCN2678). Photographed by D. Esparza

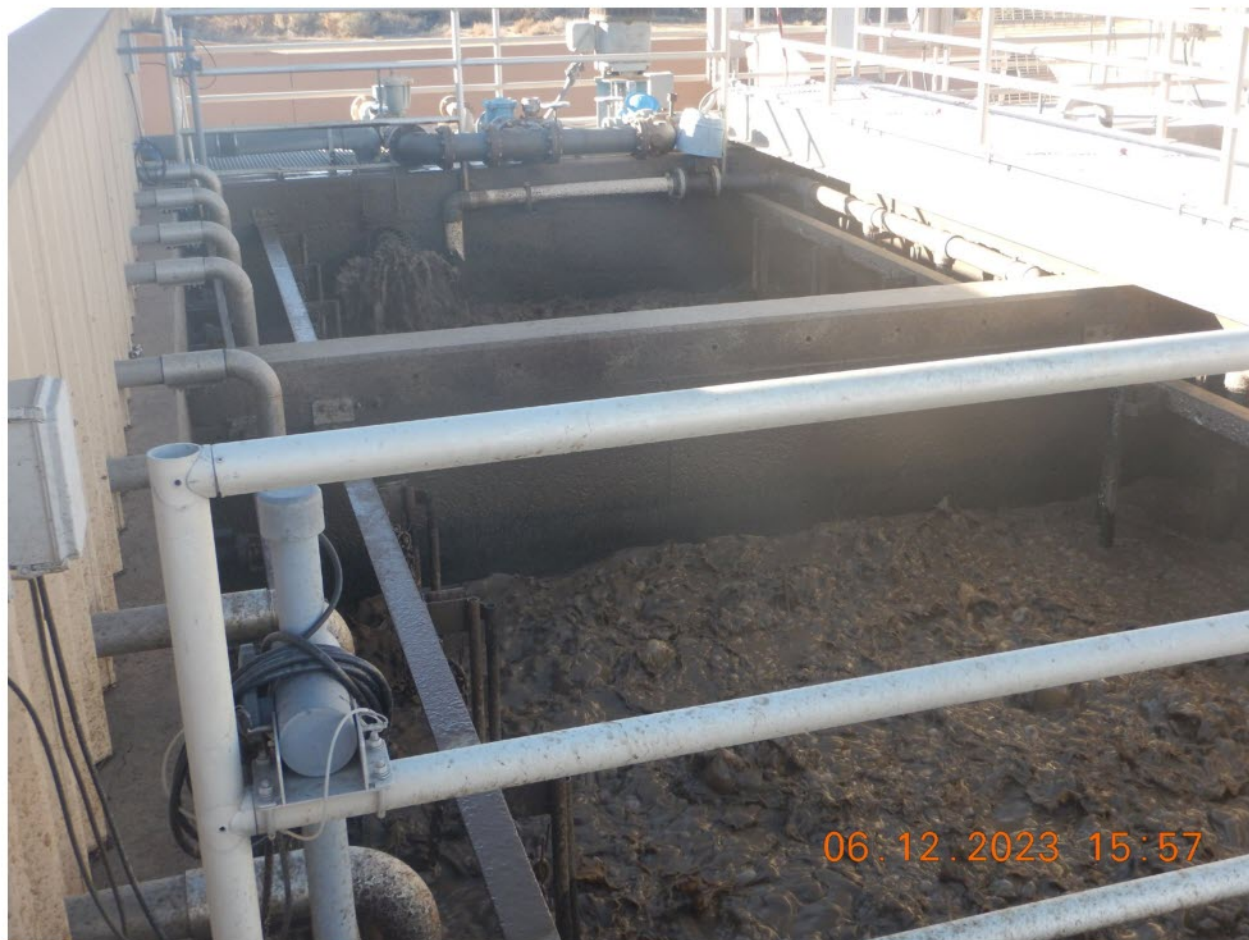
Photo No. 2

View of the bioreactors. (DSCN2681). Photographed by D. Esparza

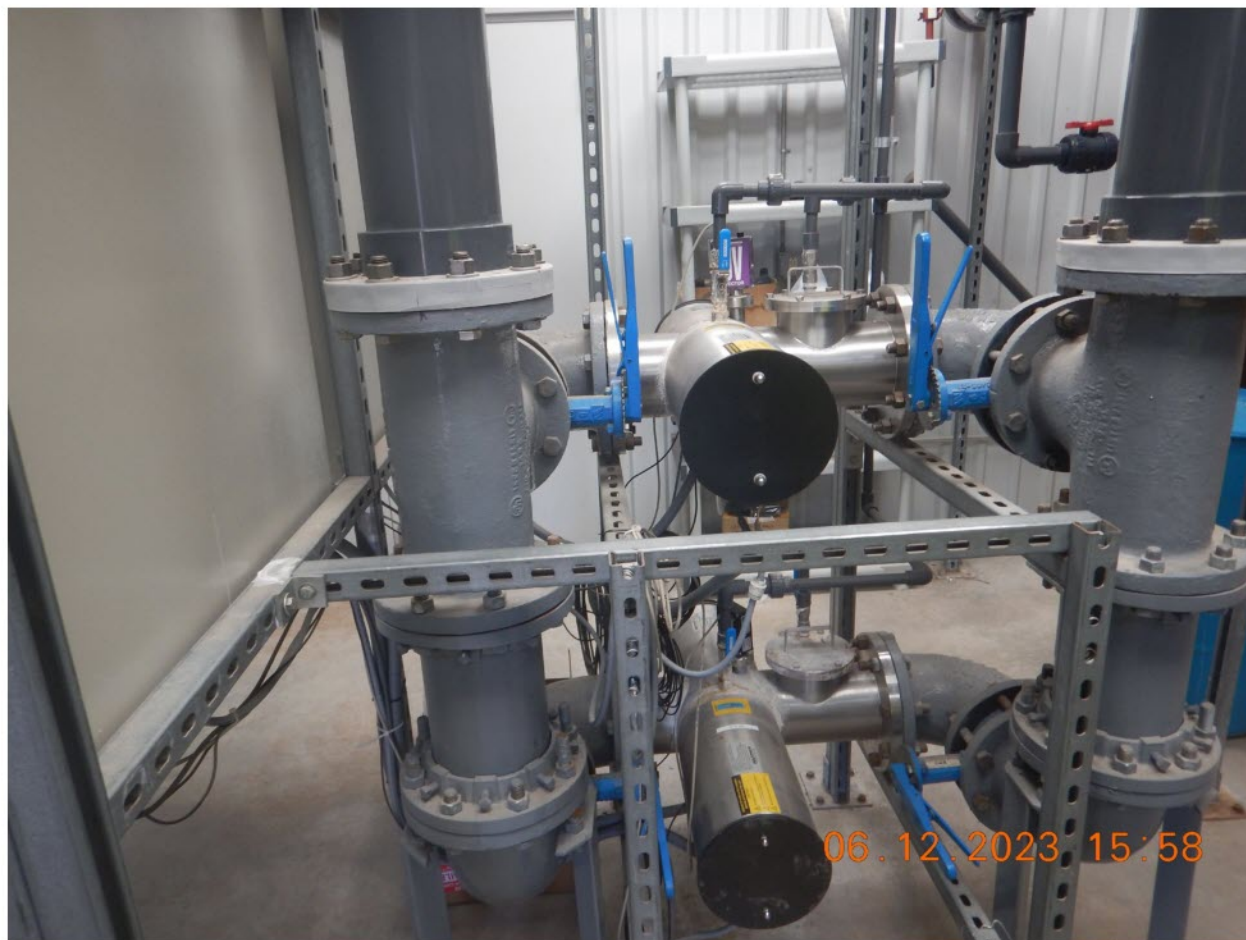
Photo No. 3

View of the ultraviolet (UV) disinfection treatment system. (DSCN2682). Photographed by D. Esparza

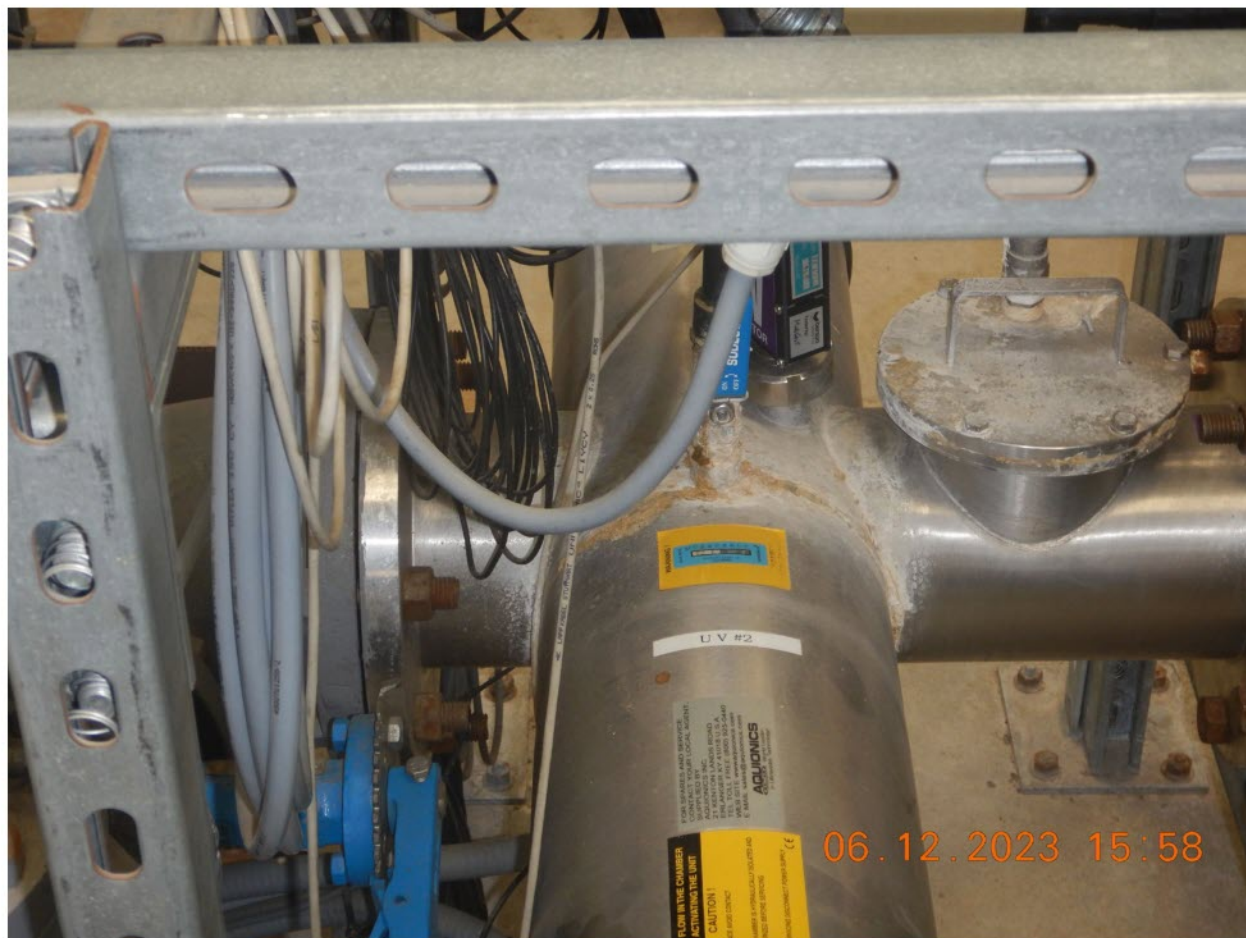
Photo No. 4

View of the one (1) of the ultraviolet (UV) disinfection treatment systems (UV-2) injection ports exhibiting corrosion. (DSCN2683). Photographed by D. Esparza

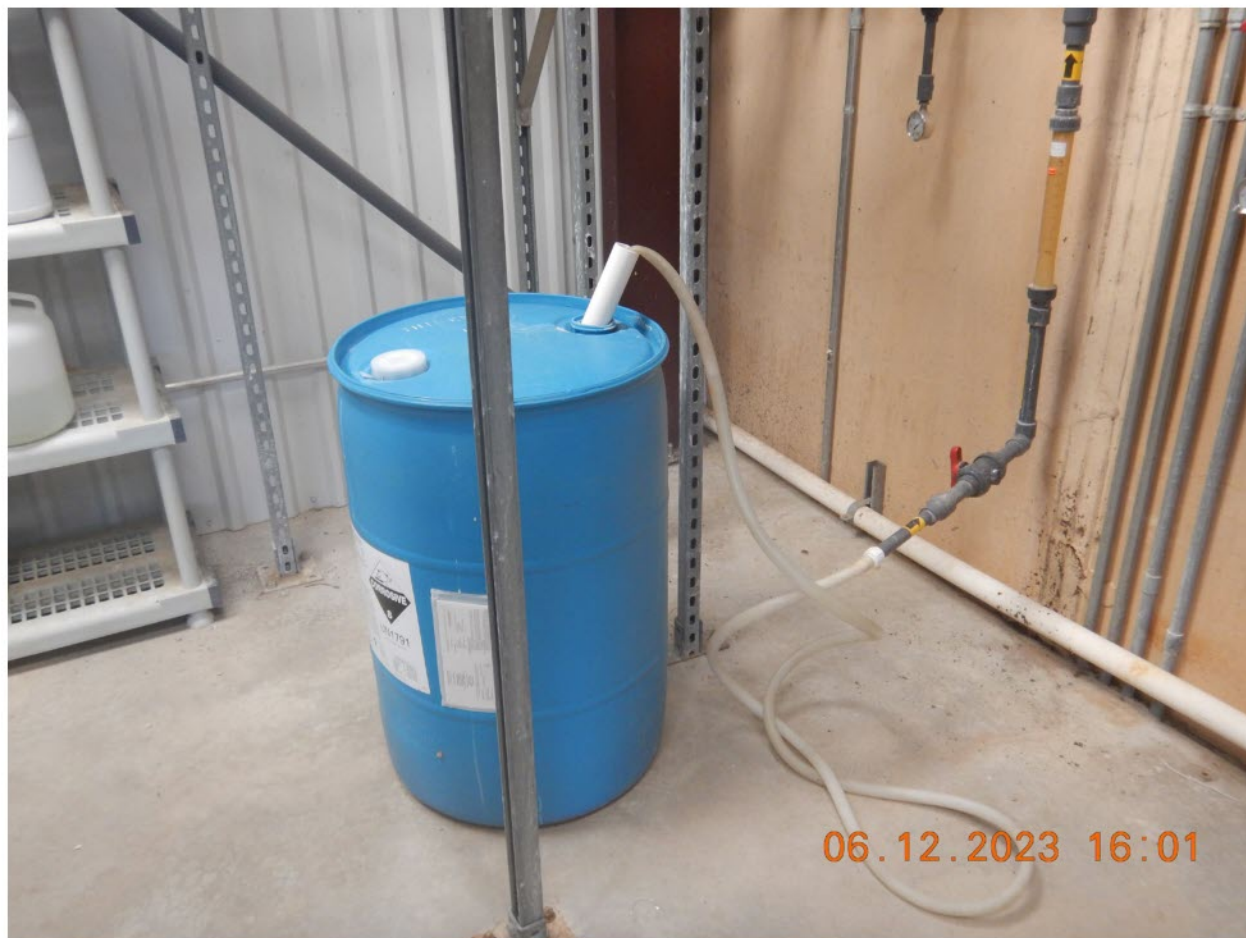
Photo No. 5

View of the sodium hypochlorite (UN1791) un-restrained drum. (DSCN2684). Note: not clear why the sodium hypochlorite (typically used in wastewater treatment as an oxidizing and disinfection agent) and the UV are plumbed into the system. Photographed by D. Esparza

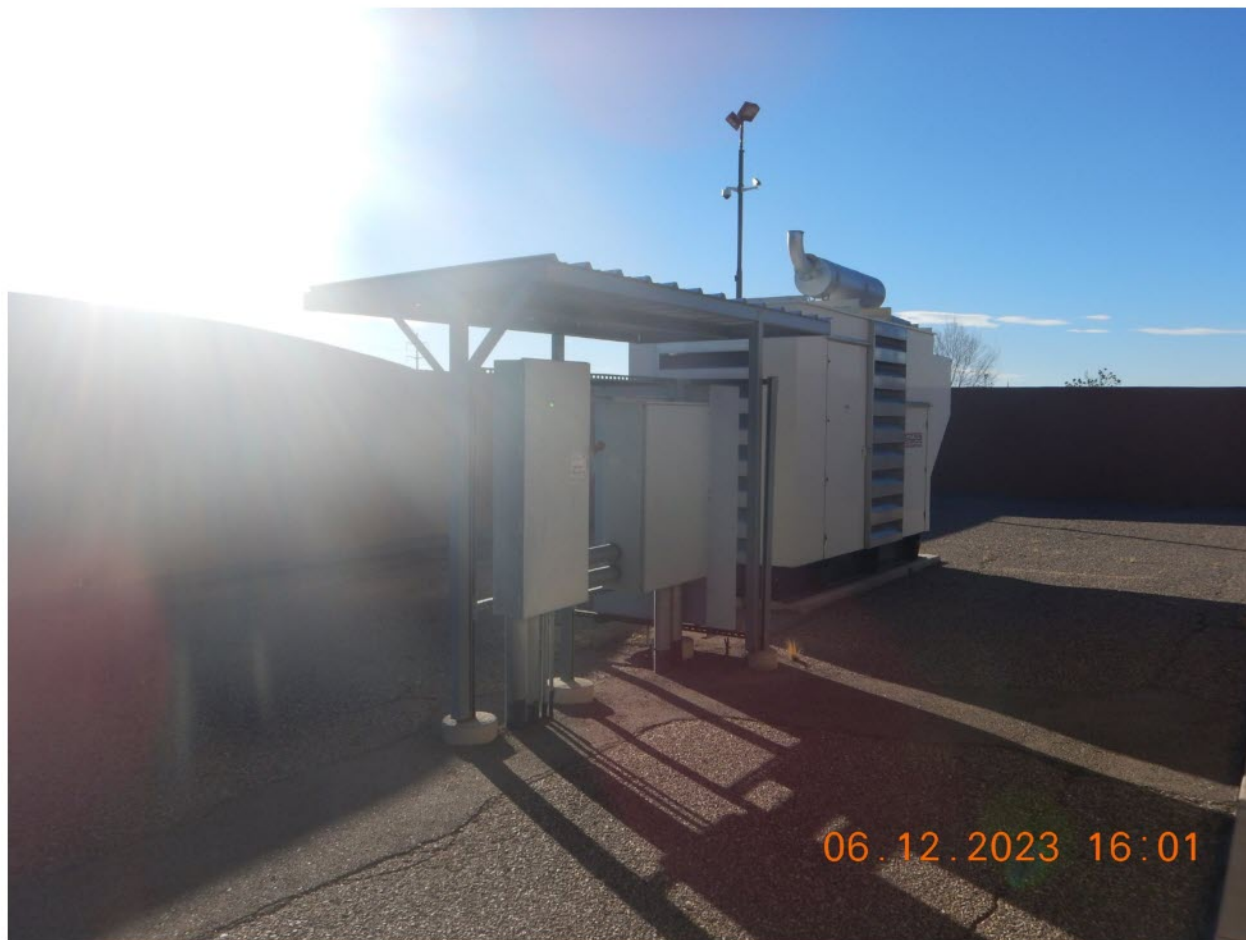
Photo No. 6

View of the onsite back-up generator. (DSCN2685). Photographed by D. Esparza

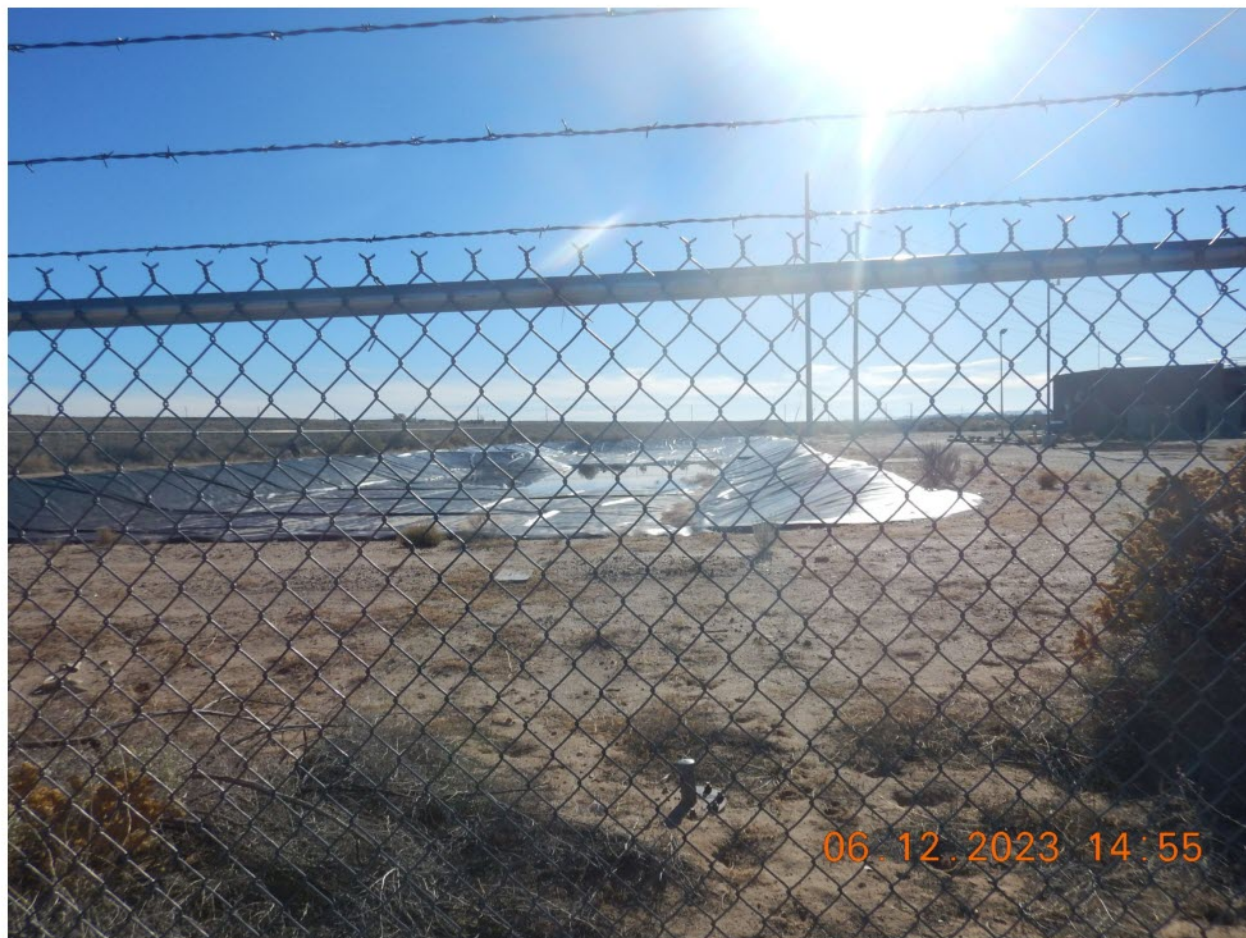
Photo No. 7

View looking south of the 500K-gallon emergency storage lagoon. (DSCN2675). Photographed by D. Esparza

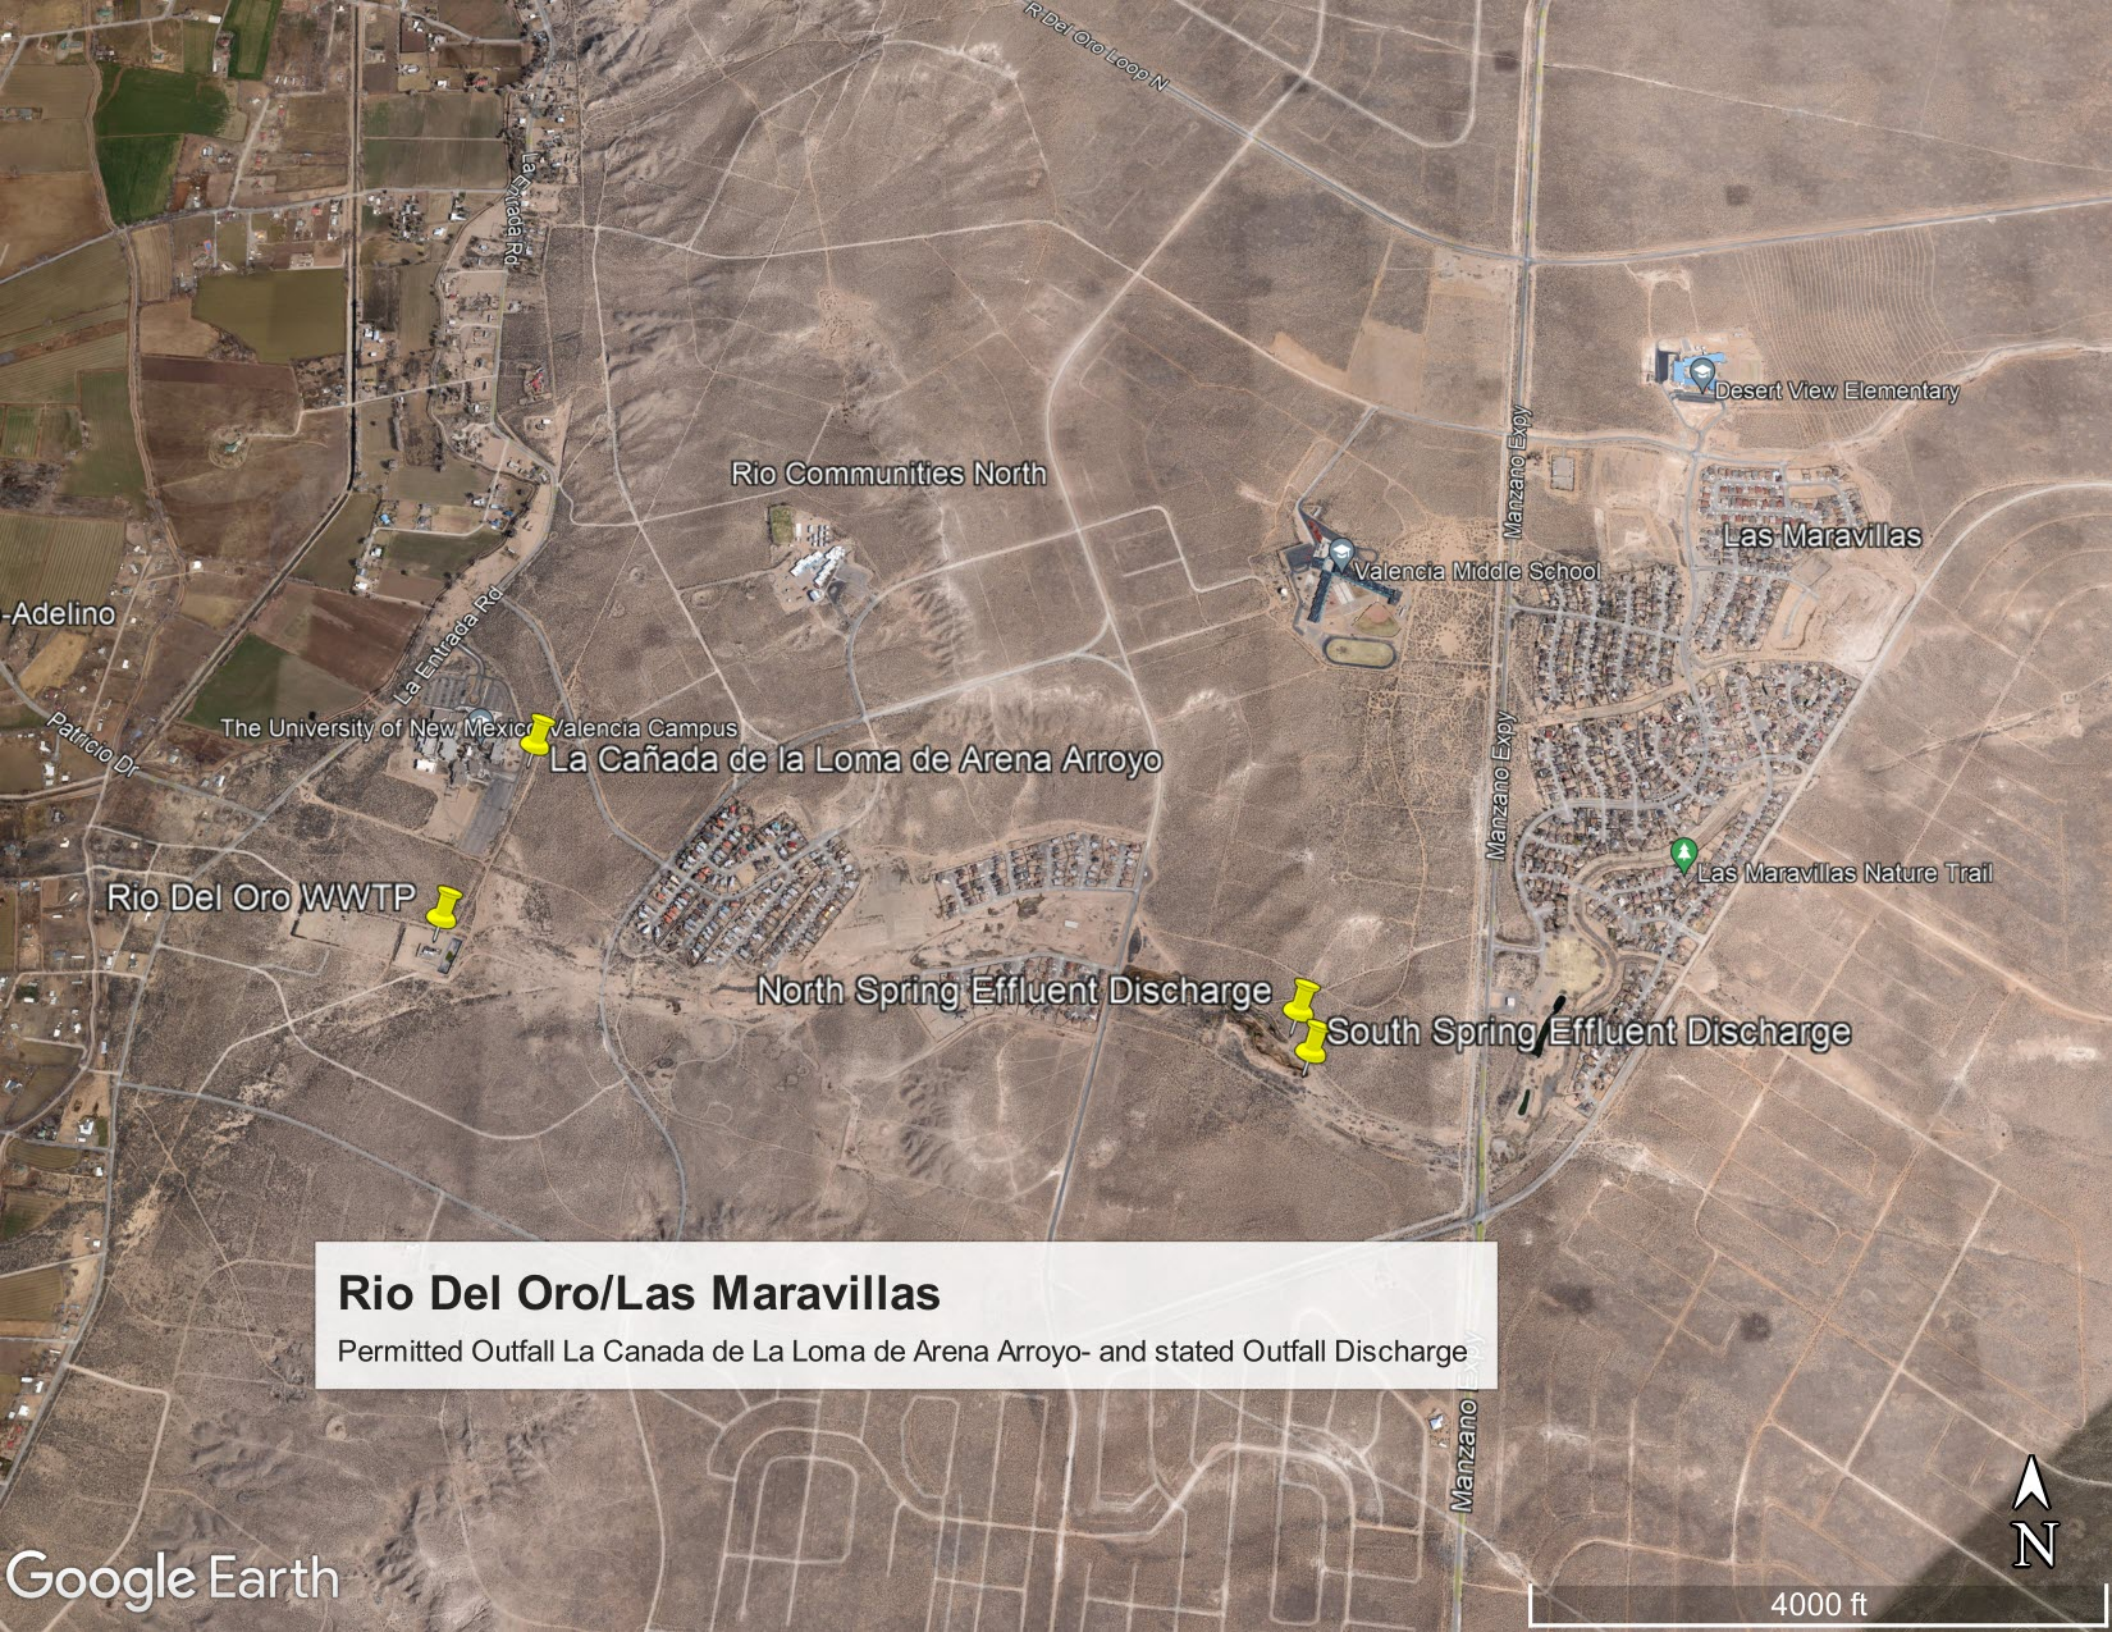
## Rio Del Oro/Las Maravillas

Permitted Outfall La Canada de La Loma de Arena Arroyo- and stated Outfall Discharge
