## NPDES Wastewater Lagoon Inspection Report

| Facility Location Information | |
|---|---|
| Site/Facility Name & Location:<br><b>Town of Reserve Wastewater Lagoons</b><br>Off West Reserve Road<br>48.599276°N; 104.471433°W | Email Report to:<br>Lindsay Brensdal, Director<br>Reserve County Water and Sewer District<br><a href="mailto:lbrensdale@sheridancountymt.gov">lbrensdale@sheridancountymt.gov</a> |

## Inspection Narrative and Site Description

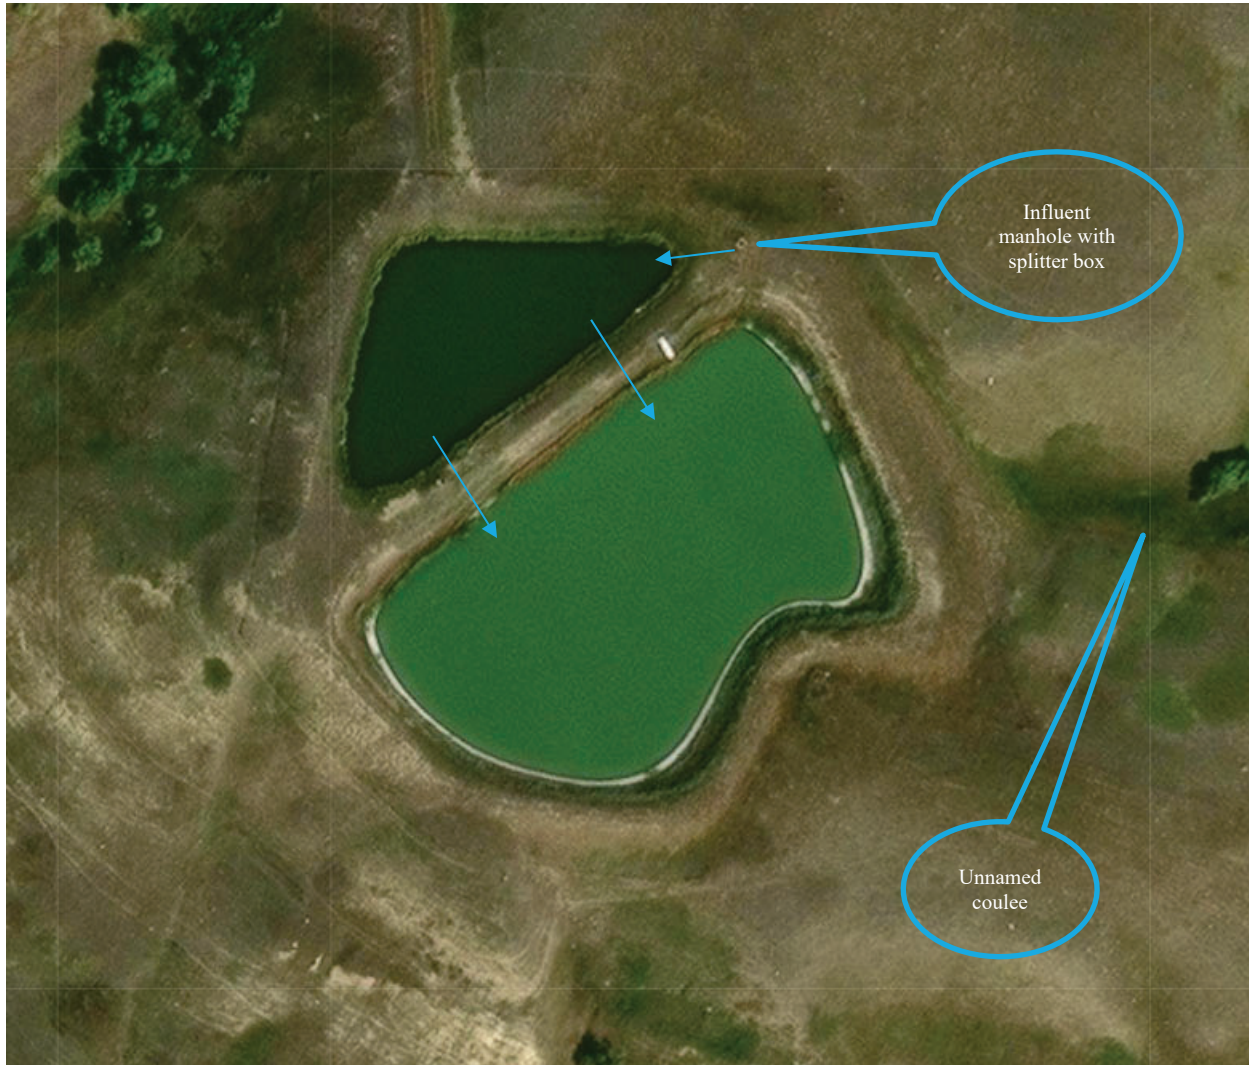
Mr. Anderson, Mr. MacDonald and the inspector then drove to wastewater lagoons. The site visit included walking around the system. We started at the northeast point of cell 1 where the influent manhole and splitter box (photo 69) are located. The splitter box was deteriorating, and Mr. Anderson stated the valves are rusted to a point that the facility has to run in series, as the valves can no longer be changed. We observed lagoon cell 1 (photos 66, 67, and 71) and cell 2 (photos 67, 68, 71, and 72). The inspector observed vegetation in the form of cattails and sedges starting to grow within the slopes and inside of each of the lagoon cell dike walls (noted in the photos). The inspector noted the lagoon depth gauge on northeast side of lagoon cell 2 (photo 70). On the southeast portion of lagoon cell 2 is a coulee; however, no discharge pipe between cell 2 and the coulee was observed. We then drove to the lift station in town (photo 73). The lift station is equipped with light and sound alarms.
