**Well Inspection**  
**Osage DNR / Environmental Protection Agency**  
**1201 Elm Street, Suite 500**  
**Dallas, Texas 75270**

| <b>Operator Info</b> | Contango Resources, LLC | <b>Inventory ID</b> | OS3127000 | | |
| | Phone: 918-392-3396 | <b>Well ID</b> | NWN C-1 | | |

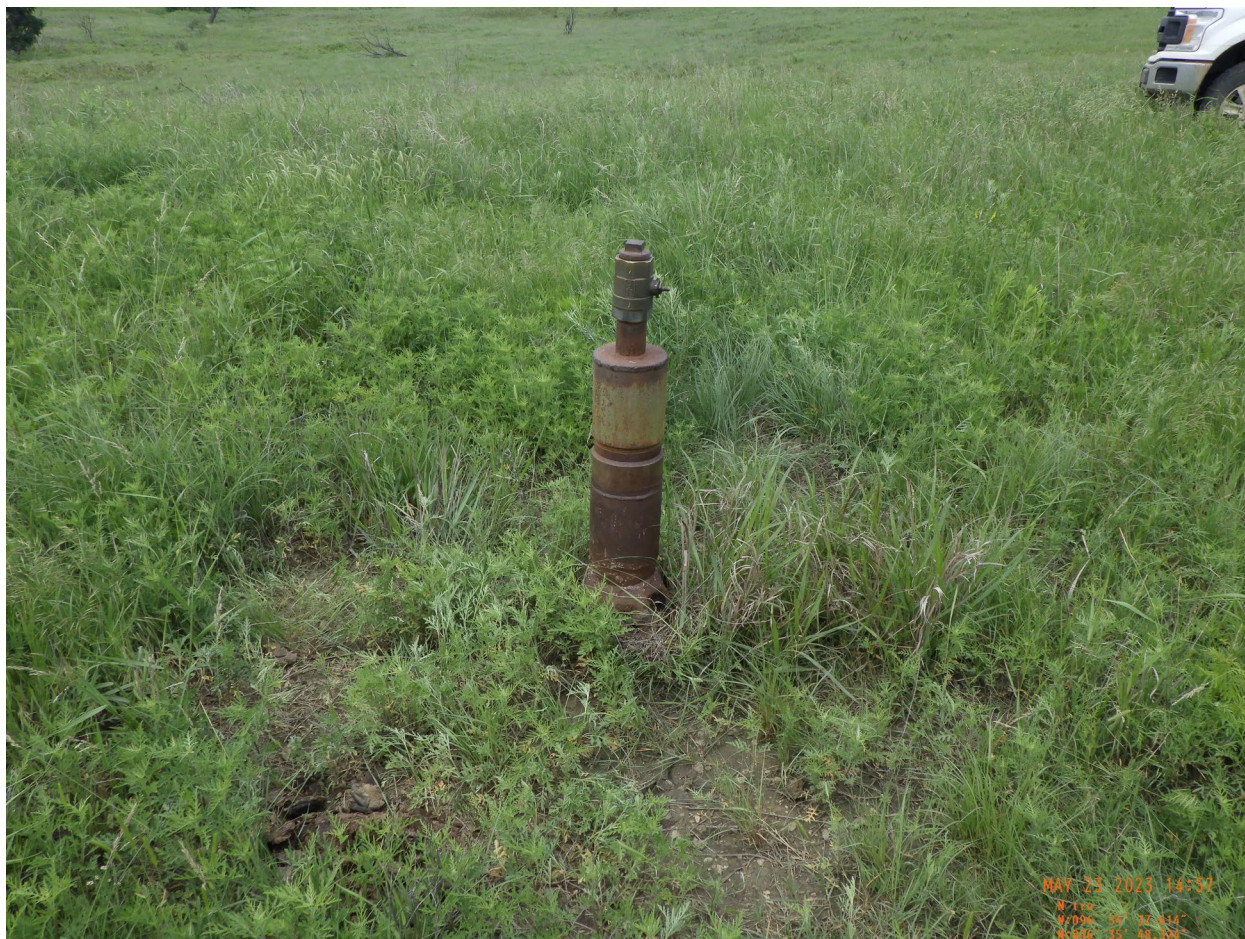
Photo No. 1

| <b>Inspection Comments</b> | A fluid level was taken with a properly calibrated EPA issued Echometer. The fluid level observed during the inspection was 426 feet deep. The well was not connected during the inspection. The casing size was approximately 6-inch. One photograph was taken during the inspection and can be seen in the Inspection Photo Log. | | | | |

**Description:** Contango Resources, LLC Well No. C-1 overview.
