CAA Inspection Report

Inspection Date: April 30, 2024

Facility Name: Municipality of Arecibo Landfill

Appendix C: Photo Log for Municipality of Arecibo Landfill, Arecibo, PR

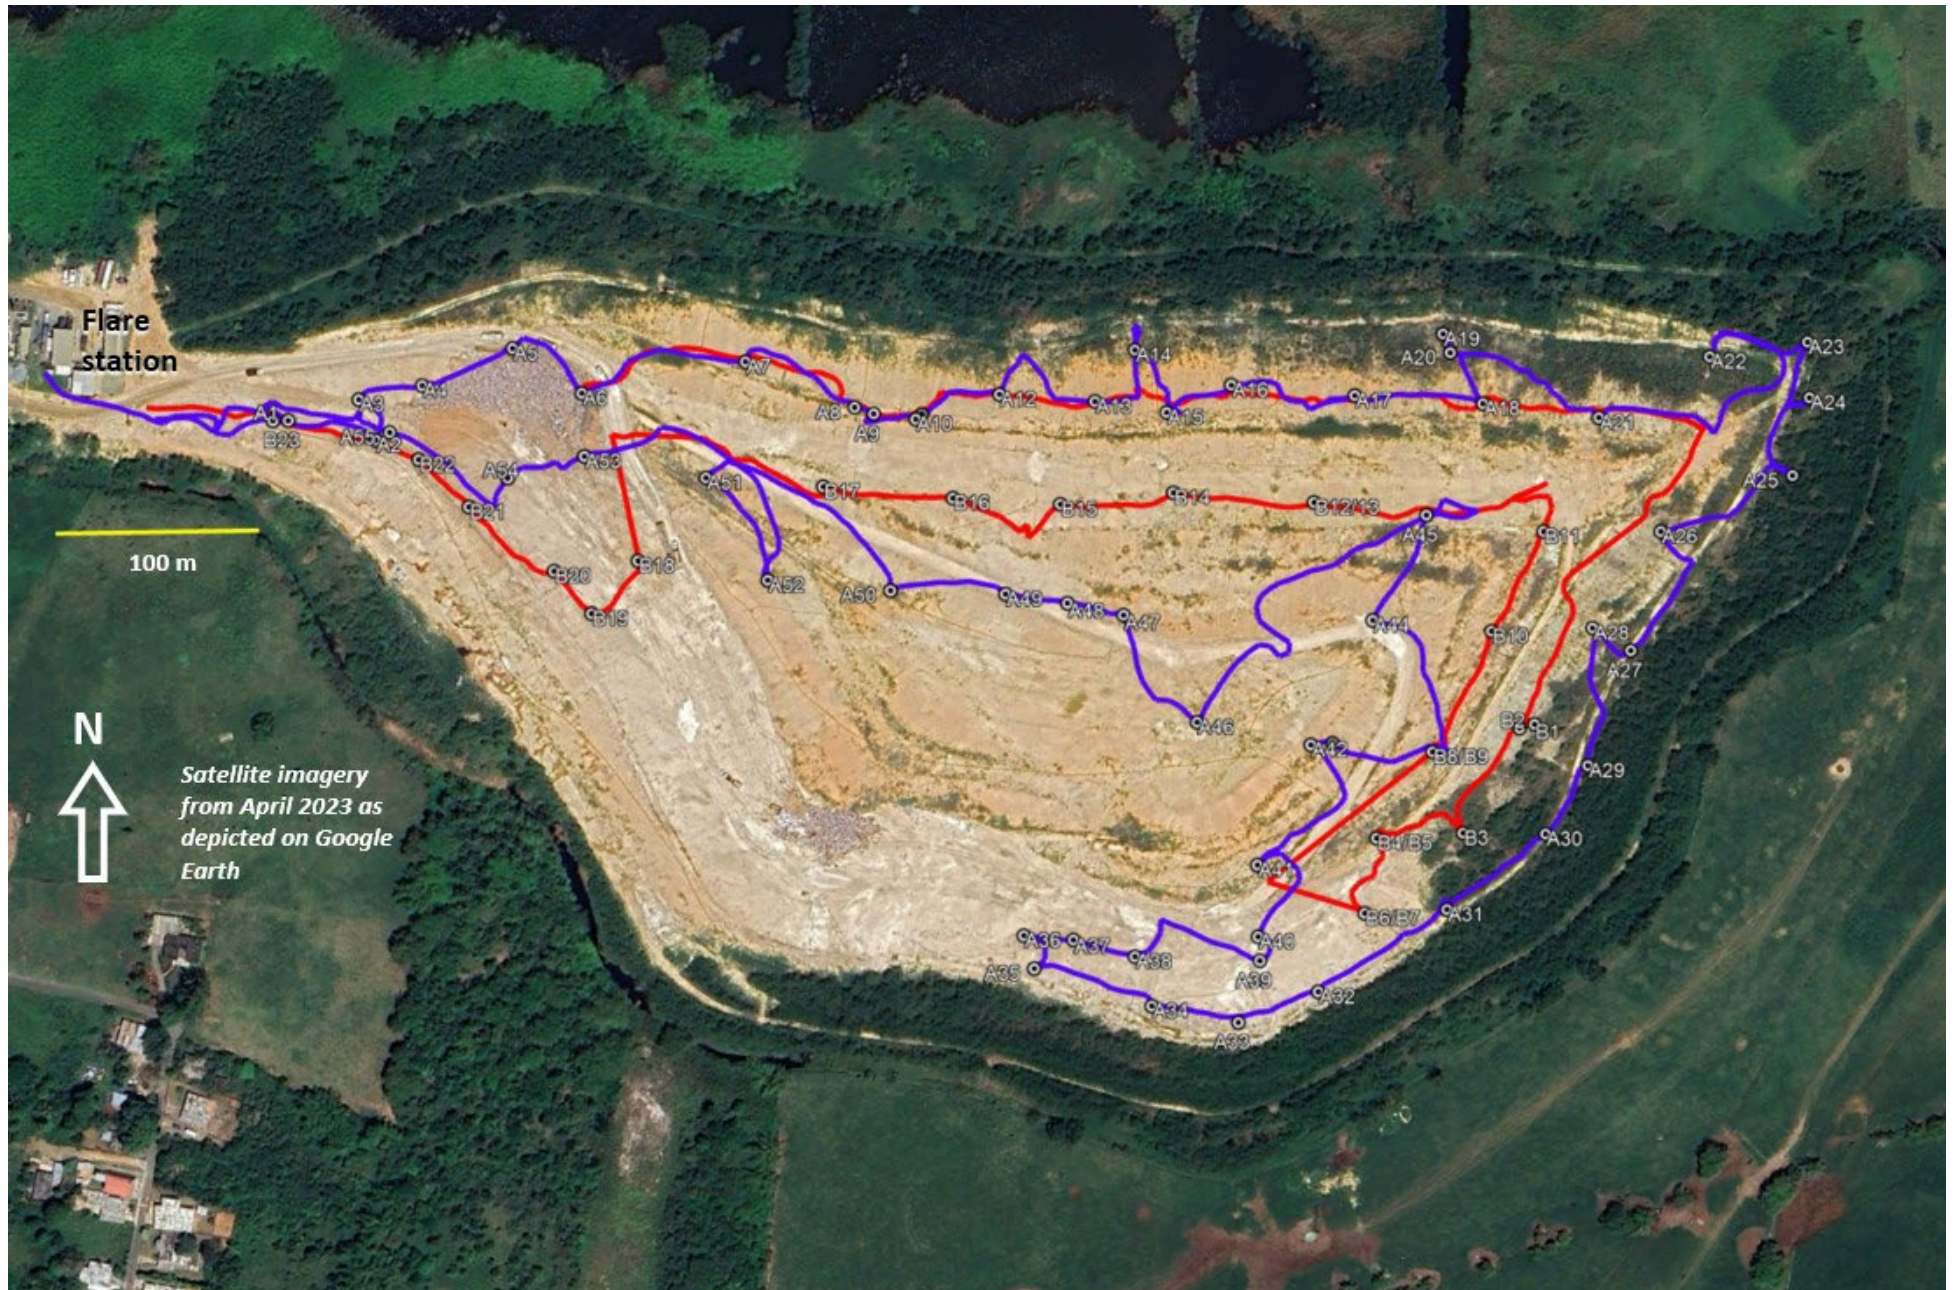
Appendix B: SEM Map

3. Although the monitoring activity did not cover the entire extent of the facility SEM plan, the inspectors were able to find over 70 different locations with surface concentrations of methane over 500 ppm.

Blue and red lines trace each team's monitoring path. Exceedances are plotted and labeled as described in Appendix A.

The survey covered less than 32 acres of the landfill.

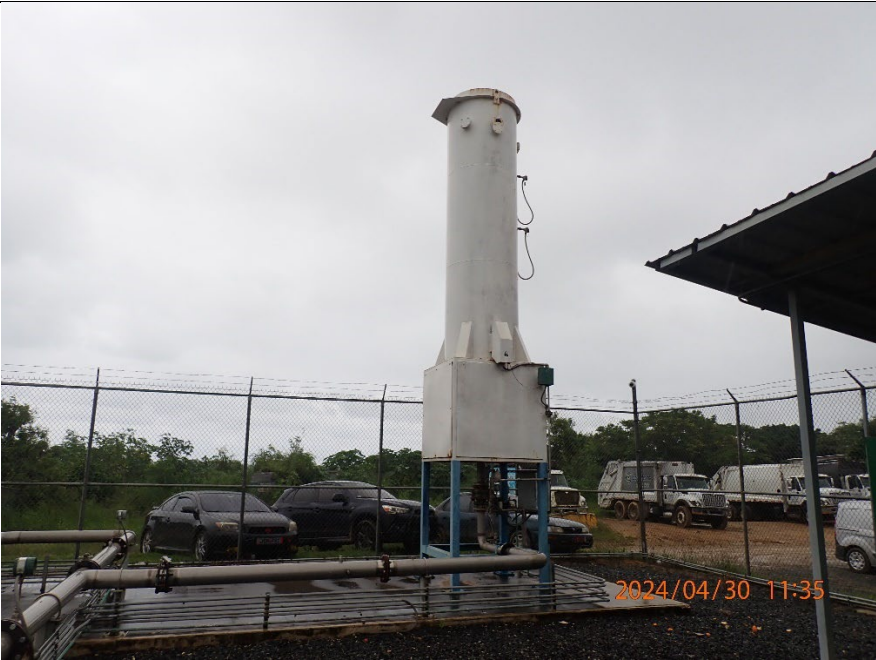
Enclosed flare stack (right)

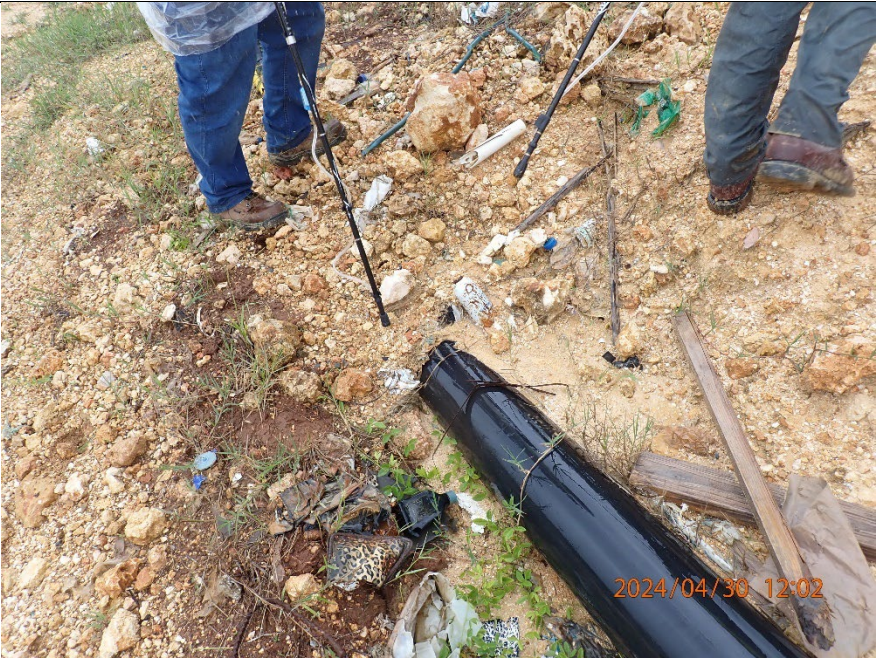
7	P4300052.JPG

4/30/2024	1202
Horizontal pipe penetrating ground

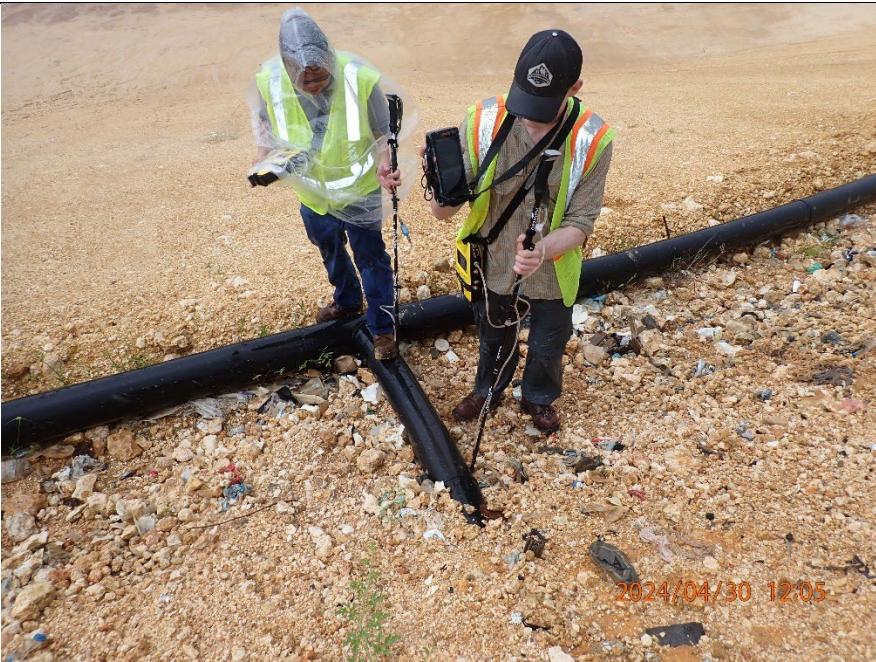
4/30/2024	1205
Horizontal pipe penetrating ground

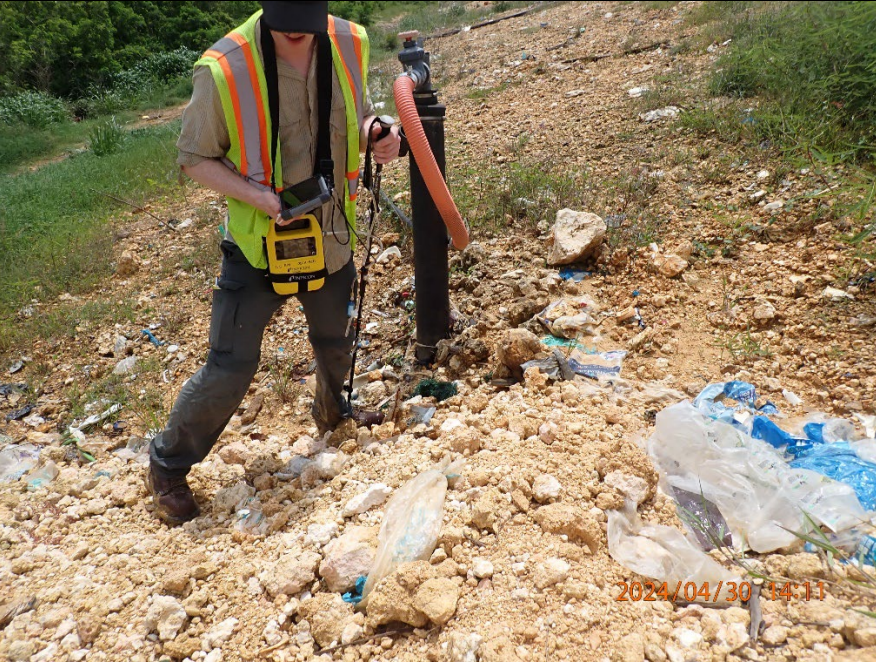
<p>2024/04/30 14:11</p>	4/30/2024	1411
Landfill gas monitoring well (tag #79033) venting through sampling port and base

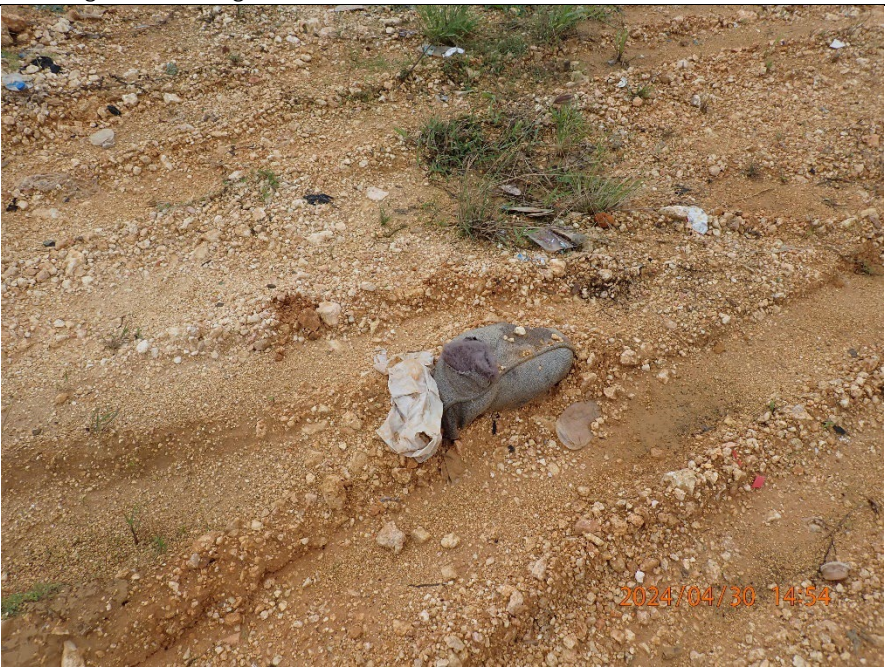
8. Exposed waste, lack of adequate cover issues observed throughout the walkthrough. Mr. Camis indicated that the facility is planning to use hydroseeding at several areas to improve the cover issues.

<p data-bbox="573 1390 735 1421">Exposed waste</p>	4/30/2024	1454
