### **Campbell Sand & Gravel, Co. Big Escambia Mine (North) Site Inspection Photographic Log**

Escambia County, Florida  
*(unless notated otherwise in comment section of  
field tables)*

December 6, 2022

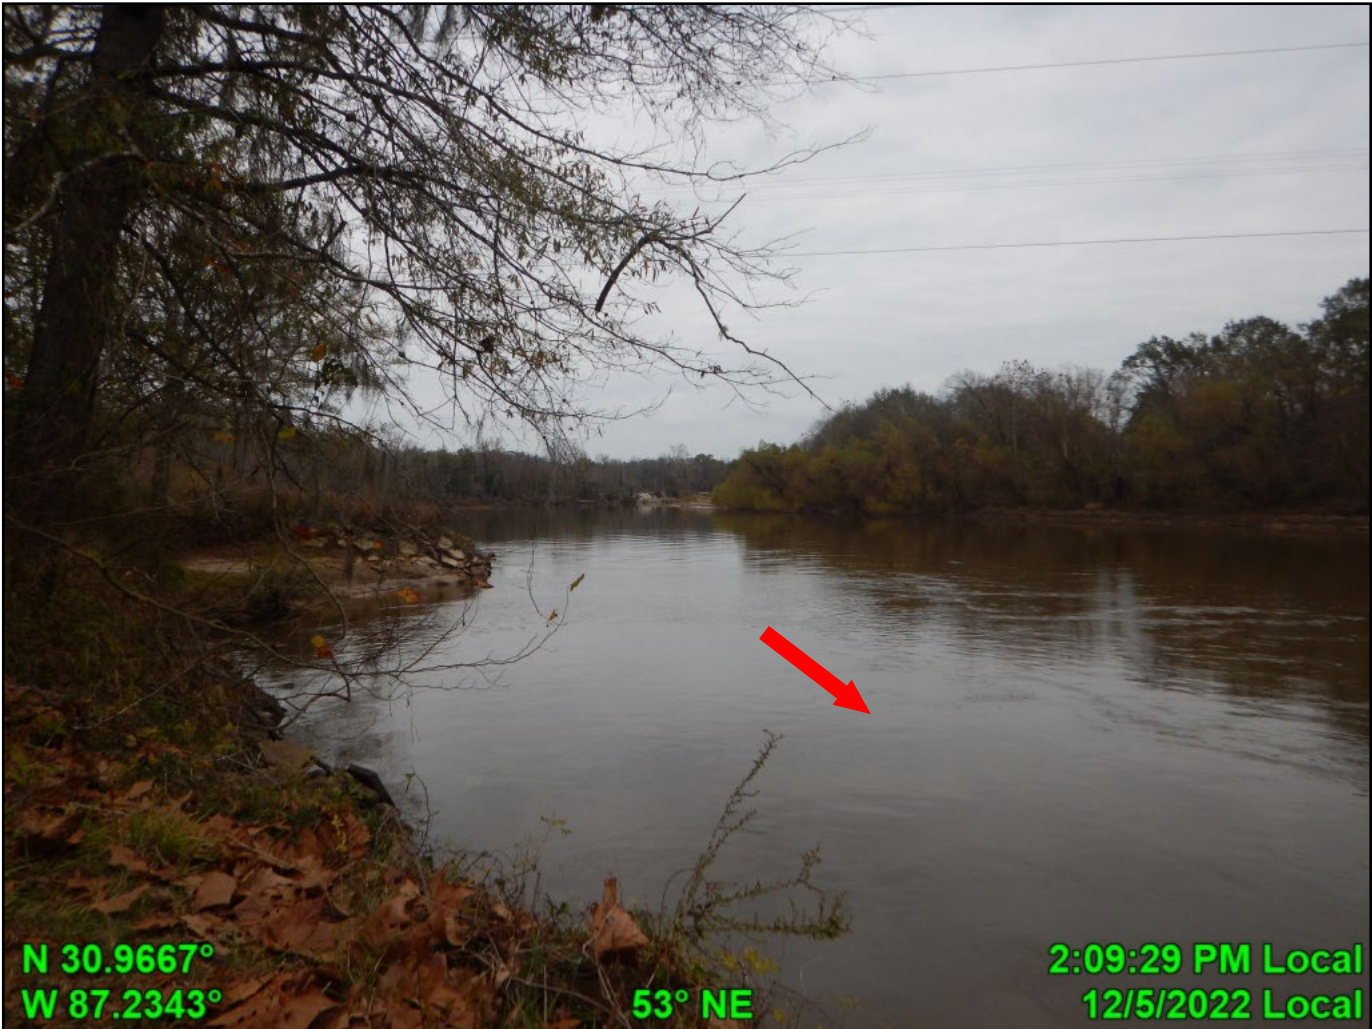
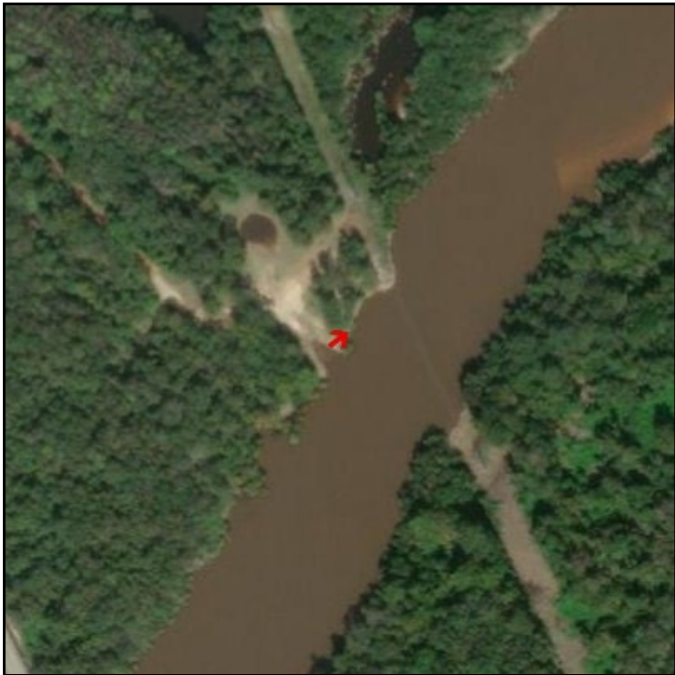
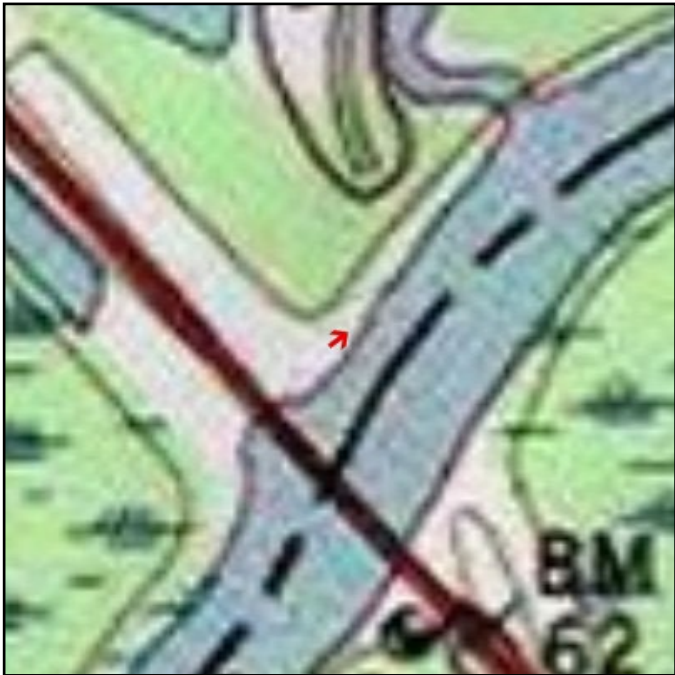
| Title | Photo 1 |

| Description | Striking northeast/north; upstream. Looking toward Campbell property used for mining (Big Escambia Mine North) with bridge in horizon. Red arrow in top photo indicates direction of flow. |

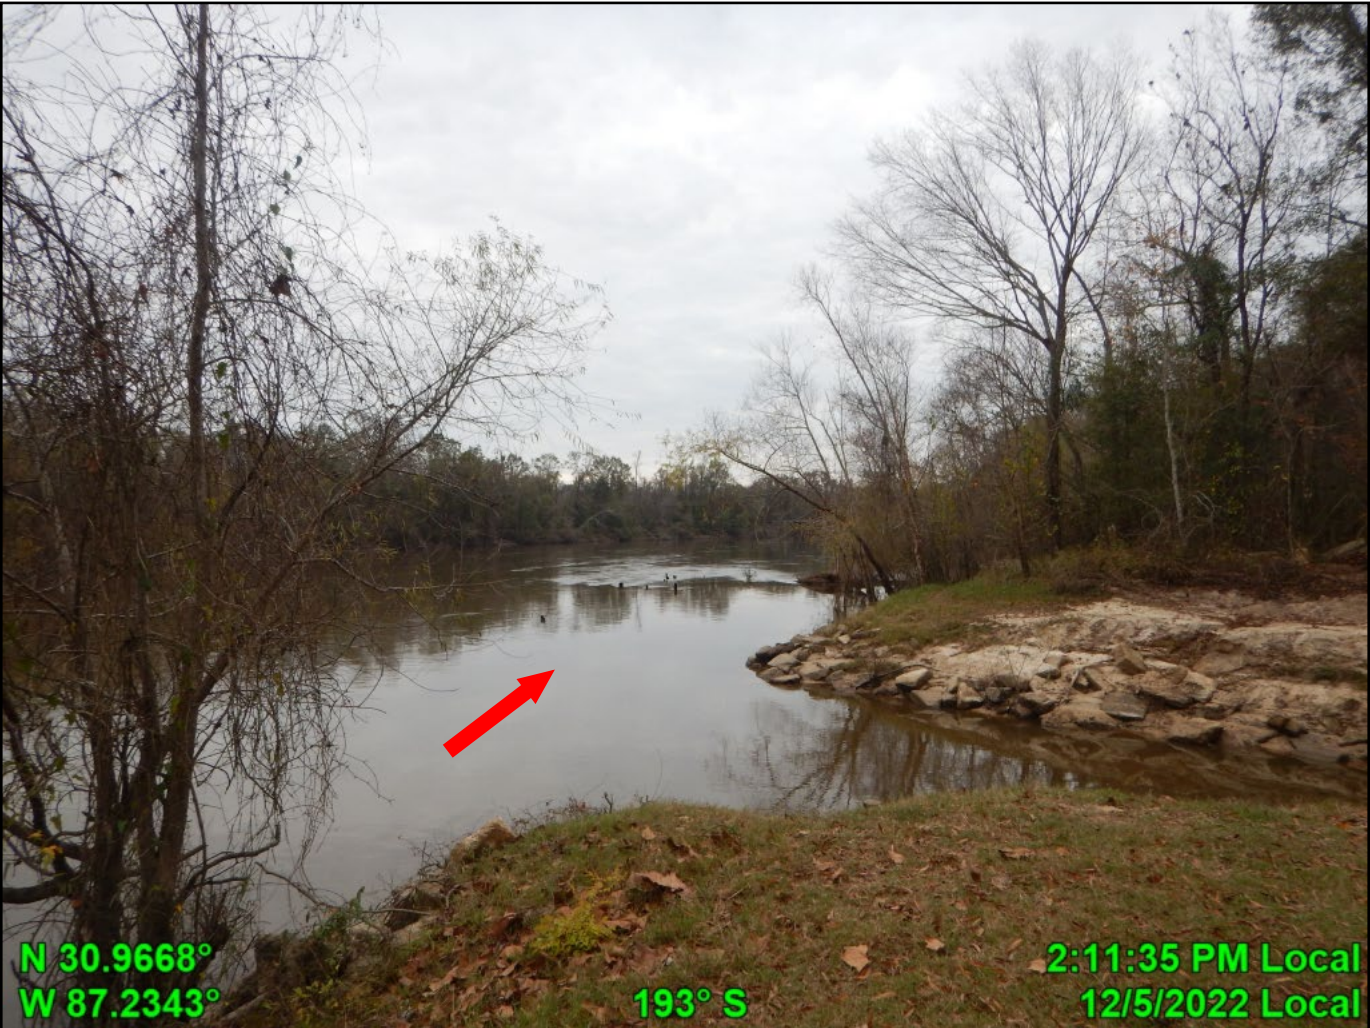
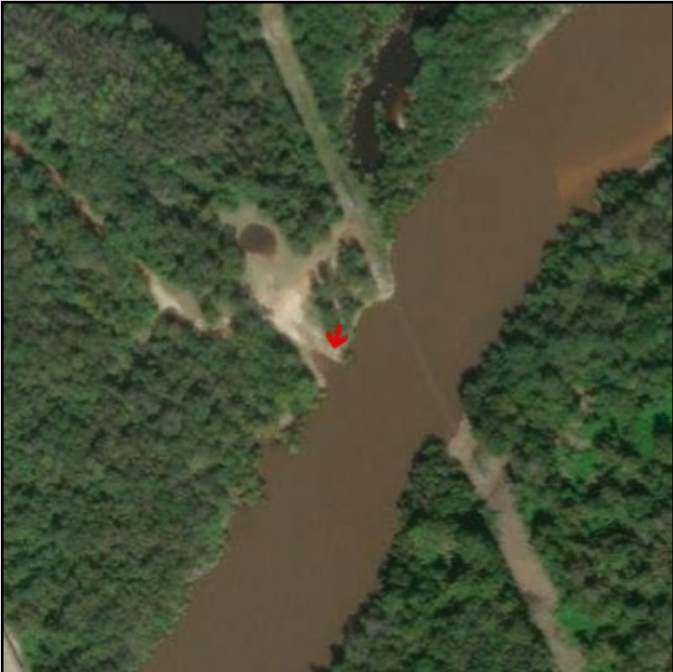
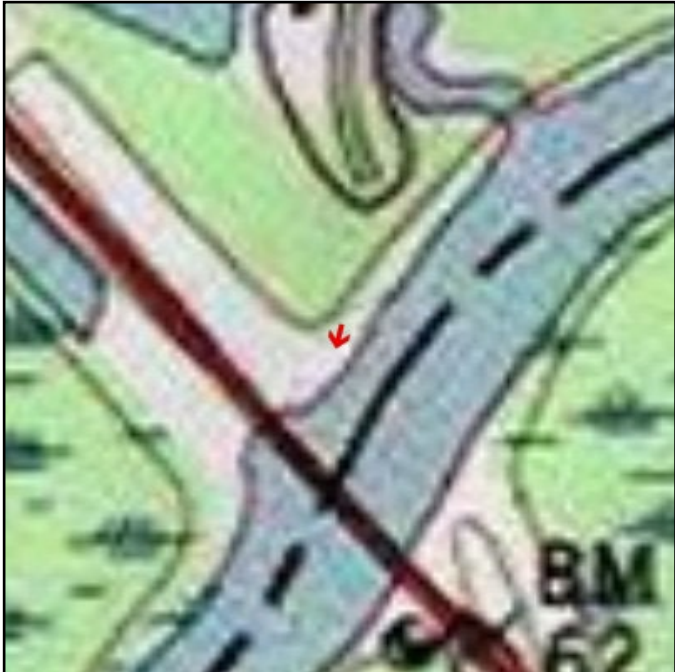
| Title | Photo 2 |

| Description | Striking south, southwest; downstream. Looking toward highway bridge (FL-4). Red arrow in top photo indicates direction of flow. |

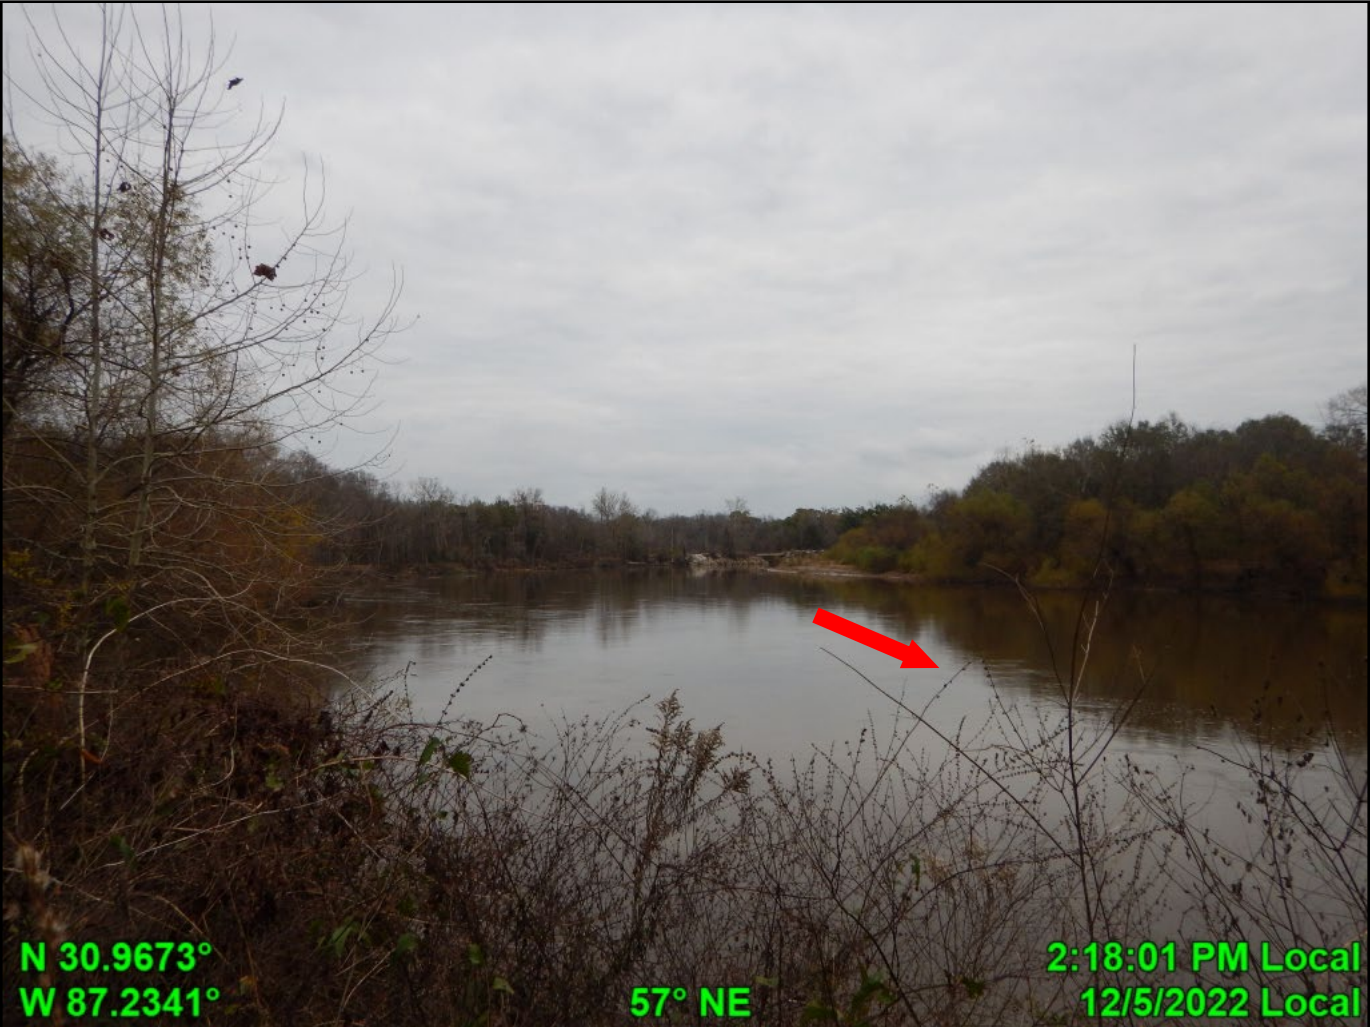
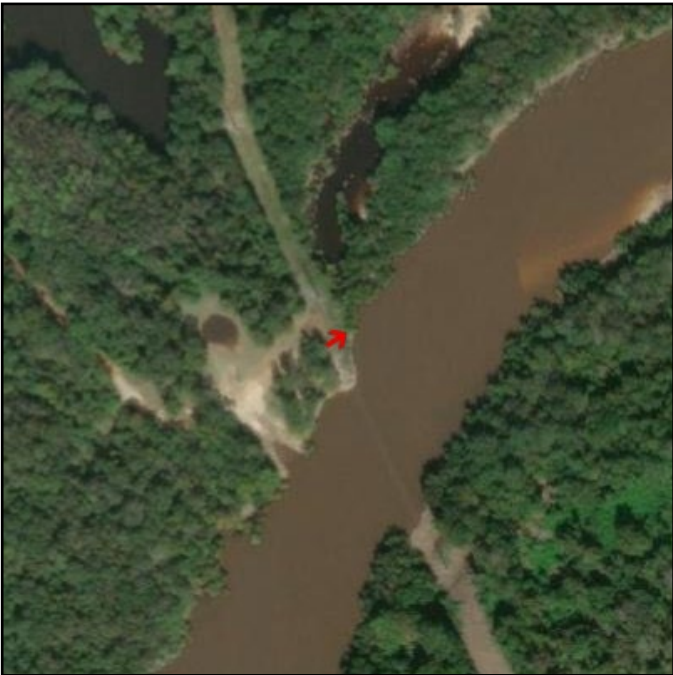
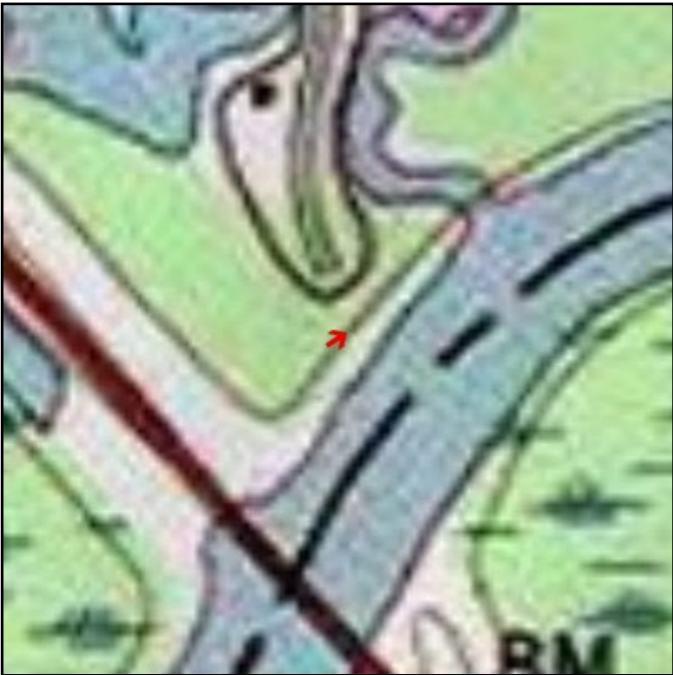
| Title | Photo 3 |

| Description | Striking northeast, north; upstream. Close-up of bridge at facility taken from Fischer Landing boat launch parcel. Red arrow in top photo indicates direction of flow. |

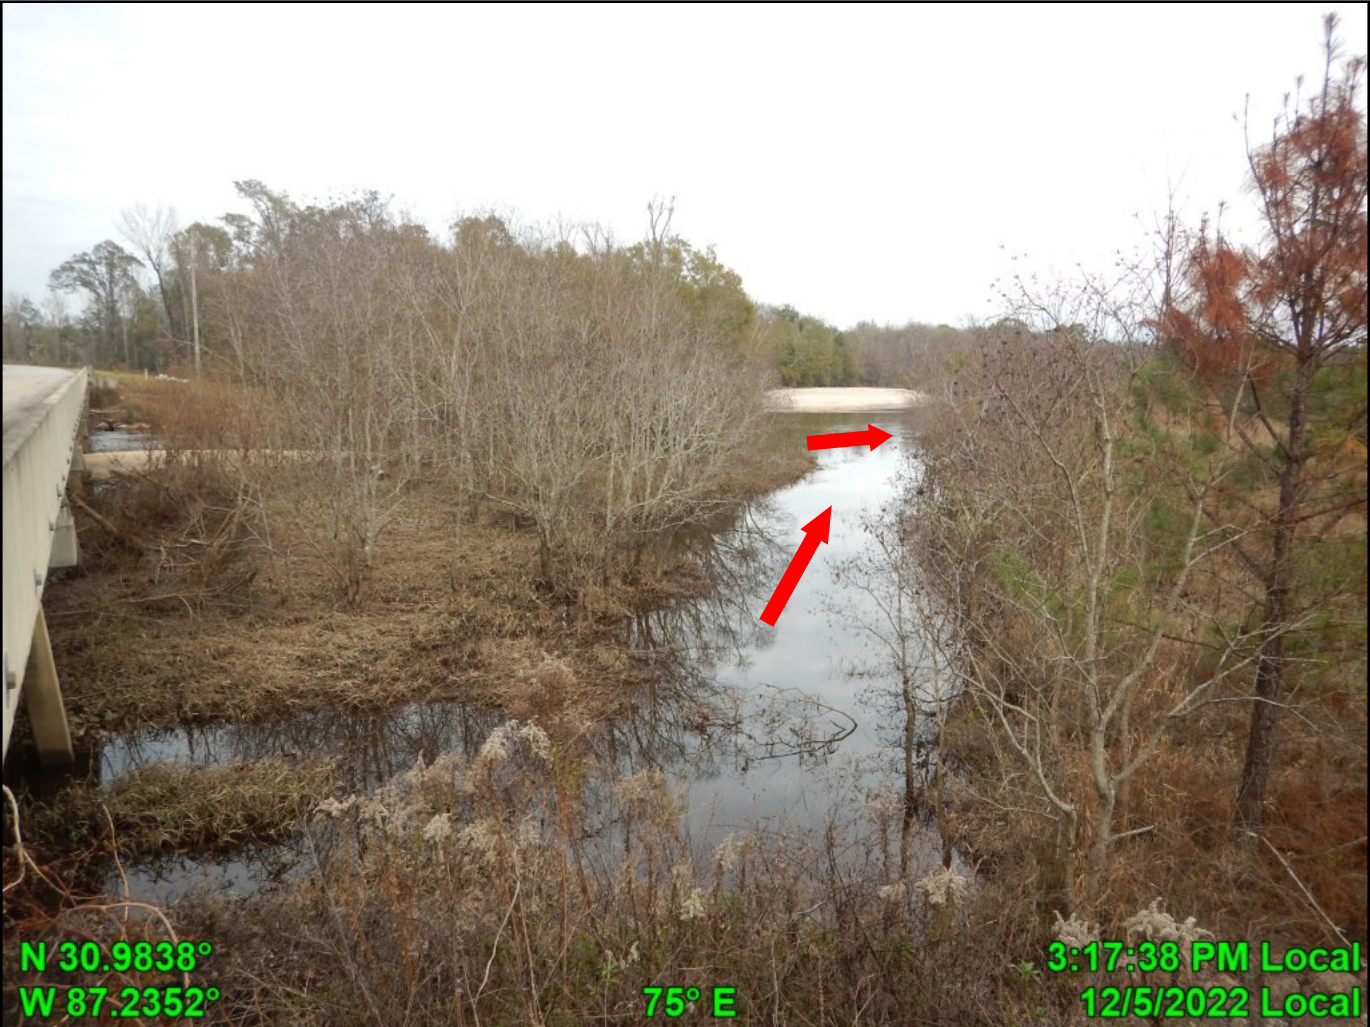
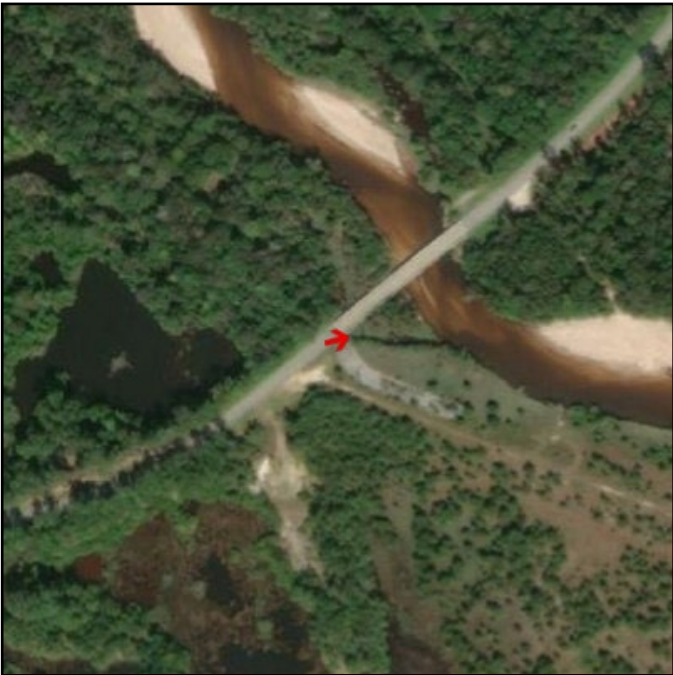
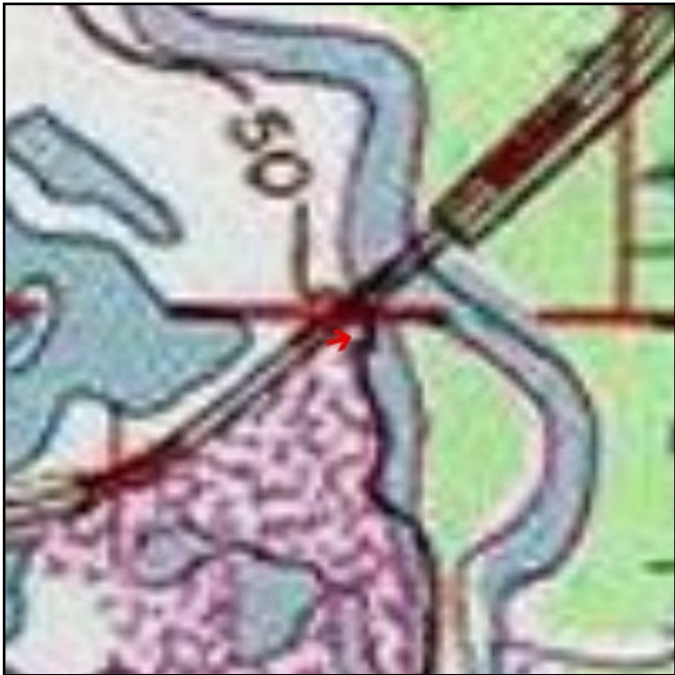
| Title | Photo 4 |

| Description | Striking northeast, east; downstream. Big Escambia River taken from bridge/Fannie Road. Red arrow in top photo indicates direction of flow. |

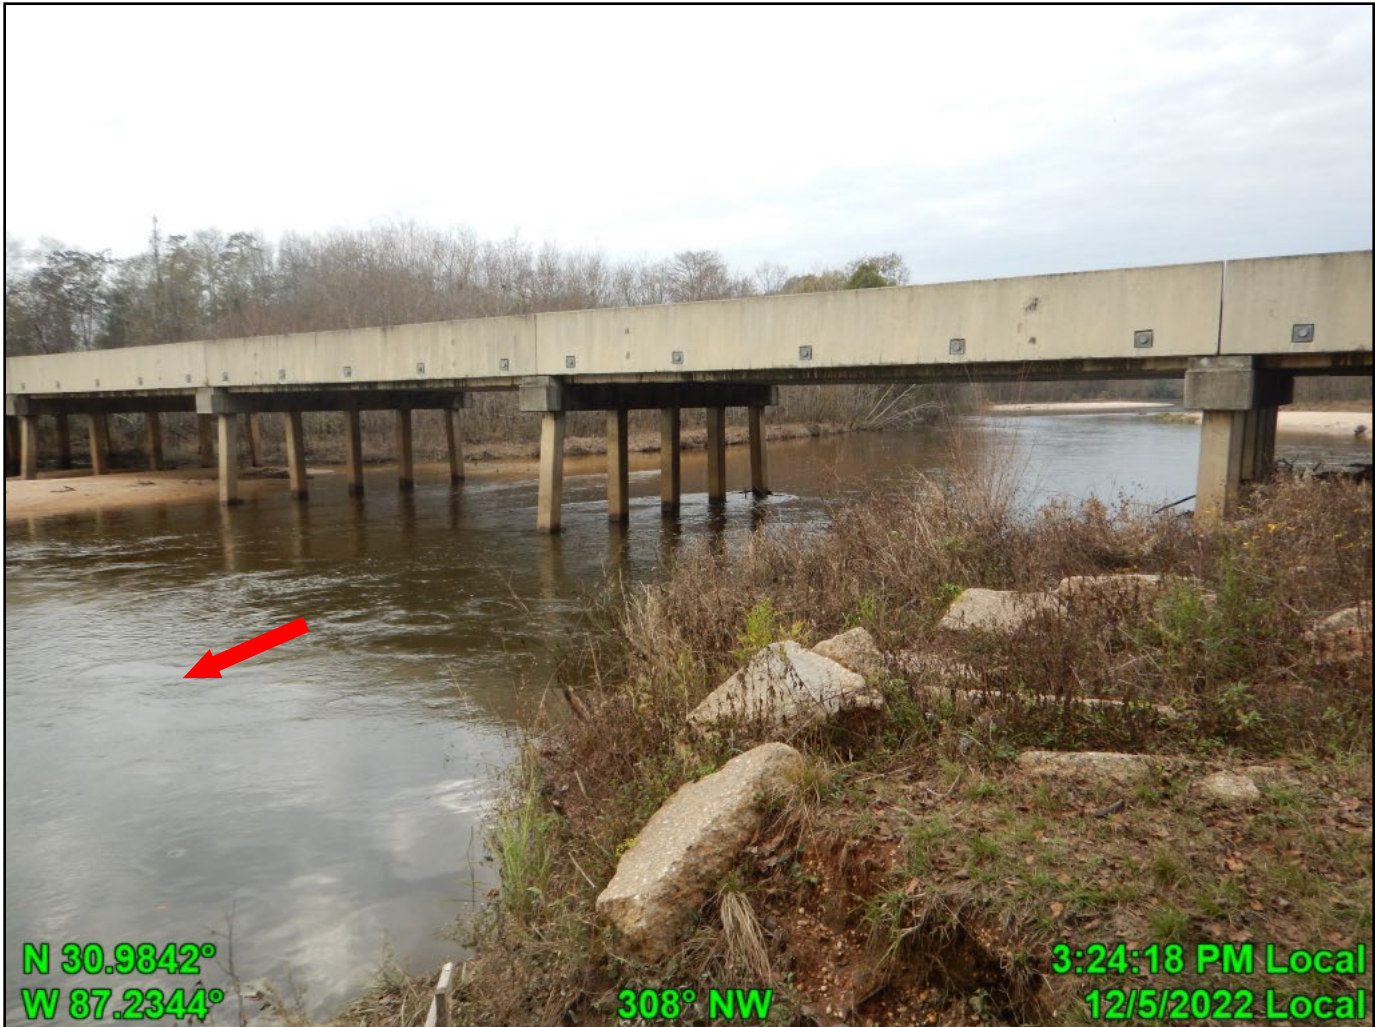
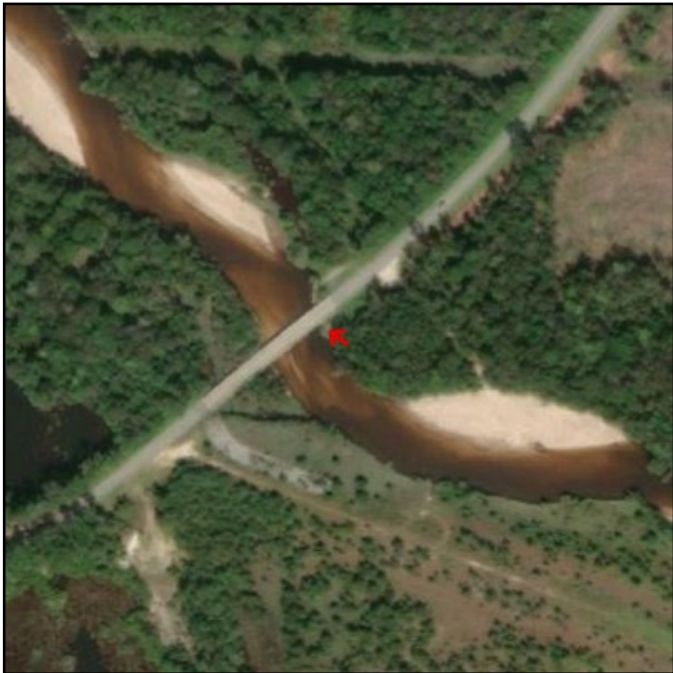
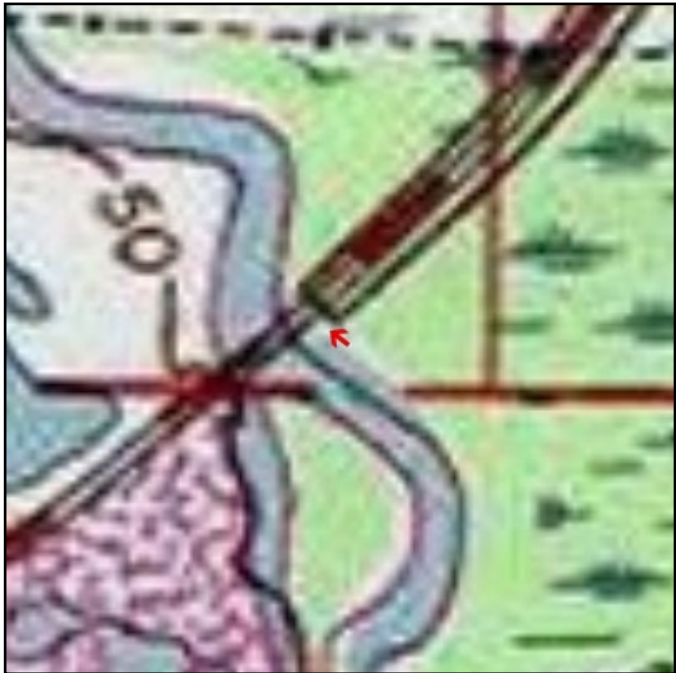
| Title | Photo 5 |

| Description | Striking north, northwest; upstream. View of Big Escambia Creek from further northward off bridge. Red arrow in top photo indicates direction of flow. |

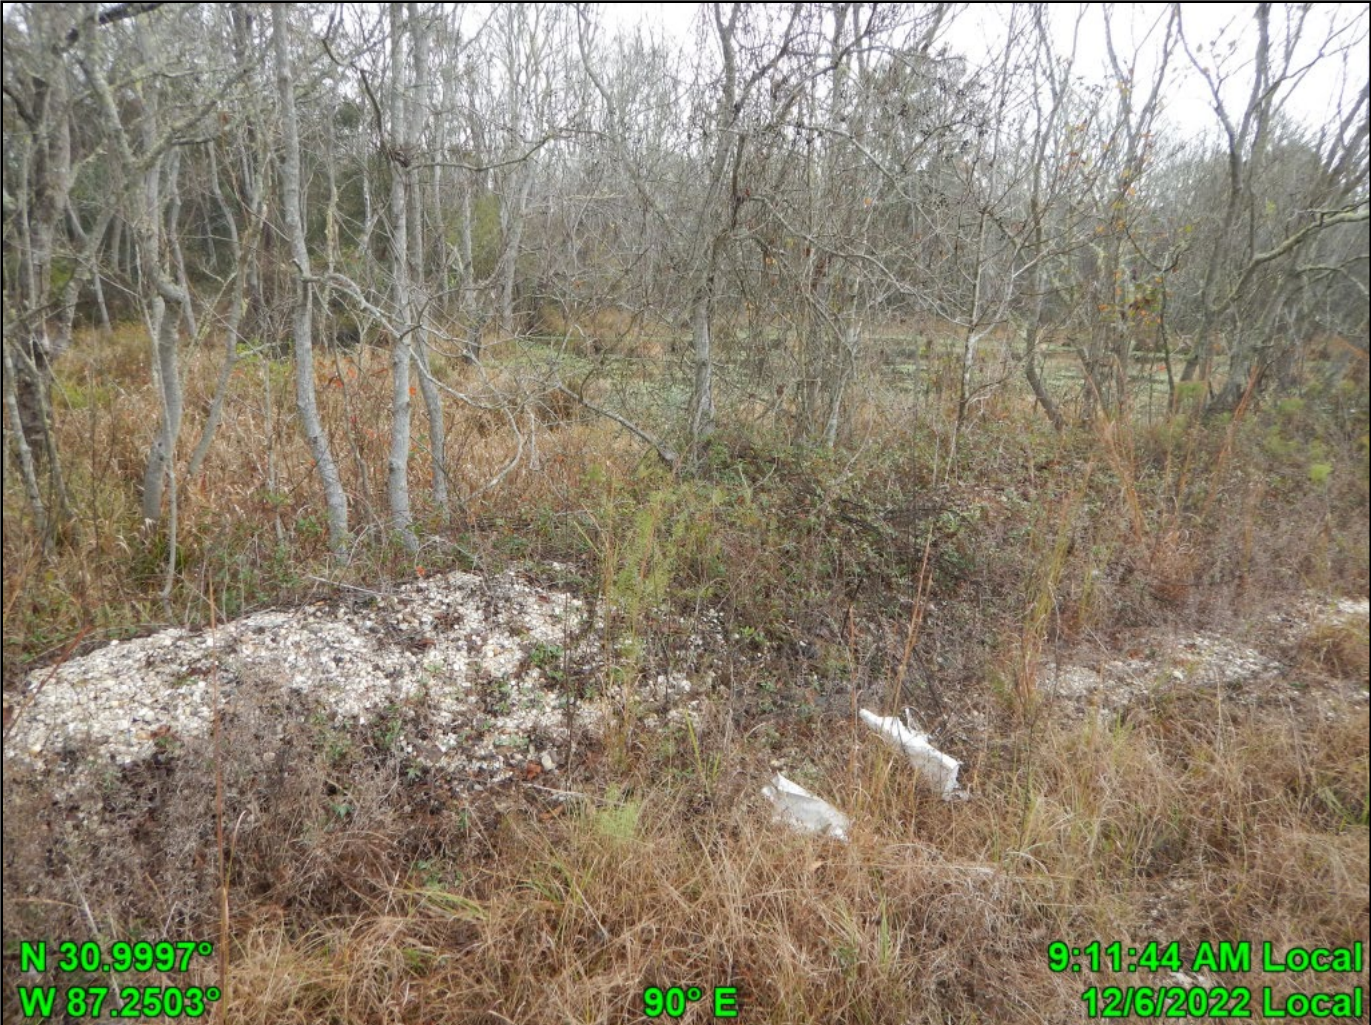
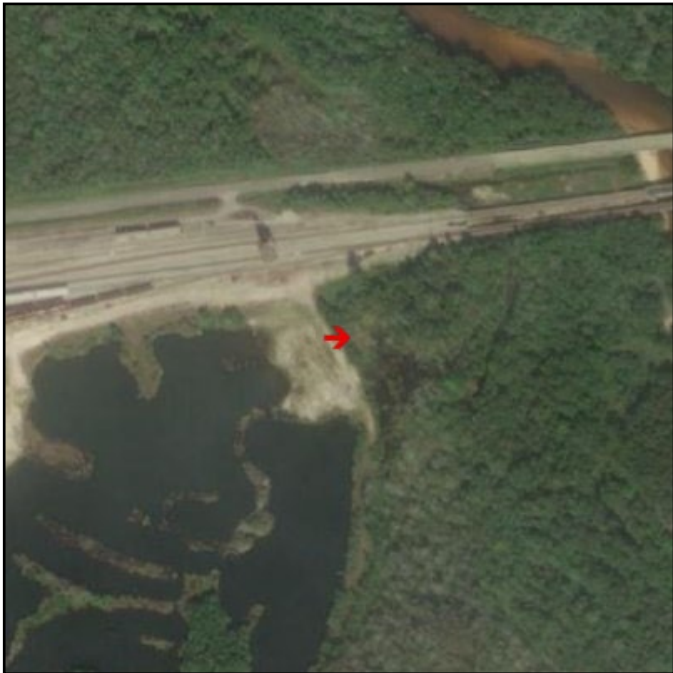
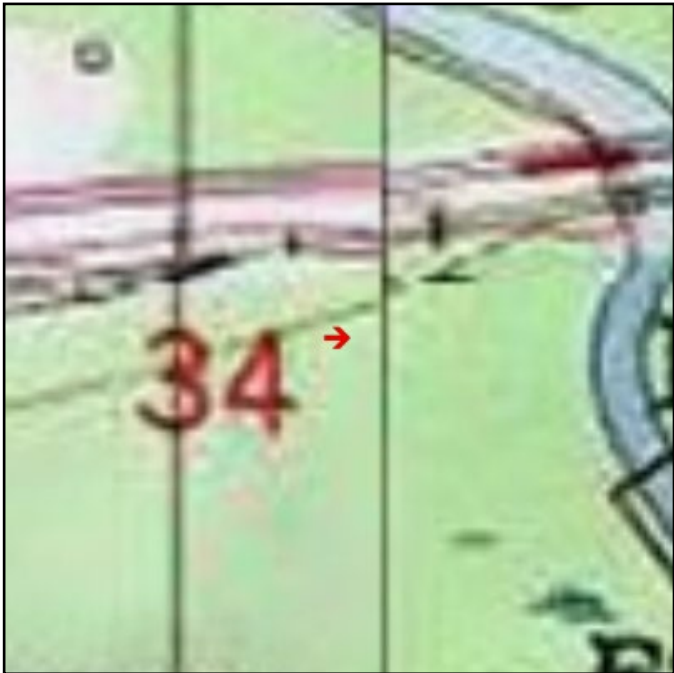
| Title | Photo 6 |

| Description | Striking east. Looking toward Big Escambia Creek, standing water present past initial tree line. |

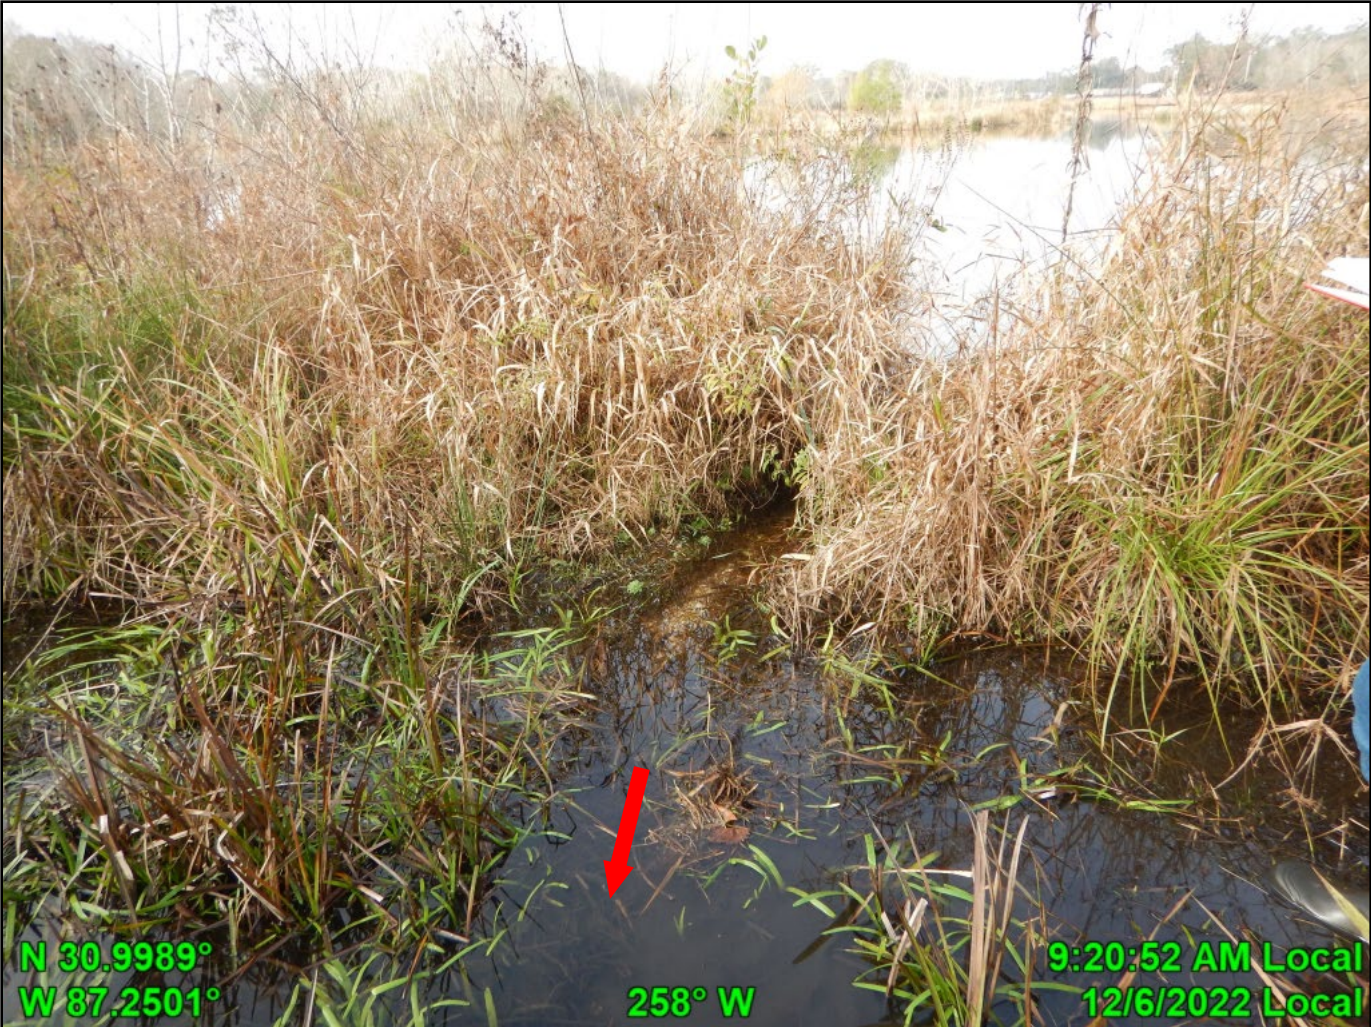
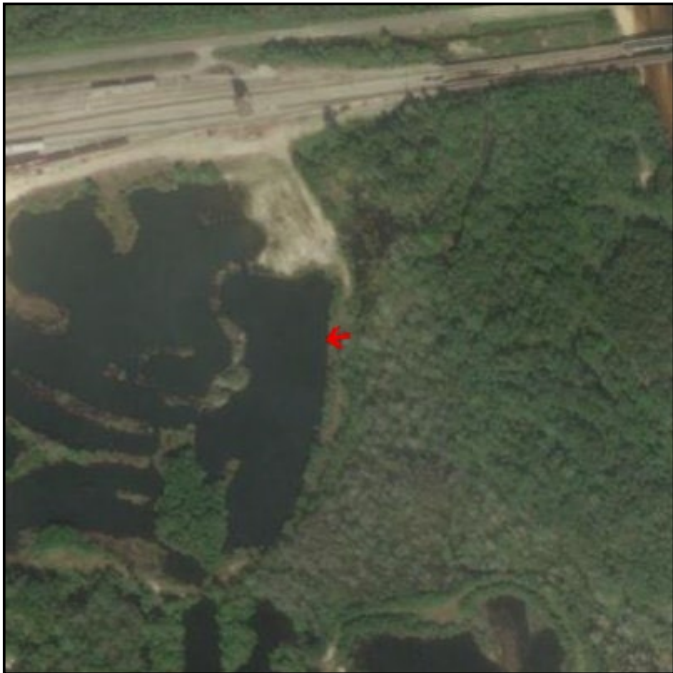
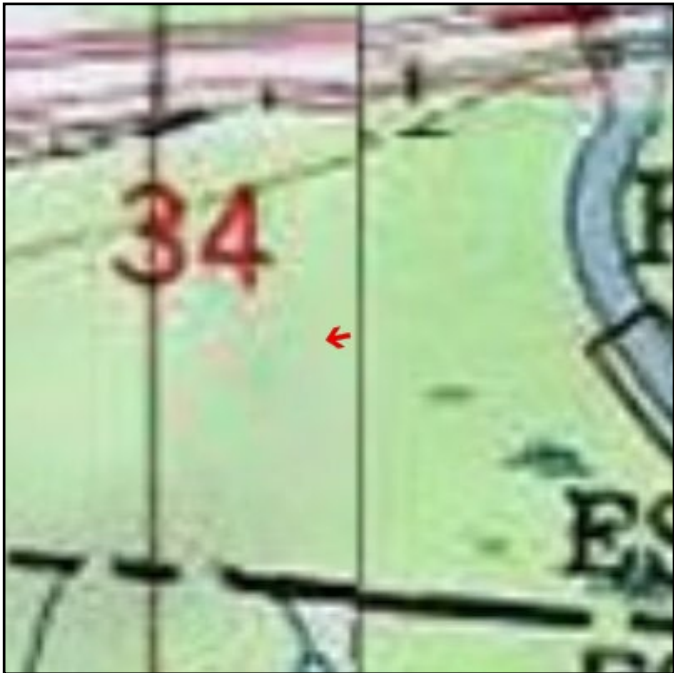
| Title | Photo 7 |

| Description | Striking west, southwest; upstream. Water flowing from mine pond to floodplain of Big Escambia Creek. Red arrow in top photo indicates direction of flow. |

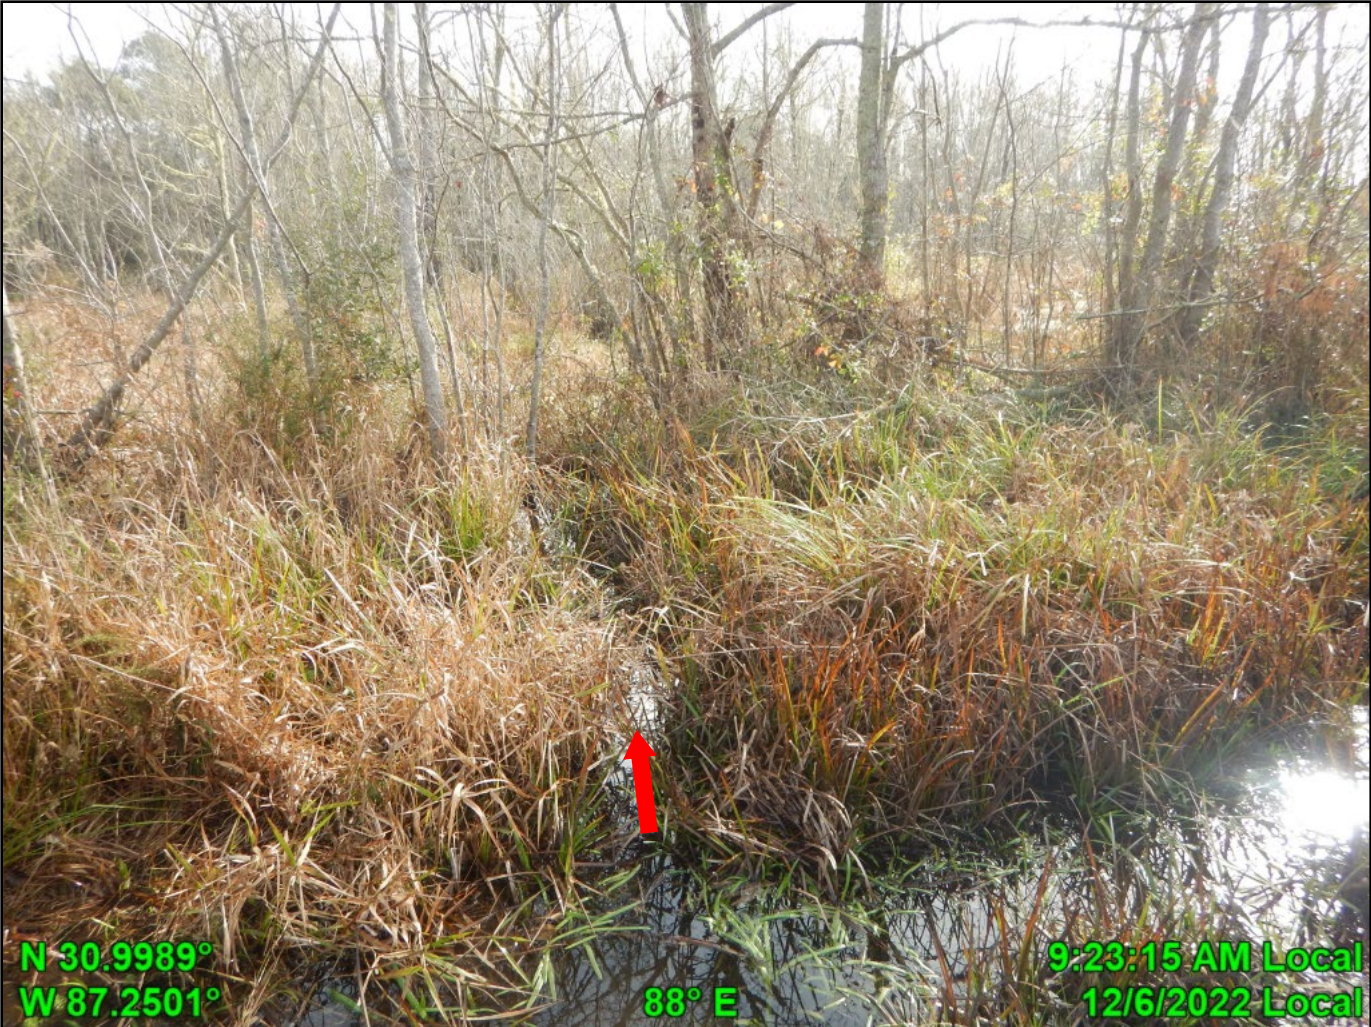
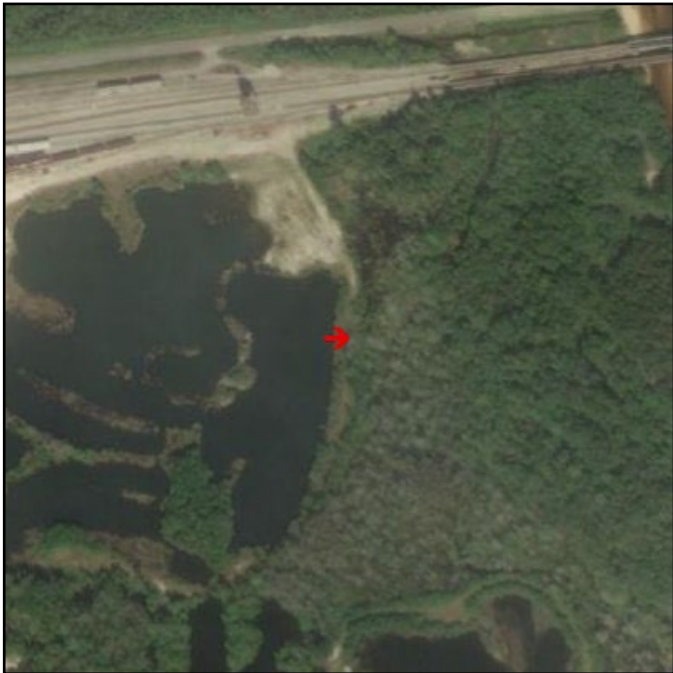
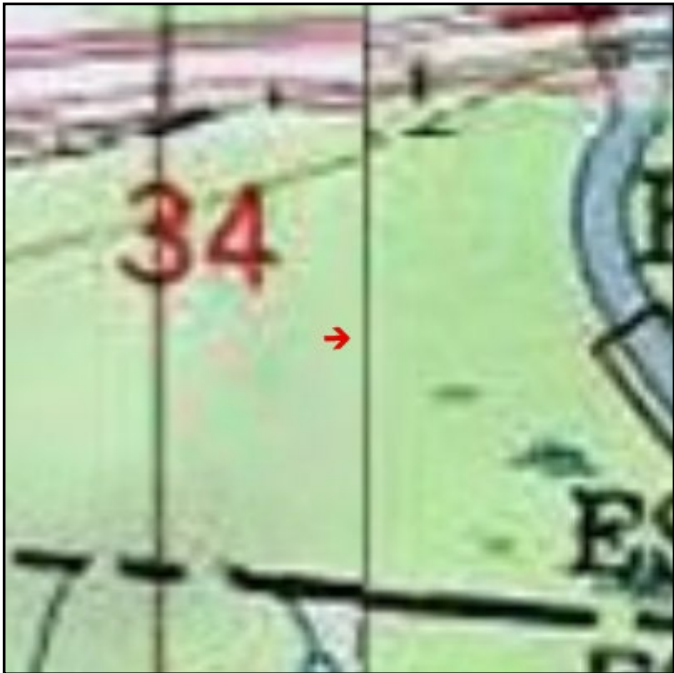
| Title | Photo 8 |

| Description | Striking southeast; downstream. Looking toward floodplain of Big Escambia River. Red arrow in top photo indicates direction of flow. |

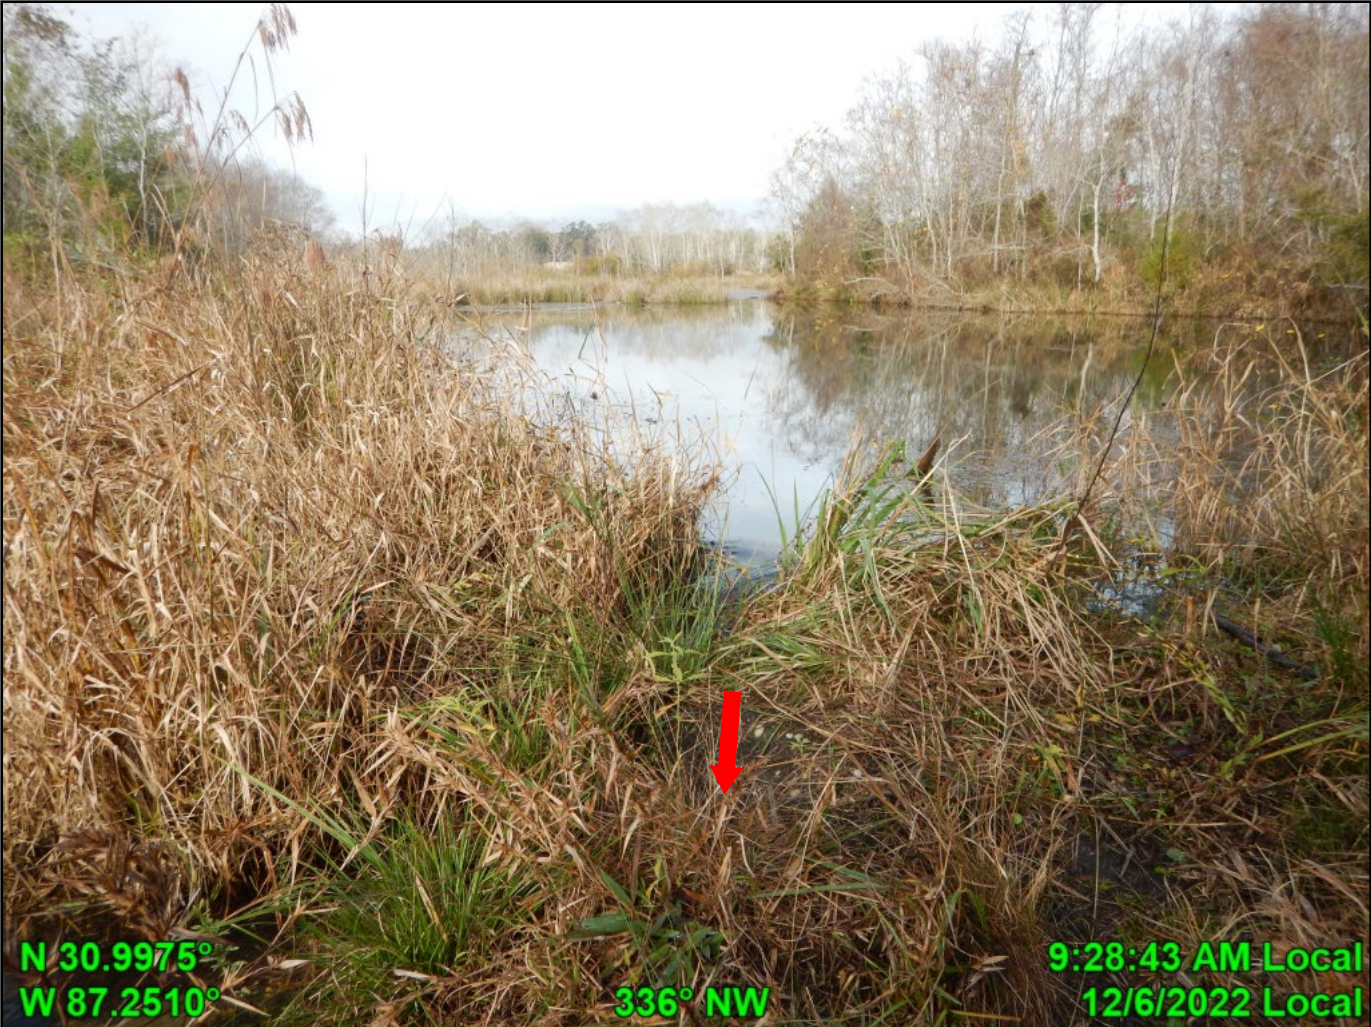
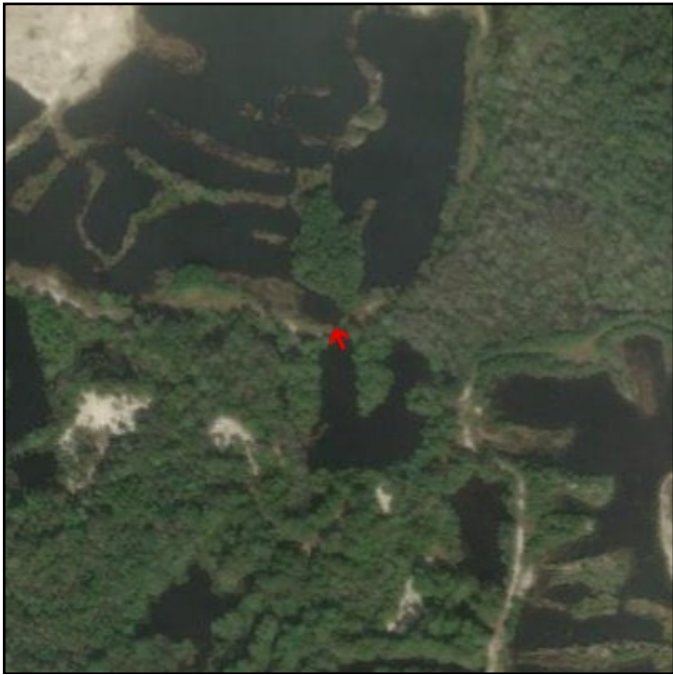
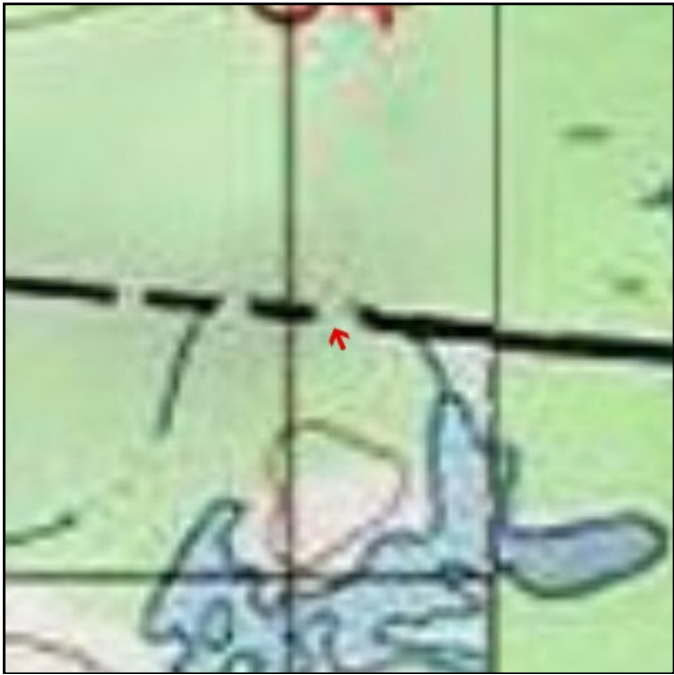
| Title | Photo 9 |

| Description | Striking northwest; upstream. Mine pond. Red arrow in top photo indicates direction of flow. |
