### **Campbell Sand & Gravel, Co. Big Escambia Mine (North) Site Inspection Photographic Log**

Escambia County, Florida  
*(unless notated otherwise in comment section of  
field tables)*

December 6, 2022

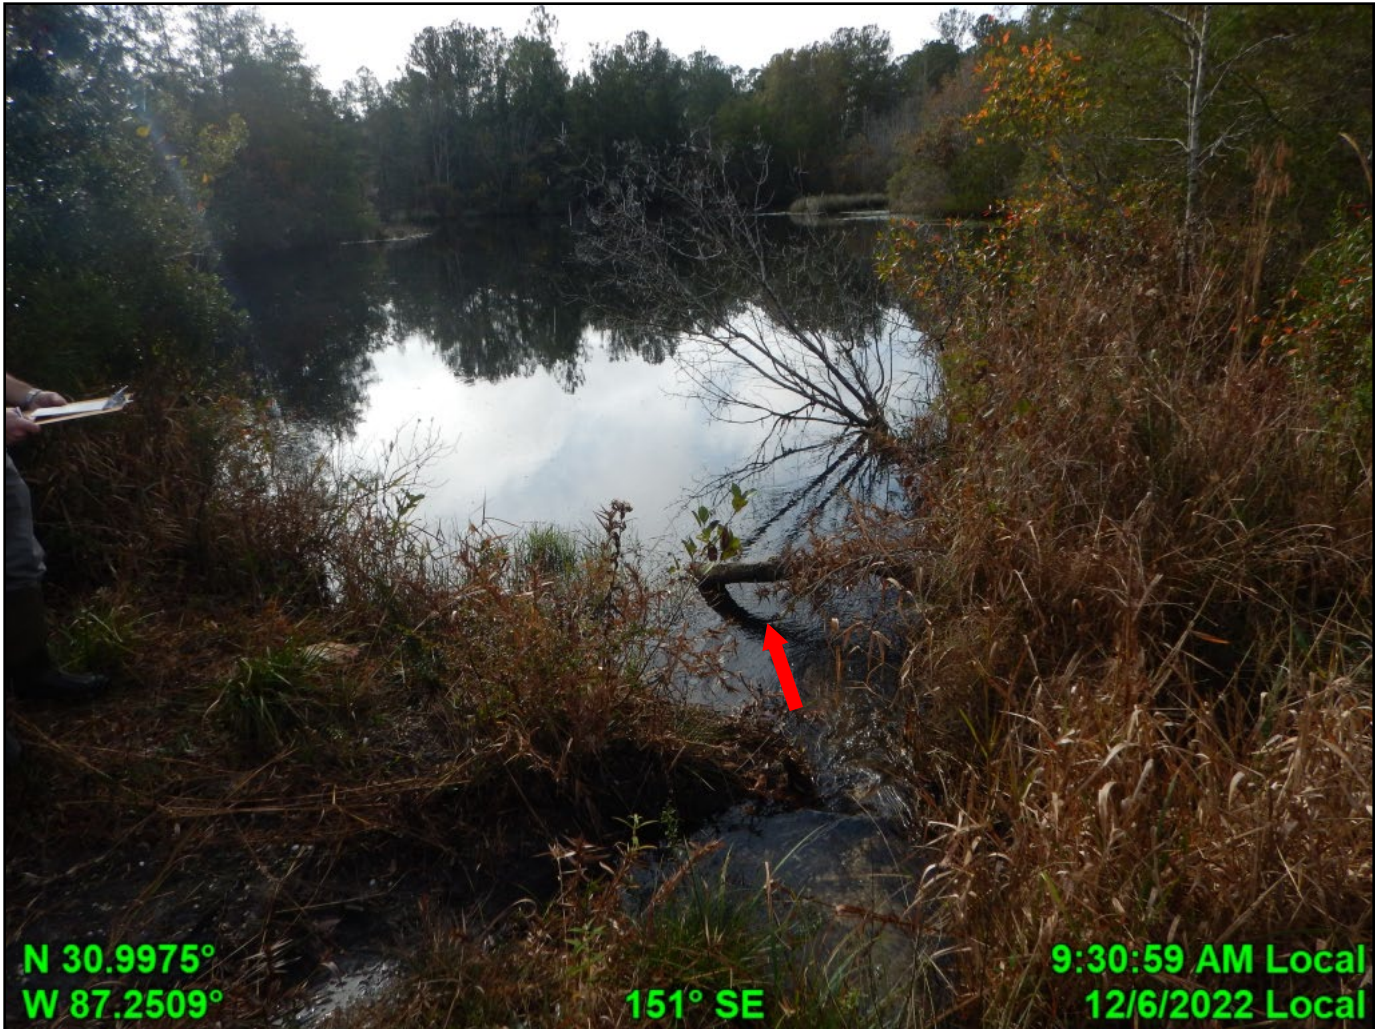
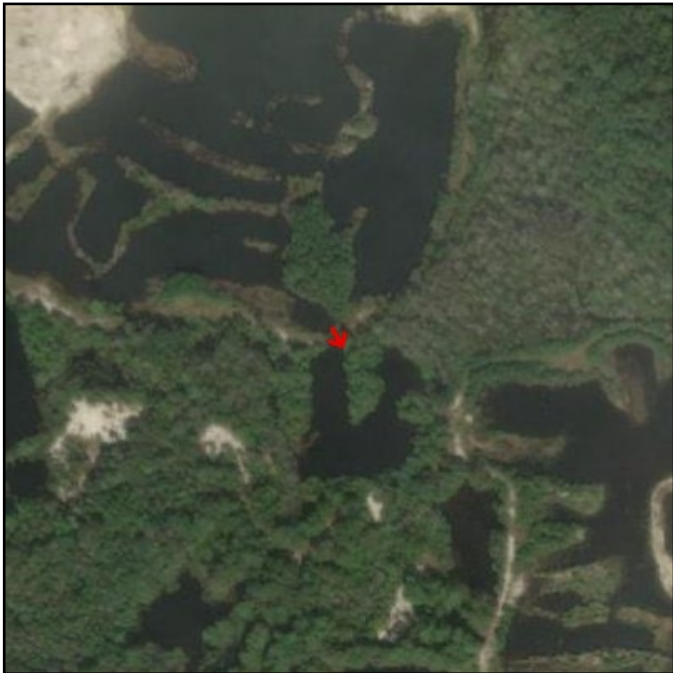
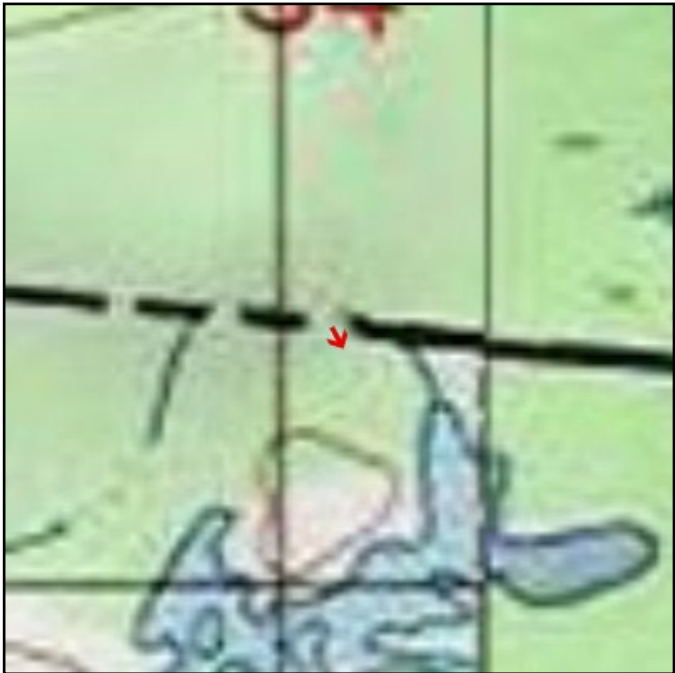
| Title | Photo 10 |

| Description | Striking south, southeast; downstream. Receiving pond. Red arrow in top photo indicates direction of flow. |

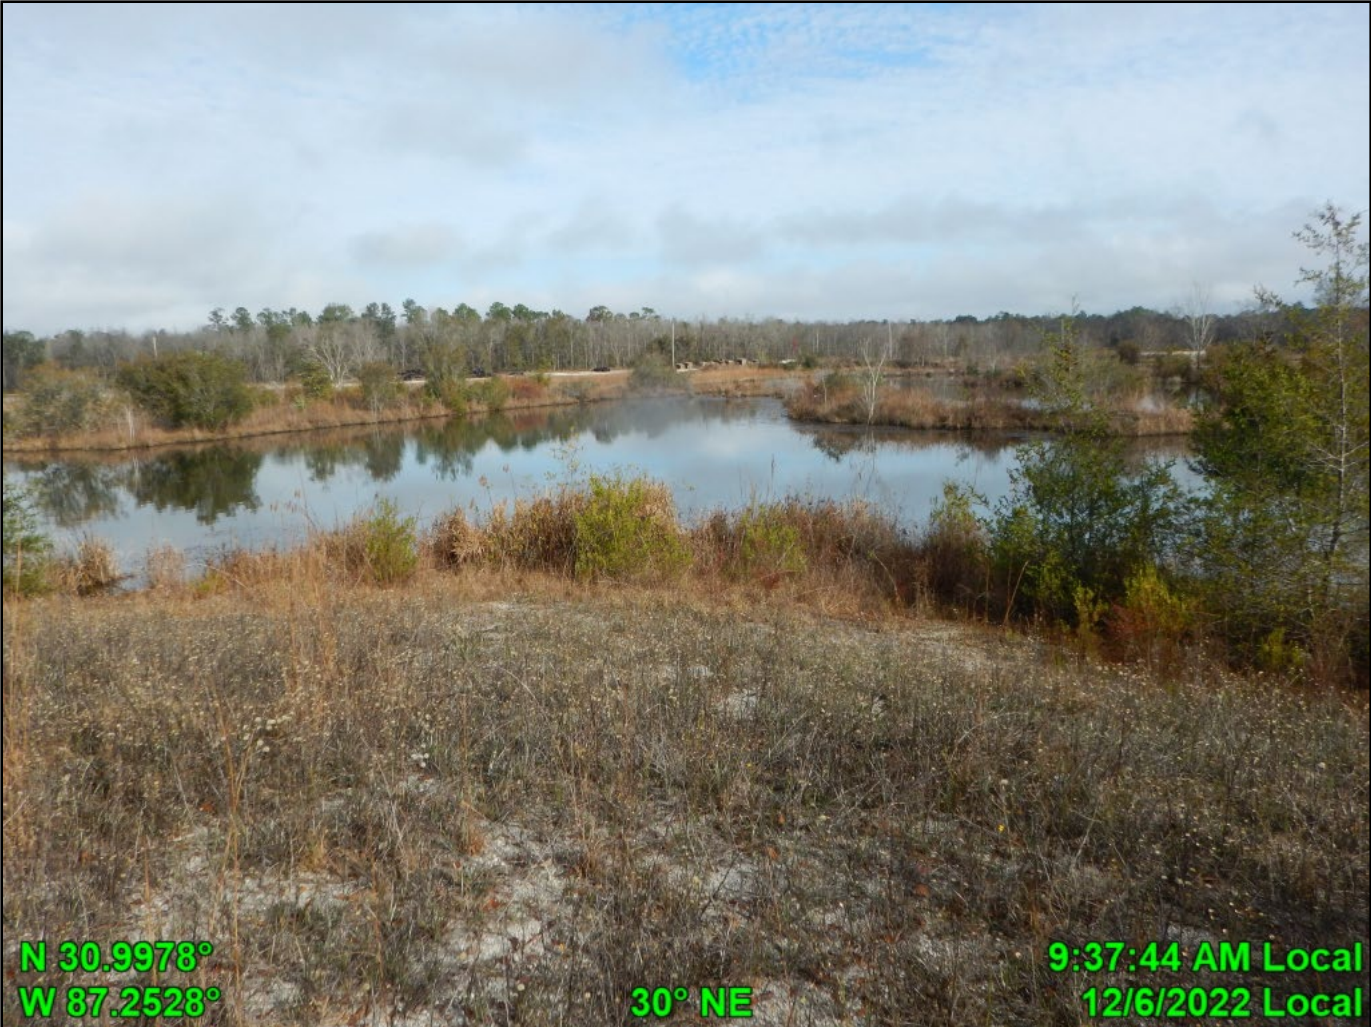
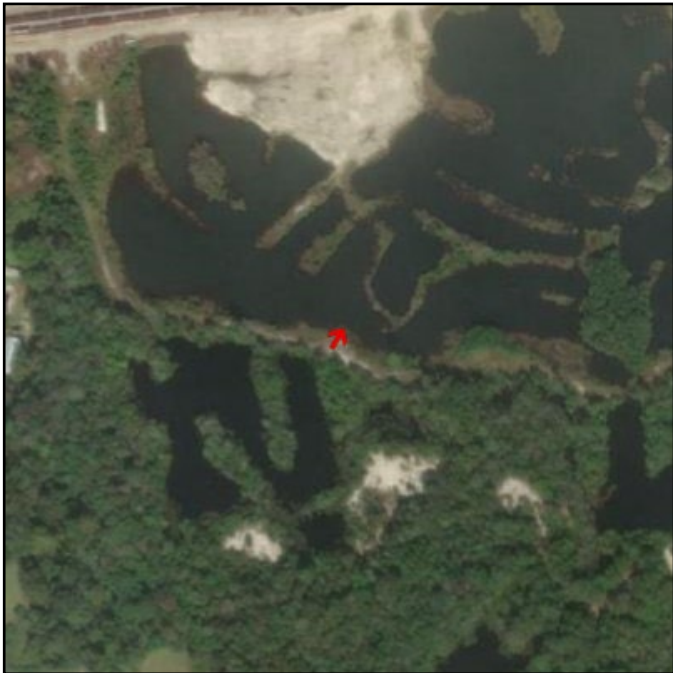
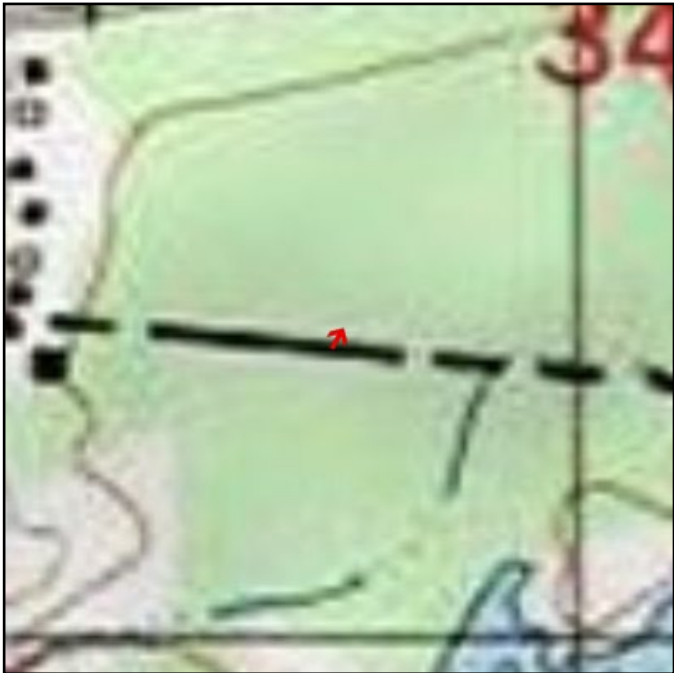
| Title | Photo 11 |

| Description | Striking north, northeast. U-shaped berm taken from walkable road. |

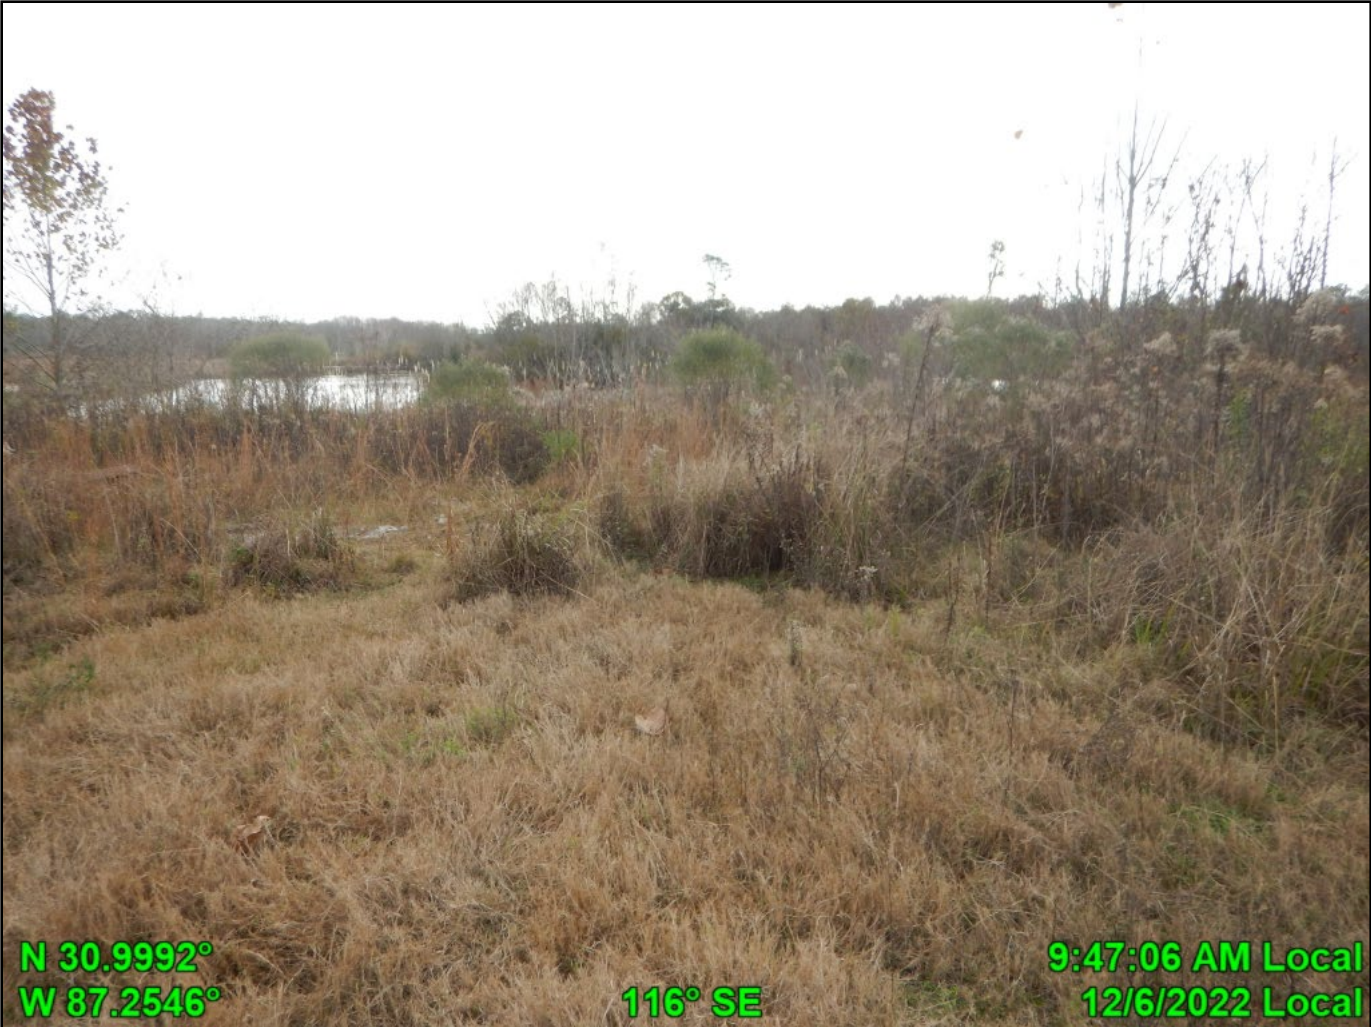
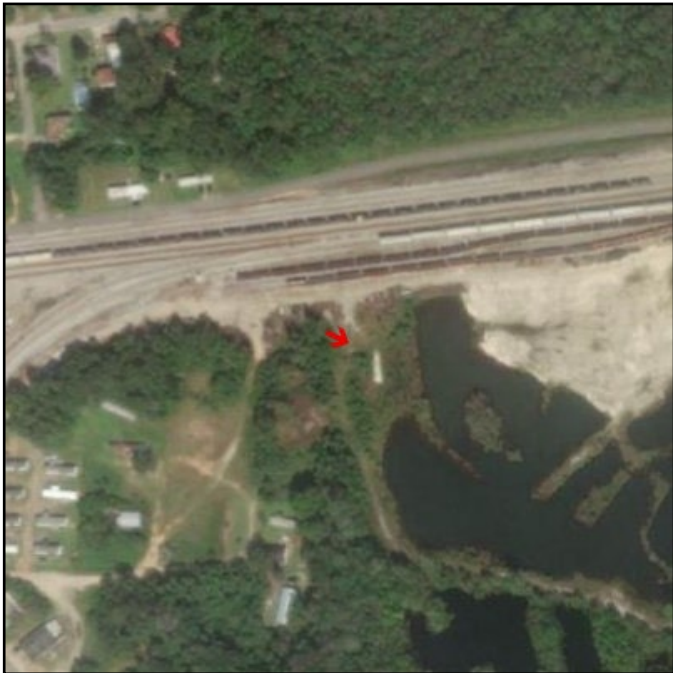
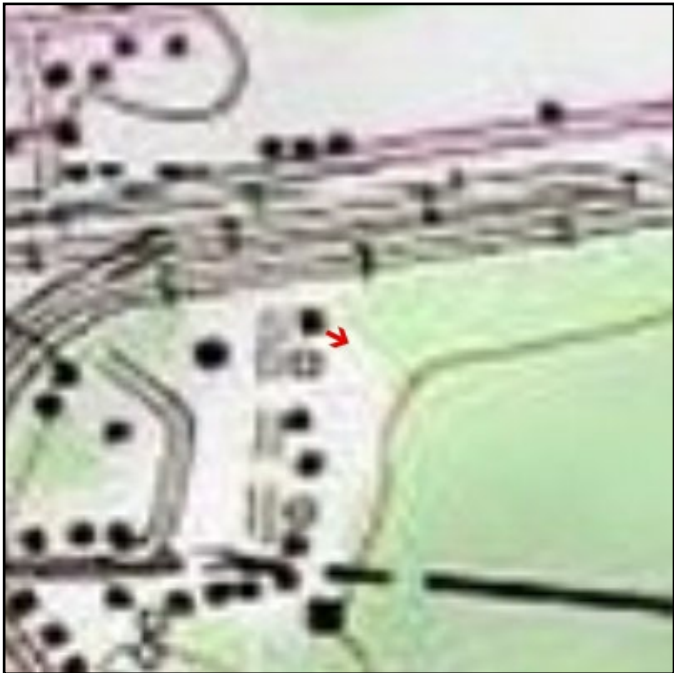
| Title | Photo 12 |

| Description | Striking southeast. Mine pond taken from fill in wetland. |

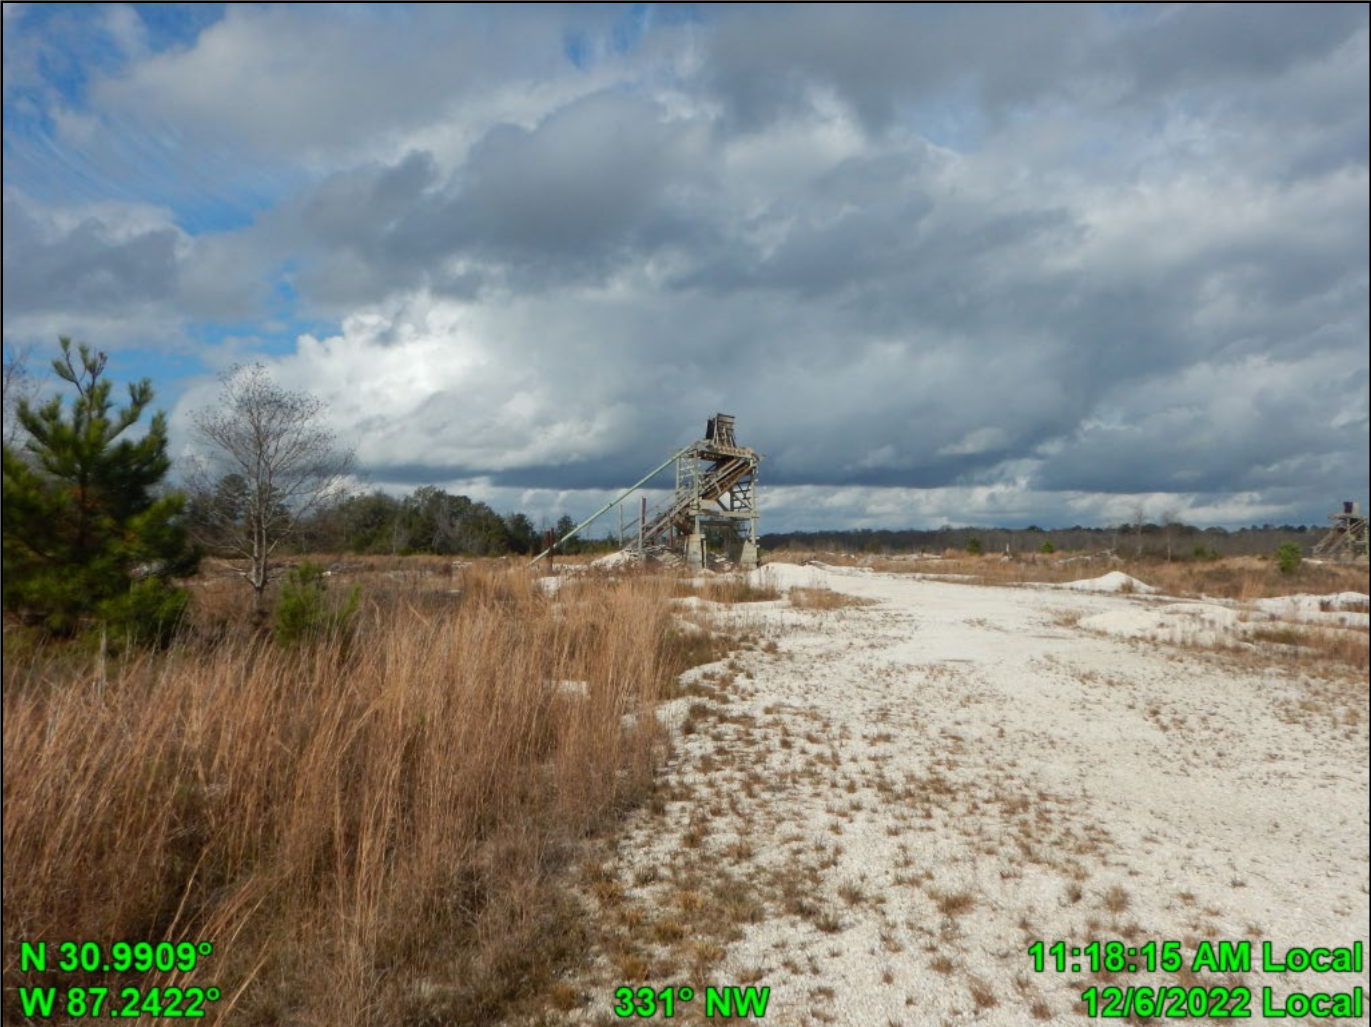
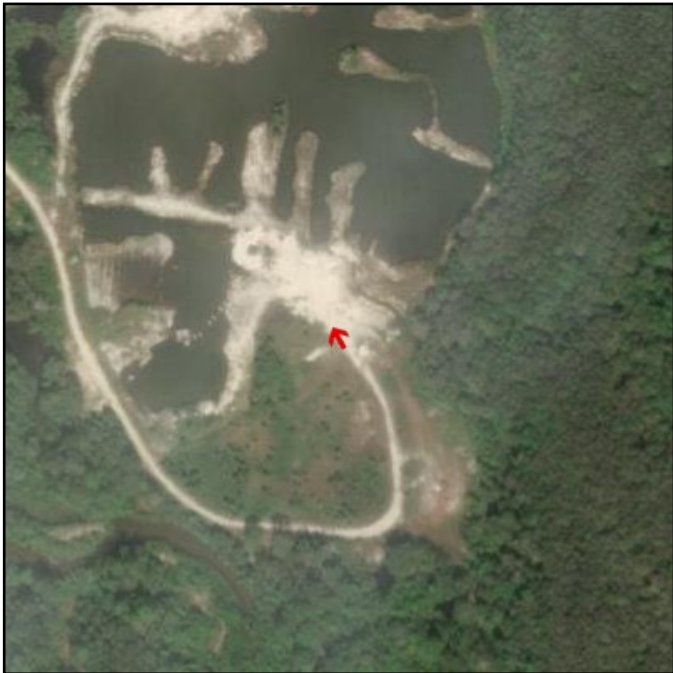
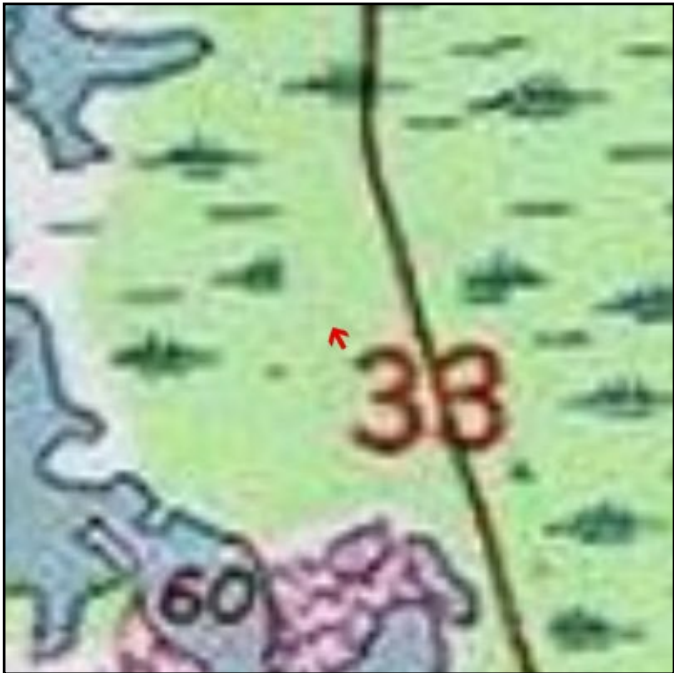
| Title | Photo 13 |

| Description | Old sorter at the wash plant. |

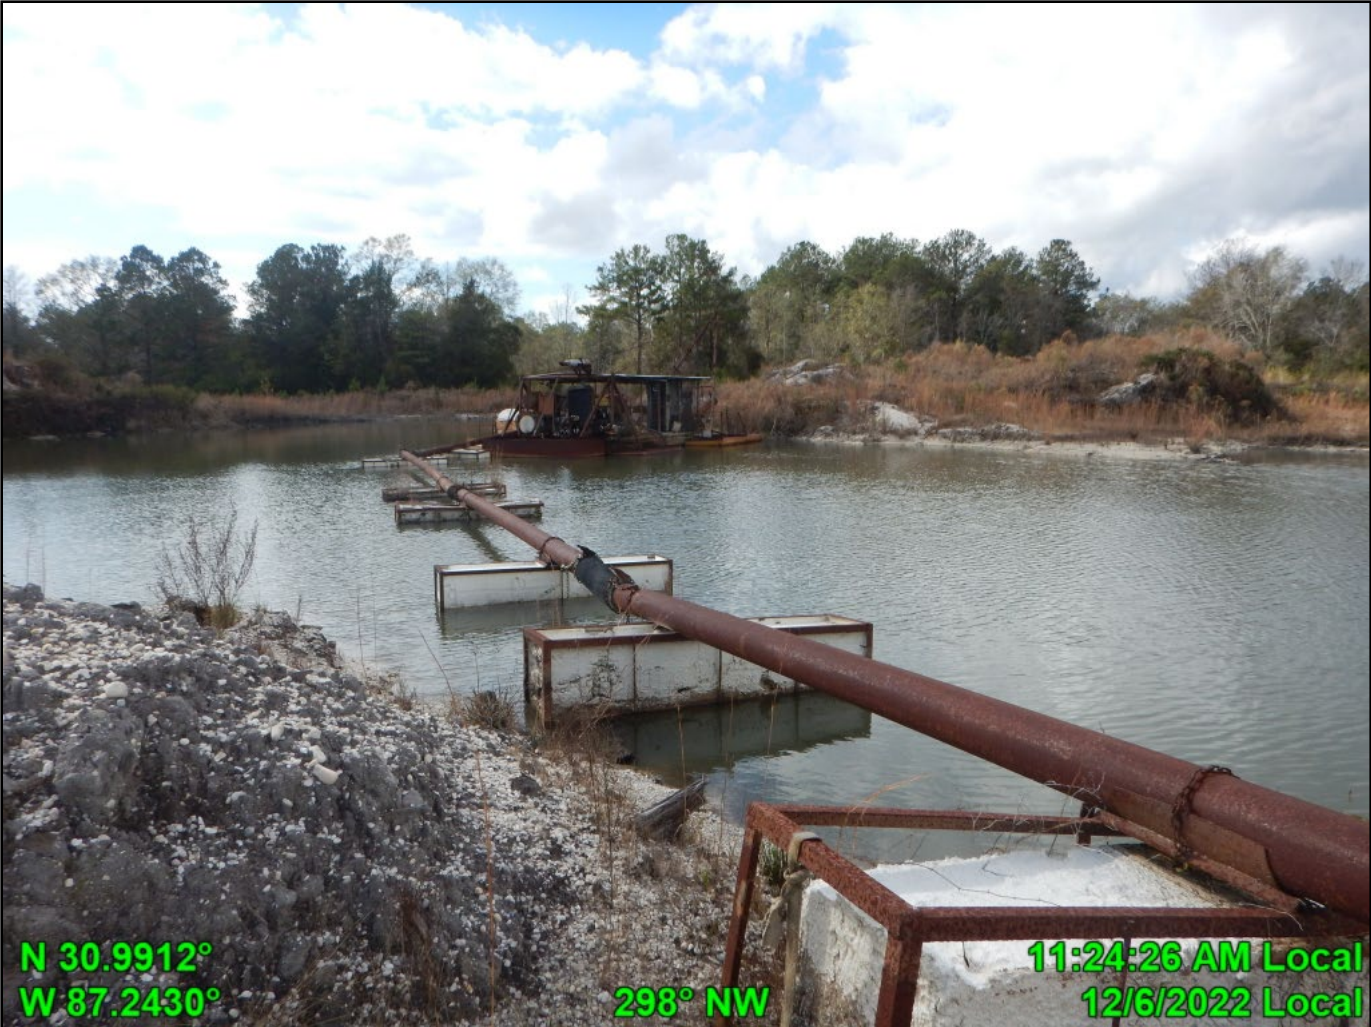
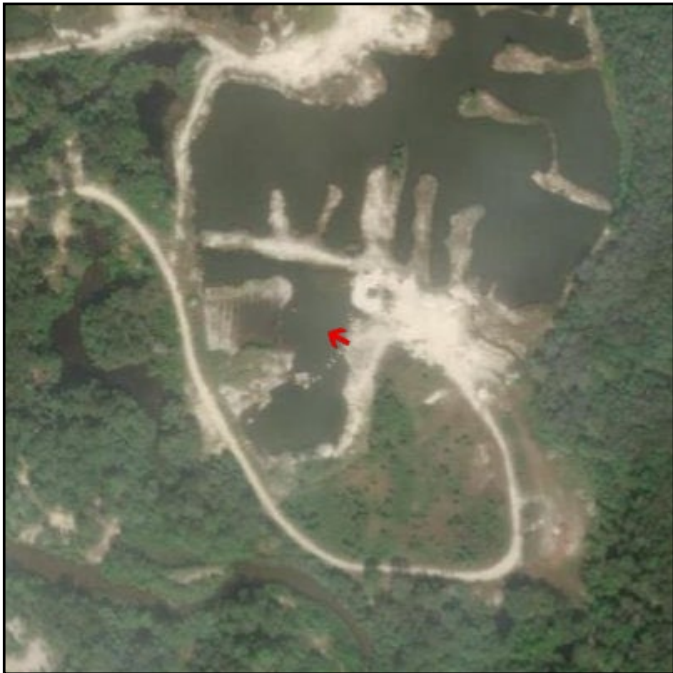
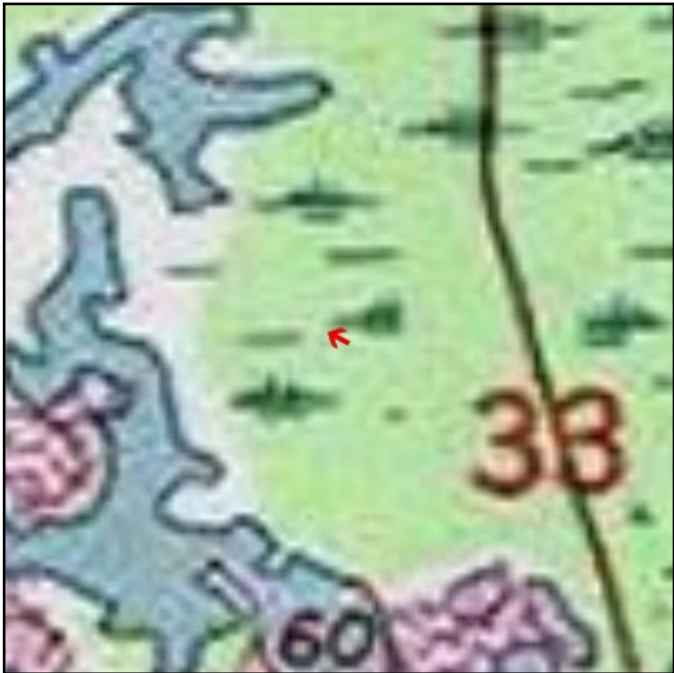
| Title | Photo 14 |

| Description | Dredge, idle since approximately 2019. |

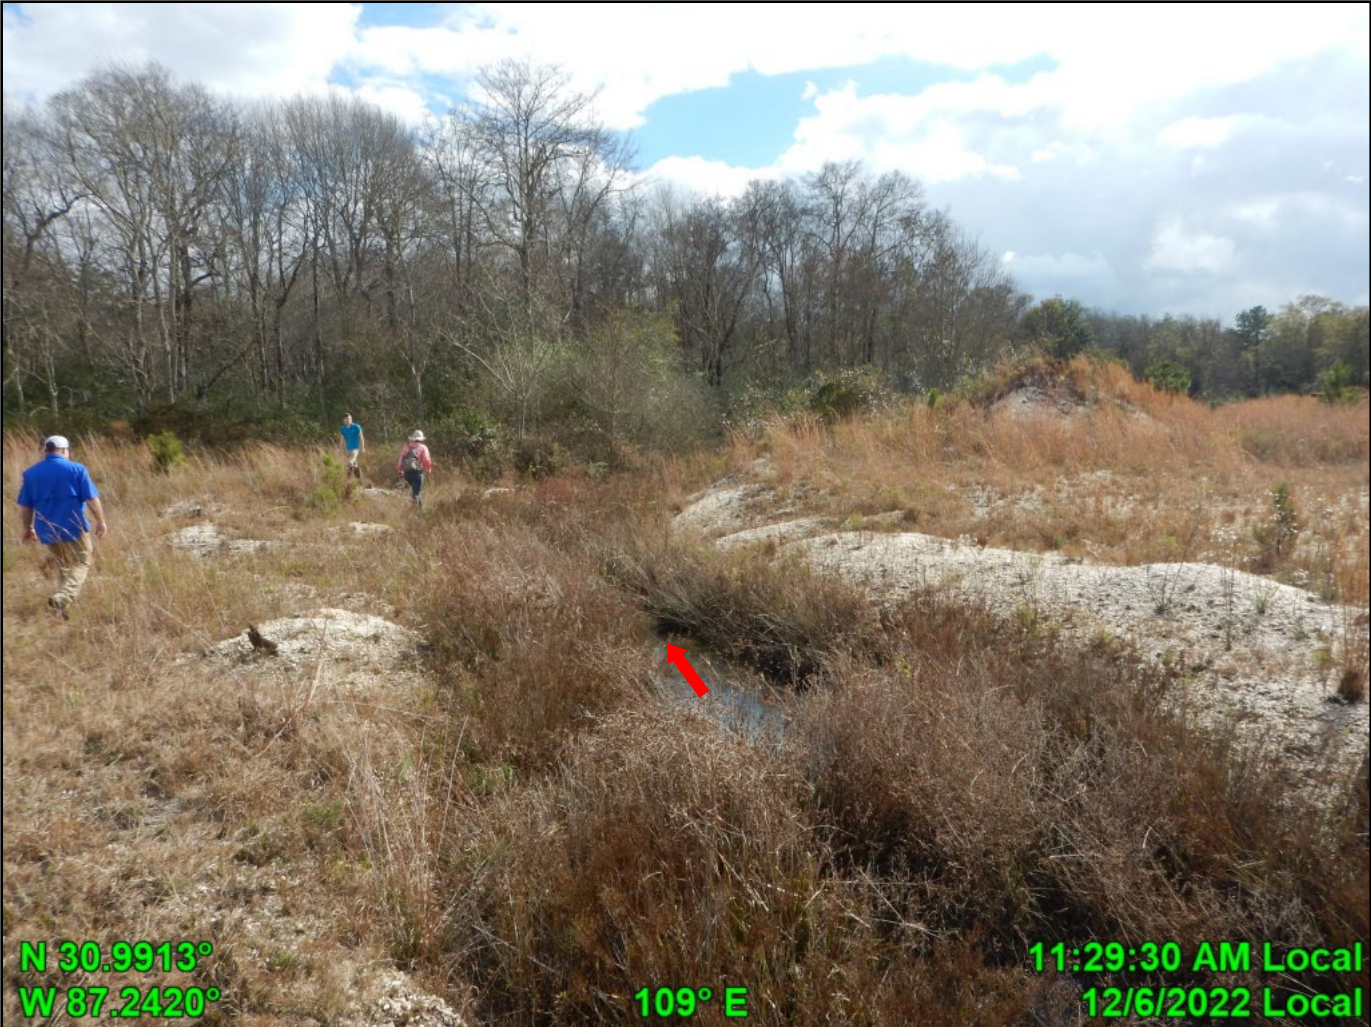
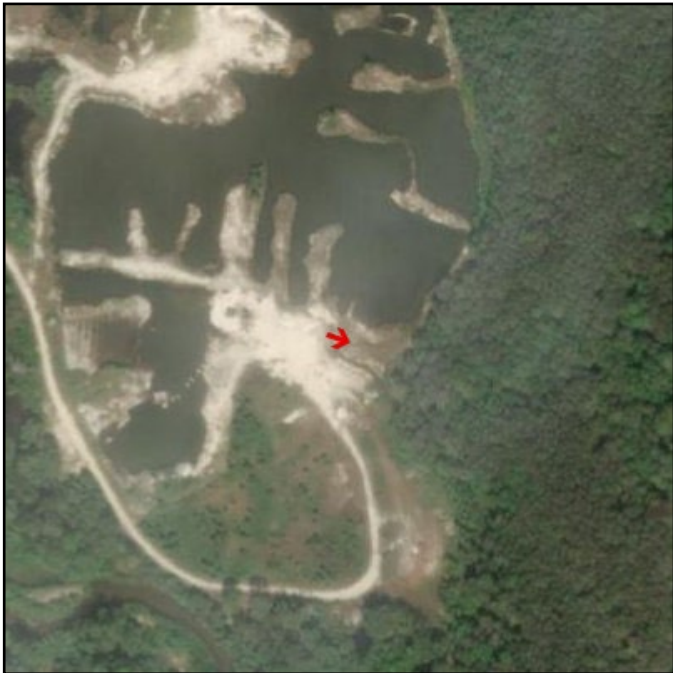
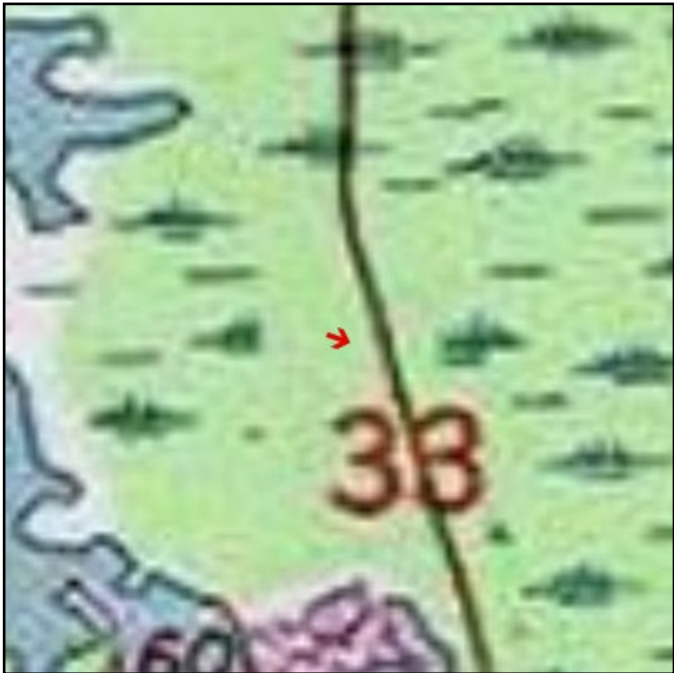
| Title | Photo 15 |

| Description | Striking east; downstream. Ditch from wash plant leading to wetland area adjacent to Big Escambia Creek. Red arrow in top photo indicates direction of flow. |

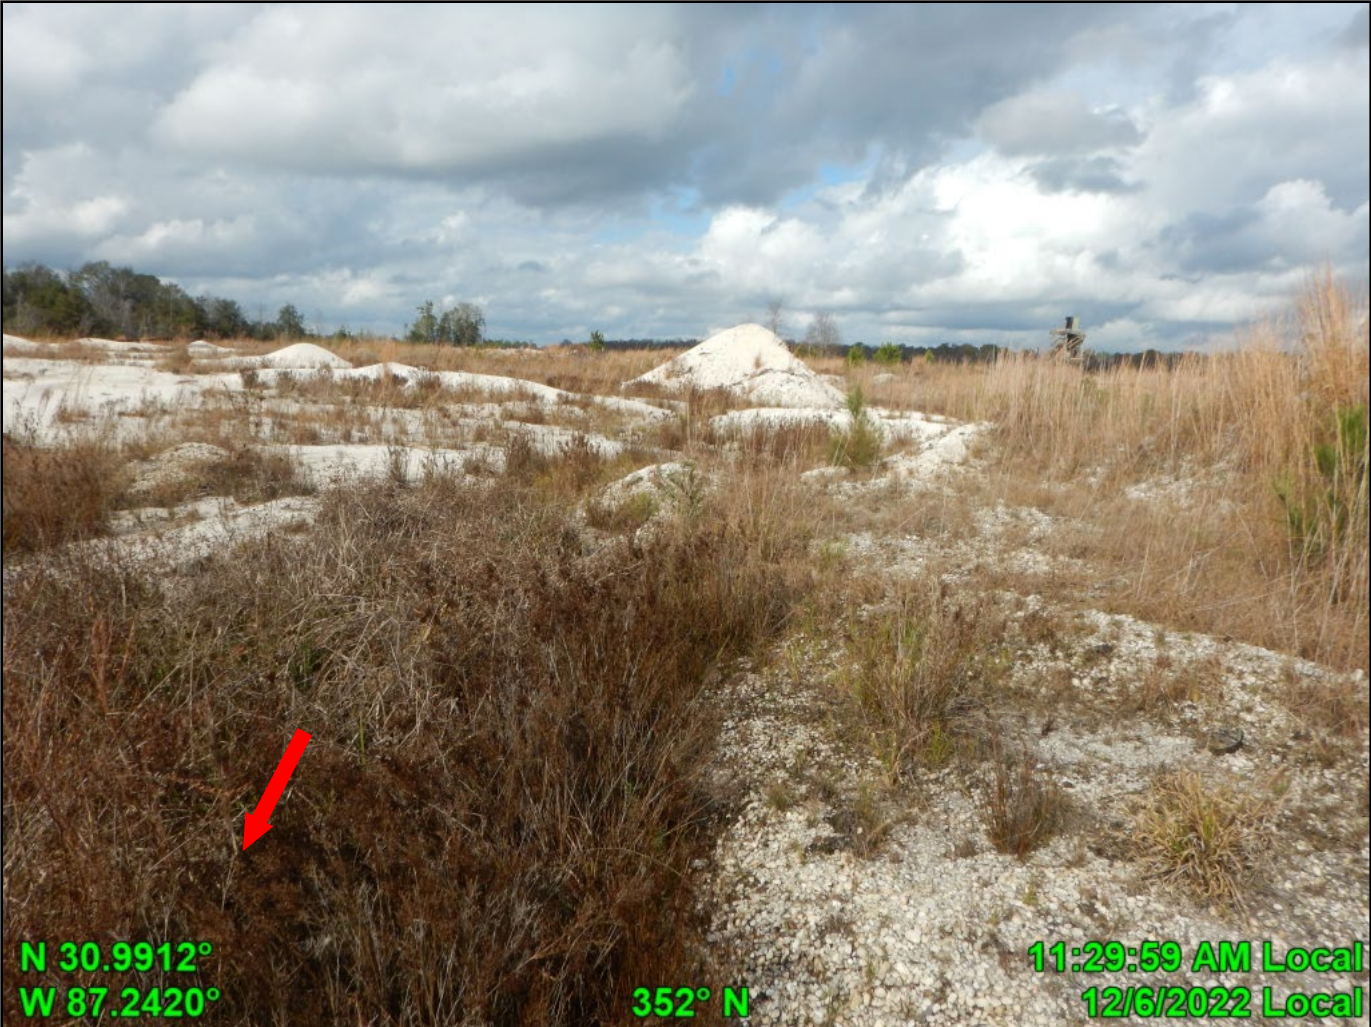
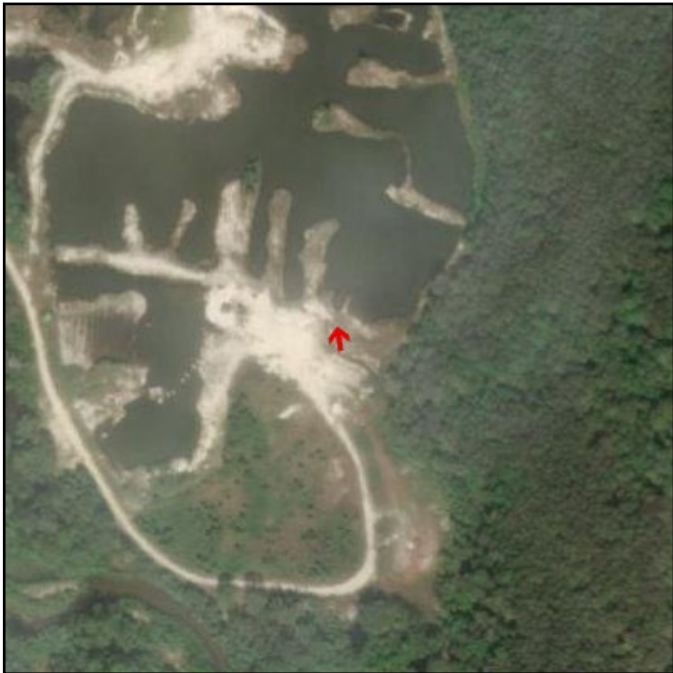
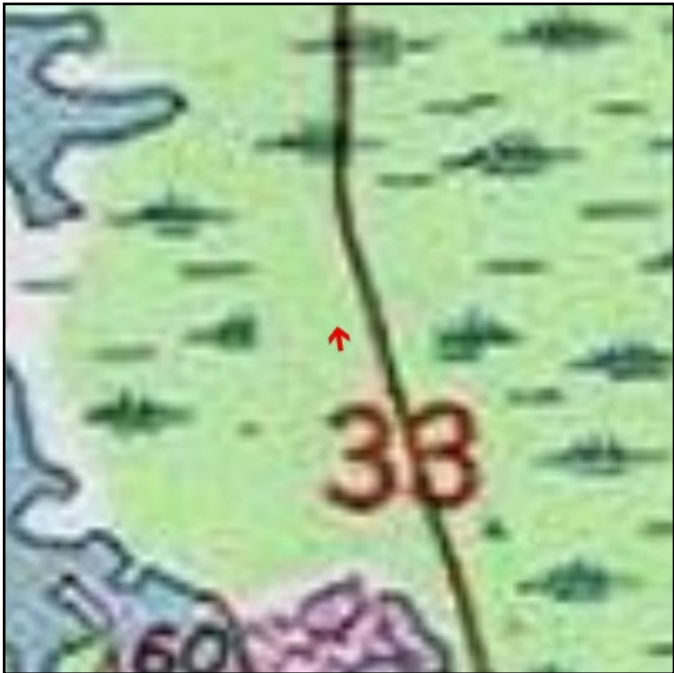
| Title | Photo 16 |

| Description | Striking north; upstream. Ditch from wash plant leading to same wetland area. Red arrow in top photo indicates direction of flow. |

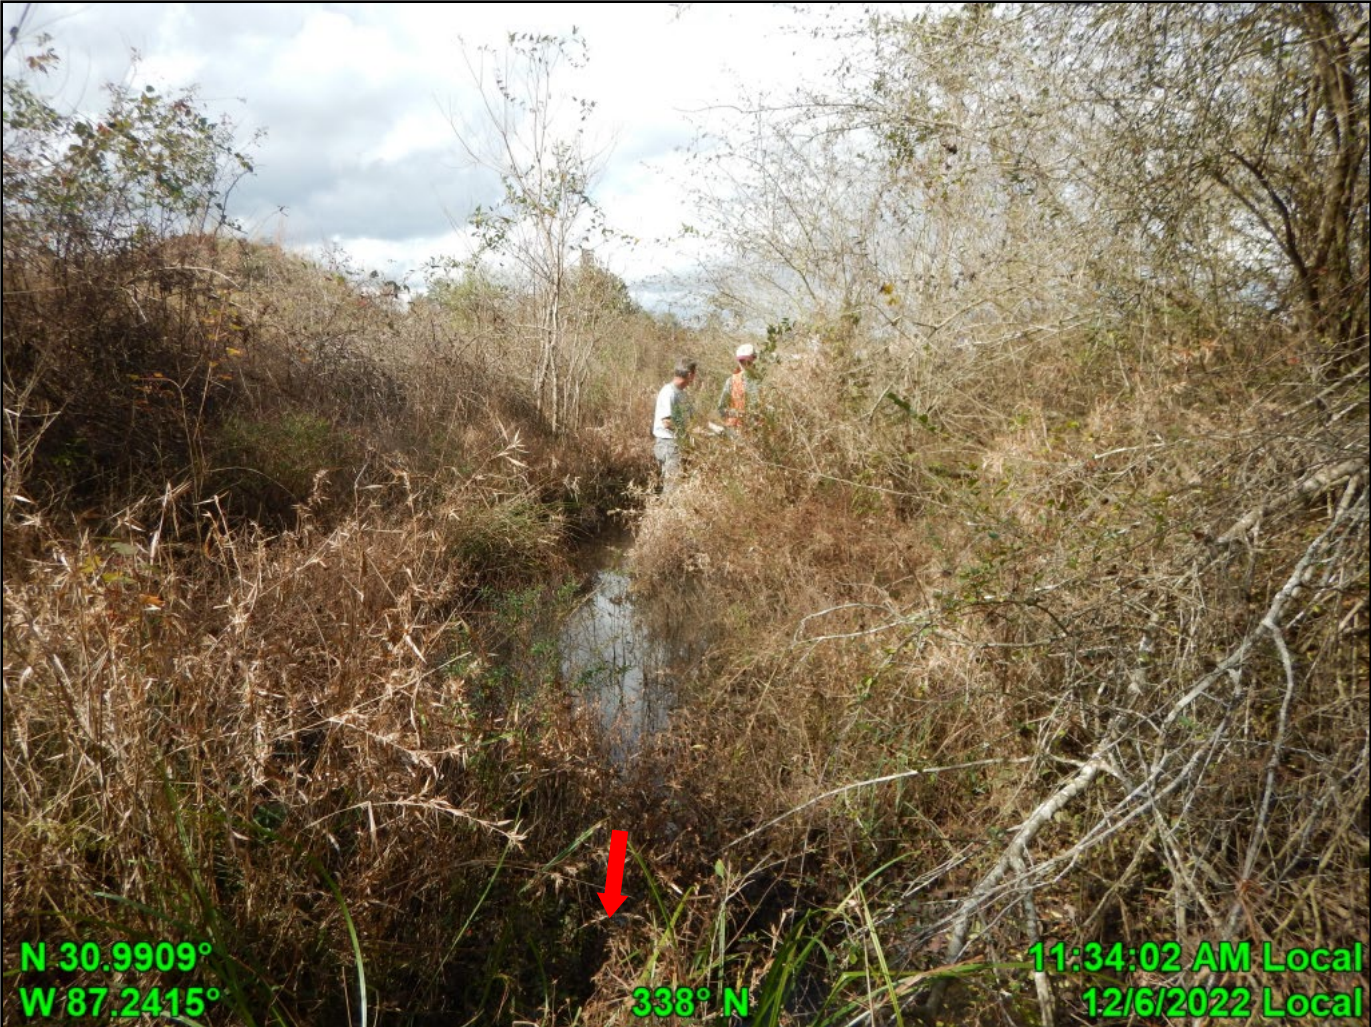
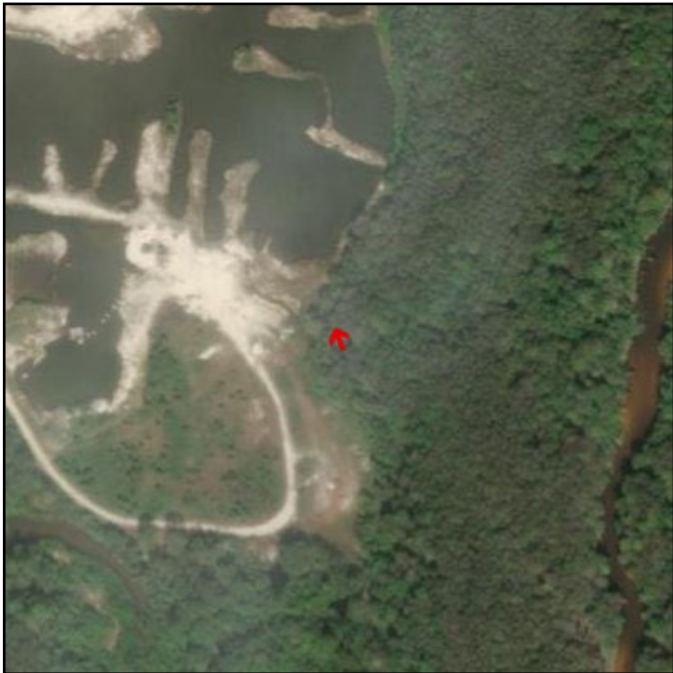
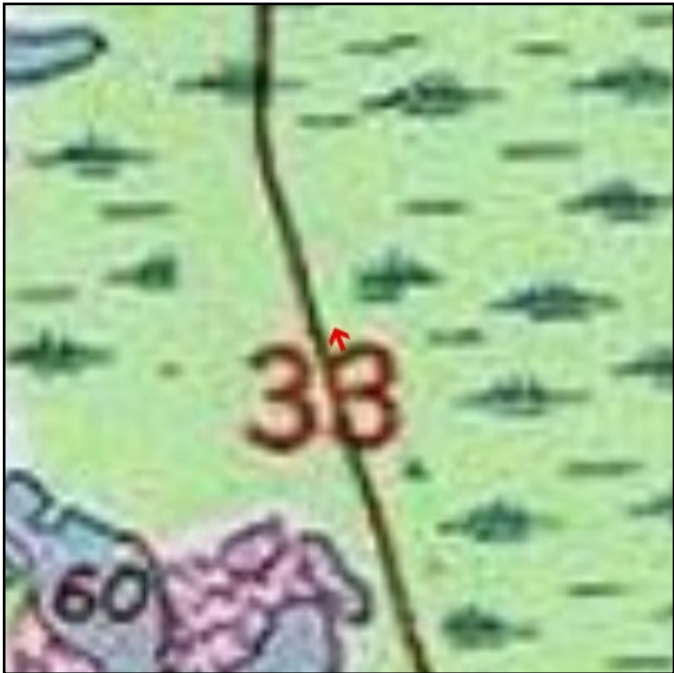
| Title | Photo 17 |

| Description | Striking north; upstream. Taken from reference wetland area. Red arrow in top photo indicates direction of flow. |

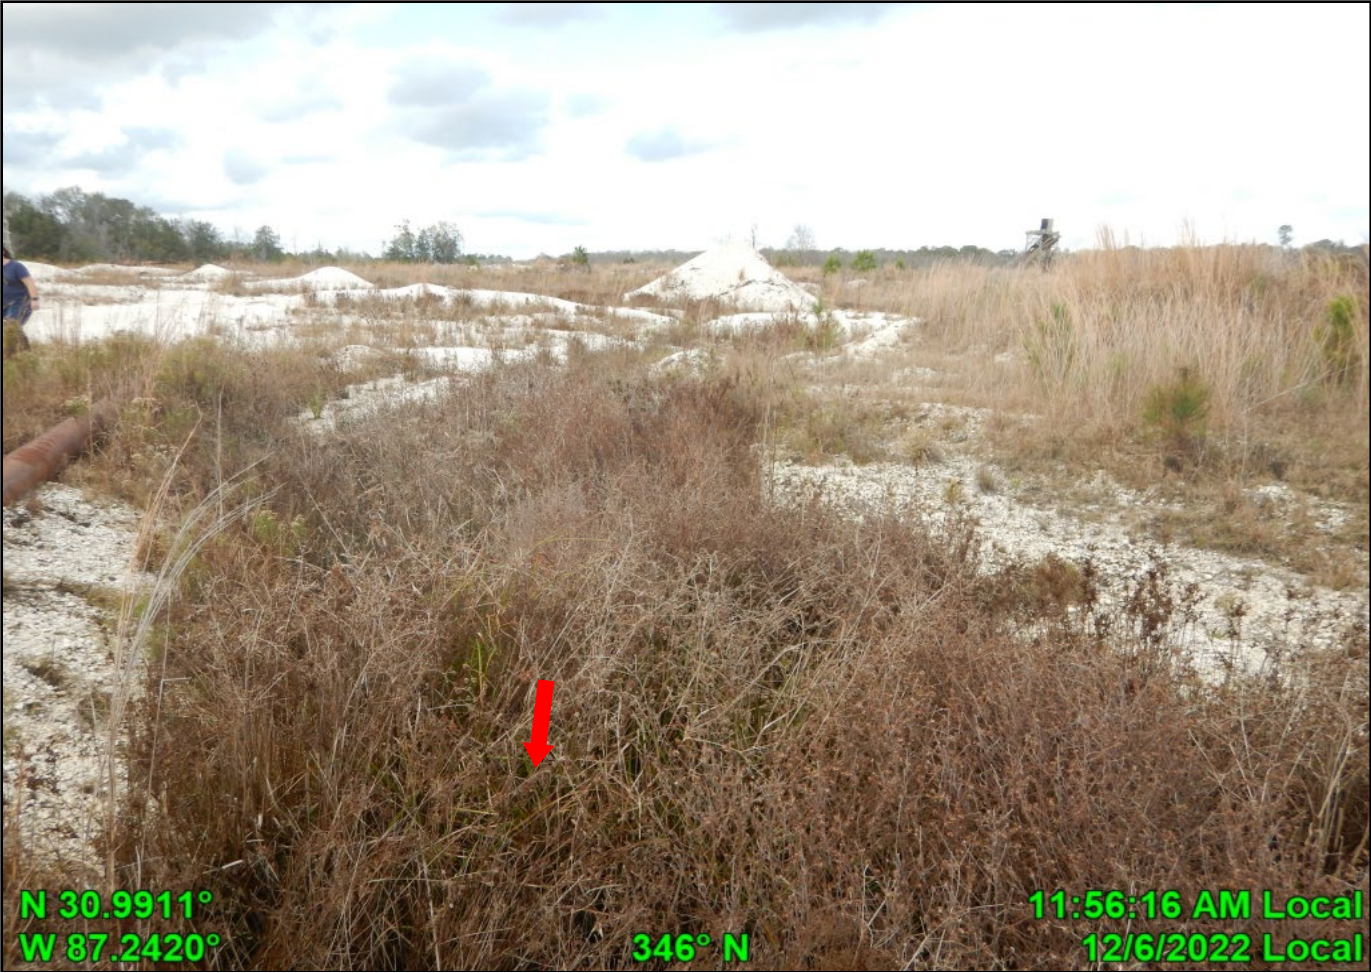
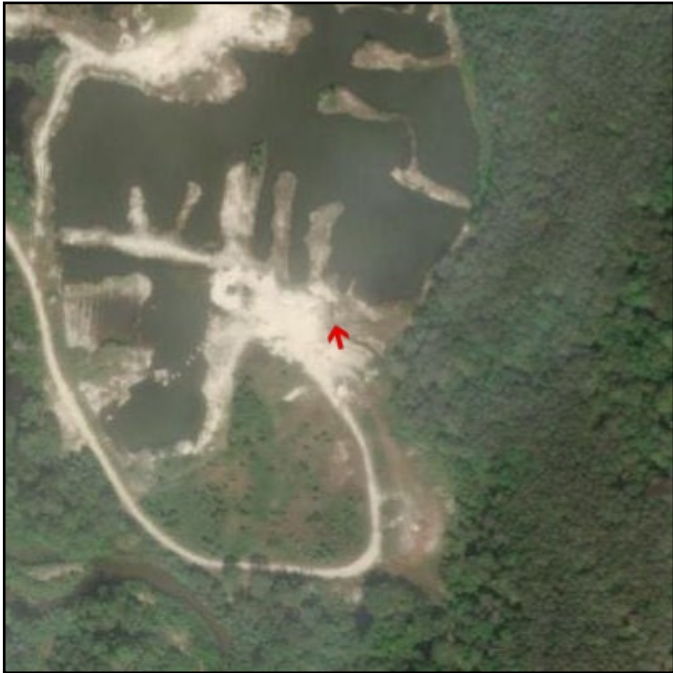
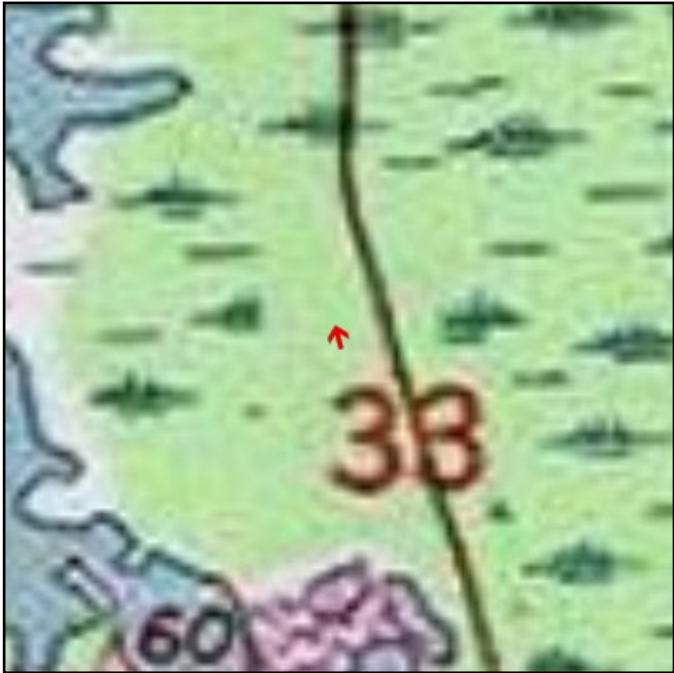
| Title | Photo 18 |

| Description | Striking north; upstream. Taken from area below wash area. Ditch draining from wash area towards reference wetland. Red arrow in top photo indicates direction of flow. |

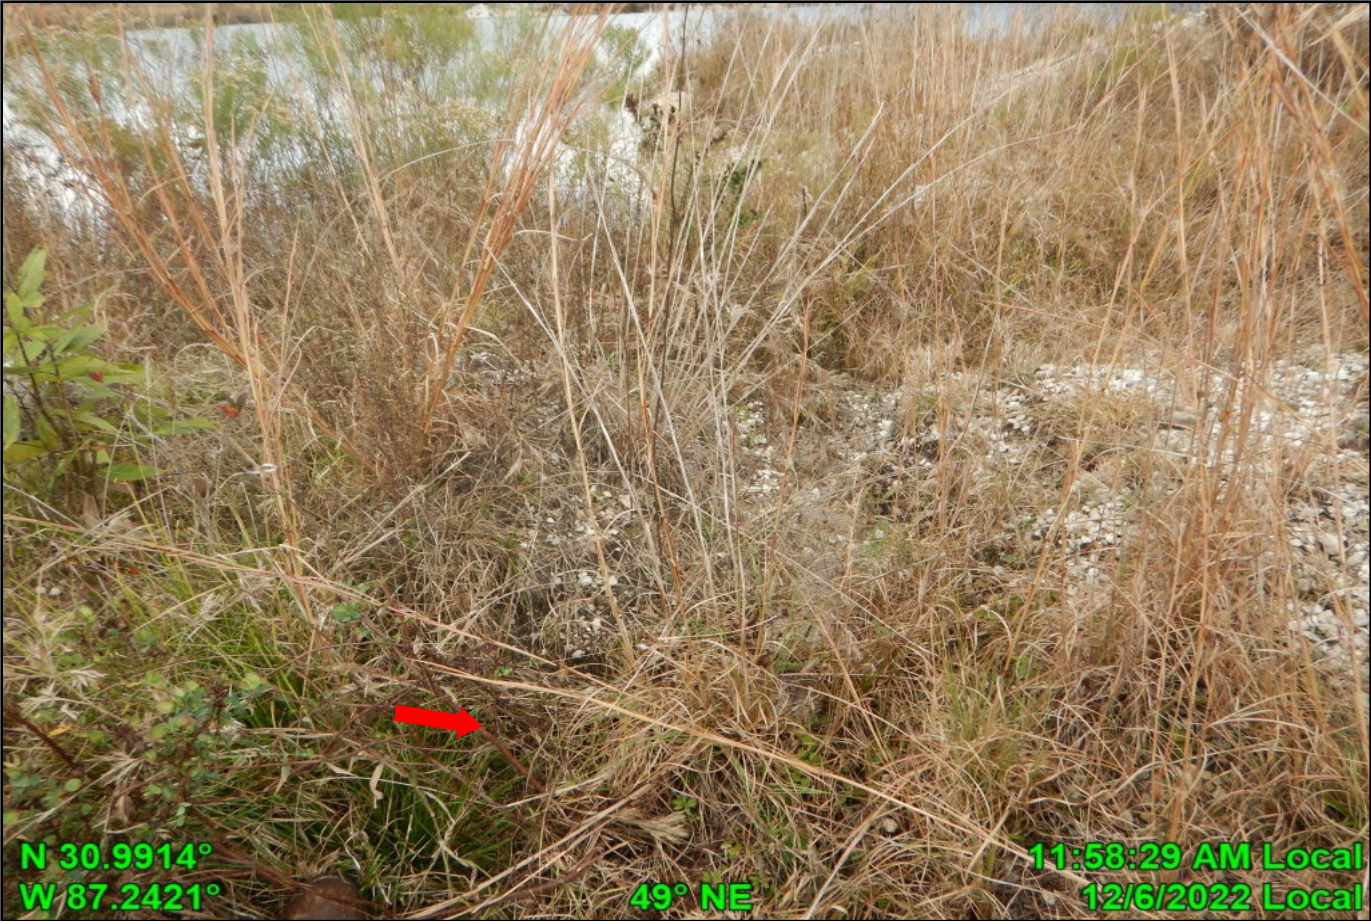
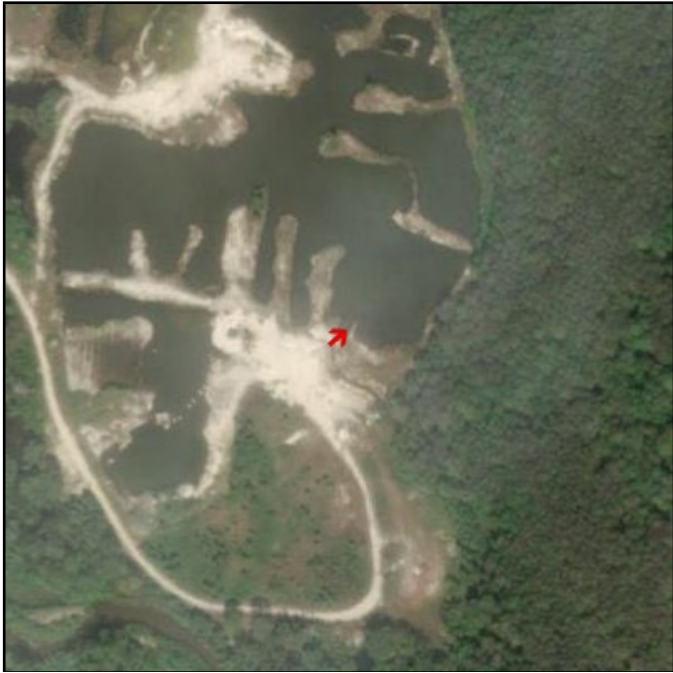
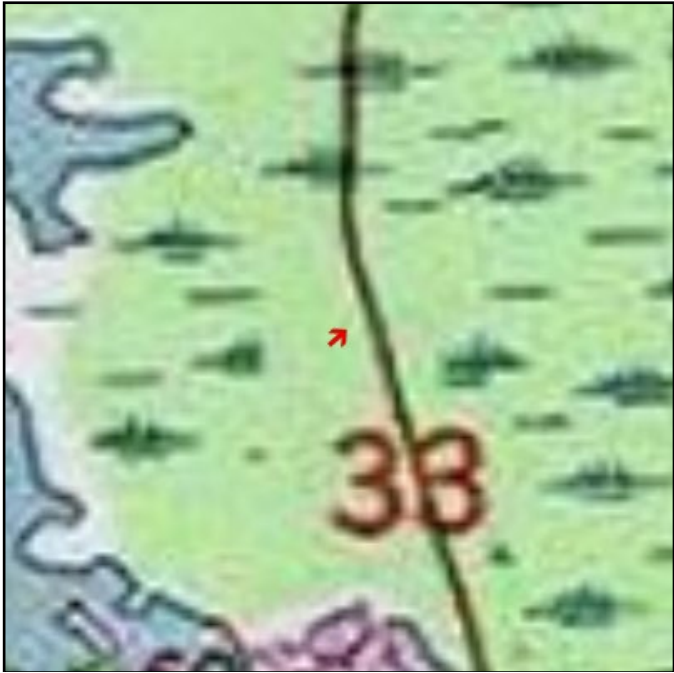
| Title | Photo 19 |

| Description | Striking northeast; upstream. Taken from area near wash area. Channel from pond at wash plant that connects to ditch leading from wash area to reference wetland. Red arrow in top photo indicates direction of flow. |
