### **Campbell Sand & Gravel, Co. Big Escambia Mine (North) Site Inspection Photographic Log**

Escambia County, Florida  
*(unless notated otherwise in comment section of  
field tables)*

December 6, 2022

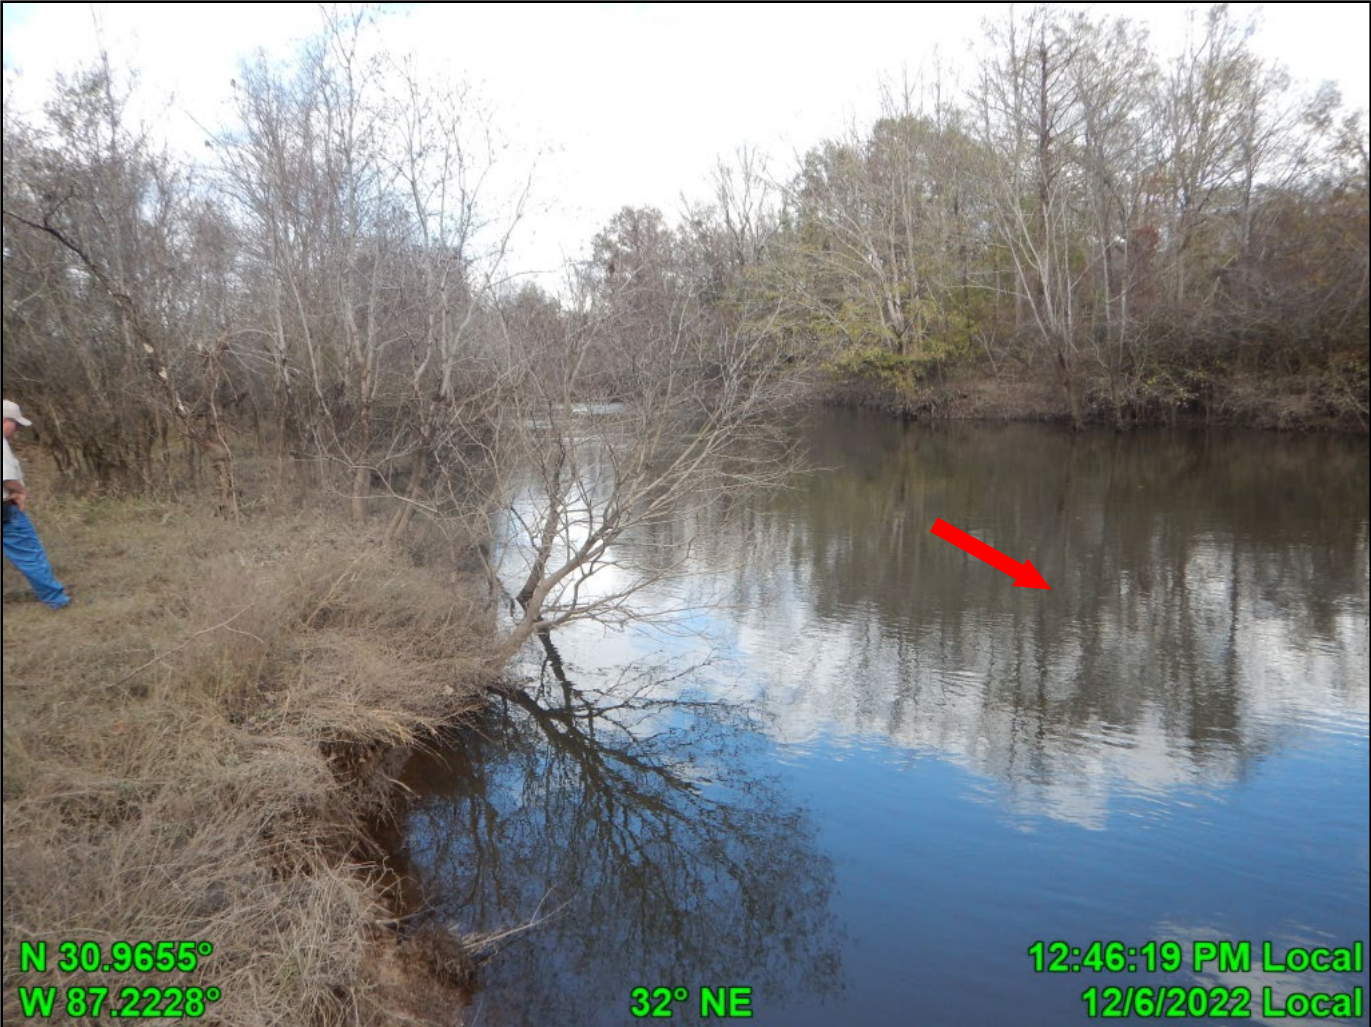
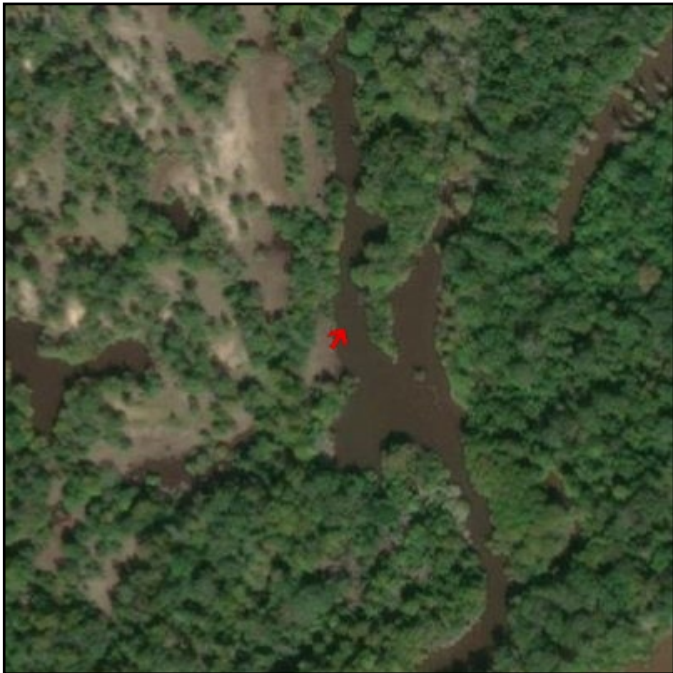
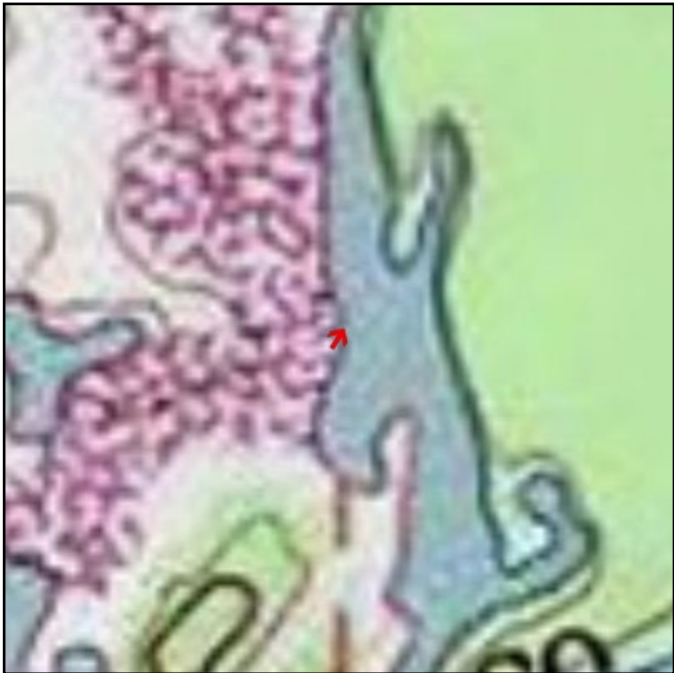
| Title | Photo 20 |

| Description | Striking northeast; upstream. Big Escambia Creek approximately 0.2 miles north of its confluence with the Escambia River. Red arrow in top photo indicates direction of flow. |

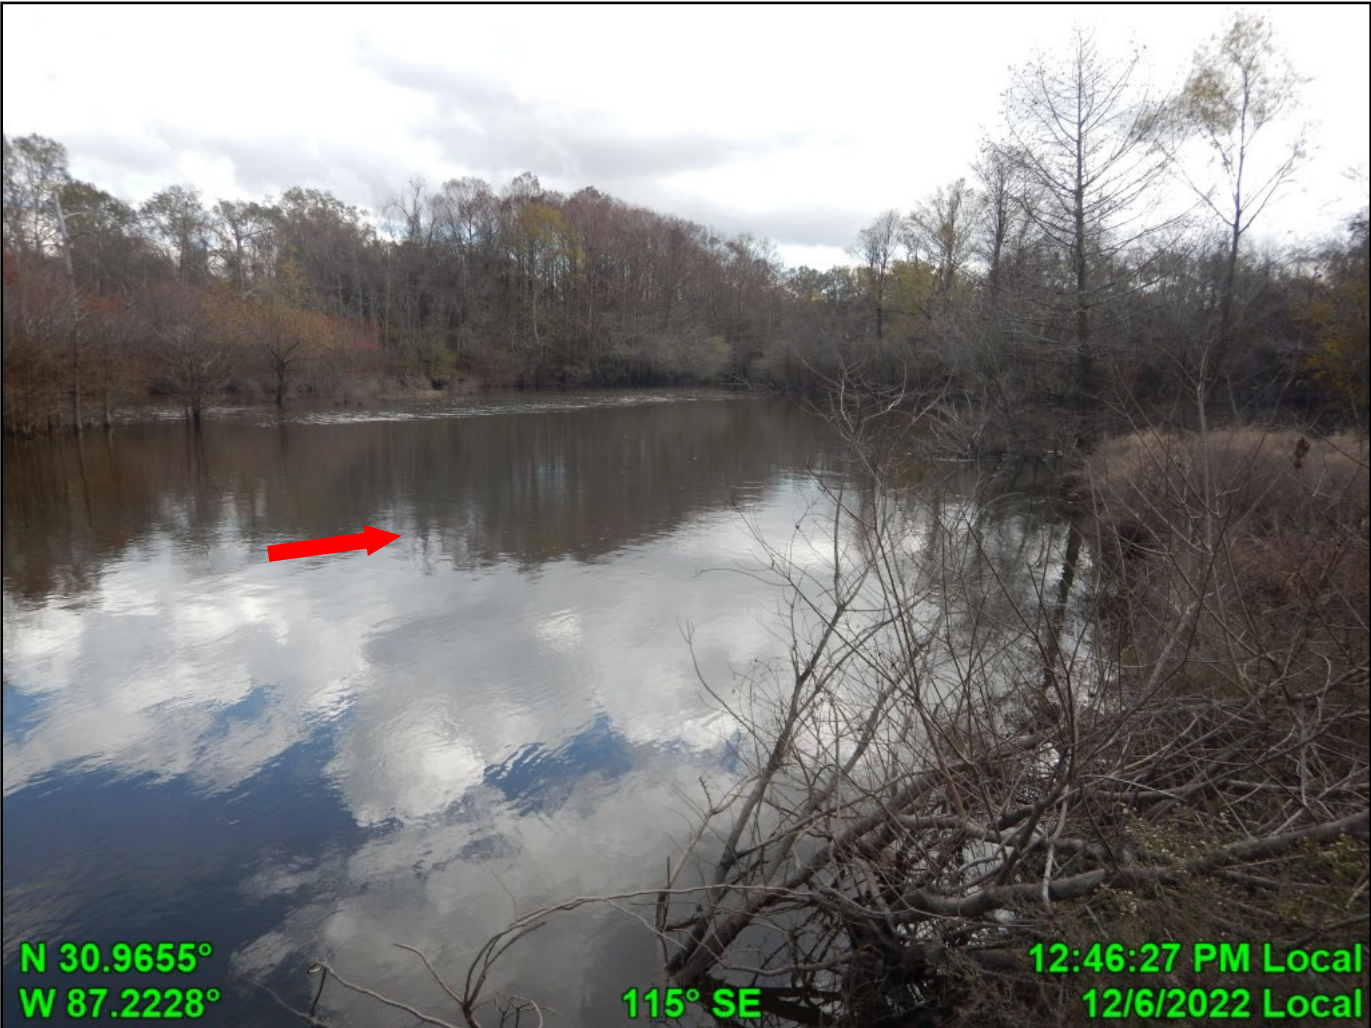
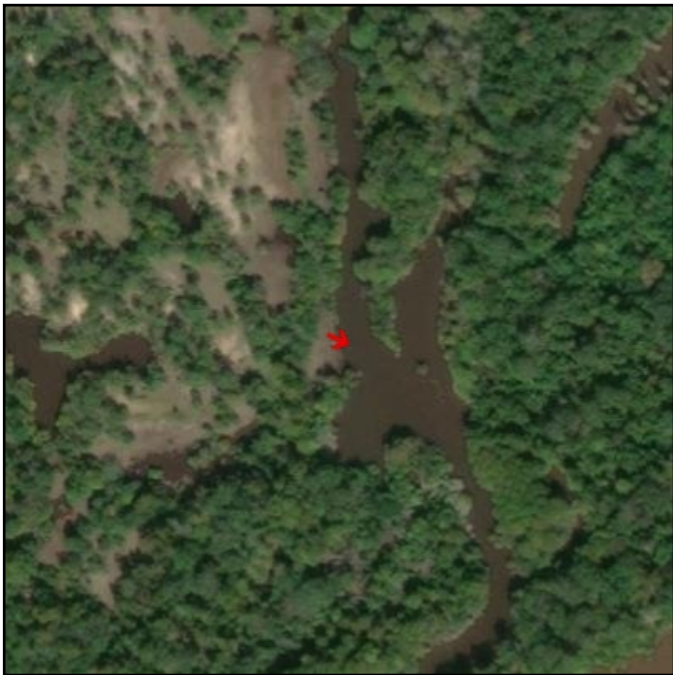
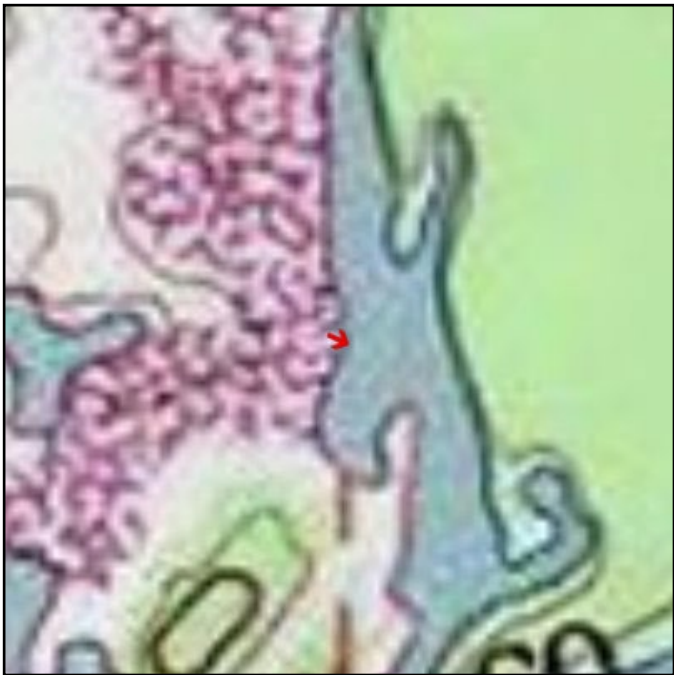
| Title | Photo 21 |

| Description | Striking southeast; downstream. Big Escambia Creek north of its confluence with the Escambia River. Red arrow in top photo indicates direction of flow. |

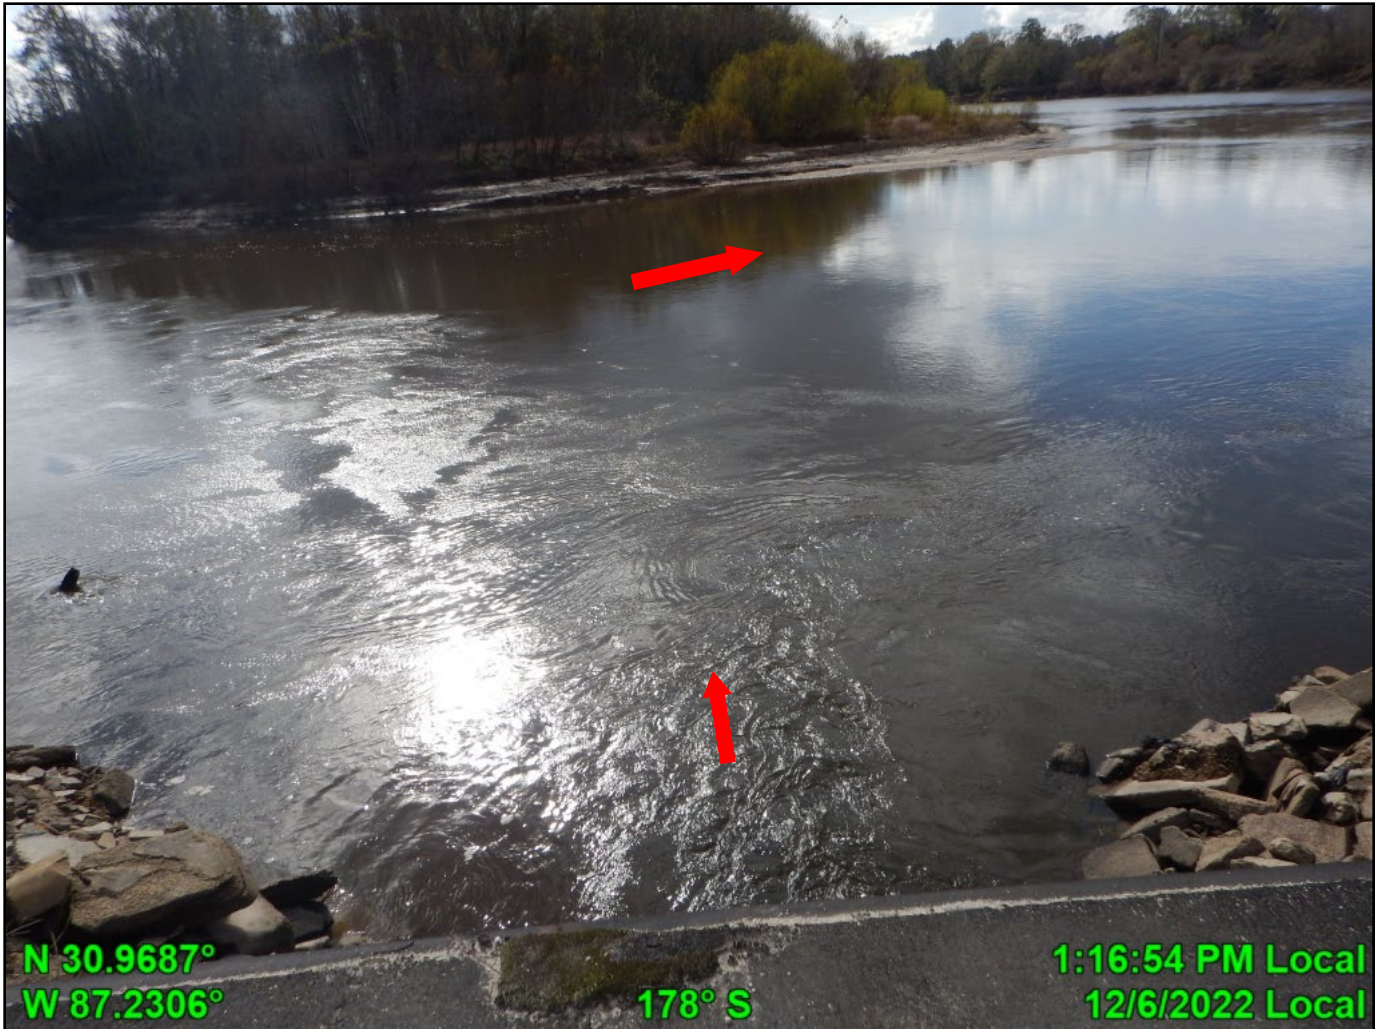
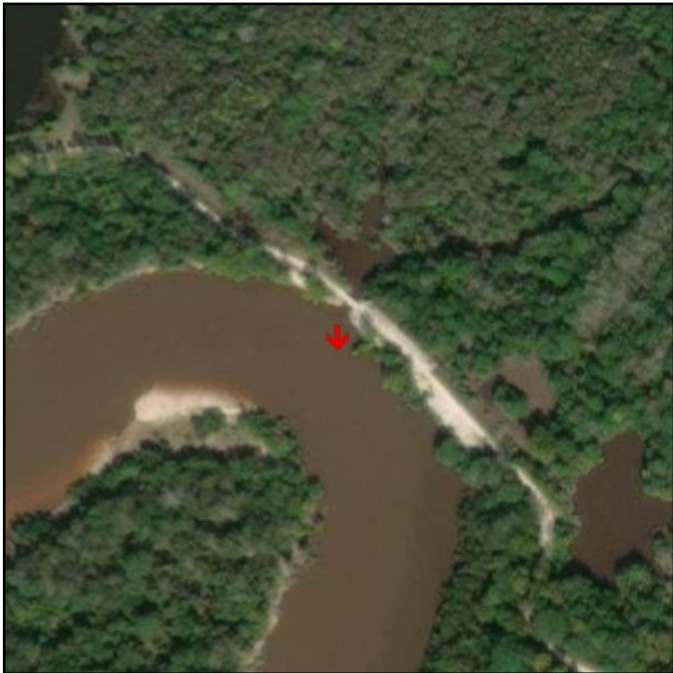
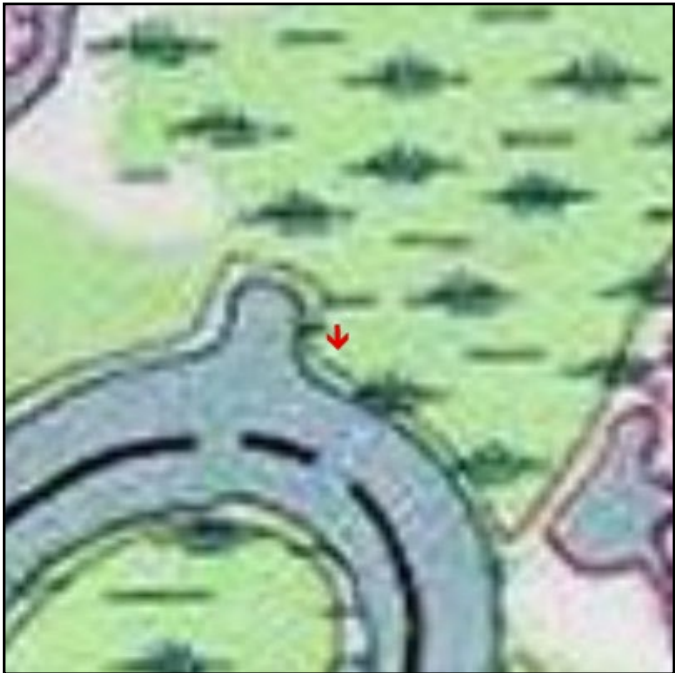
| Title | Photo 22 |

| Description | Striking south; downstream. Big Escambia Creek from the facility bridge. Red arrow in top photo indicates direction of flow. |

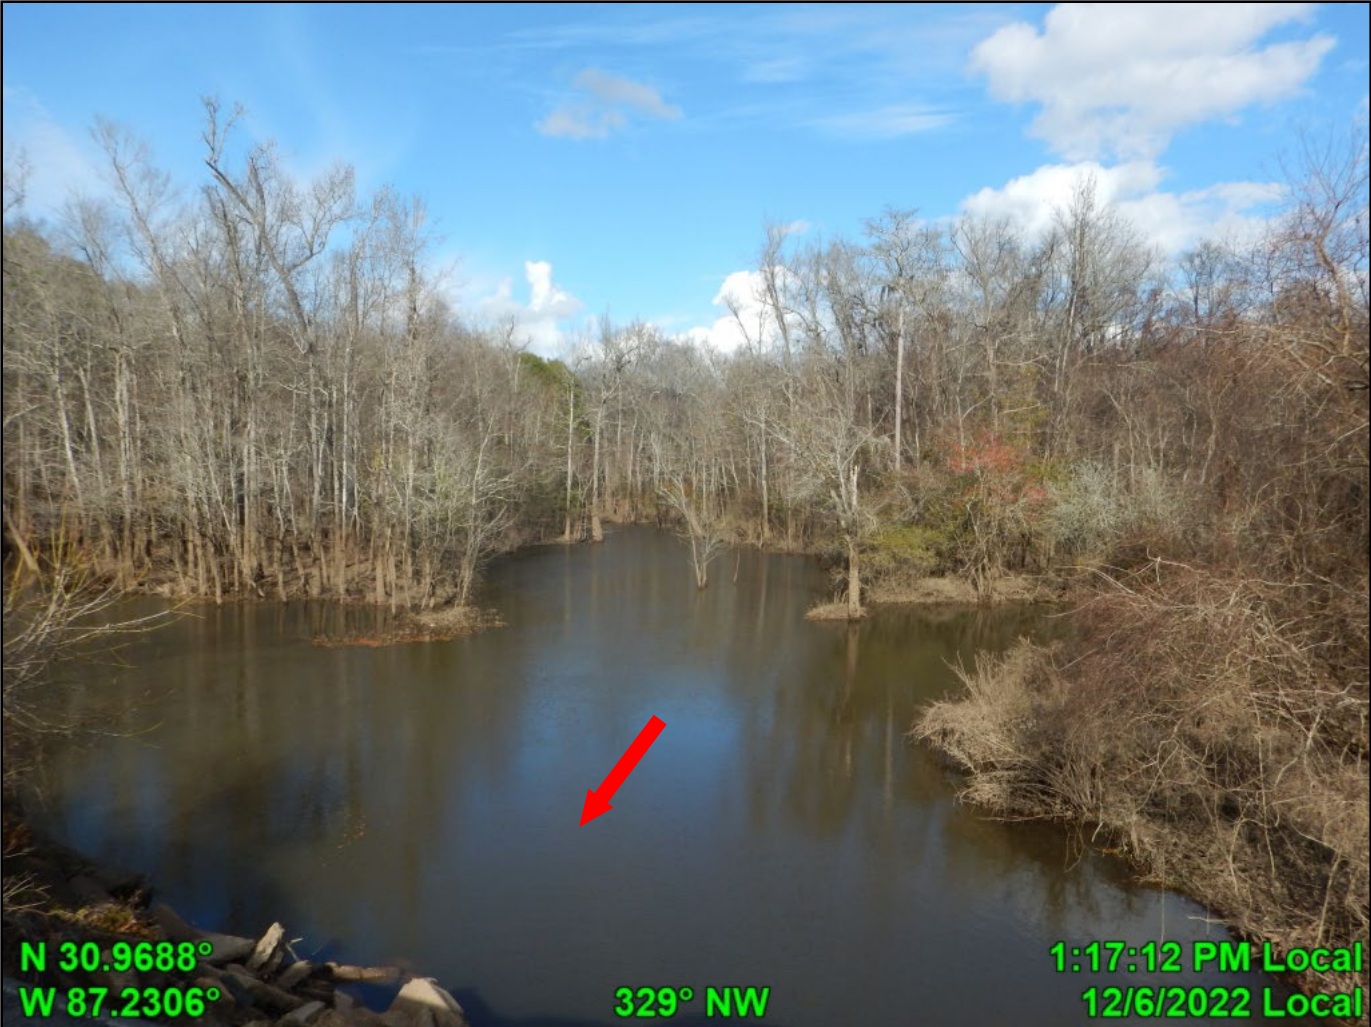
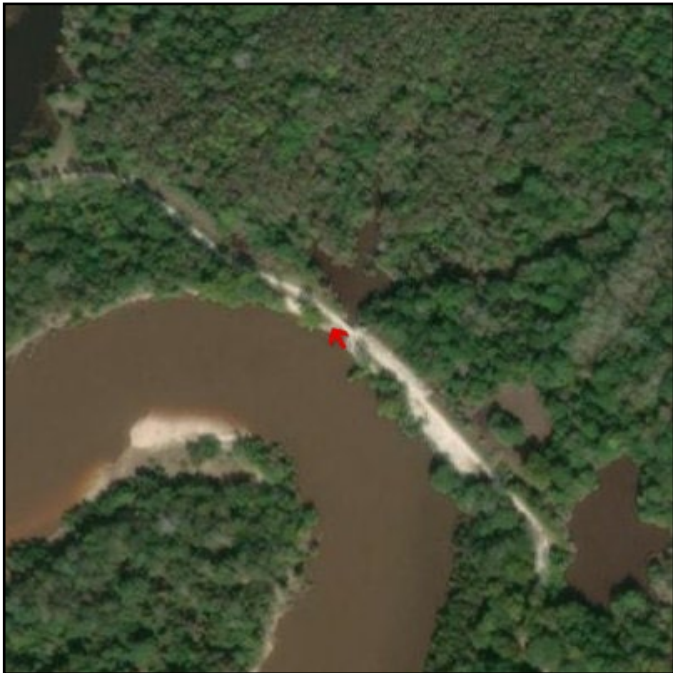
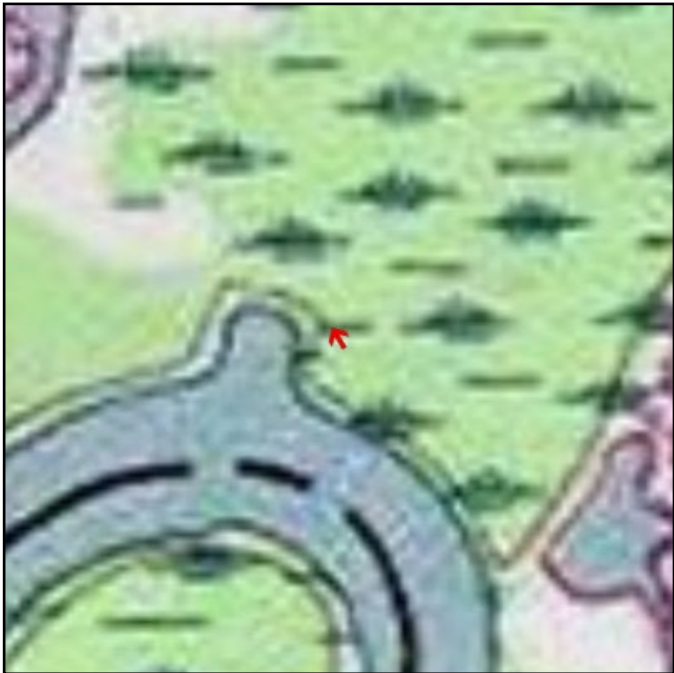
| Title | Photo 23 |

| Description | Striking northwest; upstream. Big Escambia Creek from the facility bridge. Red arrow in top photo indicates direction of flow. |
