**Region 6 - Enforcement & Compliance Assurance Division**  
**INSPECTION REPORT**

| Inspection Date(s): | 06/09/2025 | |
| Company Name: | <b>Calgary Energy, LLC</b> | |
| Facility Name: | <b>Tidal Osage 1 Lease</b> | |

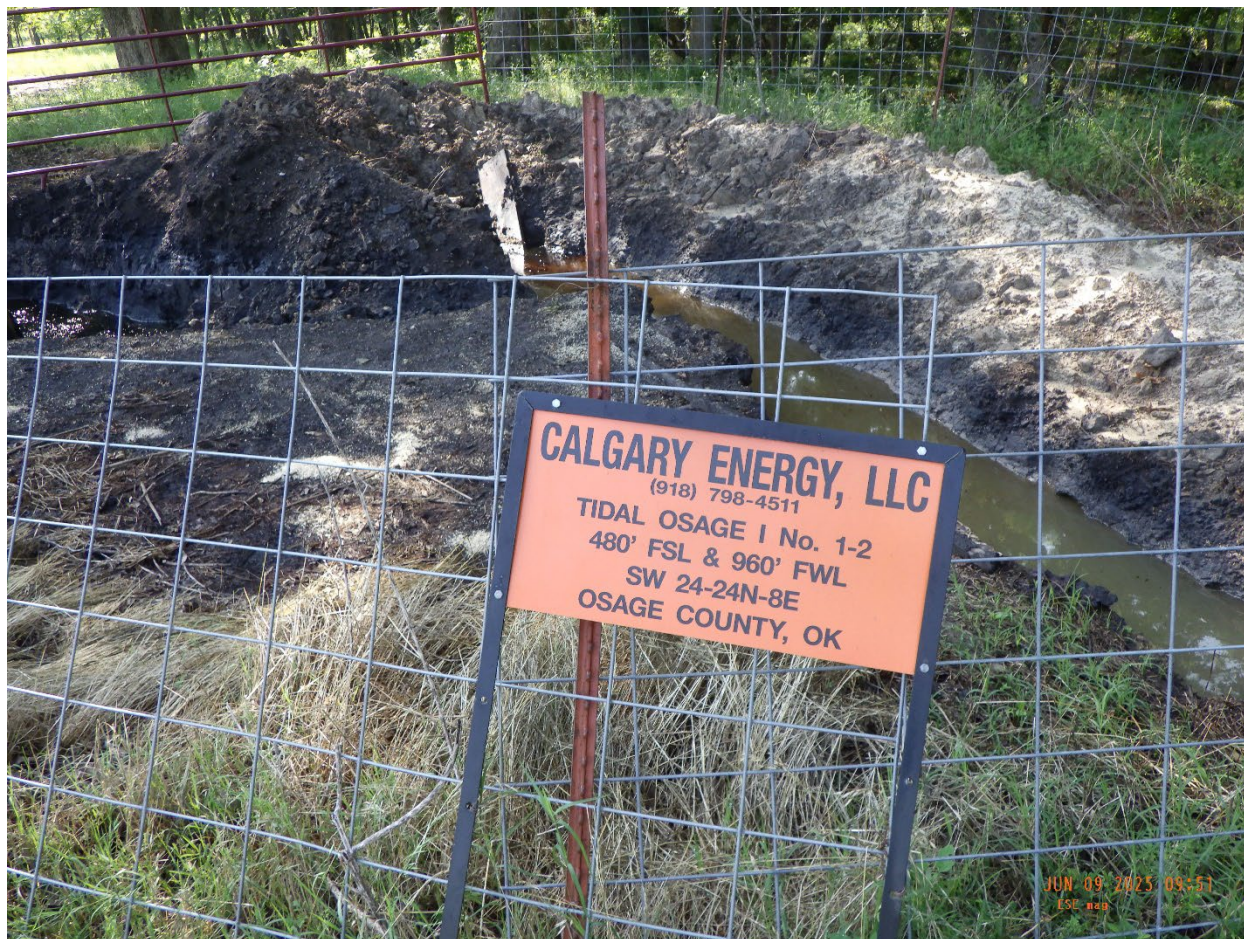
Photo No. 1

I observed the release point for the spill which was the Tidal Osage 1 well 1-2. The well was temporarily abandoned and was not in production at the time of the inspection. A catchpit had been installed at the location. I observed crude oil on the surface of the catchpit. See photos No. 1 and No 2. For additional GPS location information and photo metadata, please see Appendix 1 (photo log) attached to this report.

**Description:** This was the facility signage observed at the spill location.

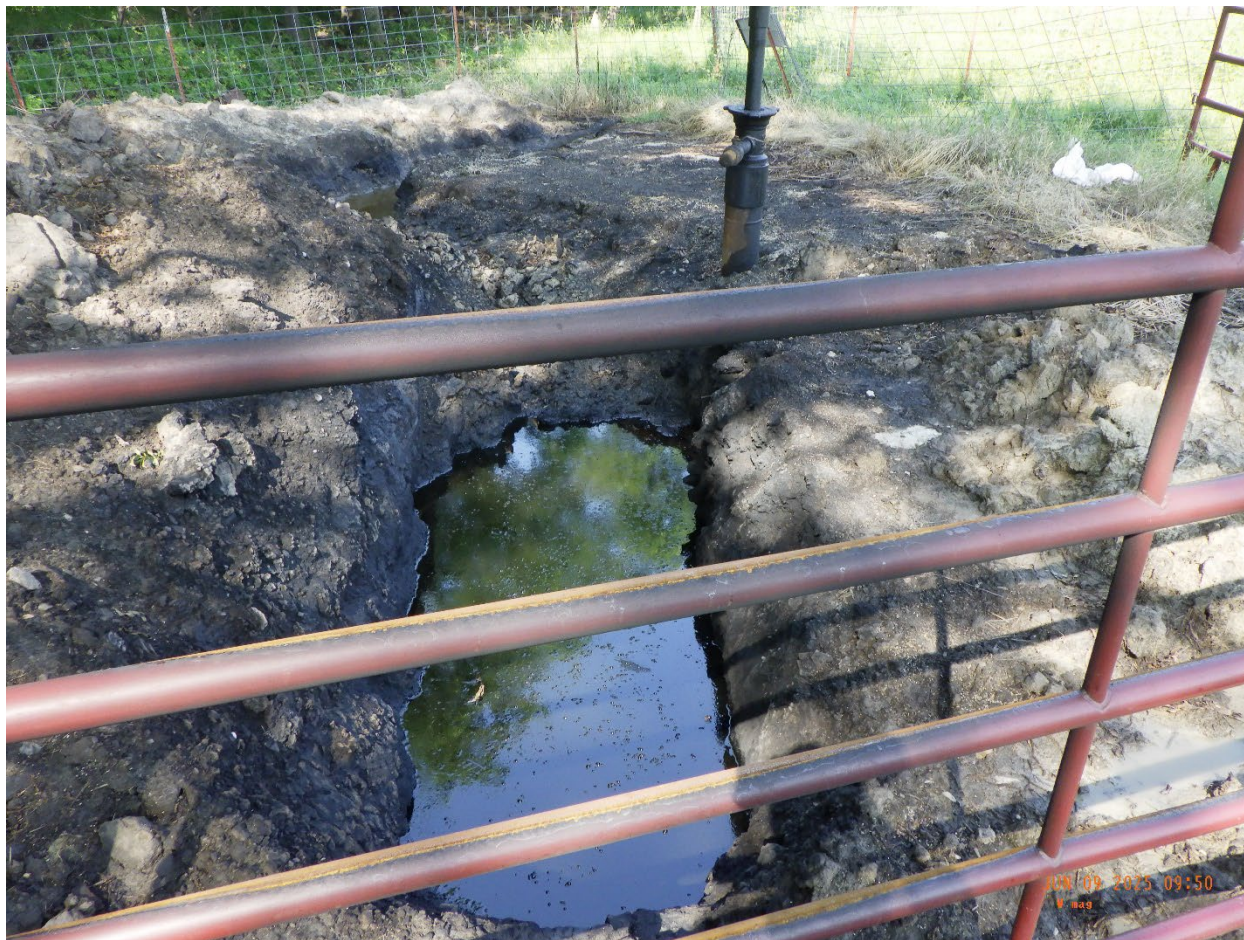
Photo No. 2

The primary area of concern was the crude oil located in the catchpit. No progress was made to prevent recurrence of the spill event. More than 45 days had passed since the spill inspection on April 23, 2025.

A temporary solution was applied to the well in 2021 but failed to prevent recurrence of the purging event.

**Description:** This was the source of the spill, Tidal Osage 1 well number 1-2. The well was inactive at the time of the surfacing event. The catch pit was covered in oil at the time of the inspection.

A permanent solution to the failed well casing should be achieved to prevent additional recurrence of the spill event.

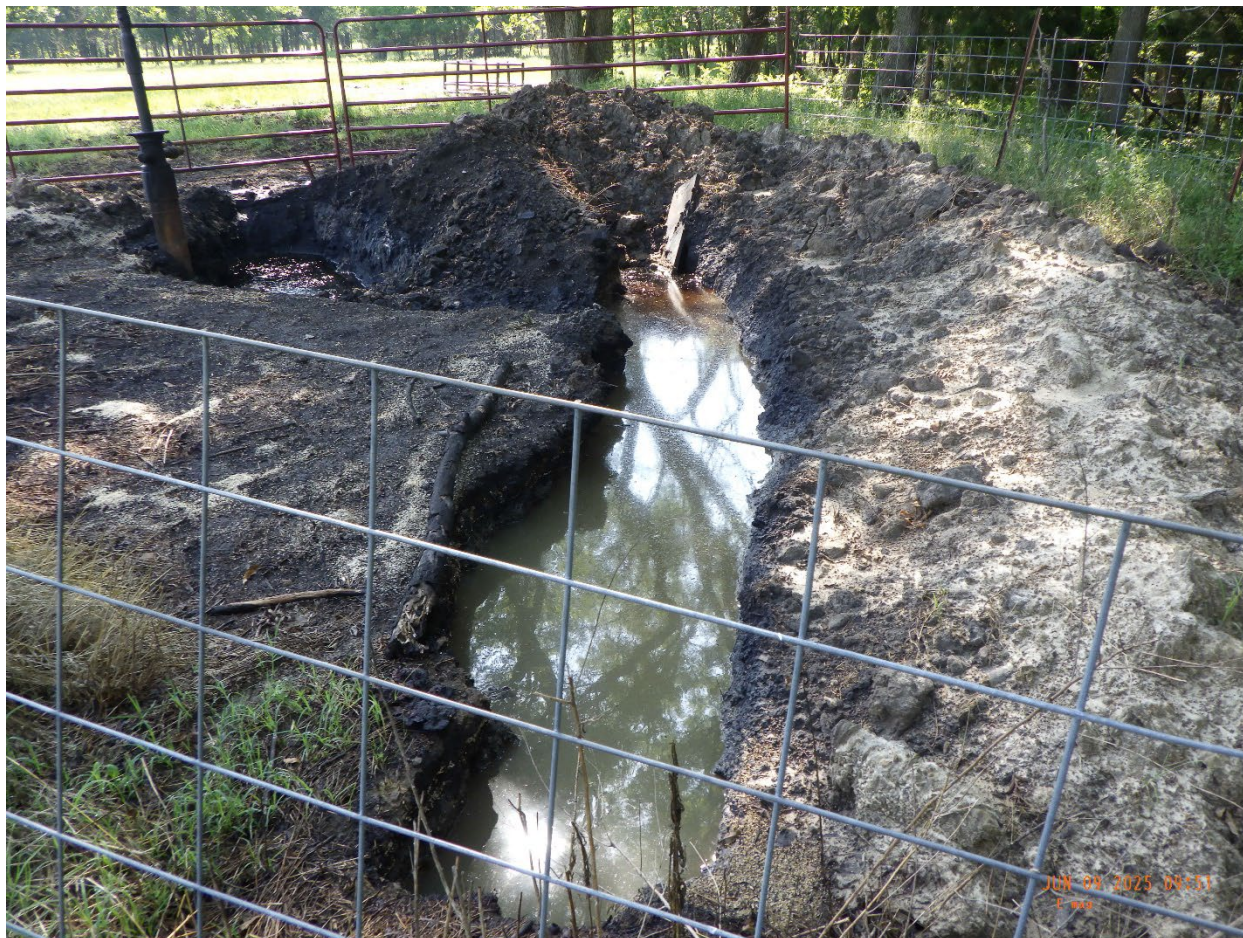
Photo No. 3

I observed an additional catchpit at the spill location which did not contain crude oil. See photo No. 3.

**Description:** This was an additional catchpit installed by the operator.
