# NPDES Compliance Inspection Report

## Copper River Seafoods Anchorage, AK

**NPDES Permit Tracking Number  
# AKU000398**

**Inspection Date: July 29 & 30, 2024**

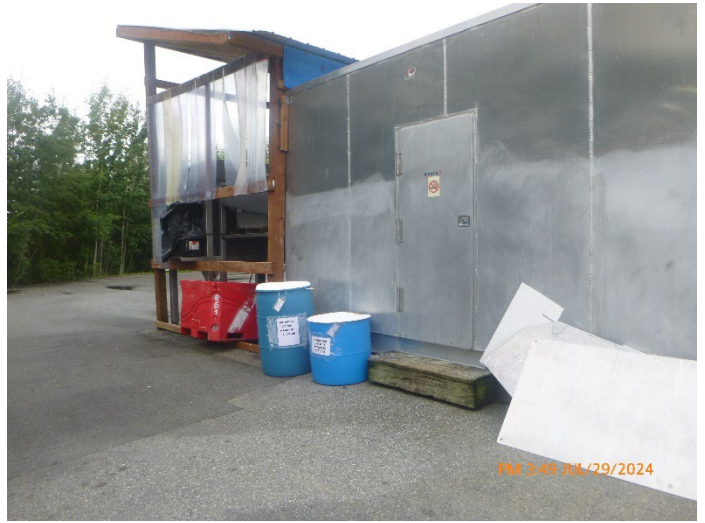
Photo #:06 (P1010207)  
Description: Butchering room. Area where staff wash their bibs outside.

Facility representatives also explained that staff working in the butchering line exit the building on the south-side and clean their aprons outside (see Photo 06). The location of the apron-cleaning station is uphill from the SE storm drain (see Photos 21 and 22).

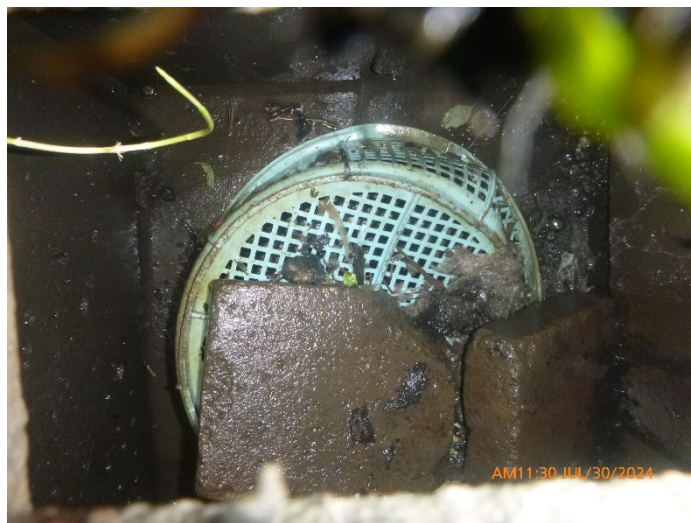
Photo #:18 (P1010220)  
Description: Northwest storm drain with blue bucket weighed down with a rock.

On July 30, 2024, we returned to the site and met with Mr. Purkerson, Mr. LaCroix and Ms. LaCroix. We again discussed the purpose of the inspection and reviewed documents. We then returned to the storm drain in the northwest corner to find the storm drain. Once the storm drain was found we observed a basket, weighed down by a rock, in the storm drain (see Photos 16, 17, 18, and 19). Facility representatives were not sure why the basket was in the storm drain. We returned to the storm drain in the southeast corner and we did not see any baskets in the storm drain.

**B.** There was a basket located in the storm drain.

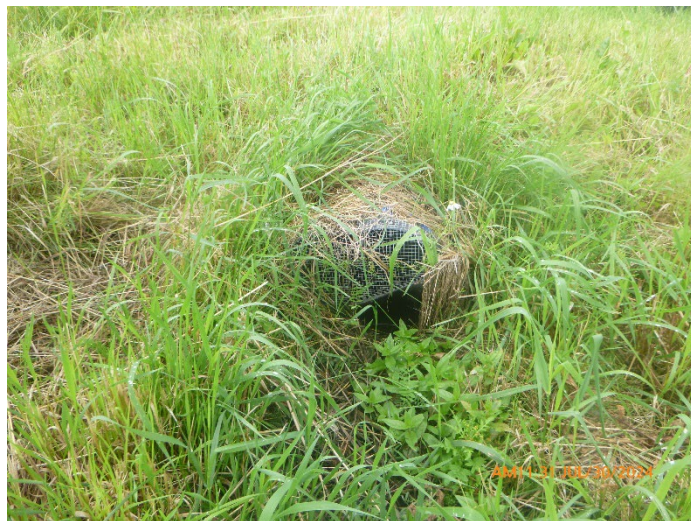
Photo #:20 (P1010223)  
Description: Manhole where samples are collected.

Grind size samples are collected from a manhole located in the front of the building.

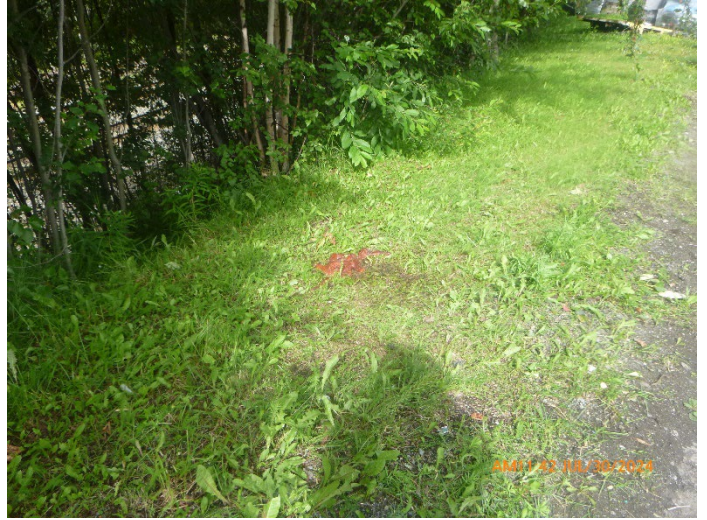
Photo #:26 (007)  
Description: Salmon roe on grass, exposed to stormwater.

Next, we walked to the southwest corner of the property to confirm there were no storm drains. No storm drain was observed, and Facility representatives confirmed there were no additional storm drains. We observed salmon roe on the ground located near the totes (see Photo 26). Facility representatives stated that the salmon roe got there from birds getting the salmon roe from the trash receptable.

**C.** There was salmon roe on the ground.
