INSPECTION REPORT

| Statute(s)/Program(s) | Clean Water Act, NPDES, Stormwater – Industrial | | |
| Type of Inspection | Compliance Evaluation Inspection | | |
| Facility or Site Name | Rosboro Lumber Company - Springfield Facility | | |

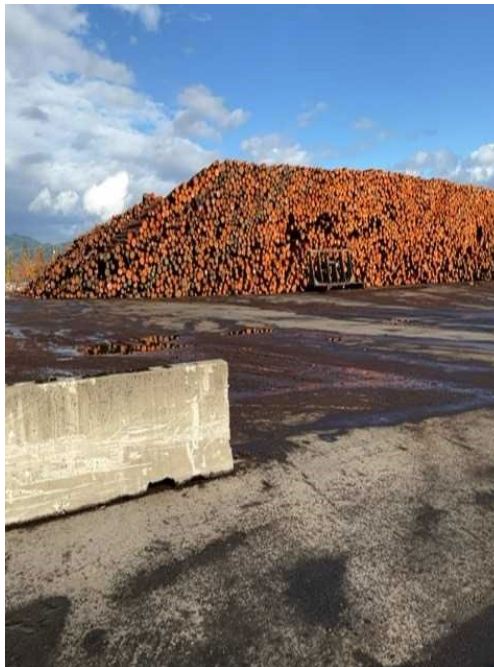
| Log Yard | | | IMG-20241122110524524106818.jpg |

| Stacked logs waiting for milling. | | | |

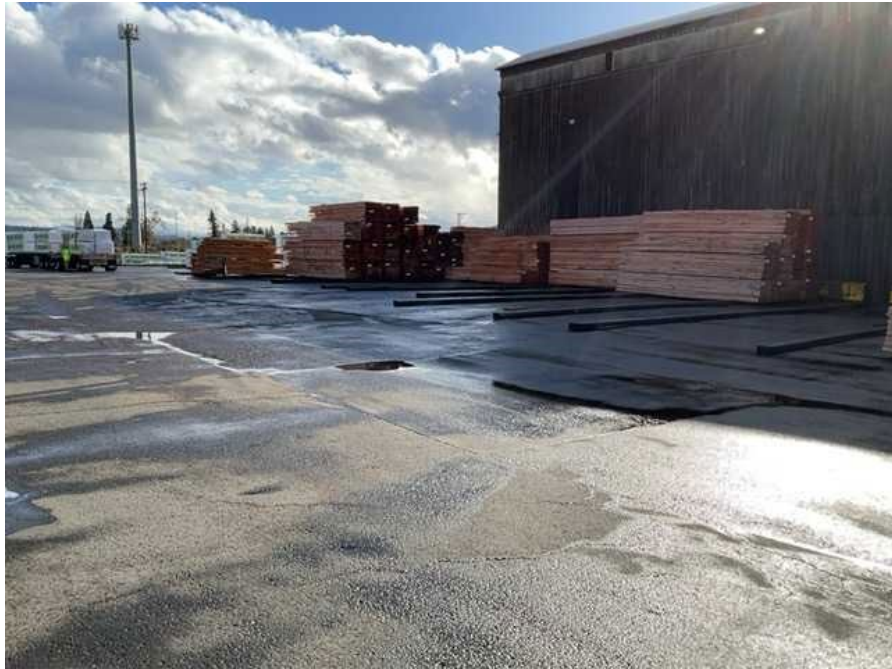
| Storage Area near Production Building | | | IMG-20241122110556556109969.jpg |

| Laminated stock, i.e., Lam Stock, that did not make the grade and will be re-cut to dimensional lumber. | | | |

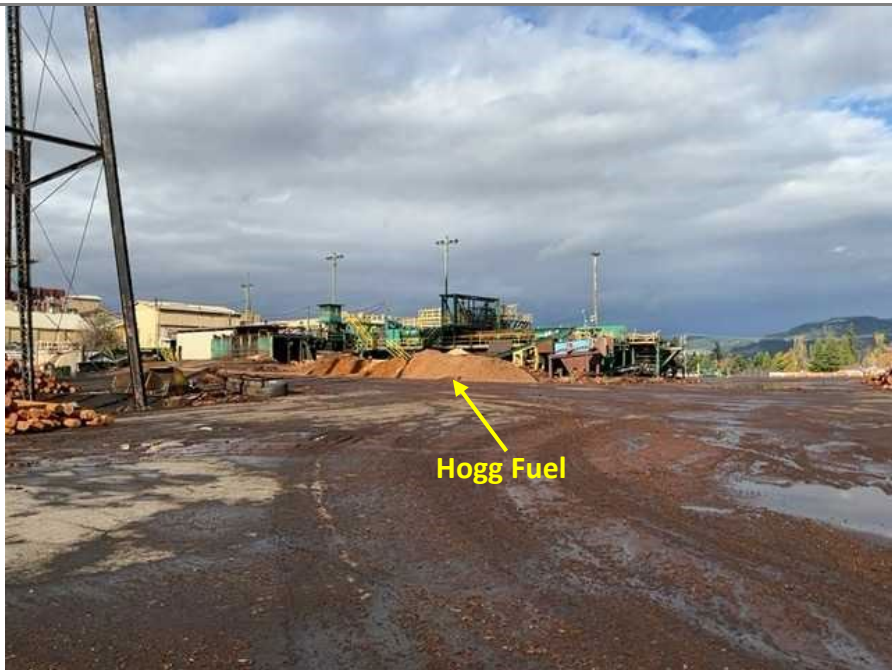
| Hogg Fuel Storage Area | | | IMG-2024112211094094096606.jpg |

| Hogg fuel piles that have been delivered and is waiting to be used in the boilers. | | | |

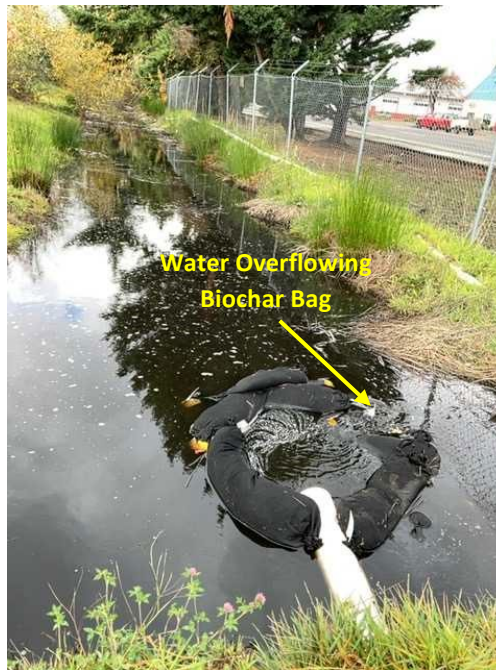
| Outfall 001 is in the bioswale used to contain and guide stormwater. Biochar bags are placed around the inlet as a Best Management Practice (BMP) to mitigate the discharge of pollutants, i.e. copper, as part of the facility's Tier 2 action plan. The biochar bags needed maintenance. The upper right segment of the biochar bags is allowing water to pass without filtration through the bags. | | |

| AOC Reference #: RA1-OB-001 | Location: Swale/Outfall 001 |
|---|---|
| <b>Permit Requirement</b><br>Schedule A.2.a of the permit states, in part, "The permit registrant must select, design, install, implement and <b>Maintain</b> (emphasis added) control measures, including all best management practices (BMPs)..." | |
| <b>AOC:</b><br>Biochar bags (BMP) needed maintenance because they were allowing unfiltered water to pass. | |

| <p>Bioswale with biochar bags around inlet as required by part of the Tier 2 corrective action plan. Biochar bags need maintenance. Water that enters the inlet flows out through the white pipe and discharges to the Q Street ditch. Samples are collected from the center of the biochar bags using a bottle on a long pole.</p> | | | |

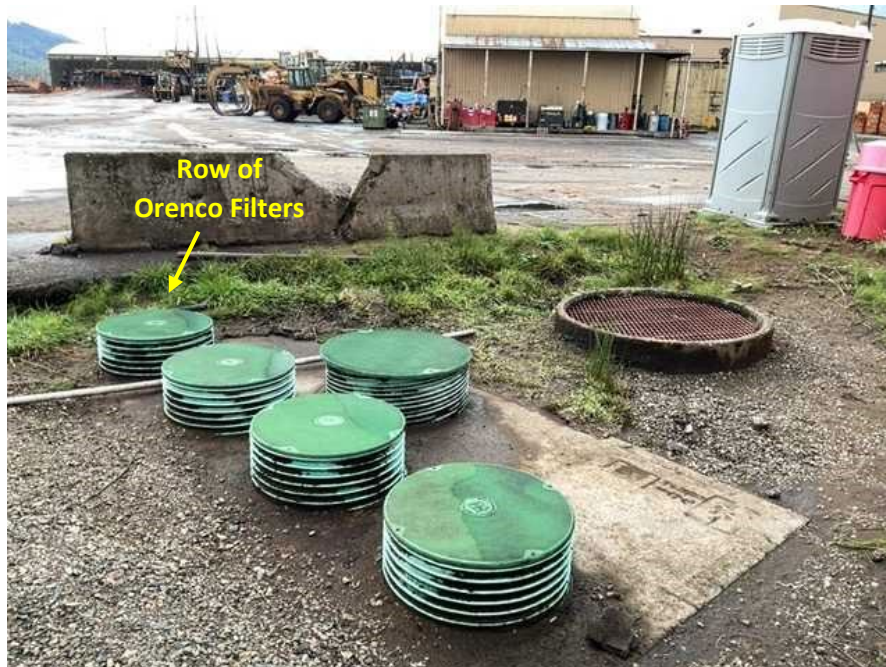
| <p>The iron grate covers a sediment catch basin. There are four Orenco filters in the foreground. The flow is split equally through the four filters and comes back together to enter underground to an “Aqua-Swirl®” system. NOTE: The Aqua-Swirl® Stormwater Treatment System is a custom engineered, post-construction flow-through water quality device designed to remove coarse sediment, debris and free-floating oil by utilizing hydrodynamic separation technology. (Definition is from the AquaShield Website, <a href="#">Aqua-Swirl®, Stormwater Hydrodynamic Separator - AquaShield, Inc.</a>, accessed 1/10/2025.)</p> | | | |

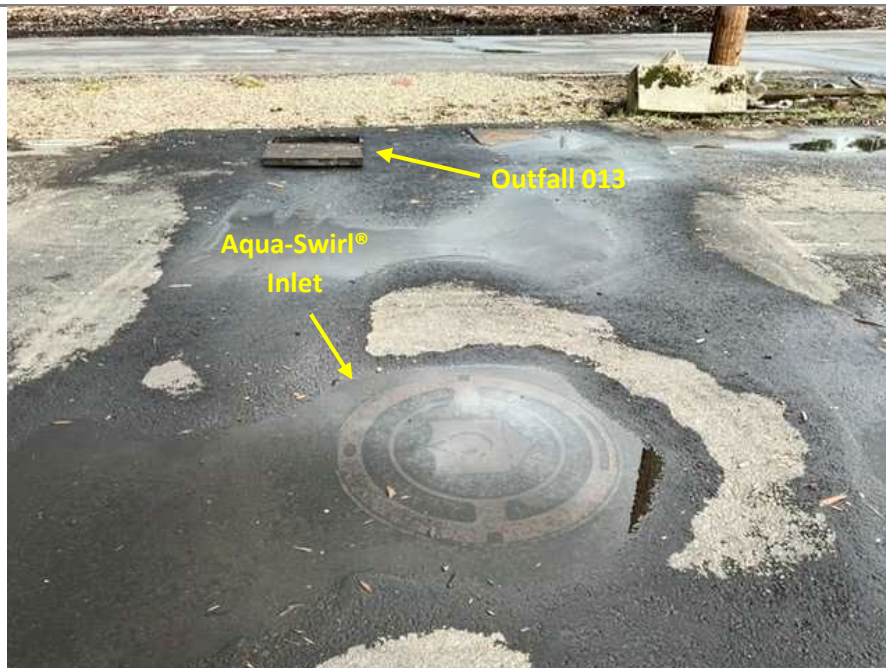
| Aqua-Swirl® | | | IMG-202411221135203520132602.jpg |

| Aqua-Swirl® inlet in foreground. | | | |

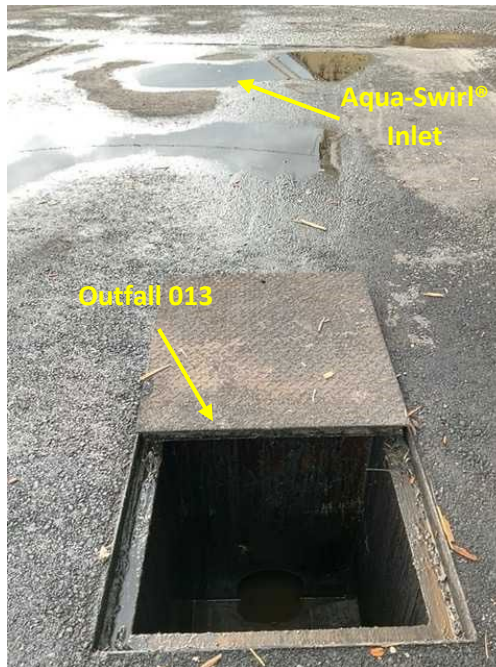
| Outfall 013 | | | IMG-202411221135563556145852.jpg |

| Outfall 013 in relation to Aqua-Swirl®. | | | |

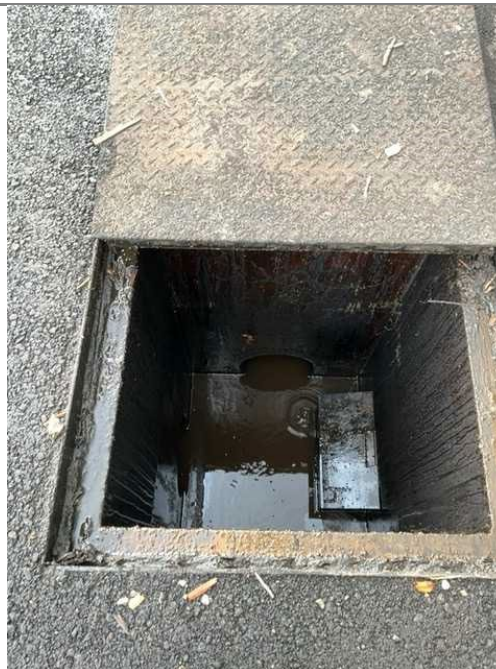
| Outfall 013 | | | IMG-20241122113601361156832.jpg |

| Outfall 013 sampling point. | | | |

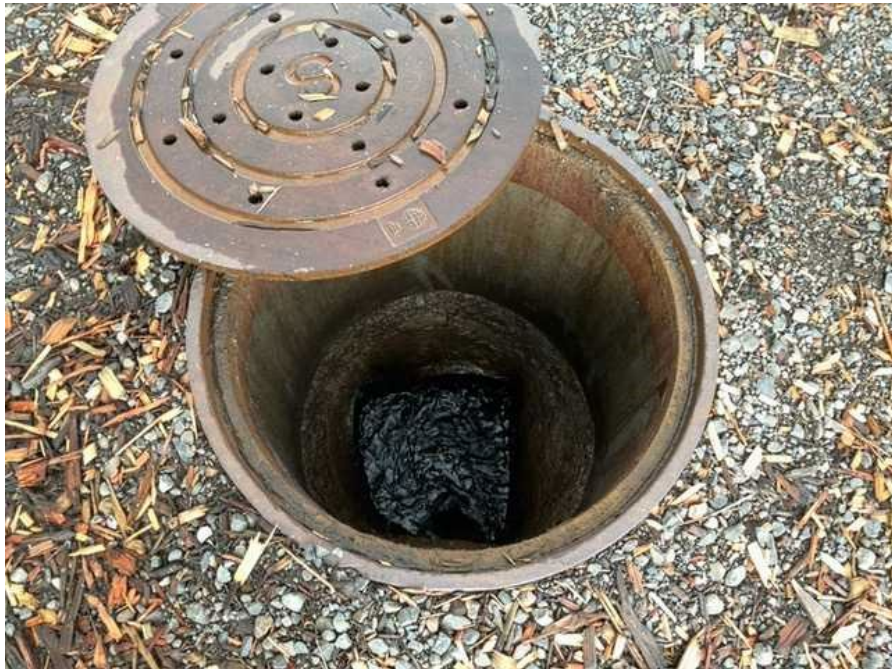
| Outfall 023 | | | IMG-202411221139263926175021.jpg |

| Outfall 023 sampling point. | | | |

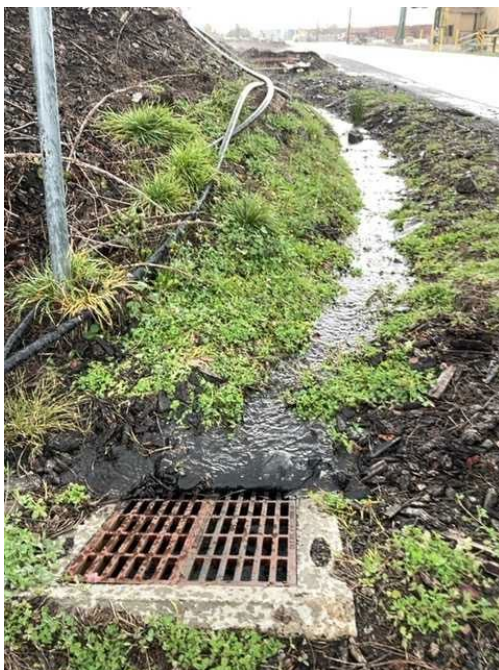
| Outfall 003 | | | IMG-202411221141404140189201.jpg |

| Flow in relation to Outfall 003 | | | |

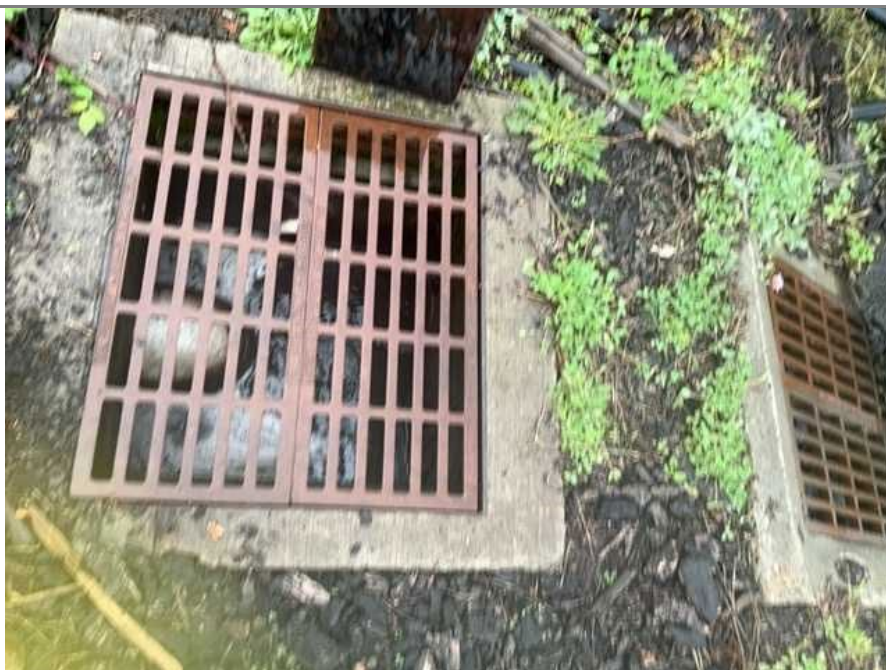
| Outfall 003 Sampling Point | | | IMG-202411221143134313131416.jpg |

| Outfall 003 is sampled from the grate to the left of the outfall. | | | |

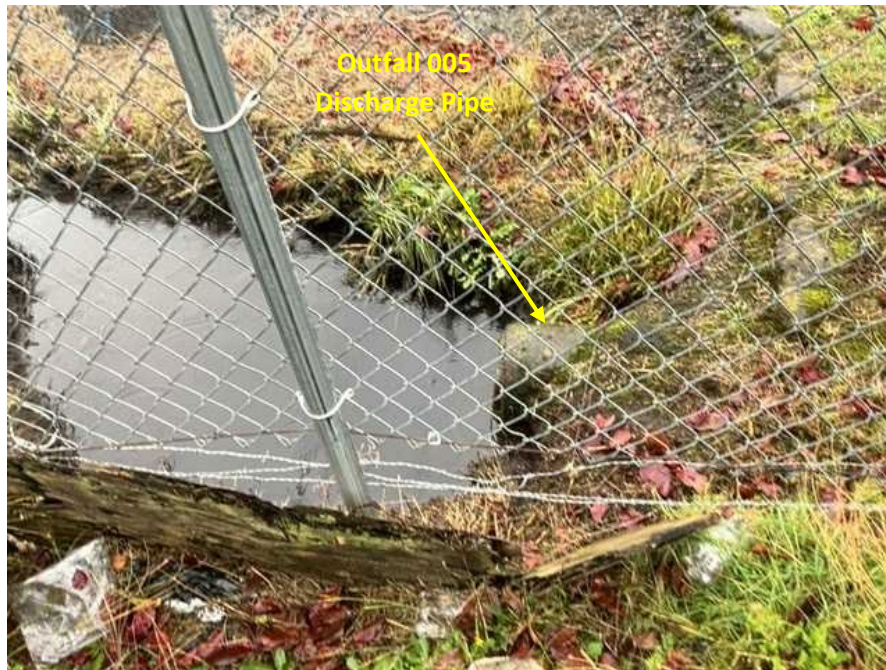
| Outfall 005 | | | IMG-202411221149214921182370.jpg |

| Outfall 005 is outside of the property fence boundary. | | | |

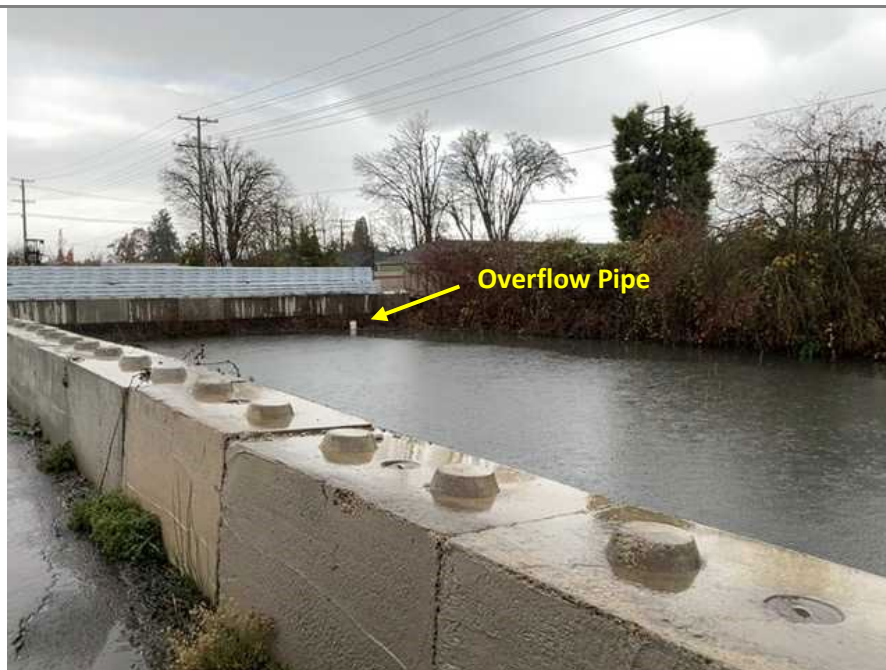
| Evaporation pond, photo 1. The white pipe in the background is for overflow. If the pond's water level gets too high, water overflows into the pipe and flows west to discharge out of Outfall 006 into the city's sewer system. Outfall 006 is not a monitoring point. | | | |

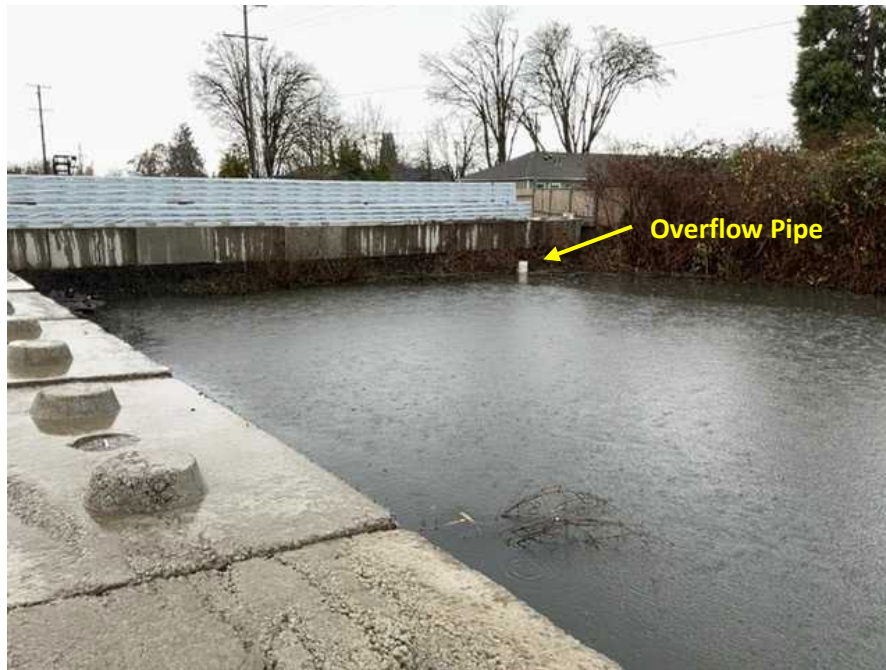
| Evaporation pond | | | IMG-20241122120158158117976.jpg |

| Evaporation pond, photo 2. | | | |

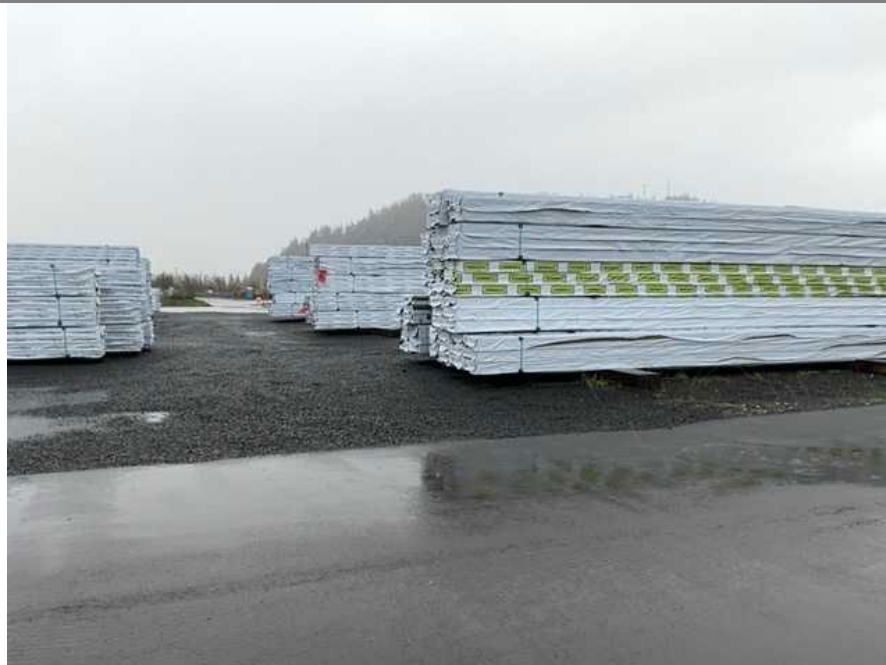
| Packaged "glulam beams". NOTE: A "glulam beam" is a structural engineered wood product made up of layers of dimensional lumber bound together with long-lasting, moisture-resistant structural adhesives. (Definition is from the HPD Consultant, inc. website, <a href="https://www.hpdconsult.com/what-is-glulam-beam/">https://www.hpdconsult.com/what-is-glulam-beam/</a> , accessed 1/10/2025.) | | | |
