Clean Water Act (CWA) Inspection Report

| <b>Type of Inspection</b> | CEI - Compliance Evaluation Inspection | | | |
| <b>Facility Name</b> | Pacific Steel and Recycling – Lewiston | | | |
| <b>NPDES Permit Tracking #</b> | IDR053088 | | | |

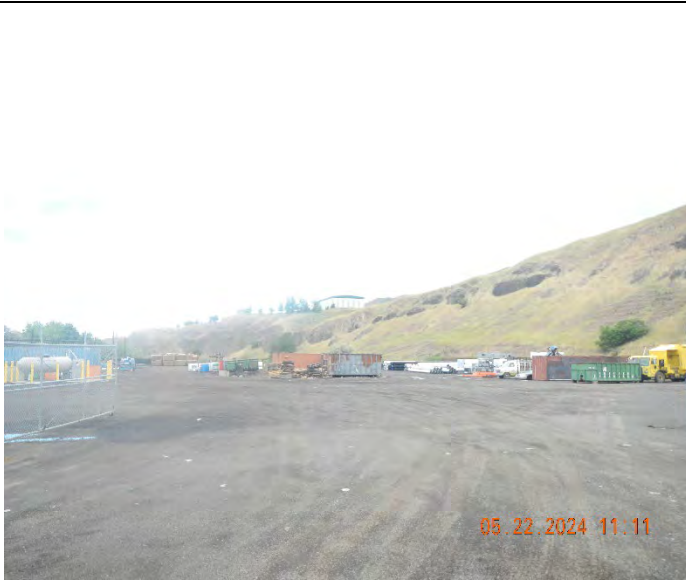
Photo #:01 (DSCN3740)

We first walked north from the main office and observed the unpaved areas along the northeast portions of the Facility (**Photo 1**). Perimeter fencing surrounds the property, there were two open gated entrances along the northeast perimeter. One primary paved entrance is used for the main office and the employee parking area, the second entrance is just north of the primary entrance and is unpaved and is generally used for truck trailer entry and exit. The northern portion of the Facility is unpaved and flat, stormwater is generally infiltrated within the graveled surface. The area is used for truck/trailer parking and storage, new steel storage and temporary scrap and recycling storage bins.

Description: Facing west, photo of material storage and trailer parking area located in the northern portion of the Facility.

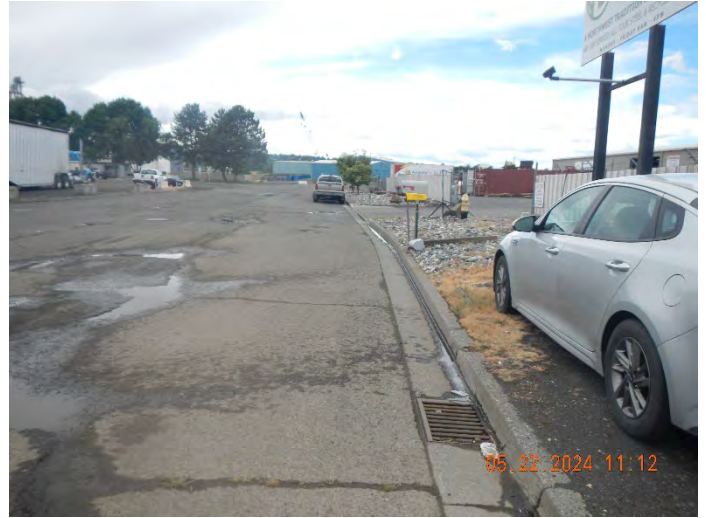
Photo #:02 (DSCN3741)

From the eastern perimeter along 12<sup>th</sup> Street North, we first observed a roadside catch basin that the Facility has identified as Outfall 002 (**Photo 2**) within the Site Plan (**Attachment C**). The catch basin is located outside of the Facility's perimeter fencing and collects stormwater along 12<sup>th</sup> Street North. An adjacent strip of graveled land/surface separates the Facility's fenced areas and 12<sup>th</sup> Street North. No discharge into the catch basin was observed at the time of inspection. Due to the slope and surface types, it appeared that during rain events, most of the flow to the catch basin would be from the paved areas of 12<sup>th</sup> Street North and not from the paved/unpaved portions of the Facility. As 12<sup>th</sup> Street North is within the Port of Lewison, I discussed that to the extent possible, the Facility should consider direction of flow and source if/when collecting a sample from Outfall 002 (to ensure the flow is representative of Facility's contribution/operations).

Description: Facing south, photo of stormwater Outfall 002. Roadside catch basin located along 12<sup>th</sup> Street North.

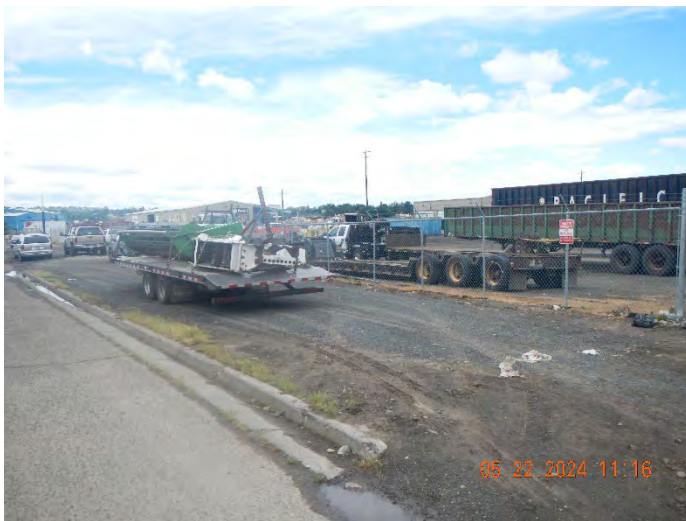
Photo #:03 (DSCN3742)

We continued north along the 12<sup>th</sup> Street North. and observed a parked trailer containing some scrap metal to be parked along the adjacent strip of graveled land/surface (**Photo 3**). Mr. Miller discussed that the trailer and parking area is not associated with the business; however, potential customers will occasionally arrive after hours and leave items/trailers within the area and then return for scrap sales/delivery.

Description: Facing south, photo from 12<sup>th</sup> Street North. Facility boundary is within the fenced area. Parked trailer observed within the public right of way. Was discussed the trailer was likely from a customer who arrive outside of business hours.

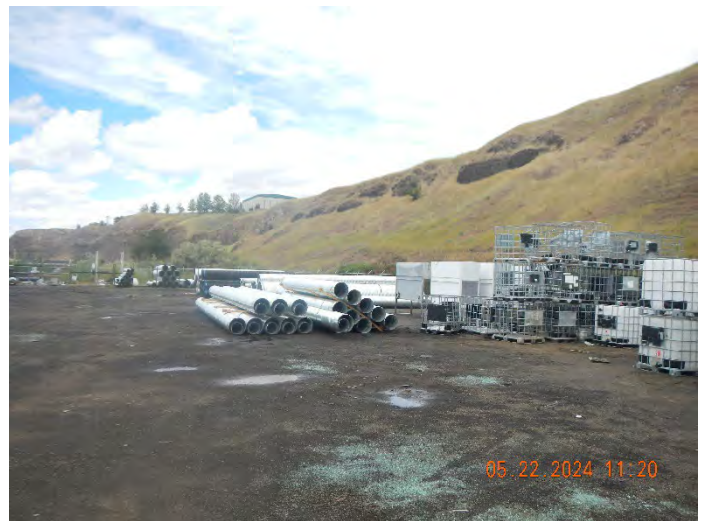
Photo #:04 (DSCN3743)

We continued inside the northern gated entrance and observed the norther unpaved portions of the property including the storage areas. We observed empty totes and new steel storage/culverts (**Photo 4**). Mr. Miller discussed that the empty totes were triple rinsed and are staged at this location to be later utilized by for scrap sorting and storage/transport, as the plastic also serves as a containment structure for any residual debris.

Description: Facing west, photo of material storage area north of the Facility. Triple rinsed/empty totes are stored and used to package and transport materials off-site.

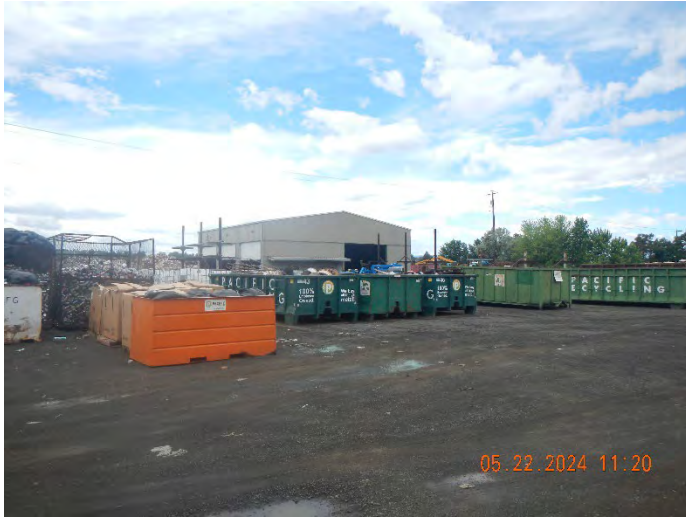
Photo #:05 (DSCN3744)  
Description: Facing south, photo within material storage area. Bins are delivered and stored temporarily until brought into the crushing/processing area.

We observed several roll-off bins/containers south of the northern storage areas (**Photo 5**). It was discussed that the roll-off bins/containers are received and staged at the location until they are brought back to the scrap area for processing/crushing. Bins are typically only staged at this receiving location for a half-day.

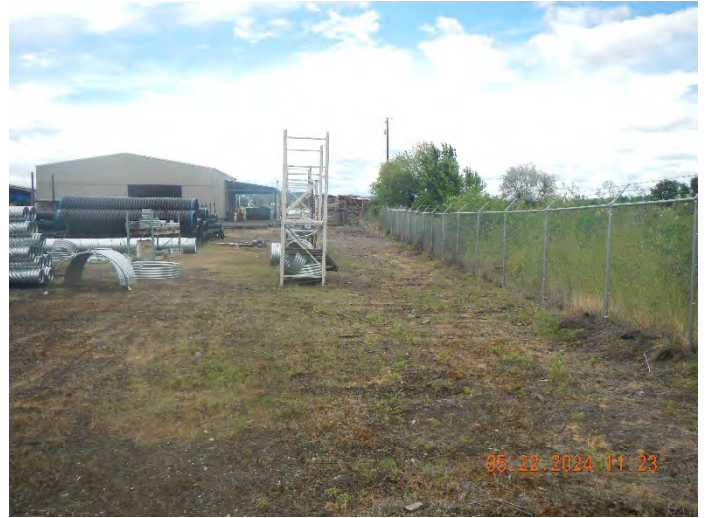
Photo #:06 (DSCN3745)  
Description: Facing south, photo of western perimeter along the northern material storage area.

We continued west to the northwest perimeter and observed the fencing and a slight berm separating the northwestern areas from what was described as a marsh area that was heavily vegetated (**Photo 6**). It was discussed that the marsh area is adjacent to the City of Lewiston's wastewater treatment plant and is not part of the Facility's property.

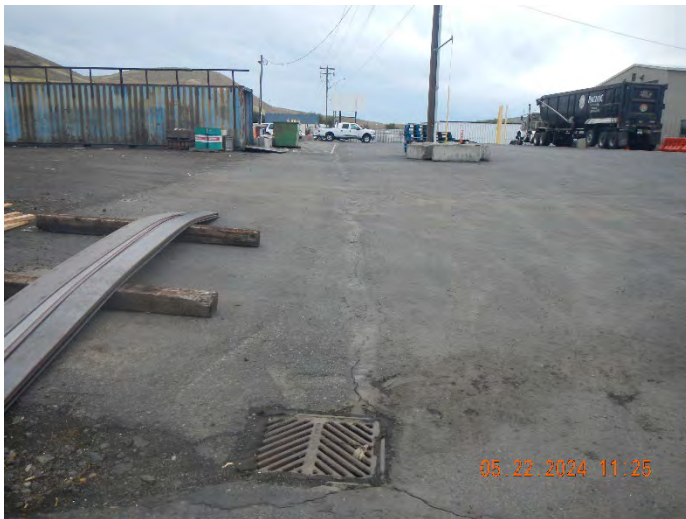
Photo #:07 (DSCN3746)  
Description: Facing east, photo of central catch basin identified as Outfall 001. Filter/sediment fabric installed within catch basin. Catch basin is located northeast of the New Steel Building.

Northeast of the new steel building, we observed the central catch basin identified as Outfall 001 (**Photo 7**). The paved area was sloped so that the central catch basin receives stormwater from the surrounding paved areas to north, south, east, and west. In general, the paved areas near Outfall 001 appeared to be well maintained and free of debris/staining. These areas include the areas northwest of the office building, areas north and east of the new steel building and areas north of the mixed recycling bins (**Photo 8, Photo 9**).

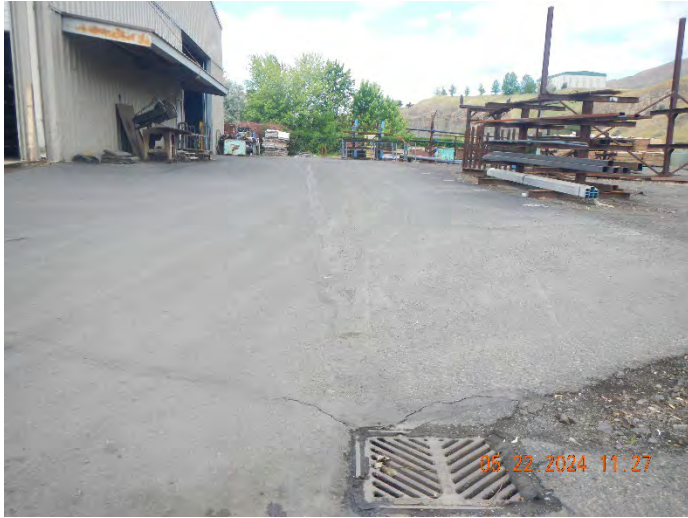
Photo #:09 (DSCN3748)

Description: Facing west, photo of catch basin/collection area for Outfall 001. Photo taken east of New Steel Building.

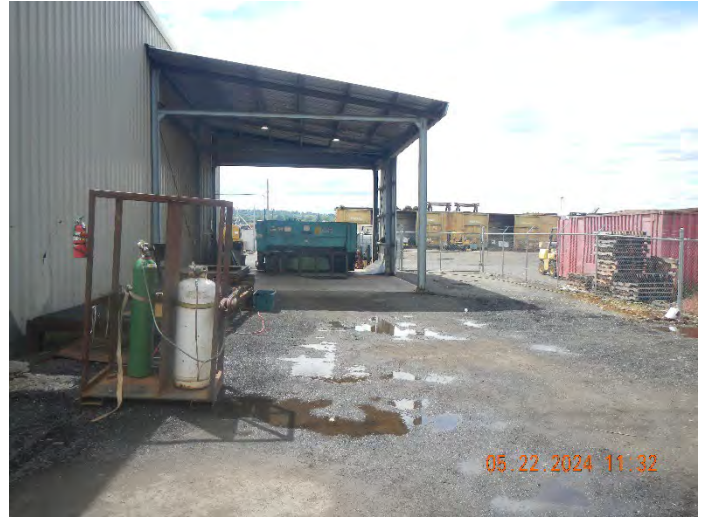
Photo #:10 (DSCN3749)

We walked around the north side of the new steel building to the western perimeter and observed the cutting area used to process/cut the longer lengths of new steel product (**Photo 10**). We observed the plate sheering machine/area outdoors under cover on a concrete slab. The torch/cutting area was within an uncovered graveled area north of the plate sheering machine/area. Various steel products were observed to be stored north of the new steel building on storage racks (**Photo 11**).

Description: Facing south, photo of unpaved area east of the New Steel Building. Area is used for cutting/torching of longer metal pieces.

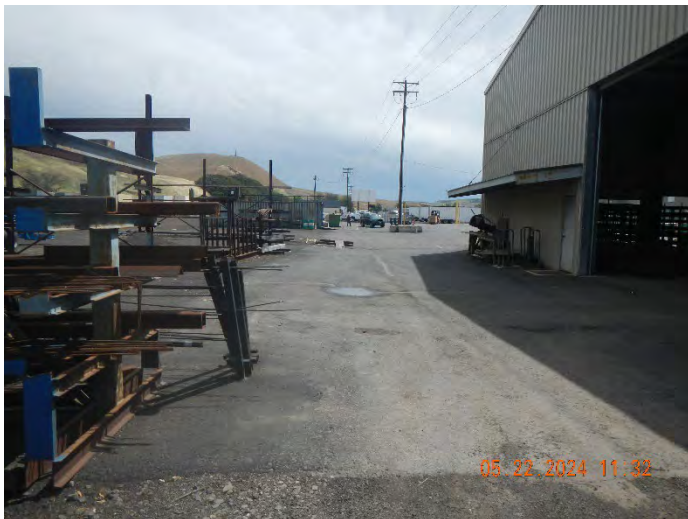
Photo #:11 (DSCN3750)

Description: Facing east, photo of material storage area located north of the New Steel Building.

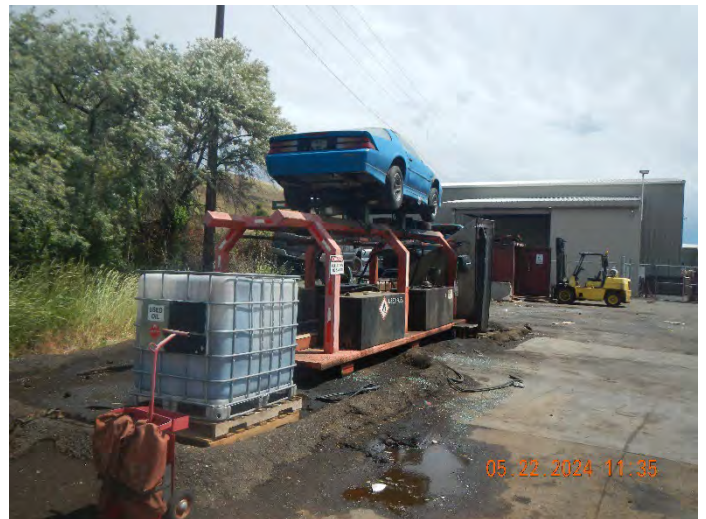
Photo #:12 (DSCN3751)

We continued southwest of the new steel building towards the scrap processing area. We observed the Facility's vehicle fluid drain station used to empty/collect fluids from scrap vehicles before they are processed (**Photo 12**). The area utilizes an asphalt berm for containment, staining was observed throughout the containment area. Noth of the area, a large, vegetated berm and swale extends along the north perimeter,

Description: Photo of bermed area used for fluid drainage of scrap vehicles.

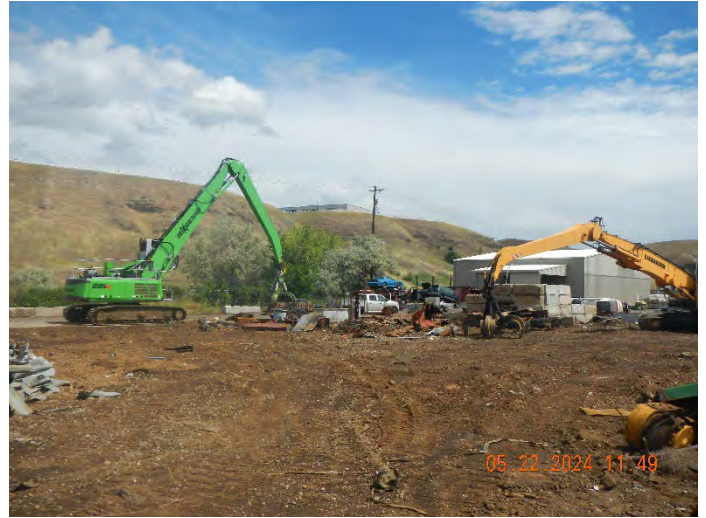
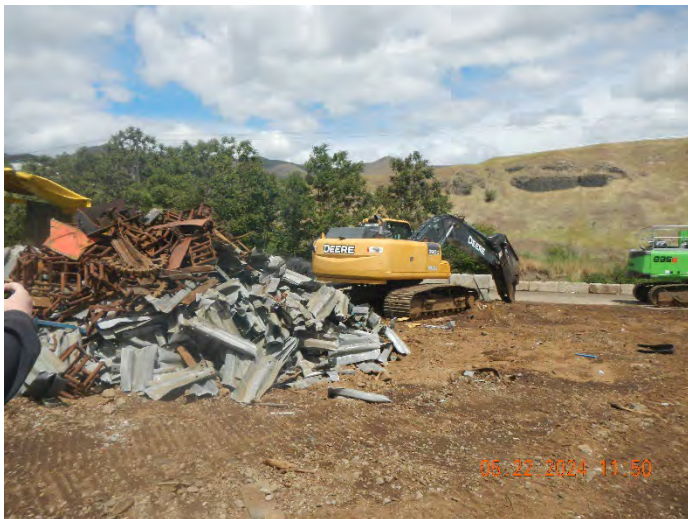
We continued west through the scrap processing area, where scrap metal sorted and compacted. It was discussed that processed scrap is ultimately delivered to Schnitzer Steel in Portland, Oregon. We observed the vegetated berm and swale throughout the northern perimeter (**Photo 14**), as well as the vegetated berm continuing across the western perimeter of the scrap processing area (**Photo 15**). We then observed the southern and central portions of scrap processing area. Southern portions of the scrap processing area were unpaved and stacked concrete ecology blocks extended across the southern property line and rail spur entrance (**Photo 16, Photo 17**). Primary/central scrap sorting and processing areas remain unpaved, and stormwater is designed to be infiltrated (**Photo 18, Photo 19**).

Photo #:18 (DSCN3757)  
Description: Facing northeast, photo of central processing/sorting area.

Photo #:19 (DSCN3758)  
Description: Facing north, photo of central processing/sorting area.

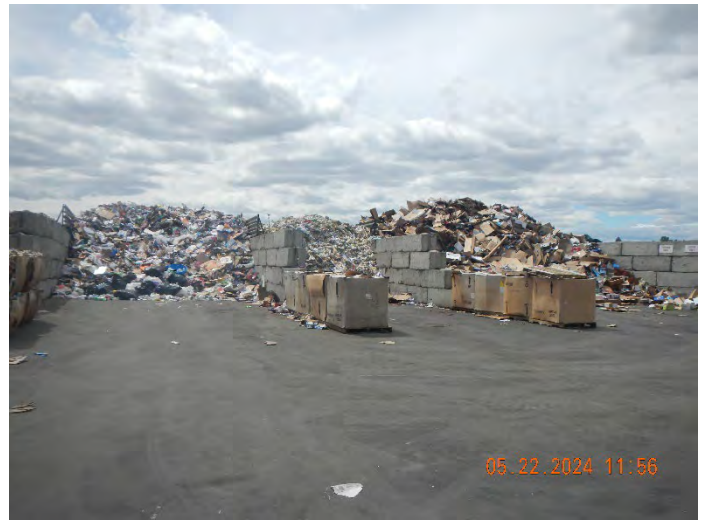
Photo #:22 (DSCN3761)  
Description: Facing south, photo of mixed recycling receiving area.

We continued east along the southern perimeter to the area south of the New Steel Building, we observed the receiving area for the consumer/commercial recycling areas (**Photo 22**). Materials include mixed recycling, cardboard and newspaper. It was discussed that no sorting consumer/commercial recycling occurs at the Facility, only bailing of the received materials for shipping/transport. The area is generally sloped that stormwater would travel towards Outfall 001.

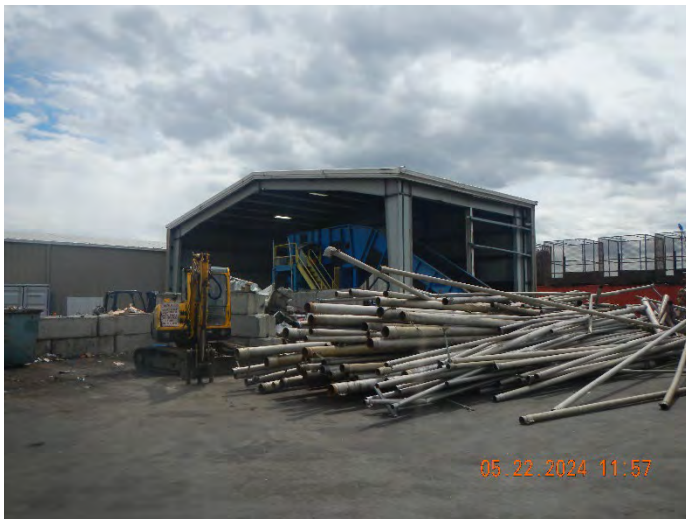
Photo #:23 (DSCN3762)  
Description: Facing southeast, photo of staged aluminum piping awaiting cutting. Due to length/size, piping was staged at location. Area is northeast of mixed recycling receiving area.

The bailing machine was located just east of the area under cover. NE of the covered bailing area we observed a pile of aluminum piping (**Photo 23**). It was discussed that due to the longer lengths of piping, the material was temporarily stored at the location so it could be sheared into smaller lengths prior to further processing. From this area we viewed the paved collection area south of Outfall 001, east of the new steel building (**Photo 24**).

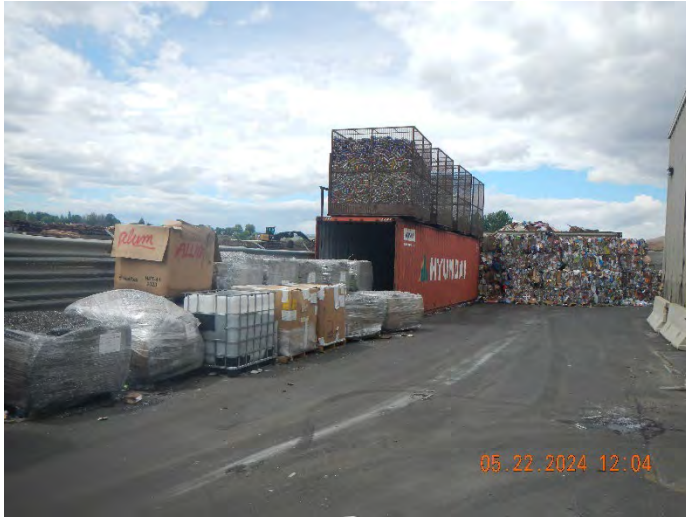
Photo #:25 (DSCN3764)

We continued around the south side for the bailing building and observed stockpiled aluminum scrap awaiting pick-up/shipping (**Photo 25**). It was discussed that in general, processed materials awaiting pick-up/shipping are stored under cover within shipping containers. Mr. Miller discussed that the stockpiled aluminum materials observed were just pulled from the shipping containers, in preparation for truck shipment to Post Falls, Idaho.

Description: Facing east, photo of aluminum scrap awaiting pick-up/transport off-site. Shipping container is normally used to store the material awaiting pick-up/transport.

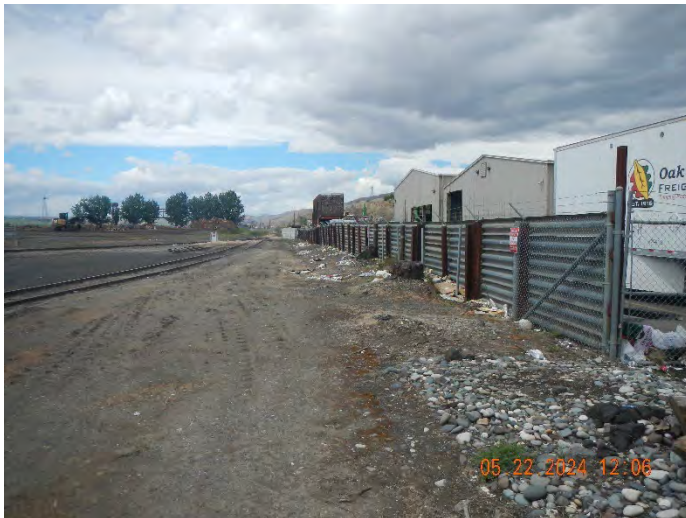
Photo #:27 (DSCN3766)

Description: Facing west, photo of southeast perimeter fencing between railway and Facility.

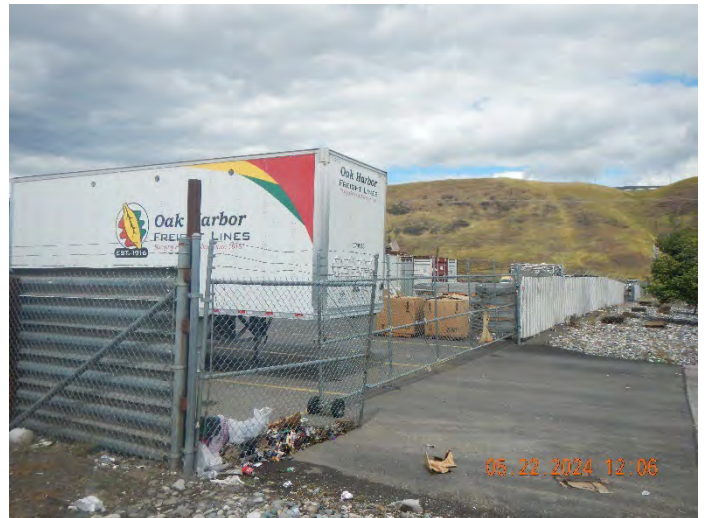
Photo #:28 (DSCN3767)

Description: Facing north, photo of eastern perimeter fencing between 12<sup>th</sup> Street North
