**Well Inspection**  
**Osage DNR / Environmental Protection Agency**  
**1201 Elm Street, Suite 500**  
**Dallas, Texas 75270**

| | | <b>Well ID</b> | 102 W6 | | |
| <b>Inspection Reason</b> | Plugging Witnessed | <b>Responsible Company at Time of Inspection</b> | CapturePoint, LLC | | |

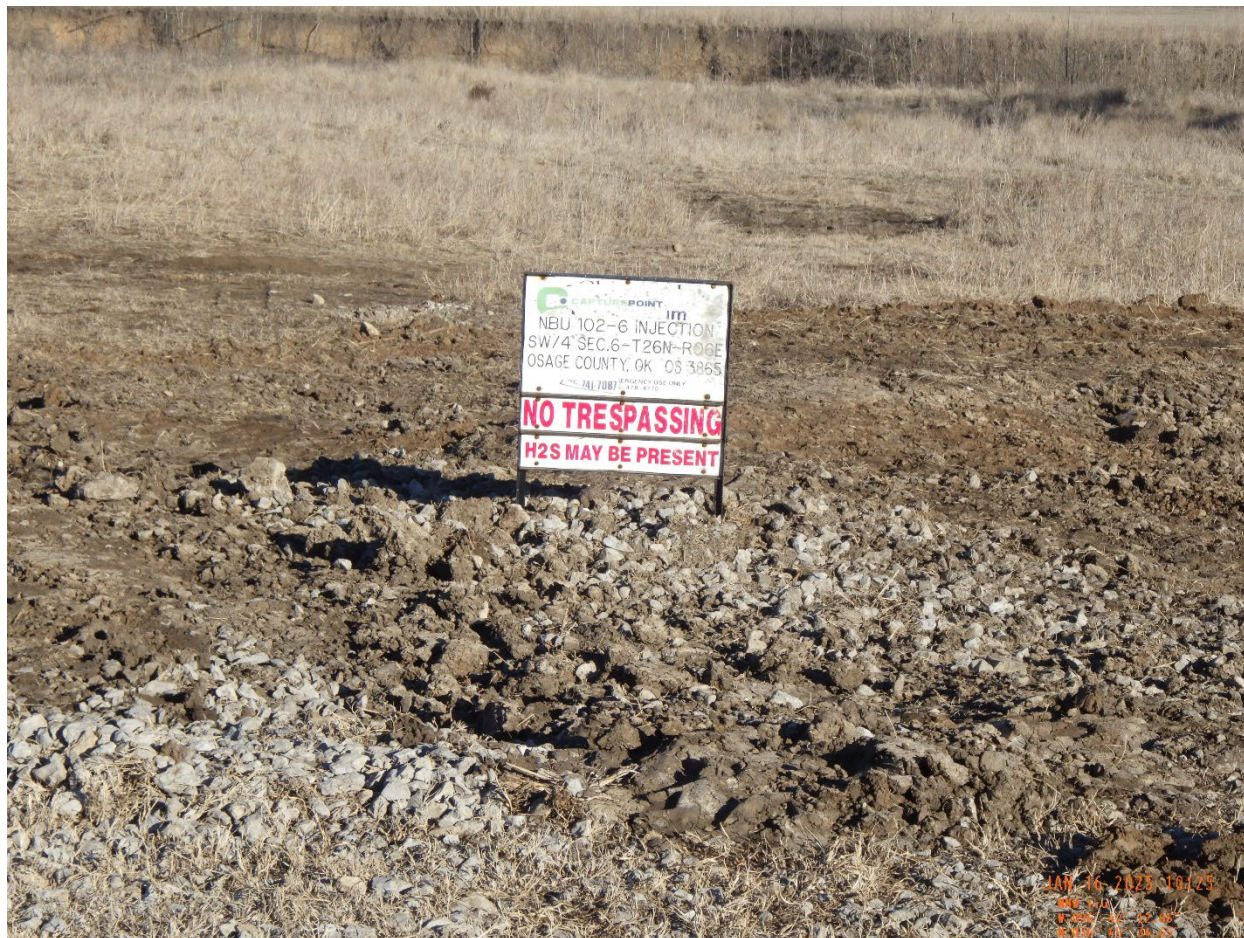
Photo No. 1

Description: This was the location of well OS3865000 with the casing cutoff and capped 3 feet below the land. Surface restoration completed.
