## EPA REGION 10 Enforcement Division

### INSPECTION REPORT

| Company Name | Alyeska Pipeline Service Company | |
| Facility or Site Name | Alyeska Taps Valdez Marine Terminal | |

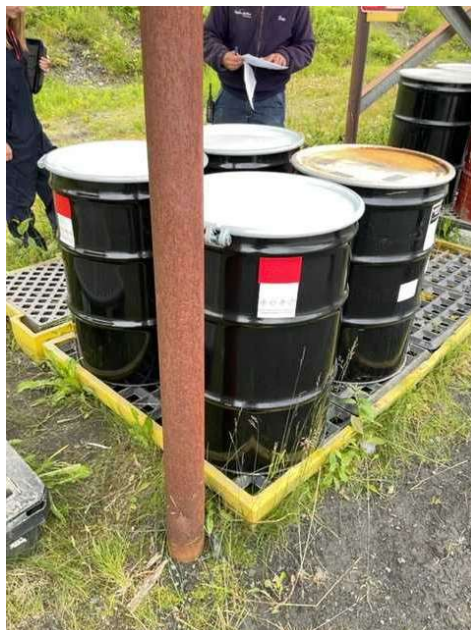
| Pole Barn: Four 55-gal Drums Missing Hazard Indicators | | | IMG-20240806095002502137897.jpg |

| We observed four, 55-gallon containers marked "hazardous waste" with no hazard indicators at the Pole Barn. There were two barrels of Isocyanates, one barrel of amines, and one barrel of C-Boiler refractory debris. Dan Gilson informed us that this barrel of C-Boiler refractory debris was awaiting a hazardous waste determination, | | | |

| No hazard indicators on these four 55-gallon drums of hazardous waste, located at the Pole Barn. | | | |

and they were hoping to add it to their contaminated soil stockpile. The missing hazard indicators for these barrels were added at time of the inspection by Dan Gilson.

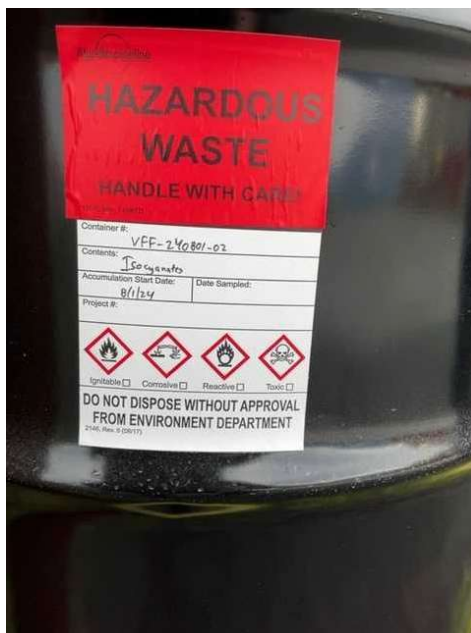
| Drum 1: 55-gal Drum of Isocyanates | | | IMG-2024080609500850869111.jpg |

| No hazard indicator on 55-gallon Drum 1 of Isocyanates. | | | |

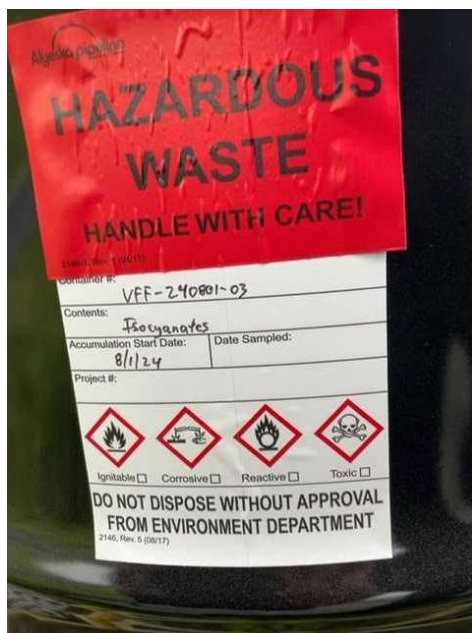
| Drum 2: 55-gal Drum of Isocyanates | | | IMG-20240806095015501585344.jpg |

| No hazard indicator on 55-gallon Drum 2 of Isocyanates. | | | |

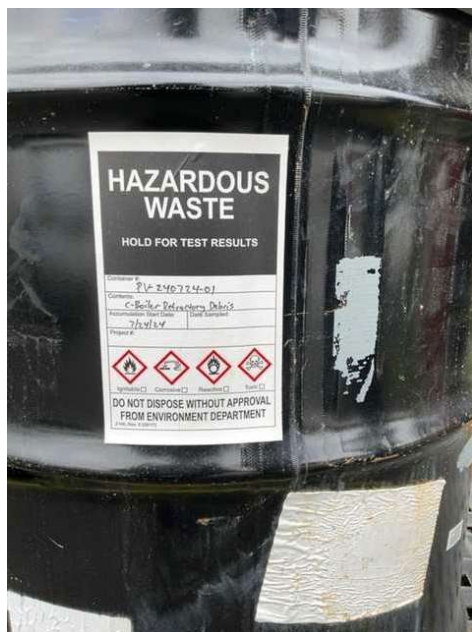
| 55-gal Drum of C-Boiler Refractory Debris | | | IMG-202408060950485048100511.jpg |

| No hazard indicator on 55-gallon drum of C- Boiler Refractory Debris. Holding for test results. | | | |

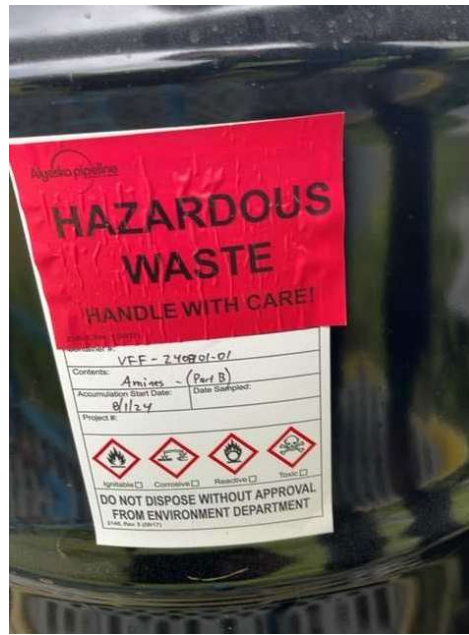
| 55-gal Drum of Amines | | | IMG-2024080609510651678956.jpg |

| No hazard indicator on 55-gallon drum of Amines. | | | |

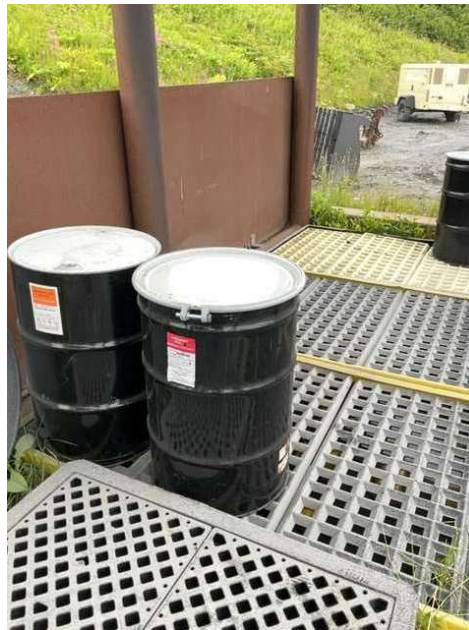
| 55-gal Drum of Crude Strainer Waste | | | IMG-202408060955535553129449.jpg |

Additionally, there was one 55-gallon drum of recovered crude strainer waste that was labeled hazardous waste but was missing the hazard indicator. The hazard indicator was added at the time of the inspection by Dan Gilson.

| No hazard indicator for one 55-gallon drum of crude strainer waste. | | | |

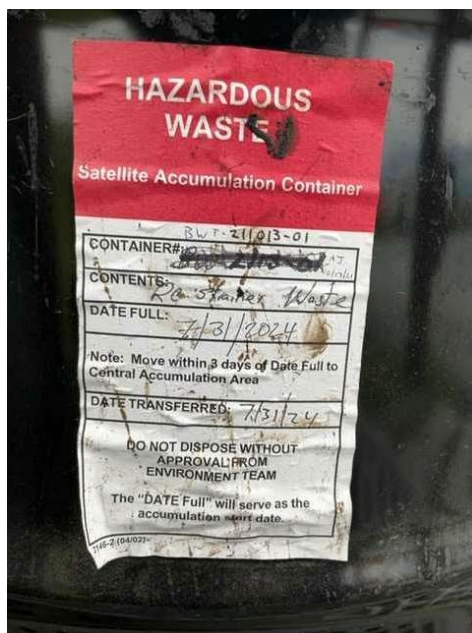
| Crude Strainer Waste Label: Missing Hazard Indicator | | | IMG-20240806095600560107089.jpg |

| No hazard indicator on label of 55-gallon drum of crude strainer waste. | | | |

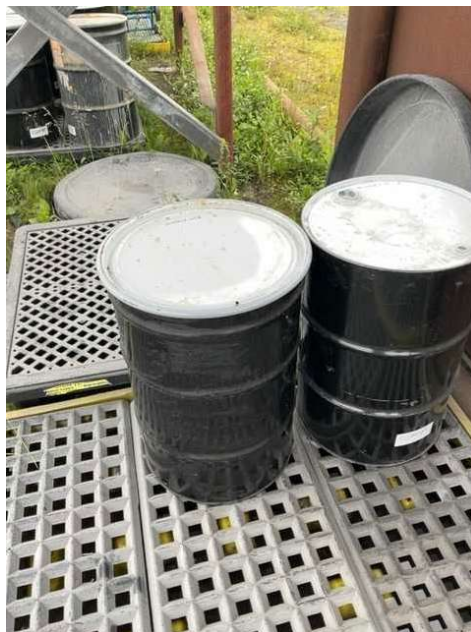
| Back of 55-gal Drum of Crude Strainer Waste | | | IMG-20240806095609569119898.jpg |

| Additional picture showing that there was no hazard indicator on the 55-gallon drum of crude strainer waste. | | | |

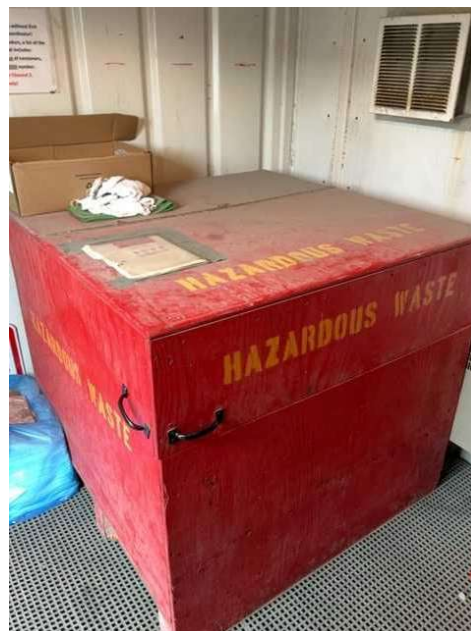
| Red Box in Waste Storage 03 | | | IMG-2024080610034434493087.jpg |

Dan Gilson led us to three waste storage containers. In Waste Storage 03b (WS3b) unit there was a large "Red Box" where all the hazardous waste is stored. The box was labeled "hazardous waste" and contained waste paint cans. The box was missing a hazard indicator. Dan Gilson marked the hazard indicator at the time of the inspection.

| Hazardous waste storage box in with no hazard indicator. | | | |

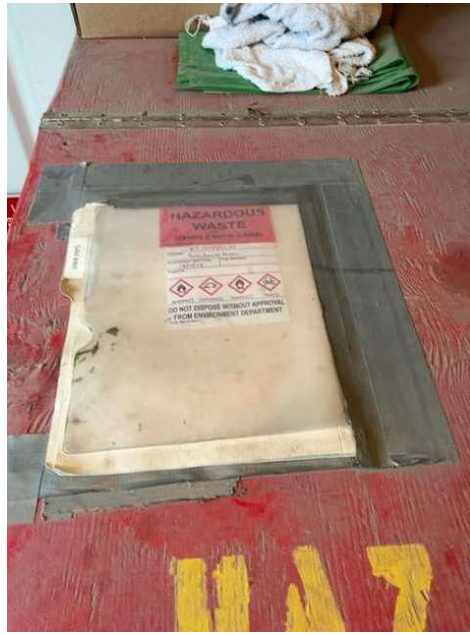
| Label on Red Box in Waste Storage 03 | | | IMG-2024080610035035086710.jpg |

| Hazard indicator missing on Red Box in Waste Storage 03. | | | |

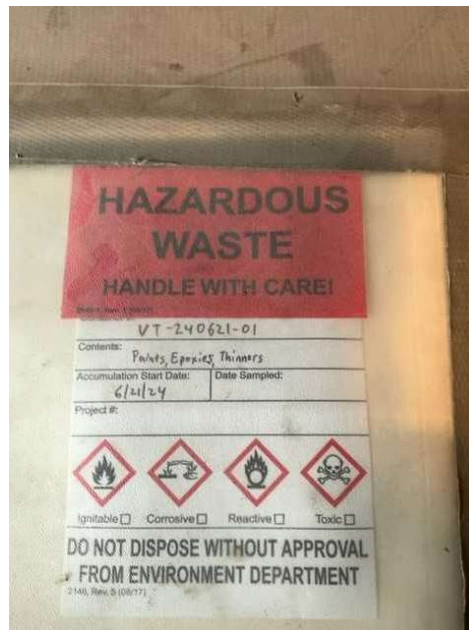
| Hazardous Waste Label on Red Box | | | IMG-2024080610035635691139.jpg |

| Label on Red Box in Waste Storage 03 missing hazard indicator. | | | |

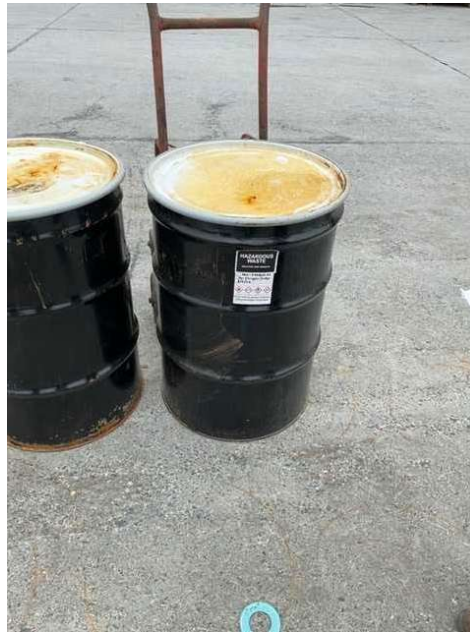
| 55-gal Drum of Stripper Sludge | | | IMG-202408061024332433113802.jpg |

| We observed a 55-gallon hazardous waste storage container of Stripper Sludge was not marked with a hazard indicator. Dan Gilson added the hazard indicator at the time of the inspection. | | | |

| 55-gallon hazardous waste storage container of stripper sludge was not marked with a hazard indicator. | | | |

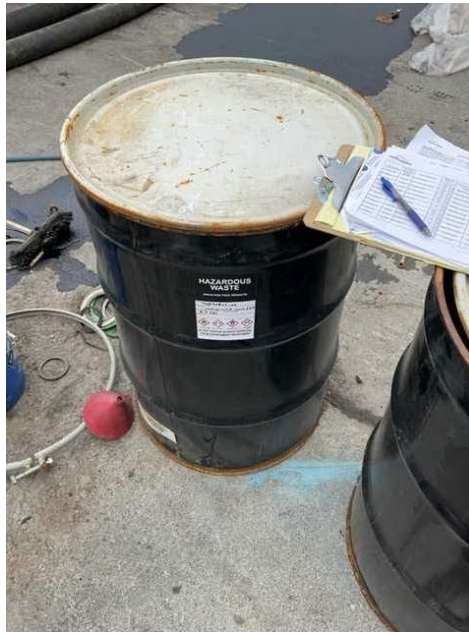
| 55-gal Container of Non-Hazardous Waste | | | IMG-202408061029462946106801.jpg |

| Additionally, we observed a 55-gallon drum that was marked with a hazardous waste label. Dan Gilson stated that this drum was not hazardous waste, but rather diesel contaminated soil that was going to be put into the contaminated soil stockpile per allowance from ADEC. | | | |

| 55-gallon container of non-hazardous, diesel contaminated soil. Mislabeled as hazardous waste. | | | |

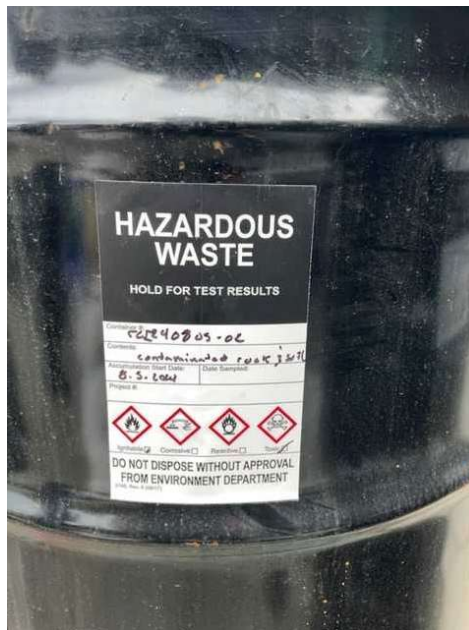
| 55-gal Container of Non-Hazardous Waste Label | | | IMG-20240806102950295098246.jpg |

| 55-gallon container of non-hazardous, diesel contaminated soil. Mislabeled as hazardous waste. | | | |

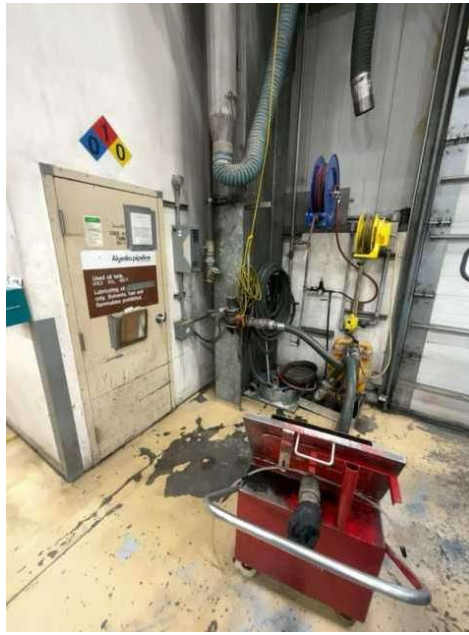
| Unlabeled Catch Pan Containing Used Oil | | | IMG-20240806115512551293714.jpg |

We observed a pan that catches used oil from a hose used to transfer the used oil from one container to their used oil tank. This pan contained used oil but was not labeled with the words "used oil". Dan Gilson had the pan marked with the words "Used Oil" at the time of the inspection.

| Pan not labeled with the words "used oil". | | | |

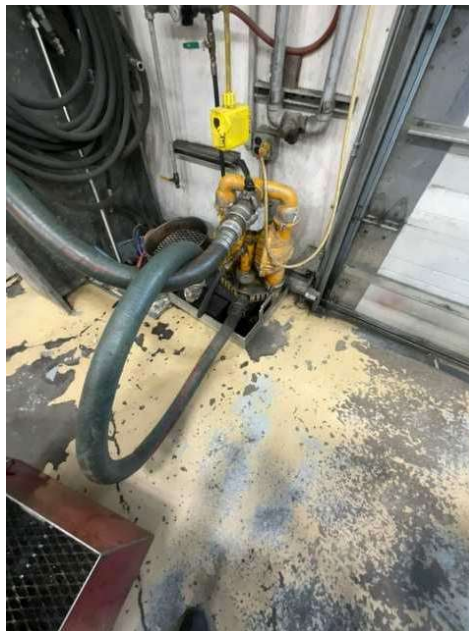
| Unlabeled Catch Pan Containing Used Oil | | | IMG-202408061155185518107964.jpg |

| Pan not labeled with the words "used oil". | | | |

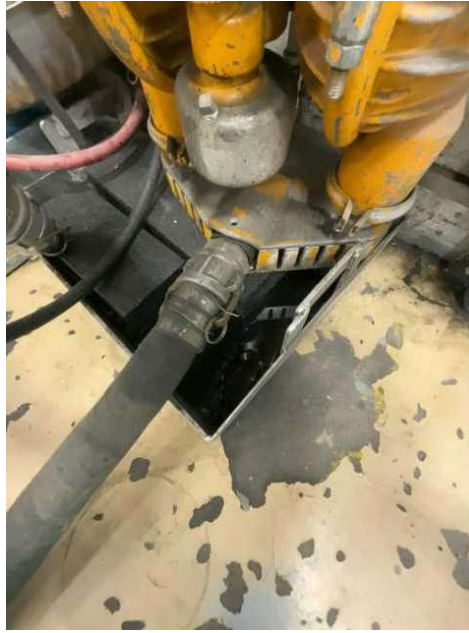
| Unlabeled Catch Pan Containing Used Oil | | | IMG-20240806115523552380039.jpg |

| Pan not labeled with the words "used oil". | | | |

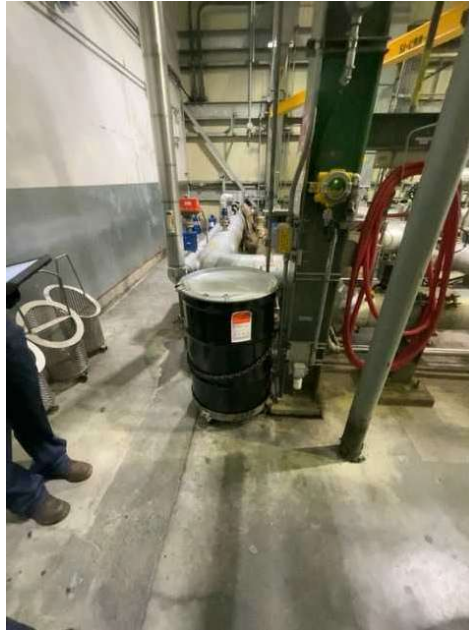
| Strainer Waste Label Missing Hazard Indicator | | | IMG-20240806131314131485224.jpg |

We observed a 55-gallon hazardous waste storage container of strainer waste that was not marked with a hazard indicator for toxicity. Dan Gilson marked the hazard indicator at the time of the inspection.

| 55-gallon hazardous waste storage container of strainer waste was not marked with a hazard indicator for toxicity. | | | |

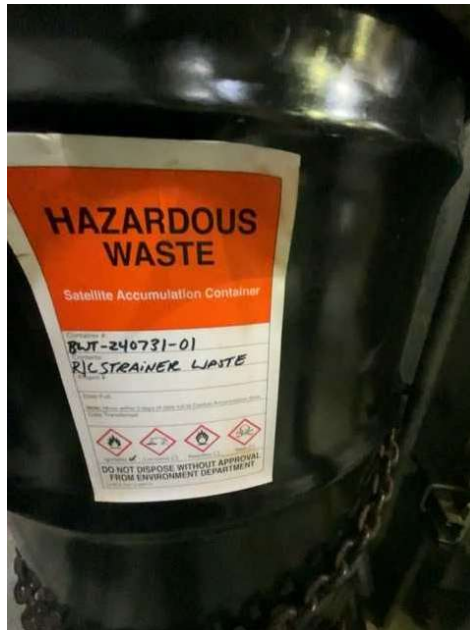
| Strainer Waste Label Missing Hazard Indicator | | | IMG-20240806131321132171008.jpg |

| 55-gallon hazardous waste storage container of strainer waste was not marked with a hazard indicator for toxicity. | | | |

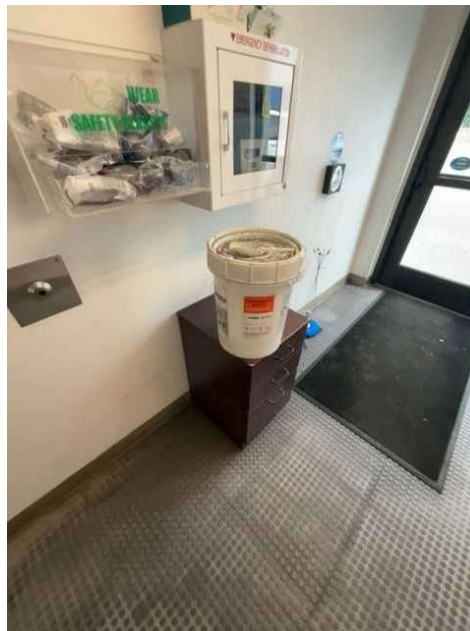
| Waste Leather Gloves Label Missing Hazard Indicator | | | IMG-20240806132829282971636.jpg |

Upon entering the laboratory building we observed a 5-gallon bucket of hazardous waste leather gloves. The bucket was labeled with the words "hazardous waste" but was missing a hazard indicator. Dan Gilson added the hazard indicator at the time of the inspection.

| 5-gallon hazardous waste storage container of leather gloves was not marked with a hazard indicator. | | | |

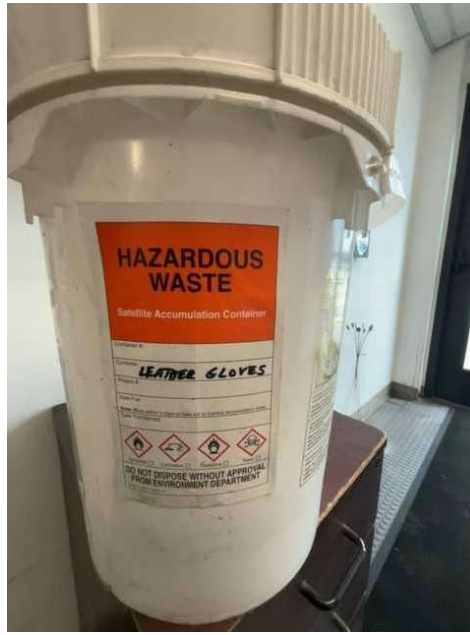
| Waste Leather Gloves Label Missing Hazard Indicator | | | IMG-20240806132837283761176.jpg |

| 5-gallon hazardous waste storage container of leather gloves was not marked with a hazard indicator. | | | |

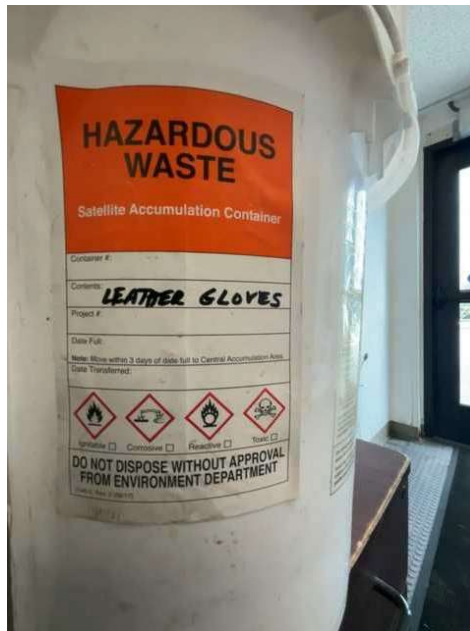
| Waste Leather Gloves Label Missing Hazard Indicator | | | IMG-20240806132853285363158.jpg |

| 5-gallon hazardous waste storage container of leather gloves was not marked with a hazard indicator. | | | |

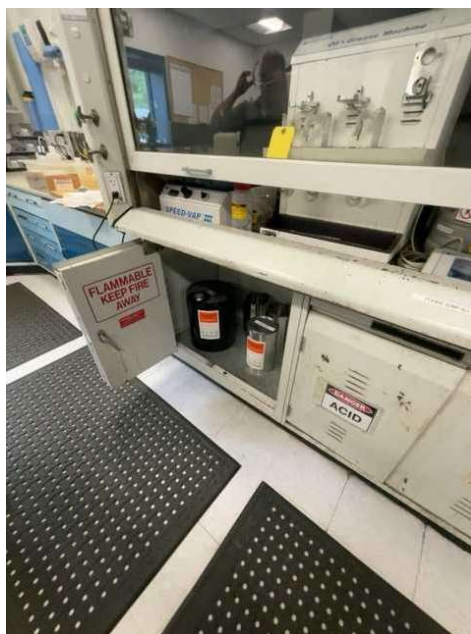
| BTEX and Waste Oil Labels Missing Hazard Indicators | | | IMG-2024080613350435498722.jpg |

In the lab we observed a 2-gallon container of "BTEX" waste that was labeled "hazardous waste" but was missing a hazard indicator. Additionally, we found a 5-gallon container of "oil and grease waste" that was labeled "hazardous waste" but was missing a hazard indicator. Dan Gilson added hazard indicators to both containers at the time of the inspection. Dan Gilson clarified that the waste oil here was a hazardous waste and was not a used oil.

| 2-gallon container of "BTEX" waste that was labeled "hazardous waste" but was missing a hazard indicator. 5-gallon container of "oil and grease waste" that was labeled "hazardous waste" but was missing a hazard indicator. | | | |

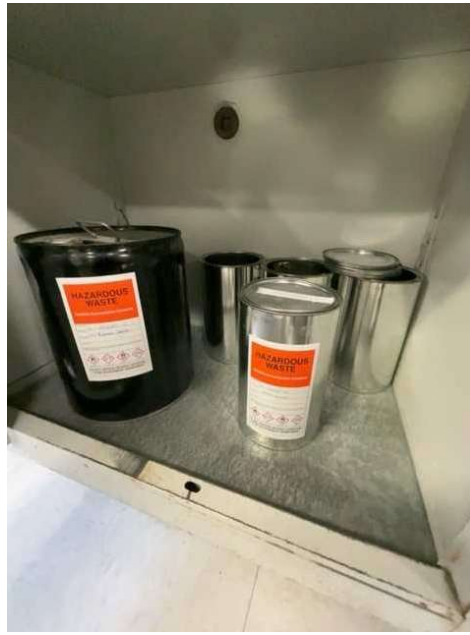
| BTEX and Waste Oil Labels Missing Hazard Indicators | | | IMG-2024080613350835860902.jpg |

| 2-gallon container of "BTEX" waste that was labeled "hazardous waste" but was missing a hazard indicator. 5-gallon container of "oil and grease waste" that was labeled "hazardous waste" but was missing a hazard indicator. | | | |

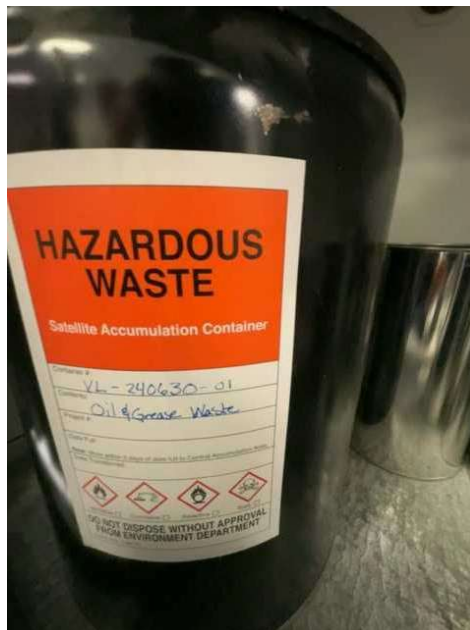
| Waste Oil and Grease Label Missing Hazard Indicator | | | IMG-20240806133513351364805.jpg |

| 5-gallon container of "oil and grease waste" that was labeled "hazardous waste" but was missing a hazard indicator. | | | |

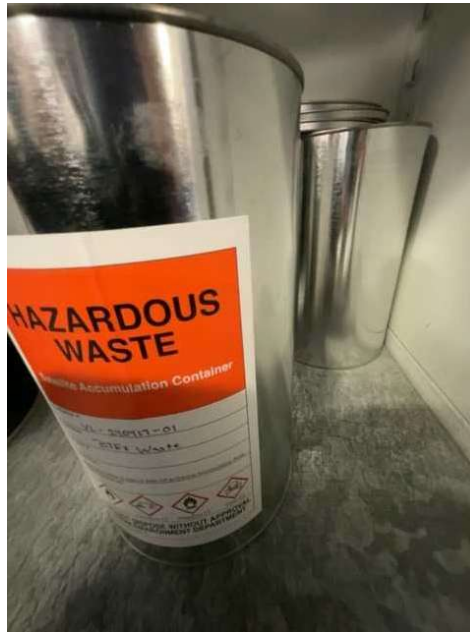
| BTEX Label Missing Hazard Indicator | | | IMG-20240806133519351963684.jpg |

| 2-gallon container of "BTEX" waste that was labeled "hazardous waste" but was missing a hazard indicator. | | | |

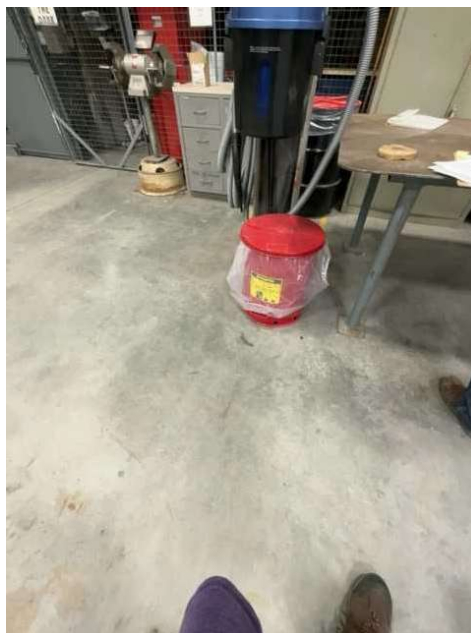
| Unlabeled 15-gal Container of Waste Aerosol Cans | | | IMG-20240806134023402373008.jpg |

When entering this part of the building we observed a 15-gallon container that held waste aerosol cans. The container was not labeled or marked clearly with any of the following phrases: "Universal Waste-Aerosol Can(s)," "Waste Aerosol Can(s)," or "Used Aerosol Can(s)." Dan Gilson added a "Universal Waste Aerosol Cans" label at the time of the inspection.

| Waste aerosol step-can in which the aerosol cans are contained was not labeled or marked clearly with any of the following phrases: "Universal Waste-Aerosol Can(s)," "Waste Aerosol Can(s)," or "Used Aerosol Can(s)." | | | |

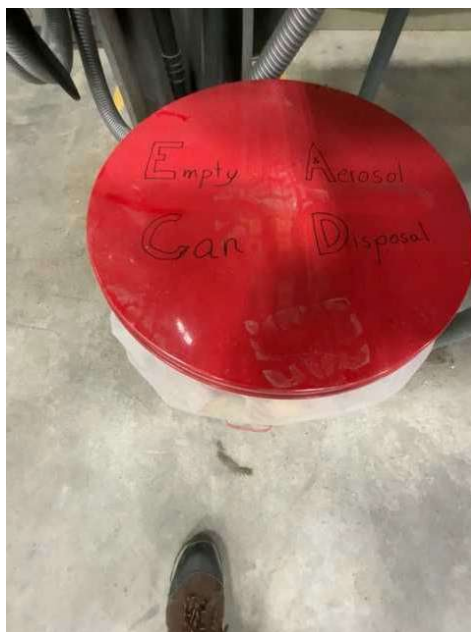
| Unlabeled 15-gal Container of Waste Aerosol Cans | | | IMG-20240806134028402863672.jpg |

| Top-down view of waste aerosol step-can in which the aerosol cans are contained was not labeled or marked clearly with any of the following phrases: "Universal Waste-Aerosol Can(s)," "Waste Aerosol Can(s)," or "Used Aerosol Can(s)." | | | |

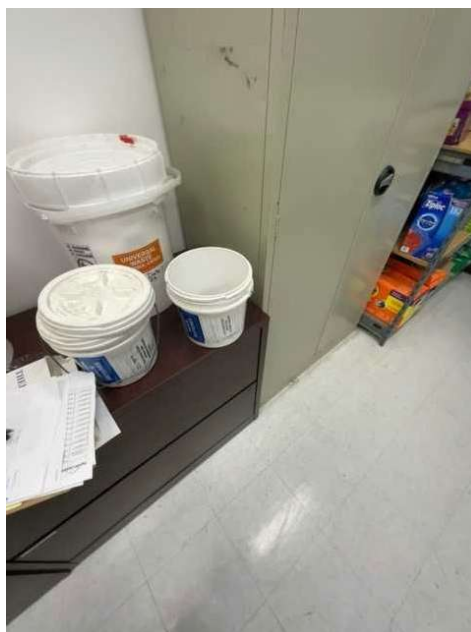
| UW Battery container > One Year Accumulation | | | IMG-20240806135141514154868.jpg |

Additionally, in the "fire team area", an upstairs office, we observed a small bucket that contained two Nickle-Cadmium (NiCad) batteries labeled "universal waste" and had been in accumulation for greater than one year from the date the universal waste was generated of 7/23/23. Dan Gilson removed the batteries at the time of the inspection to be taken to the CAA where they would be picked up by their universal waste contractor.

| A small container that held two universal waste NiCad batteries has been in accumulation for greater than one year from the date the universal waste was generated on 7/23/23. | | | |

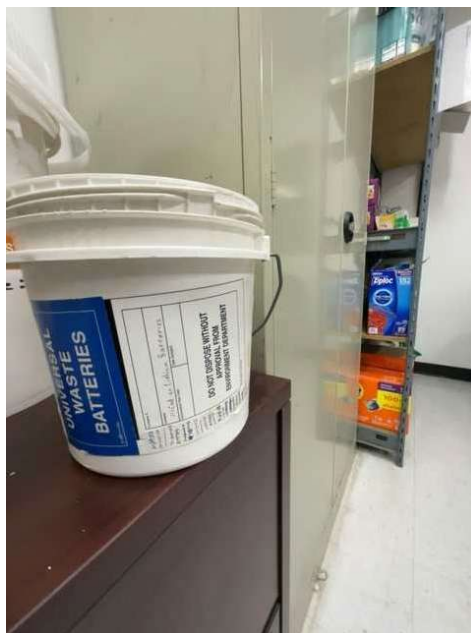
| UW Battery container > One Year Accumulation | | | IMG-20240806135150515060802.jpg |

| Close-up view of container that held two universal waste NiCad batteries has been in accumulation for greater than one year from the date the universal waste was generated on 7/23/23. | | | |

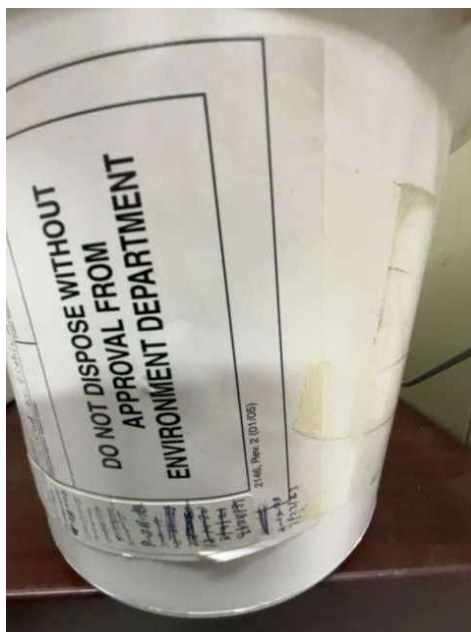
| UW Battery container > One Year Accumulation | | | IMG-2024080613520052052010.jpg |

| A small container that held two universal waste NiCad batteries has been in accumulation for greater than one year from the date the universal waste was generated on 7/23/23. | | | |
