**Region 6 - Enforcement & Compliance Assurance Division**  
**INSPECTION REPORT**

| Inspection Date(s): | 11/08/2024 | |
| Company Name: | <b>SMI Operating Company, LLC</b> | |
| Facility Name: | <b>Walker-Gregory #3 &amp; #4 Tank Battery</b> | |

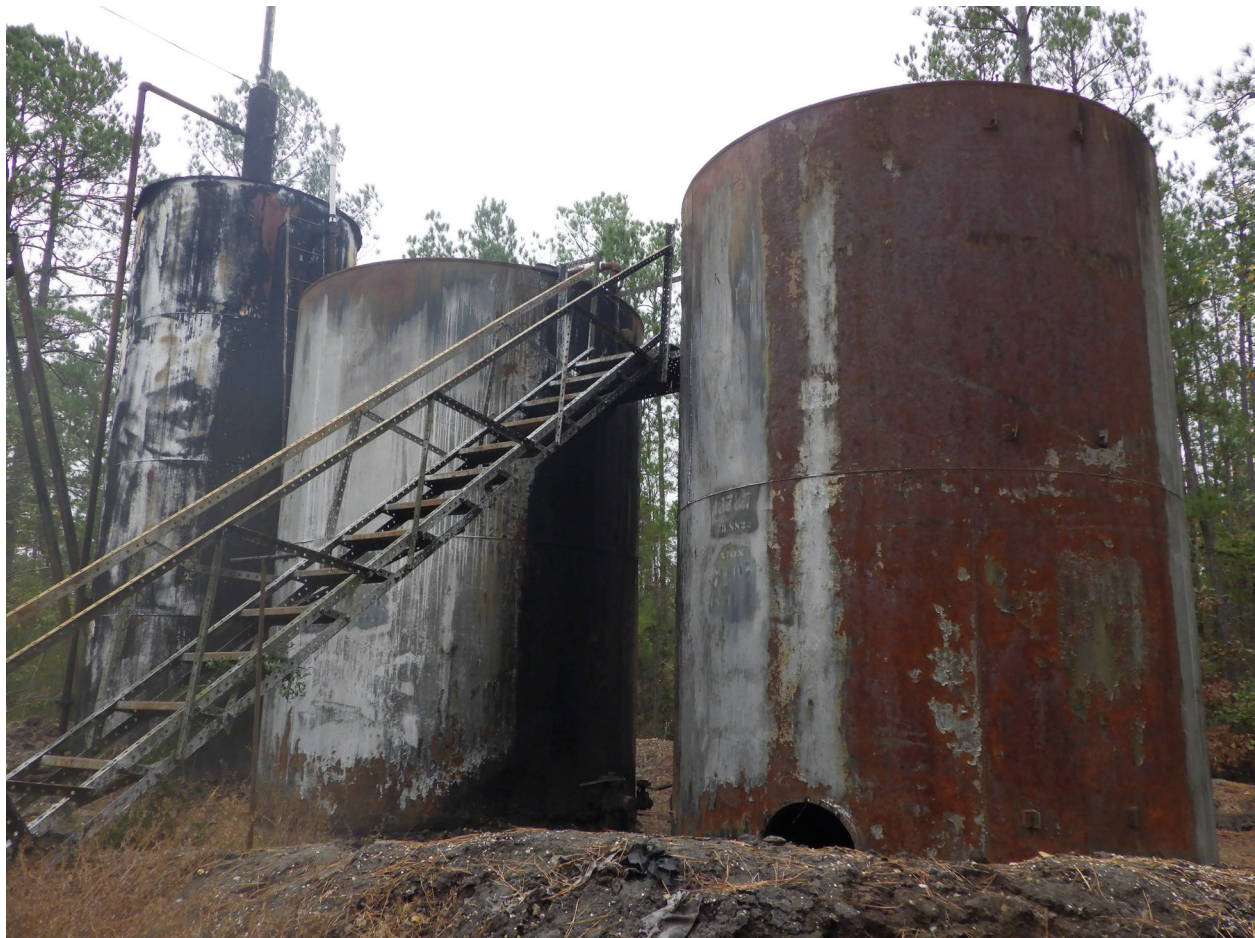
Photo No. 1

I observed the SMI Operating Company, LLC / Walker-Gregory #3 & #4 Tank Battery facility and associated secondary containment and storage tanks; see Appendix 1 (Photograph Log), Photo No. 1. For additional GPS location and photo metadata, see Appendix 1.

**Description:** Looking ENE, this photo shows two (2) crude oil storage tanks and one (1) separator/gun barrel inside secondary containment.

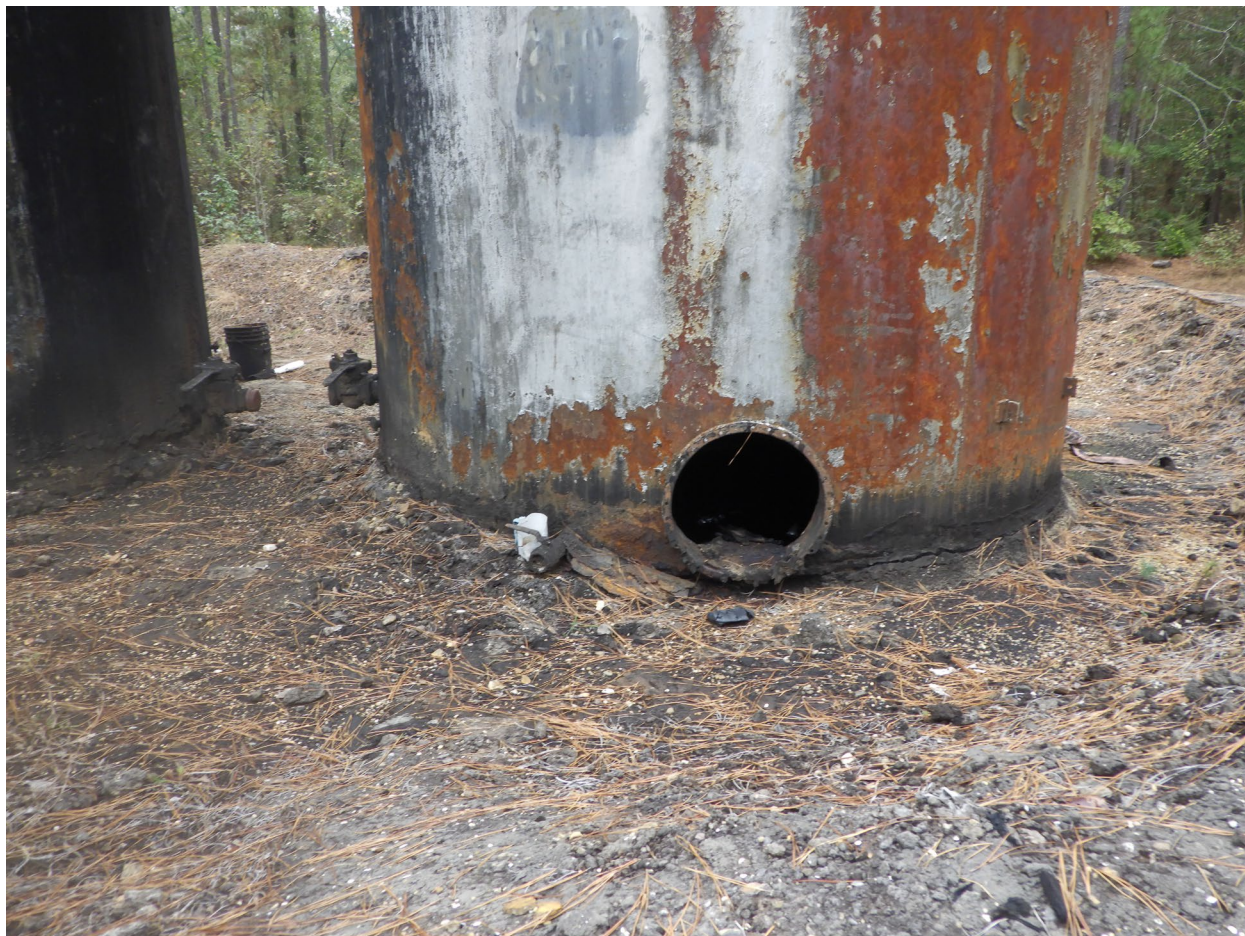
Photo No. 2

I observed one tank with an open hatch, see Photo No. 2.

**Description:** Looking ENE, this photo shows a crude oil storage tank with an open hatch.

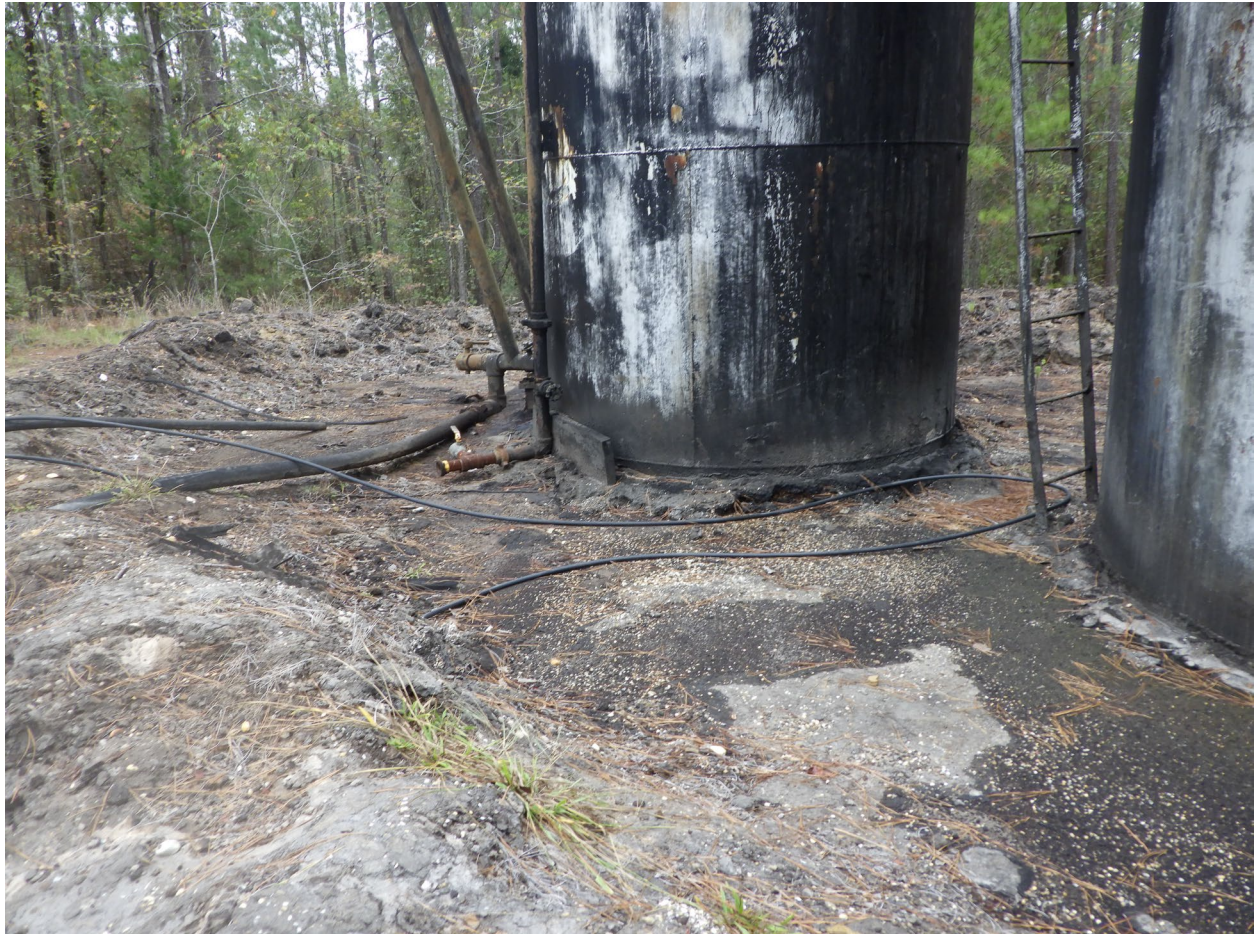
I observed loose oil inside secondary containment, see Photo No. 3 through No. 5.

**Description:** Looking NNE, this photo shows loose oil inside secondary containment and a crude oil storage tank with an unstable bottom.

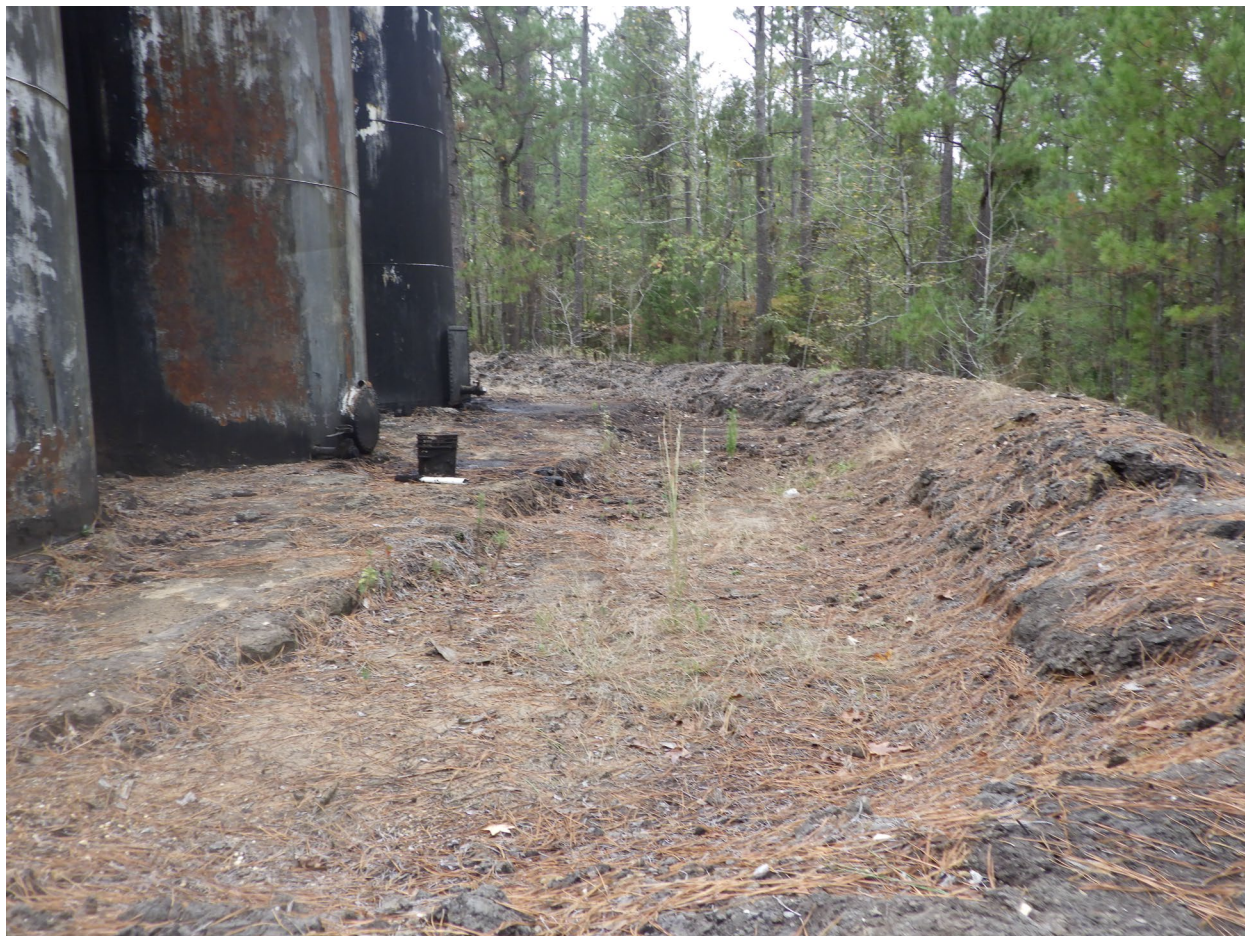
Photo No. 4

**Description:** Looking N, this photo shows the backside of the tank battery with loose oil inside containment and solidified oil on the berm of the secondary containment.

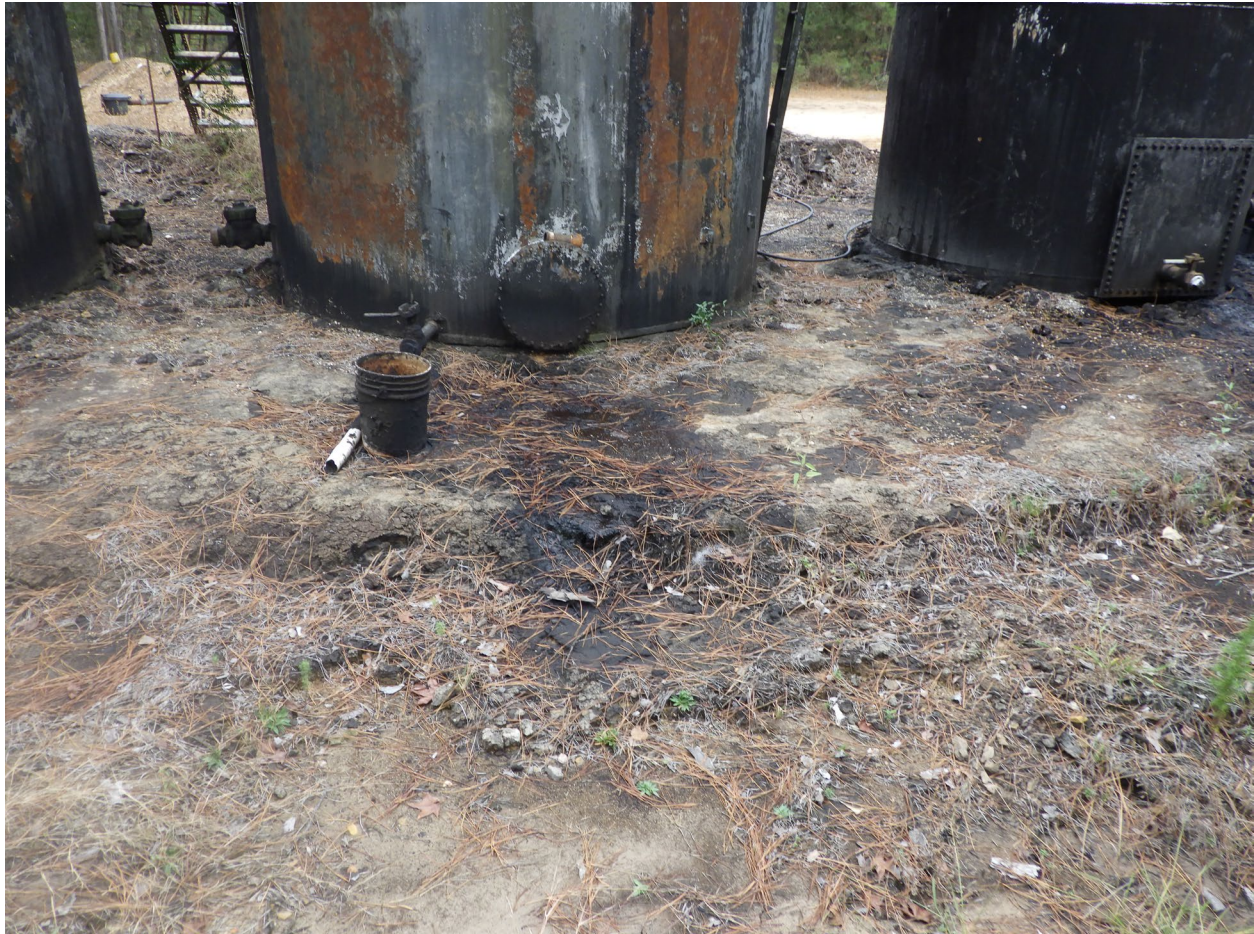
Photo No. 5

**Description:** Looking NW, this photo shows loose oil inside secondary containment.

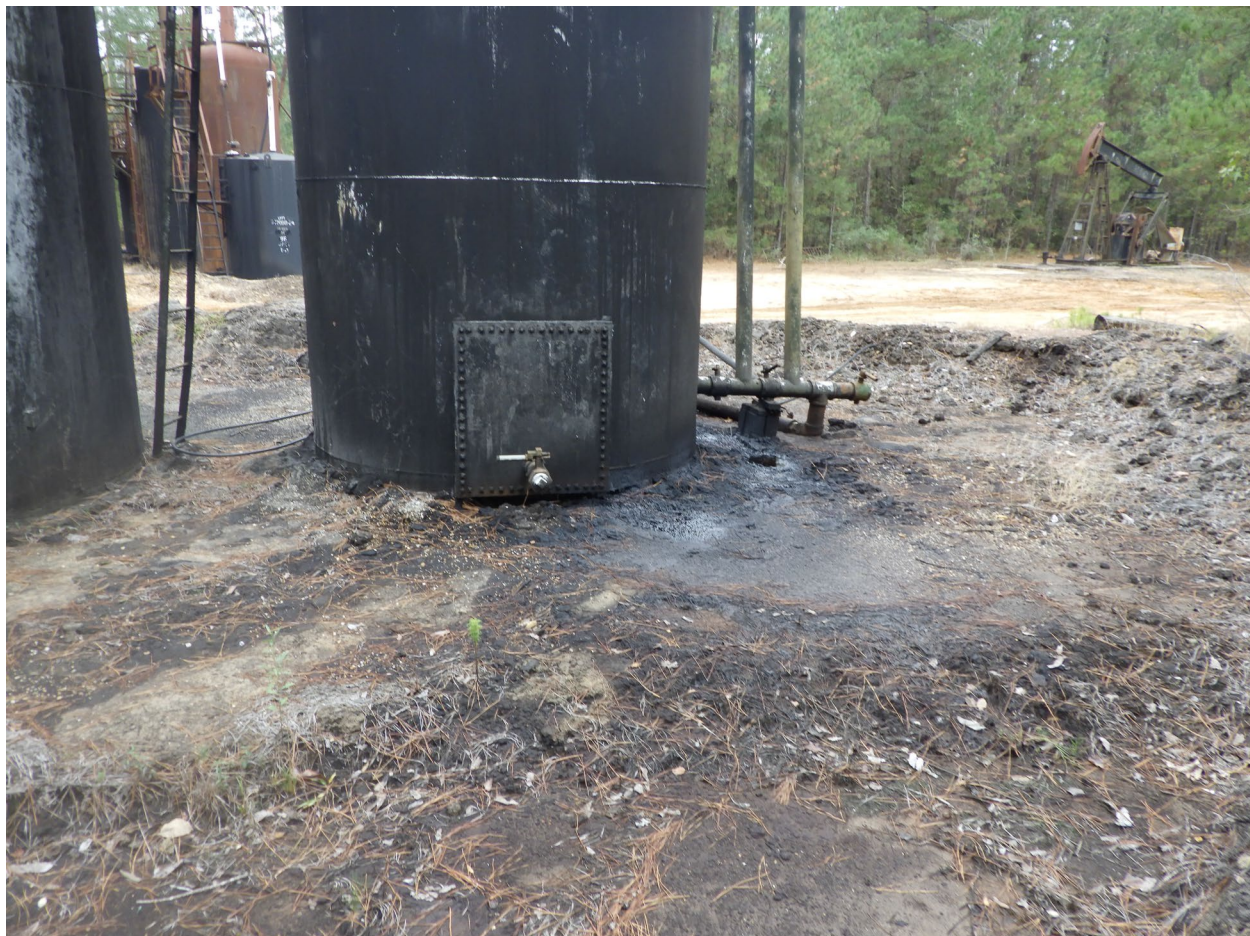
Photo No. 6

I observed an active leak of crude oil at one of the tanks inside secondary containment, see Photo No. 6.

**Description:** Looking WNW, this photo shows an active leak from the separator/gun barrel inside secondary containment.

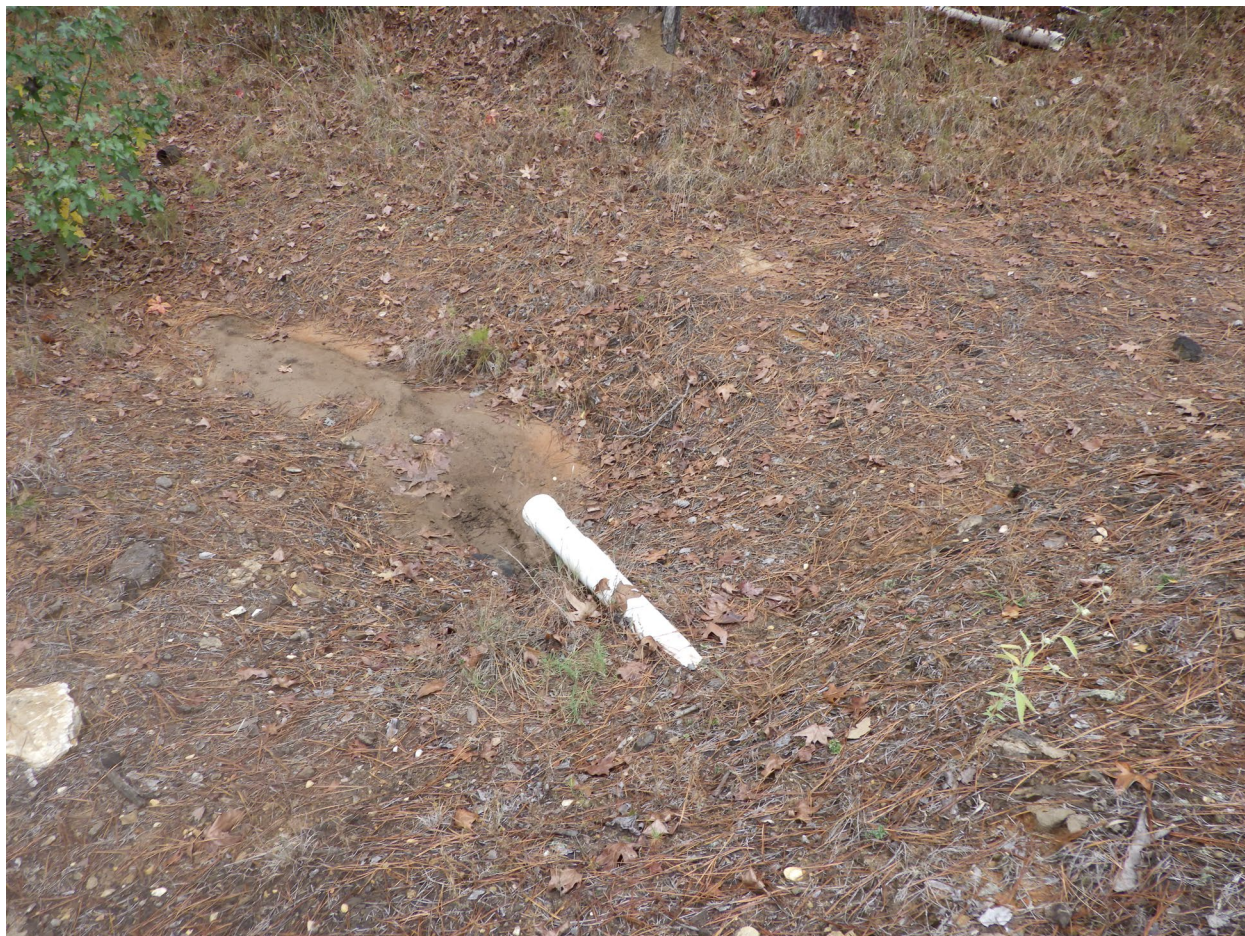
I observed the drainpipe for the secondary containment that was open without a cap, see Photo No. 7 through No. 9.

**Description:** Looking ENE, this photo shows the drainpipe for secondary containment with flow indicators noted.

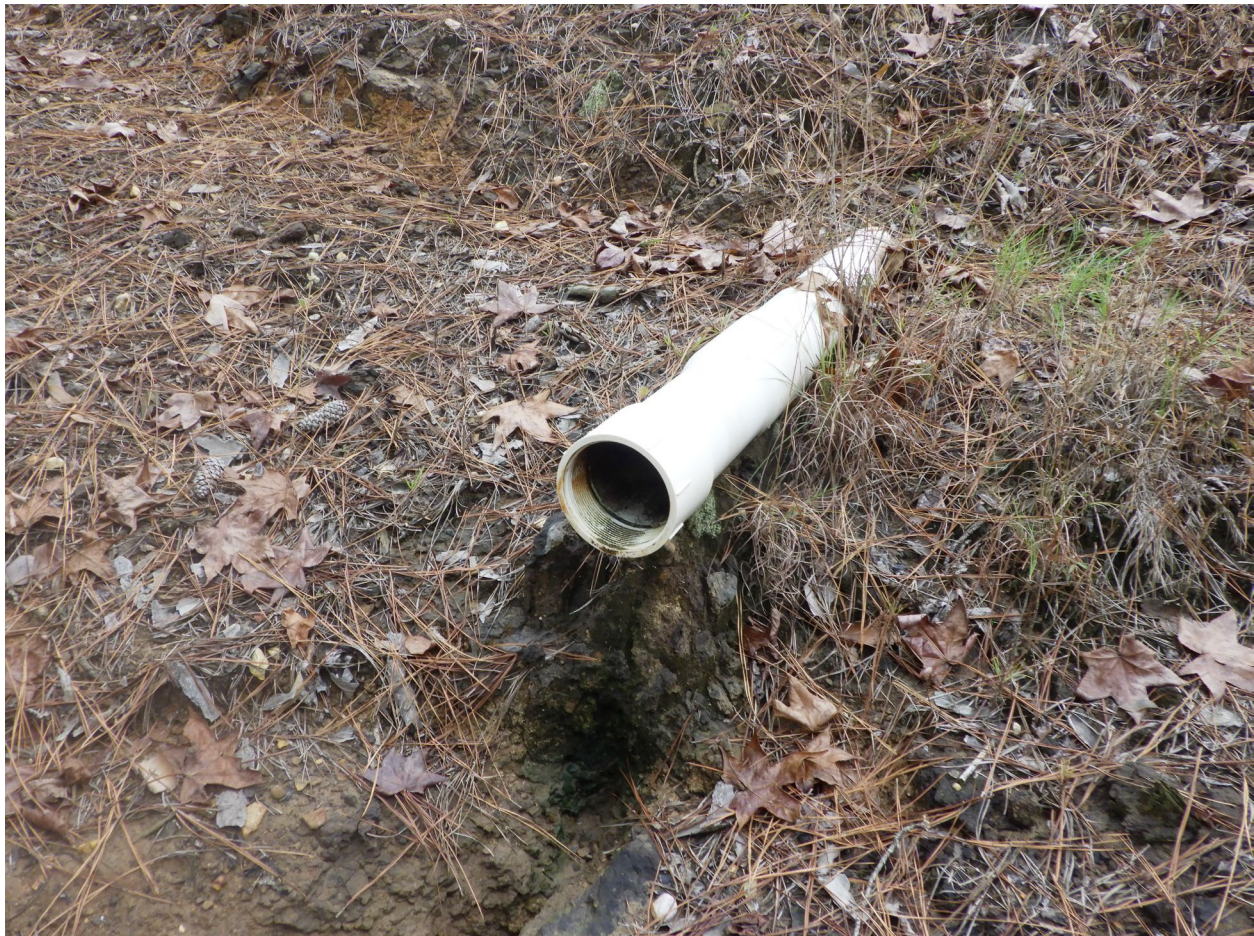
Photo No. 8

**Description:** Looking SE, this photo shows a closeup of the drainpipe for secondary containment with no cap.

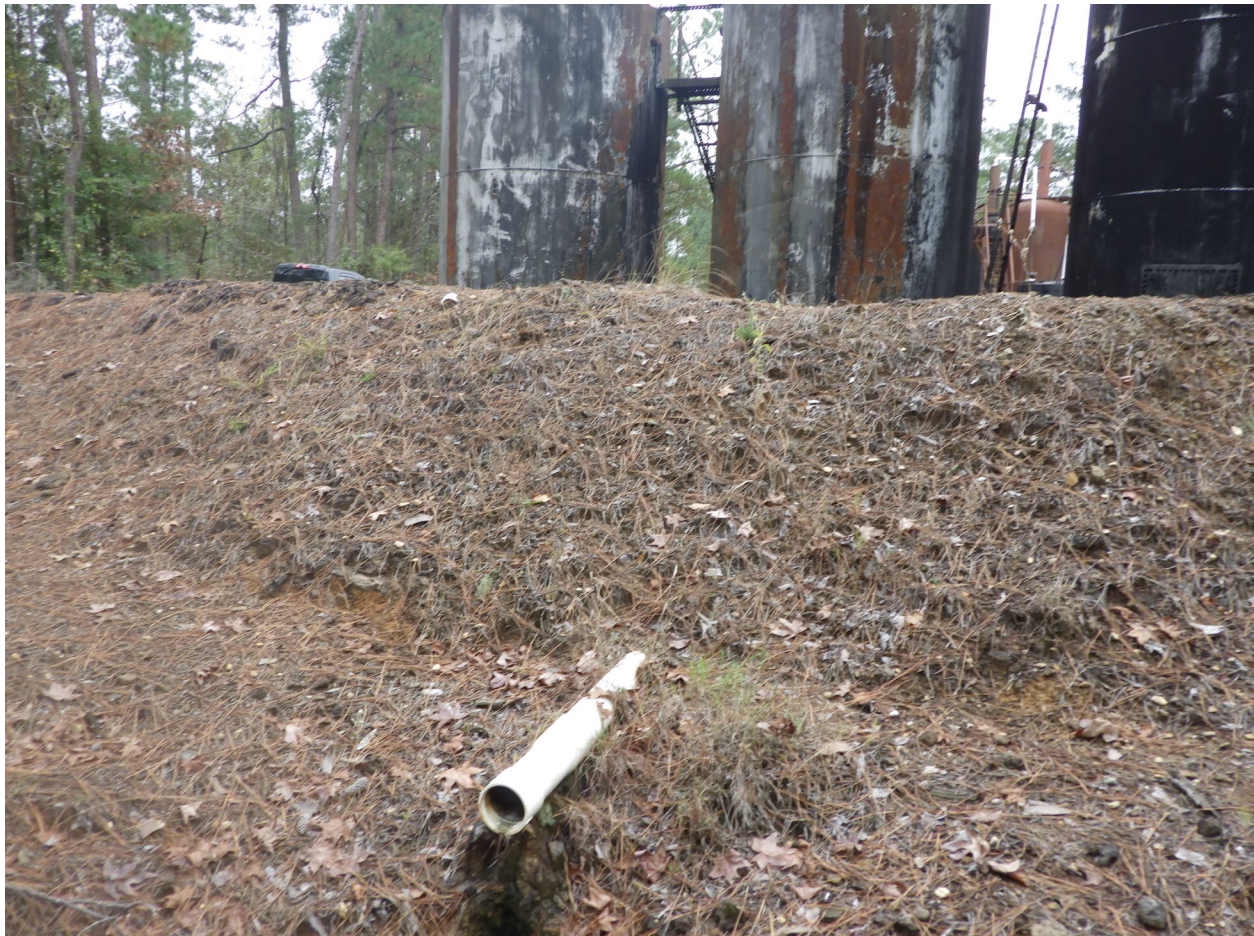
Photo No. 9

**Description:** Looking SSE, this photo shows an additional view of the open drainpipe for the secondary containment.
