# ESSO CHEMICAL CANADA

Re: Survey Results -  
Corrosion in Recovery System

SUBJECT: CORROSION IN RECOVERY SYSTEM

CORROSION IN RECOVERY SYSTEM

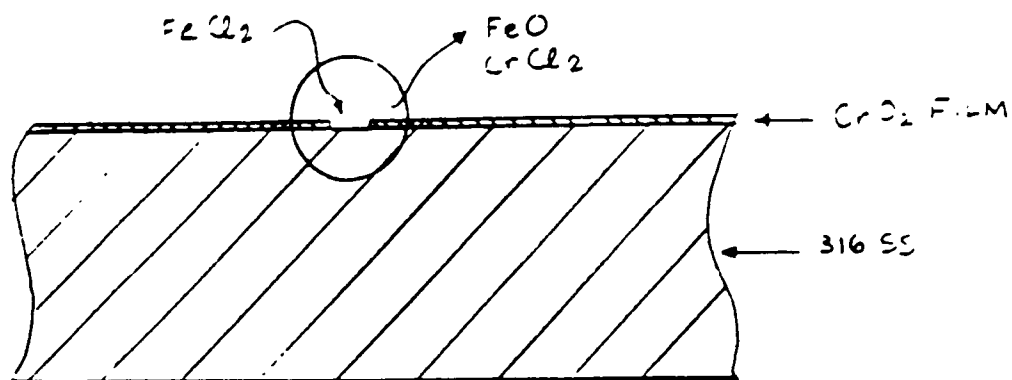
FIG. 1: BREAKDOWN OF OXIDE FILM

- CORROSION PROTECTION FOR SS DRUMS PROVIDED BY OXIDE LAYER.
- IRON CHLORIDES CHEMICALLY "BREAKDOWN" THE OXIDE FILM.
- STAGNATION PREVENTS RE-PASSIVATION.
- HYDROCHLORIC ACID ATTACKS THE UNPROTECTED SITE.
- A PIT DEVELOPS.
- PROPAGATION ASSISTED BY THE ELECTROCHEMICAL EFFECT.
- FACTORS THAT ACCELERATE PROCESS:
  - (1) ACIDITY
  - (2) TEMPERATURE

- SHORT-TERM: ● PURCHASED GL VESSEL TO REPLACE MAIN SS DRUM.  
● ONE DRUM OPERATION TO PREVENT STAGNATION.

- LONG-TERM: ● CONSIDERING WAYS OF CONTROLLING OR ELIMINATING FACTORS.
