**NPDES Compliance Evaluation Inspection  
Industrial Facility**

**CAROLINA MUNICIPAL SOLID WASTE LANDFILL**

**NPDES ID: PRR053155**

**Inspection Date: July 16, 2024**

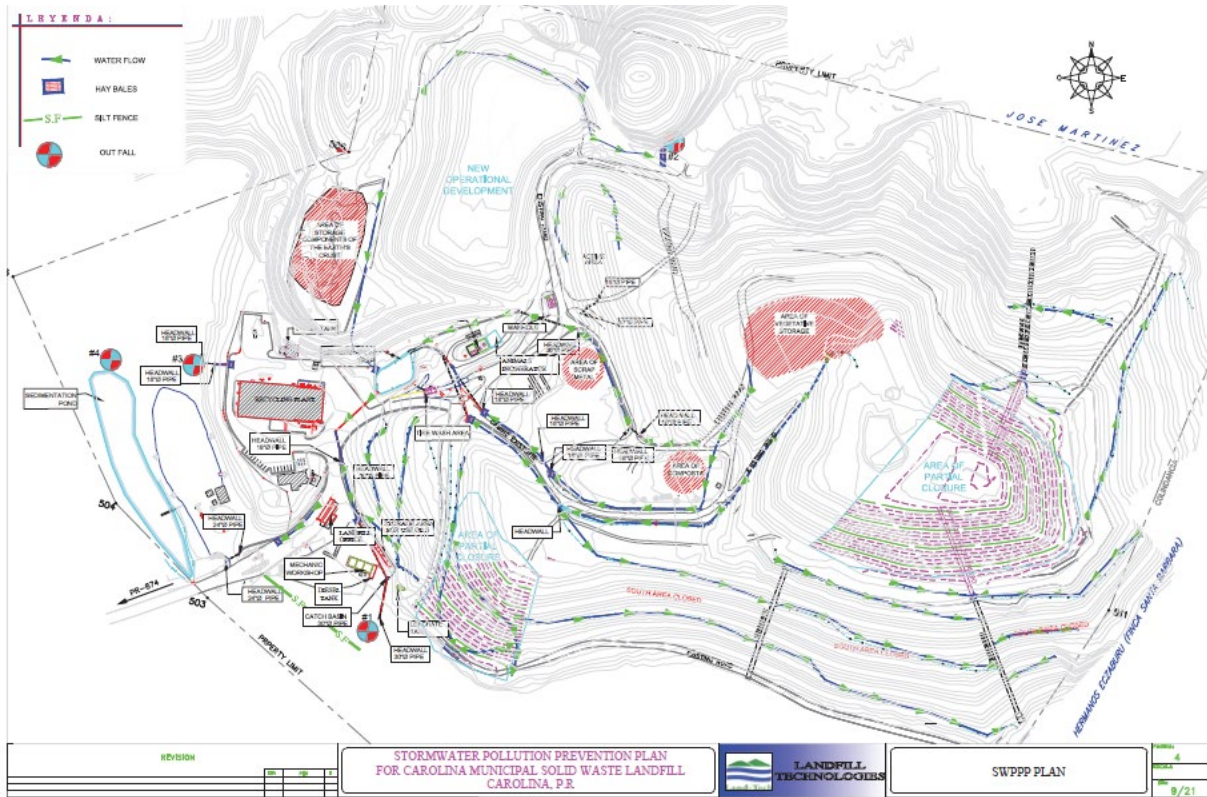
**Figure 1** (next page) depicts a Site Map found in the Stormwater Pollution Prevention Plan (“SWPPP”) developed for Site, including the stormwater sampling points.

- a tributary flowline of the Caño Martín Peña and the River. Refer to Pictures 9-12, 15, in Attachment 1.
- d. Four discharge points at the Site, as described in Part 4 (*Description of the Stormwater Collection, Conveyance and Discharge System*) of this Inspection Report. Inspector López was informed that Outfall 002 will be relocated to an area opposite of the actual location. Refer to Picture 23 and Figure 1, above.

- j. Established vegetative cover at the closed cells on the south and southeast slopes of the Landfill. Refer to Figure 1 above.
  - k. A leachate seepage stain located at the north bottom slope face of the Landfill. No leachate flows reaching the stormwater drainage ditch were observed. Refer to Picture 19 in Attachment 1.
