**Region 6 - Enforcement & Compliance Assurance Division**  
**INSPECTION REPORT**

| Regulatory Program: | Water (CWA) Brine Program (Oil & Gas Inspection) | |
| Company Name: | Enerco Operating Corporation | |
| Facility Name: | Fouke D-3 SWD System; Goldman A, Goldman-Mariman, Hunter Collins Leases | |

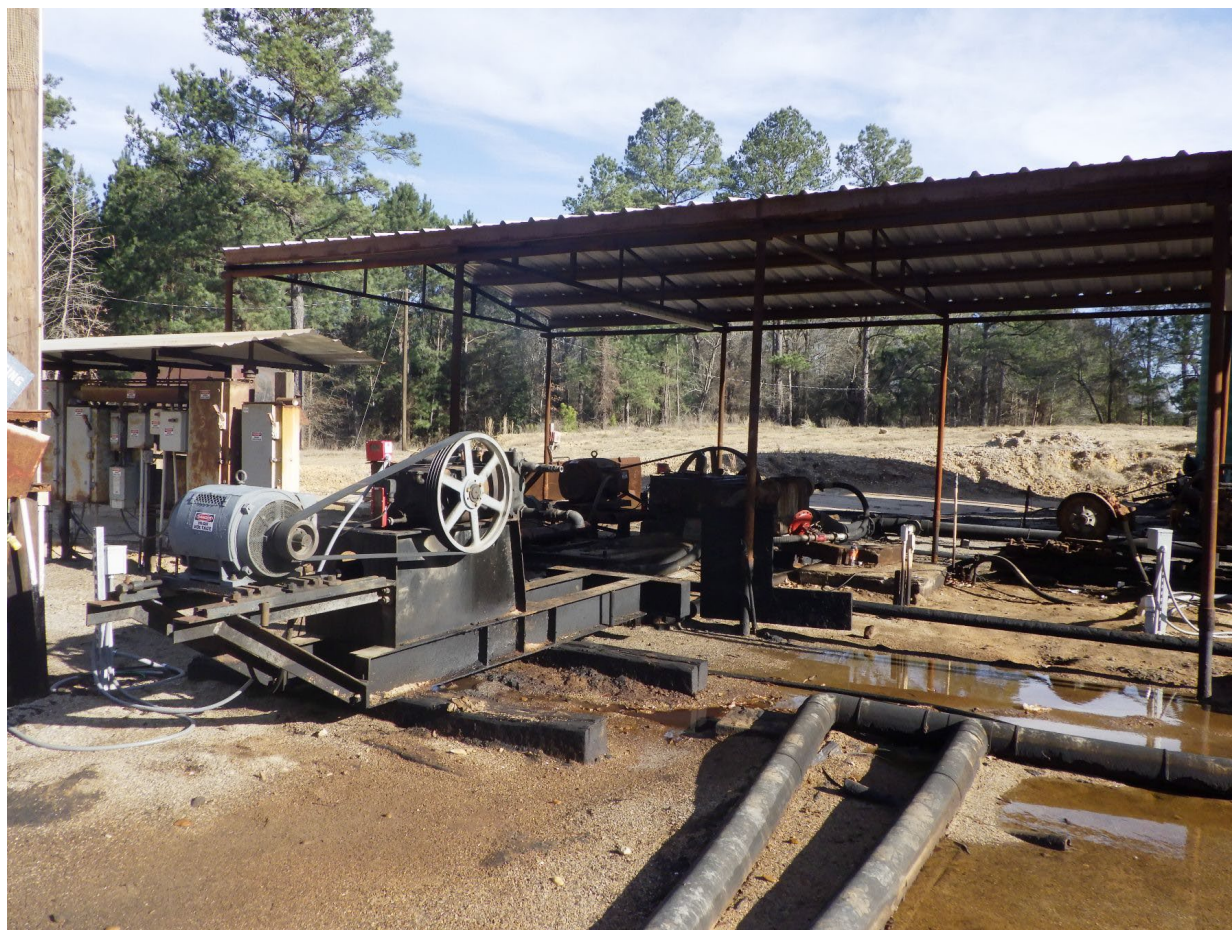
I observed two (2) injection pumps leaking crude oil at the Fouke D-3 SWD System, see Photo No. 3 through Photo No. 6. Loose oil surrounded the pumps.

| Description: | This photo was taken facing south-southwest and shows one leaking injection pump at the Fouke D-3 SWD System. | | |

On January 17, 2026, Mr. Collum submitted documentation demonstrating that Enerco Operating Corporation completed repairs on the injection pumps to stop the leaks and removed the loose oil surrounding the pumps.

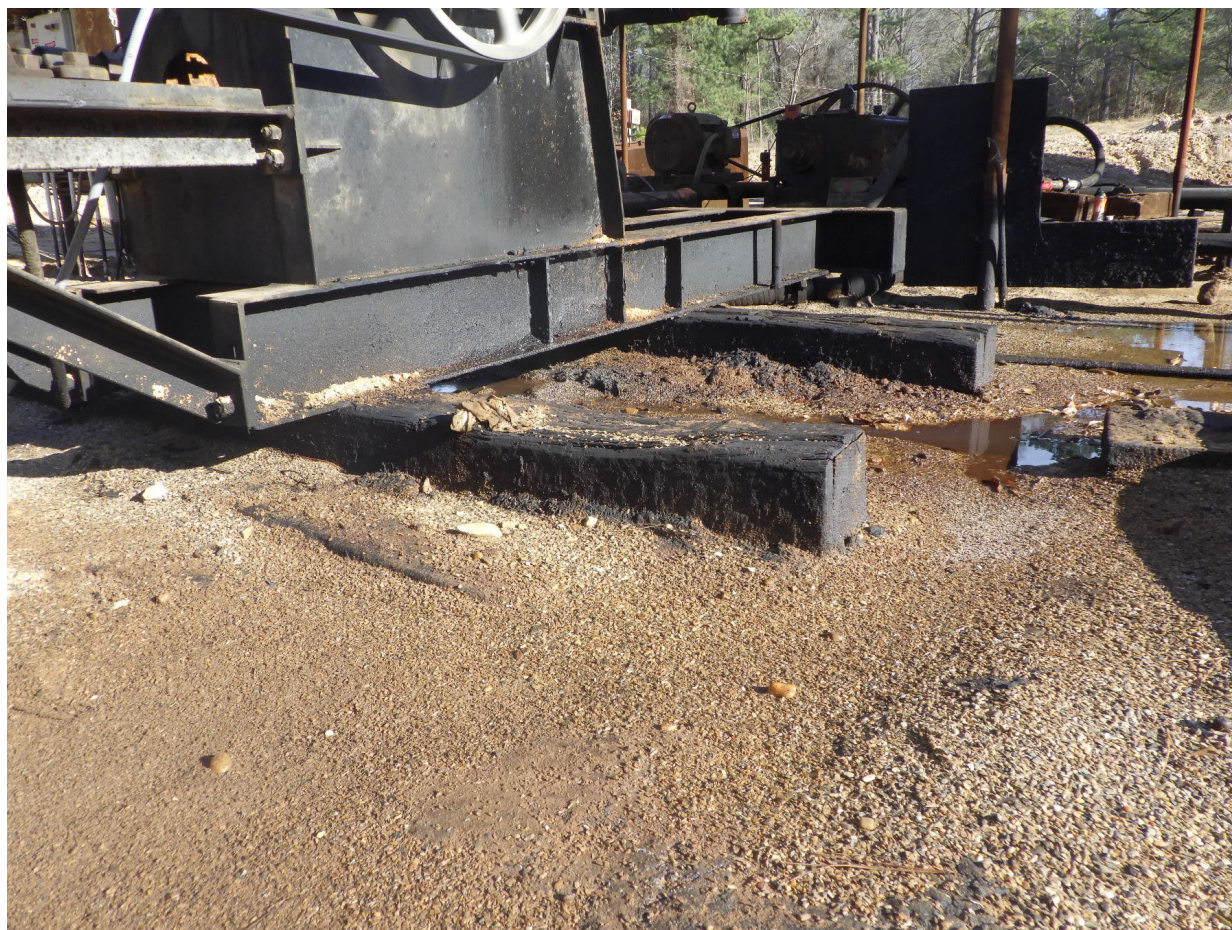
Photo No. 4

| Description: | This photo was taken facing south-southwest and shows loose oil from the leaking injection pump in Photo No. 3. | | |

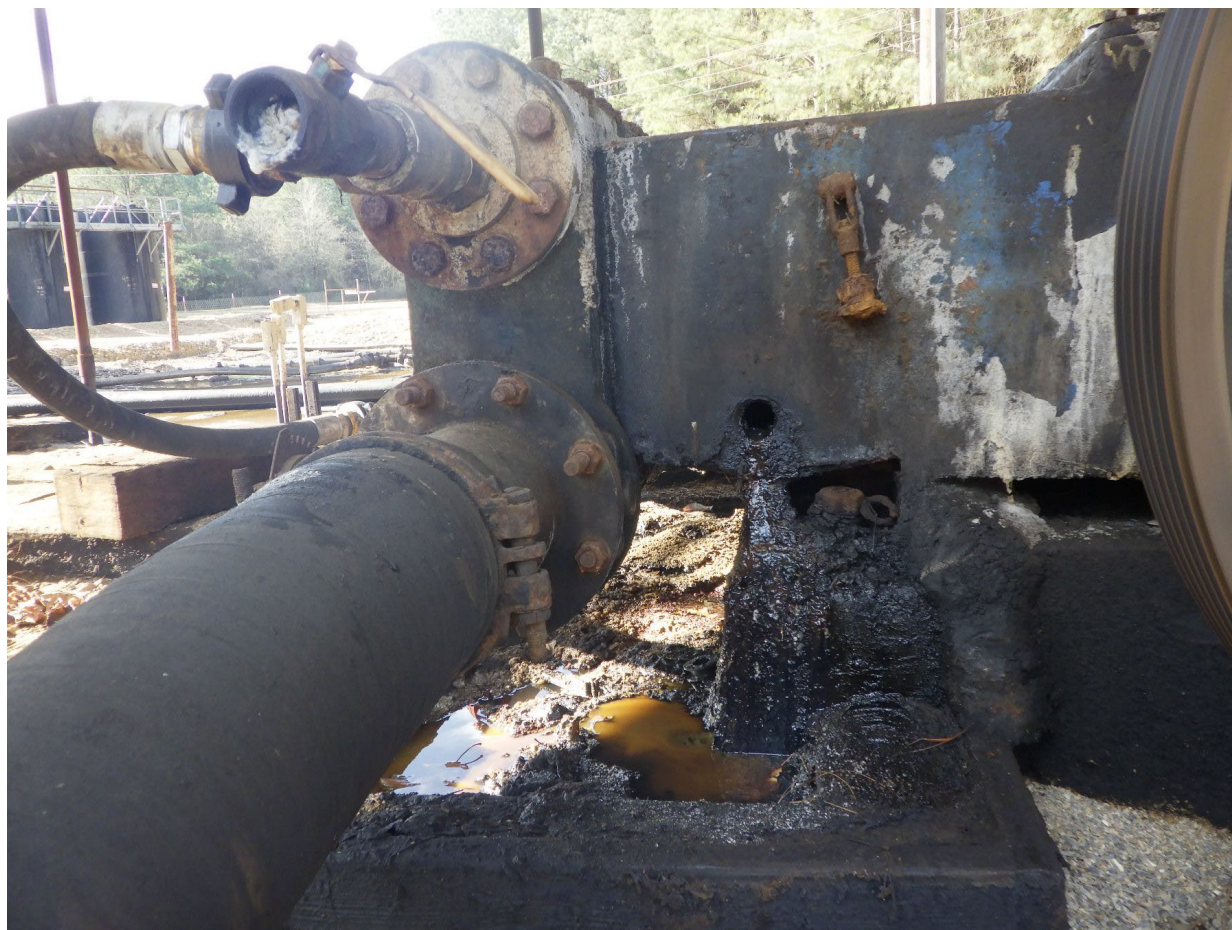
Photo No. 5

| Description: | This photo was taken facing south-southwest and shows a second leaking injection pump with loose crude oil and salt at the Fouke D-3 SWD System. | | |

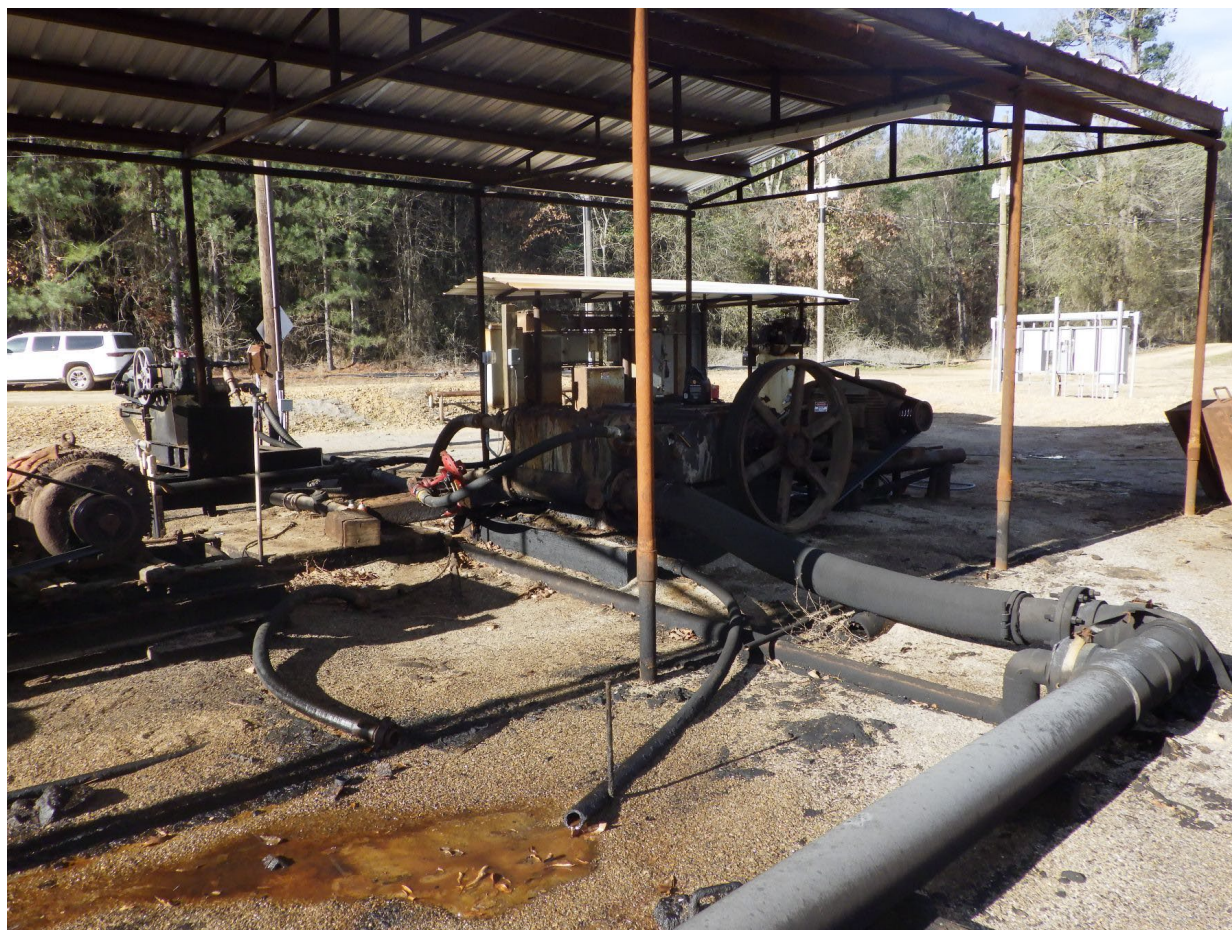
Photo No. 6

| Description: | This photo was taken facing southwest and shows the second leaking injection pump at the facility. | | |
