**Region 6 - Enforcement & Compliance Assurance Division**  
**INSPECTION REPORT**

| Inspection Date(s): | 1/28/2025 | |
| Company Name: | <b>Cornerstone Energy, LLC</b> | |
| Facility Name: | <b>Careyville Landing Tank Battery</b> | |

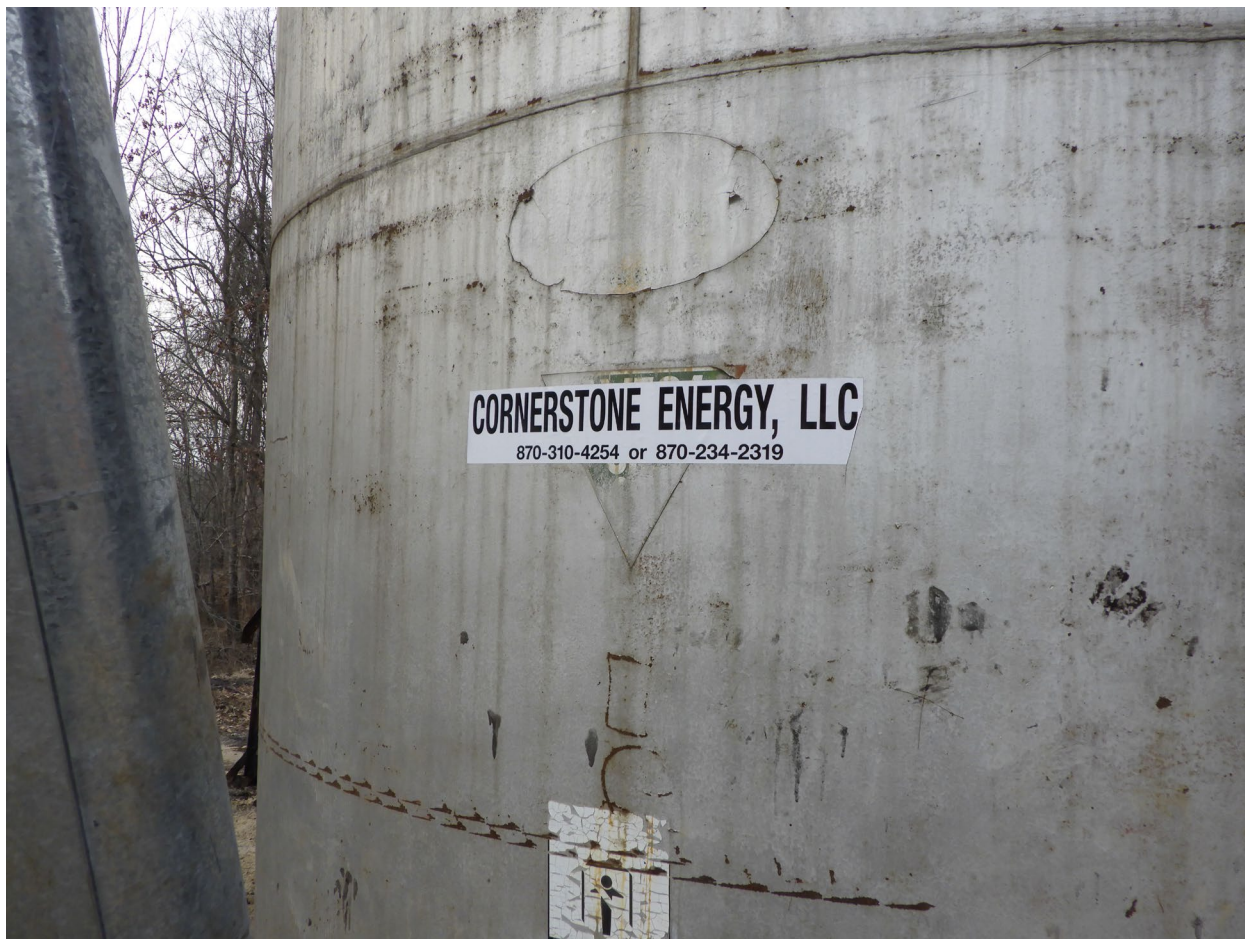
Photo No. 1

**Description:** This photo was taken looking north and shows the facility sign.

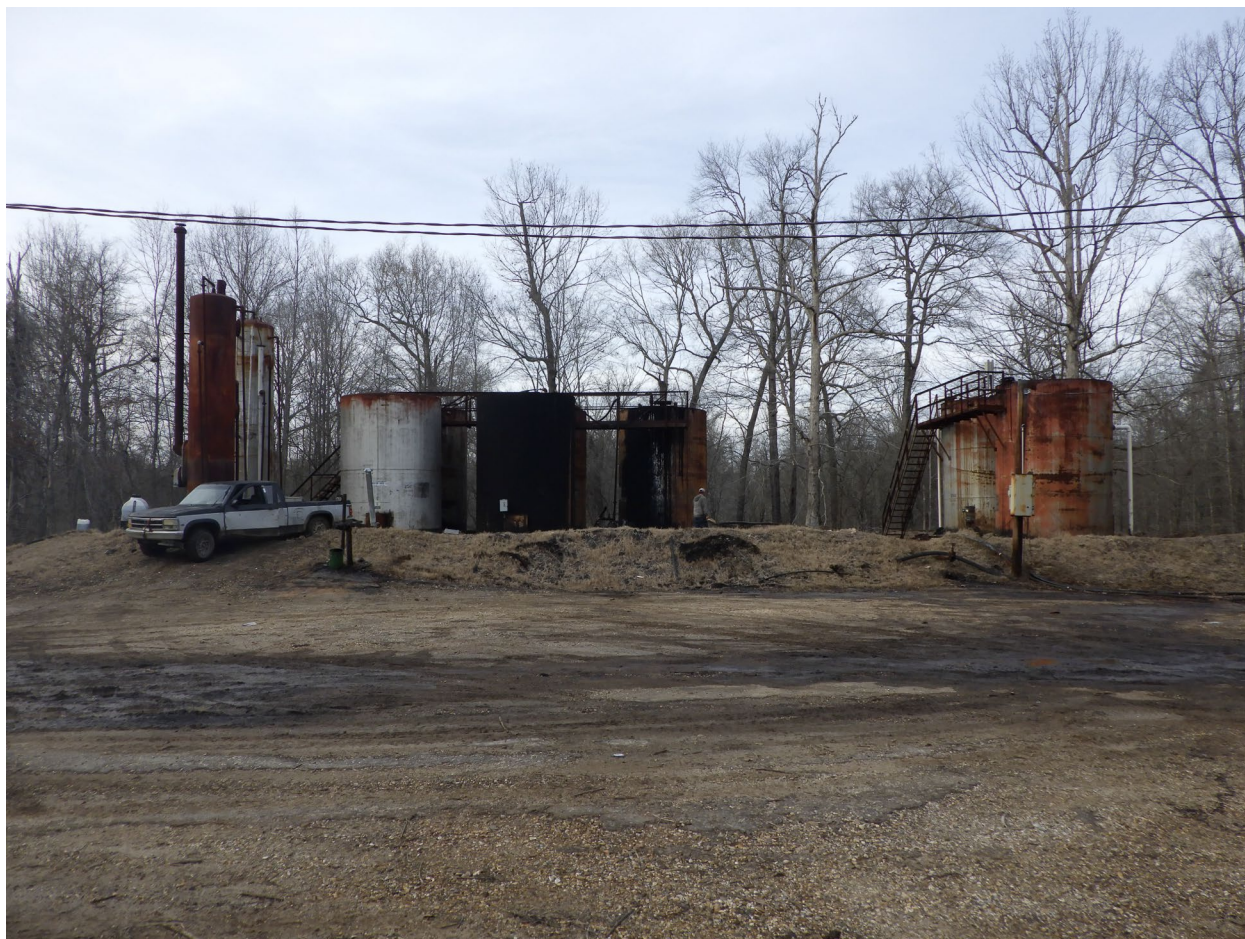
Photo No. 2

**Description:** This photo was taken looking north and shows an overview of the facility.

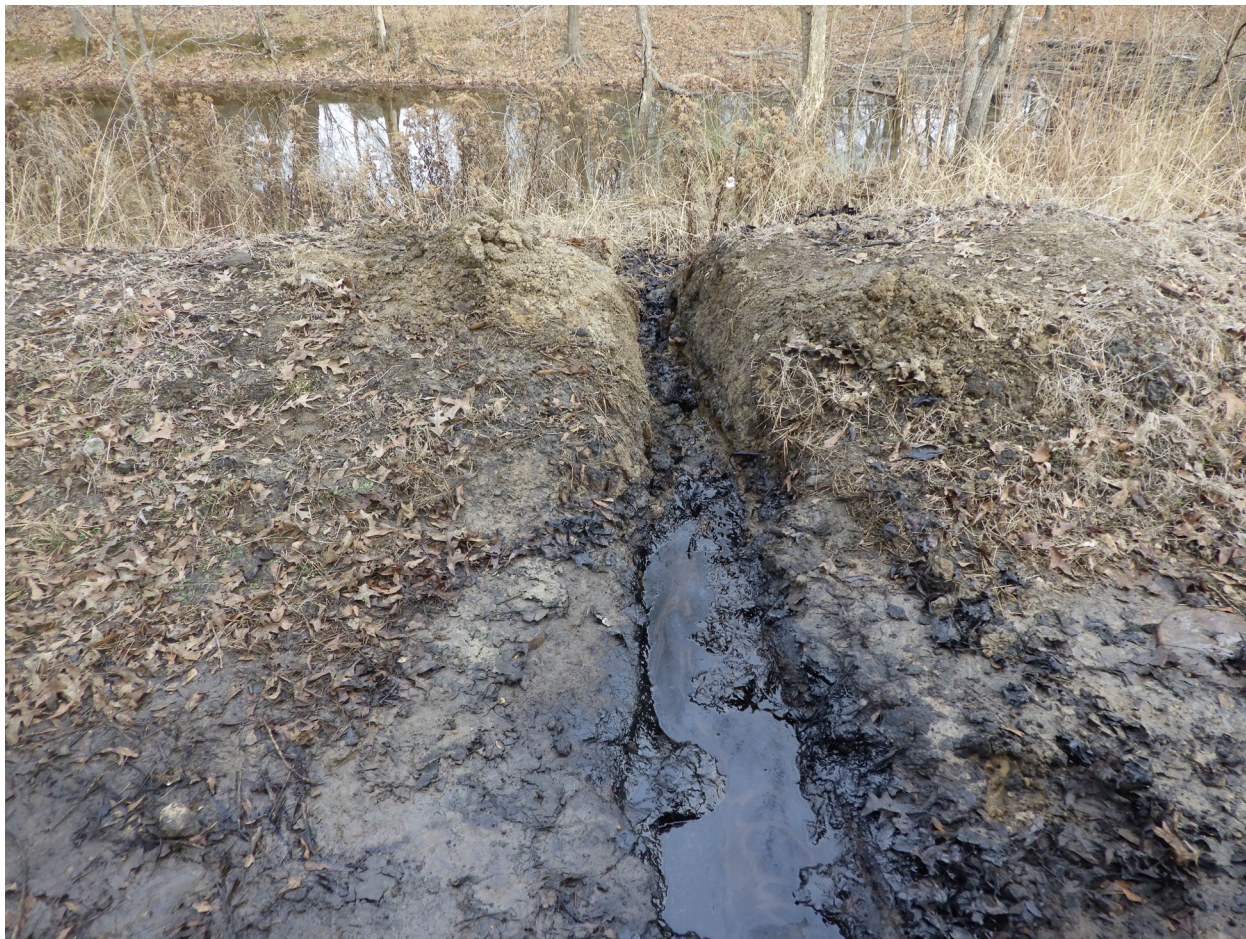
Photo No. 3

I observed a cut into the secondary containment berm allowing crude oil and produced water to release outside of containment, see photo No. 3.

No closing conference was held due to no Cornerstone Energy, LLC staff being present during the inspection. Areas of concern at the time of the inspection include the cut in the secondary containment berm, loose crude oil outside of secondary containment, and produced water outside of secondary containment.

**Description:** This photo was taken looking east and shows a cut in the berm releasing crude oil and produced water outside of secondary containment.

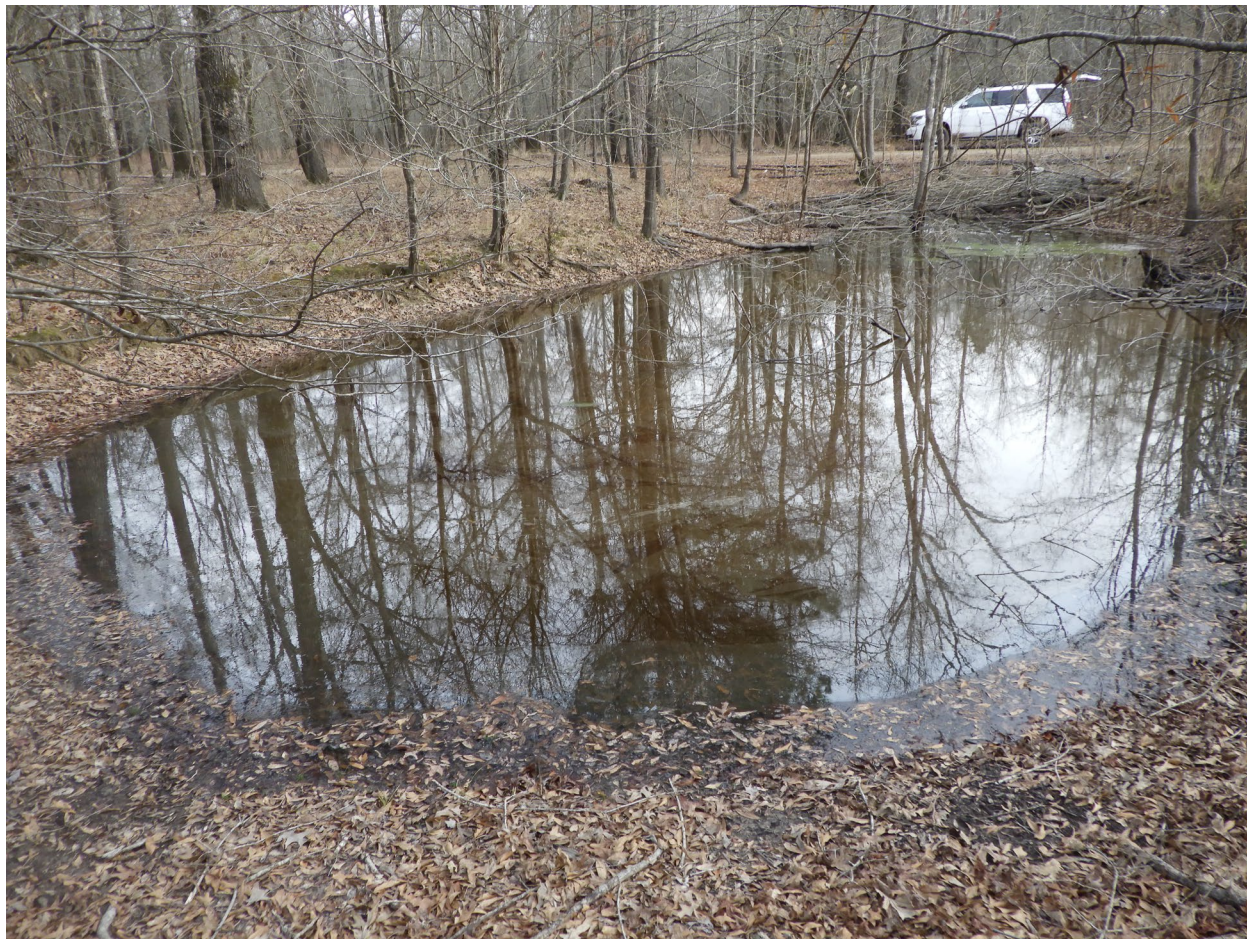
Photo No. 4

I observed the pool of water impacted by the crude oil and produced water outside of containment, see photo No. 4.

**Description:** This photo was taken looking southeast and shows the pool of water containing loose oil and produced water near the cut in the berm.

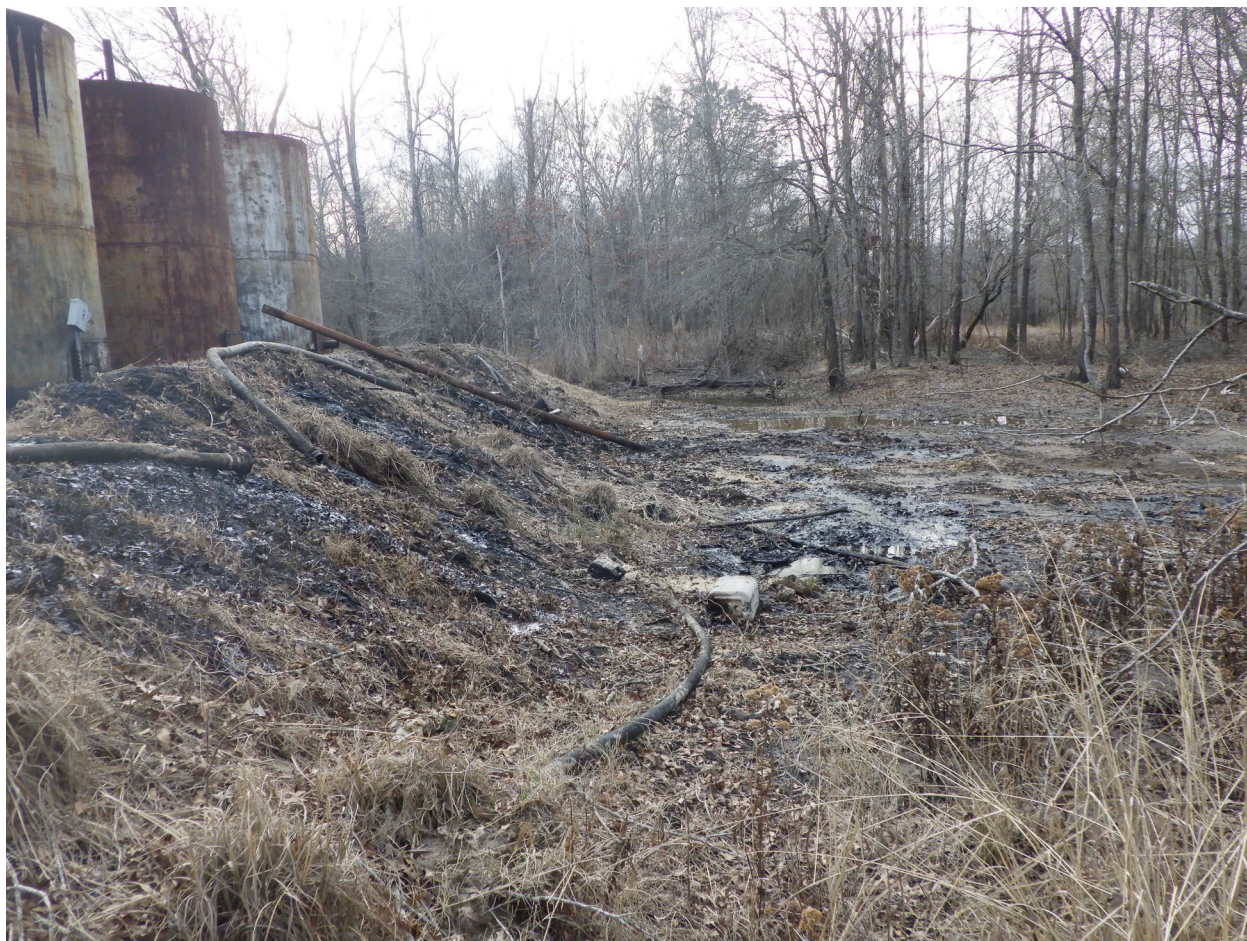
Photo No. 5

I observed loose oil outside of secondary containment, see photo No. 5.

**Description:** This photo was taken looking west and shows loose oil outside of secondary containment.

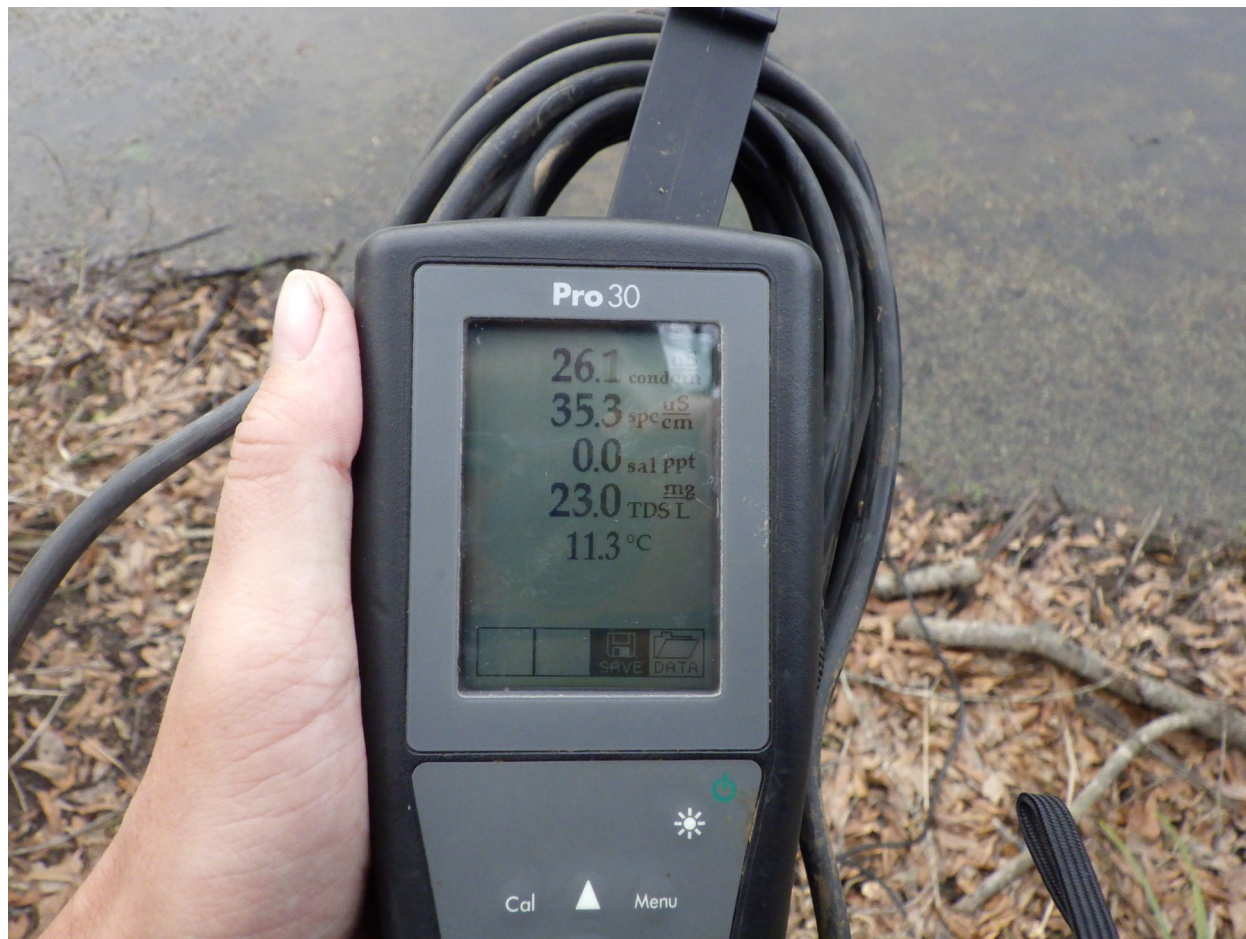
Photo No. 6

I observed an unnamed tributary north of the facility. I measured a Total Dissolved Solids (TDS) value of 23 mg/L for the unnamed tributary, see photo No. 6 through photo No. 8.

**Description:** This photo was taken showing a Total Dissolved Solids reading of 23 mg/L in the nonimpacted unnamed tributary north of the facility.

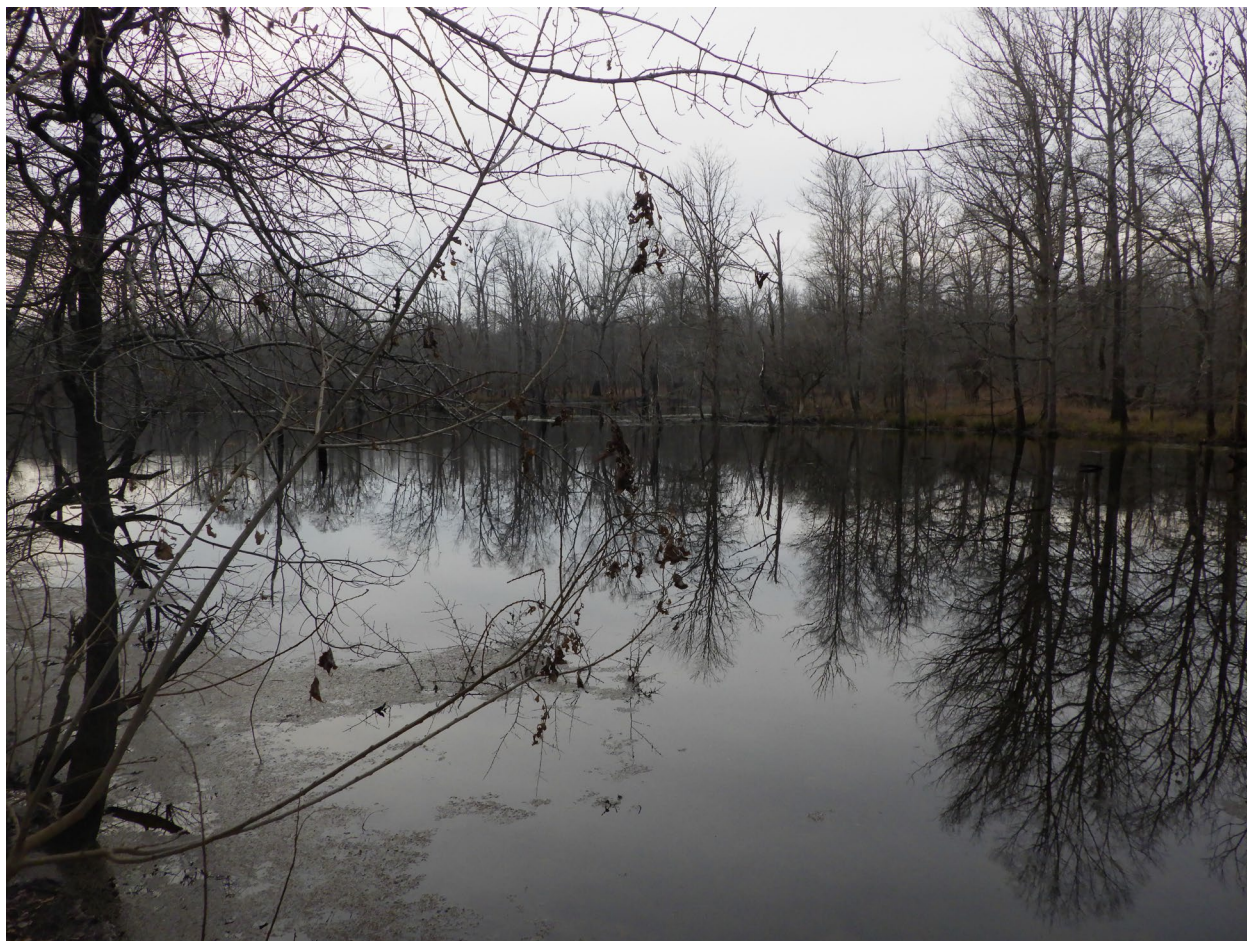
Photo No. 7

**Description:** This photo was taken looking NW showing the unnamed tributary north of the facility.

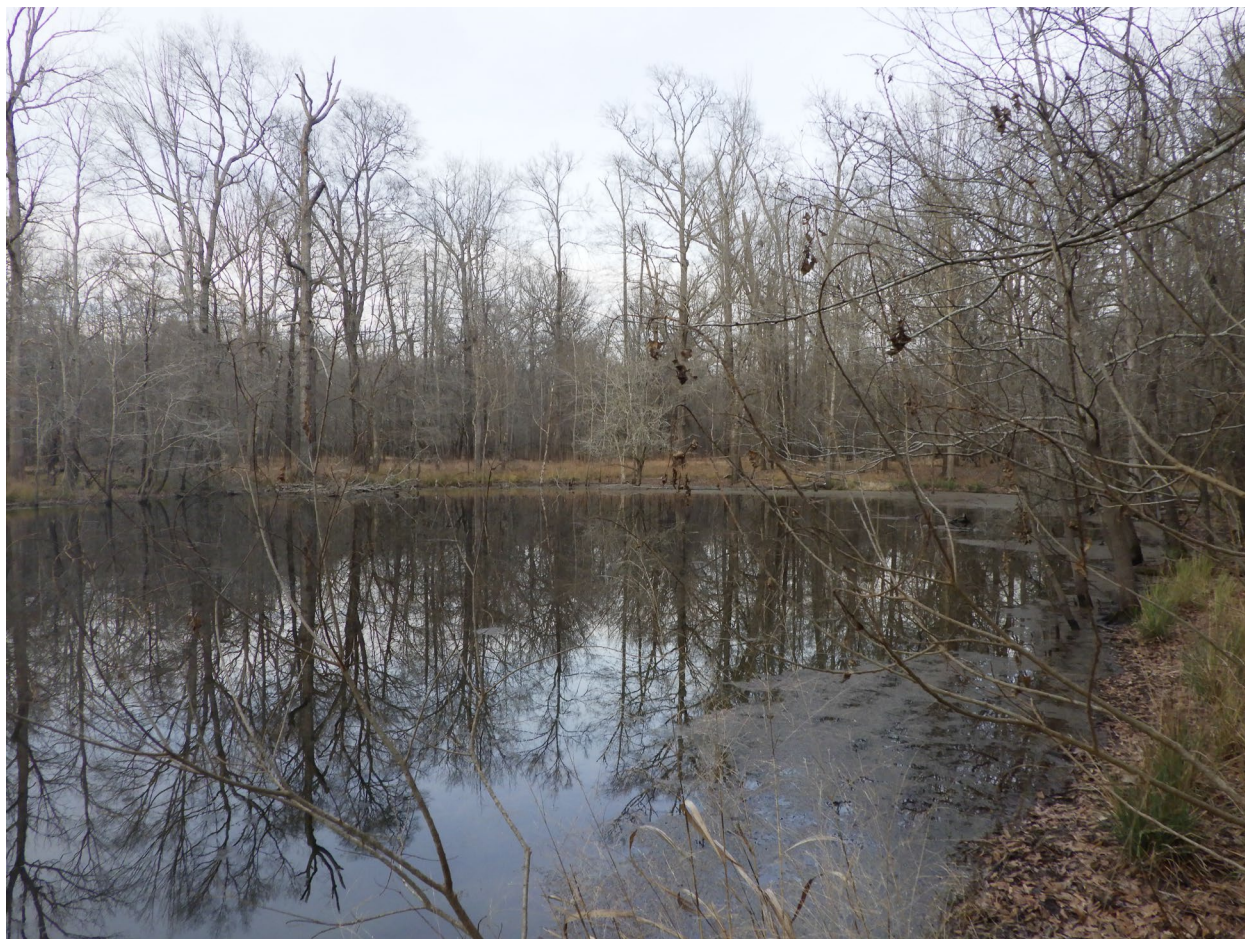
Photo No. 8

**Description:** This photo was taken looking NE showing the unnamed tributary north of the facility.

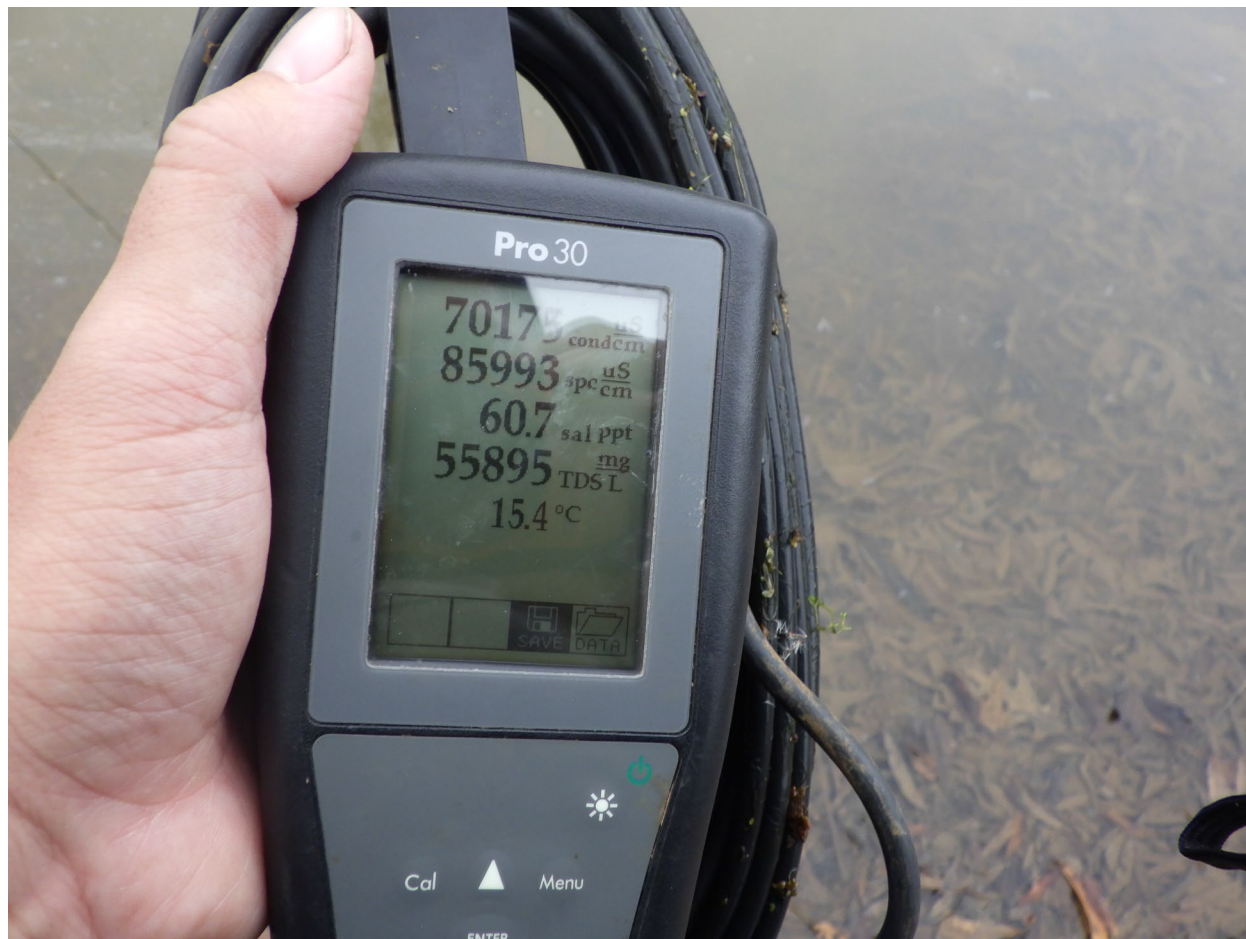
Photo No. 9

I observed a pool of water also north of the facility. I measured a TDS value of 55,895 mg/L for the pool of water, see photo No. 9 through photo No. 11.

**Description:** This photo was taken showing a Total Dissolved Solids reading of 55,895 mg/L in the impacted pool of water north of the facility.

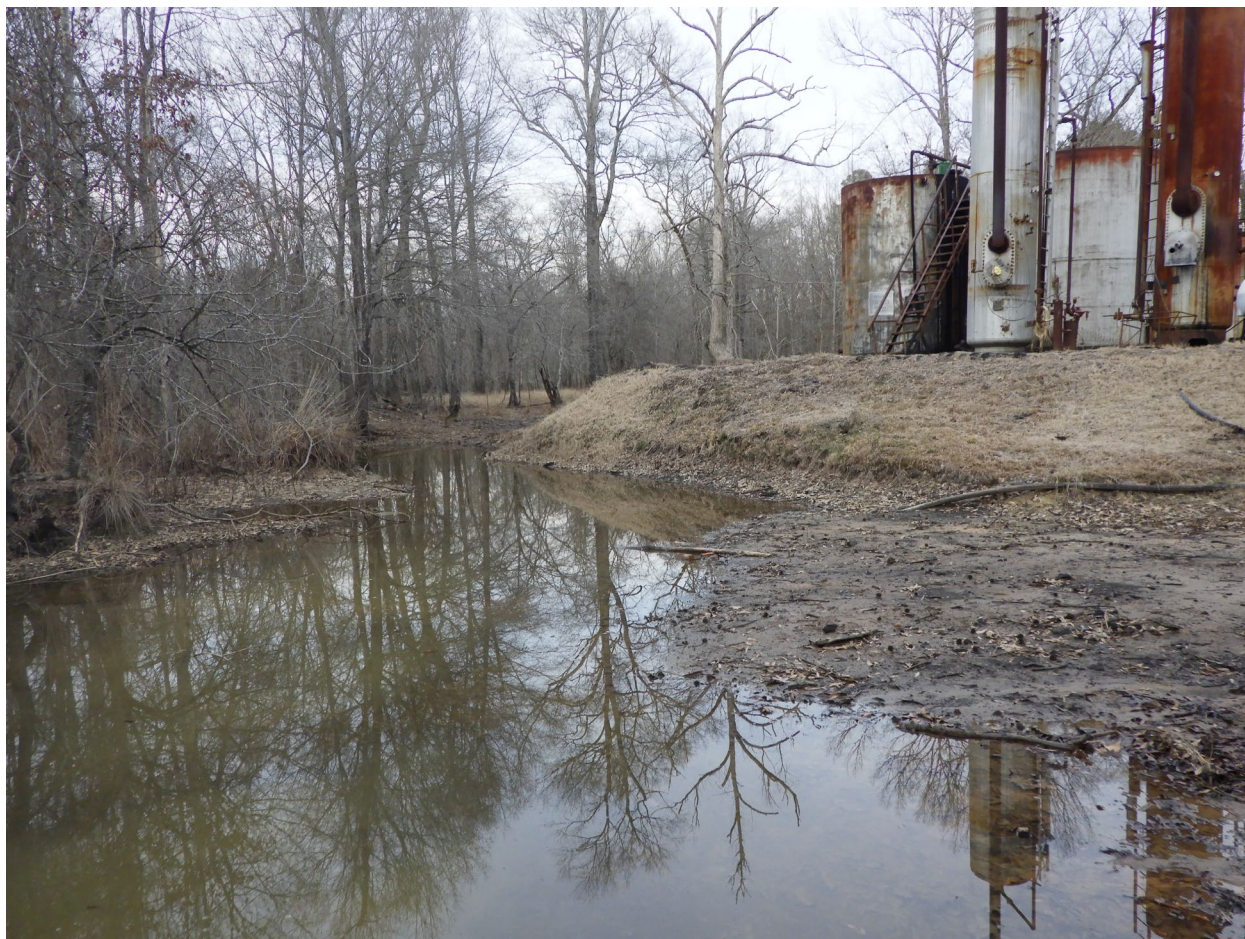
Photo No. 10

**Description:** This photo was taken looking east showing the pool of water north of the facility.

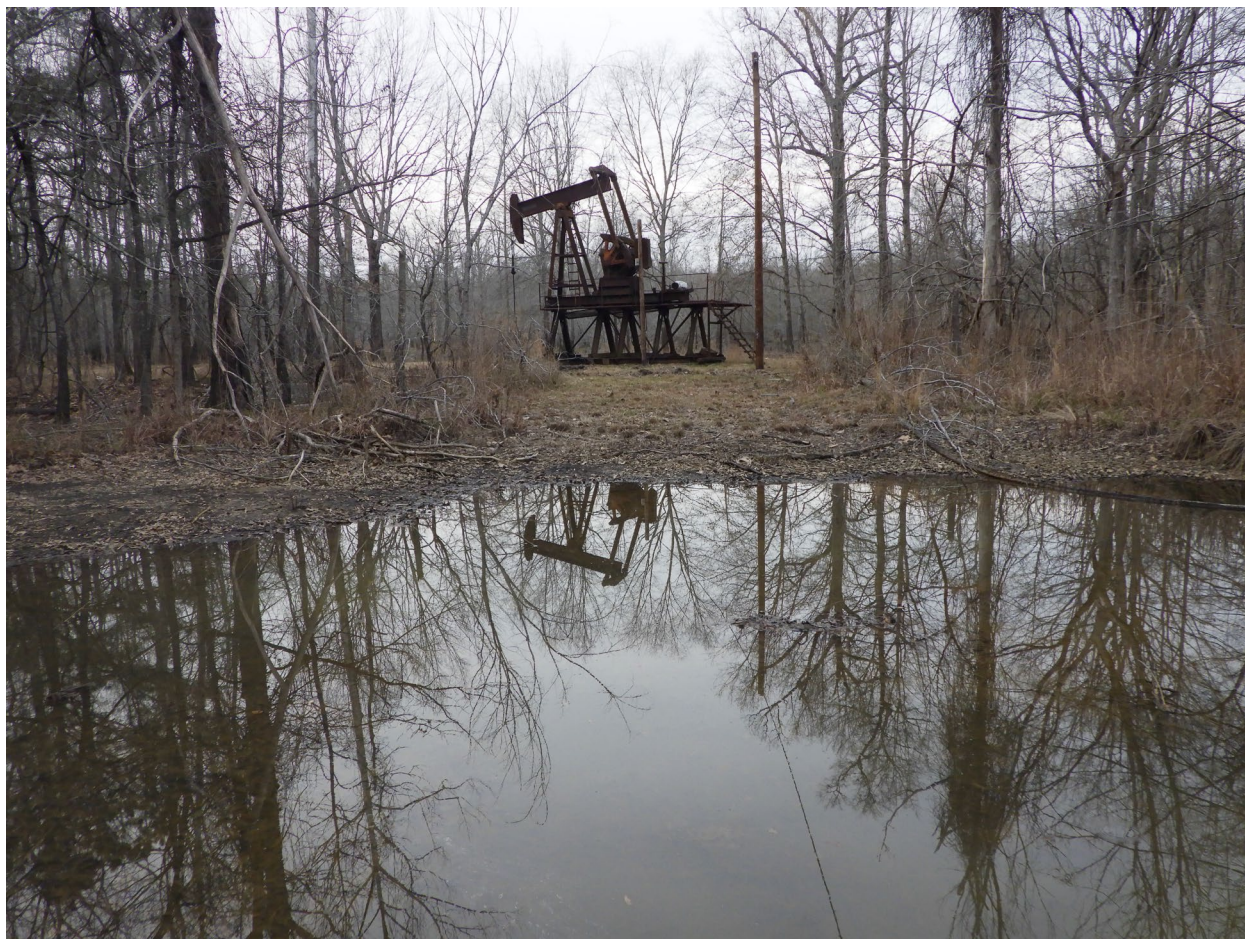
Photo No. 11

**Description:** This photo was taken looking northwest showing the pool of water north of the facility.

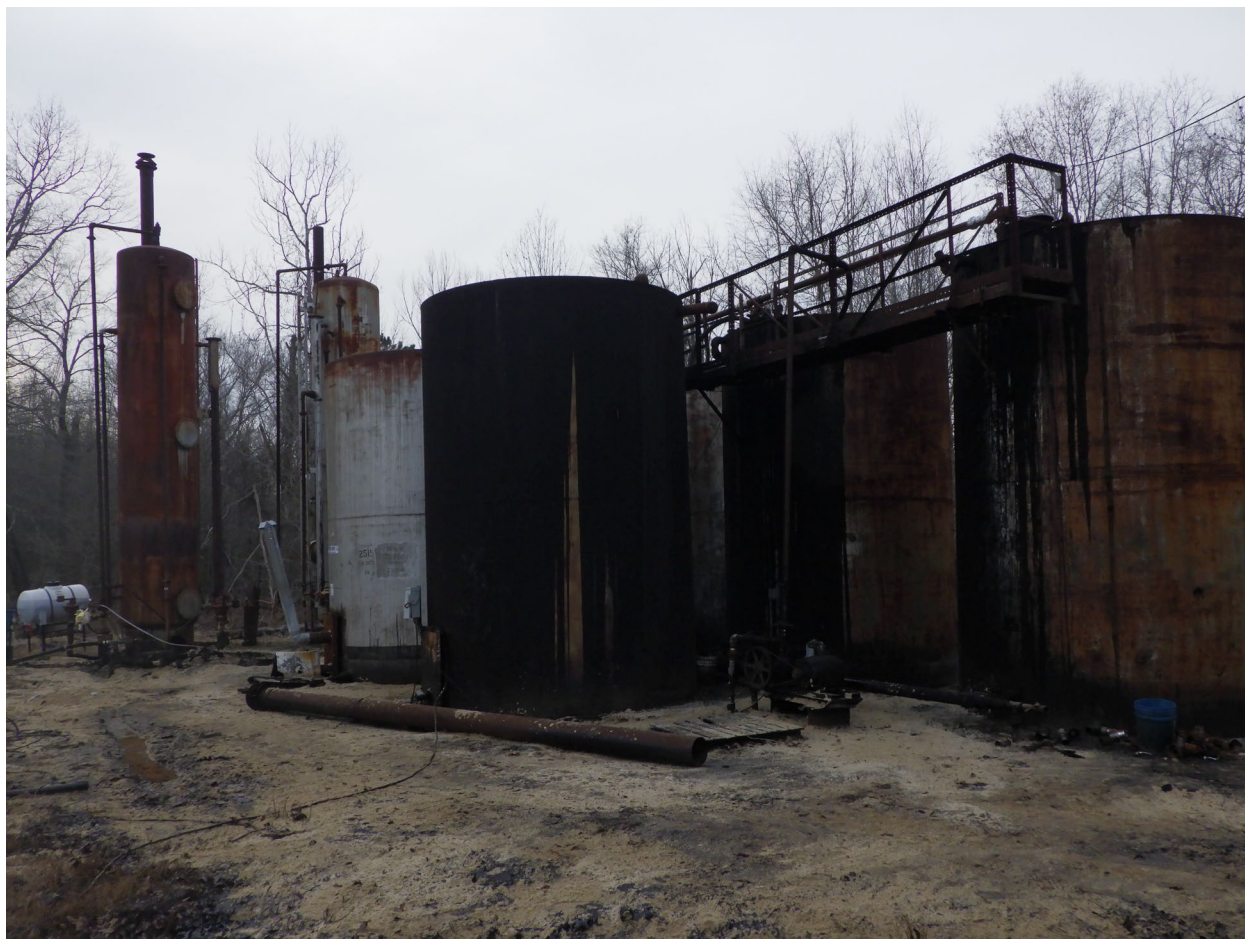
Photo No. 12

I observed fresh sand covering the loose crude oil inside secondary containment, see photo No. 12.

**Description:** This photo was taken looking west and shows loose oil inside secondary containment with sand added on top.

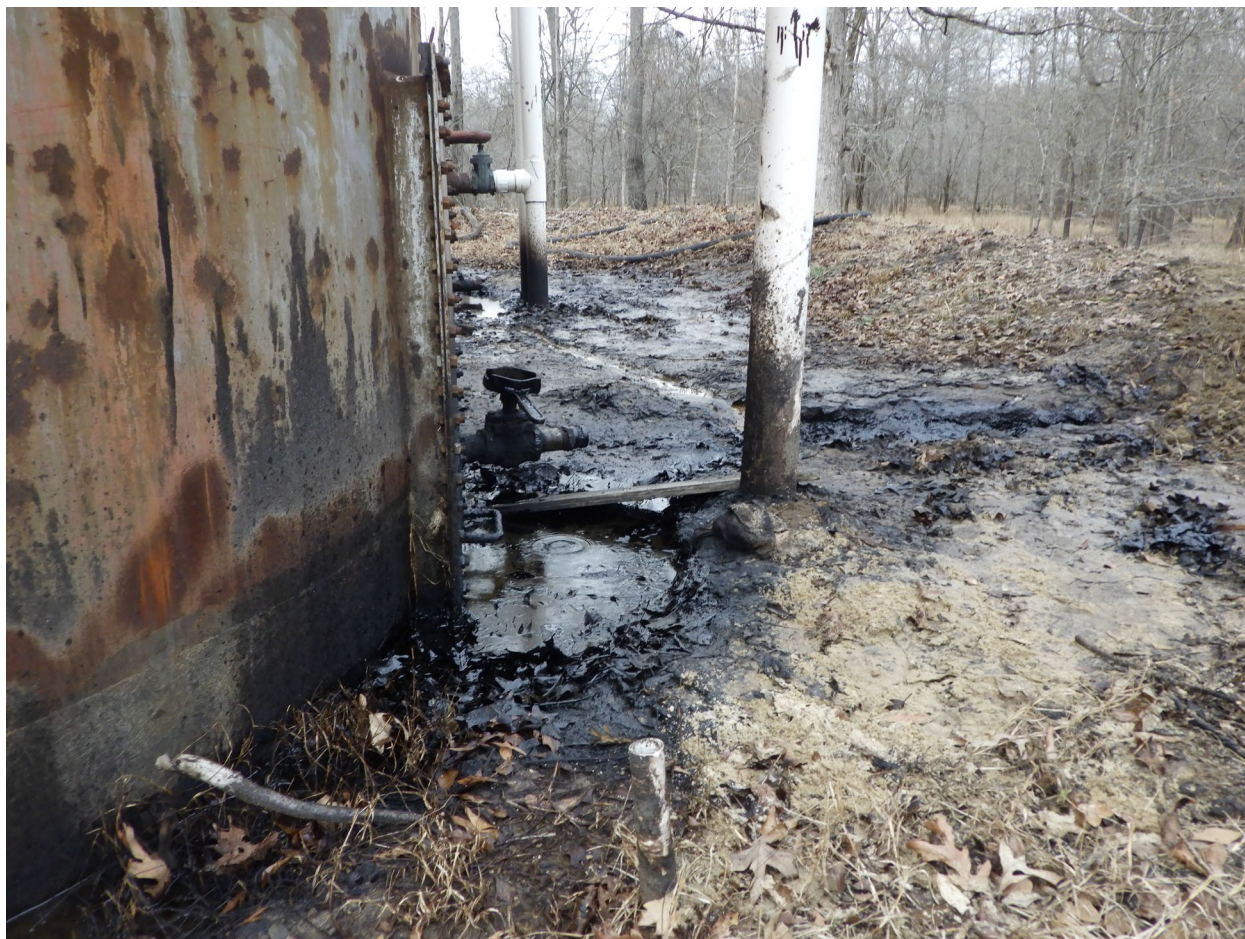
Photo No. 13

I observed a leaking tank valve near the cut in the secondary containment berm, see photo No. 13.

**Description:** This photo was taken looking north and shows an active leak from the tank valve as well as loose oil inside secondary containment.
